## **An Archaeological Watching Brief at 12 Duck End, Hinton-in-the Hedges, Northamptonshire, 2021**

## 12 Duck End, Hinton-in-the-Hedges

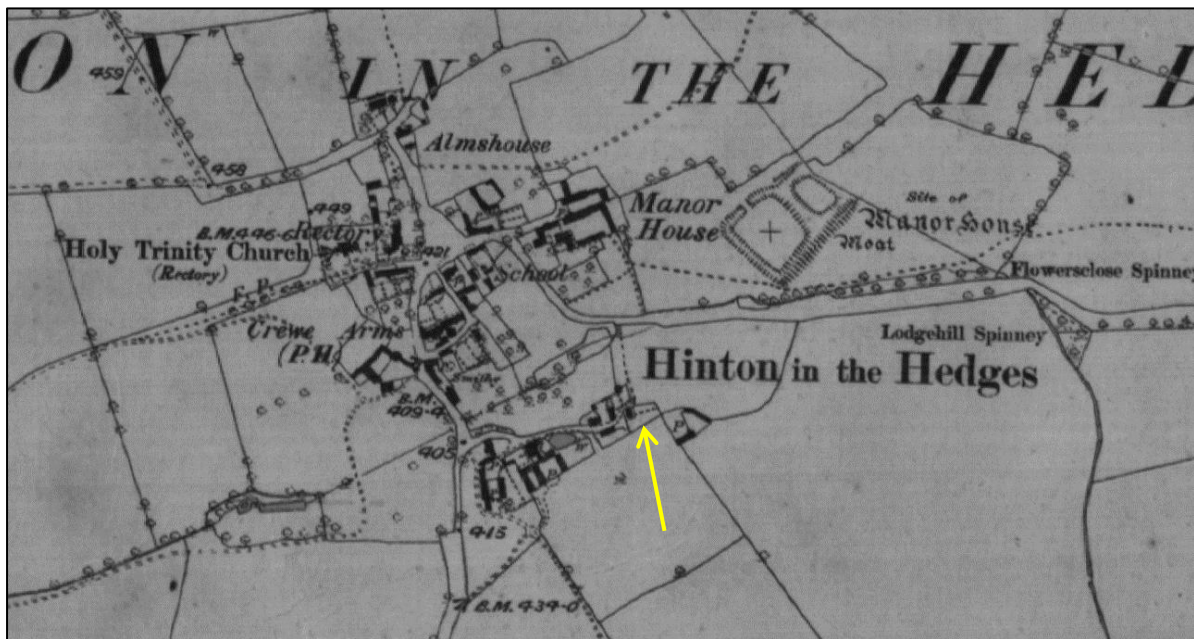
Fig 2: The village in the 1880s. The garden-plot site is arrowed. The agricultural buildings to the east no longer stand but the overgrown platform on which they stood is still there. OS 1884 6-inch map, sheet 63NW.

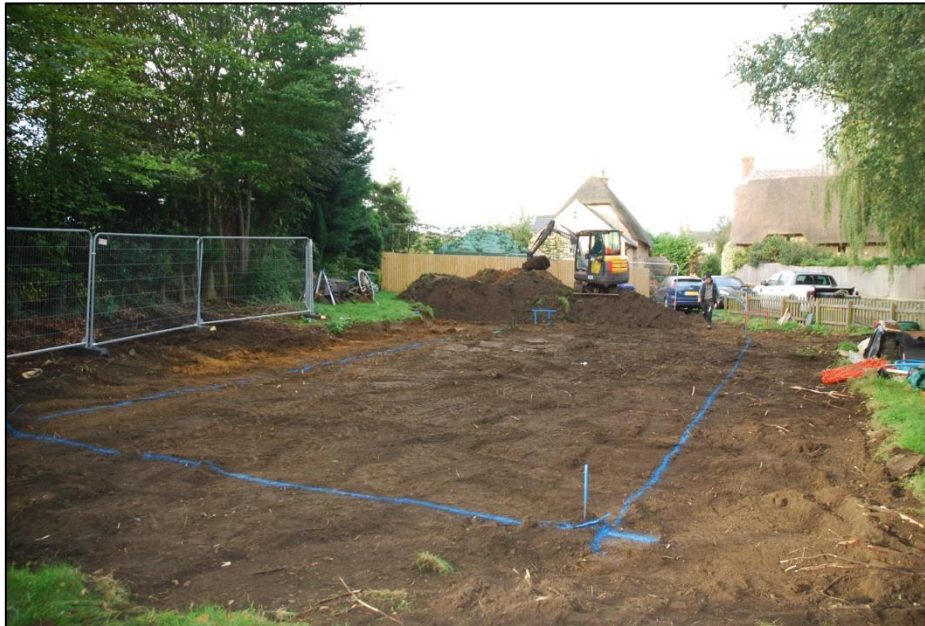
Fig 3: View across the site stripped of turf and most topsoil, looking west towards Rookery Cottage, 10 Duck End. The ring-foundation trench is marked out in blue and the tail of the terrace-bank is visible at left

The footprint of the new house was stripped, along with a border of about 2m around the outside, using a 3-ton tracked excavator with a wide toothless ditching bucket. This was to remove the turf and most of the topsoil growing medium, to a depth of about 200mm. This did not necessarily expose natural geology all over but did so noticeably along the tail of the hedged southern boundary 'bank' (at left in Fig 3, below). The resulting up-cast was temporarily stored on site before removal to tip.

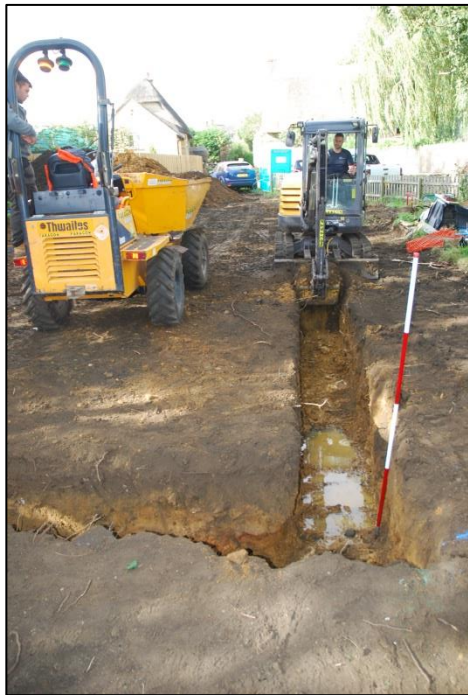
Fig 5: Machining the foundation trenches, looking west; scale 2m

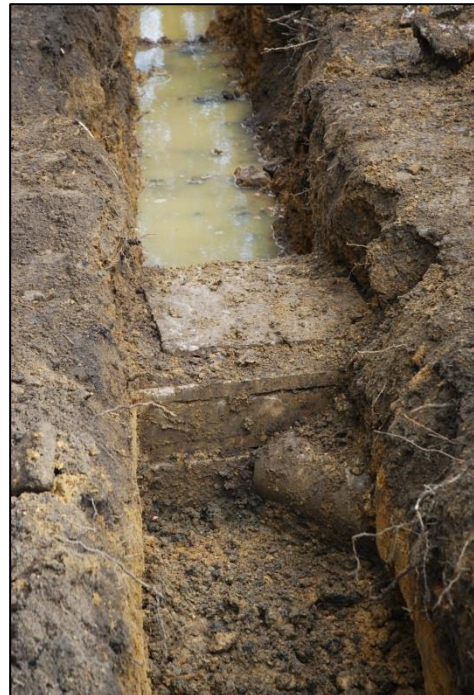
Fig 6: 8-inch ceramic collector drain and inspection chamber, looking east

At just past the mid-point of the northern foundation trench was a substantial pre-formed and lidded concrete inspection chamber, a hollow cube of some 1m dimensions (Figs 4, 6). This served a large 8-inch salt-glaze drain which angled in from the south-west. The downhill outlet was directly north, heading out of the site and behind the plots on the north side of Duck End and other village blocks to its north. The invert level of both the incoming drain and the inspection chamber lay at or below the level of the solid natural geology, cut through the drift above.
