**Archaeology and Conservation
in
Ironbridge**

**CBA Research Report 123
Council for British Archaeology
1999**

1 Introduction: Archaeology and the Severn Gorge Repairs Project

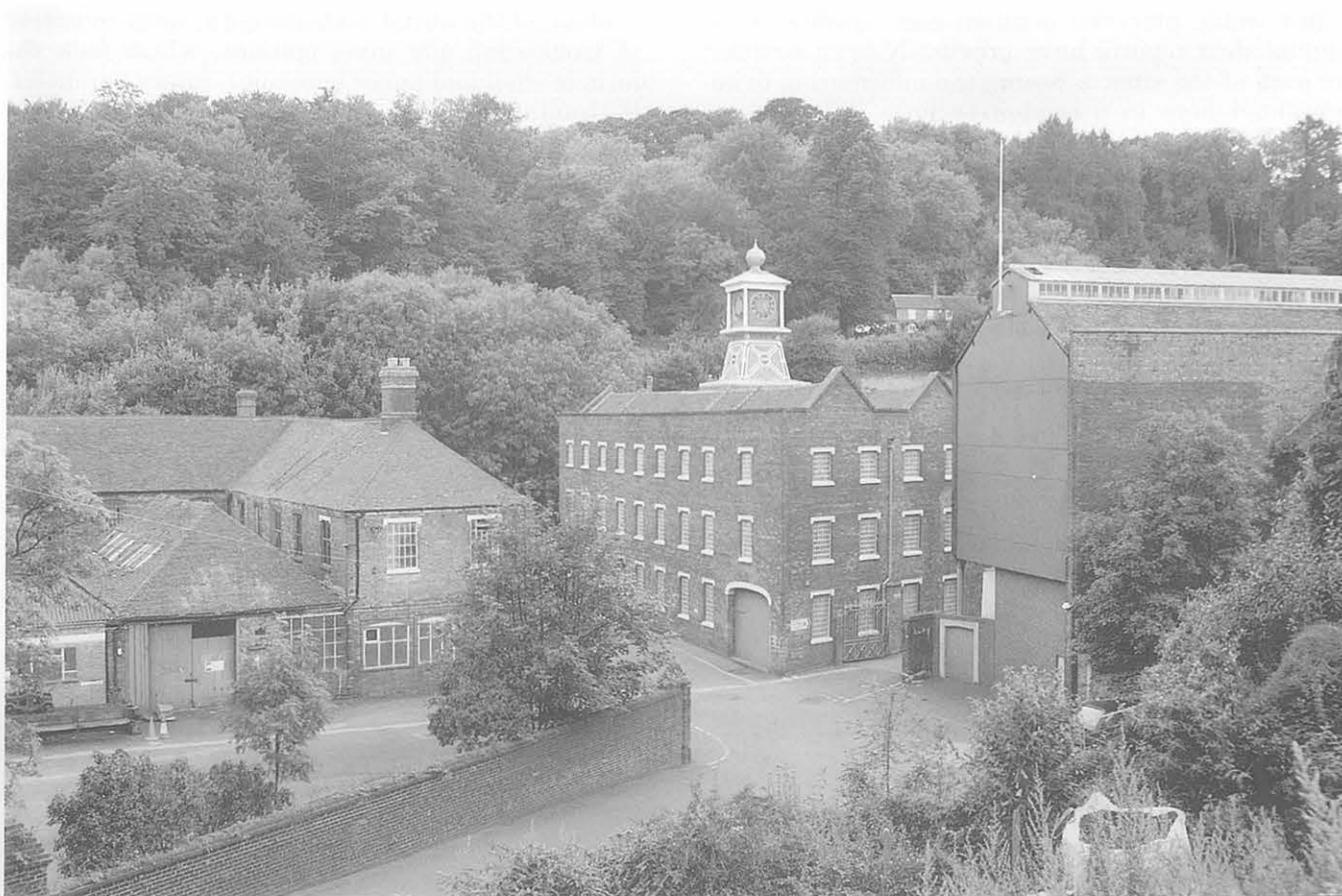
Figure 2 The Museum of Iron is housed in a warehouse built in 1838, standing at the south end of the Coalbrookdale Upper Works. After repairs the museum was refurbished and reopened in 1995.

were underlying structural problems and generally involved the removal of unsympathetic modern building materials. In some cases, notably the Museum of Iron in Coalbrookdale, it was necessary to remove the contents of the building before the repair work could proceed (Fig 2). This was taken as an ideal opportunity to redesign the museum and its exhibits. The new Museum of Iron was opened in 1995.

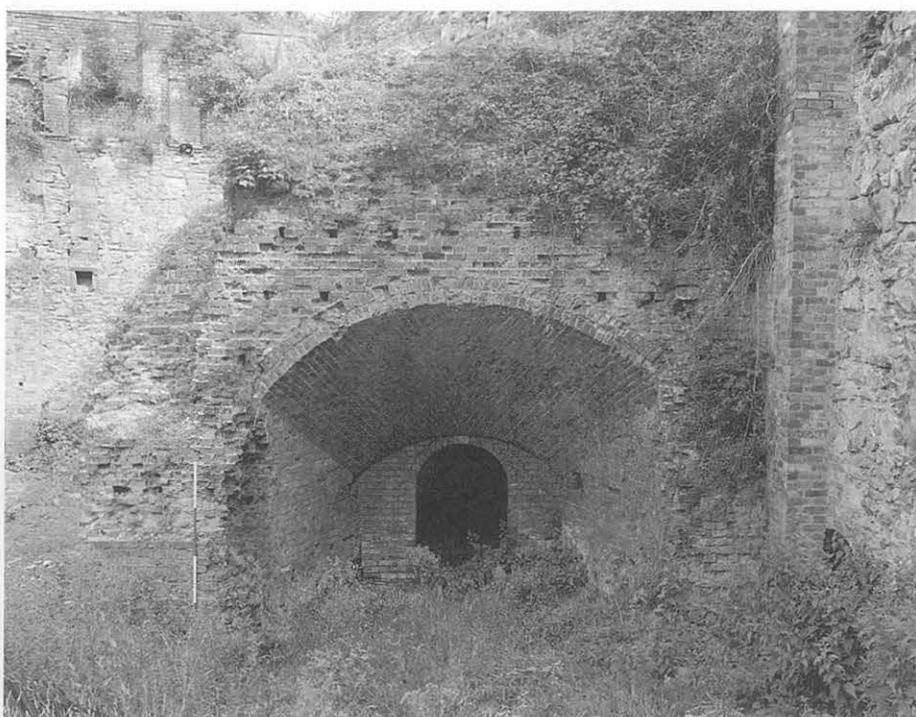
Figure 3 The snapper furnace at the Upper Works, photographed in 1991 and looking north, showing one of the arched openings at the base of the furnace. Although it had previously undergone minor repairs it was treated as virgin archaeological territory.

Works was limited but interesting, and consisted of two boreholes through the charging platform and an auger hole in the snapper furnace (Fig 3). It was thought that the charging platform might be a solid rubble structure, but this proved not to be the case, as confirmed during the later stages of the project, when vaulted chambers were found beneath the charging level (see below, Chapter 2).

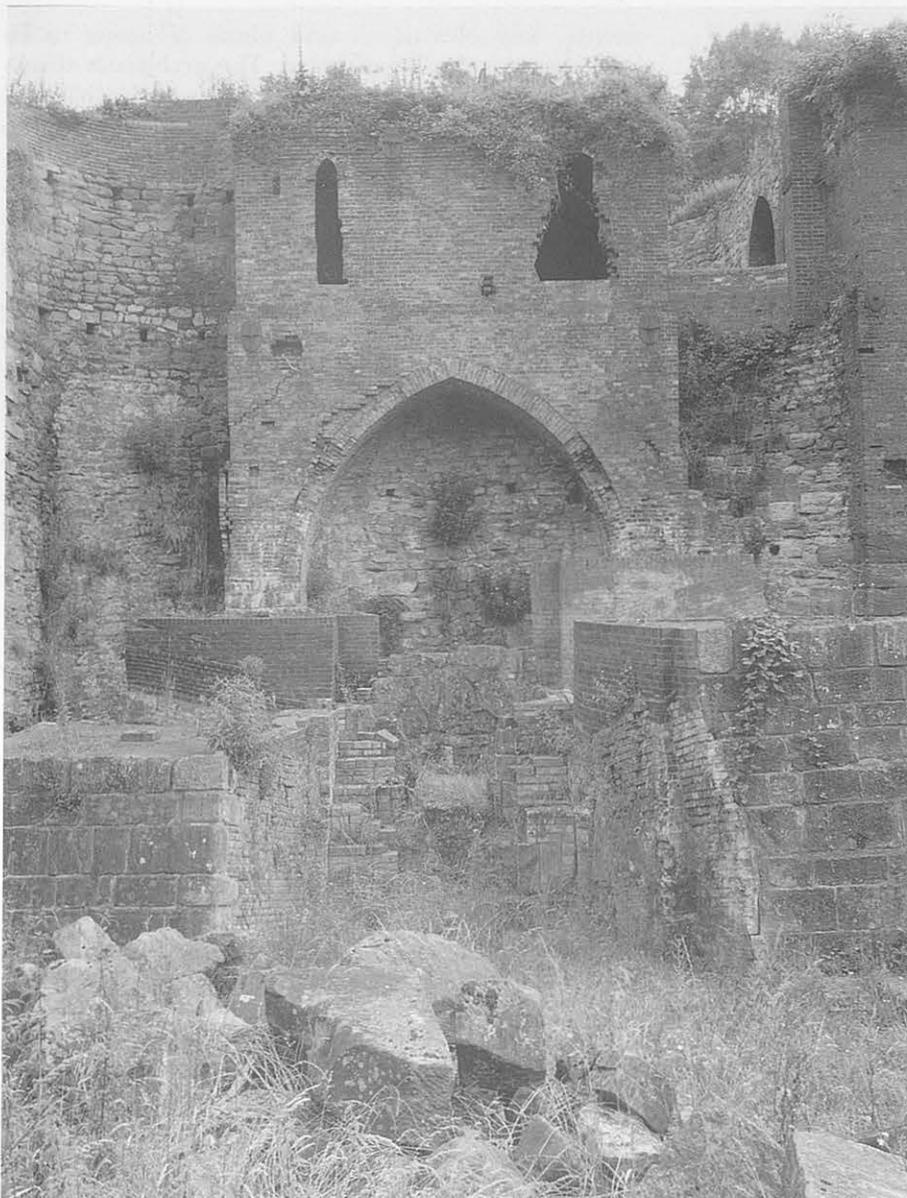
Figure 4 Furnace I and the north charging house at Blists Hill, photographed in 1991. Full recording of the charging house was not undertaken until scaffolding was erected. The stone rubble in the foreground was excavated in 1973 with the furnaces and probably formed part of the furnace bases. The bases were substantially repaired with brick following their excavation.

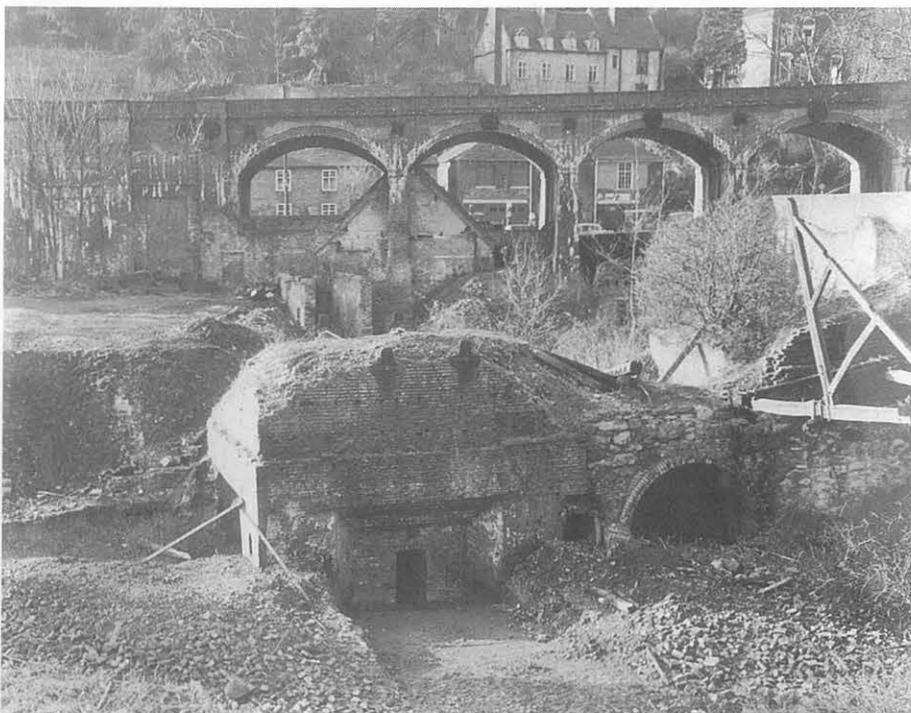
Figure 6 The Upper Works in the early 1950s, viewed from the east side, showing the upper furnace in the centre and the former turning mill in the background beneath the viaduct. The spoil around the site was cleared in 1959. The gabled truss on the right of the picture was taken down during the clearance works but was not reinstated. (Ironbridge Gorge Museum Trust)

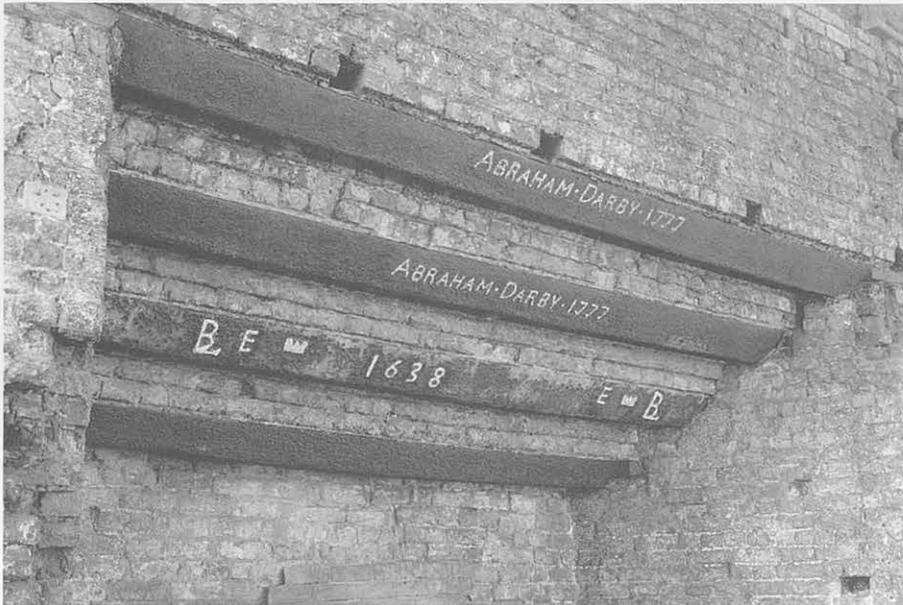
Figure 23 Lintels above the forehearth of the upper furnace. The date 1638 was introduced in the 1950s when the legends were renewed in white paint.

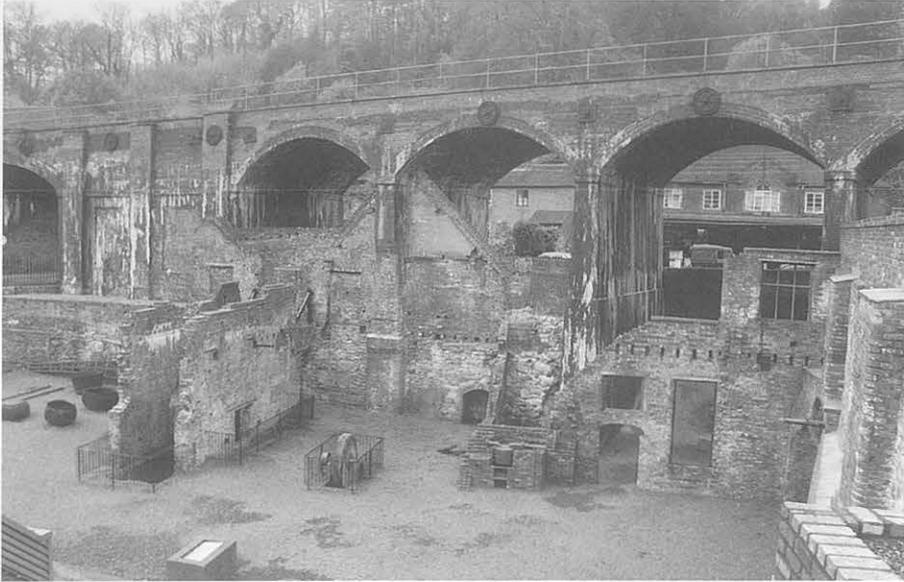
Figure 32 The turning mill and viaduct, photographed from the west side in 1991 prior to the commencement of repairs. The two free-standing walls to the left enclose the turning mill wheelpit. The structure on the right is part of the fitting shop built against the dam wall between 1838 and 1847.

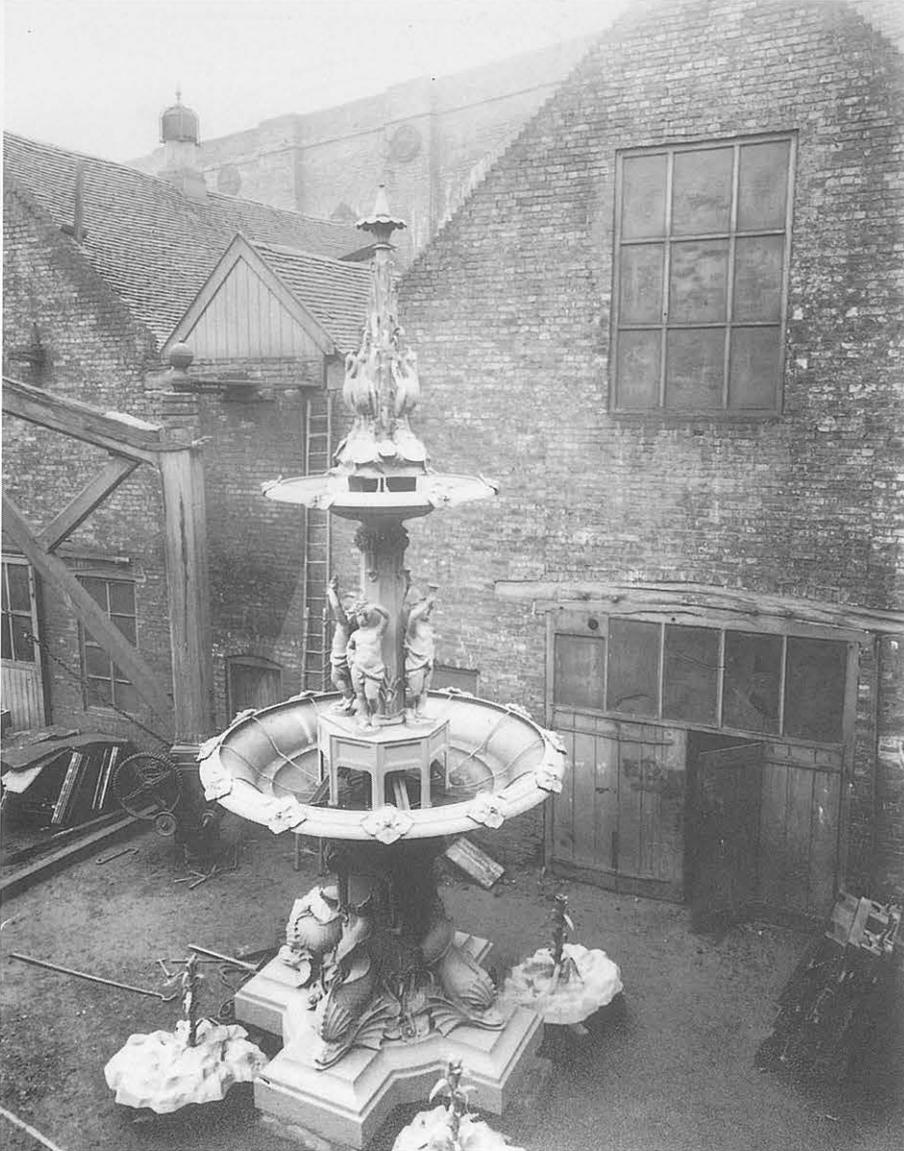
Figure 35 A cast-iron fountain in the yard at the Upper Works, with the turning mill in the background, photographed in the late-19th century. It shows the pitched roof added to the wheelpit, the tall attic storey of the north wing and its crow-stepped gable. (Ironbridge Gorge Museum Trust)

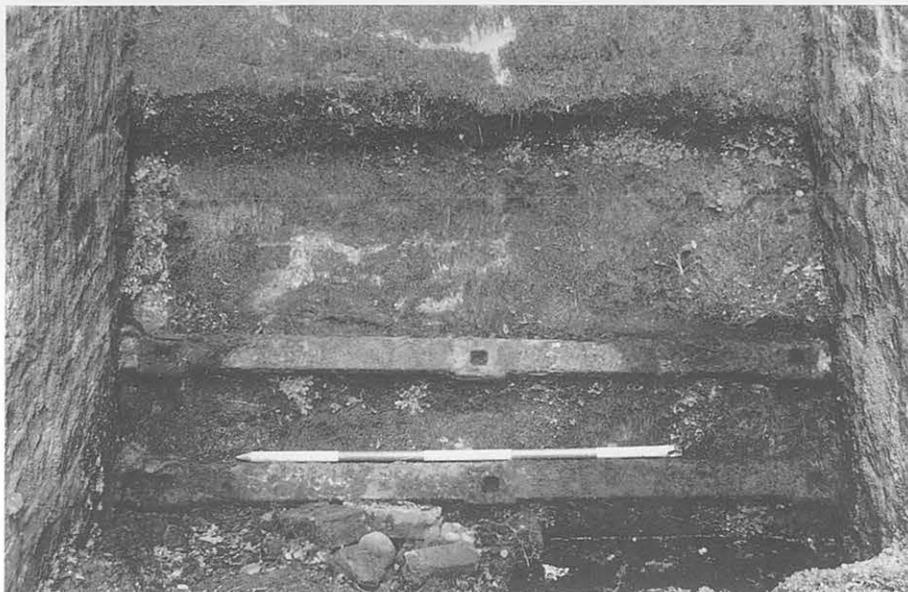
Figure 36 Two cast-iron rails embedded in the west wall of the turning mill wheelpit, of a type first cast at Horsehay in 1767.

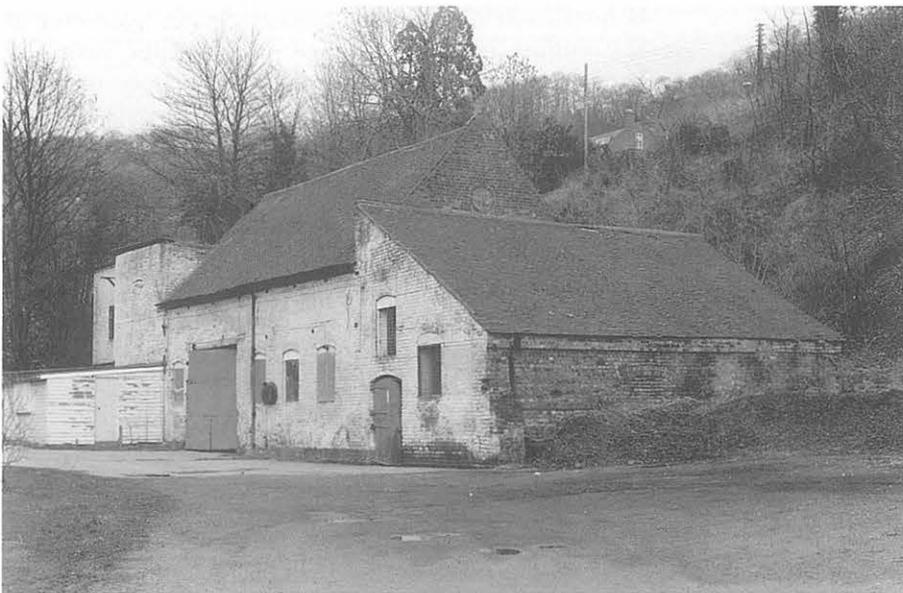
Figure 43 The Upper Forge looking north east in 1985, after the upper storey of the engine house had been taken down and with a lean-to added to the front. Most of the openings associated with its use as a stable have survived. (Ironbridge Gorge Museum Trust)

Inside, a loft was inserted in the central range for storing hay and straw, and two corresponding openings were cut into the south wall (Fig 47A). A new brick floor was laid above the earlier forge floor, with a tiled floor beneath the loft, perhaps indicating a harness room. Evidence for the use of the building as a stables was provided by a central gully in the brick floor of the south wing. The mill continued in use until at least the 1920s, but by the 1950s was in a poor condition (Fig 46). It was subsequently used for a variety of less than glamorous purposes – principally vehicle storage and offices – and in the 1970s the upper storey of the former mill was taken down (Fig 43).

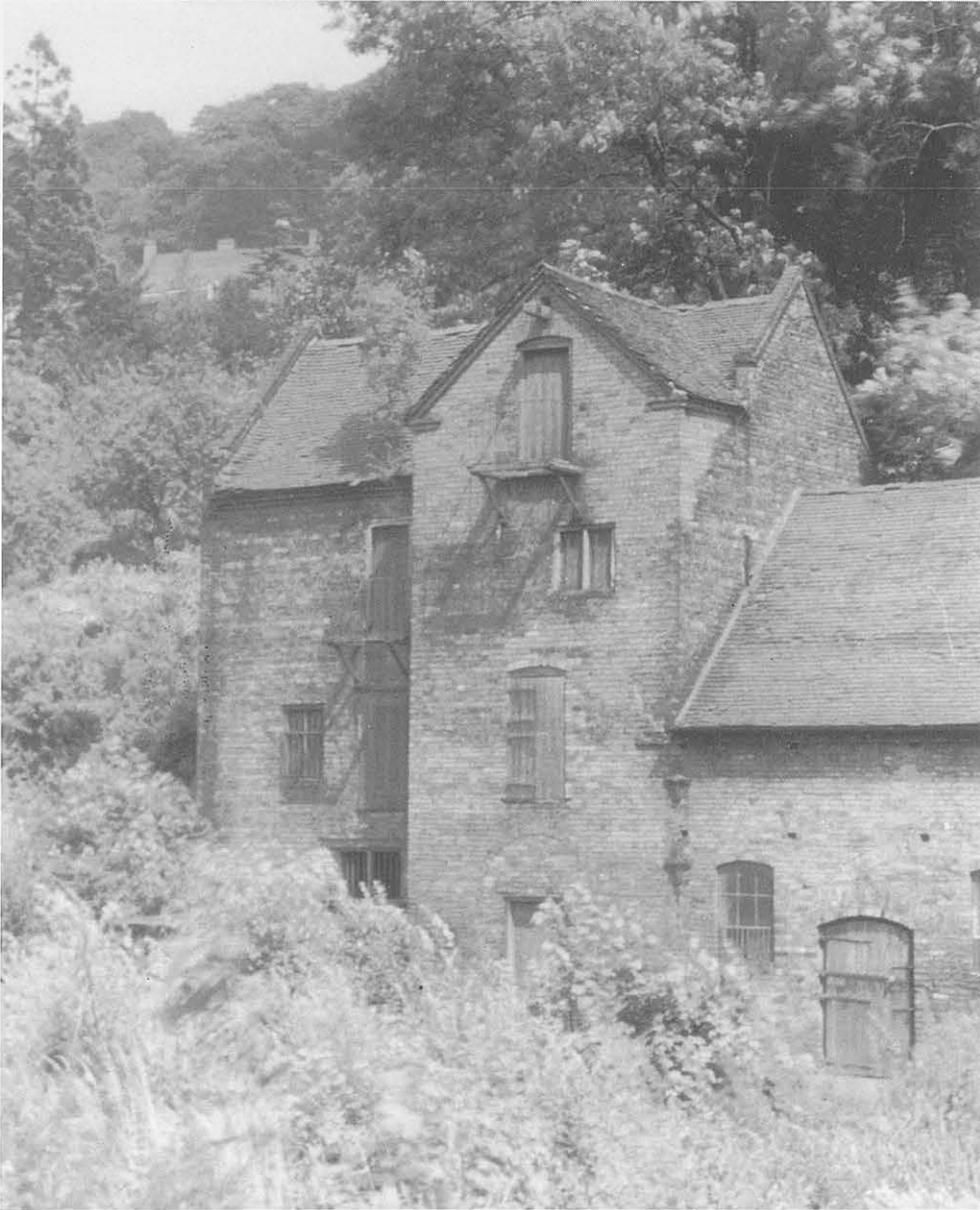
Figure 46 The former mill and stables photographed in the 1950s looking east. The mill occupies the former engine house, in which the upper gabled bay with hoist and door is clearly added as there is a change in the shade of the brickwork. To the right, above the stable door of the central range, are fragments of two former arches belonging to the first two phases of the building. (Ironbridge Gorge Museum Trust)

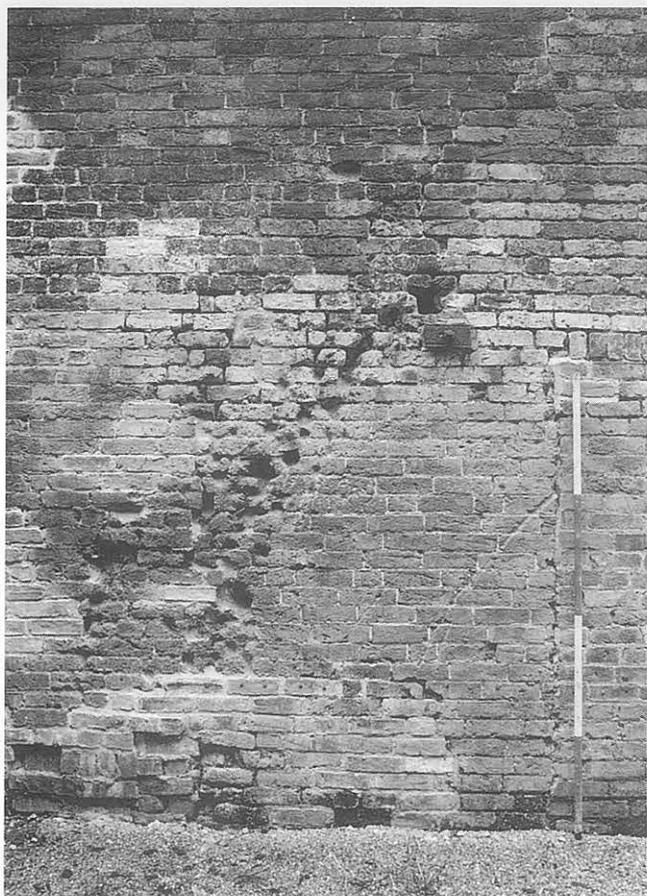
Figure 48 Waterwheel score marks on the central range east wall.

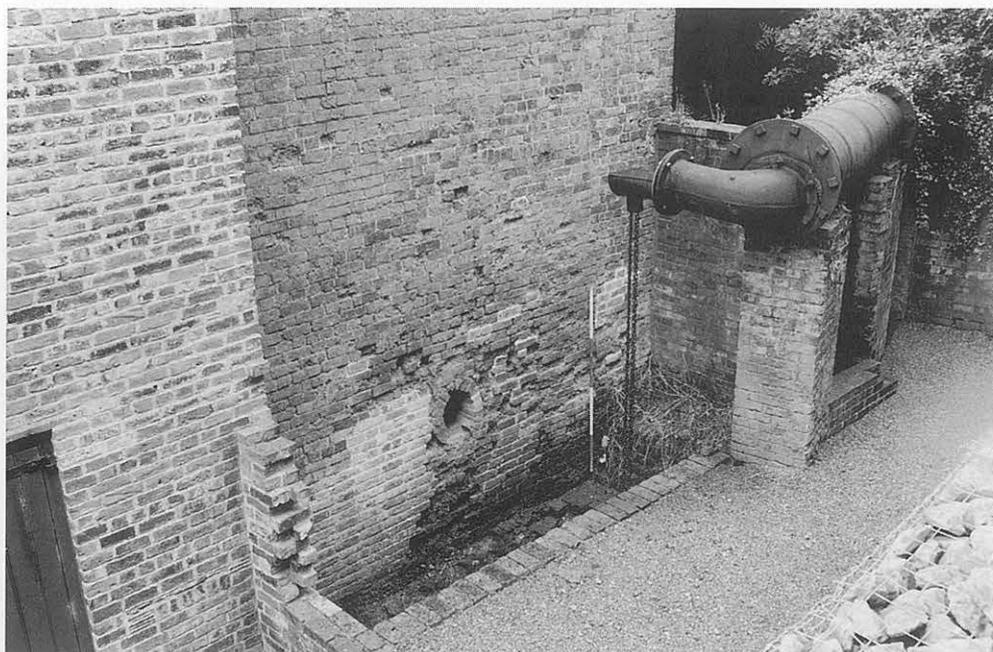
Figure 54 Wheelpit 2 and cast-iron pipe, photographed looking north west in 1998 after the completion of repairs. The opening for the waterwheel's axle is clearly visible. The direction of the pipe suggests it originally supplied the wheel in wheelpit 1. The brick piers supporting it are built above the former boiler base.

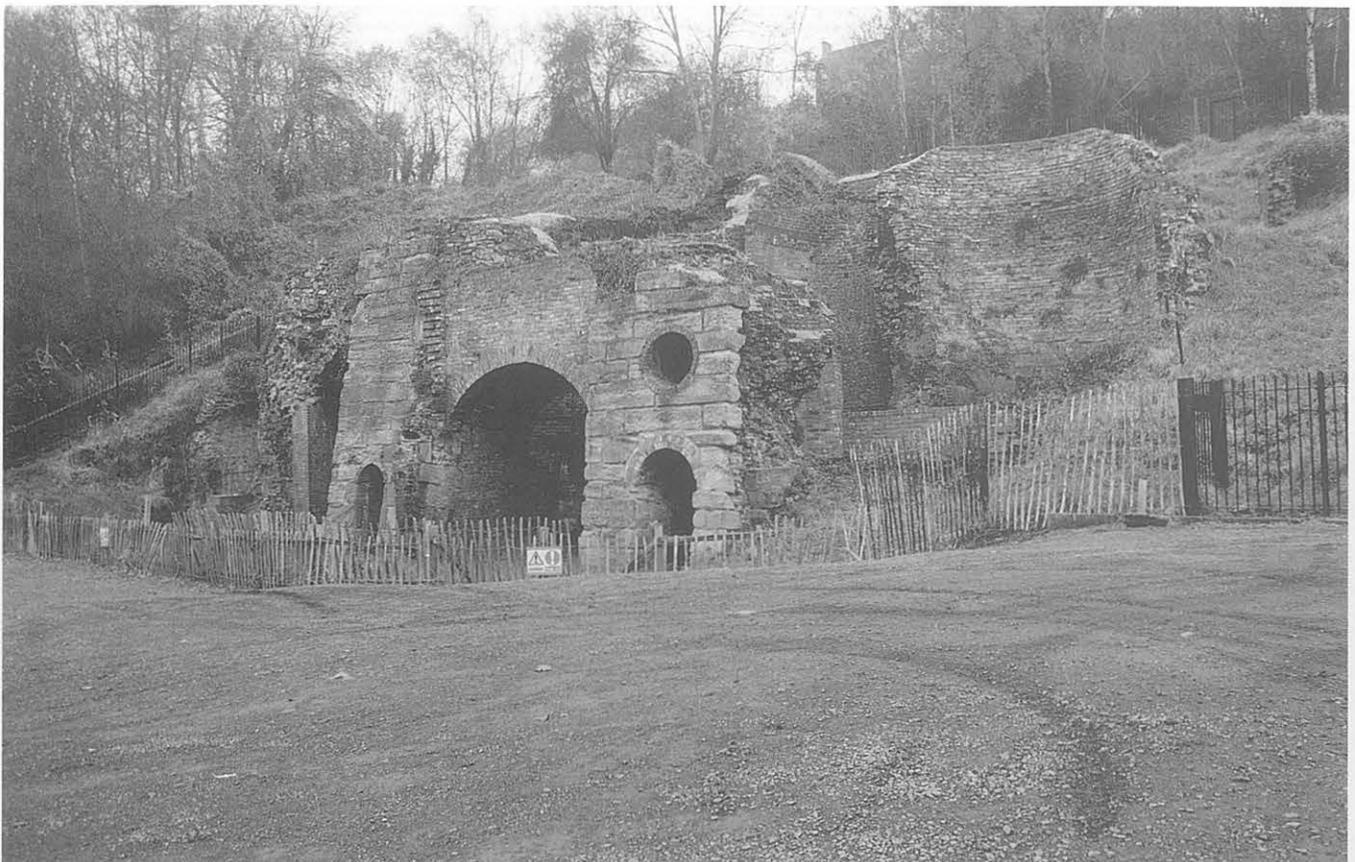
Figure 57 Bedlam furnaces photographed looking north from Waterloo Street in 1993, before repairs, showing the brick stack of furnace II on the right and the masonry encased furnace I on the left.

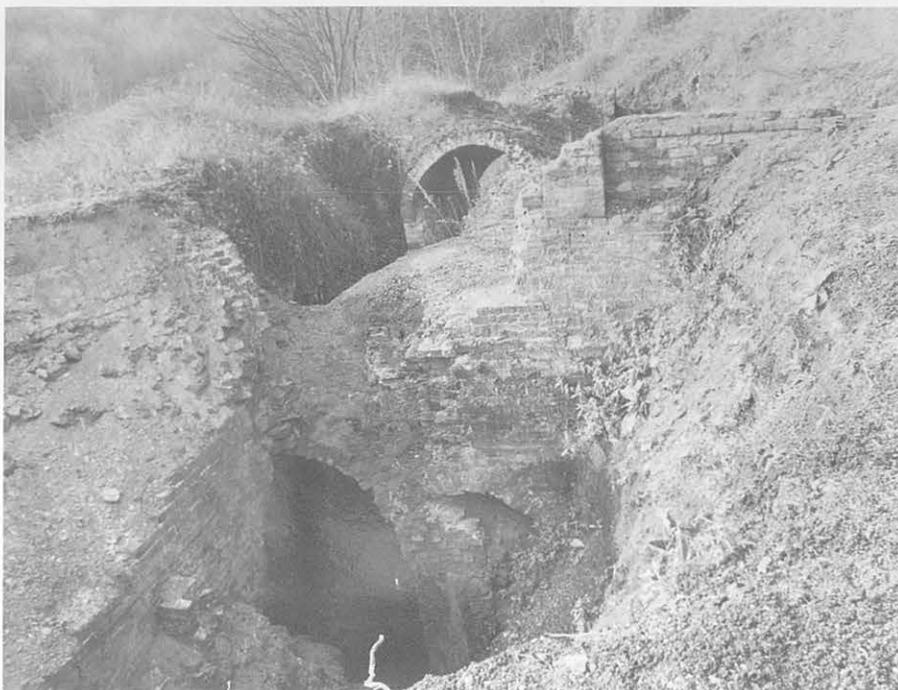
Figure 58 A void in the charging platform photographed looking west c 1972 before the site was restored. The north side of furnace I is to the left, with the west wall of the charging houses in the centre. The arched opening indicates the existence of a passage at the back of the furnace and into the wheel chamber. The roofless wheel chamber is in the background with only part of its vault surviving.

Until 1971, when excavation began, the lower level of the site was partially buried by spoil and debris, and the structures were obscured by vegetation (Fig 58). Major repairs were undertaken in the period 1974–5 and between 1975 and 1979, to the extent that nearly half of the visible structure is modern (Fig 59). The excavations, undertaken by volunteers primarily to expose features for consolidation and display, were not conducted for archaeo-

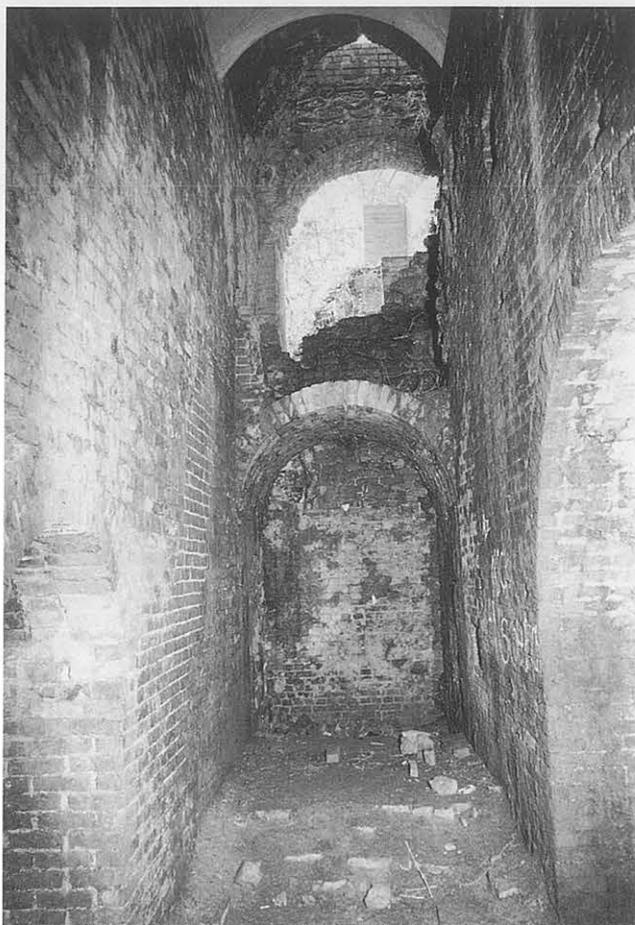
Figure 59 The wheel chamber photographed in 1993 before repairs were undertaken, looking west towards the engine pit. On the right is an opening where the waterwheel's bearing was fixed, while on the left is an opening to the bellows room. Above the lower of the arches in the background was a small reservoir feeding the water launders. The wheelpit is in the foreground, hidden beneath a later brick floor.

The wheel chamber is a tall narrow structure with a modern concrete barrel vault (Figs 59 and 74). Most of the south wall, the dividing wall between the wheel chamber and bellows room, is also modern. The chamber is wider at high level at the west end, next to the engine pit, while at the east end, behind furnace I, is the scar of a former return wall. In the north wheel chamber wall is a large vaulted recess above the wheelpit (Fig 69). Embedded into the floor of the recess are two timber baulks.

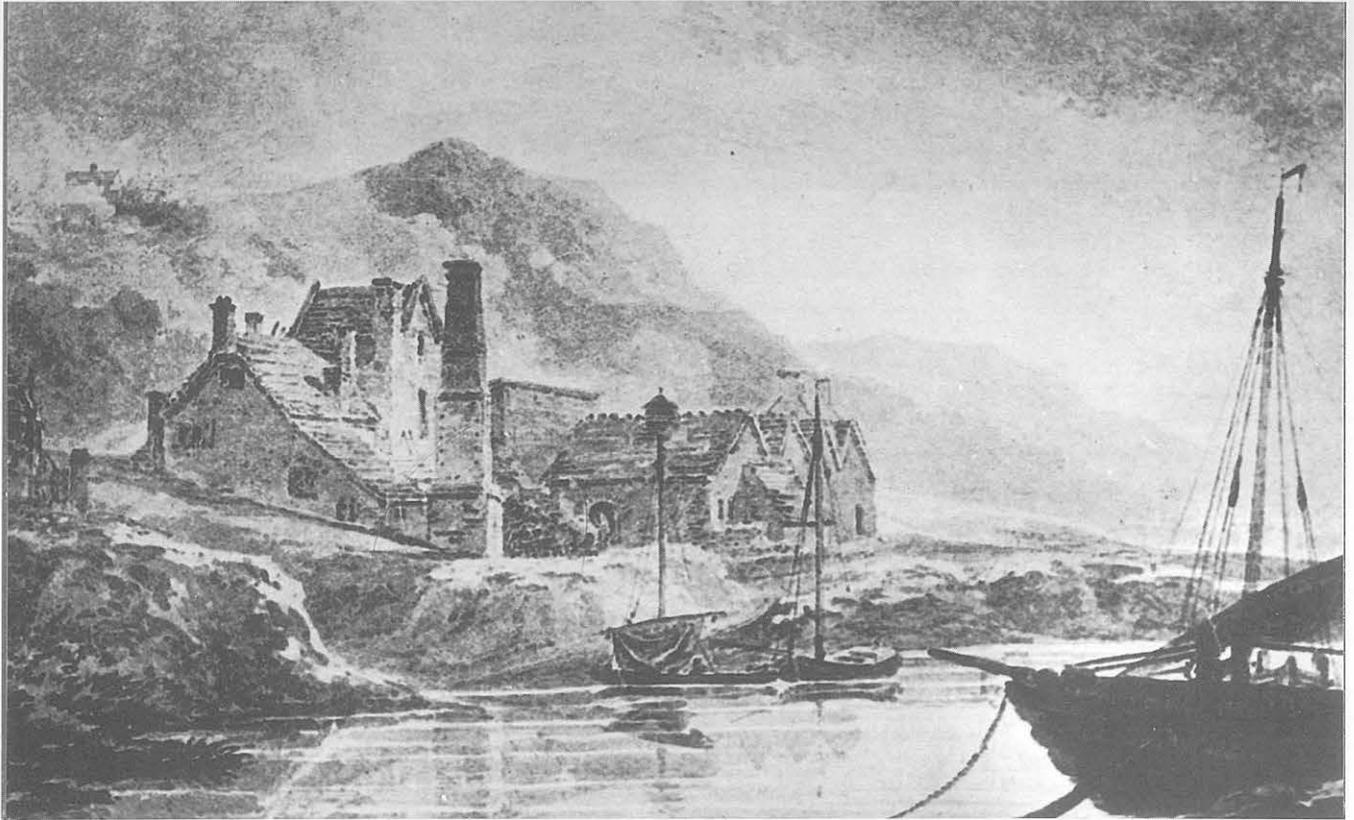
Figure 61 Wash drawing of Bedlam furnaces attributed to Edward Dayes. Undated but probably before 1789. The viewpoint is from the south west: on the left is the smithy with the taller engine house adjacent. The furnaces are to the right of the tall boiler stack; the four-span roof in front indicates the casting and moulding rooms, with the gable of the office at right angles beyond it. (Tate Gallery)

The appearance of Bedlam in the later-18th century can be judged from a wash drawing by Edward Dayes (1763–1804), one of a number of works by the artist purchased by J M W Turner in 1833 (Fig 61). It is not dated but it was probably drawn before 1789 because it does not show the coke ovens discussed below and is in general agreement with Perry's plan (Fig 60). Viewed from the south-west, Perry's smith's shop and loam house are on the left of the picture, with the engine house next to it. The engine house has a chimney in its gable end. Perry shows this stack as one of a pair built in the angles of the engine house, but this is obscured in the Dayes drawing by the large chimney adjacent to the loam house. At the back of the engine house the engine

beam can be seen projecting from the building, indicating that the engine pit was not a roofed structure. Adjacent to the engine house is the furnace structure, presumably housing both furnaces in a stone outer casing. The building at the front has a ridge and furrow roof line with four gables, which are the casting room and moulding room on the Perry plan. Beyond the moulding room another gable is visible, at right angles to the roof lines of the moulding and casting rooms. This is the office shown by Perry. The drawing is equally interesting for what it does not show: no second engine house is visible, and nor are there any signs of a warehouse or the coal tar buildings mentioned in the earlier lists of buildings at Madeley Wood.

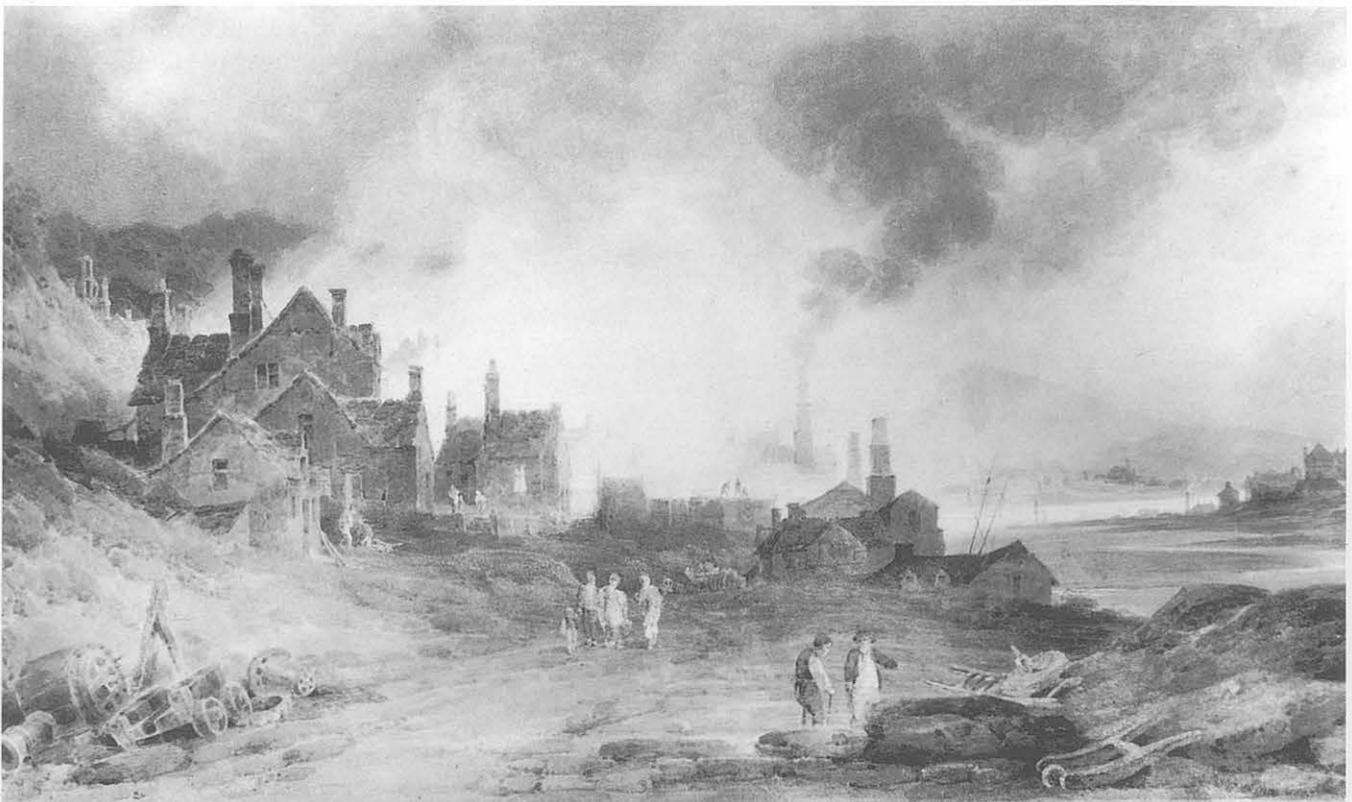
Figure 63 'Bedlam Furnace, Madeley Dale, Shropshire' by Paul Sandby Munn, 1803. Bedlam Hall is on the left. The ironworks is in the middle distance, denoted by the two stacks, with the taller stack of the coke ovens behind. No charging houses are shown, contradicting the archaeological evidence. (Ironbridge Gorge Museum Trust)

Of the pictorial evidence for Bedlam in the early-19th century, it is only necessary to discuss the painting by Paul Sandby Munn for the purposes of the archaeological interpretation (Fig 63). The other images will be considered later in discussions of contemporary portrayals of industrial scenes and the relationship between pictorial evidence and archaeological interpretation (see Chapters 10 and 11). Munn's painting was made in 1802 and views

the site from the west side. On the left of the picture is Bedlam Hall, in the right foreground the cottages shown on the lease plan let to Richard Langley. Behind the cottages are the two stacks of the engine house and in the background is a tall stack associated with the Dundonald coke ovens. To this extent it agrees tolerably well with the lease plan, but it will be argued later that asking more of a work such as this is stretching the evidence too far. What both the lease plan and Munn suggest is that the original works of the 1750s survived largely unaltered to the early-19th century, whereas previous archaeological interpretations have argued for substantial changes by this time (Smith 1979b; Higgins 1988a).

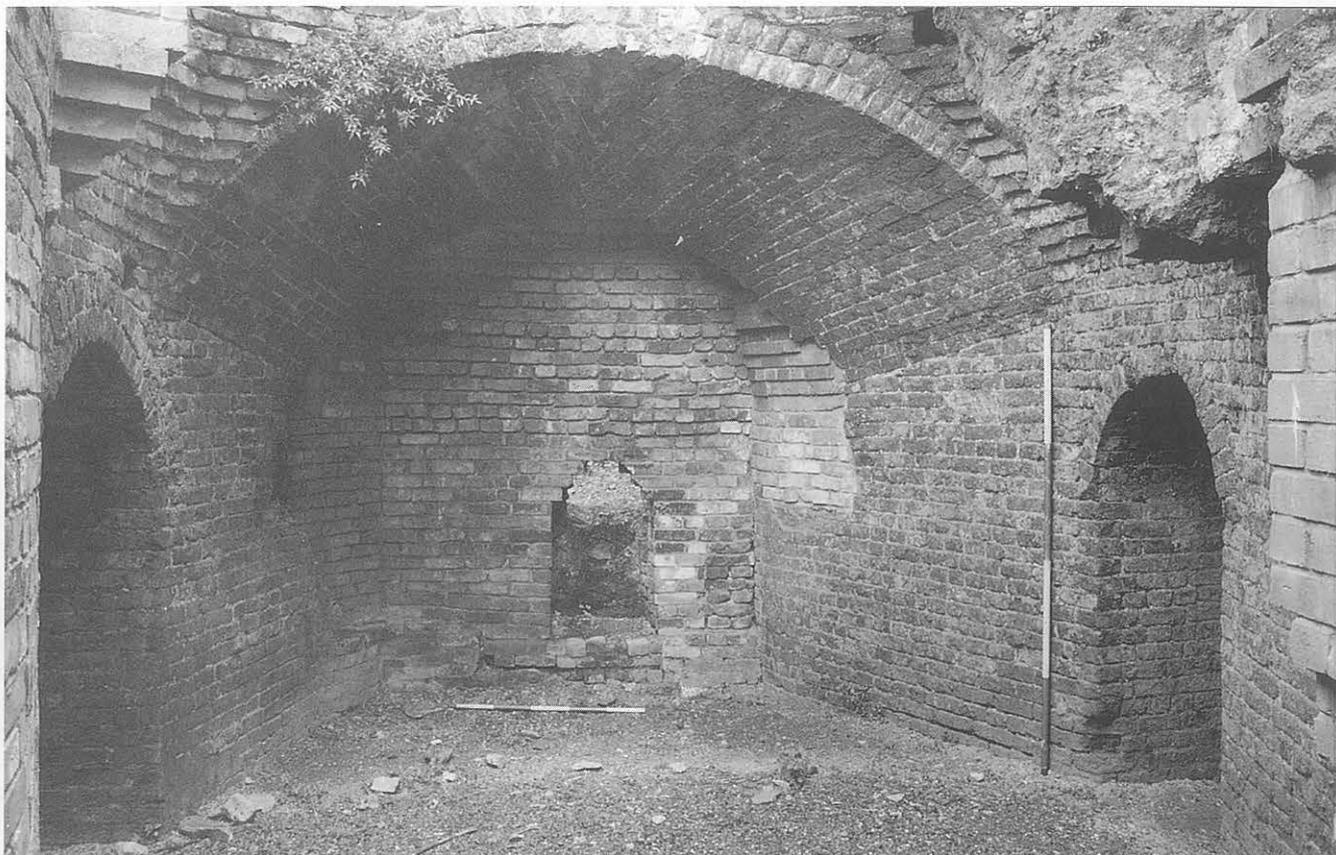
Figure 75 The tuyère chamber, looking west towards the tuyère recess of furnace I. The impression of a former tuyère can be seen in the furnace bear. On the right is the passage to the rear of the furnaces, now inaccessible, while on the left is the passage to the south side of the furnaces.

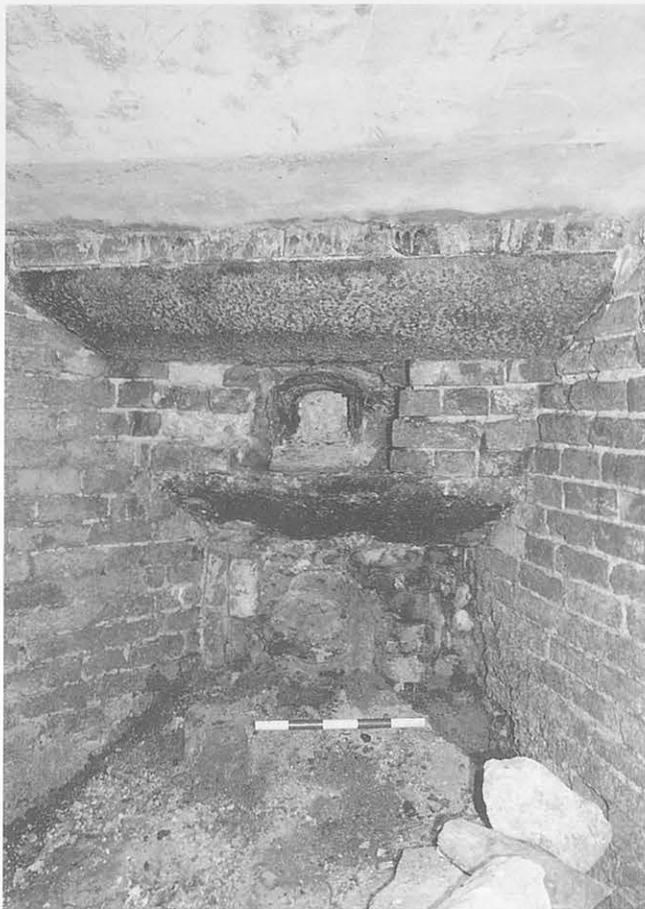
Figure 76 The tuyère recess on the north side of furnace I, at the east end of the wheel chamber. The recess is supported by cast-iron lintels instead of the brick arches used for the other tuyère recesses, and the remains of two superimposed tuyères can be seen.

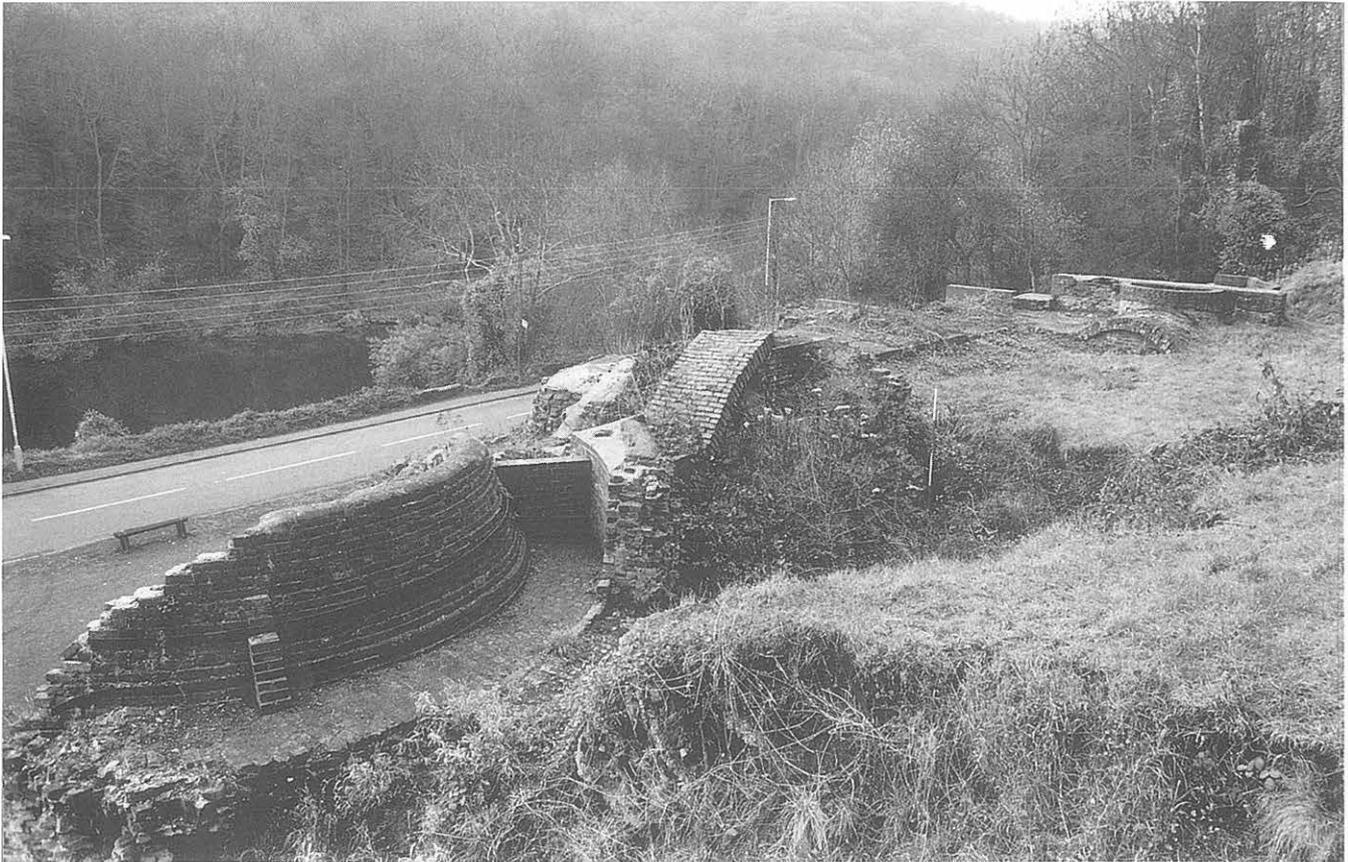
Figure 78 The upper level of the site, photographed looking west in 1991 before repairs began. The curved brickwork of the furnace II stack is clearly visible on the left. The charging house walls are obscured by vegetation cover.

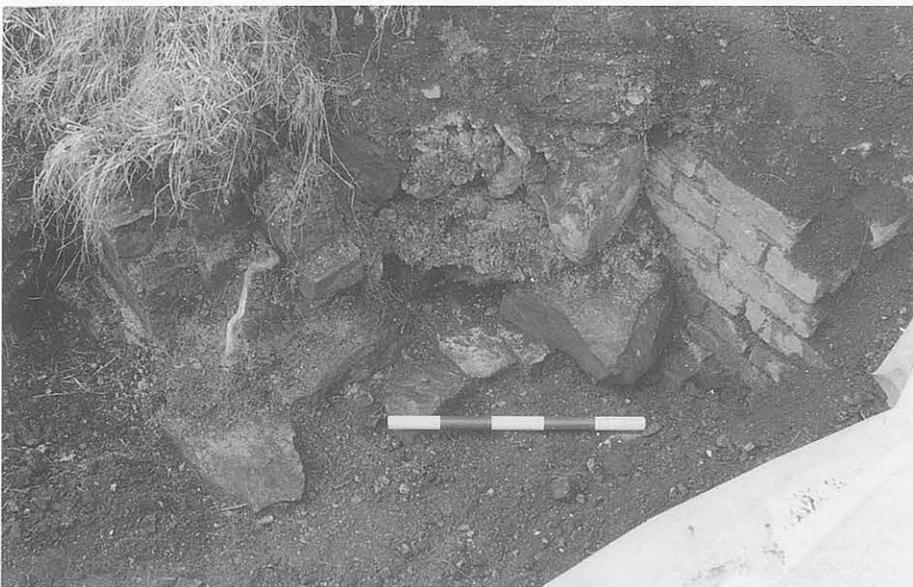
Figure 80 The 19th-century charging bank wall partially revealed during groundworks on the upper level of the site. It consists of two brick walls with rubble fill between them.

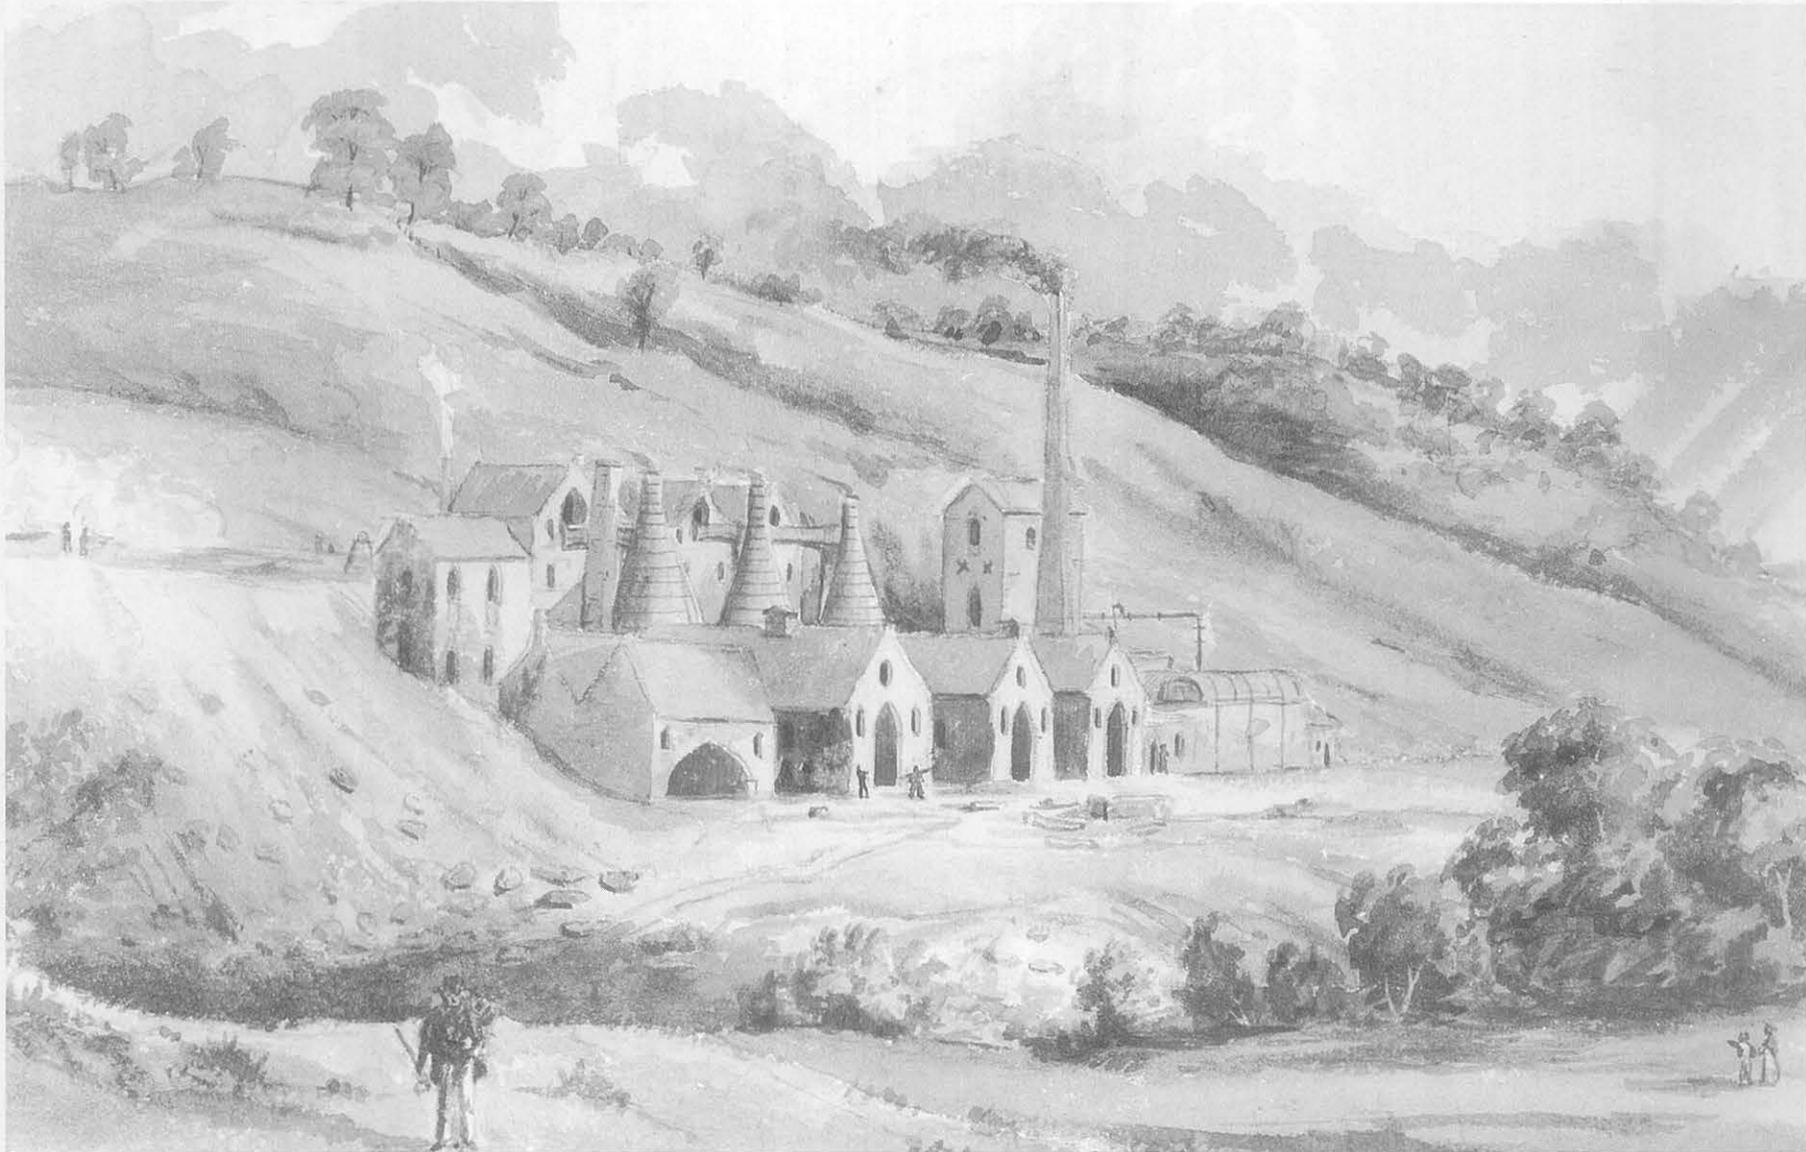
Figure 82 Blists Hill blast furnaces by Warrington Smyth, 1847. The site is viewed from the north west. The original north engine house is on the left, the taller south engine house with boiler stack is on the right. The northern casting shed and corresponding blast furnace are set back from the line of the other two and are larger. Note the resemblance of the blast furnaces to pottery kilns. (Ironbridge Gorge Museum Trust)

Furnace I is clearly the earliest as it stood adjacent to the earlier north engine house and is therefore dated 1832 (Figs 82 and 84). The main doorway of its casting shed is said to have had the date 1832 on the keystone (Randall 1908, 471). Furnaces II and III were built as a pair but documentary evidence suggests they were blown-in in 1840 and 1844. An alternative argument, that the bases were built in the 1870s when the later furnace stacks were erected, has little to recommend it: The original casting houses survived into the 20th century and would most likely have been demolished if the
