**Archaeology and Conservation
in
Ironbridge**

**CBA Research Report 123
Council for British Archaeology
1999**

1 Introduction: Archaeology and the Severn Gorge Repairs Project

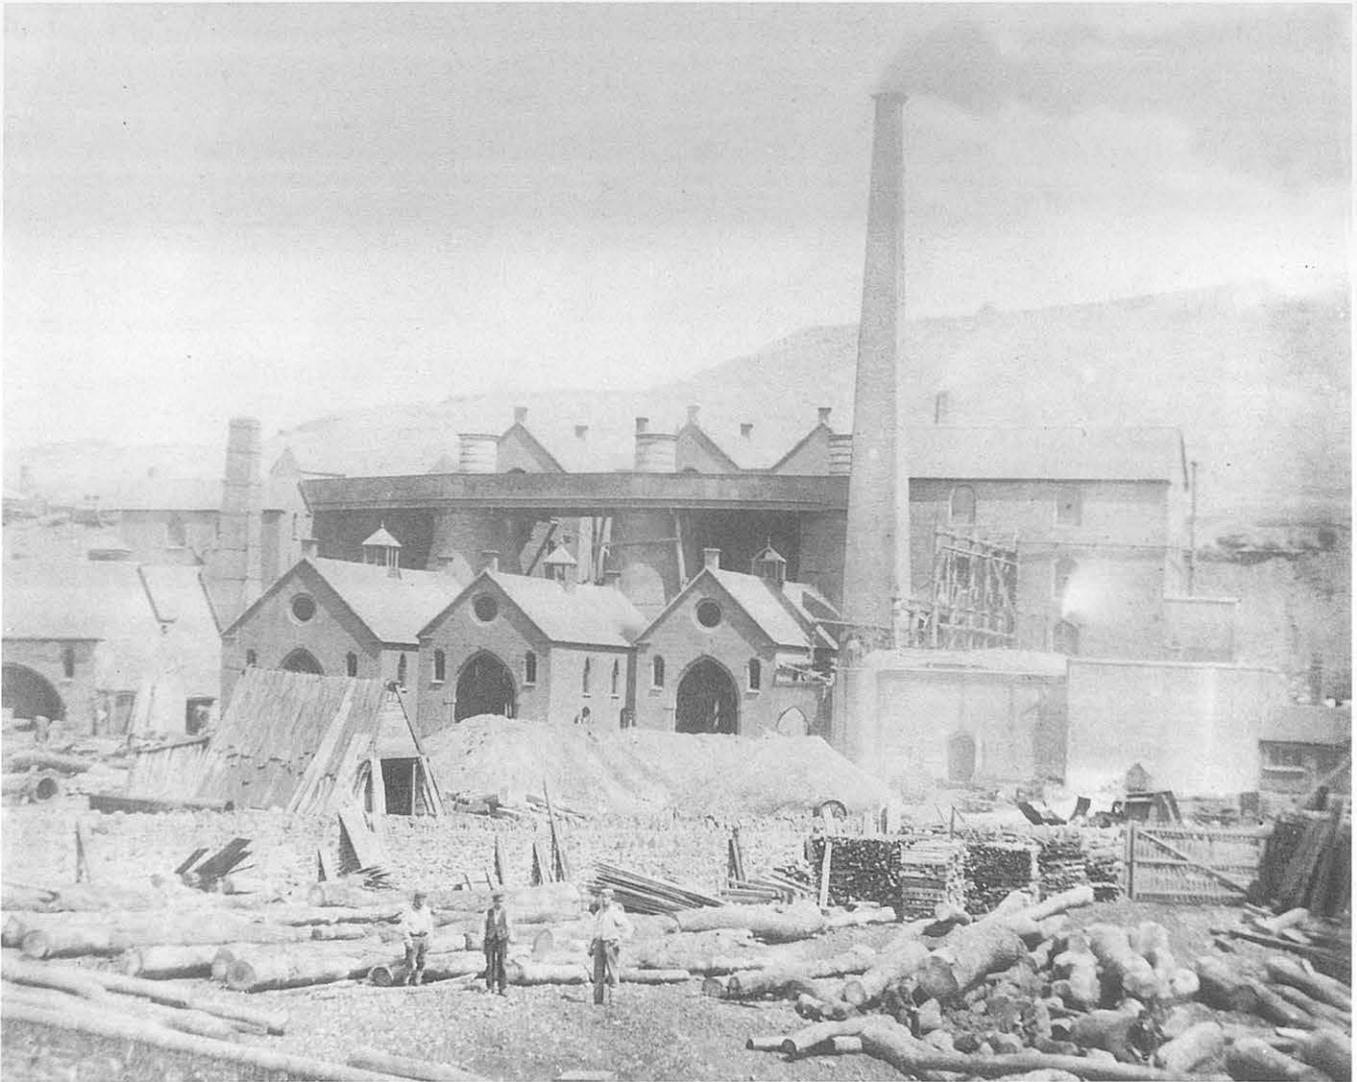
Figure 84 Blists Hill blast furnaces photographed before 1871 from the west side. The south engine house and boilers are on the right, the north engine house and stack on the left. Note the continuous gantry at charging level, in front of the charging houses, linking the same blast furnaces shown by Smyth. In the foreground is the Madeley Wood Company timber yard. (Ironbridge Gorge Museum Trust)

Furnace I is clearly the earliest as it stood adjacent to the earlier north engine house and is therefore dated 1832 (Figs 82 and 84). The main doorway of its casting shed is said to have had the date 1832 on the keystone (Randall 1908, 471). Furnaces II and III were built as a pair but documentary evidence suggests they were blown-in in 1840 and 1844. An alternative argument, that the bases were built in the 1870s when the later furnace stacks were erected, has little to recommend it: The original casting houses survived into the 20th century and would most likely have been demolished if the

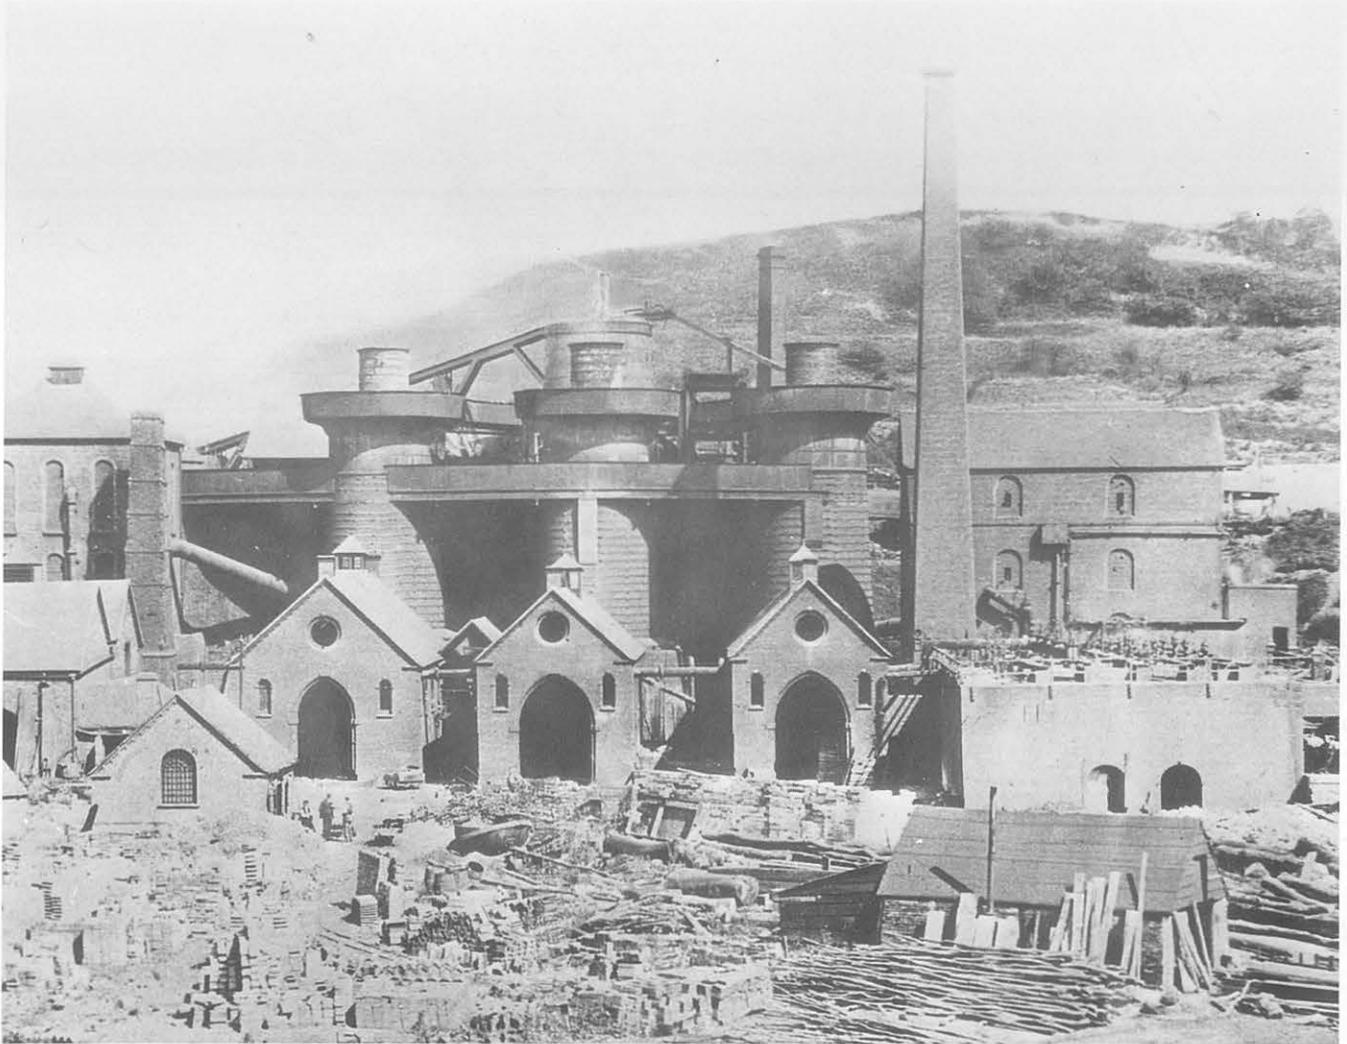
Figure 85 Blists Hill blast furnaces in the late-19th or early-20th century, photographed from the west side. The south engine house is on the right, the new north engine house on the left. The furnaces have been rebuilt and are higher than previously, as shown by the gantry at the earlier charging level. The original charging houses have gone. Between the centre and right furnaces is the superstructure of a lift to the new charging level. Behind the central furnace is a calcining kiln with ramp on the north side and winding cable on the south side. In the background is the stack of the incline engine. (Ironbridge Gorge Museum Trust)

An late 19th- or early 20th-century photograph, viewing the site from the west, shows all the major changes of the 1870s (Fig 85). In front of the furnaces, the original casting houses were retained, a significant fact because it will be used to date the blast furnace bases. The furnaces themselves are larger than before: the charging gantry for the previous furnaces can still be seen in the picture, well below the new charging level. In 1908 Randall described the furnaces as 50 feet (15.24m) high and 13 feet (3.96m) wide across the boshes, a rise of only 5 feet (1.52m) above the earlier furnaces, if either of the figures are accurate (Randall 1908, 472; Percy 1864, 560). At charging level is a continuous gantry.

furnaces were superseded, the new, larger furnaces built on the original bases were of a standard design seen throughout England, Wales and Scotland, consisting of cylindrical stacks clad in iron sheets (Fig 85).

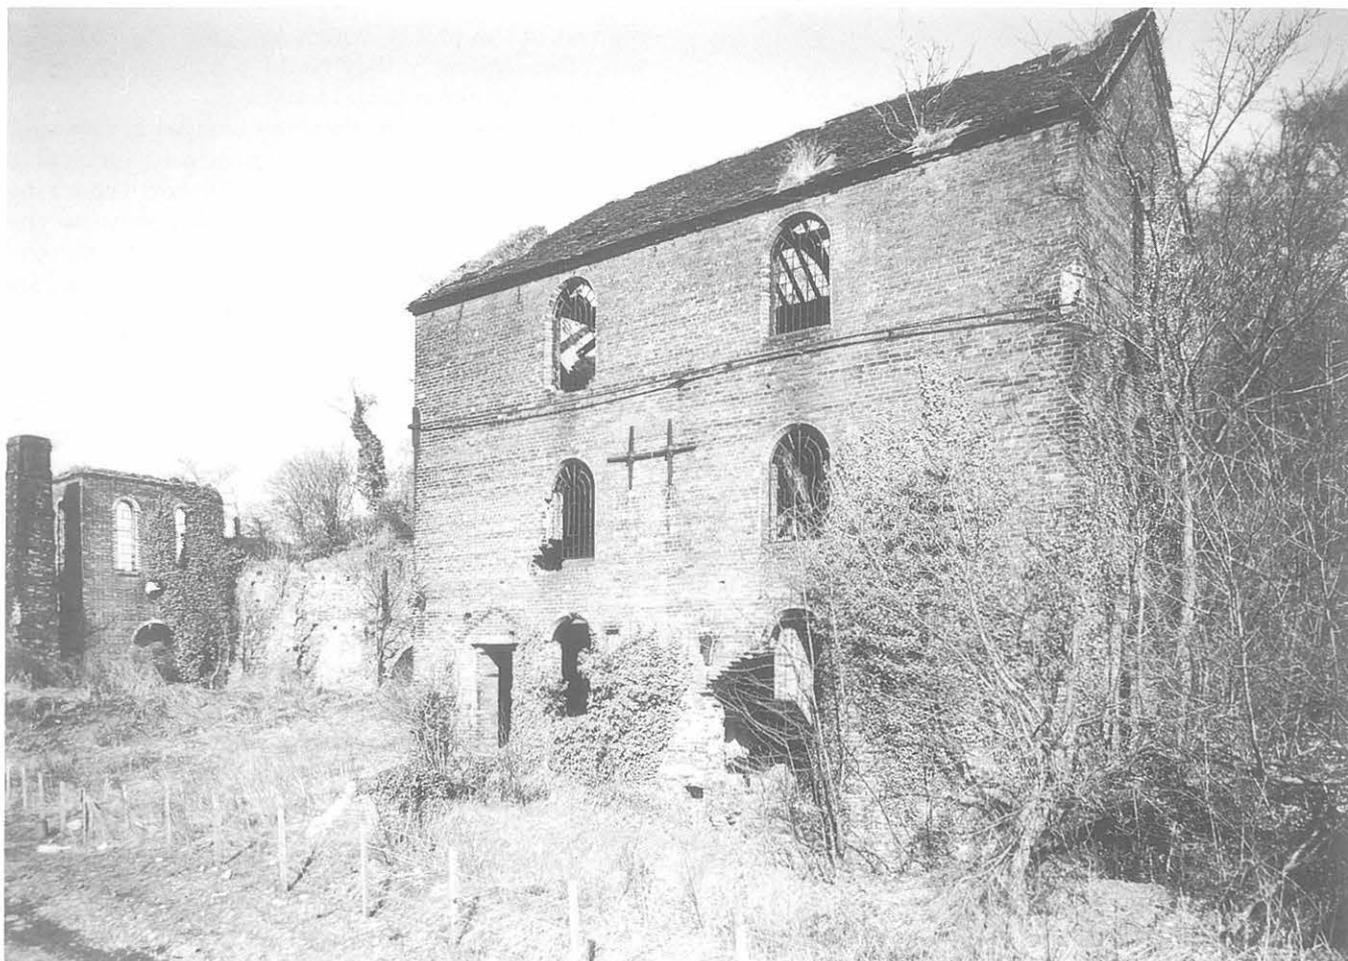
Figure 88 Blists Hill photographed looking north east in the 1960s, showing the ruined engine houses. In the south engine house on the right is a large gap in the ground-floor wall caused by removal of the flywheel, while the middle-storey window to the left has missing brickwork caused by removal of the steam pipe. The blast furnace bases were buried at this time. (Ironbridge Gorge Museum Trust)

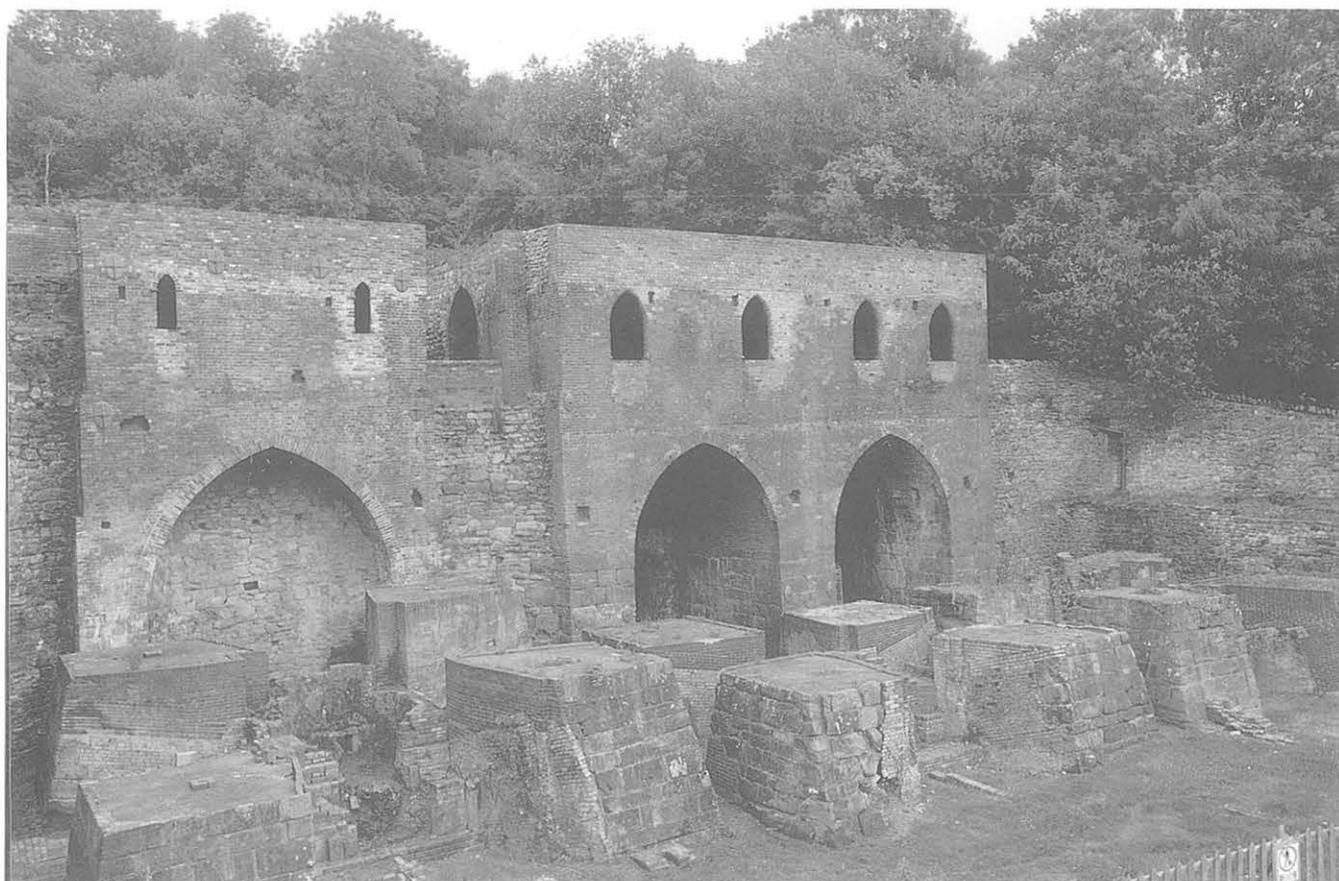
Figure 91 The blast furnace bases with the charging houses behind, photographed looking east in 1997 after repairs to the charging houses.

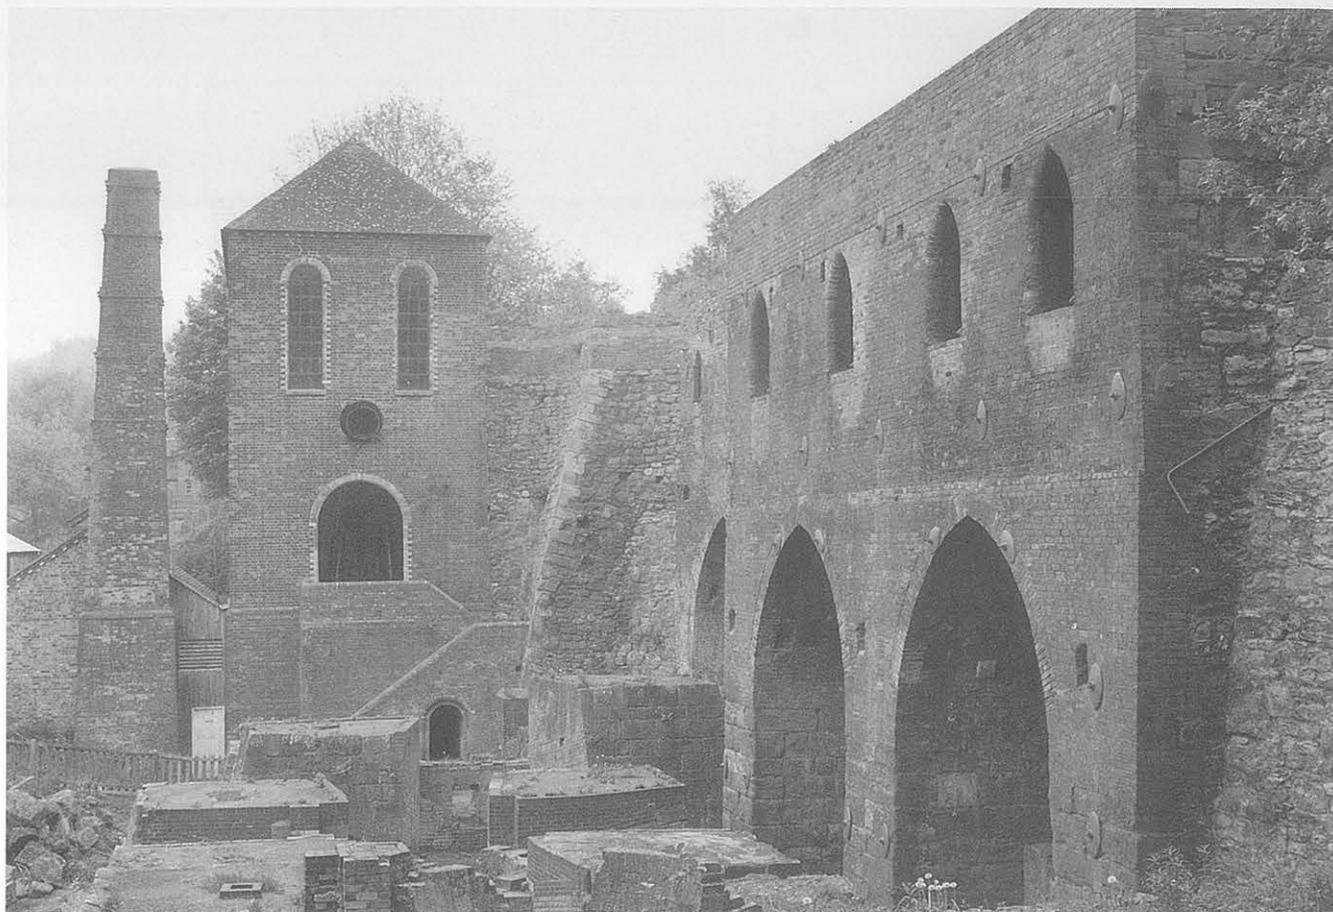
Figure 98 The north engine house, photographed looking north across the blast furnace bases in 1995, after the completion of repairs.

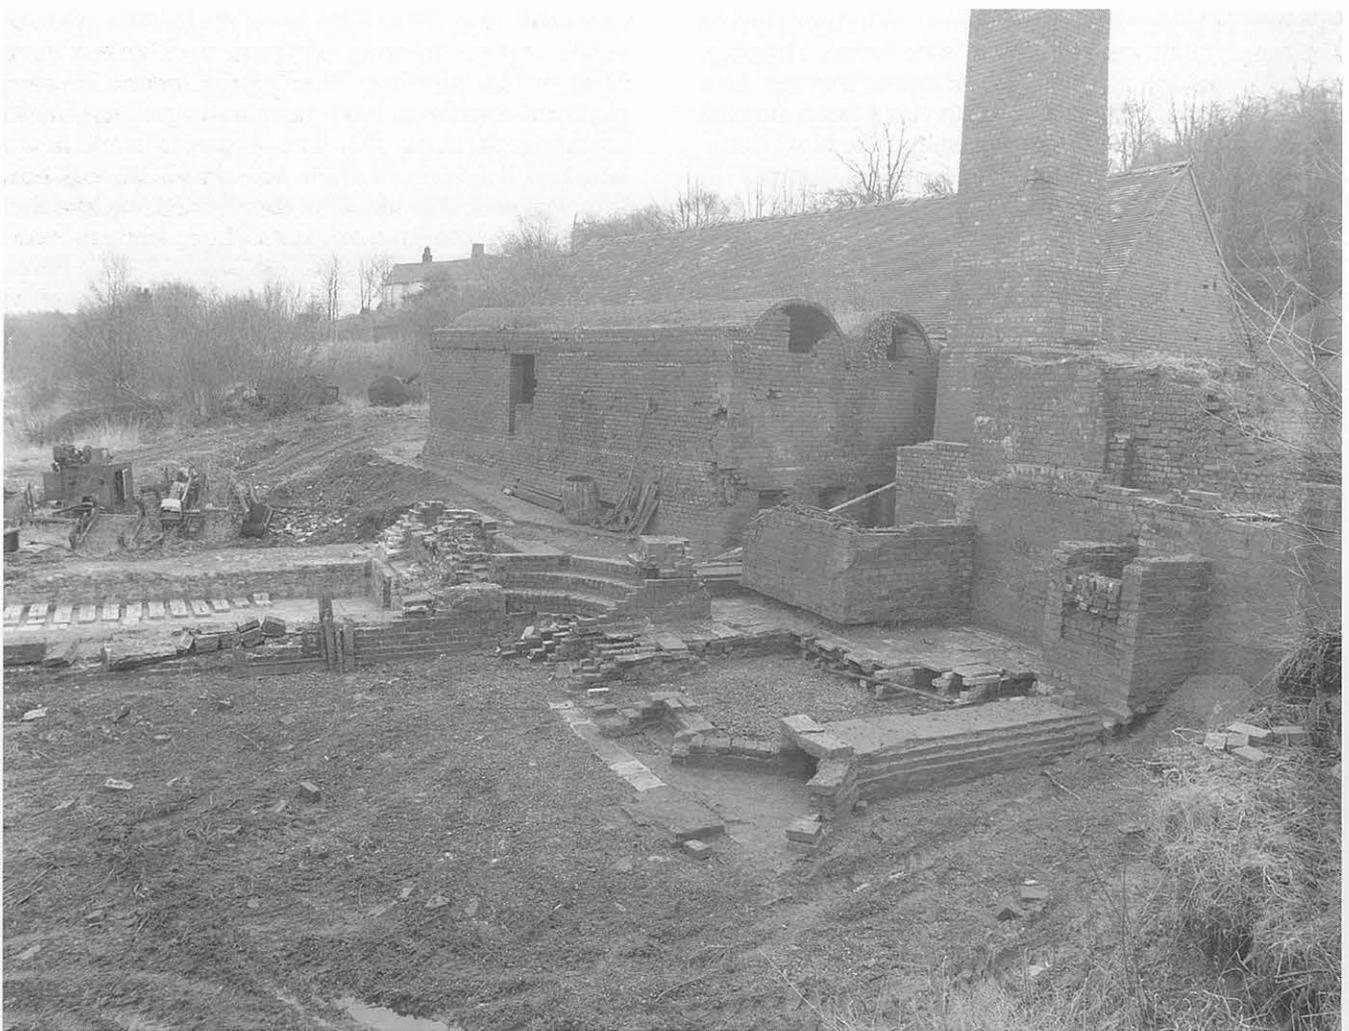
Figure 103 Blists Hill Brick and Tile Works in the 1970s. Next to the tall boiler stack is drying shed 2 with a two-span barrel-vaulted roof, and the larger drying shed 1 behind it. In the left foreground was drying shed 3, from which a flue can be seen to the stack base, built against the wall of the boiler settings on the right of the picture. In the middle distance, to the left, is a kiln base. (Ironbridge Gorge Museum Trust)

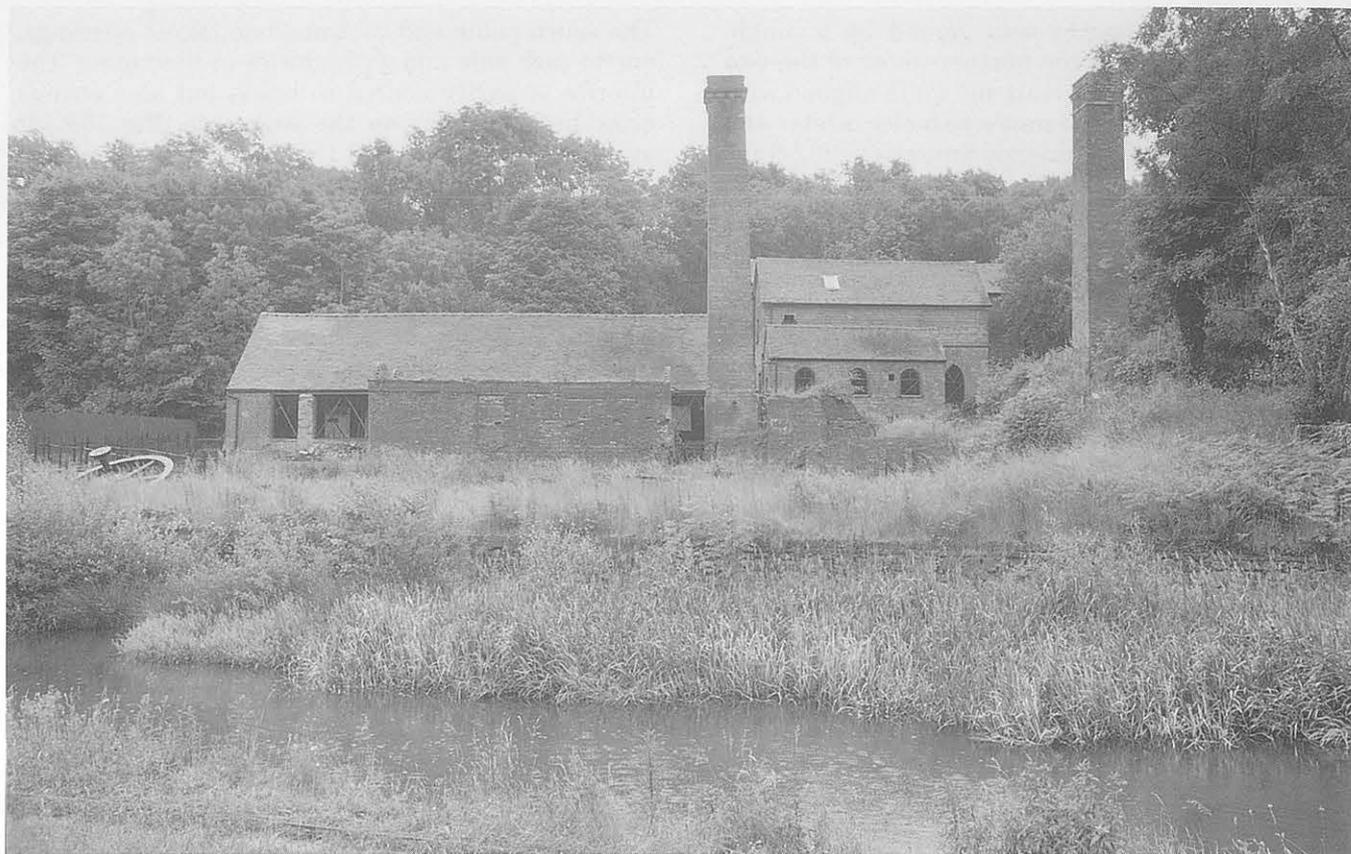
Figure 108 The brick and tile works, looking east across the Shropshire Canal. The engine house and roofs of the clay preparation block can be seen between the boiler stacks. Drying sheds 1 and 2 are to the left.

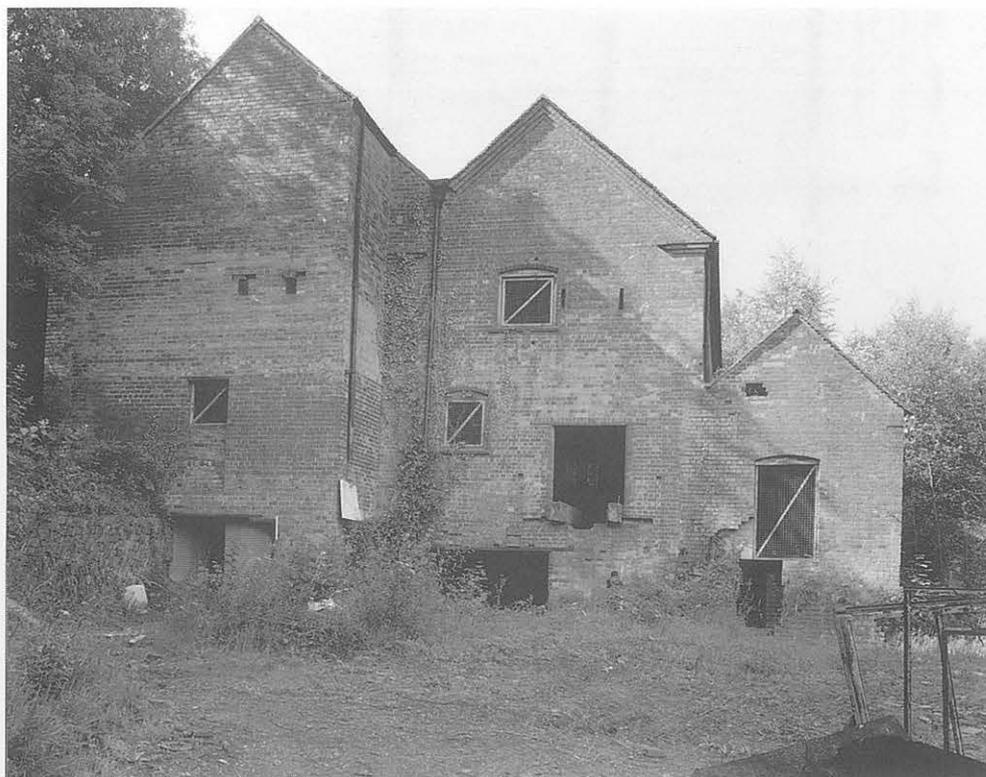
Figure 109 The north side of the clay preparation block and engine house with the yard in the foreground. The east range of the clay preparation block, to the left, was added later. Photographed in 1993 before the start of the repairs.

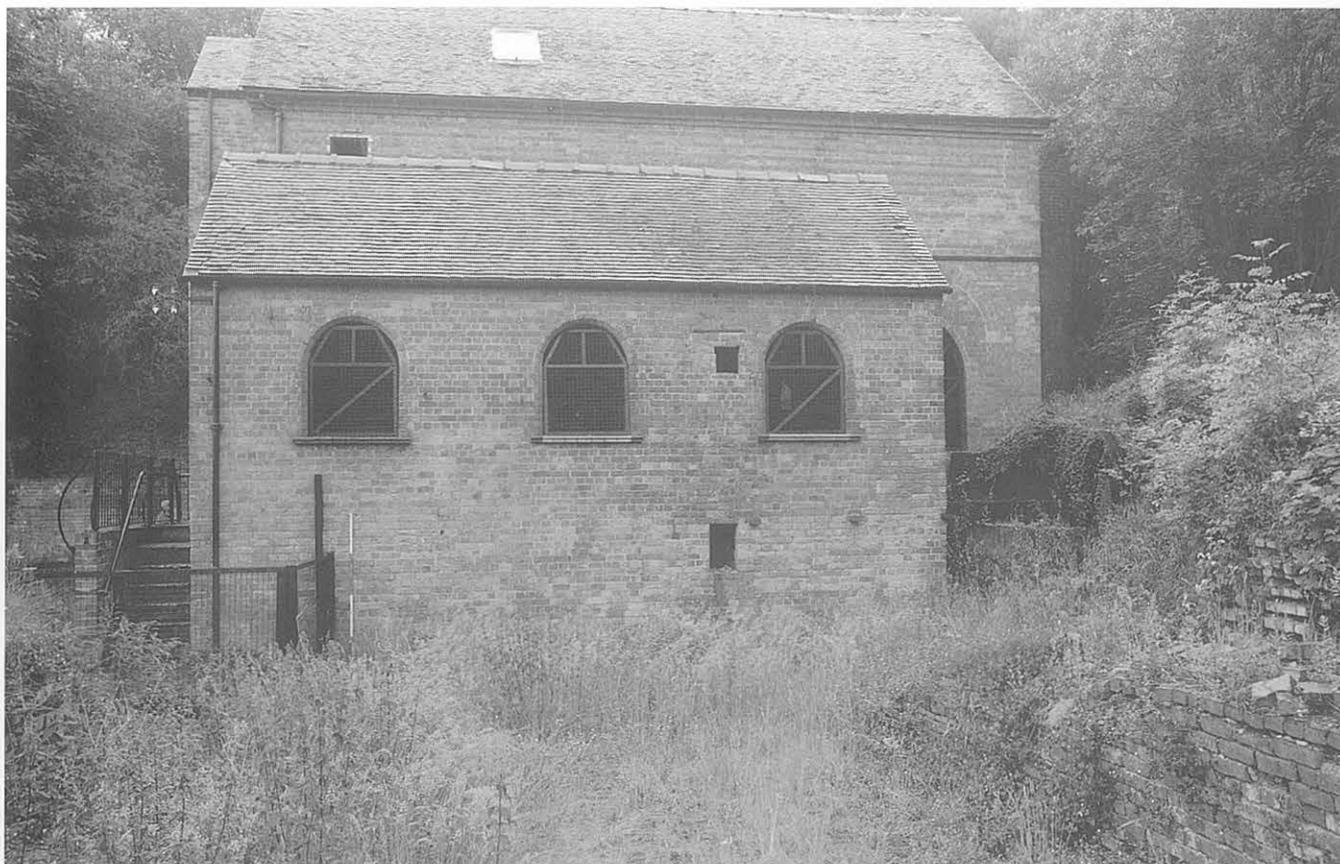
Figure 111 The west side of the engine house. A bearing box can be seen at a high level in the wall of the clay preparation block behind. The boilers stood in front.

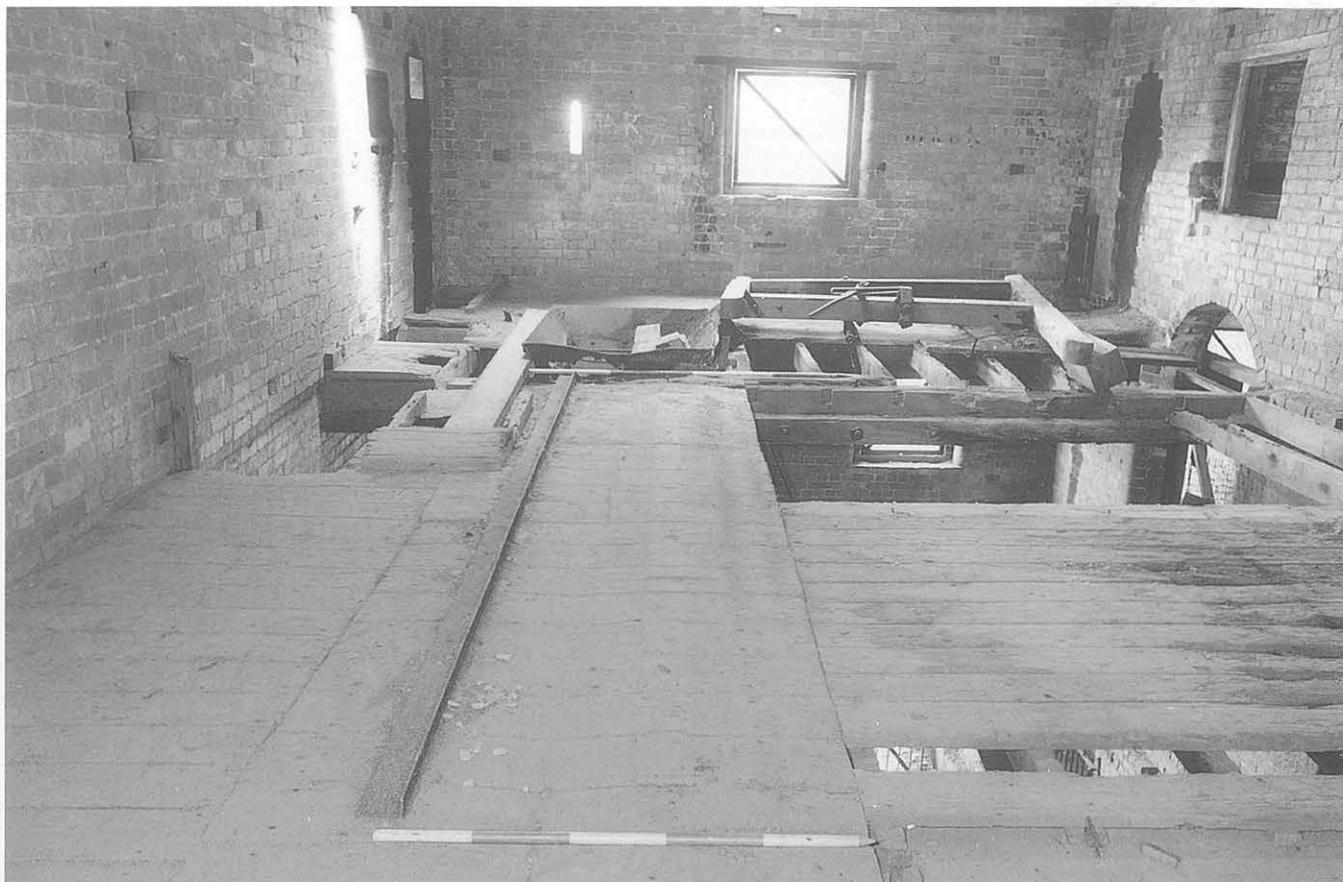
Figure 114 The ramped floor and plateway in the upper storey of the west range. The hopper is at the end of the plateway.

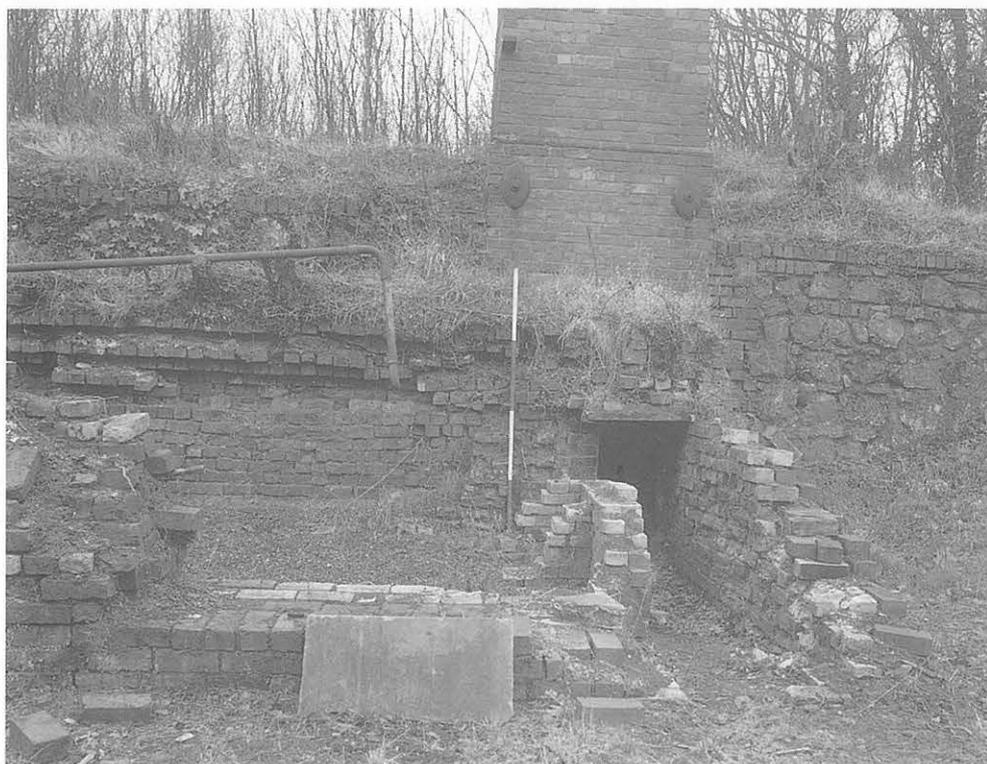
Figure 115 The base of the southern boiler with flue running into the stack. The boiler was of the Cornish or Lancashire type.

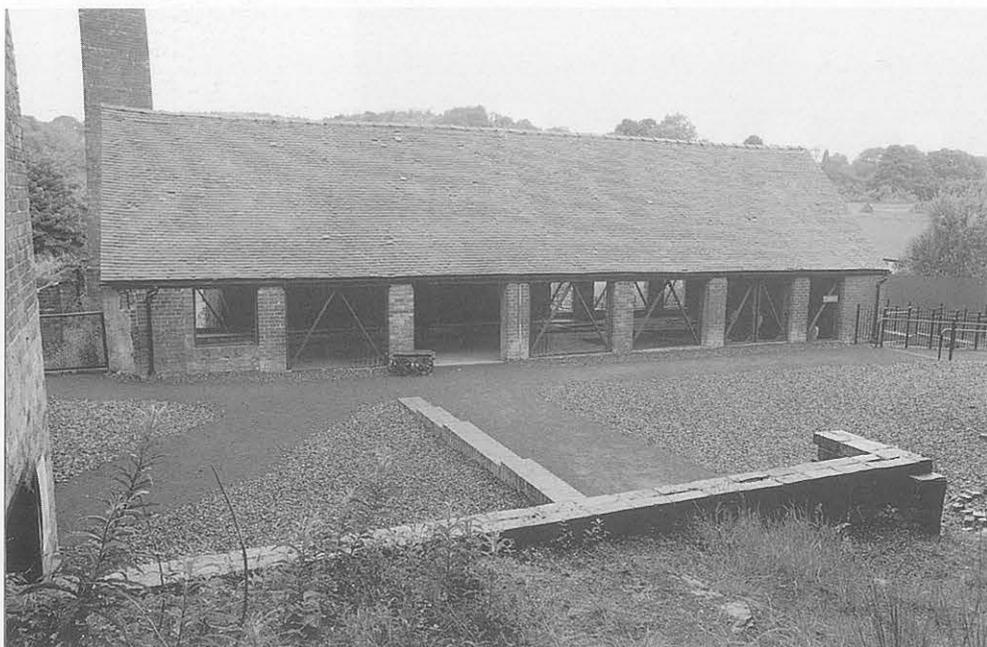
Figure 116 The east side of drying shed 1 viewed from the yard. The flue of the drying shed led to the stack on the left, which also served the northern boiler.

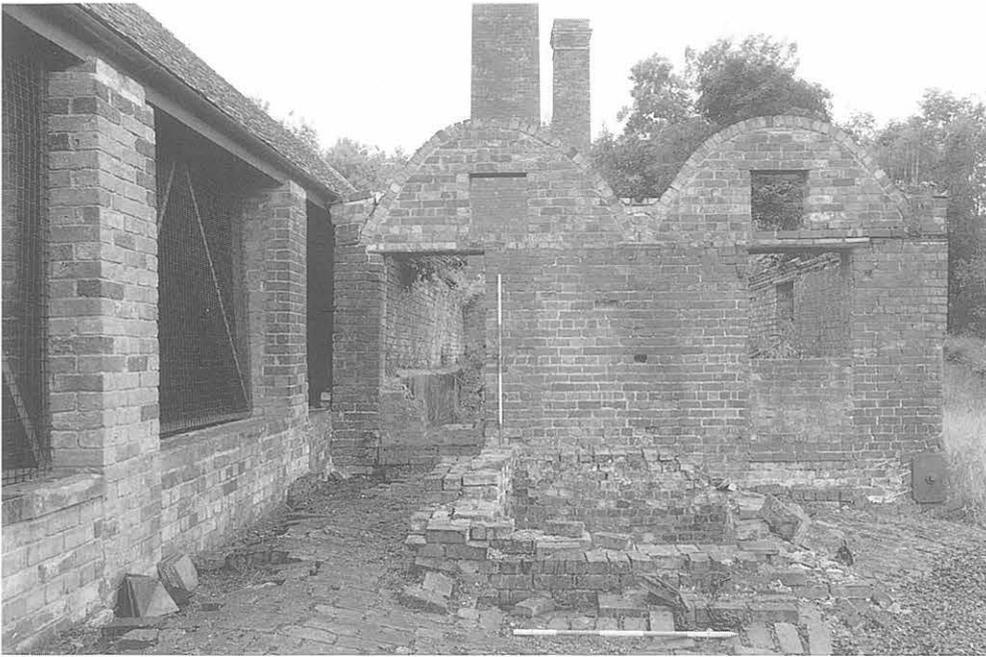
Figure 119 The north end of drying shed 2, with the large stack base in the foreground, and drying shed 1 on the left, photographed in 1998 after the completion of repairs. The ends of the barrel-vaults were reconstructed from fragments during the course of the project.

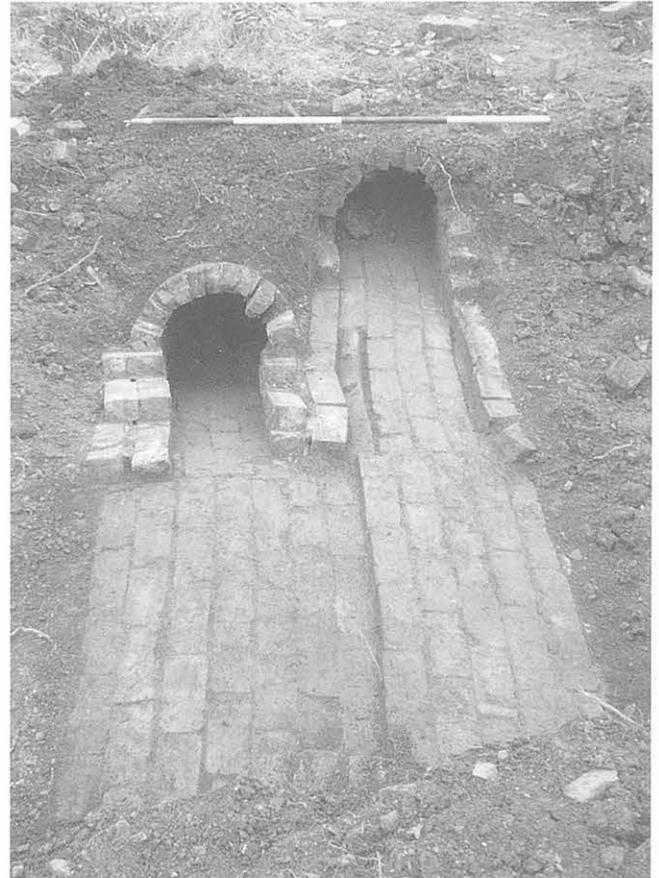
Figure 120 Two parallel flues excavated during access works in 1995, linking the northern kiln with the stack base adjacent to drying shed 2. This arrangement shows that the kiln was of the downdraught type. The photograph looks north.

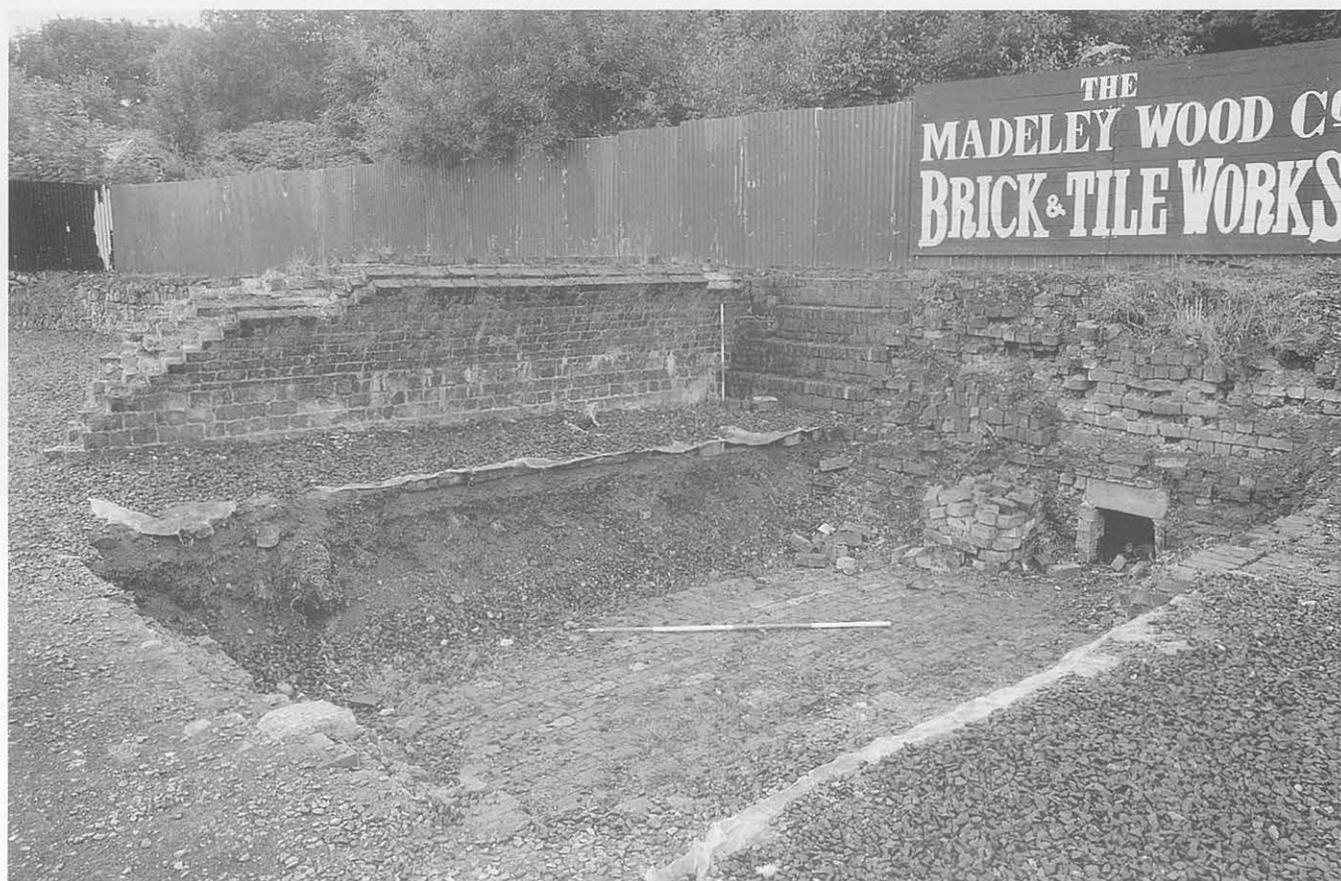
Figure 121 Base of the north kiln, erected on the site of the brickworks buildings shown on the Madeley tithe map of 1847. The rectangular kiln, viewed from the south west, had a vaulted roof with flue leading out to the east.

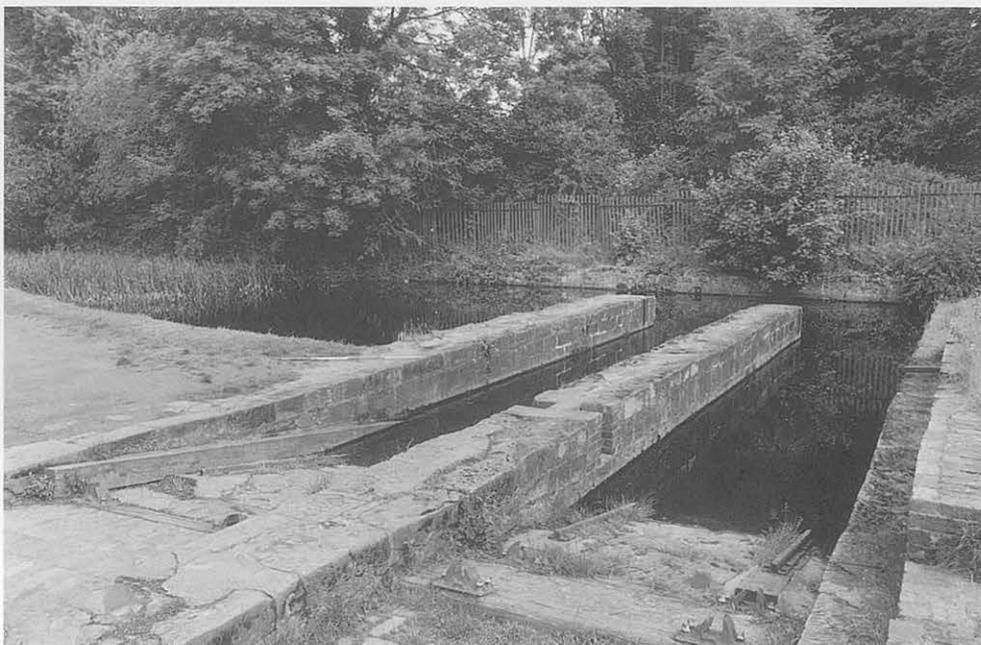
Figure 140 The upper canal basin at the Hay Inclined Plane, photographed looking north in 1998 after it had been refilled with water. The rails in the loading bays run down into the water, so that tub-boats could be easily attached to the cradles on the incline.

The upper canal basin was built after the loading bays but the two are probably roughly contemporary (Fig 140). The basin is rectangular in plan and bounded by masonry walls to the north and east, repaired and altered in the 1970s. On the south side is a graded earth bank to the west of the loading bays, while the canal runs off from the west side. The basin was originally lined with red clay. Map evidence from 1803–4 until 1902 suggests that the basin was never remodelled (Figs 132, 133, and 135). Alterations did occur, most notably the insertion of an overflow culvert into the east wall, which fed the lower (Coalport) Canal. The Shropshire Canal

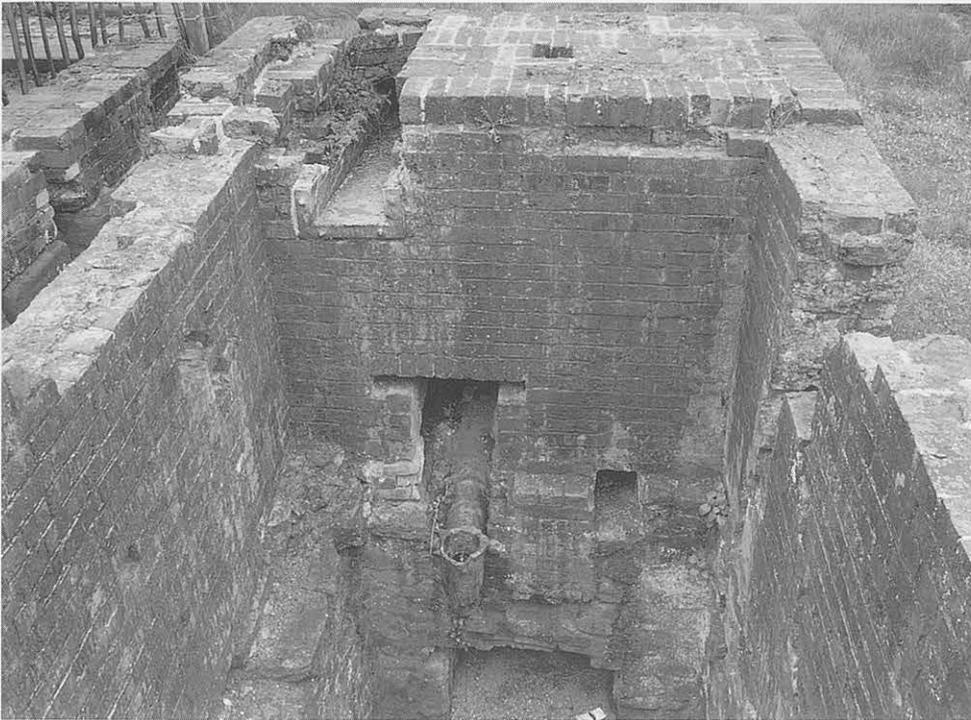
Figure 142 Detail of the engine house at the Hay Inclined Plane, photographed looking north in 1993. The plinth for the receiving cylinder of Heslop's engine is to the north. The pit in the foreground has been modified: the large recess with cast-iron pipe replaced one of a pair of timber beams running north-south which would have supported a water tank in which the working cylinder was immersed. The flywheel pit is on the left.

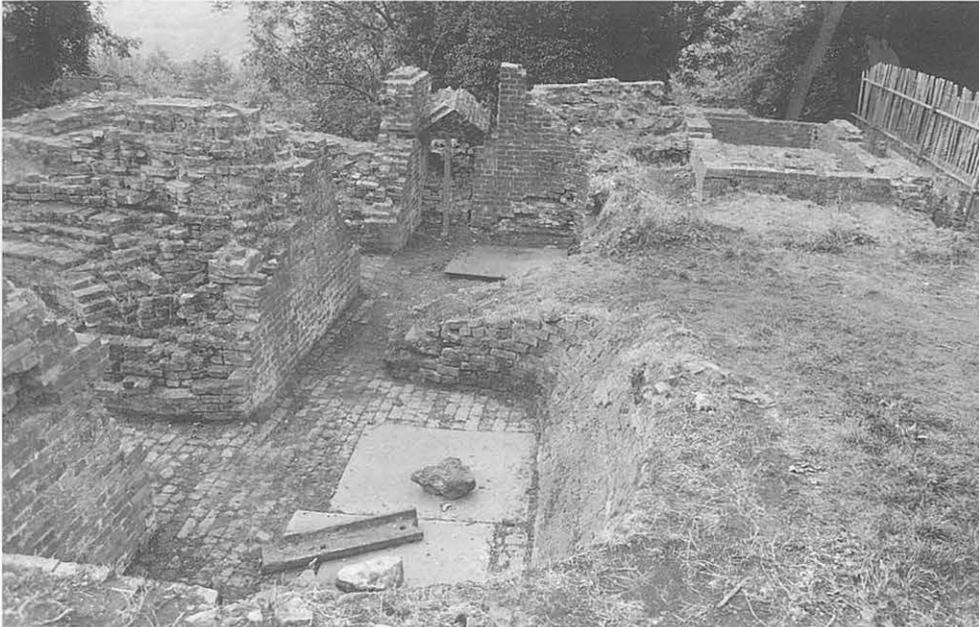
Figure 145 The coal storage and stoking areas, photographed looking south in 1993. The coal was kept on cast-iron plates. The original boiler may have been in the area of the south coal storage area. A pier was inserted here later, supporting a half arch which has now fallen into the former stack base.

Each boiler base has a corresponding area for stoking and coal storage (Figs 137 and 145). The coal storage areas are defined by sloping brick retaining walls with rounded angles. As noted above, the south end of the south coal store retaining wall is very disturbed. In front is the passage from where the boilers were stoked. All these areas are paved with brick and three large cast-iron plates have been laid over the top.

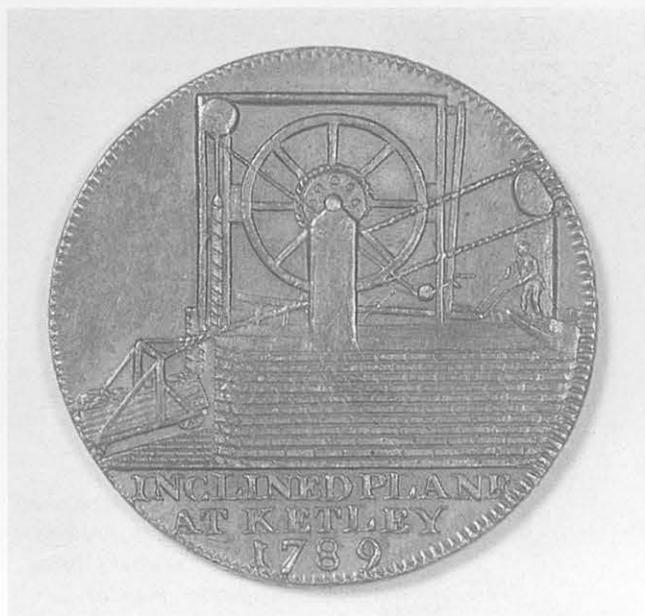
Figure 147 The Ketley inclined plane, shown on the reverse of a trade token of 1789. The incline was operated by counter-balancing, so that the weight of a full boat descending would raise an empty boat. A simple brake mechanism was operated by hand. Trade tokens were a form of currency which compelled the work force to buy provisions at company shops, often at inflated prices. (Ironbridge Gorge Museum Trust)

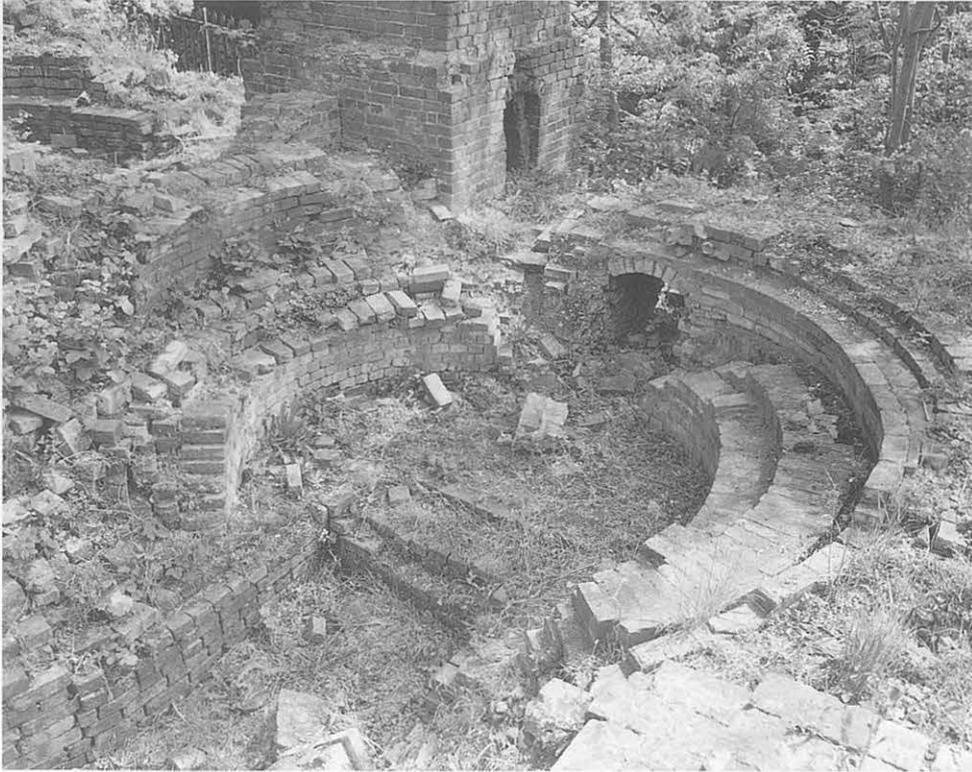
Figure 149 The south boiler setting, photographed looking north-east in 1993 in advance of repairs. Note the concentric rings of firebricks, which were originally laid dry to allow for expansion. A flue can be seen leading to the stack and another to the exterior east wall.

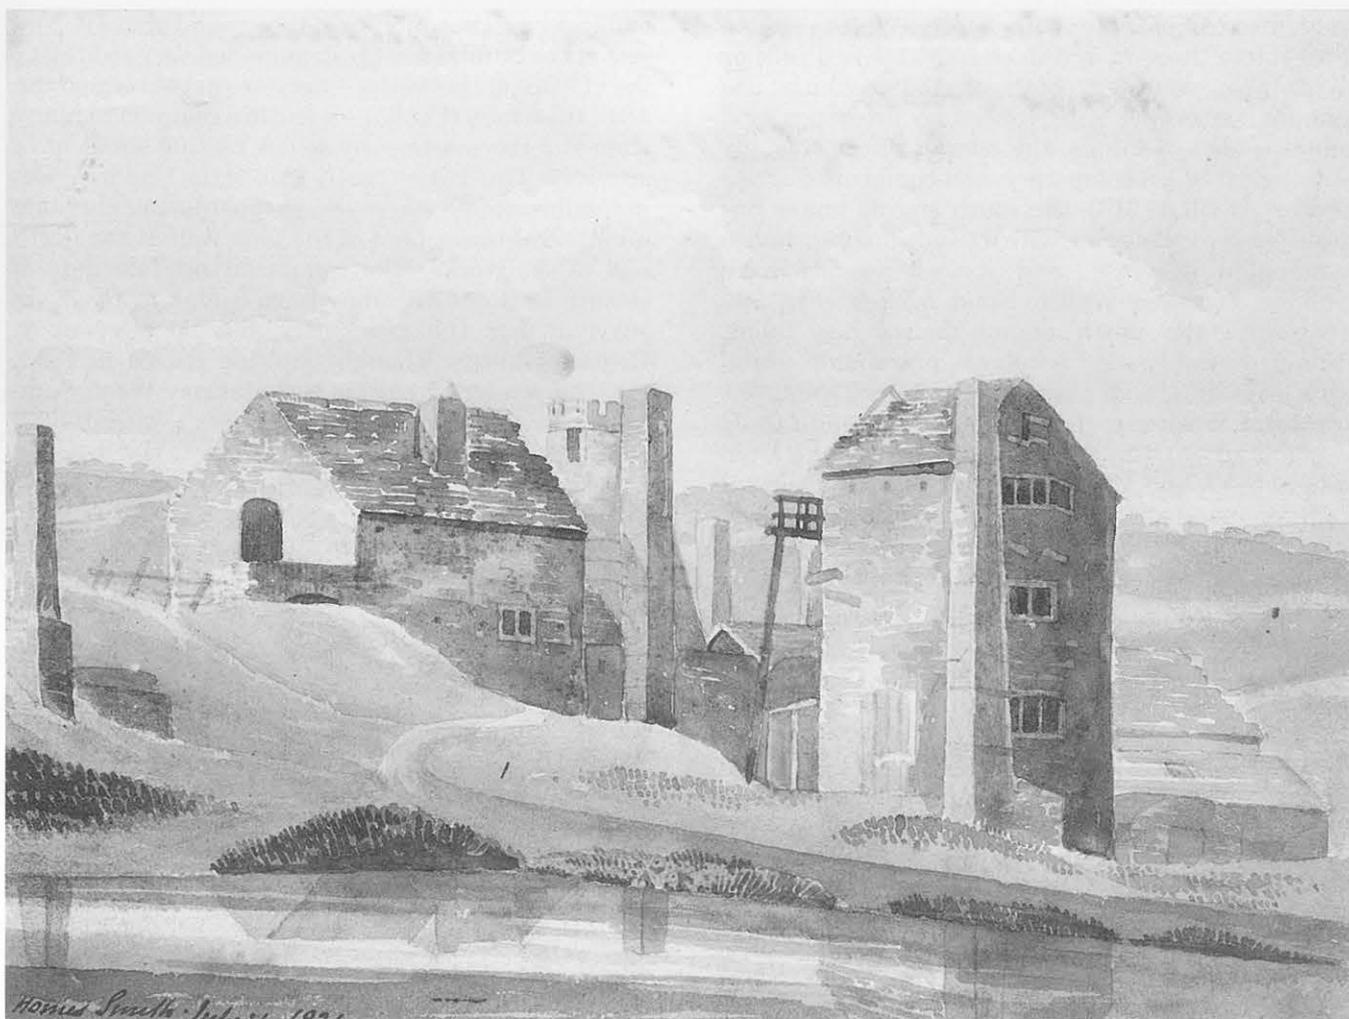
Figure 153 'Old Furnace, Broseley' by Homes Smith, 1821. The site is probably the Coneybury furnace. The profile of the furnace, built in 1786, is similar to the furnaces at Madeley Wood and Barnetts Leasow with a tapering round stack. The artist appears to have added battlements to the tunnel head, and the charging house on the left is 'inaccurately' depicted at a lower level than the charging level of the furnace. (Shropshire Archaeological and Historical Society)
