**Archaeology and Conservation
in
Ironbridge**

**CBA Research Report 123
Council for British Archaeology
1999**

1 Introduction: Archaeology and the Severn Gorge Repairs Project

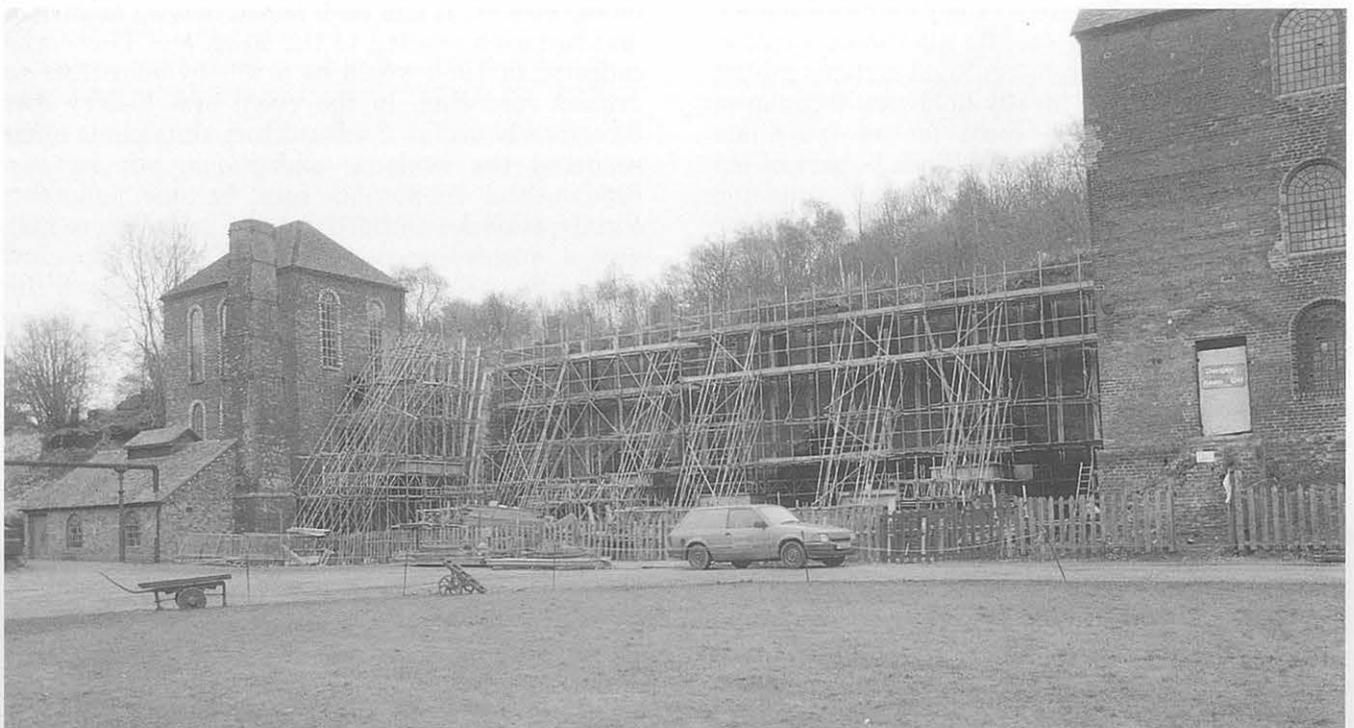
Figure 162 The scaffold erected in front of the charging houses at Blists Hill blast furnaces.

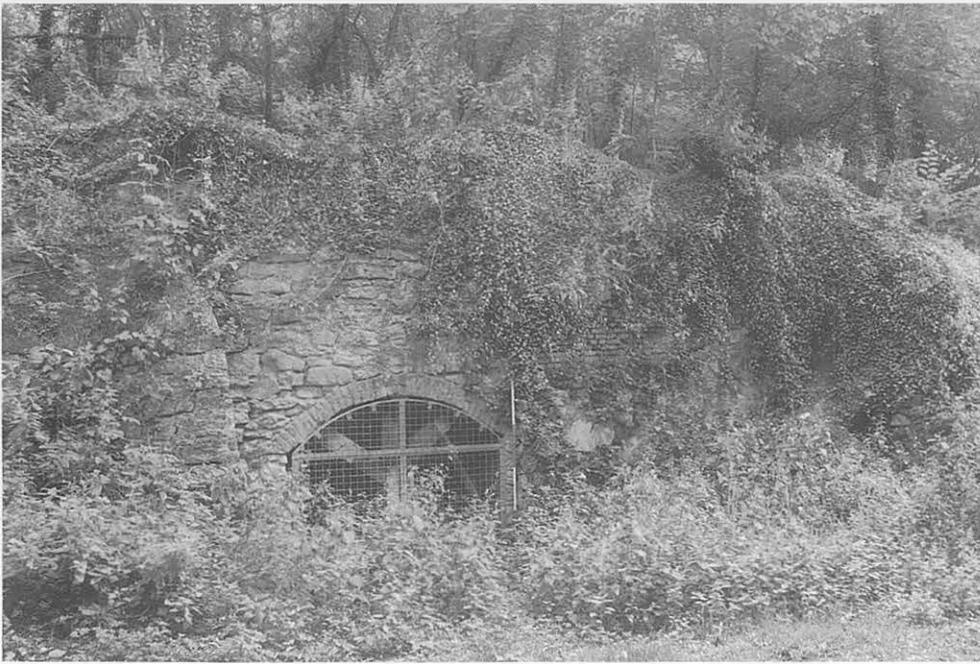
Figure 163 Bower Yard lime kilns, on the south side of the River Severn. The structures were not repaired in the present project.

Chronological development and technological context have been established as the fundamental requirements of site-specific studies of industrial sites. The same requirement should be fulfilled for at least one other local site, namely the lime kilns at Bower Yard, a site which is not satisfactorily understood at present and whose context in the local landscape makes it especially worthy of attention (Fig 163). The Blists Hill Brick and Tile Works is the only site discussed in this volume whose buildings have not been fully recorded, which must be a priority for future enquiries at the site.

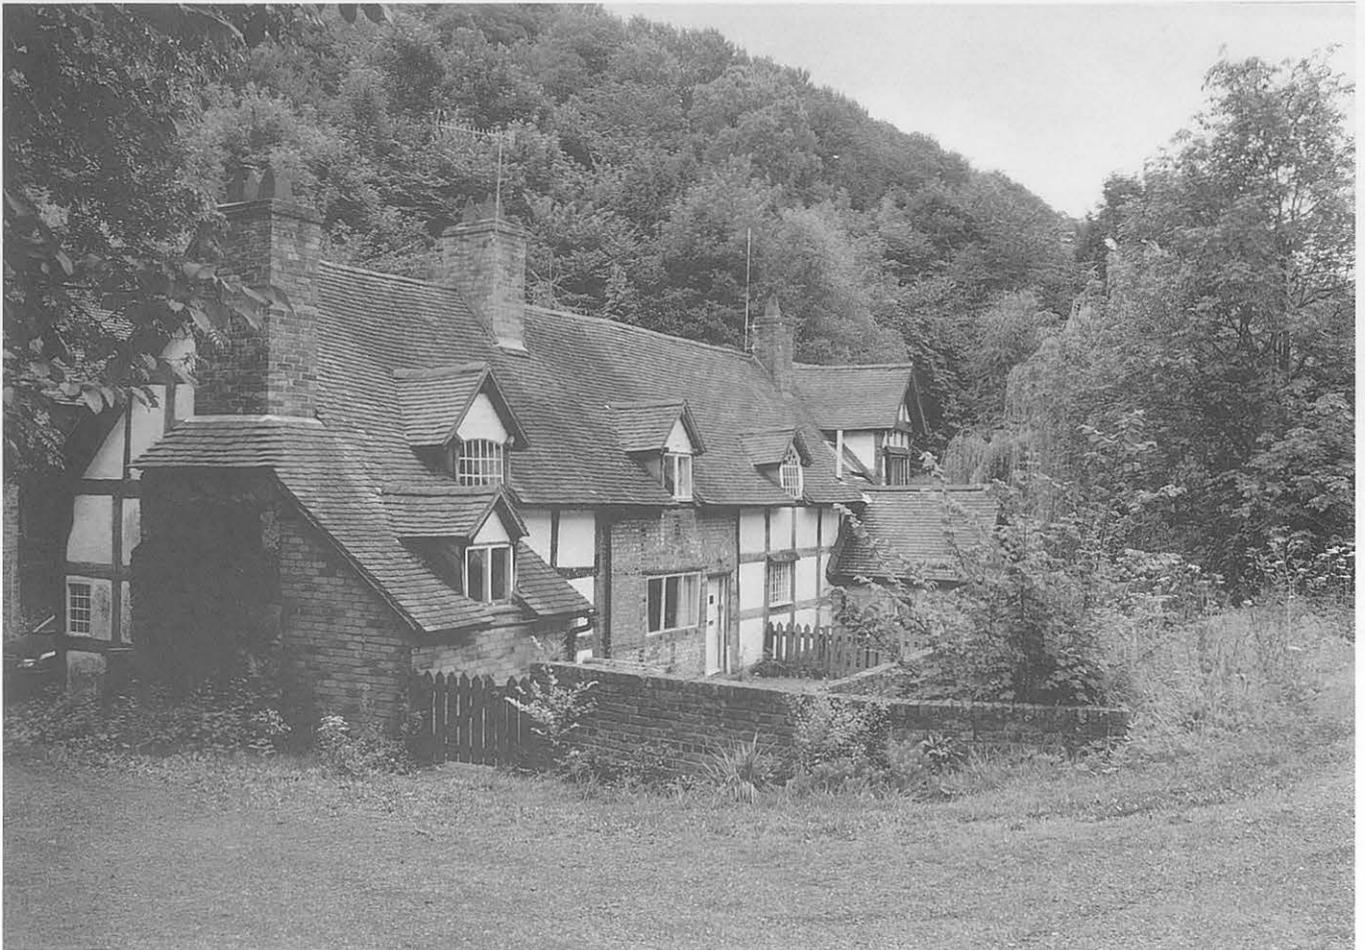
Figure 164 Rose Cottages, Coalbrookdale, consisted of four dwellings by 1642 but may have been adapted from an earlier agricultural building.

suggested that the dwellings may have been created by inserting upper floors and partitions into an earlier farm building (Fig 164) (Mercer 1979, 196). Even so, the cottages are the oldest surviving buildings connected with the Coalbrookdale iron industry and were perhaps associated with Basil Brooke's manufacture of steel under his own patent. Brooke's innovation is a reminder that the Industrial Revolution did not begin with Abraham Darby I, or with any other single event. If archaeology can effectively ensure that the potential of such areas in the Iron-bridge Gorge is recognised, protected, and at some future date investigated, then it will have fulfilled much of its intentions to integrate curatorship with research into the archaeology of industry.

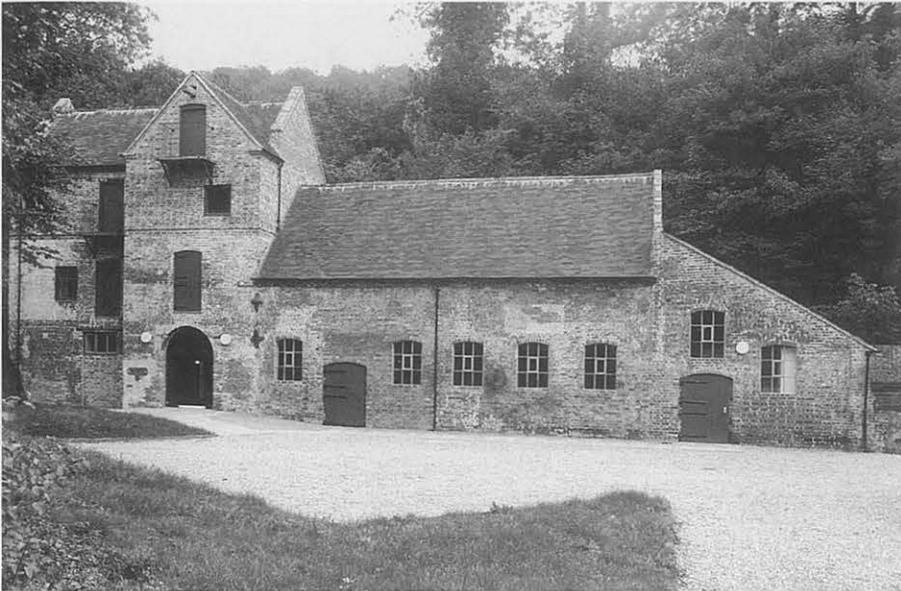
Figure 165 The Upper Forge, photographed looking east in 1995 after repairs and showing the reinstated upper storey of the former mill.

In certain cases new building work was deliberately made to stand out. At the Upper Forge, the upper storey of the mill (formerly engine house) was reconstructed, based on photographs of the 1950s (Fig 165). The new build was separated from the original by a band of recessed blue bricks. At the Upper Works a part of the charging platform had to be rebuilt as it had collapsed in the 1980s. Second hand bricks were laid, but it was not possible to replicate the mortar which had previously been used. To acknowledge this, it was therefore pointed with a green-brown mortar which was totally different from any other at this particular site. In some instances, new brick structures were required which bore no relation to any historic structures. A good example is at the snapper furnace, where new brickwork was required on the top of the monument to aid drainage. New blue brick was used so that it could not be confused with original fabric and it was constructed in such a way that it is barely visible from ground level. Old railway sleepers were used for retaining or protecting structures, which are clearly distinguishable from original materials without being prominent. For example, they were laid over the wheelpit walls and above the cellars at the Upper Forge (Fig 53). Old ironwork was normally treated with micaceous oxide and sometimes painted brown, whilst new structural steelwork was painted black. Timber lintels were generally replaced with blackened, pre-cast, concrete lintels rather than new timber, simply as the best long-term solution. Most upper surfaces were capped. However, lead flashing and tiles were used at the

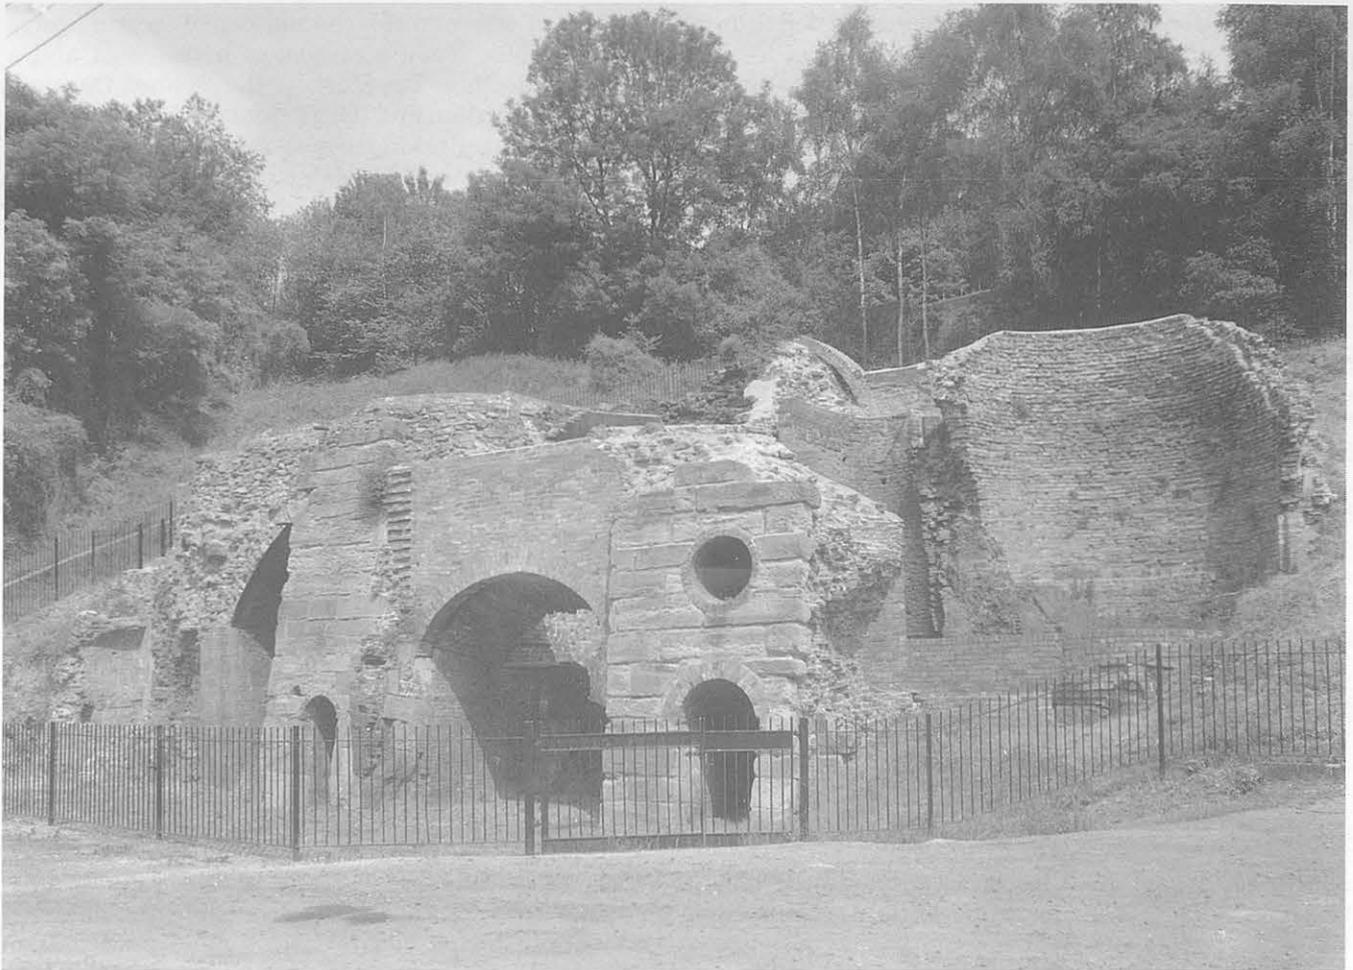
Figure 171 Bedlam, photographed looking north west in 1995 after its repair. Public access to the monument will always have to be restricted on safety grounds.

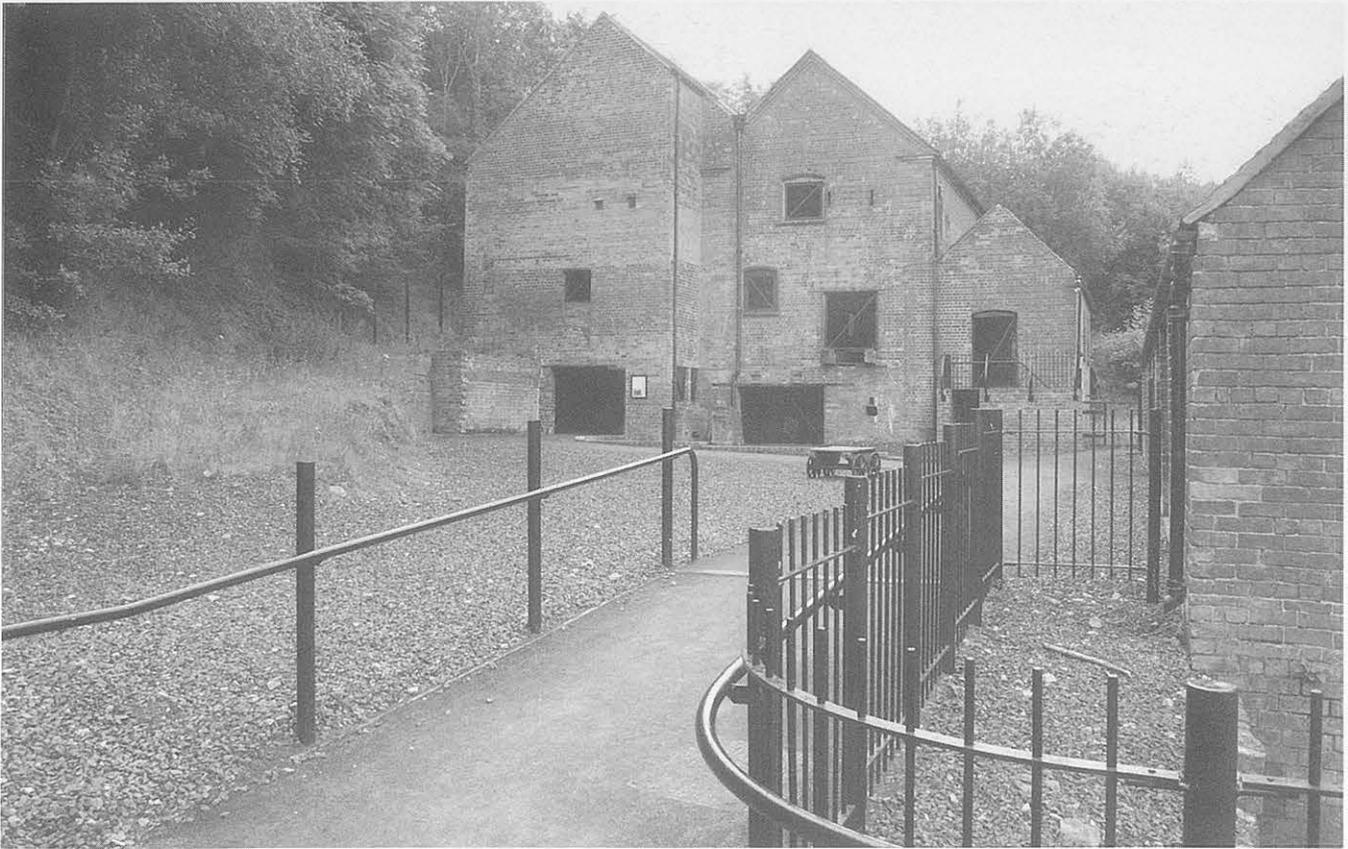
Figure 172 The Blists Hill Brick and Tile Works photographed looking south across the yard to the clay preparation block in 1998, showing the path provided during access works in 1995.

Public access to the brick and tile works was provided in 1995 (Fig 172). Access is now available into drying shed 1 (Fig 118), and the eastern range of the clay preparation block, with a view into the western range and engine house. A more distant view is available from the opposite side of the canal. Interpretation panels within the accessible area explain clay-working and brick-making processes whilst there are exhibits in the drying shed. It is
