# Meon Vale Estate (Phase 3)

Long Marston, Stratford upon Avon, Warwickshire

Archaeological recording

Site code: LME15

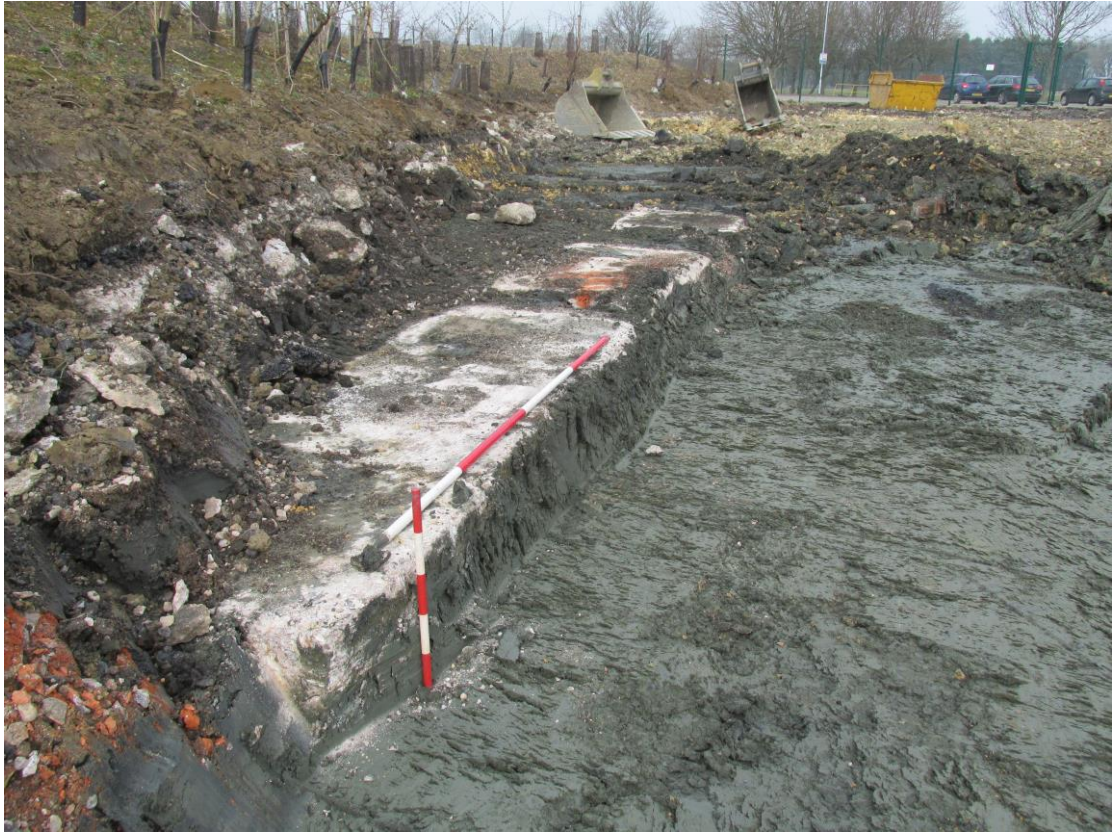
Overlying the natural clay (context 103) on the western edge of the study site was a layer of compacted crushed limestone (context 102) which acted as bedding for an overlying layer of concrete (context 101) which was interpreted as a former yard area. Situated on the western edge of the excavation were two areas of concrete footings (Contexts 104 & 105) representing the remains of two

Plate 3; context 105, from the south-east

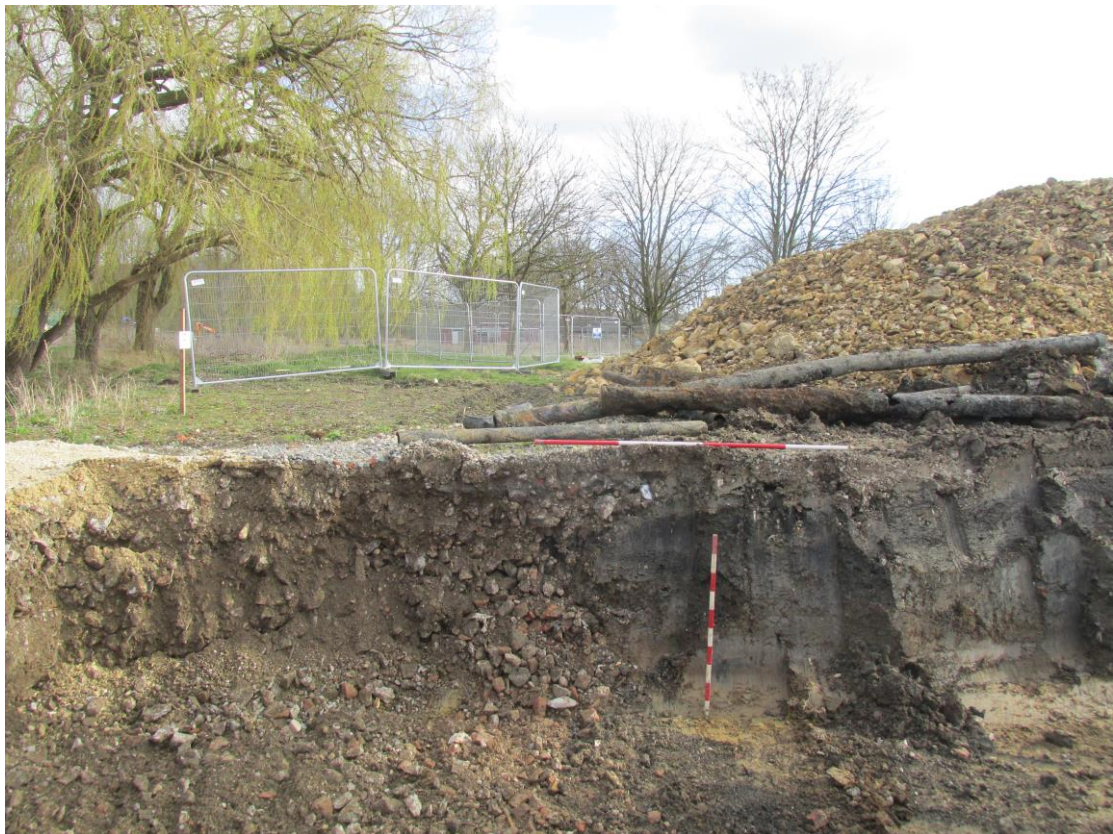
Plate 10; section 23

In the central area of the excavation (sections 21 & 23) the deposit of dark purple clinker (context 111) reappears in addition to a deposit of clinker and brick rubble (context 112).

In the south-east corner of the study site (sections 23-25) the natural geology, comprising a brown Lias clay (context 114) was overlain by a thick layer of redeposited blue-grey Lias clay (context 110). Sealing all of these was the loamy topsoil (context 106) which was itself truncated by a modern feature filled with soil and mostly rubble (context 115).

Significant truncation of deposits in the south-east corner of the site (modern feature; section 23) was associated with the construction of a new bridge across the watercourse. Re-deposited soil was also added along the eastern boundary probably during recent works associated with the management of the watercourse and which probably included the modern drain/culvert (Plates 14 & 15) before its demolition.

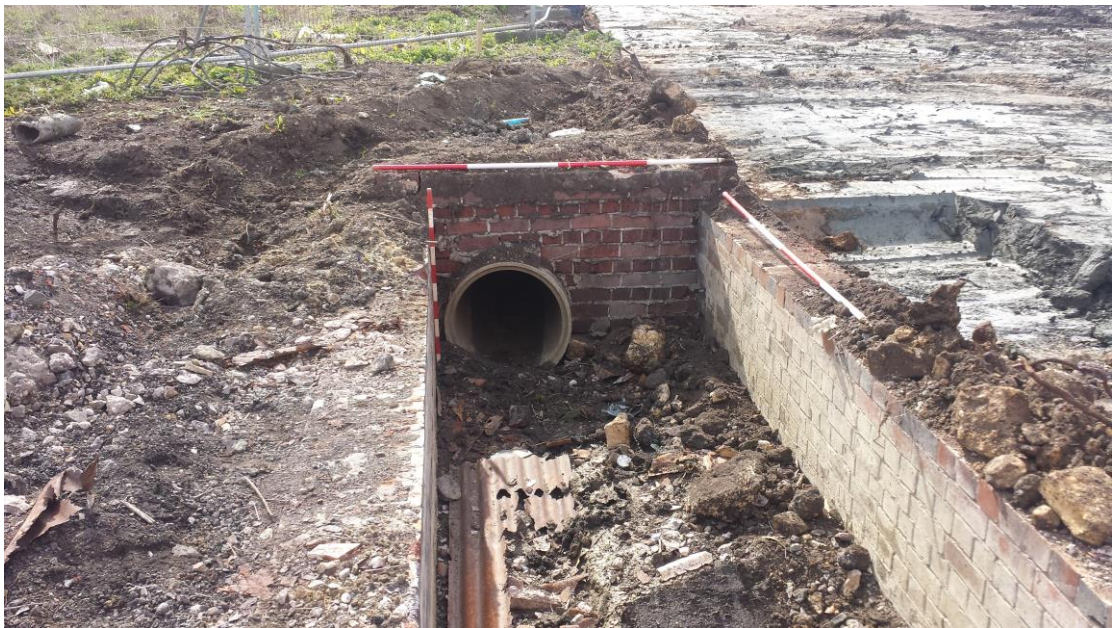
Plate 14; modern drain, from the north

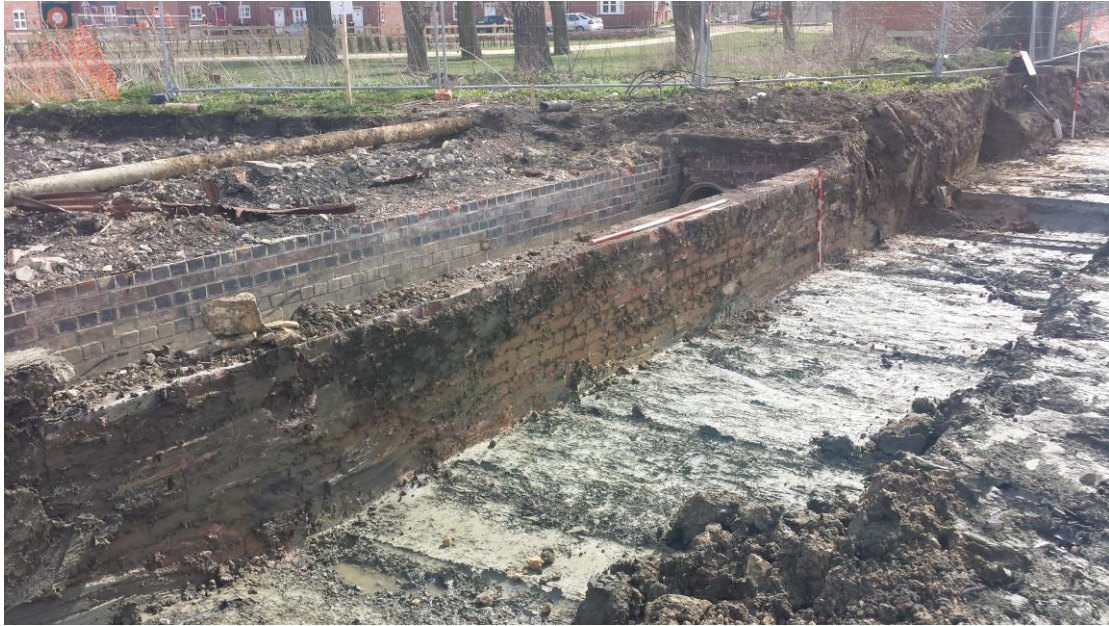
Plate 15; modern drain, from the north-west

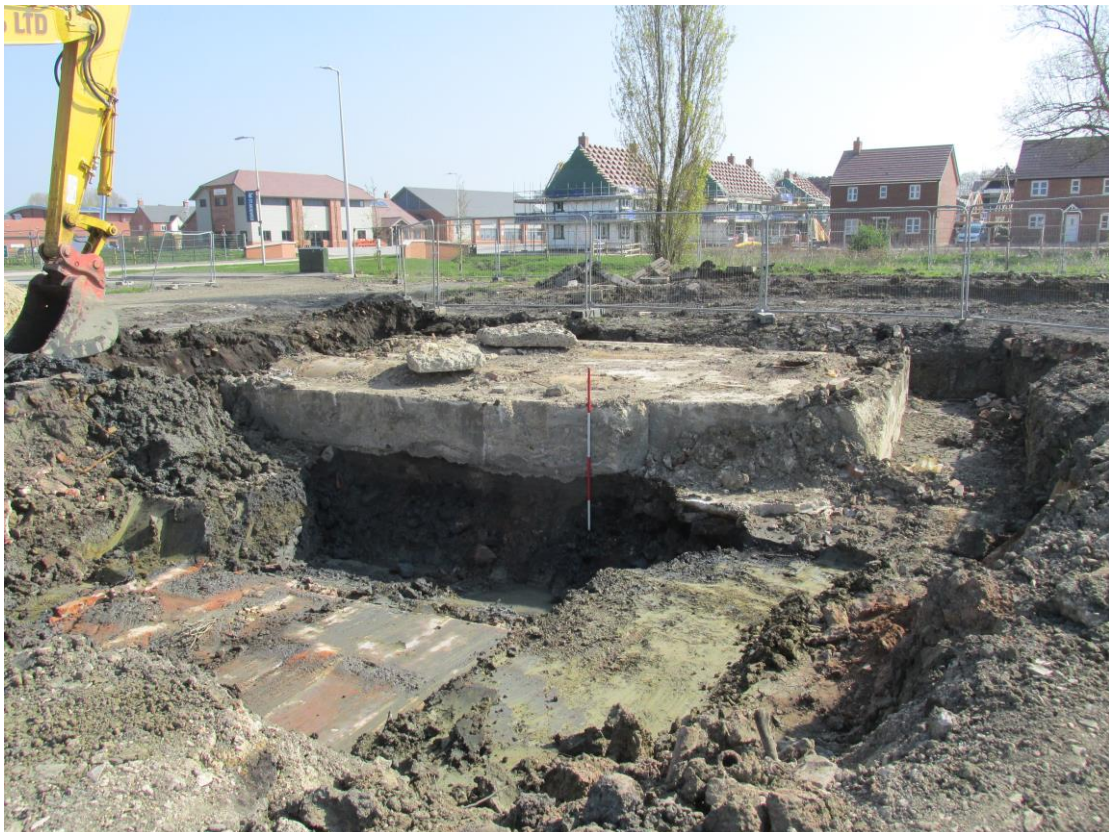
Plate 16; fuel storage tank

A former large fuel storage tank (Plate 16) for supplying the depot vehicles was also removed. A number of deposits immediately to the south-east of this (section 13) relate to another former large (?shed) building (OS 1970).
