Dodderhill Court

Crutch Lane, Elmbridge, Droitwich Spa, Worcestershire

Archaeological recording

Site code: DCD15

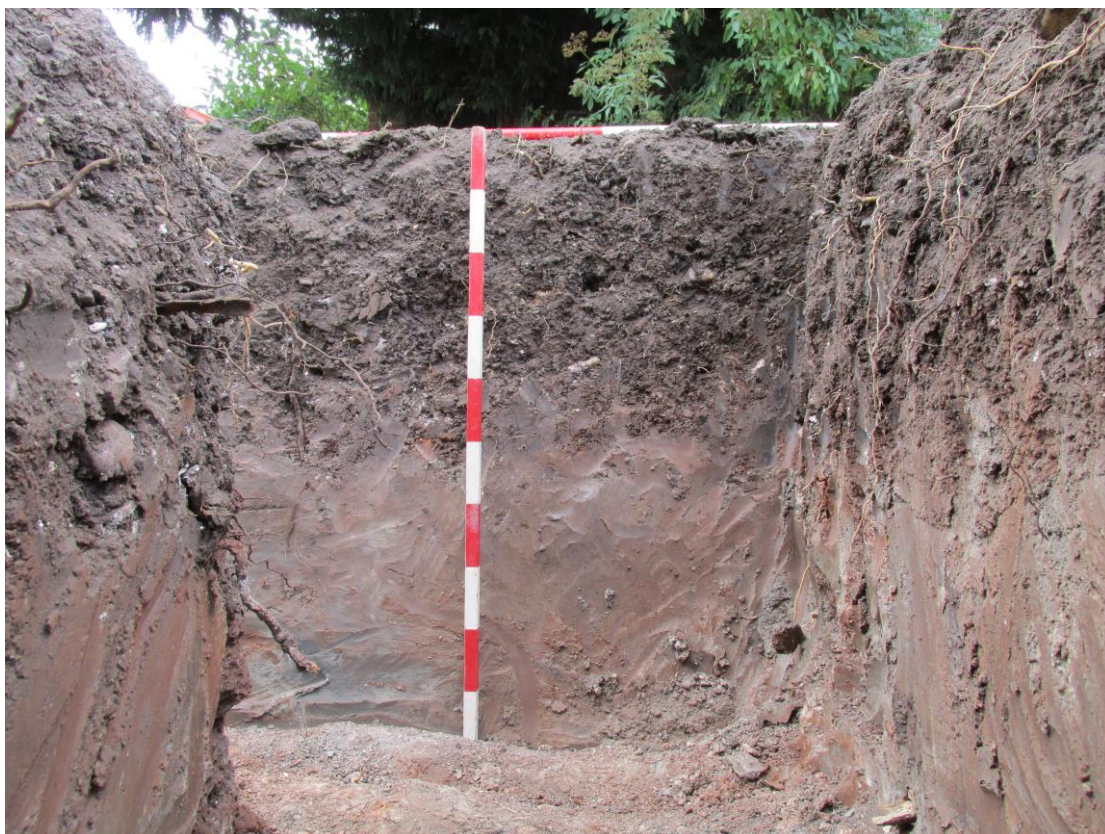
Plate 3; section 1a

Sealing all of the above contexts to a depth of about 0.50m throughout the central area of the east-west arm of the foundation trench was a layer of mixed soil comprising clay, silt and loam. Finds consisted of large flecks of mortar and fragments of brick. For the remainder of the trench, where deposits remain unaffected by later disturbance the natural clay was directly overlain by a relict subsoil (context 101) comprising a mid-dark silty-clay with numerous grit-sized flecks of limestone. This was in turn sealed by the modern topsoil (context 100) a dark greyish-brown loam.

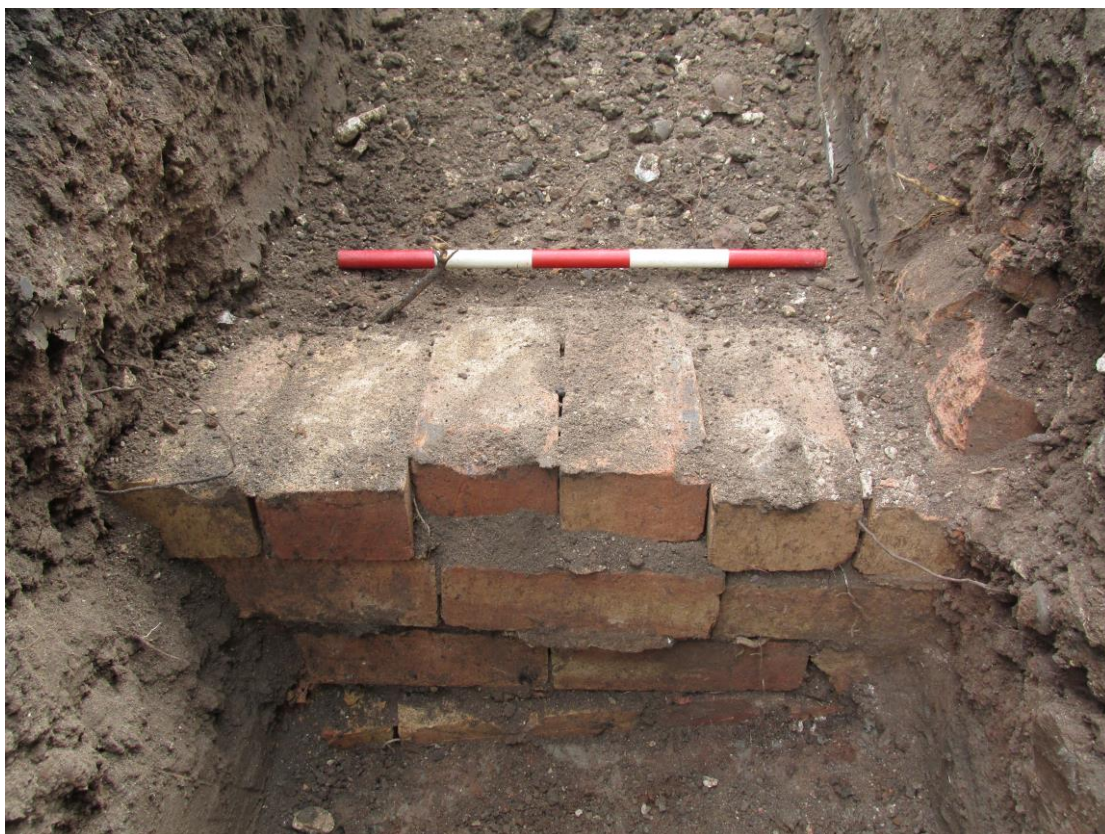
Plate 5; wall 103, from the west

The west limit of the construction trench for the former glass-house is marked by context 109, a steep sided cut, 0.50m deep. The bottom is characterised by a

narrow north-south trench, approx. 0.40m wide continuing beyond the base of the foundation trench. A brick wall (context 103, see Plate 5) aligned parallel slightly further west of this narrow trench appears to represent the remains of the west side of the former structure. This was removed during the excavation.

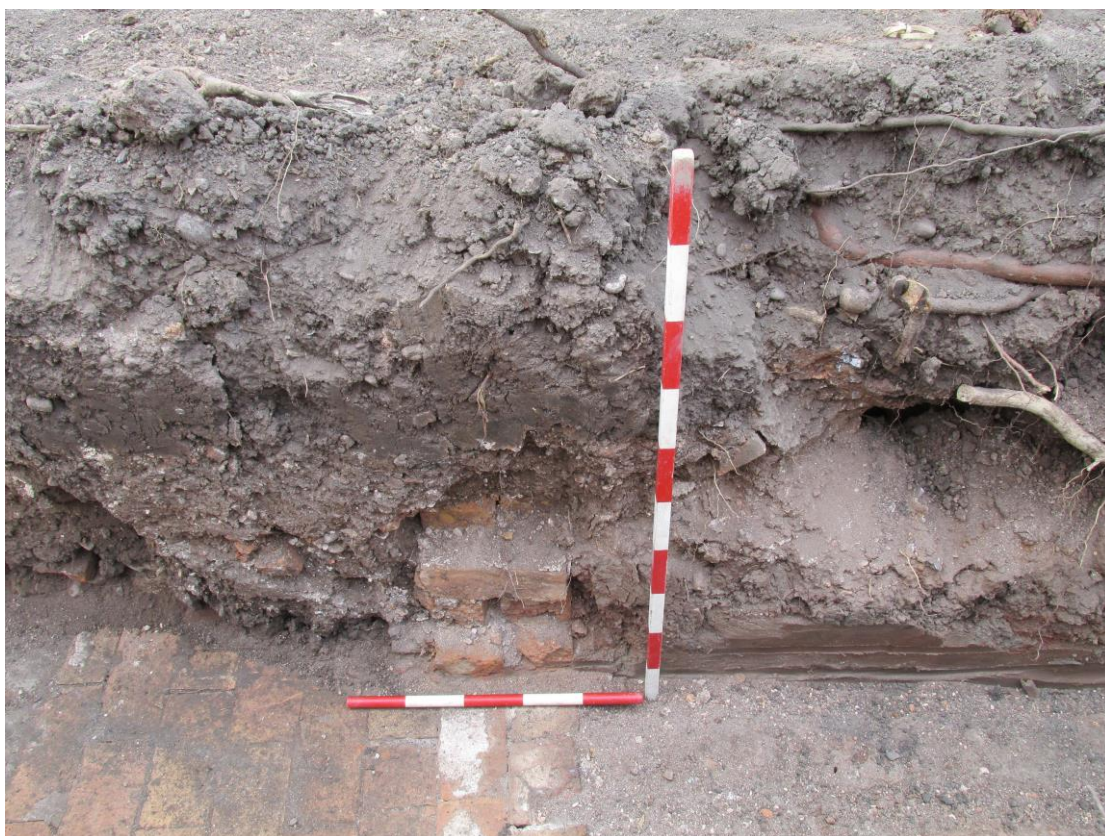
Plate 6; wall 104, from the north

Crossing the foundation trench and parallel with wall 103 in the centre of the trench was another brick wall (context 104), the area between this and wall 103 was about 2m wide, and comprised truncated, but level natural clay.

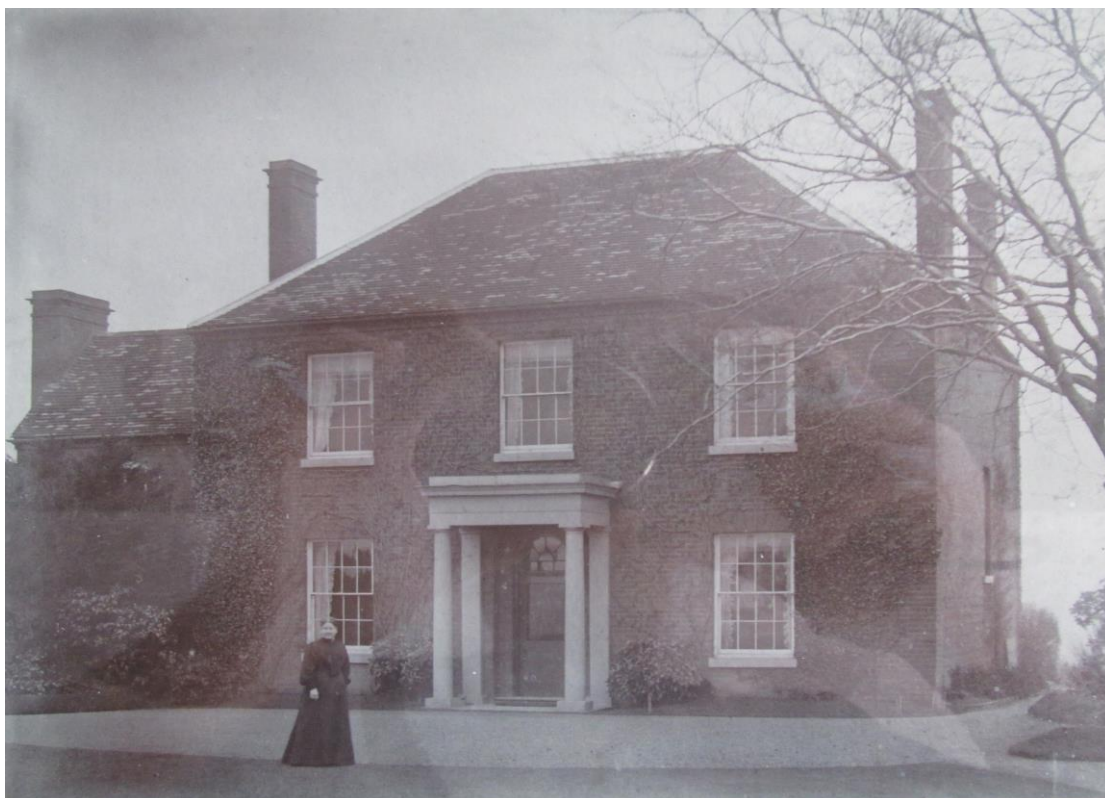
Plate 9; Hill Court in the late 19th century, from the south-west

The three-bay house is built of brick (Flemish-bond) and two ranges deep, the roof slopes back from each side and may originally have been provided with a roof light over the middle, there are a pair of tall chimneys at each end. The vaulted brick basement under the rear part of the house is accessed from the service-yard (with pump) by an external stair along the back of the service wing and formerly another door, now blocked, at the south-west corner. It is lit by a window in the south wall and a wine-cellar is constructed in the north-west corner.

The door, with fanlight, placed centrally in the façade is approached through a simple but well-proportioned classical portico. The sixteen-pane sash-windows have flat-arches (brick) and stone cills. The service-wing is shorter than the main house but the upper front window is clearly shown with a segmental-arch, its form reflecting its status, this front part of the service wing has a chimney against its gable-end. Both parts of the house have denticulated-cornices.

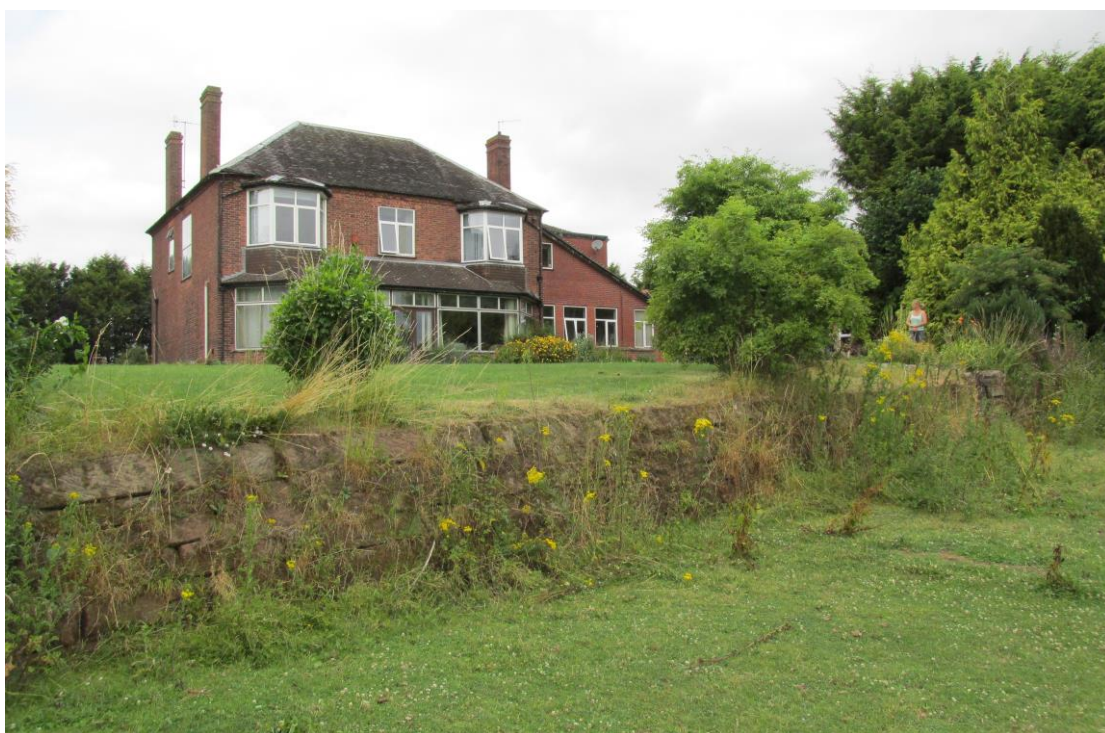
Plate 10; Dodderhill Court from the south-east with stone wall and haw-haw in the foreground

(see Plate 10). A number of these buildings were eventually demolished during development in the 1980s leaving only the west and north-west ranges surviving as converted dwellings and offices (see Plate 11).

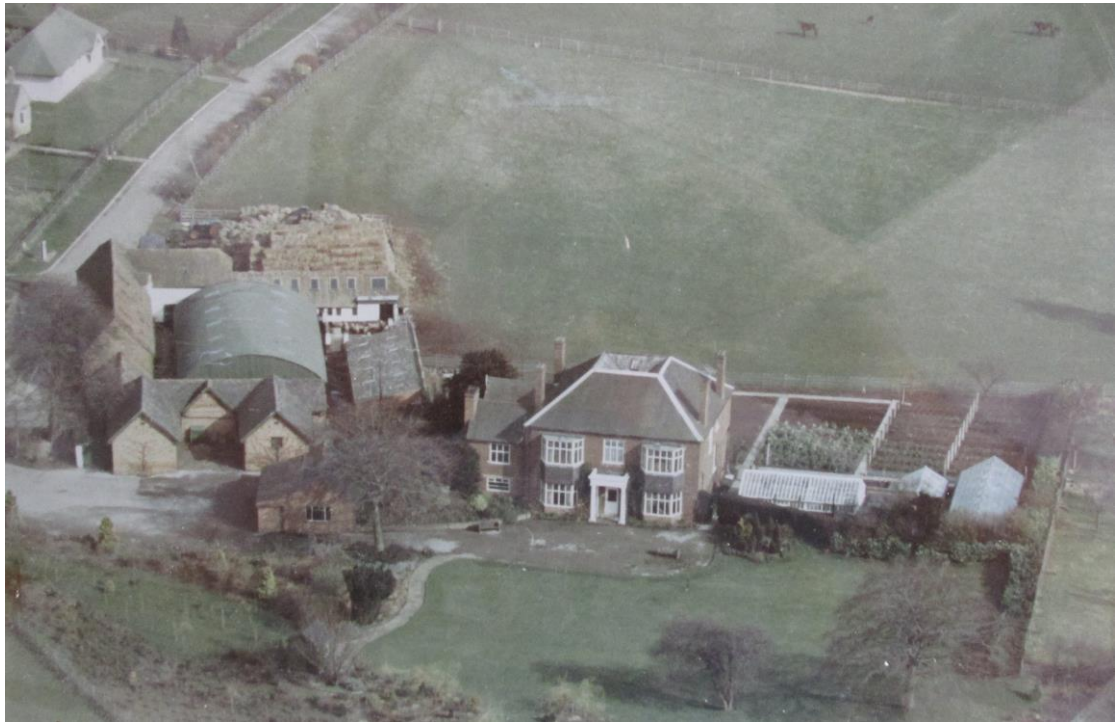
The lost barn occupied the eastern part of the north-range and appears to be of four bays, and a rear gabled projection at the rear may suggest the position of the threshing floor. An external stair provides access to the upper floor of the east end of this building, the small gable in this area, shown on the aerial view, may be associated with the door at the top of the stair. A two-bay building as tall as the barn extends southward from the east end of it and beyond that a long open-fronted shed. The roofs of these buildings terminate in half-hips. The single-storey building to the west of the barn is L shaped and continues as part of the west range and terminated in two small rooms each accessed from outside only. A pair of matching buildings, slightly taller, extend westward and between them there is gable on the back wall of the west-range. Some small buildings along the south side of the yard are not shown on the photograph but the small building with small attached yard may suggest a single pig-house, and as usual not too far from the house. A square building to the north of the fold-yard (beyond the ?rick-yard) still standing in 1885 may be the cart-shed.

Plate 11; Dodderhill Court in the ?1970s, from the west. Note the farms buildings still surviving with Dutch Barn and range added to the south-east closing off the yard. The 19th century glass-house also survives to the south of the house
