Land adjacent Dog Walk, Hill Lane
Formerly The Coach House & Stables

Elmley Castle, Worcestershire

Archaeological evaluation

one ten archaeology

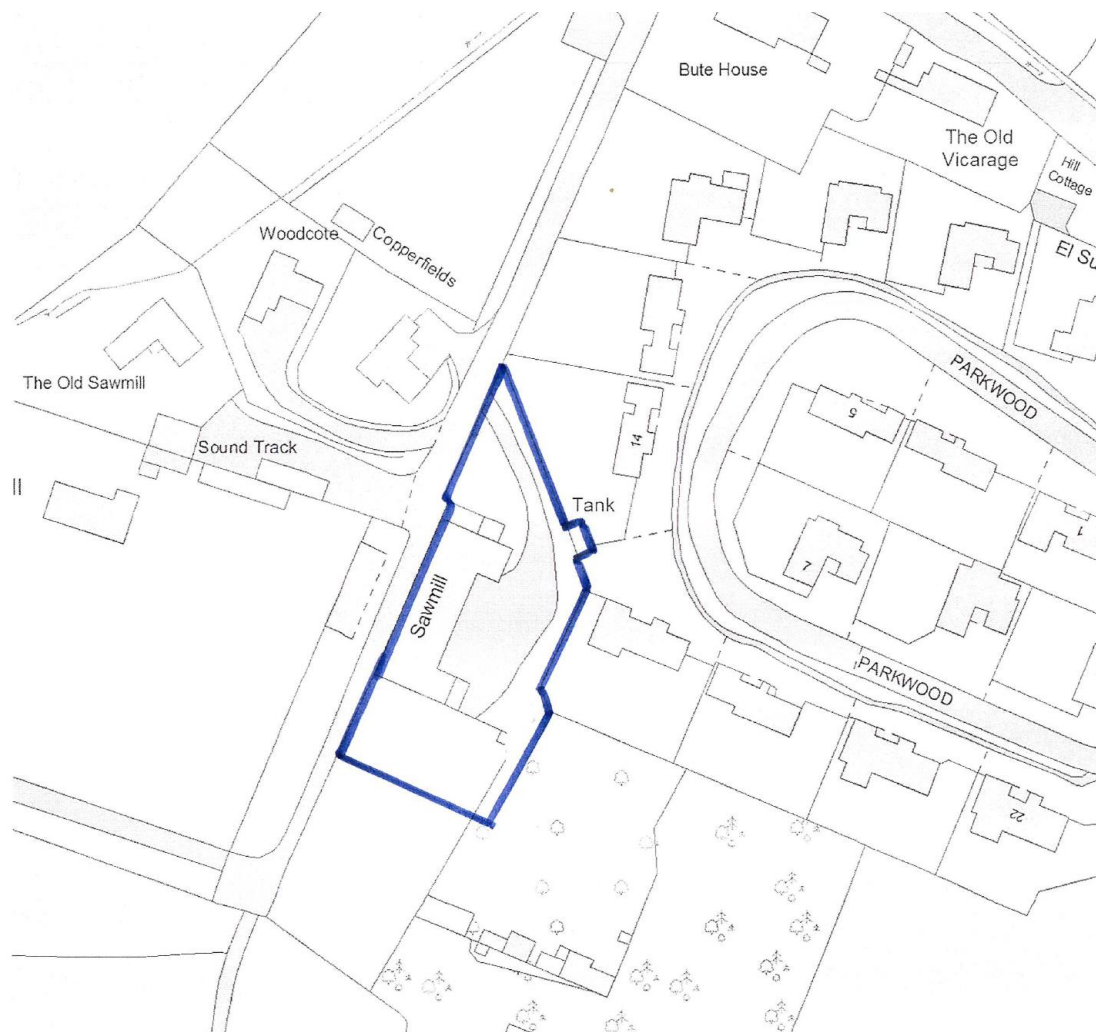
Fig. 3; outline of study area 2016

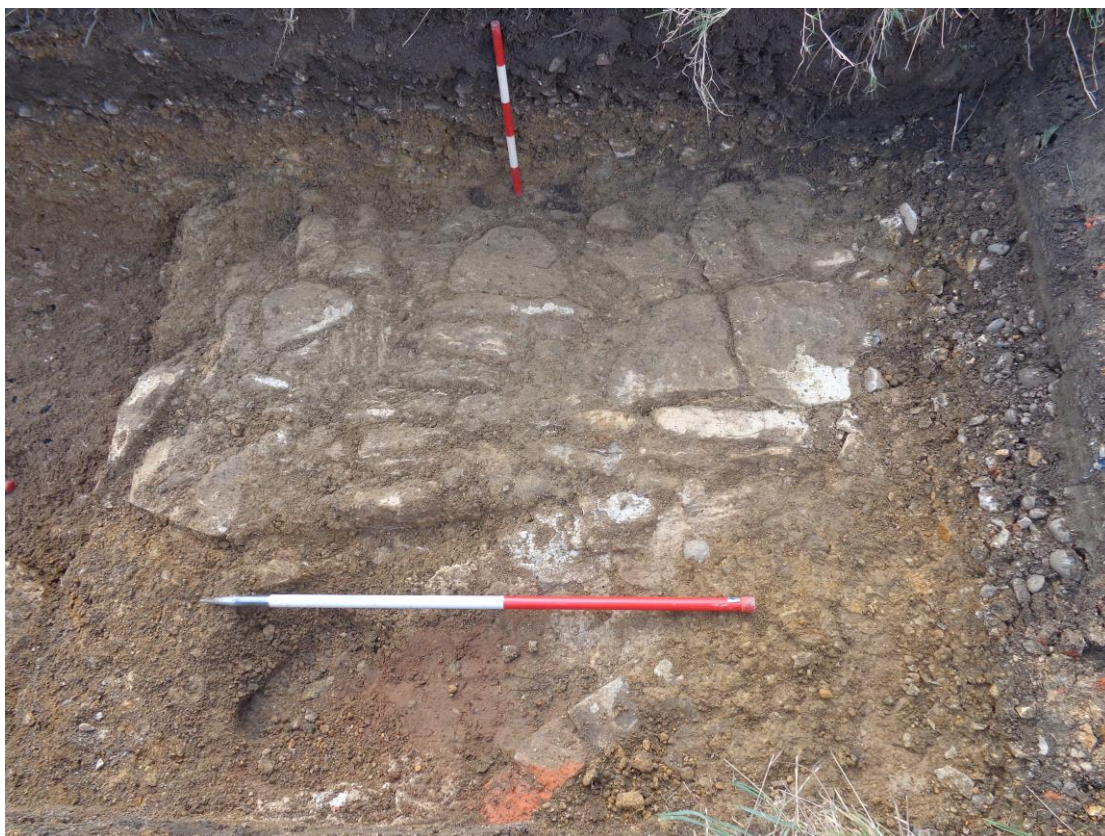
Plate 1; context 104 (stone paving), bottom half truncated, from the north-east,

Situated at the end of the north-west, south-east arm of the trench and seemingly set within context (deposit) 105 was what appears to be a former road surface constructed from limestone, some laid flat (large thick stones), some on edge (small thin stones). The surface of the feature is smooth and worn from continued use. Only the south-east side of the feature was exposed during excavation revealing stones again laid on edge to a depth of about 0.25m forming a sort of kerb edging. The surface appears to be aligned north-east to south-west. The south-west end continues beyond the edge of the trench whilst the north-east end is truncated by the construction trench associated with the stone drain (103).

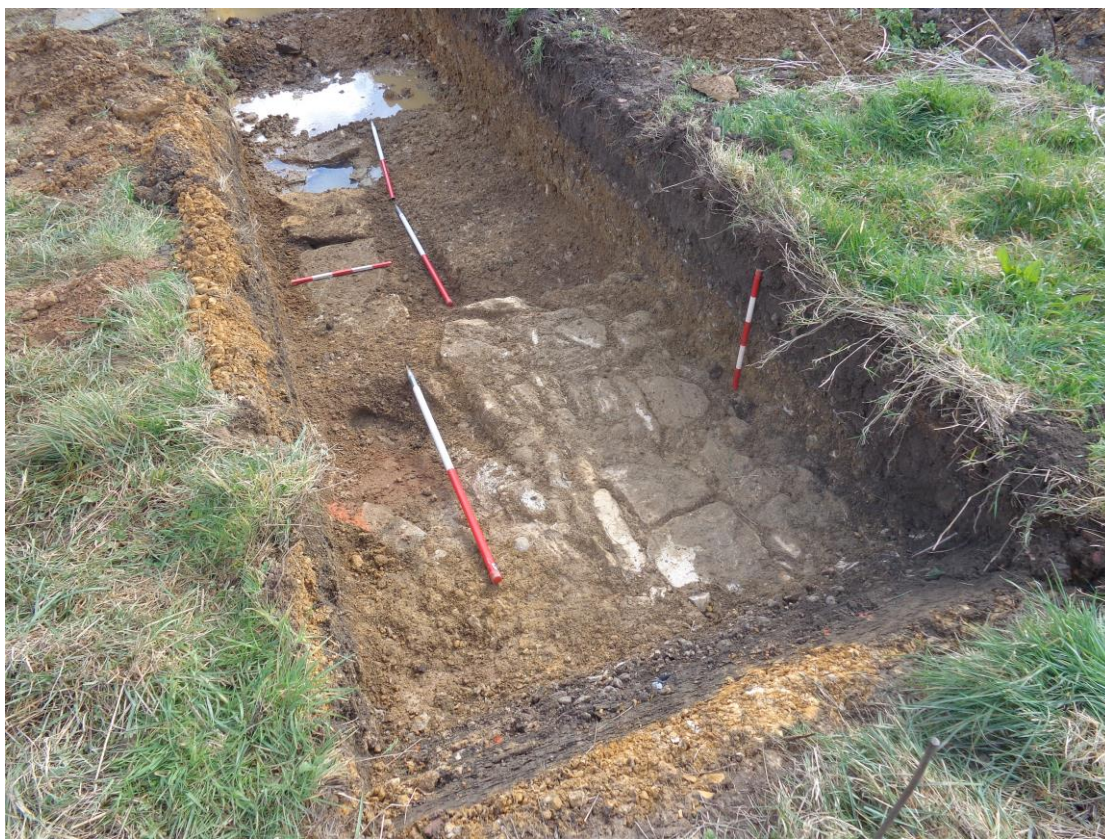
Plate 2; context 104 truncated during construction of a stone drain (103)

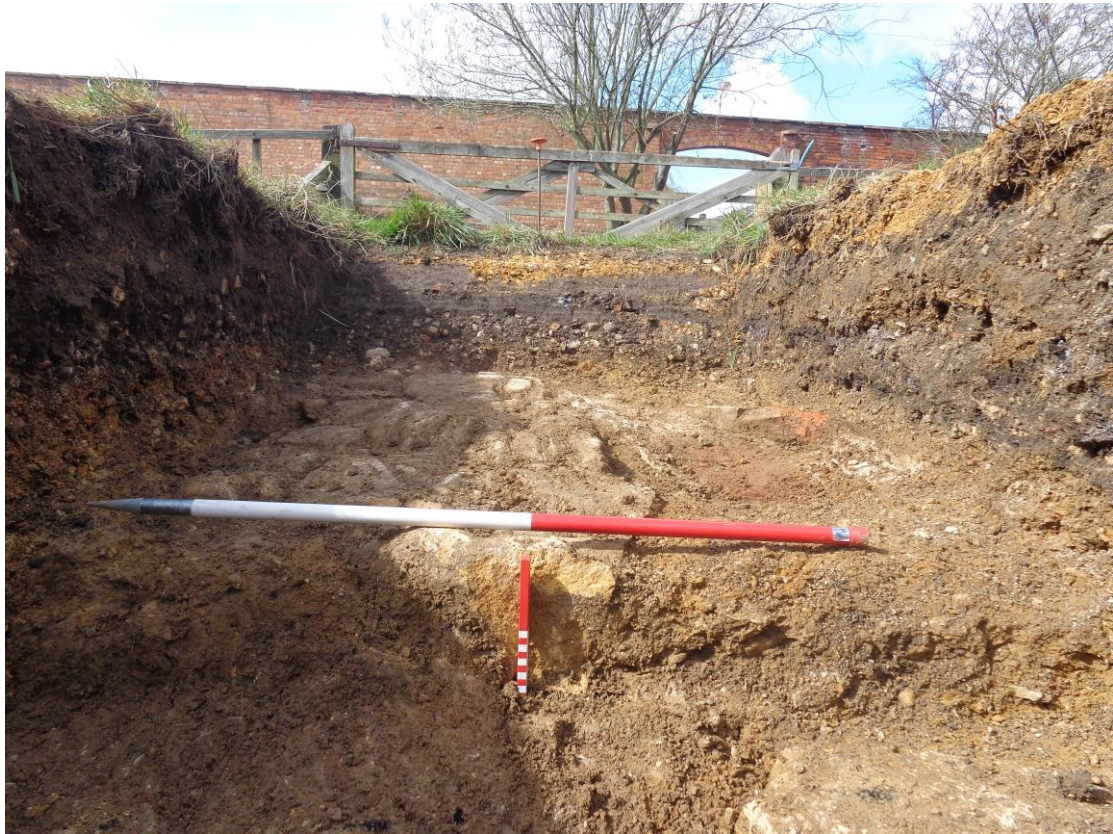
Plate 3; context 104, showing exposed stones on edge marking the south-west side of the feature, from the south-east

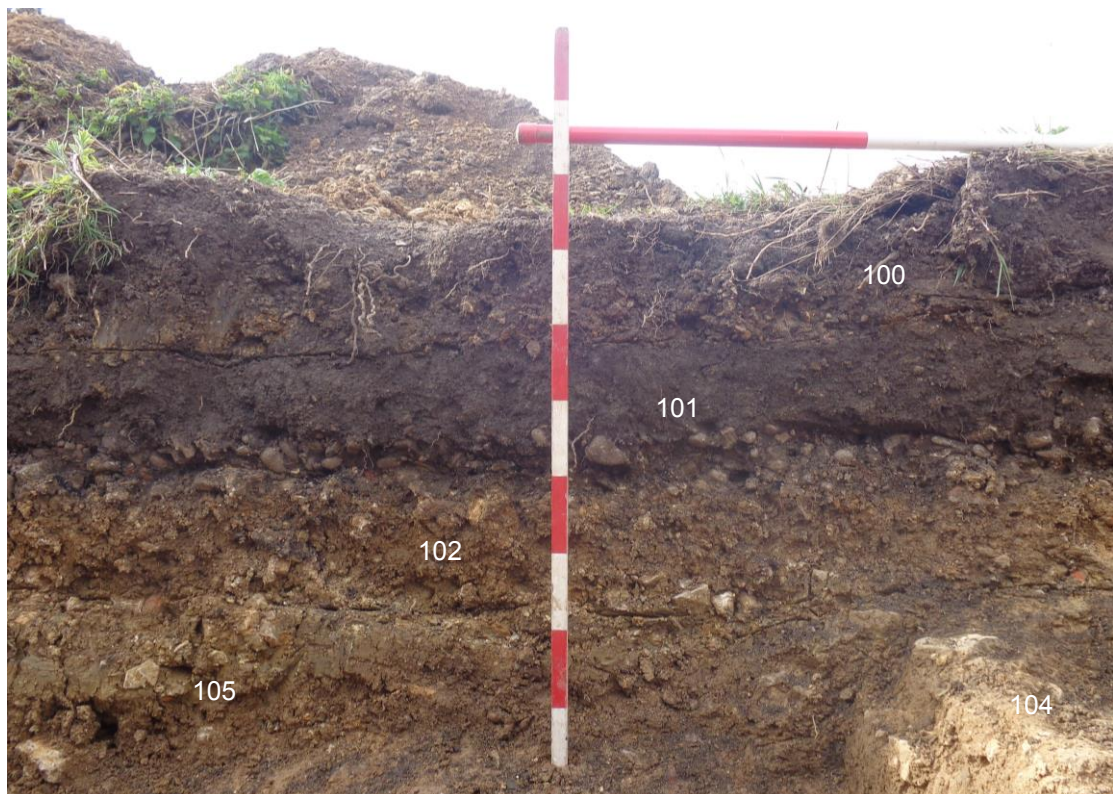
Plate 4; detail of stratigraphy within north-west end of the trench (section 1b), from the north-east

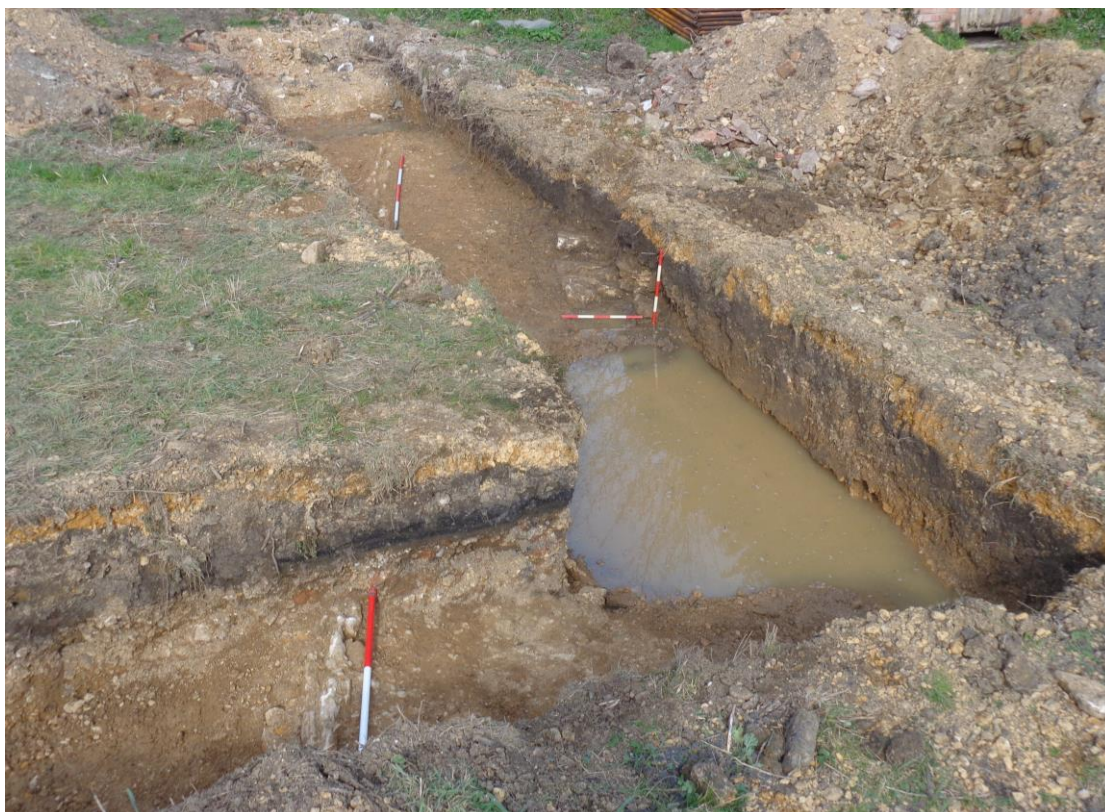
Plate 5; south-east corner of trench 1 showing linear stone feature (109) and corner of the stone structure (112) to the right, from the south-west

An undated linear limestone feature aligned across both arms of the trench and orientated north-east to south-west with a width of about 0.20m. It comprised a shallow, narrow line of mainly large, but with some small closely compacted stones laid on edge to a depth of about 0.20-25m (see plates 5-8).

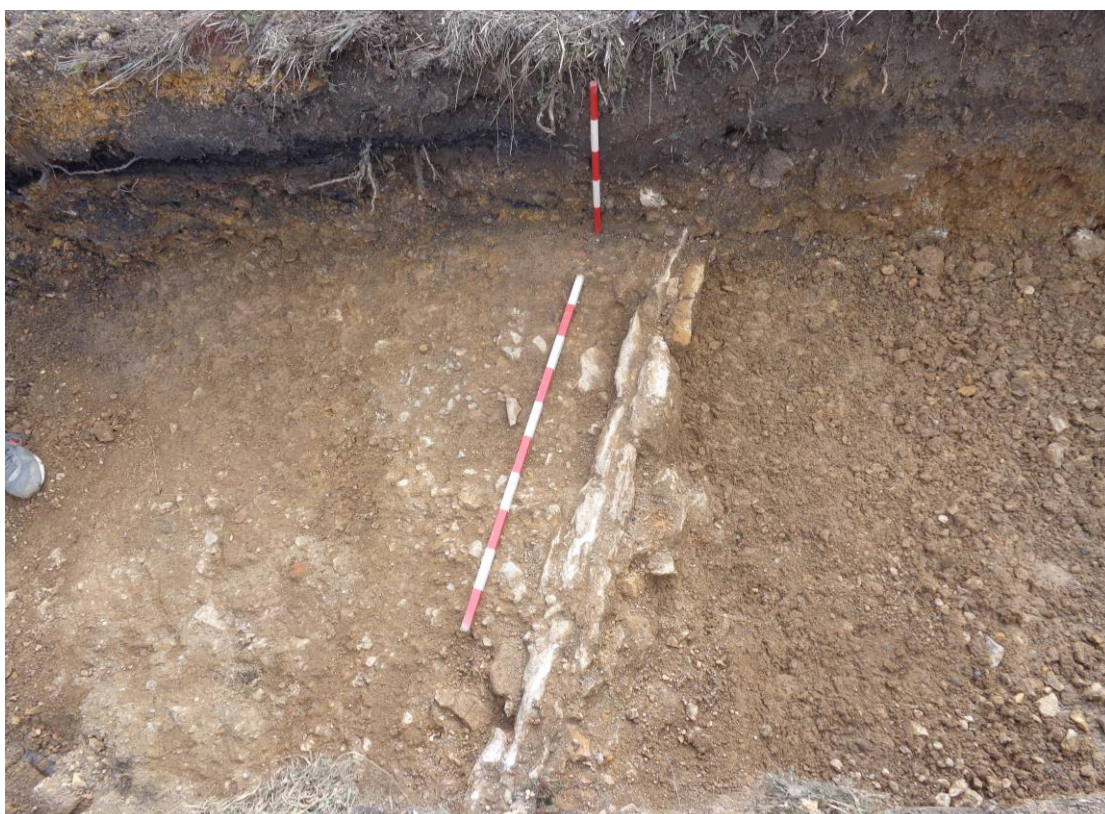
Plate 6; linear stone edging (109) within north-west to south-east arm of trench1, from the north-east

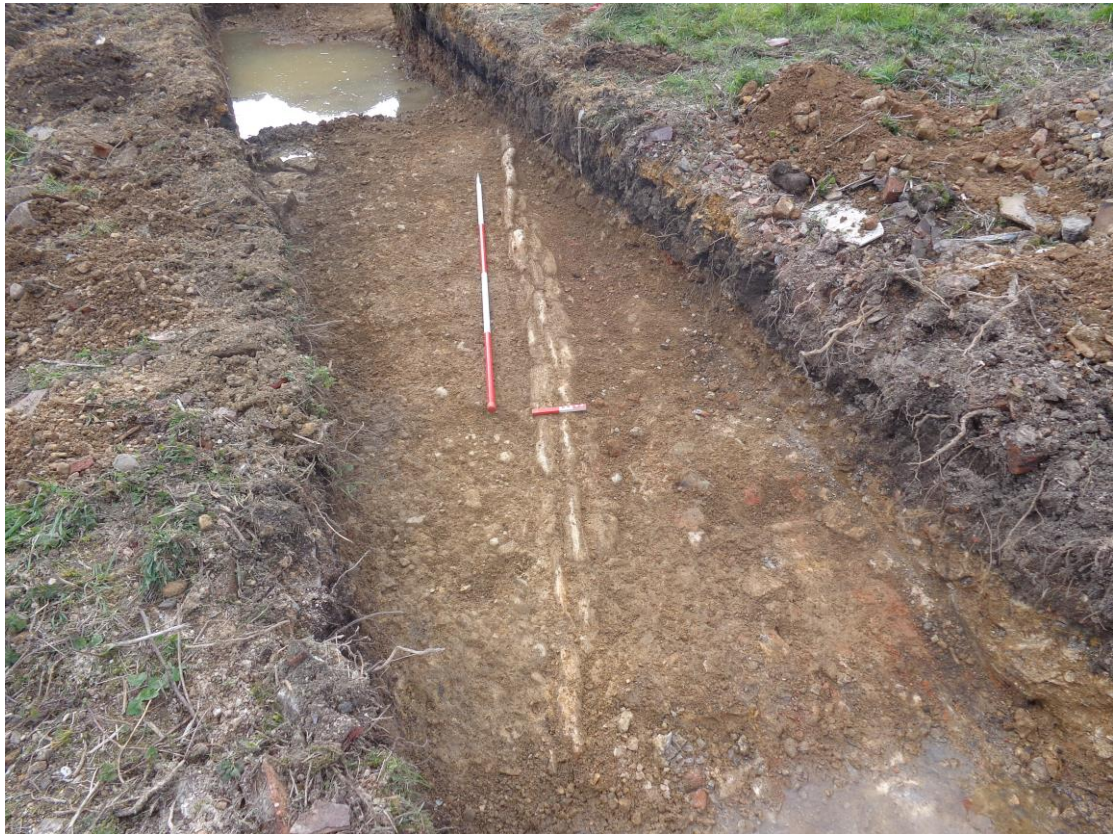
Plate 7; linear limestone feature (109) within the north-east, south-west arm of trench 1, from the north-east

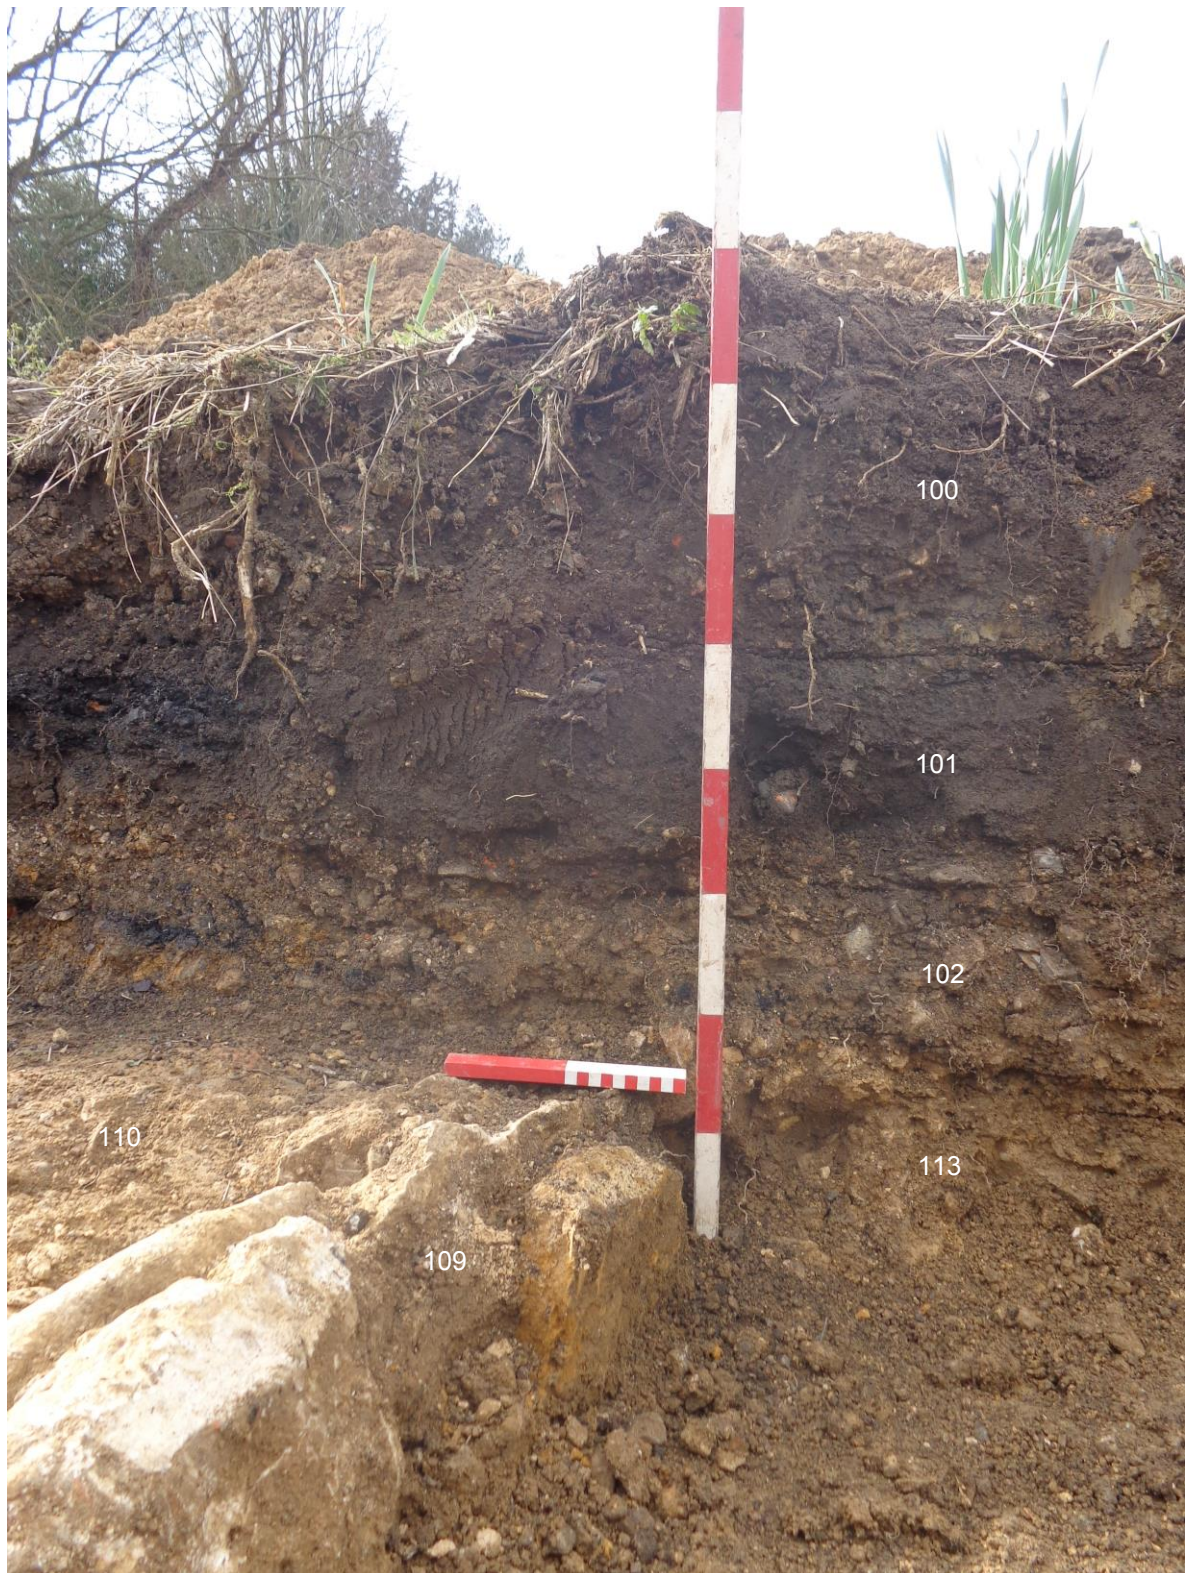
Plate 8; detail of stone feature (109) within the north-west to south-east arm of trench 1, comprised of limestones placed on edge and separating contexts 110 & 113. These deposits are then sealed by the layer (102) and subsequently by contexts (layers) 100 & 101, view from the north.

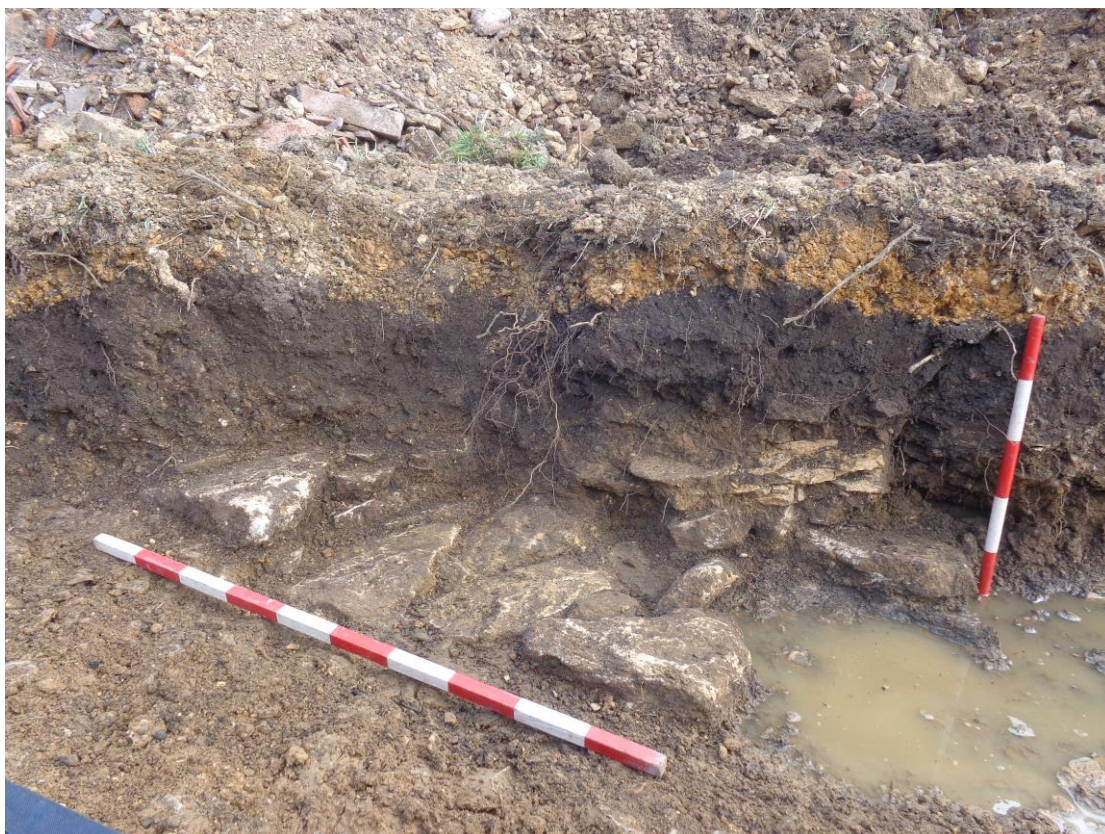
Plate 9; context 112 (stone wall), from the west. The corner stone (area of puddle) was dislodged during machining

Situated, but only partially exposed within side of the north-east to south-west arm of the trench, was a seemingly roughly constructed limestone structure interpreted as the probable (south-west) corner of an earlier (now buried) wall. A corner stone was dislodged during machining. (see plate 5; general view & plate 9; detailed view). The structure, which appears to represent the undated remains of the south-west corner of a former building, is aligned parallel (north-east, south-west) with the linear stone deposit (109).

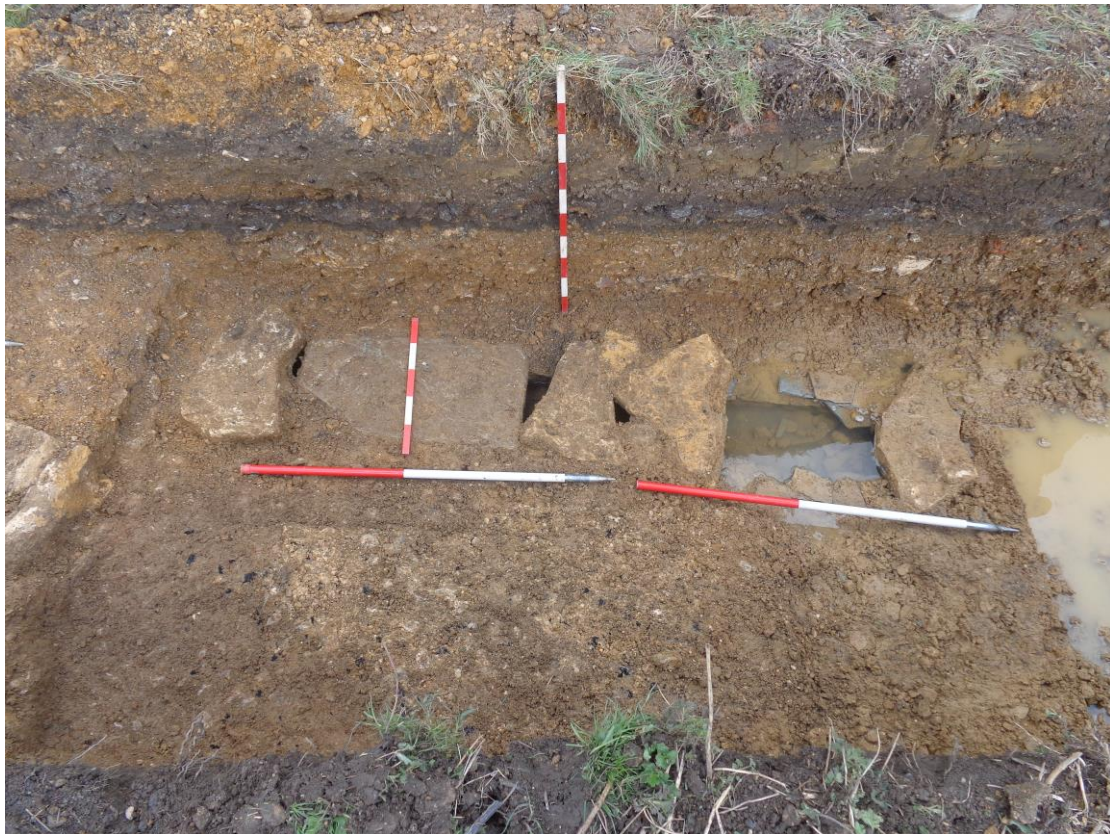
Plate 10; context 103 (stone drain), from the south-west

A stone drain (103), partially revealed sloping down from the north-west to south-east, was constructed from a combination of Lias and limestone. It comprised a stone channel of two parallel side walls and a stone base, with an internal width of 0.22m and approx. 0.20m deep. Further excavation was prevented by water inundation. Capstones made from irregular shaped flat stones, covered the drain. The largest of these was lifted (plate 11) and was shown to have been placed over a fork in the alignment indicating a junction at

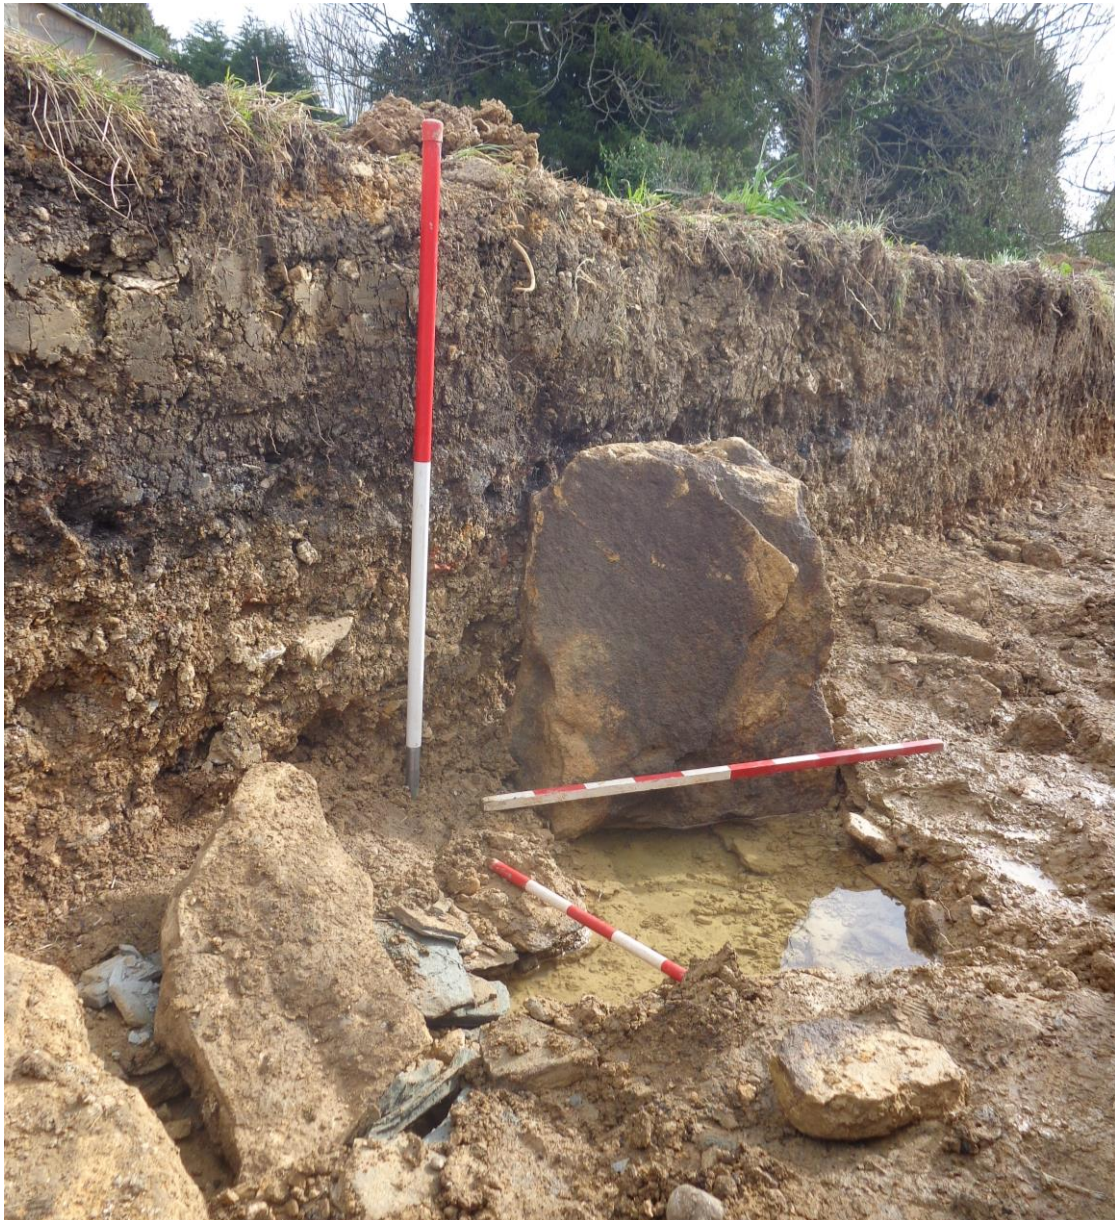
Plate 11; showing partially lifted capstone at the junction where the drain feature (103) forks in two directions and continues beyond the edges of the trench, one continuing to the south and the other to the north, towards the existing building. Detailed excavation was prevented due to the inundation of groundwater.

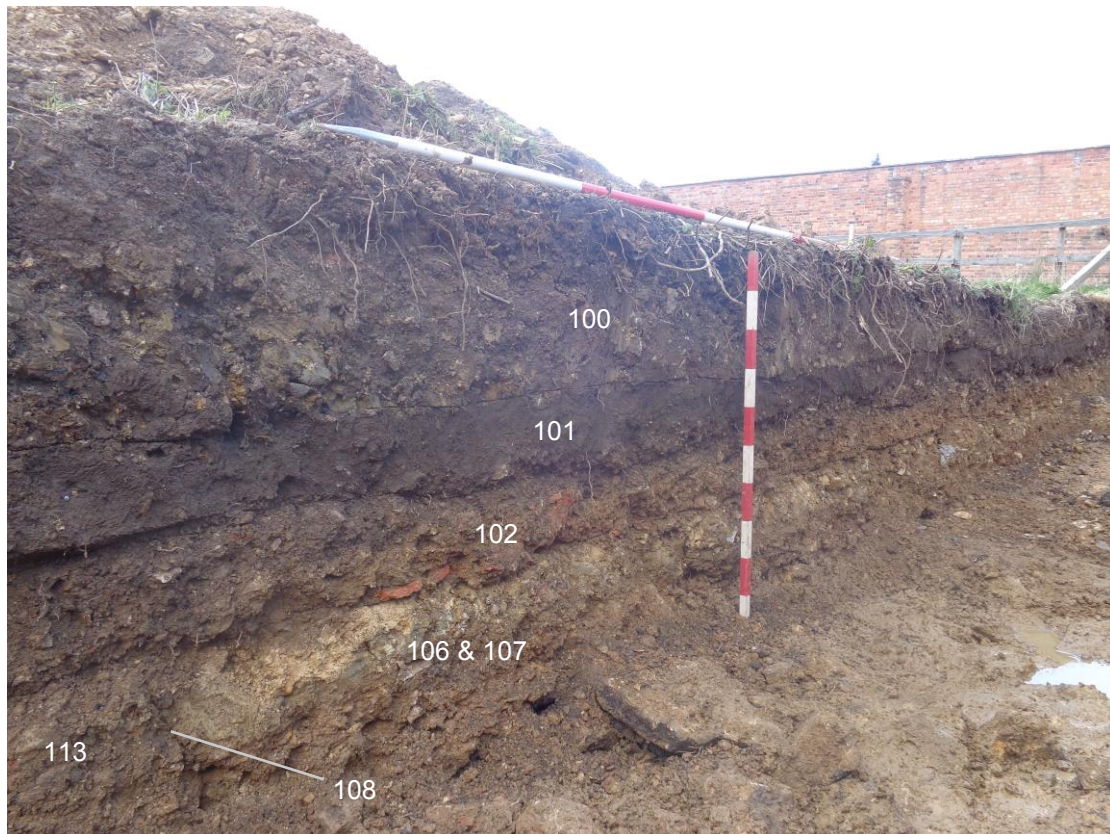
Plate 12; section 2b, detail, showing trench cut and backfill associated with the construction of the stone drain (context 103). From the north-east.

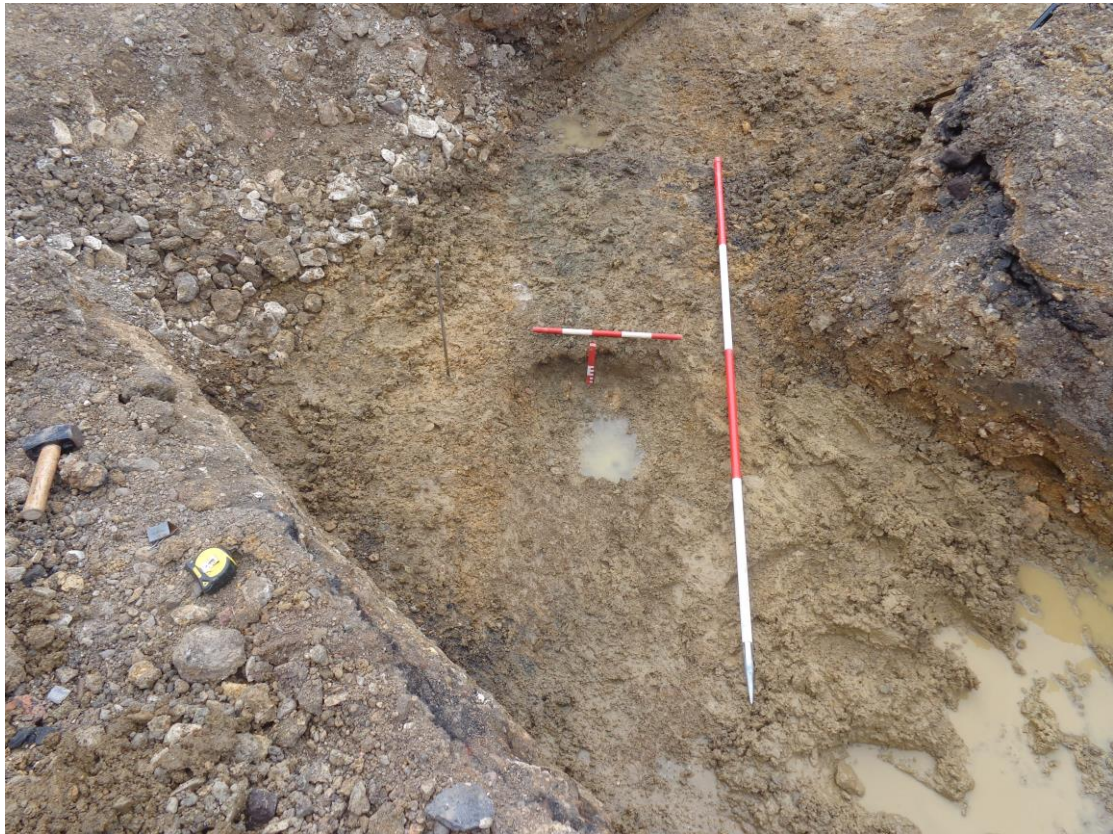
Plate 13; linear gully-like feature (208), from the north-west

Aligned north-west to south-east at the north end of the trench for a distance of about 2.50m and continuing beyond the edges of the trench, was a linear gully-like feature (208). It was about 0.20m deep, with gently sloping sides and a rounded base. It was filled by a single undated deposit (207) of light greyish-brown (with a red tinge) silty-clay with a small inclusion of charcoal flecking and the occasional small and larger fragment of limestone.

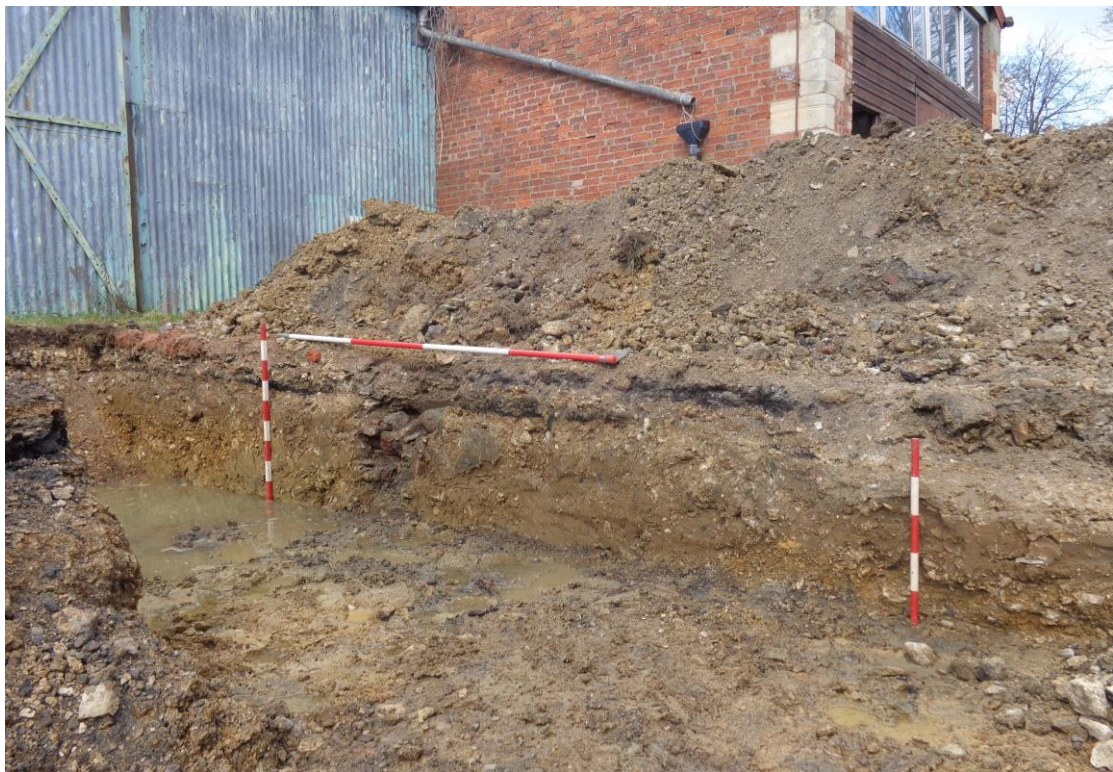
Plate 14; north-east to south-west arm of trench 2, showing the Lias clay natural (209) overlain by context 204 (redeposited sandy-clay) in turn sealed by the modern yard surface deposits, view from the south

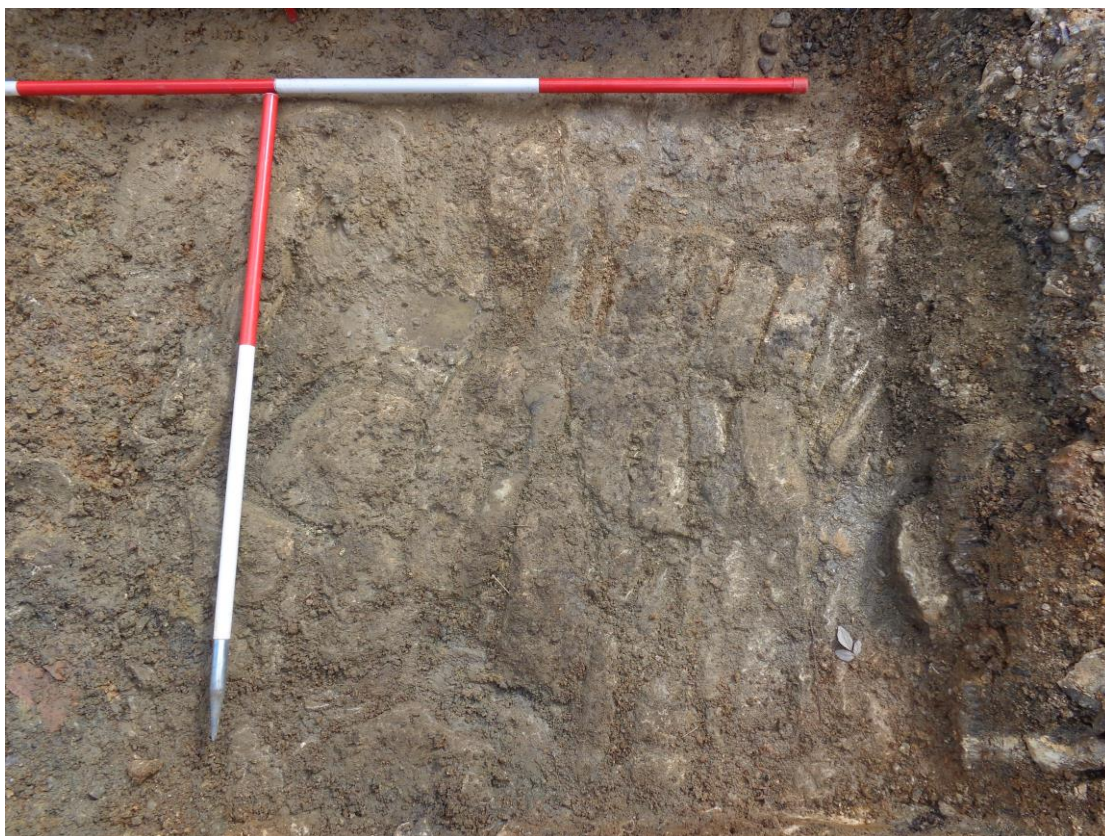
Plate 15; context 205 (stone surface), detailed view, from the north-west

Located within the central area of the trench, but separated as a result of truncation associated with modern pipe trenches (204), were two undated areas of limestone paving (205 & 206) comprised of mostly small stones laid flat over the natural Lias clay. The surface of the stones in both deposits were rounded and clearly worn through continued use. Context 205, continues south below a later road/yard area (201). Both deposits share similarities in their construction with the stone paving (104) in trench 1. Interestingly, context 205, although partially disturbed, has retained enough of the deposit to show that the north-east side of the surface contains the remains of some edging, with stones laid on edge. This is a characteristic comparable with the exposed south-east edge of context 104 and is an indication perhaps of the northern extent of an earlier yard/road area.

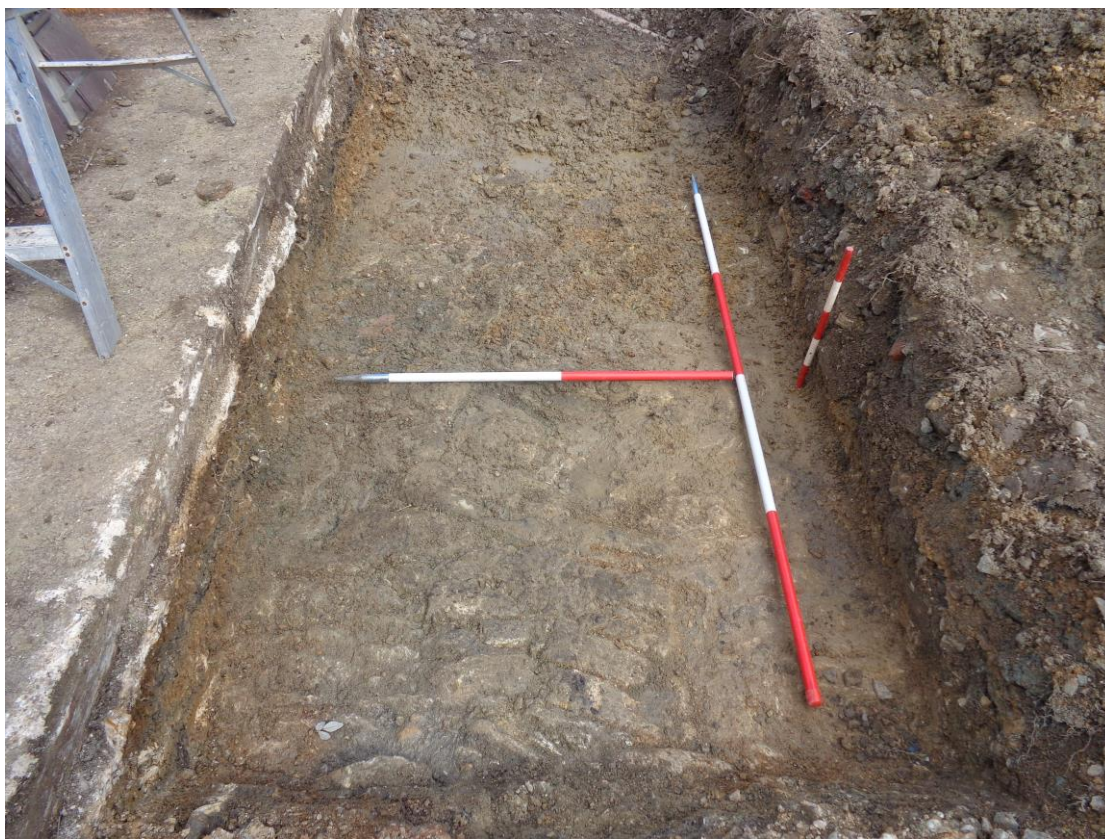
Plate 16; context 205, overall view, from the south-east

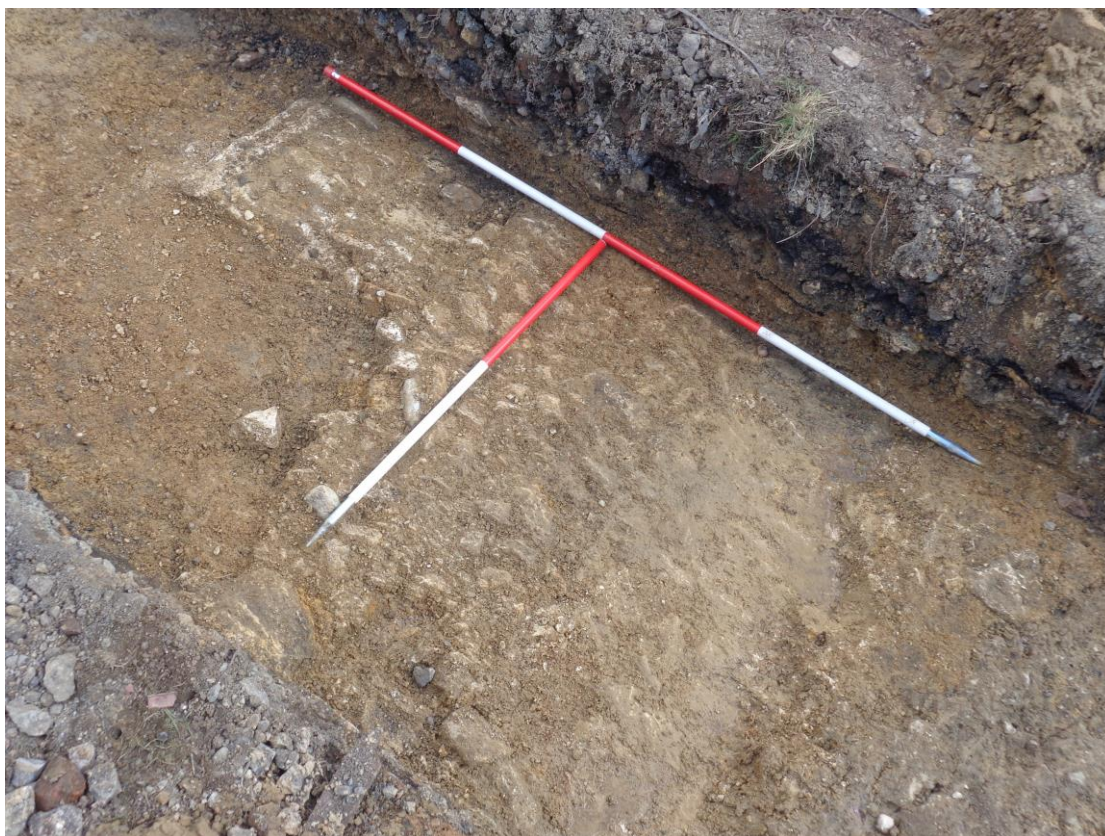
Plate 17; context 206, overall view from the west

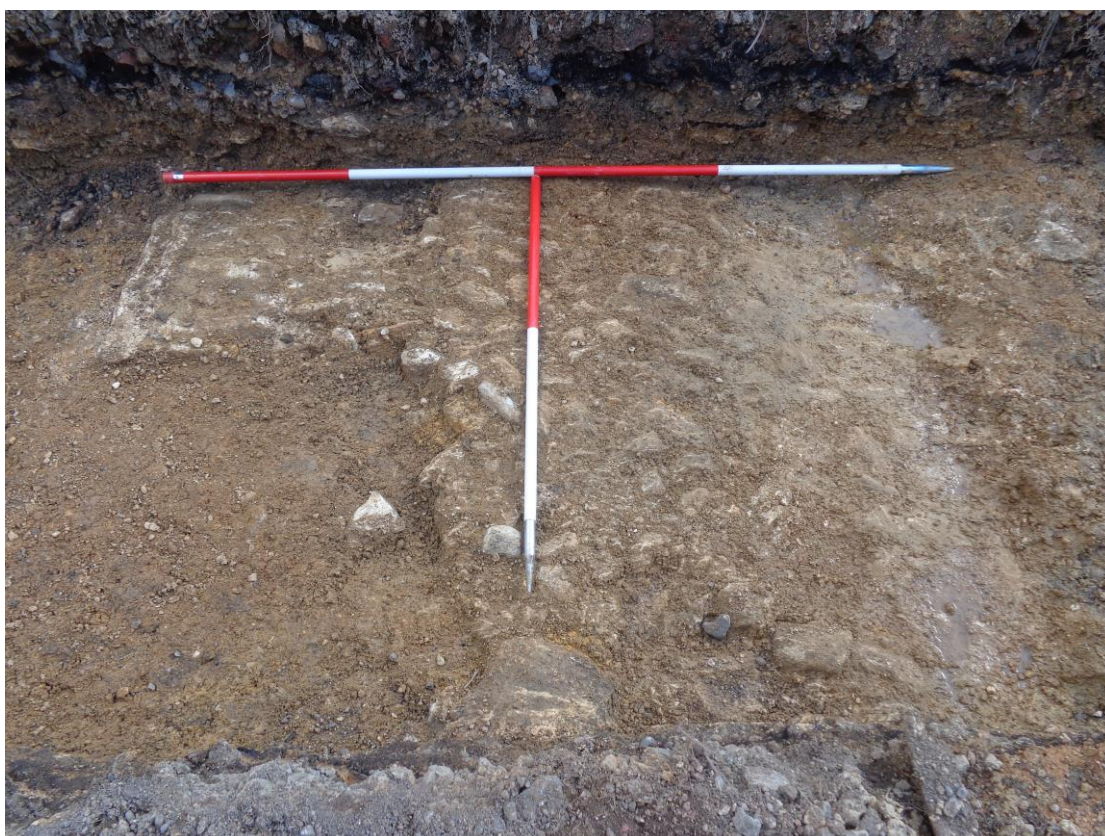
Plate 18; context 206, note edging stone in top left of image, from the north-west

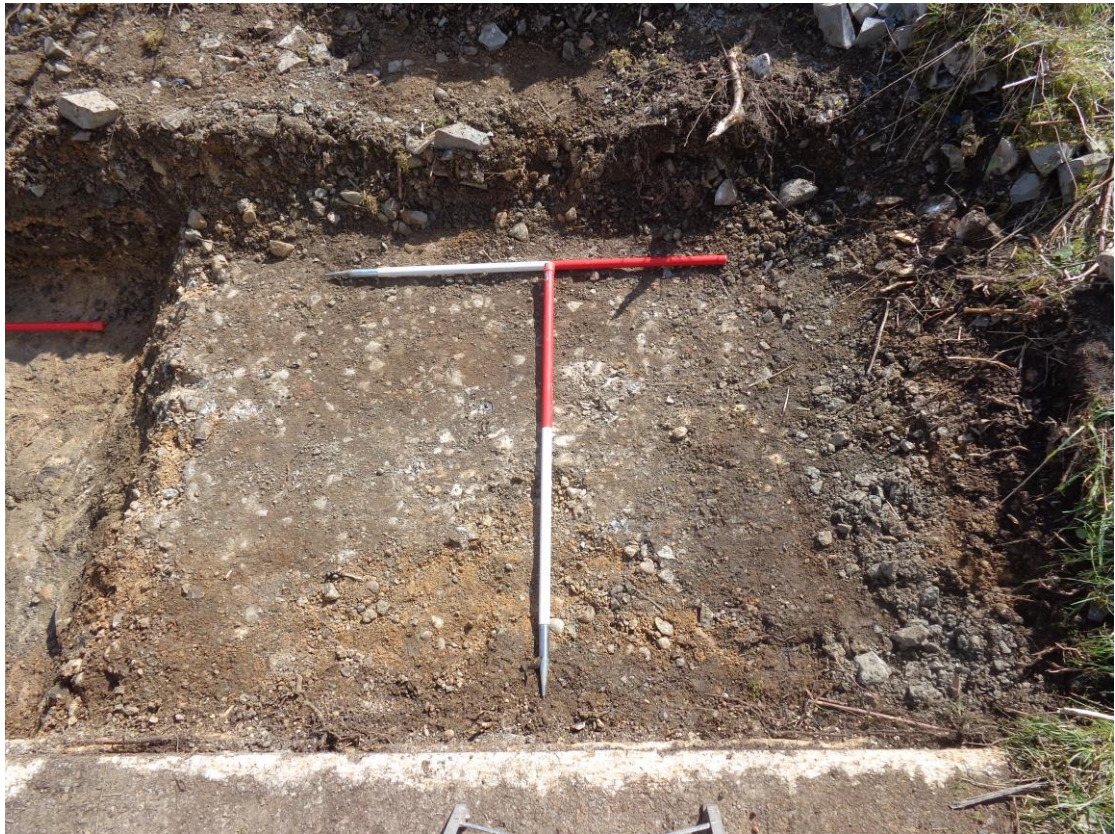
Plate 19; south-west end of trench 2 showing surface of context 202, from the north-east

Overlying stone surface 205 at the south-west end of the trench (see Section 2c; plates 19 & 20) was context 201, a thin layer (0.10m thick) of material equivalent to deposit 204.

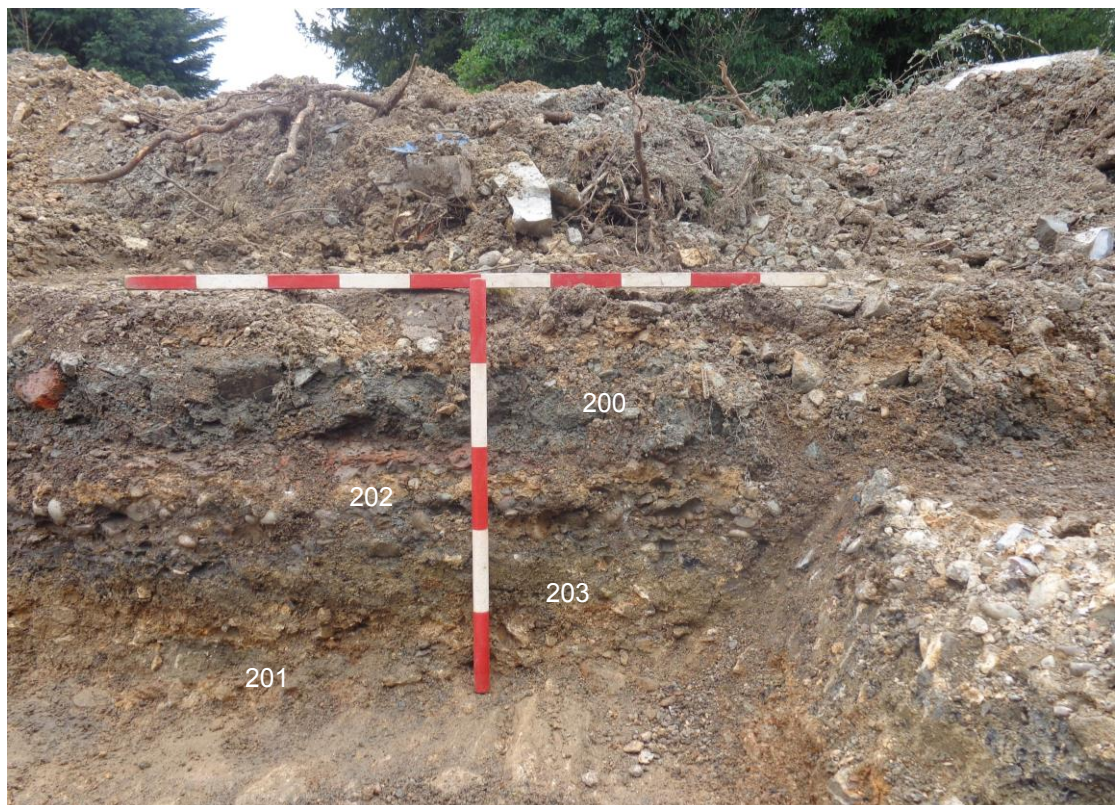
Plate 20; section 2a, detail of deposits overlying stone surface 205, view from the north-west
