Land adjacent Dog Walk, Hill Lane
Formerly The Coach House & Stables

Elmley Castle, Worcestershire

Archaeological evaluation

one ten archaeology

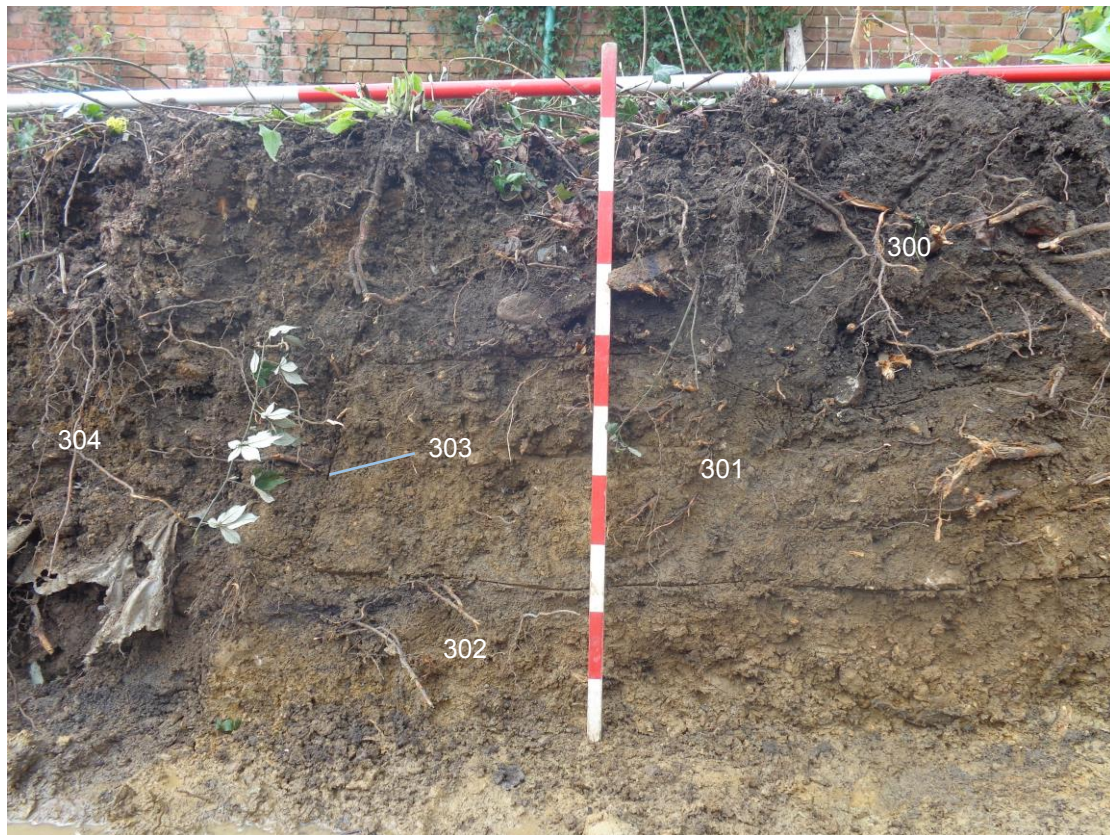
Plate 21; section 3a, detail of stratigraphy, from the north-east

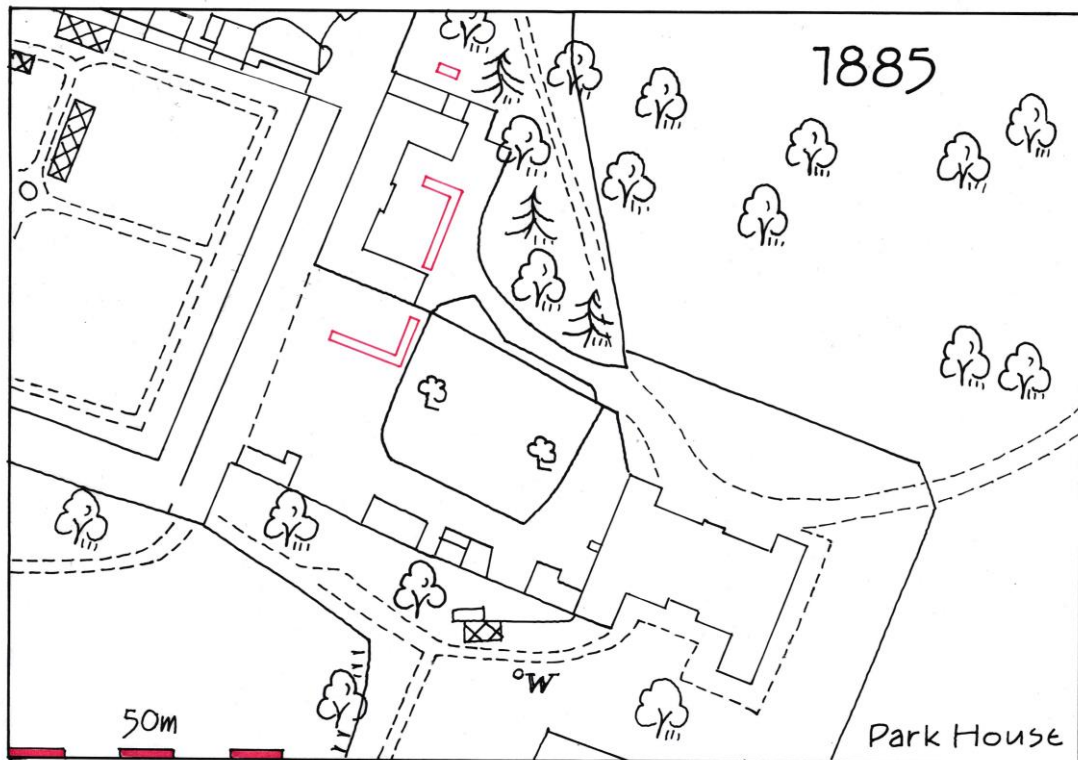
Fig. 7; OS 1885 with trench locations

The study site has historically been the location of the coach house and stables block associated with Park House, an Elizabethan mansion that formerly stood to the south-east. This was re-sited from the medieval castle on the hill which at the time survived as a ruin within view of the new house. Buried deposits that were revealed by the evaluation, and architectural details recorded during the building survey, clearly relate to phases associated with the development of the site. Some elements of this can also be traced from the historic mapping (OS, 1885, 1902 & 1923).
