The Coach House

Dog Walk, Hill Lane, Elmley Castle, Worcestershire

Historic building recording

August 2016

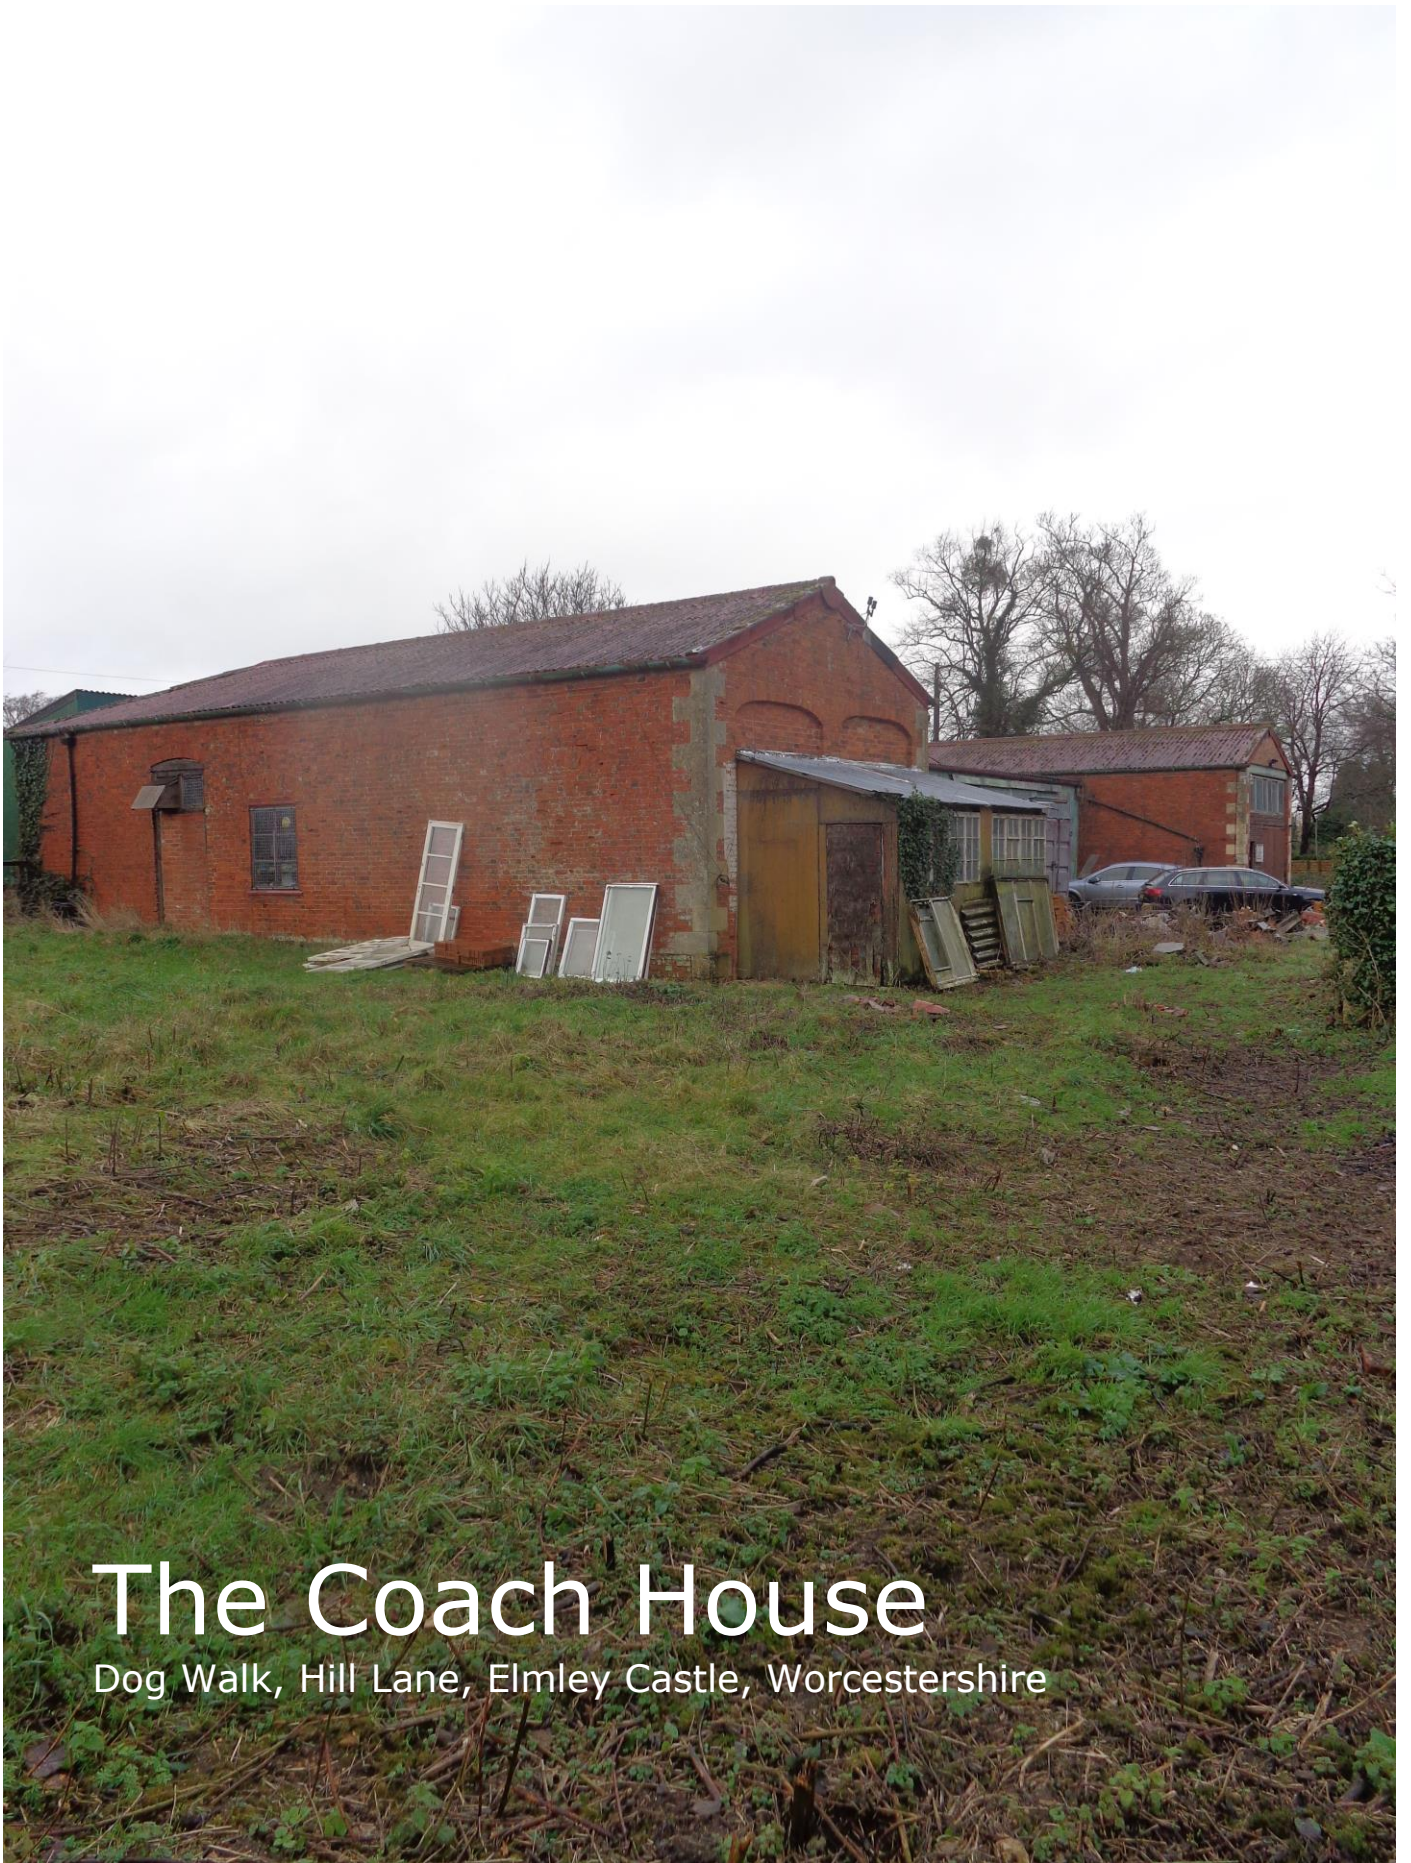
Frontispiece view of coach house from south-east

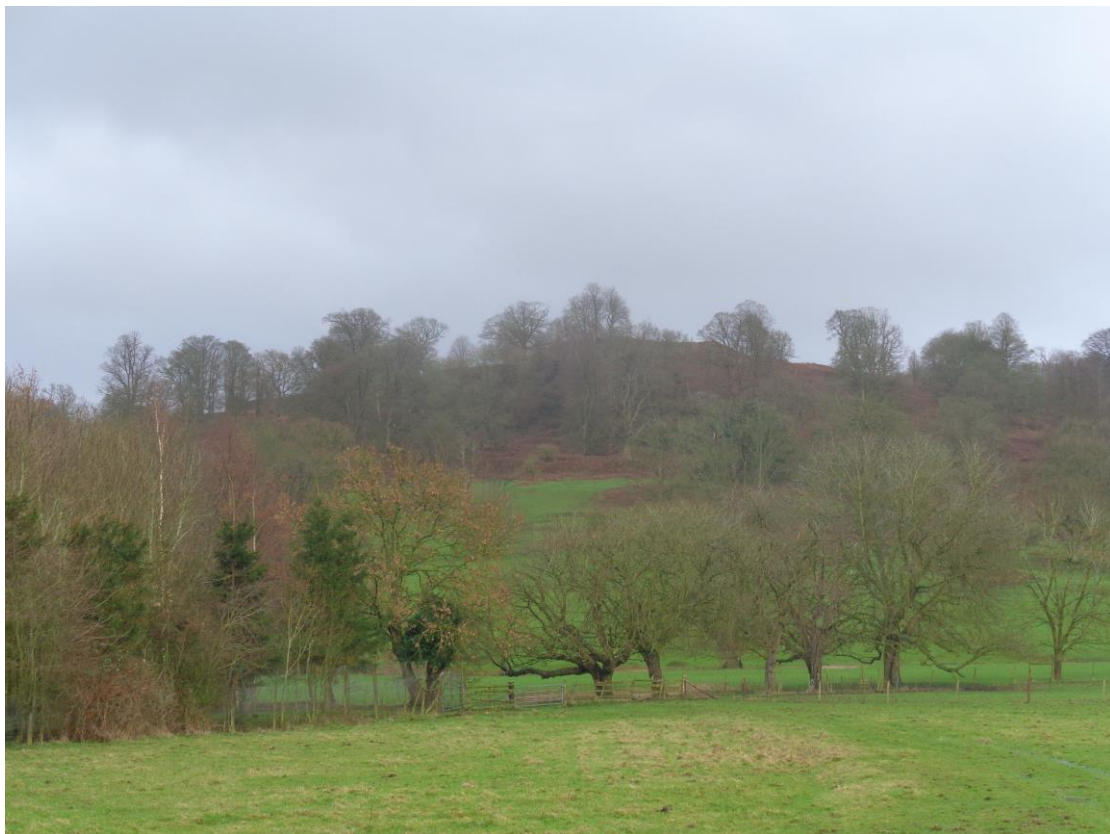
Fig.5; view of the old castle from the end of Dog Walk

Of the fabric of the ancient castle, which stood on the summit of the hill about half a mile to the south of the existing building, only a very small amount of masonry, probably forming part of the keep wall, remains. The outer and inner ditch and the site of the barbican can be distinctly traced.

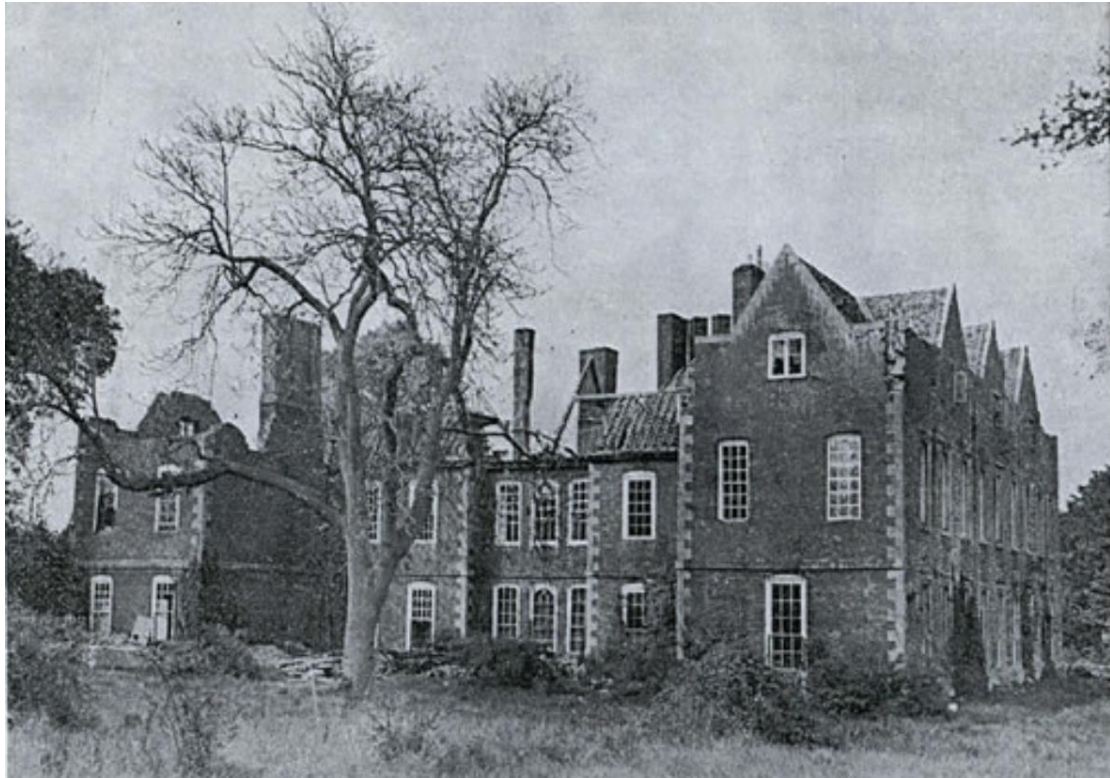
Fig. 8; Park House from south-east during demolition (1960s), showing the brickwork and distinctive quoins of the 1702 rebuild. The massive chimney, to the left of the tree, belongs to the Elizabethan service-wing.

The most striking feature of the building is the use of regular and finely wrought stone-quoins contrasting with the neat red brickwork (with segmental-headed openings). These details are also clearly shown, in a photograph of the house taken during its demolition, across the entire south elevation.

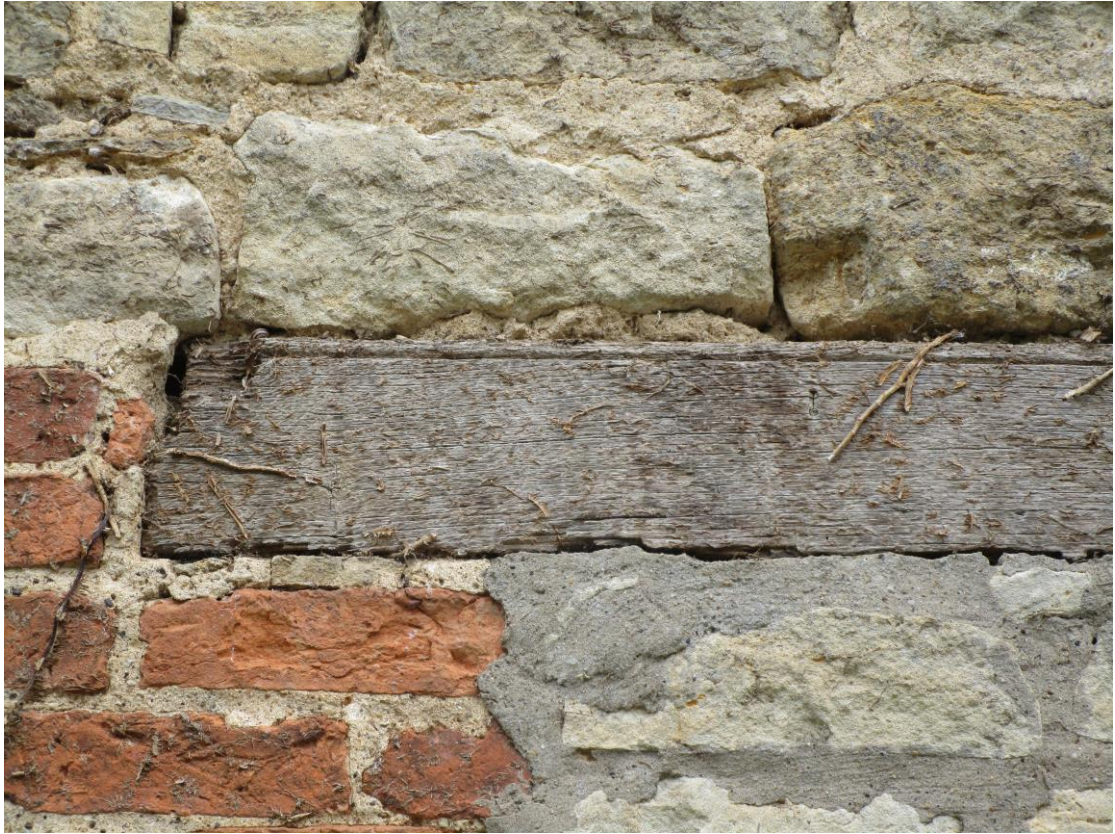
The shorter central opening is also blocked with masonry externally and brickwork internally but prior to the blocking the doorway's width had been reduced with a column of brickwork against the north jamb, both the internal and external lintels are associated with this brickwork and a corner-roll on the latter matches the same detail in the *in-situ* (blocked) door-frame original to the brick re-build, in the south wall.

Plate 5; detail of central west door, note roll on lintel

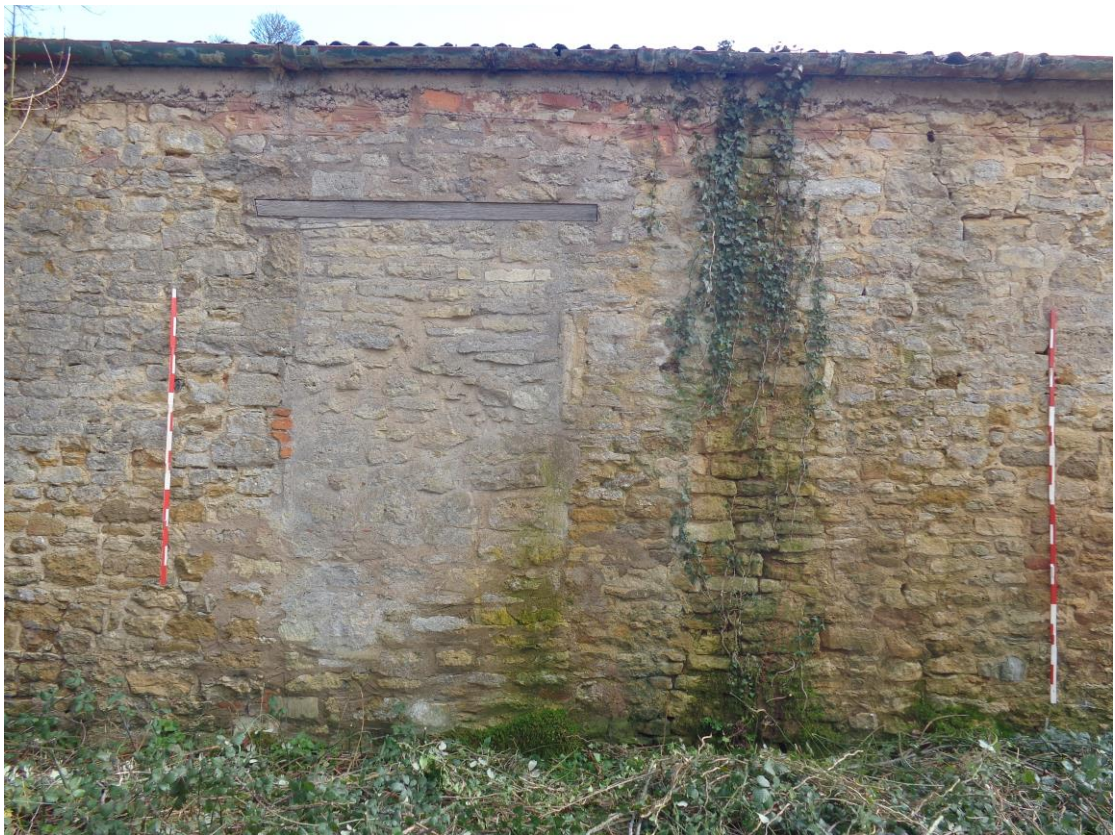
Plate 6; west elevation north end

Two ventilation bricks at the north end have been inserted to service the pair of modern WCs.

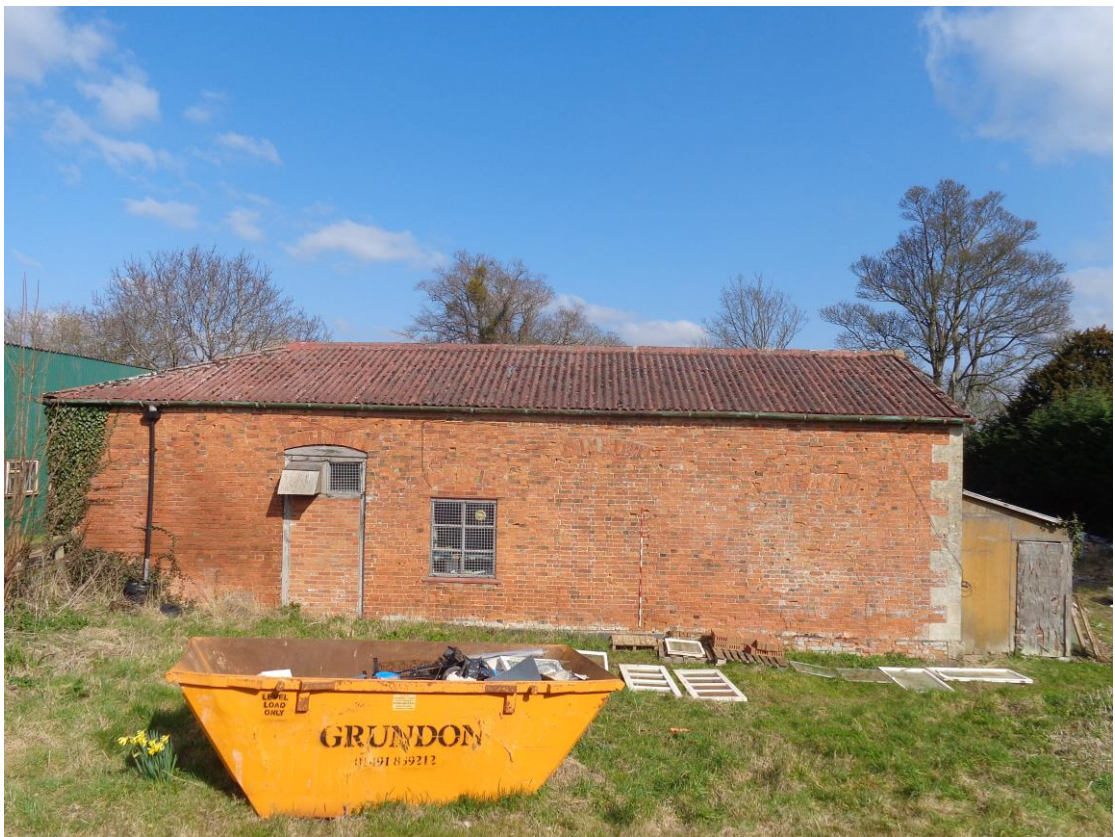
The blocked doorway in the south elevation, at the end of the main-range, retains its frame, for door and light over, with pintels. It has pegged mortice and tenon joints with a narrow roll around the doorway, mitred at the corners. The roll can be seen elsewhere on the building in a re-used context, when 19th century infilling of 1702 openings, doorways and windows, would have made this material available for re-use.

Plate 10; south elevation

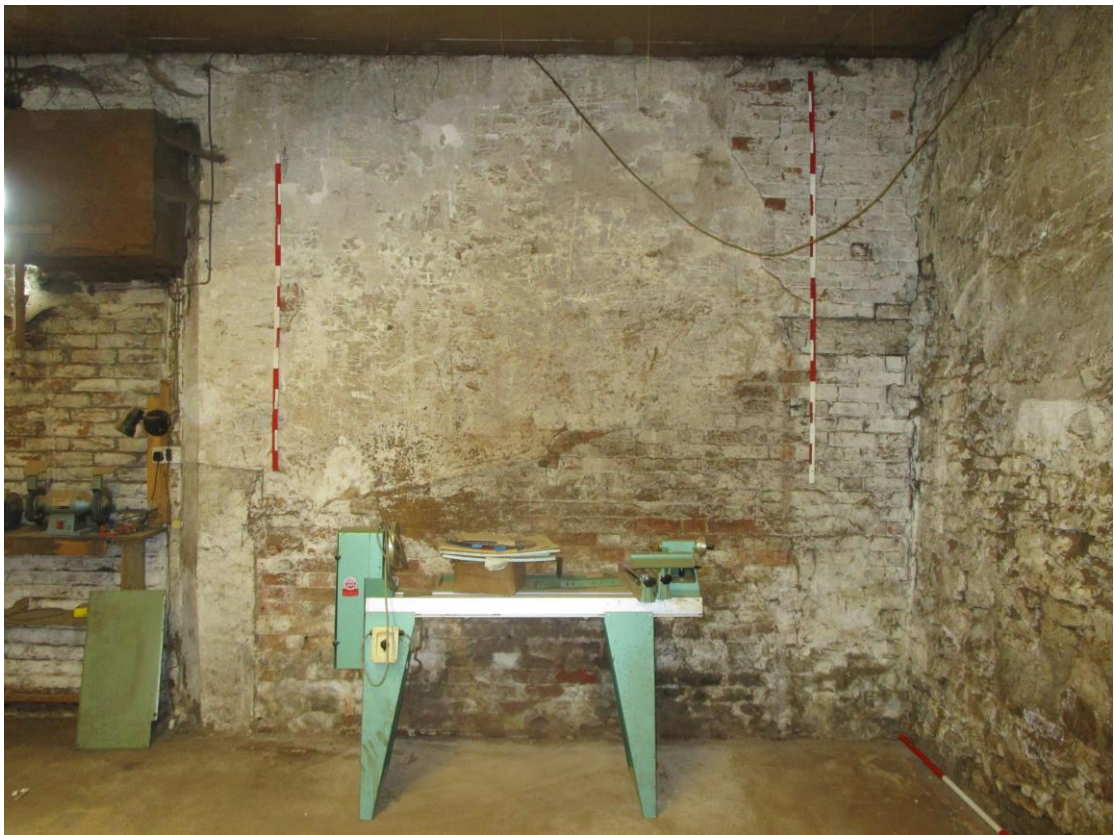
Plate12; south wall interior west end, showing stall profile

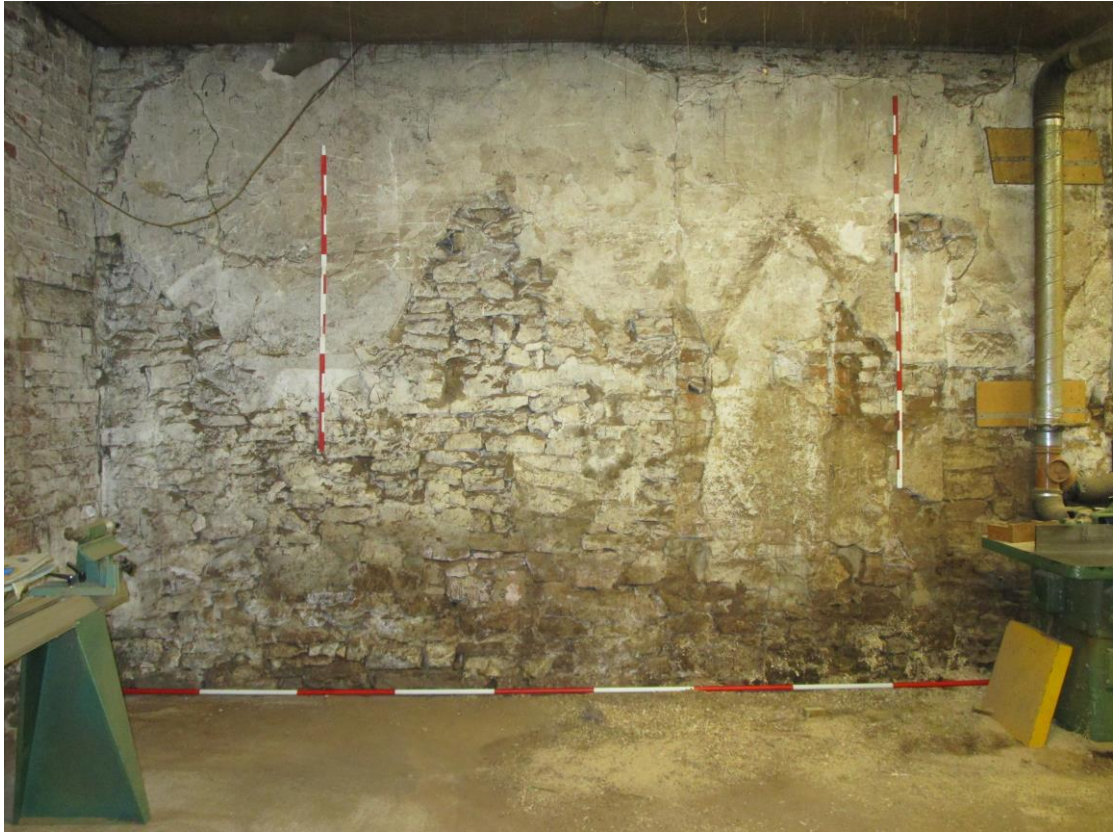
Internally plaster-work, which obscures the blocked south opening, displays evidence for five stalls with hay-racks, and further north evidence for cross walls. The width of these partitions indicate timber-frames.

Plate 13; west wall interior south end, showing evidence for stalls

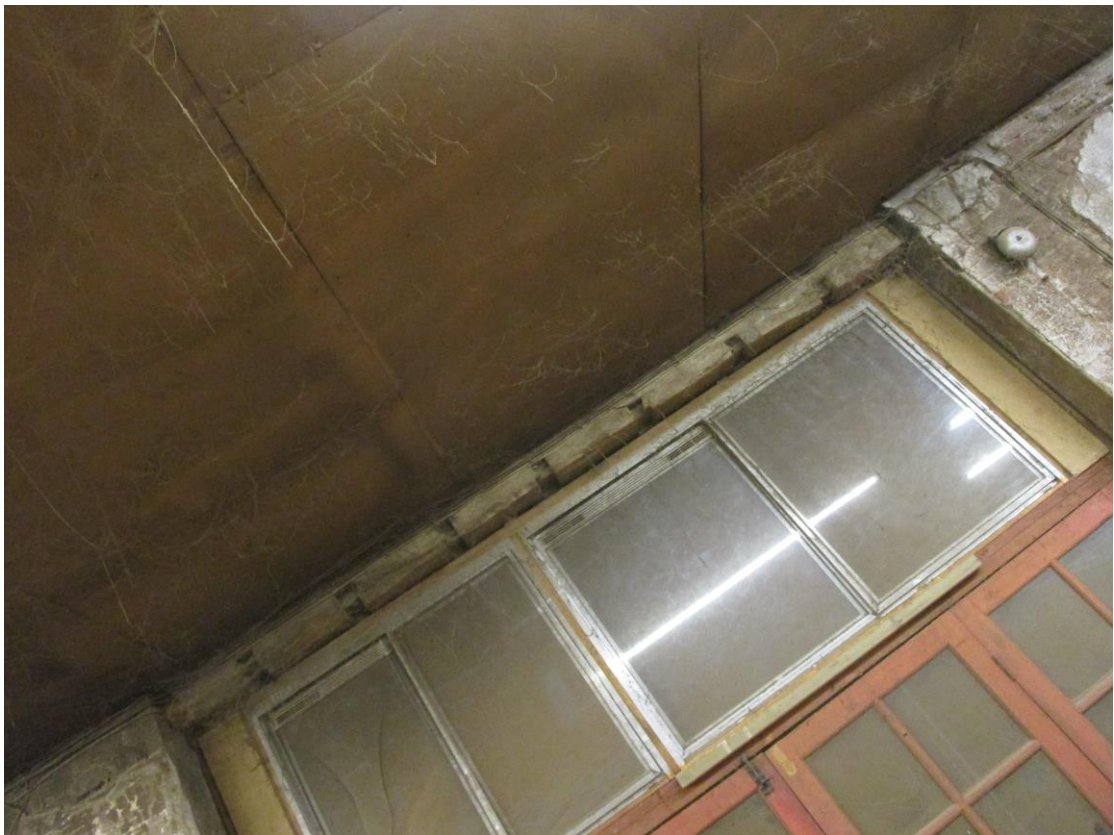
Lintels over the two large modern openings (1950s cement covered reveals) cut through to the eastern yard are reused principal-joists with notch-lapped housings for common-joists, the spacing is consistent with the spacing of the joist-sockets at the east end of the south-wing (a short length of a single joist remains here *in-situ*). The large openings are contemporary with the existing front shed and steel roof and it is at this time that the old (1702) ceiling/?hay-loft was removed providing lintels of suitable scantling.

Plate16; main range interior from west showing re-used principal-joist

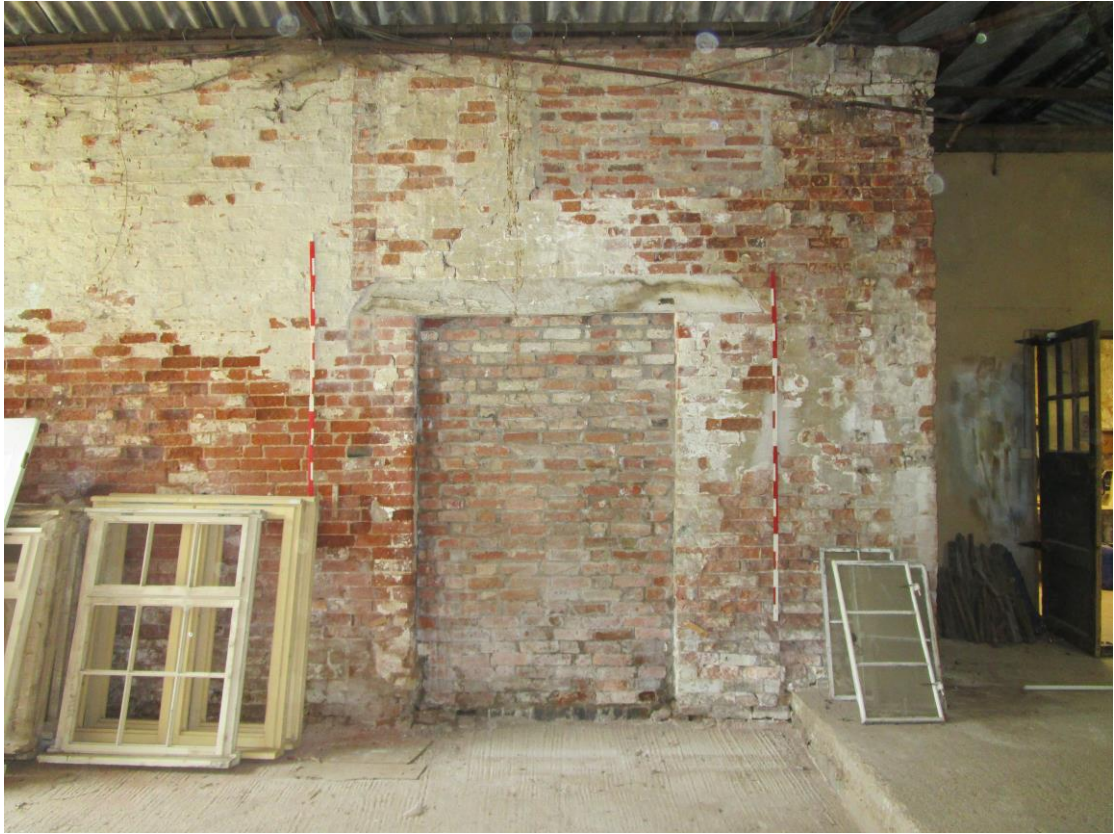
Plate 17; north range interior from north

Other re-used timbers can be found in a 1702 and a 19th century context taken from a building dating most probably from the 16th century. A large central piece of cambered tie-beam has been used over an inserted opening in the north-wall of the south-range. The original length of the beam can be deduced and the mortices indicate square panels with corner struts from the main-posts. Another lintel, over the blocked south doorway of the north-wing is a collar from a steeply-pitched roof, short mortices on the side may indicate its own re-use. A short length of rail (top groove and lathe-holes under) has been used as stitching, or fixings, at the junction of the main-range and north-wing.

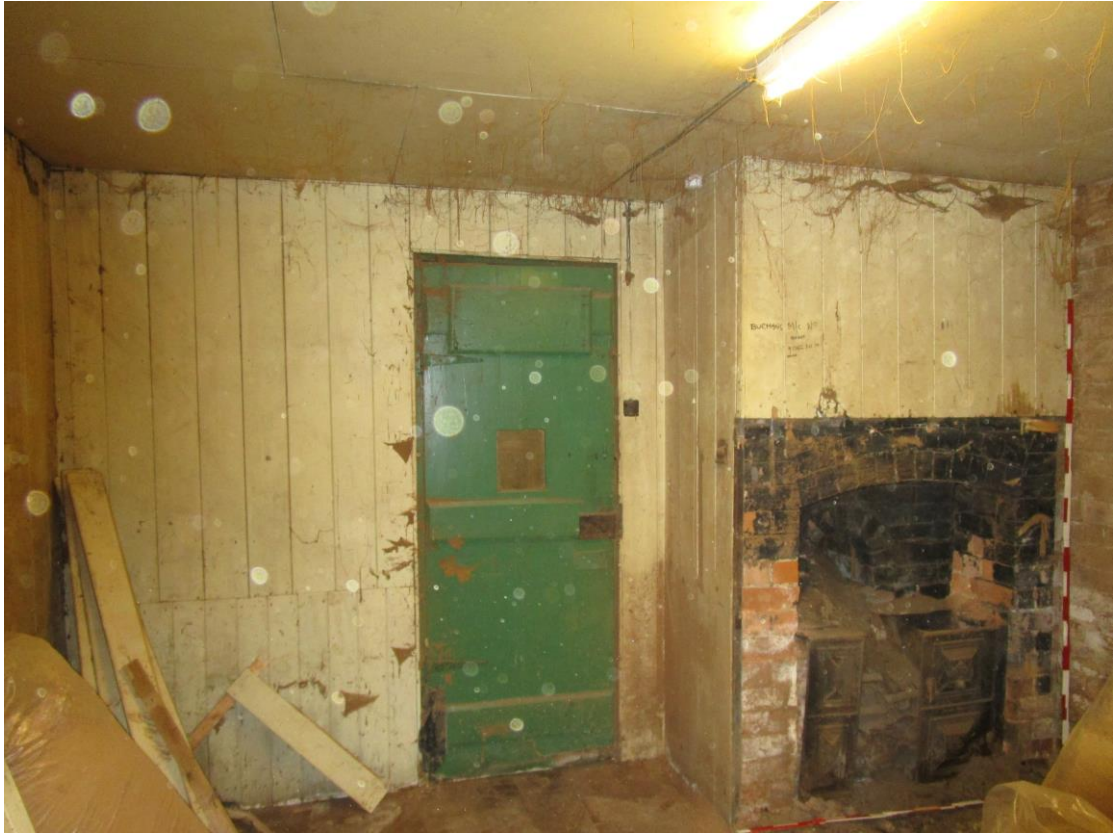
The large inserted doorway, in the south-wing, is associated with a new partition and blocking of a doorway in the south wall. The western part formed a small tiled-room accessed through the original (1702), but narrowed doorway in the north wall, there is a fireplace, (lost chimney), with a small range next to the

door and a double doored cupboard in the opposite corner of a domestic character and possibly originally from the house. This room may have provided an office or formed part of staff accommodation.

Plate 19; south-wing inserted room and fire-place from south
