The Coach House

Dog Walk, Hill Lane, Elmley Castle, Worcestershire

Historic building recording

August 2016

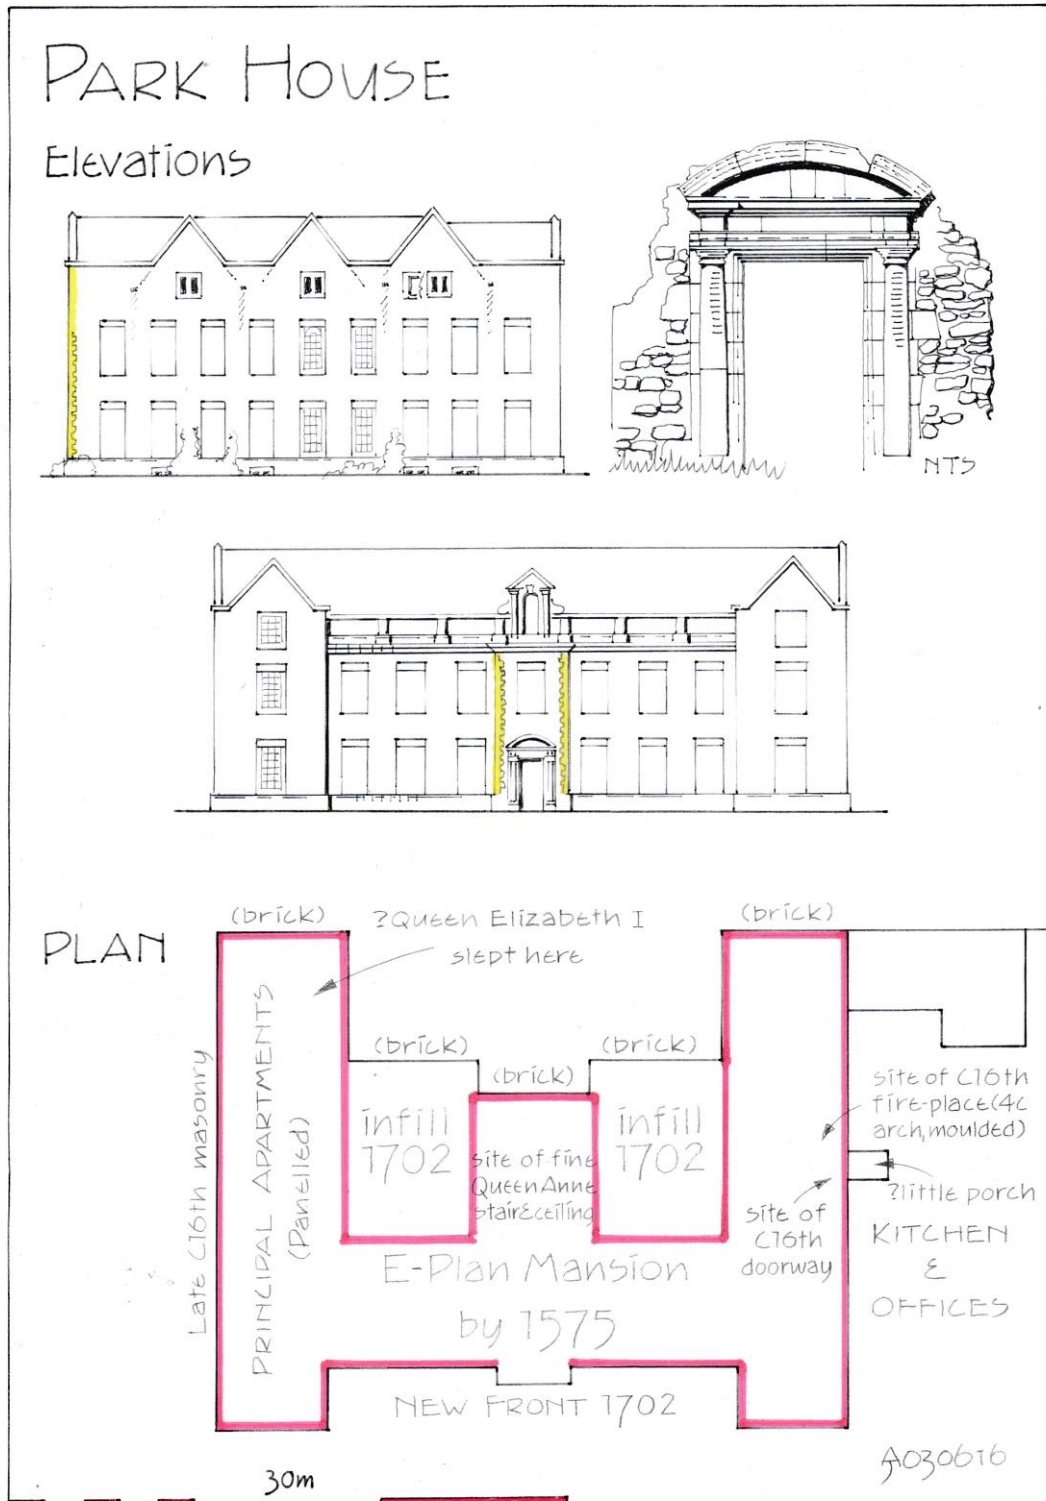
Fig. 7; the mansion, based on cartographic and photographic sources. **Pink**; the Elizabethan house, **Yellow**; stone-quoins associated with the 1702 brick rebuild.

In 1702 the mansion was thoroughly renovated; the spaces flanking the old porch filled with new rooms and a new front formed on the north side. Old photographs show the original masonry surviving on the north and east sides but the south side shows new regular stone quoins high-lighted by the darker tone of the brickwork. Later in the century sash-windows replaced the 1702 timber casements (with transoms) and also whatever windows existed in the masonry walls. In the 19th century the ground floor of the principal apartments was re-ordered and a new drawing-room formed, out of two earlier rooms, at the south end, this is consistent with the taller-paned sash-windows shown here on the photographs.

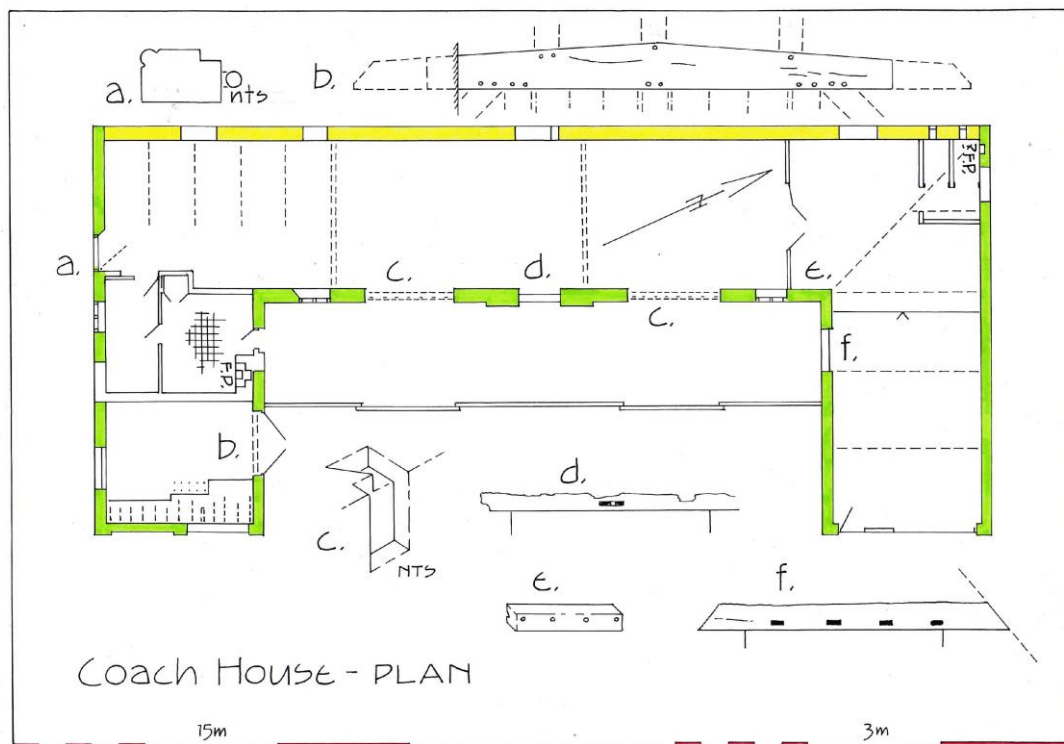
Fig. 9; plan showing Elizabethan masonry; yellow, 1702 re-build; green

The earliest part of this building is the rear (west) wall, alongside Dog Walk. The randomly-coursed limestone-rubble wall features four blocked openings, those at each end are tall with timber-lintels: the one to the north is blocked with masonry outside and brickwork inside, the internal lintel is re-used having two mortices which suggest square panels of the late 16th or early 17th centuries. Only the external brick-blocking is visible in the other feature. The height of the lintels suggests that the openings were originally constructed as windows.

The similarity of plan, E, of the coach-house to that of not only the Elizabethan house but more specifically to the 1702 front is striking and the red-brick walls, segmental-arches and regular stone quoins are clearly contemporary with the southern parts of the of the house as shown in the photographs. As a result several conclusions can be drawn about certain constructional aspects of the lost house.

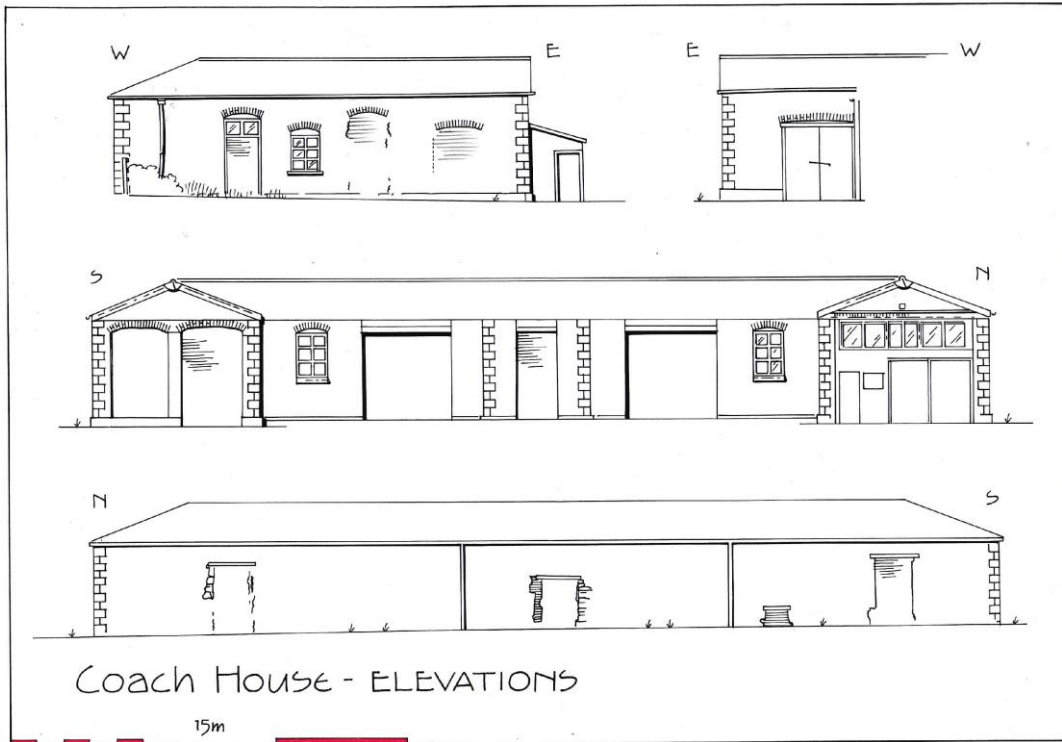
Fig. 10; external elevations

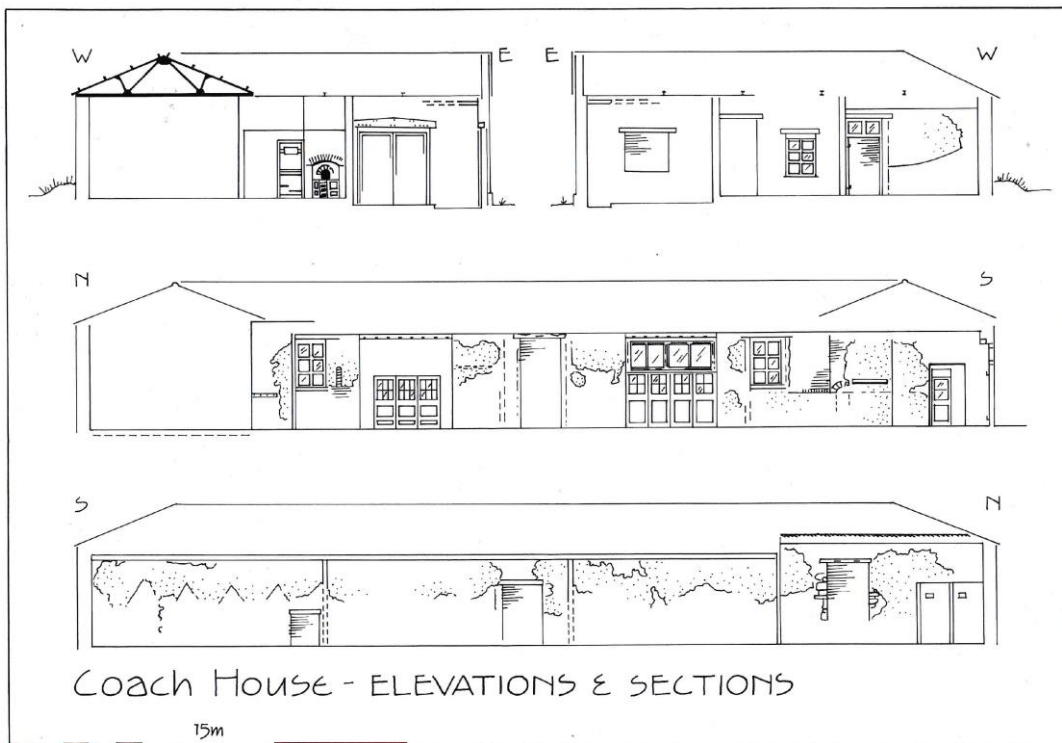
Fig. 11; internal elevations & sections

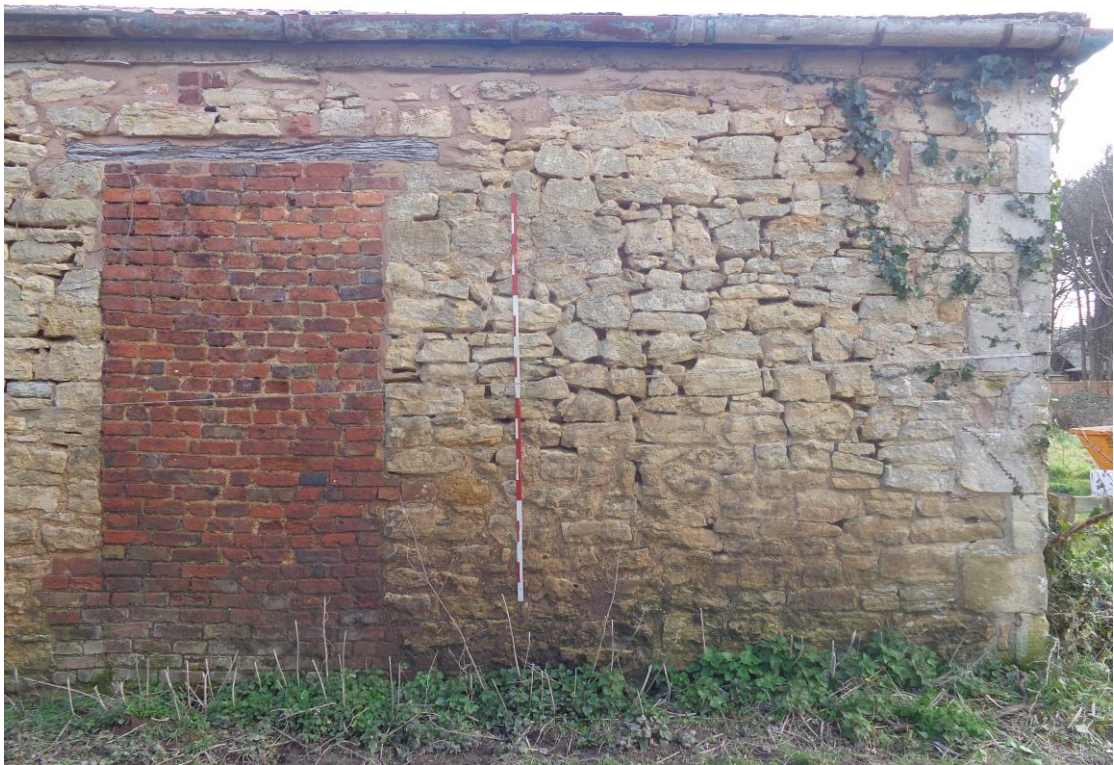
Plate 2; west elevation south end

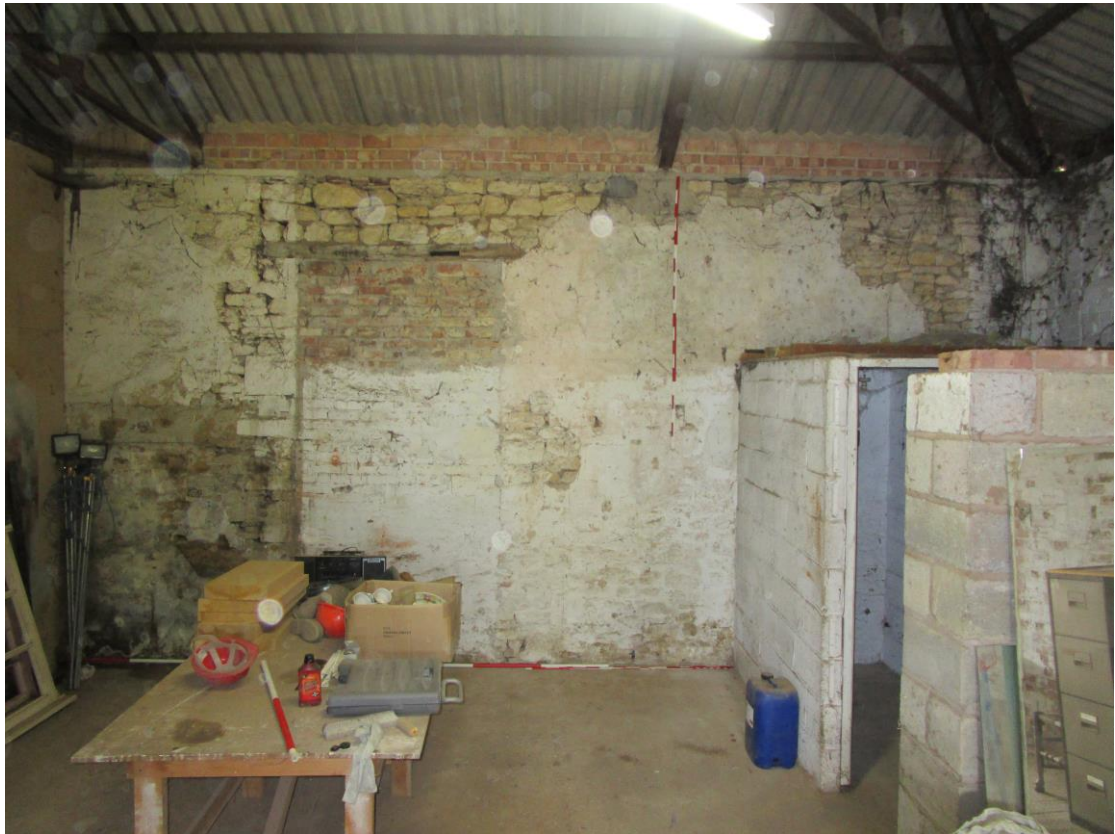
Plate 7; west wall interior north end

Two ventilation bricks at the north end have been inserted to service the pair of modern WCs.

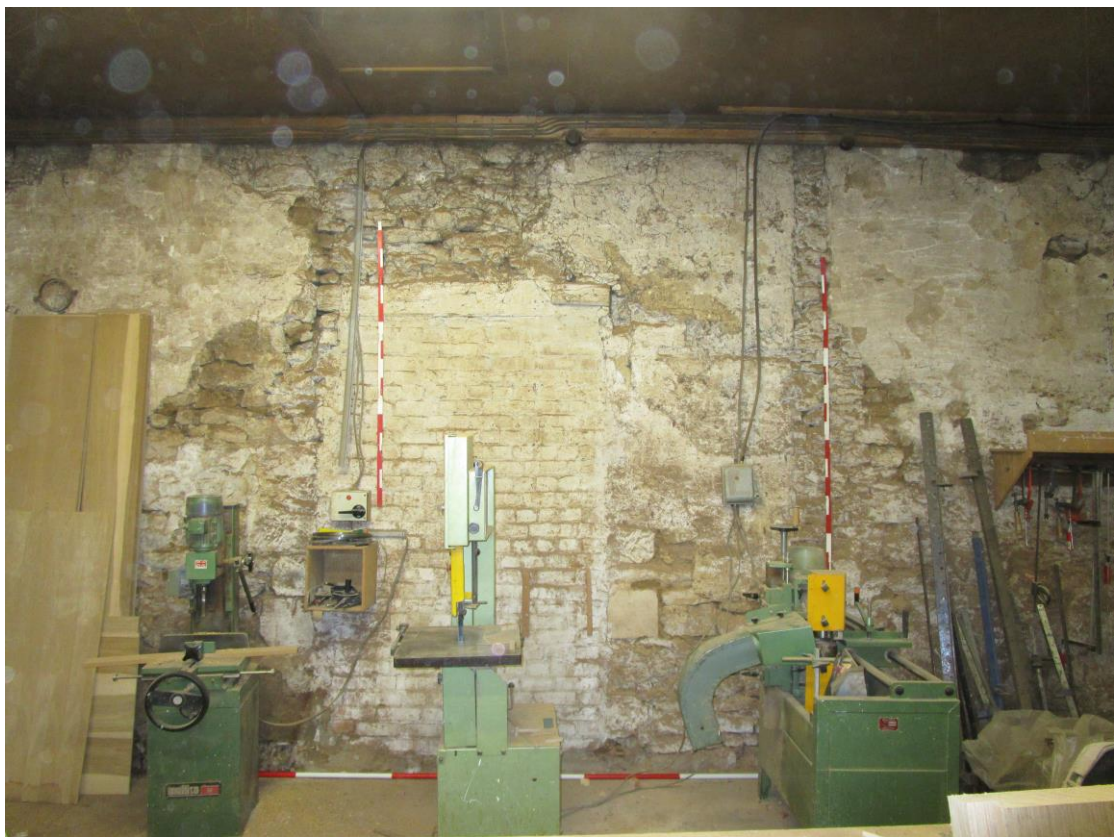
Plate 8; west wall interior centre
