Upper Holling Farm

Hollins Lane, Martley, Worcestershire WR6 6PU

Historic Building Recording

13th February 2020

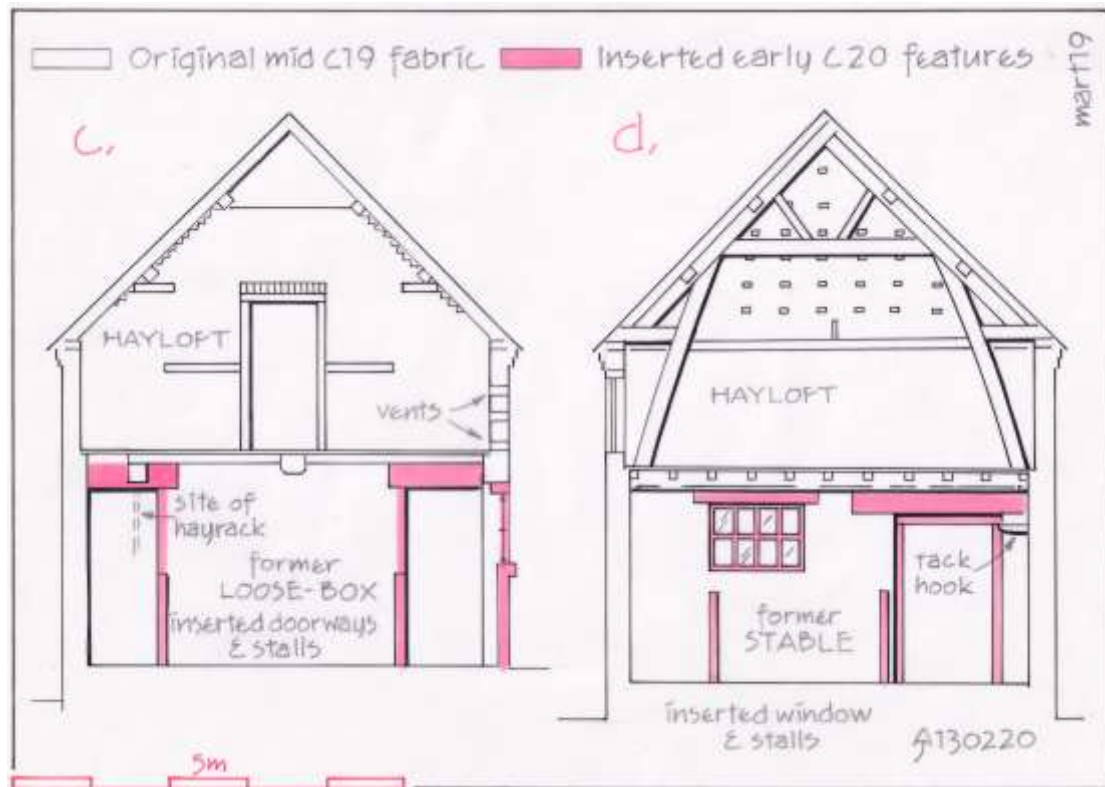
Fig 8; The North-East Range; sections to south-east.

A ridge-board sits above the traditionally constructed interrupted tie-beam frames which are shorter, due to the steps, over the original cow-house.

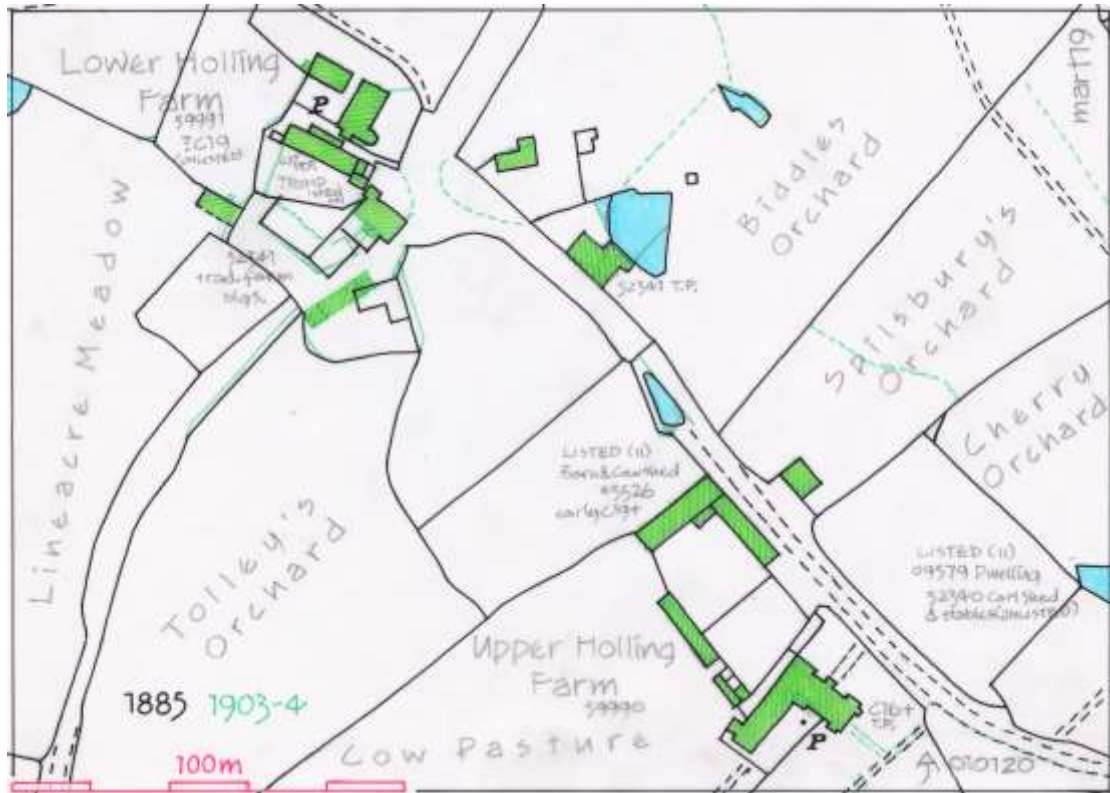
Fig 9; Historic Environment as shown on OS 1885 and 1903-4 (green), the field names are taken from the 1843 Tithe Map.

To understand the development of the mid C19 farm-buildings the surviving elements of the historic fabric were compared with Lower Holling Farm, a neighbouring example, using both the extant fabric and cartographic information. This assists greatly in showing how Upper Holling Farm developed to become a good extant example of a modest mid C19 model farm, a considerable investment and part of an important national trend at this time.

Lower Holling Farm provides significant information for the Upper Holling farm buildings, lost when they were replaced by the new brick structures in the C19. The new brick farm had already been built before the 1st Ed. OS, 1885 however, extant C19 brick buildings at Lower Holling Farm are not shown until the 2nd Ed. OS, 1904, the old irregular plan is shown and typical C17 timber-framing is also extant. The character of the brickwork of the house, the denticulated-cornice and segmental arches are consistent with the Upper Holling farm buildings but the footprint, the proportions and the irregular fenestration suggest that earlier fabric may remain inside.

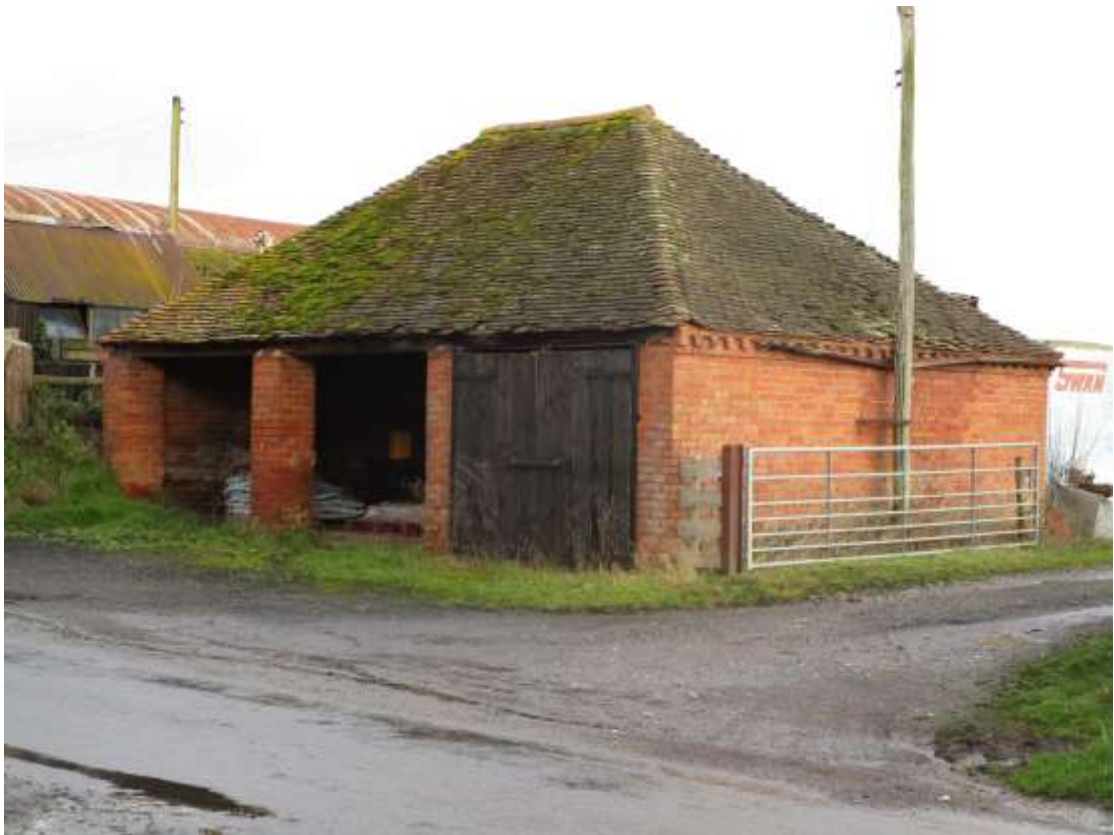
Plate 2; The cart-shed.

The three-bay brick-built *CART-SHED* is located on the other side of Hollins Lane, opposite the North-East Range. The front wall-plate is supported on square brick-piers with quarter-round corners and the the king-post roof, with threaded-bolts, is hipped.

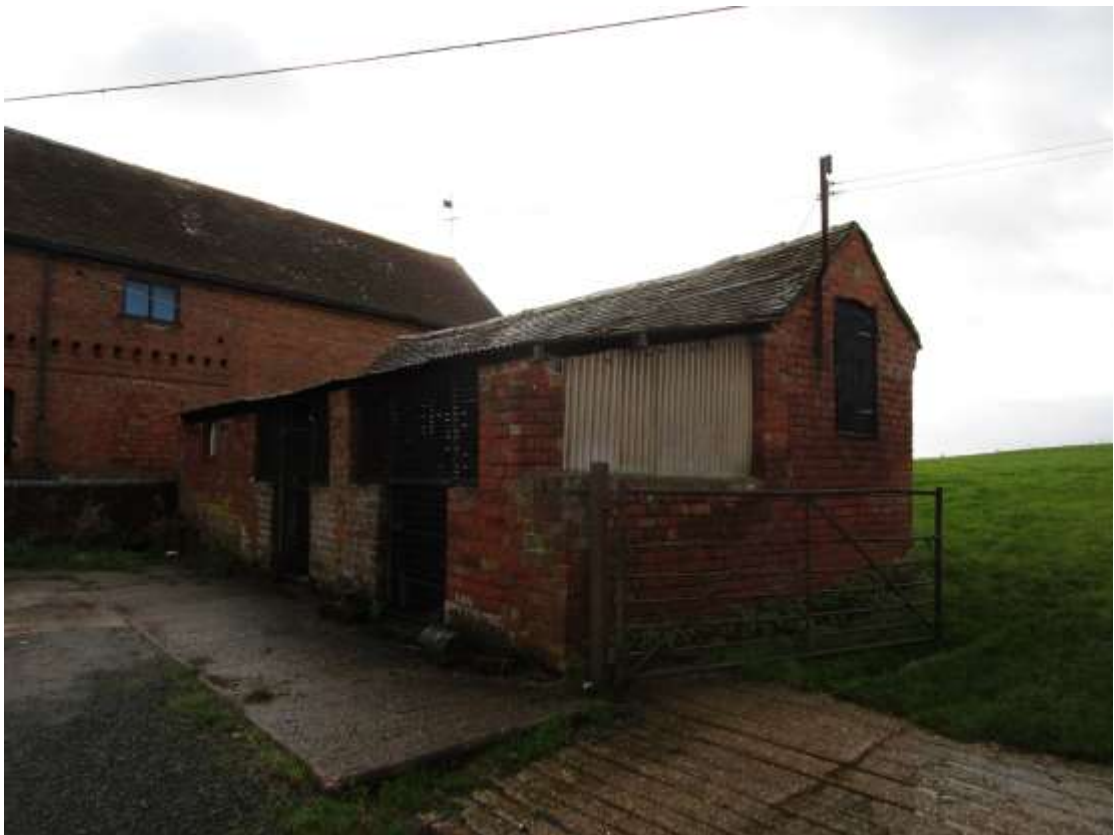
Plate 4; The pig-houses.

Beyond the byres is a gateway, providing access to 'Cow Pasture', and a pair of *PIG-HOUSES*. Attached to these is another bay under the same roof, but here the room is only accessed via a doorway from the field, the small yard in front may have formed a connecting element between the foldyard and the passage along the service side of the house. This little yard was already covered over by the time of the 2nd Ed. OS. One of the lintels over a pig-house door is reused, having two mortices (Note also reused timber with birds'-mouths in the former stable).

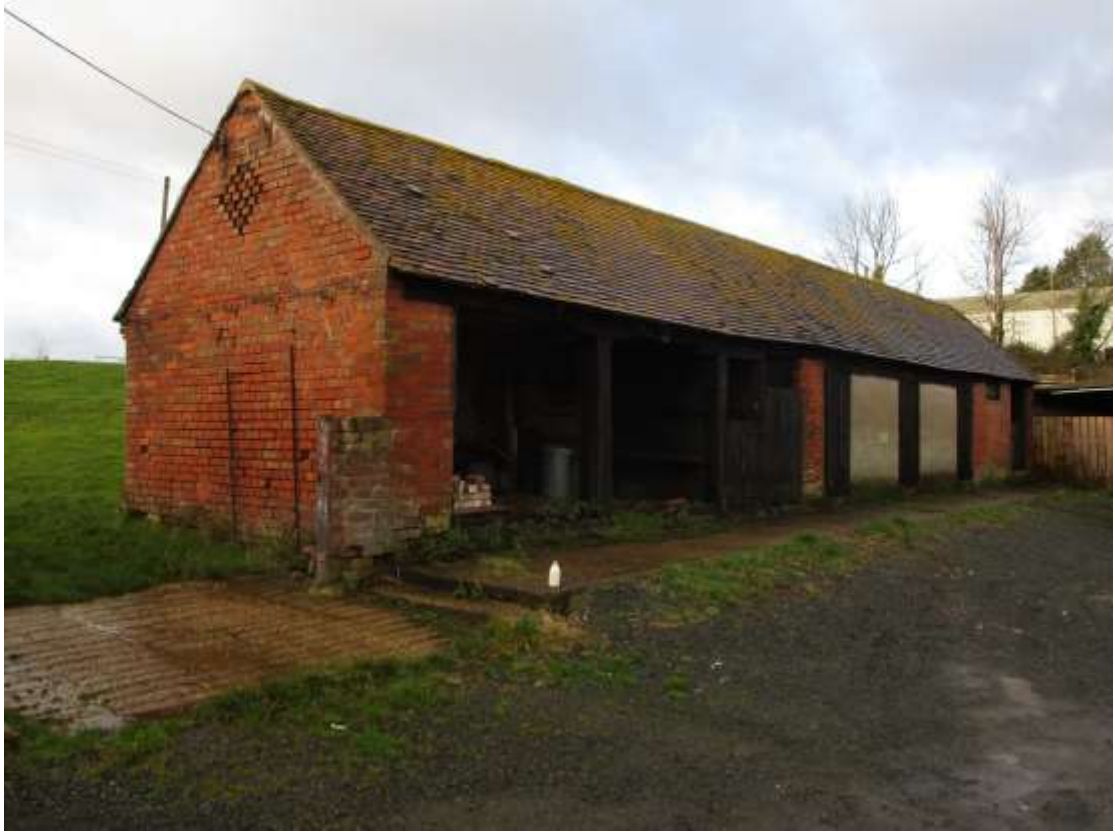
Plate 5; The byres.

The South-West Range consists of a pair of three-bay *BYRES*, either side of the masonry-wall separating the foldyards, now lost, and an enclosed *LOOSE-BOX* at the north-west end. The king-post roof-frames have threaded bolts through the tie-beams into the posts, the gable vents are arranged diamond fashion.

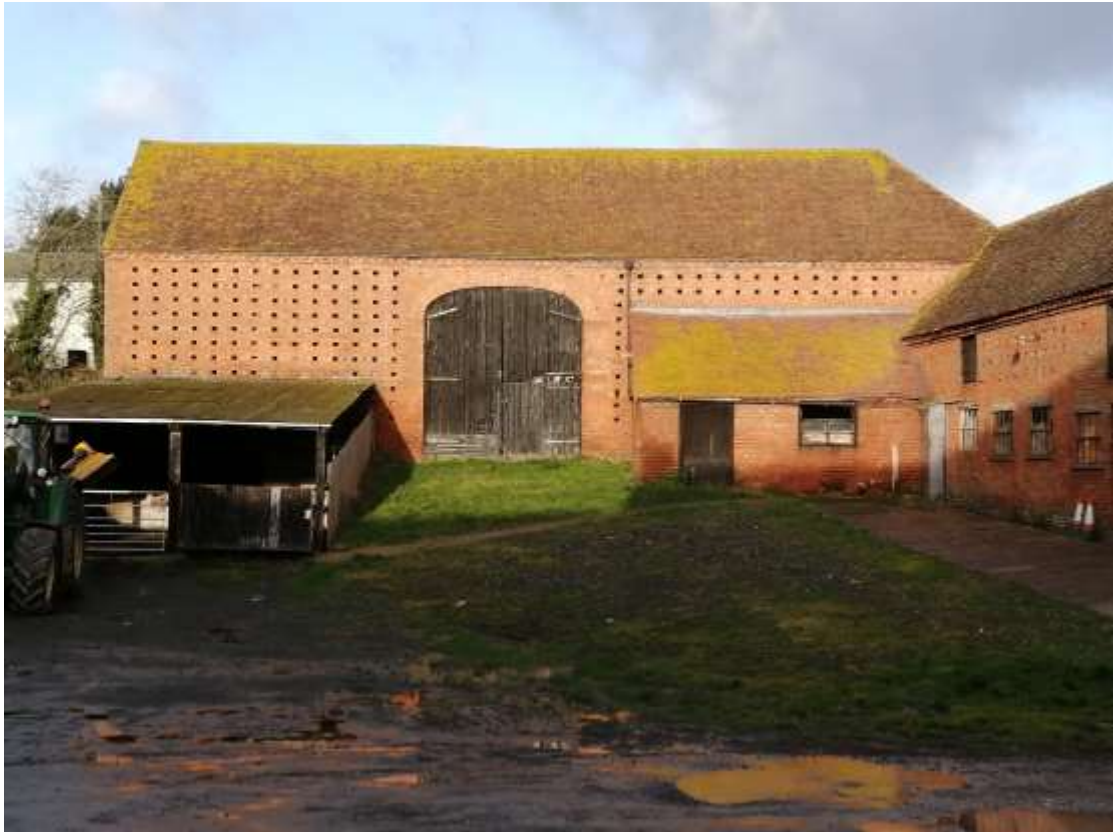
Plate 7; Foldyard elevation of threshing-barn.

The five-bay *THRESHING-BARN*, located on the north west side of the foldyards, is constructed of brick; headers are omitted every fourth course to form a regular grid of ventilators, the cornice is denticulated and the central

doorways have basket-handle heads. The roof frames are of queen-post construction with threaded bolts through the tie-beams into the posts. The roof is clay-tile clad and hipped over the corner where it meets the shorter two-storey cow-house. The paving of the threshing floor survives with few cracks. The south doors are original to the building, but the north doors have been replaced to match. The barn connects with the south-east range via three doorways in the end wall, one at 1st floor level, another door in the adjacent wall allows access to the rick-yard beyond.

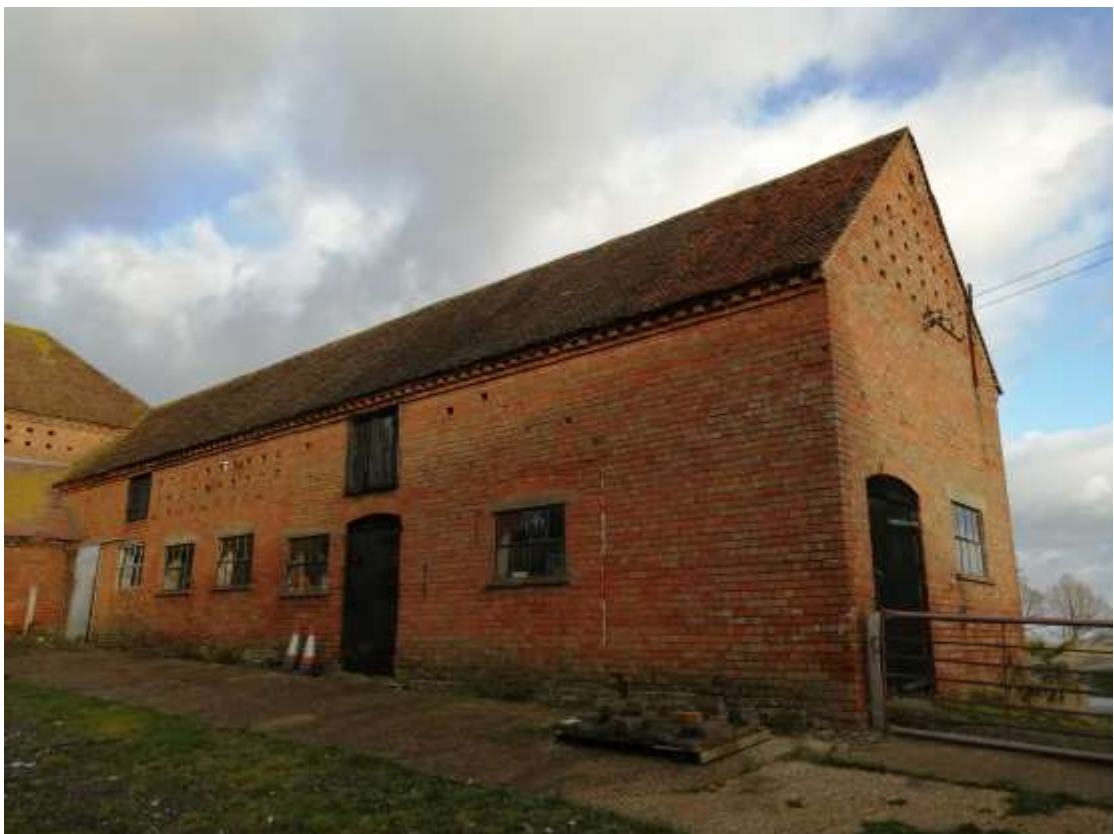
Plate 8; Foldyard elevation of north-east range.

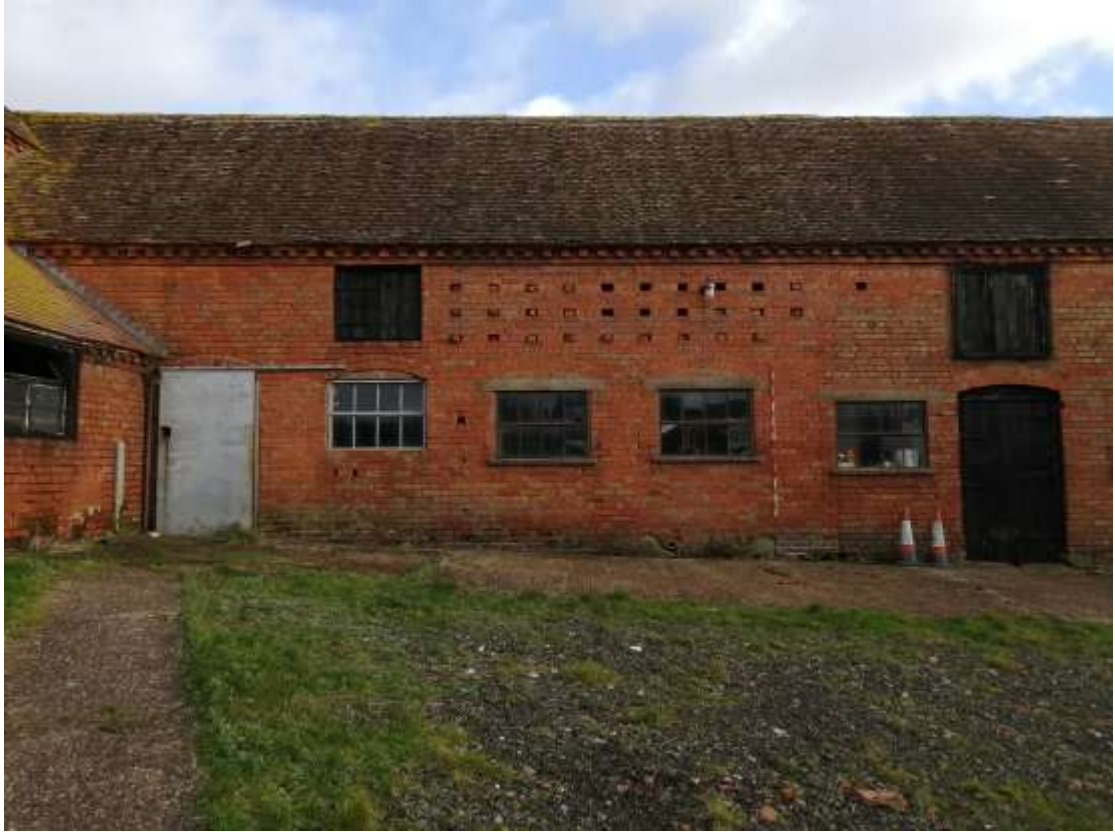
Plate 9; Foldyard elevation of loosebox.

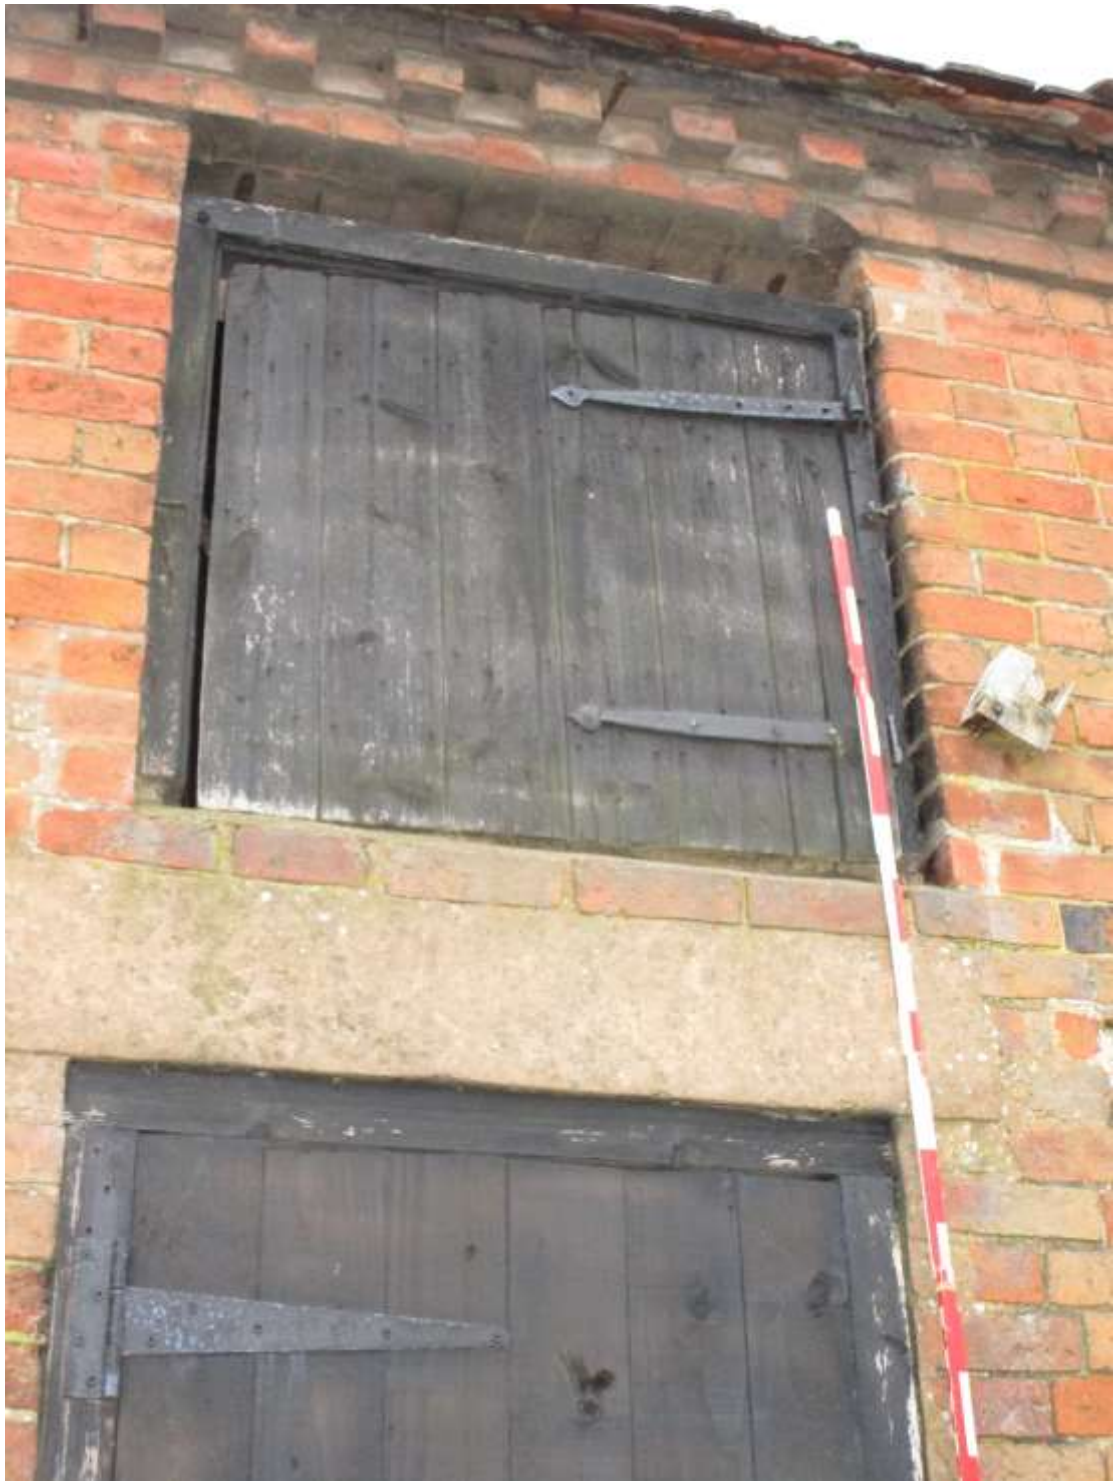
Plate 11; Detail of hayloft door and inserted door below.

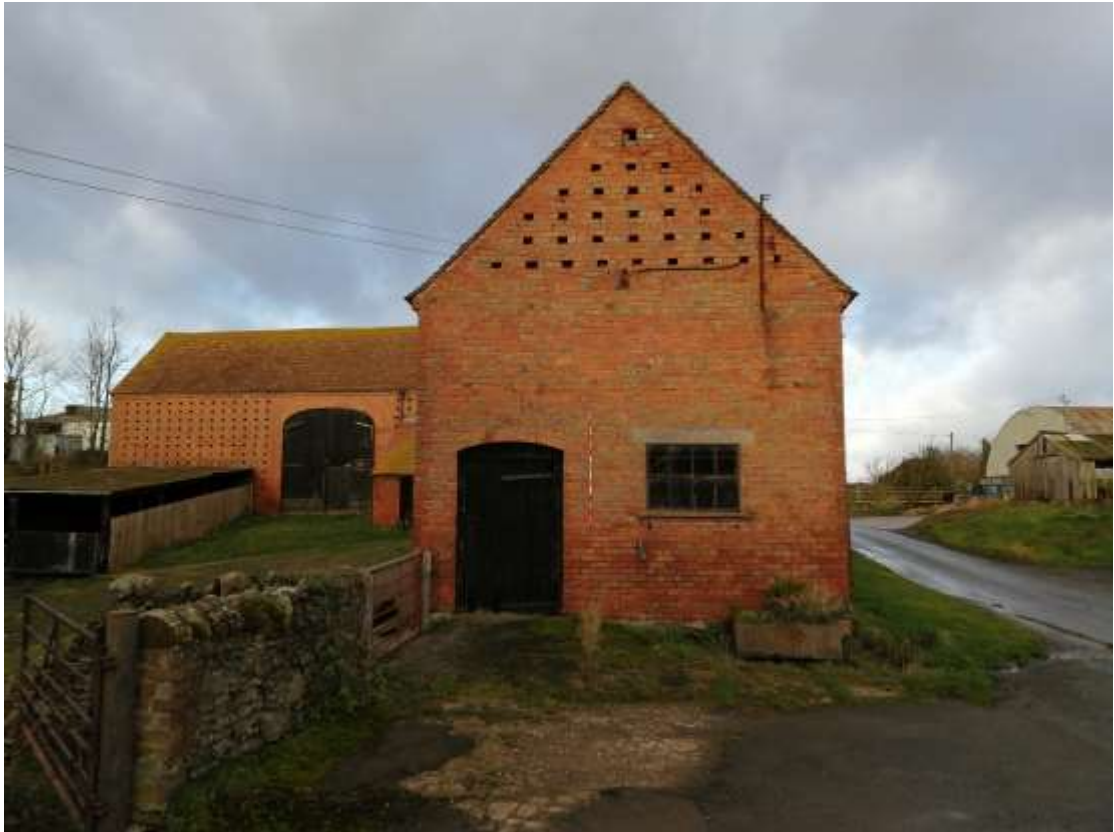
Plate 12; The gable end and remains of brick-dressed stone rubble foldyard walls.

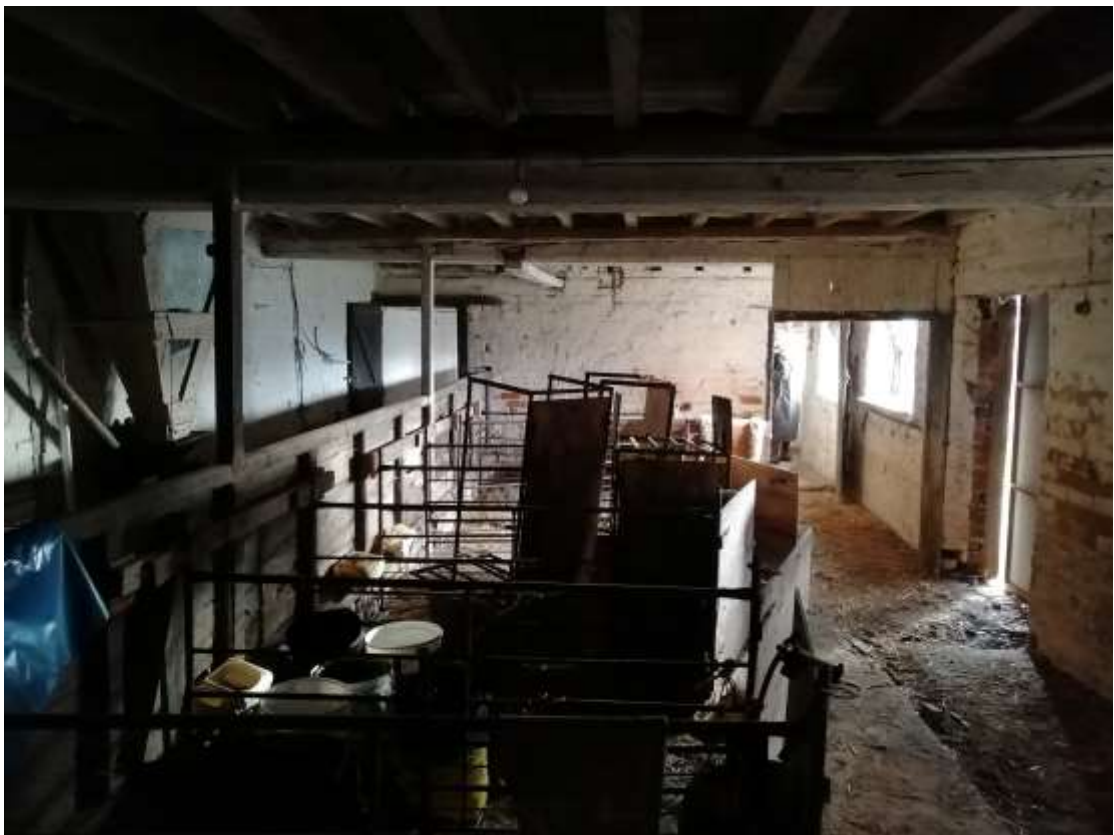
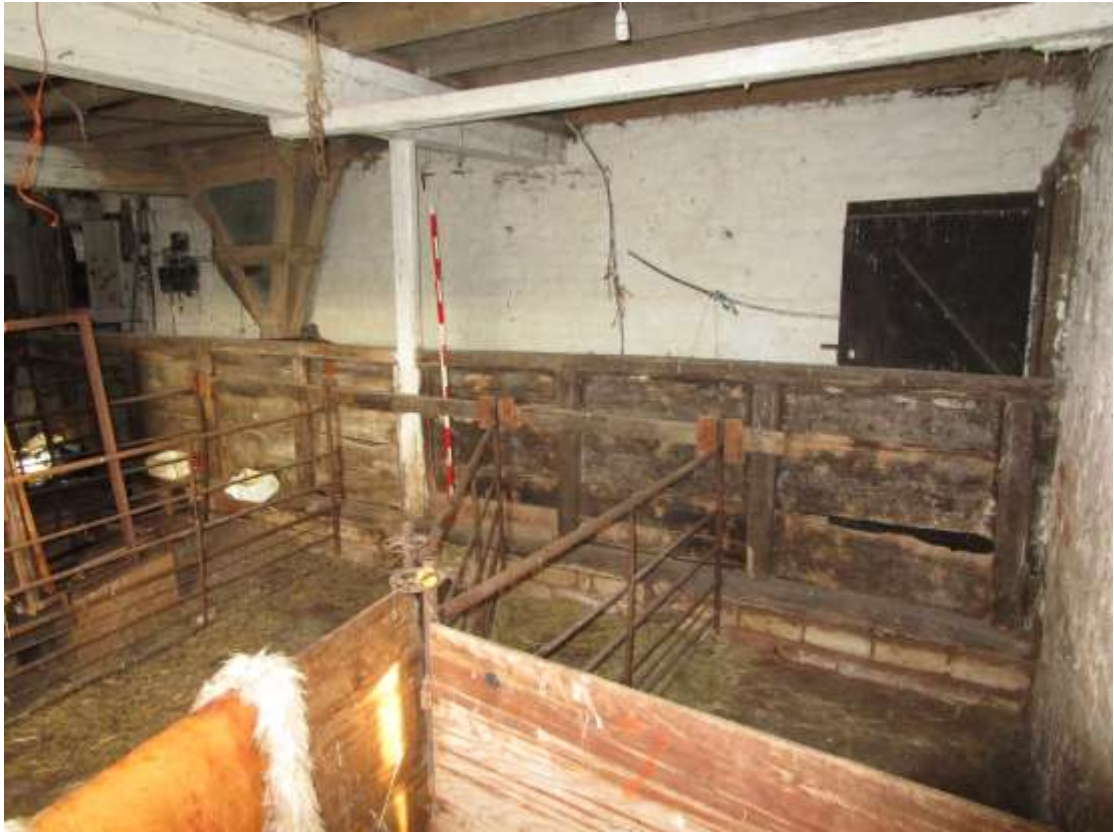
Plate 13; The former Cow-house, and remains of original feeding-passage.

Plate 14; The former Cow-house, and remains of original feeding-passage.

original cow-house partition there is a short surviving length of beam fixed to the transverse common-joists which suggests the position of the front of the manger.

The timberwork throughout is notably clean, it is well made to the extent that all the principal-joists have chamfers with nicely formed scroll-stops, this detail would not be out of place in a domestic C17 setting but these are not reused timbers. The timbers of the feeding-passage partition in the original cow-house are also neatly finished with narrow stopped-chamfers.

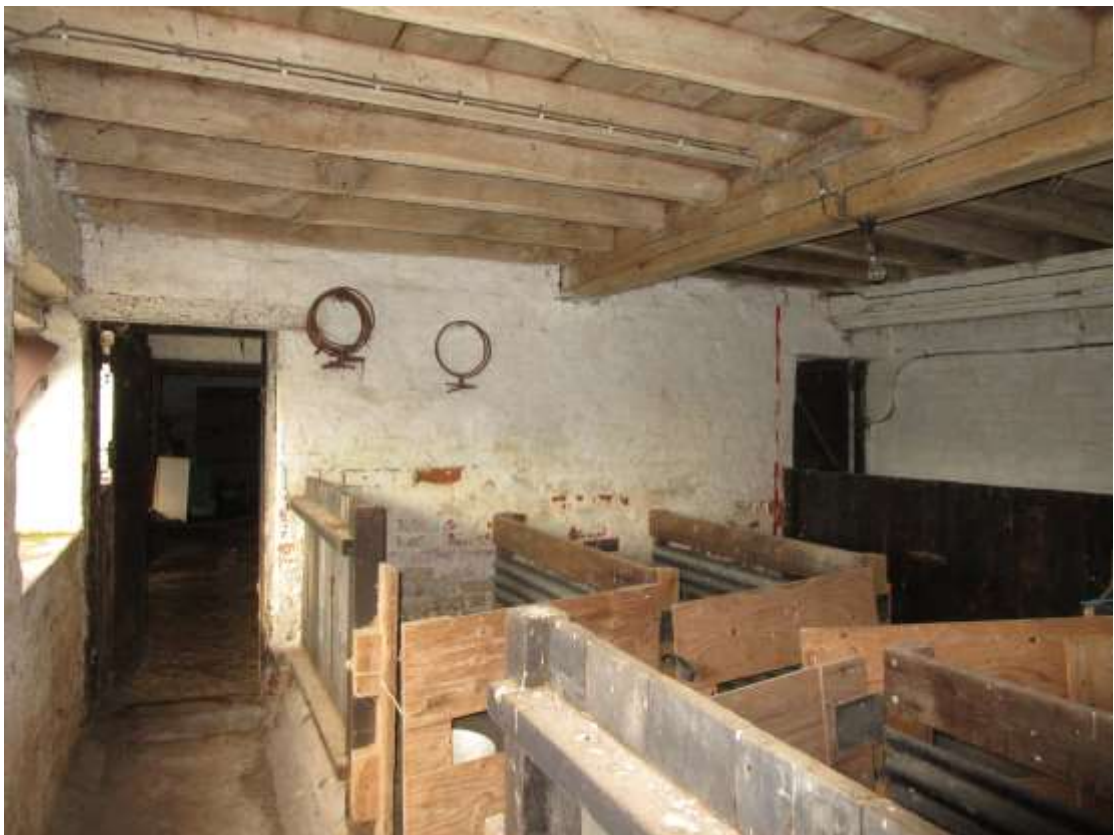
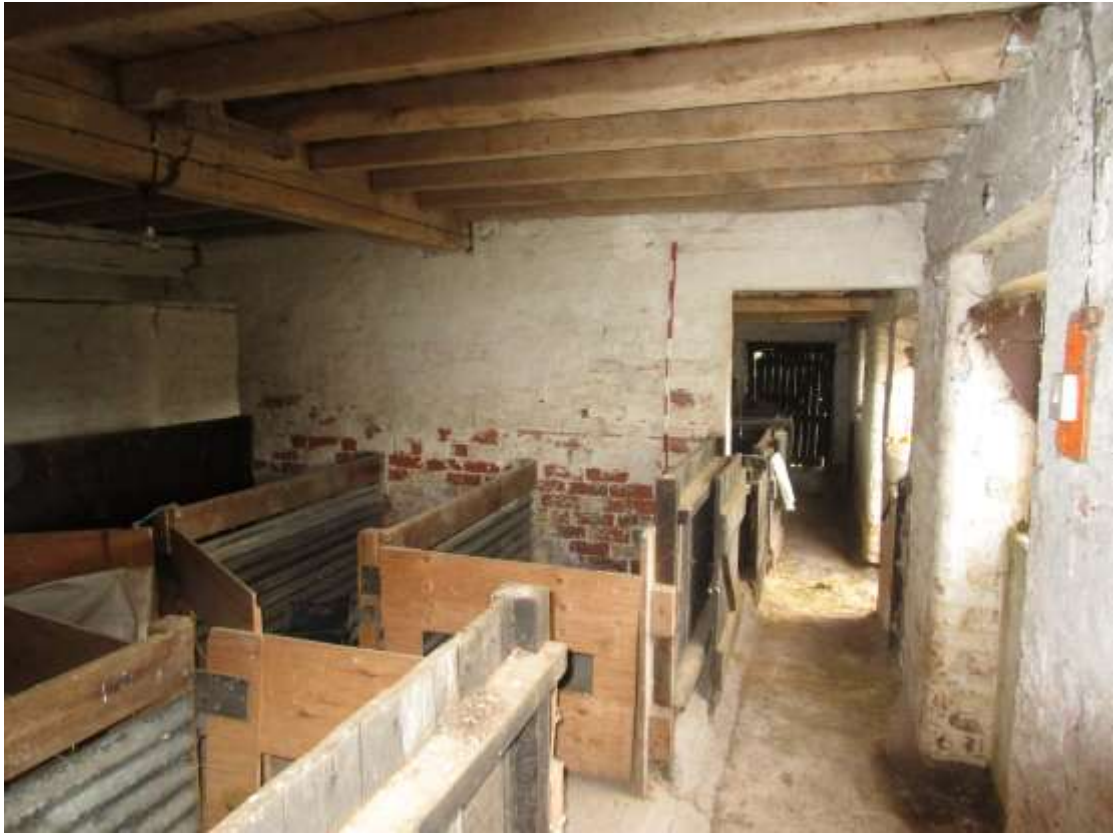
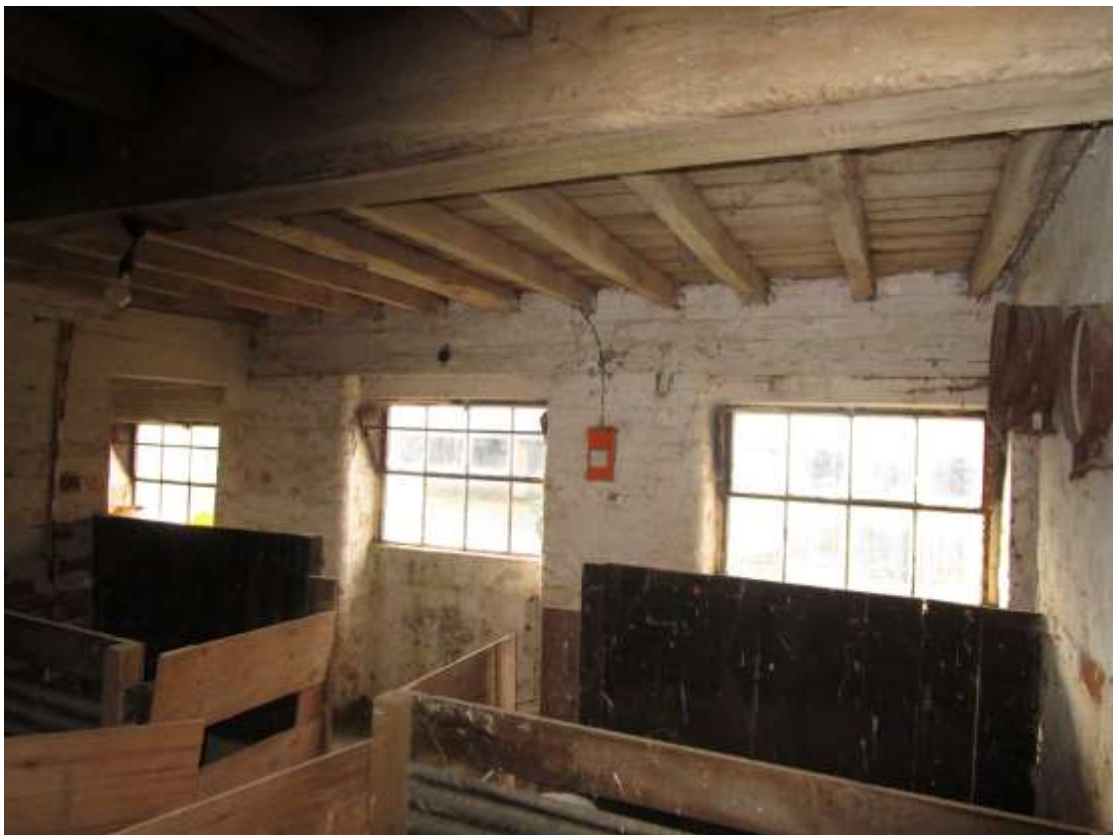
Plate 15; Former loosebox; inserted doorways, stalls and passages.

Plate 16; Former loosebox; inserted doorways, stalls and passages.

Plate 17; Former loosebox; inserted stalls, passages and blocked door.

On the ground-floor new openings were formed, with concrete lintels, in the transverse walls together with passages, partly ramped, along the front and rear walls and individual stalls were constructed. The rear passage retained the original, and extant, feeding-passage partition in the old cow-house. Concrete lintels were inserted under the existing segmental window heads and new iron window-frames inserted, two completely new windows were inserted at the end of the stable and toward the foldyard. A new doorway with lintel, was inserted at the back of the former stable allowing access to the feeding-passage from the road.

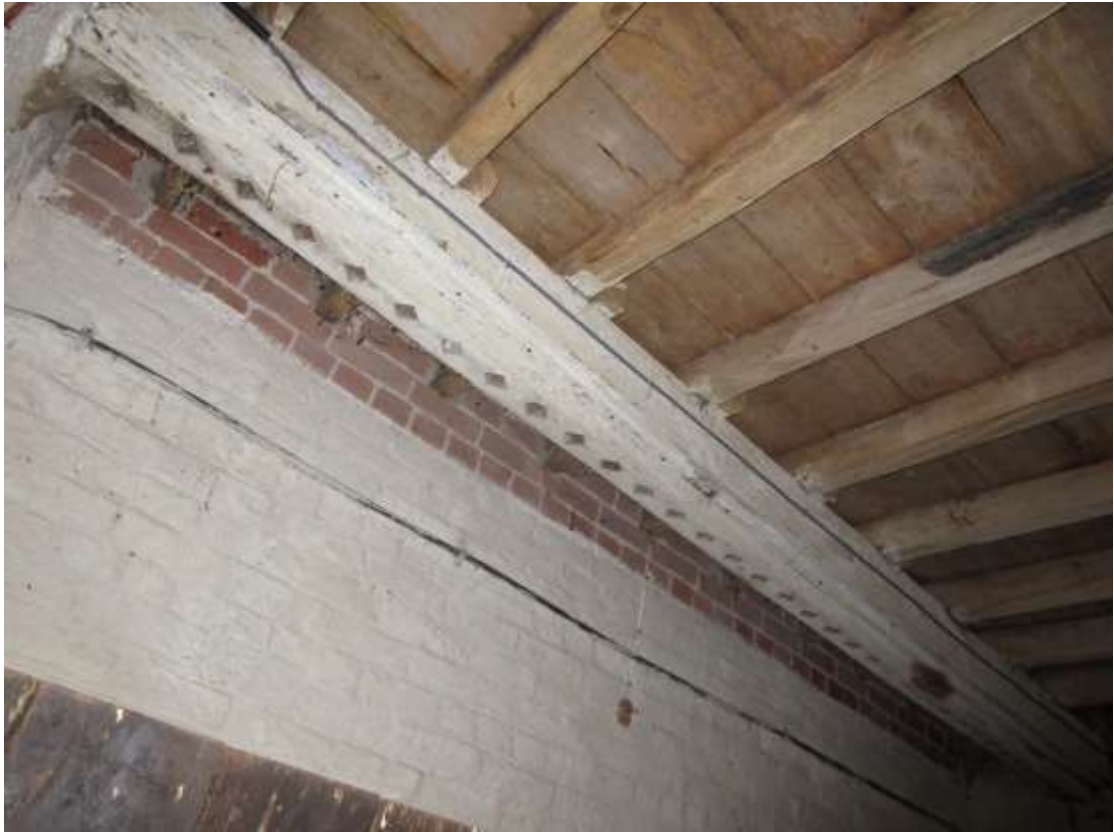
Plate 18; Former loosebox; remains of hayrack.

In the former loose-box, since it supported the common-joist ends, the socketed beam for the hayrack survives with short additional timbers to support the new upper strip of hayloft flooring next to the wall. No longer necessary, the door to the foldyard was blocked and fenestrated. In the stable a single tack-hook survives *in situ* but regularly spaced gaps in the brickwork indicates an original group of four. The positions of original doorways indicate a walkway along the south-west. The interior timber lintel over the foldyard door is a reused length of wall-plate with birds' mouths and its scantling (cross-sectional dimensions) suggests a C17 date.

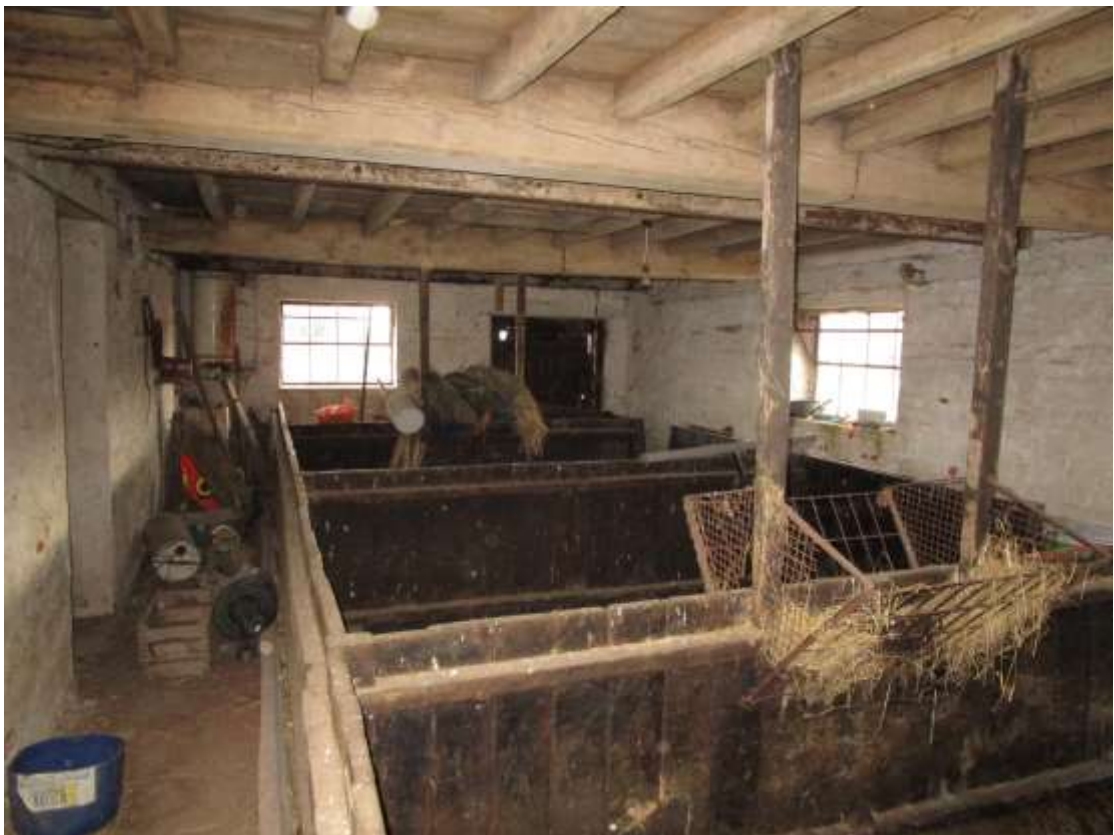
Plate 19; Former stables; with inserted cattle stalls and feeding-passage.

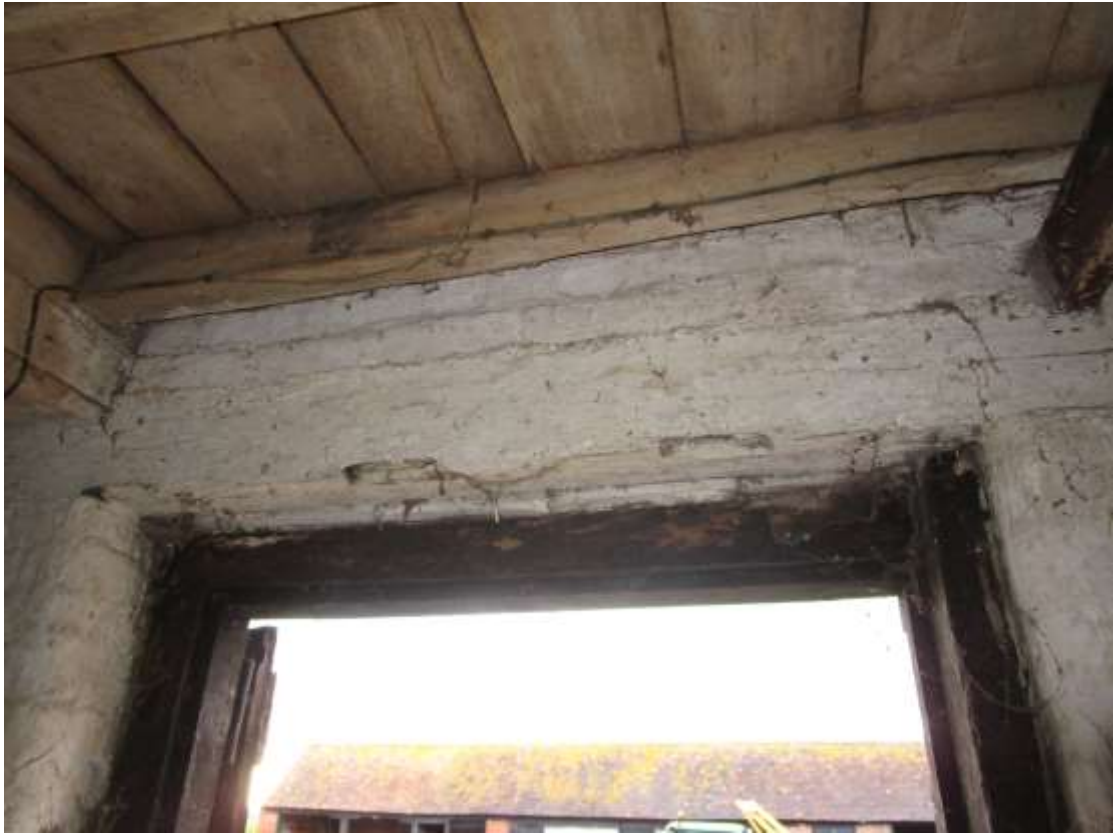
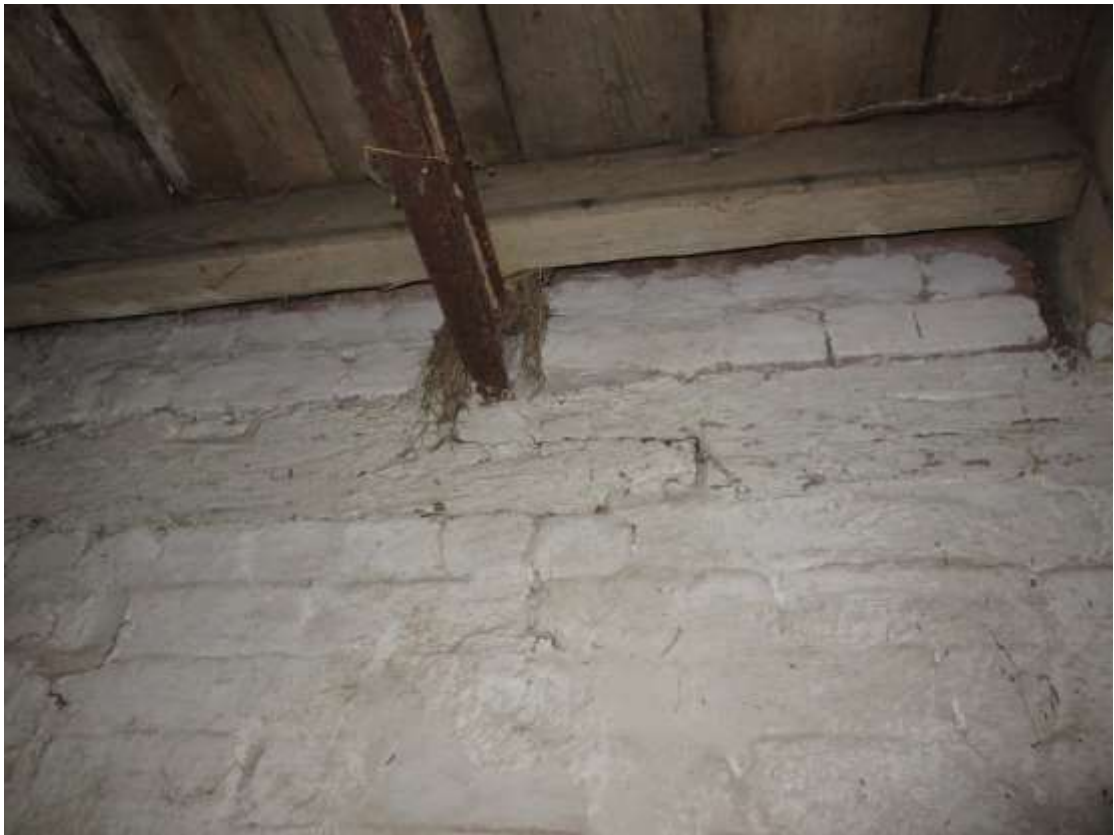
Plate 22; Former stables; Reused wall-plate displaying birds' mouths.

Plate 23; Former stables; Scarph in reused wall-plate, note birds' mouth to left.

In the stable a single tack-hook survives *in situ* but regularly spaced gaps in the brickwork indicates an original group of four. The positions of original doorways indicate a walkway on the south-west side. The lintel over the foldyard door is a reused wall-plate with birds' mouths and its scantling (cross-sectional dimensions) suggests a C17 date.

What little is visible of reused timbers in the C19 work; mortices in the pig-house and birds' mouths in the stable, is consistent with a C17 date.

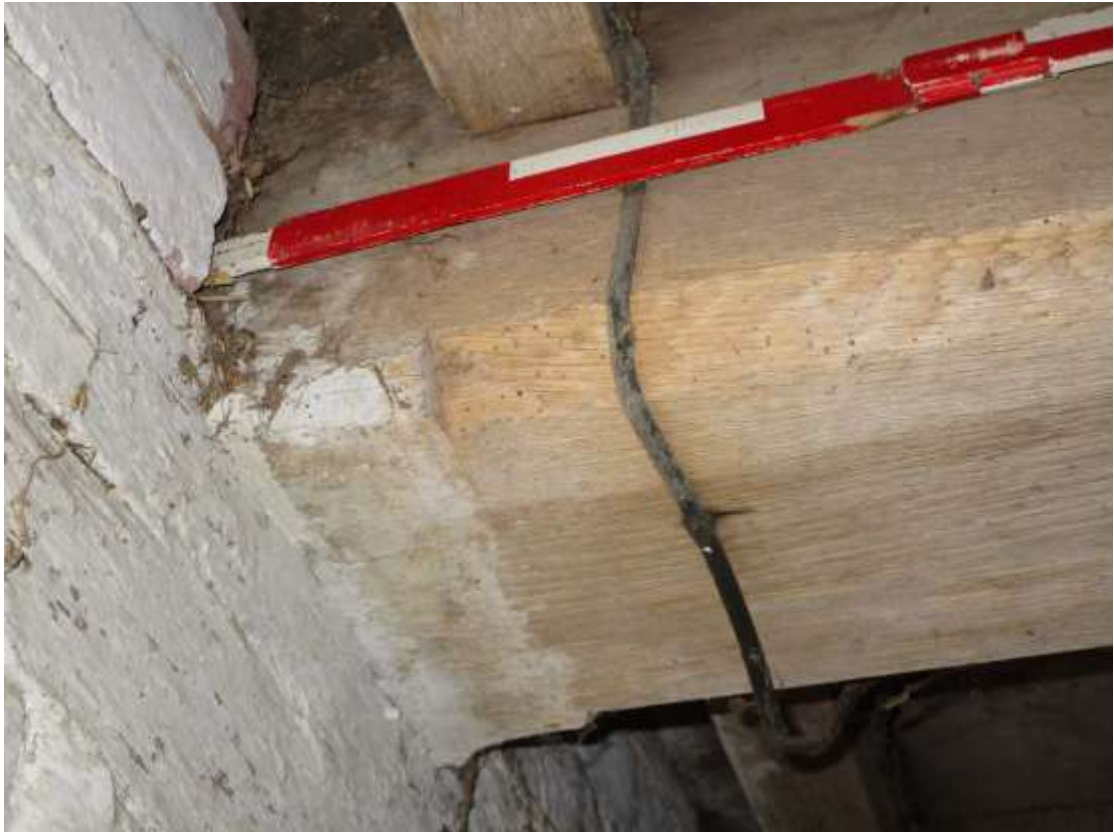
Plate 24; Former stables; neatly cut scroll-stops to chamfers on principal-joist.

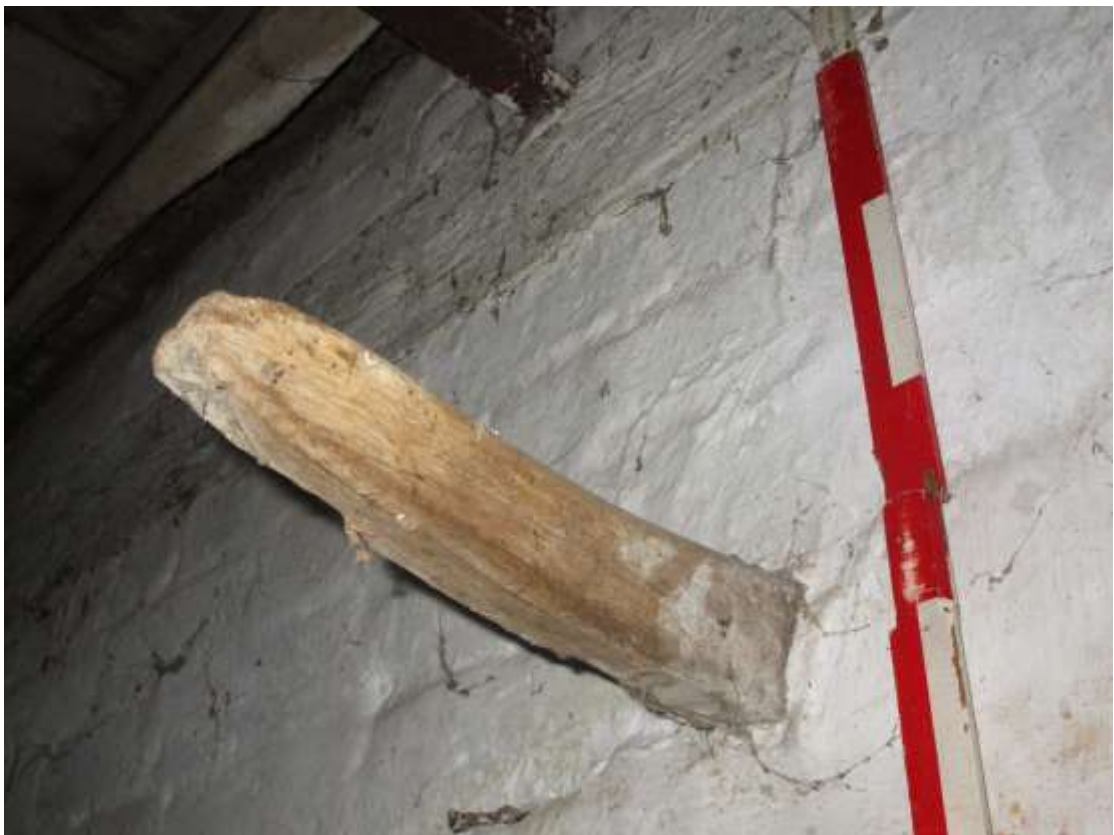
Plate 25; Former stables; tack-hook, evidence for three more to left.

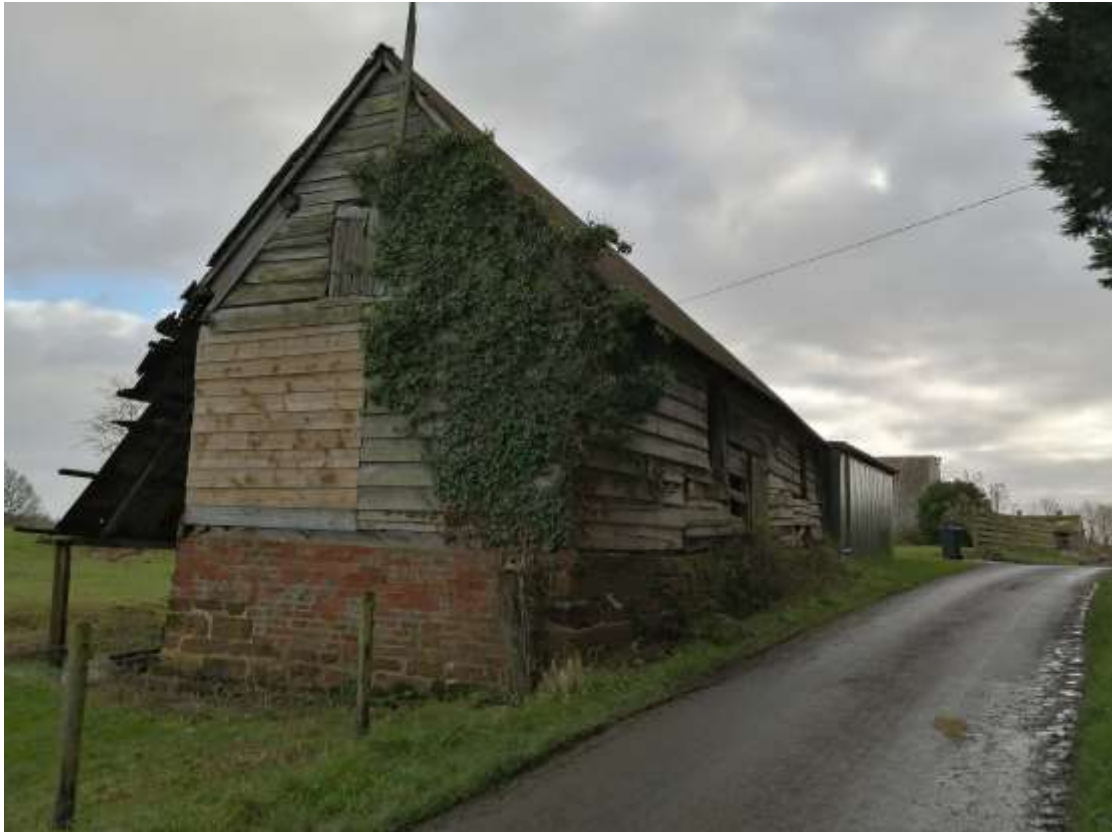
Fig 1; The timber-framed barn, late C17, north-west of the cart-shed.

Not far away, toward Upper Holling Farm is a small C17 timber-framed barn ([WSM52341](#)), on a masonry wall, currently boarded but with a little of the original stave and split-lathe infill for ventilation. This building is an example of the buildings lost when the farm was rebuilt in brick.
