Upper Holling Farm

Hollins Lane, Martley, Worcestershire WR6 6PU

Historic Building Recording

13th February 2020

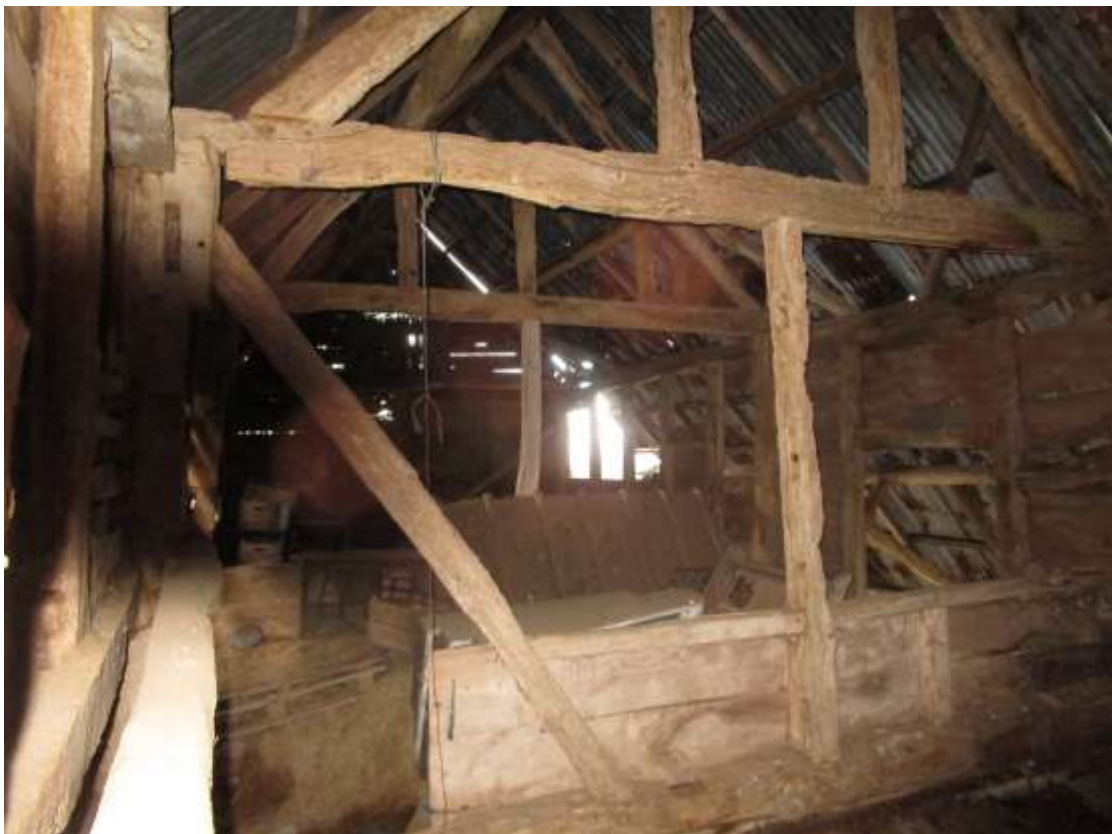
Fig 2; The barn interior showing the outshot beyond, late C17/early C18.
