Royal British Legion

Salwarpe Road, Droitwich Spa, Worcestershire, WR9 9BH.

Archaeological Evaluation

Site code: *dro22*

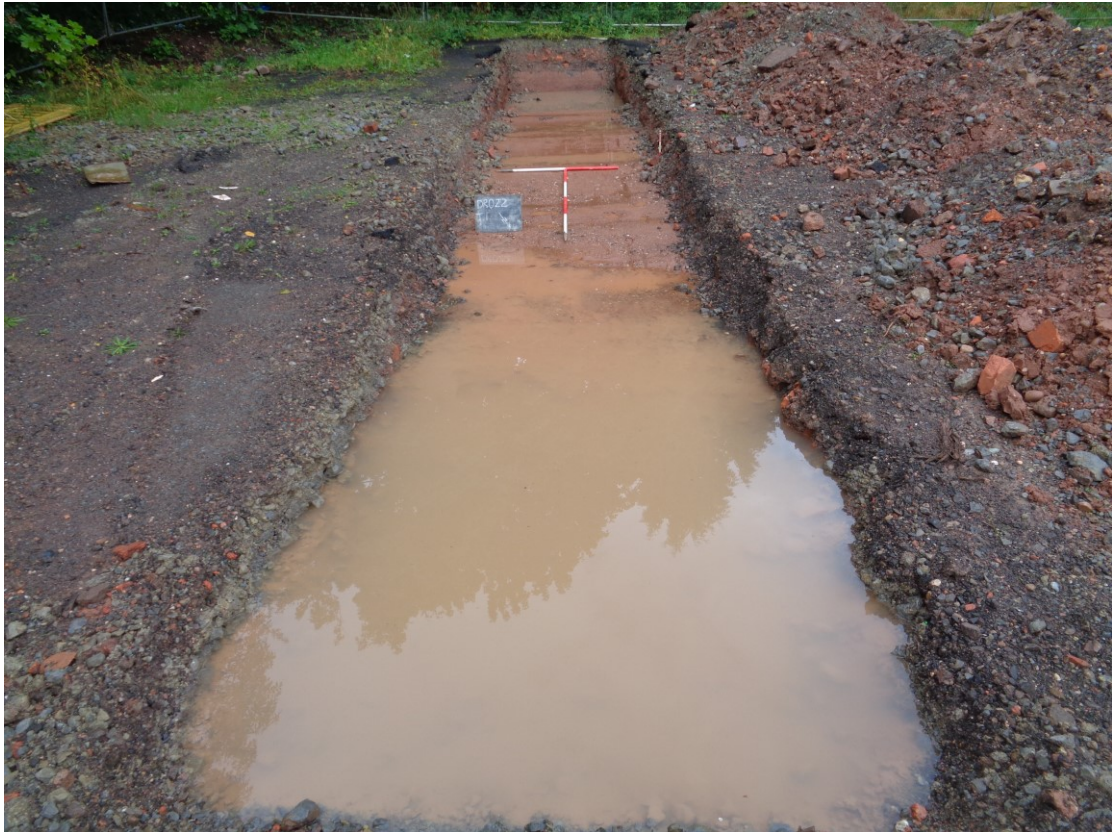
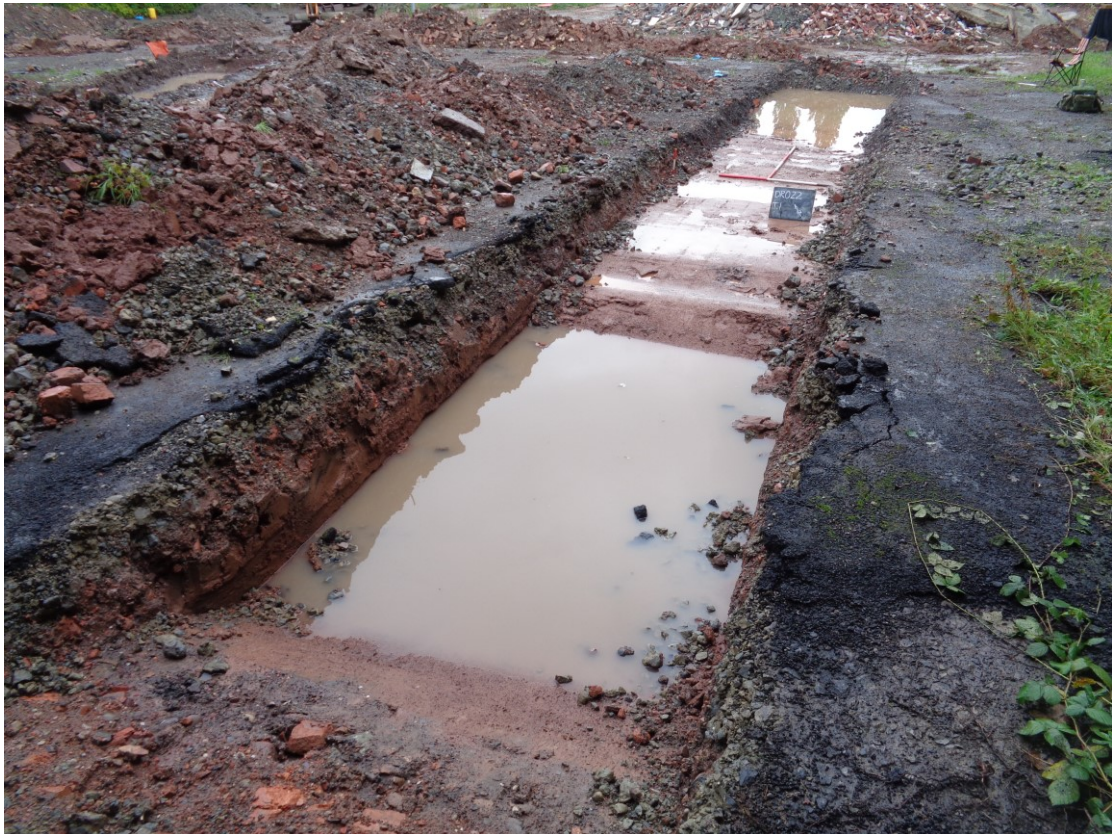
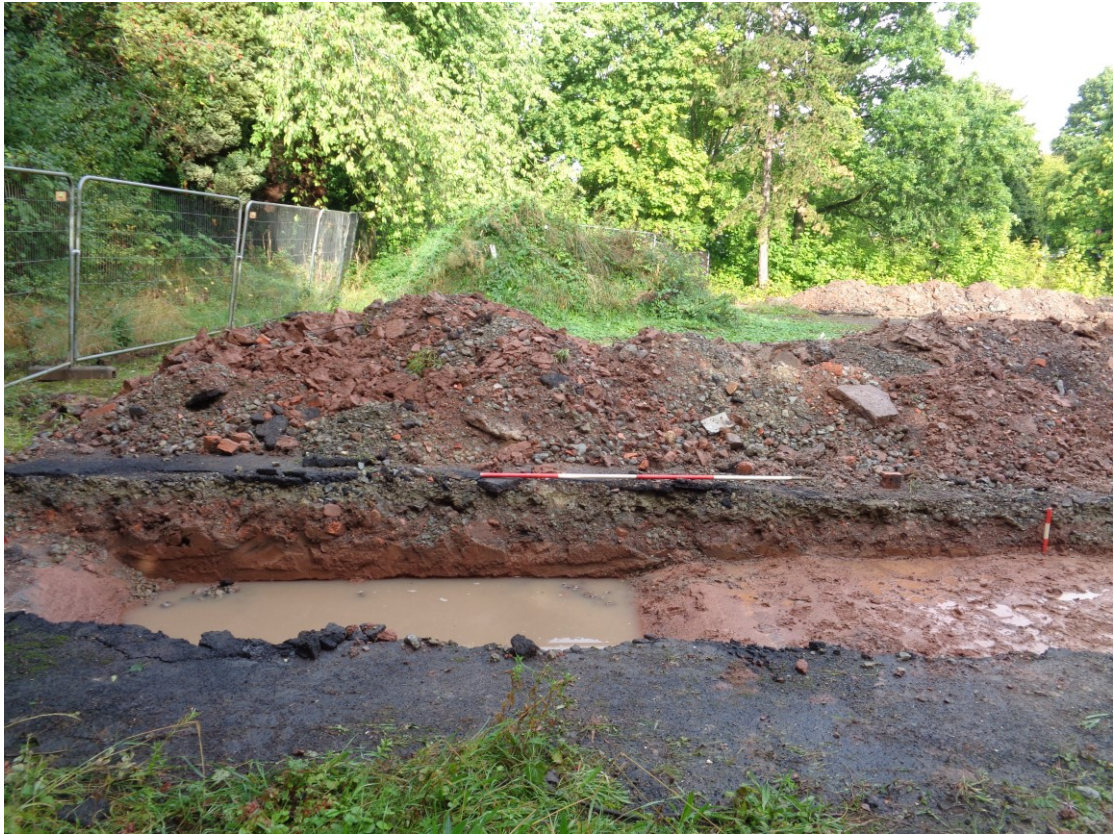
Plate 1: trench 1, view southwest

Plate 2: trench 1, view north

Plate 3: section 1a

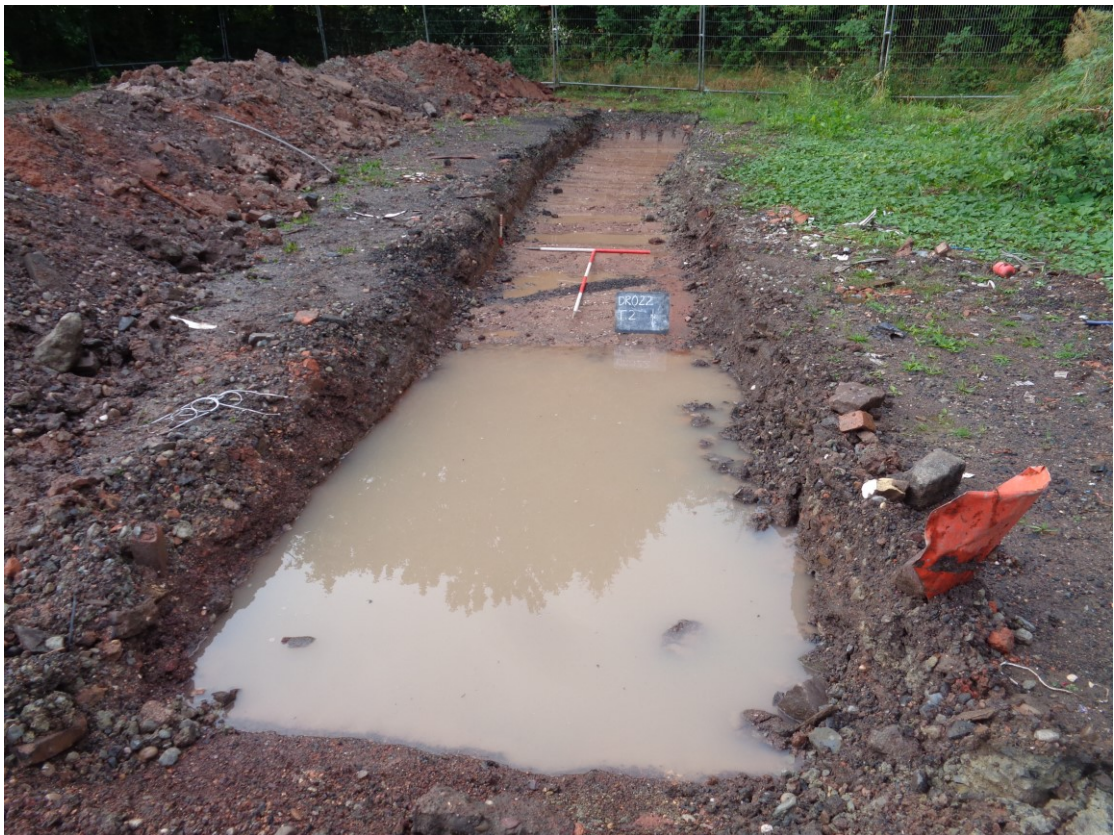
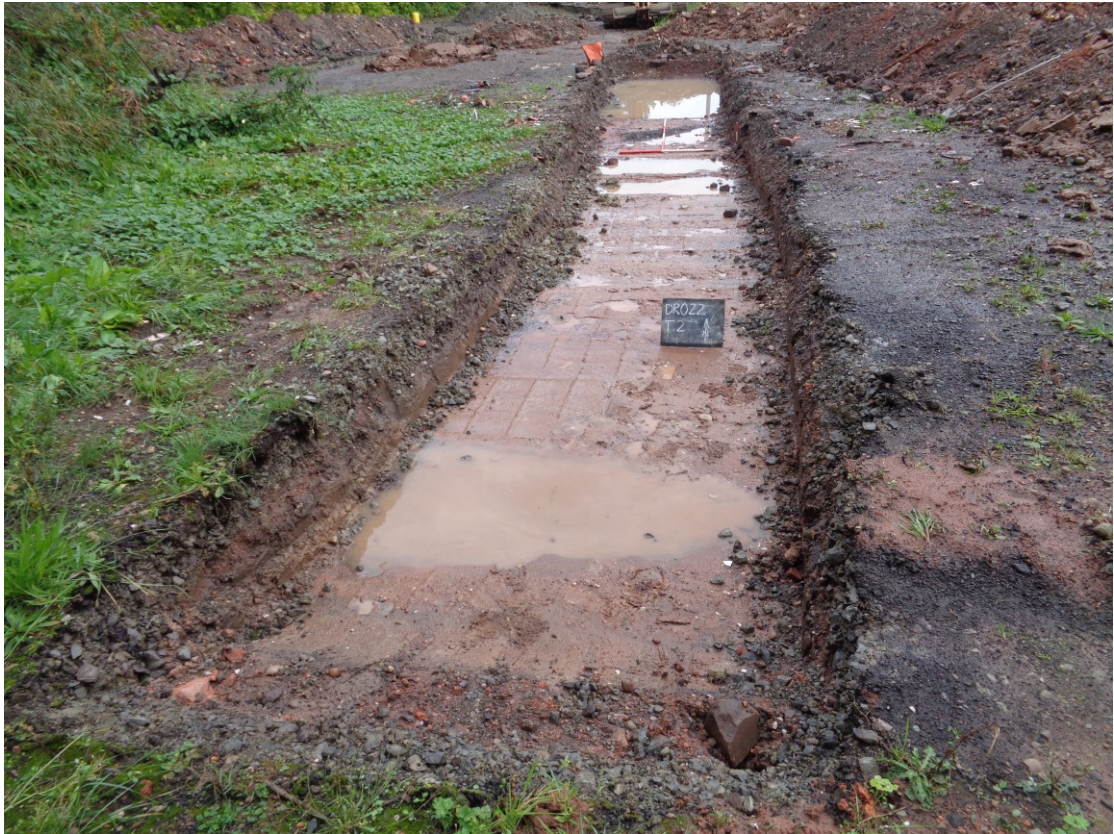
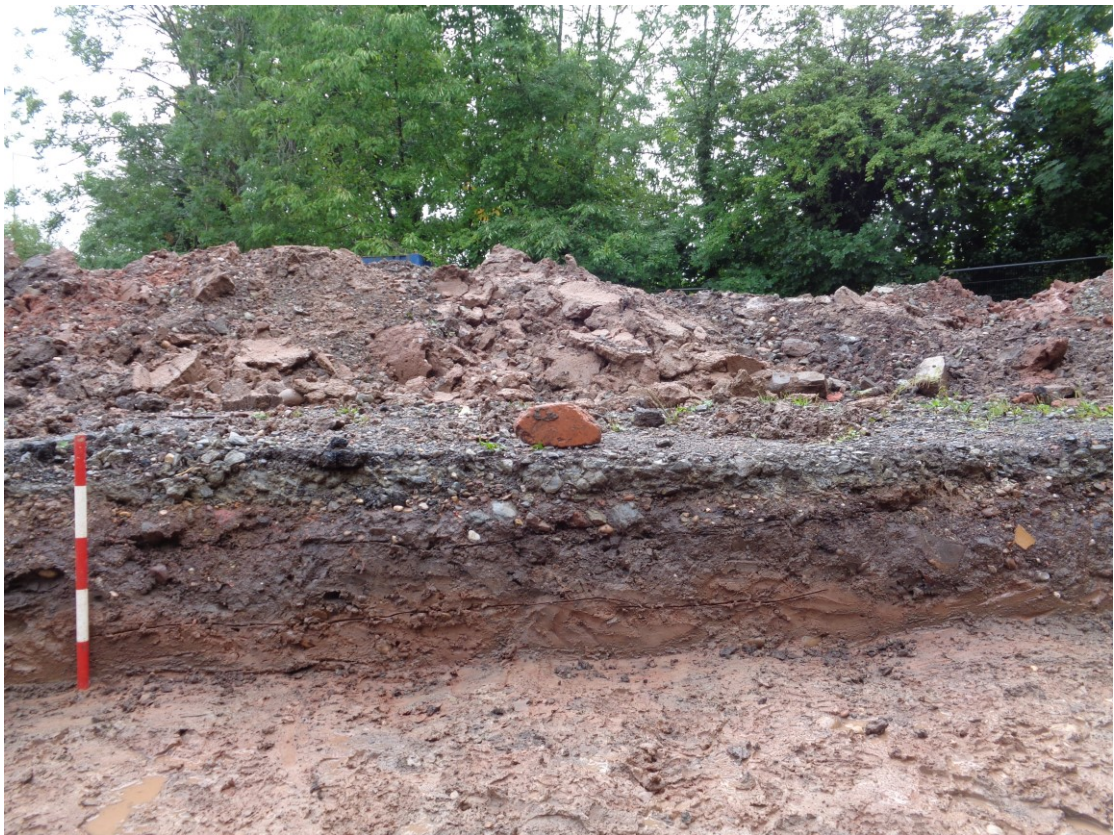
Plate 4: trench 2, view south

Plate 5: trench 2, view north

Plate 6: section 2a

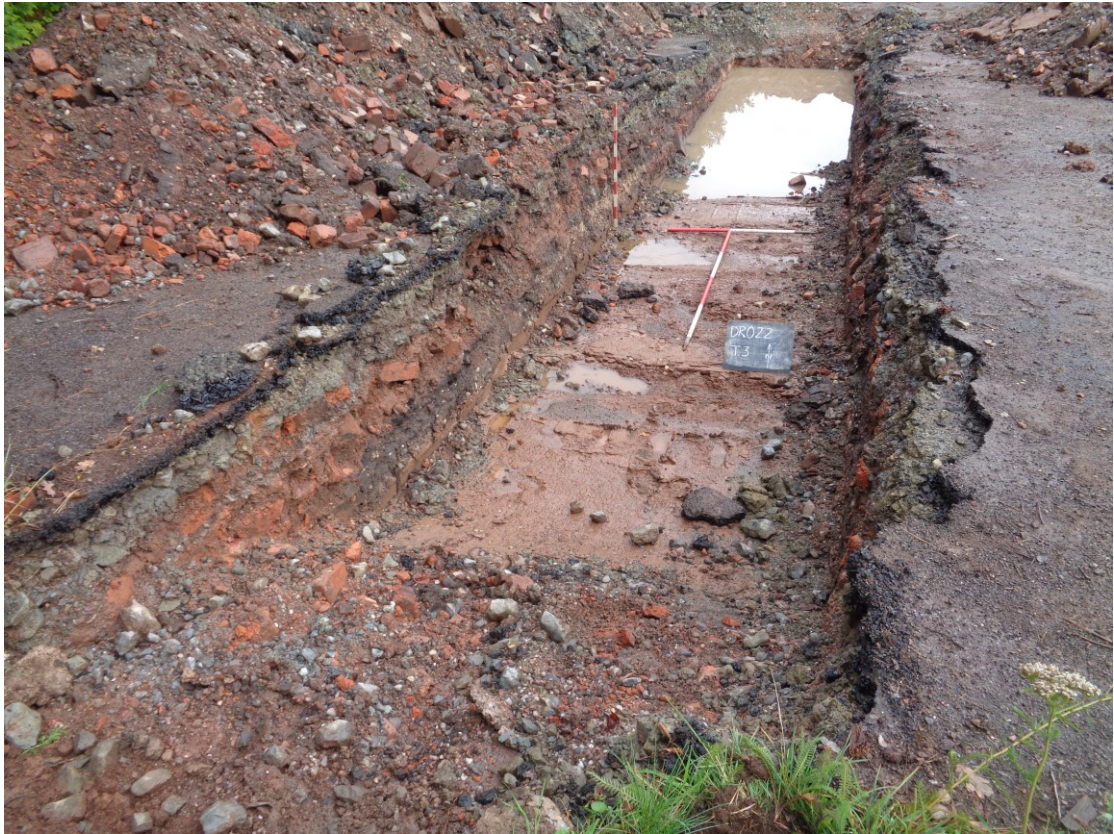
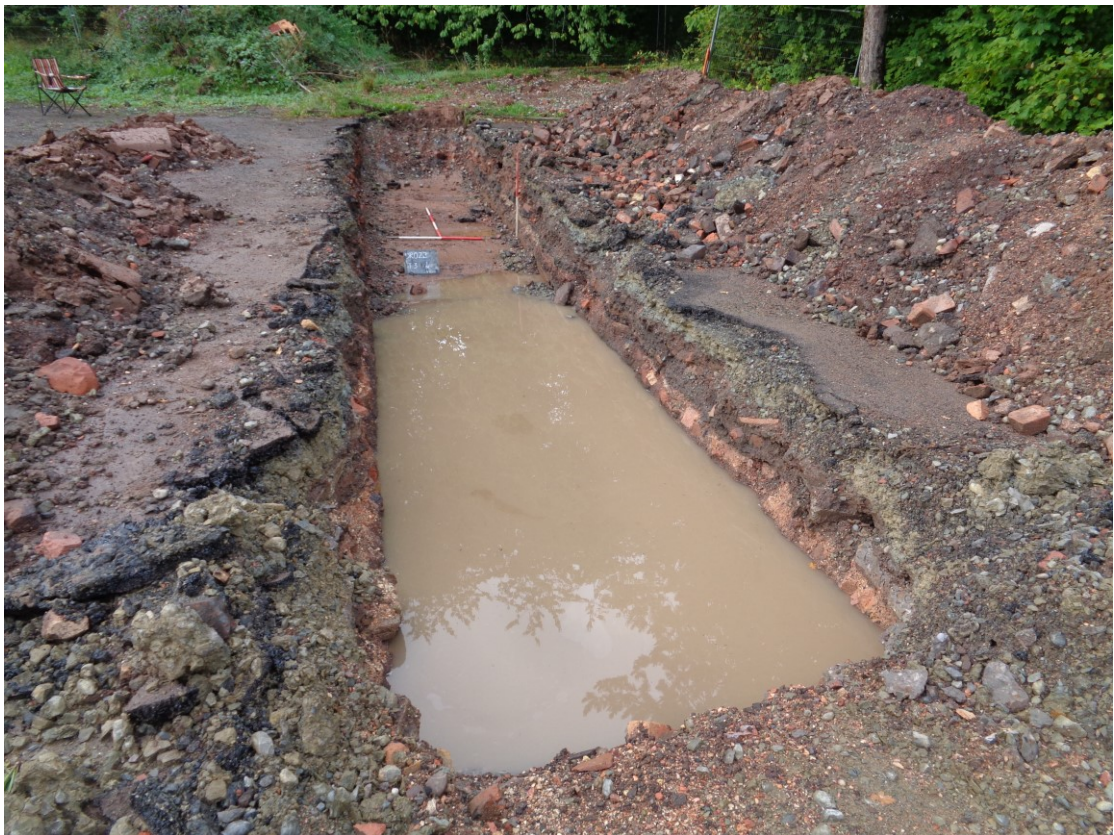
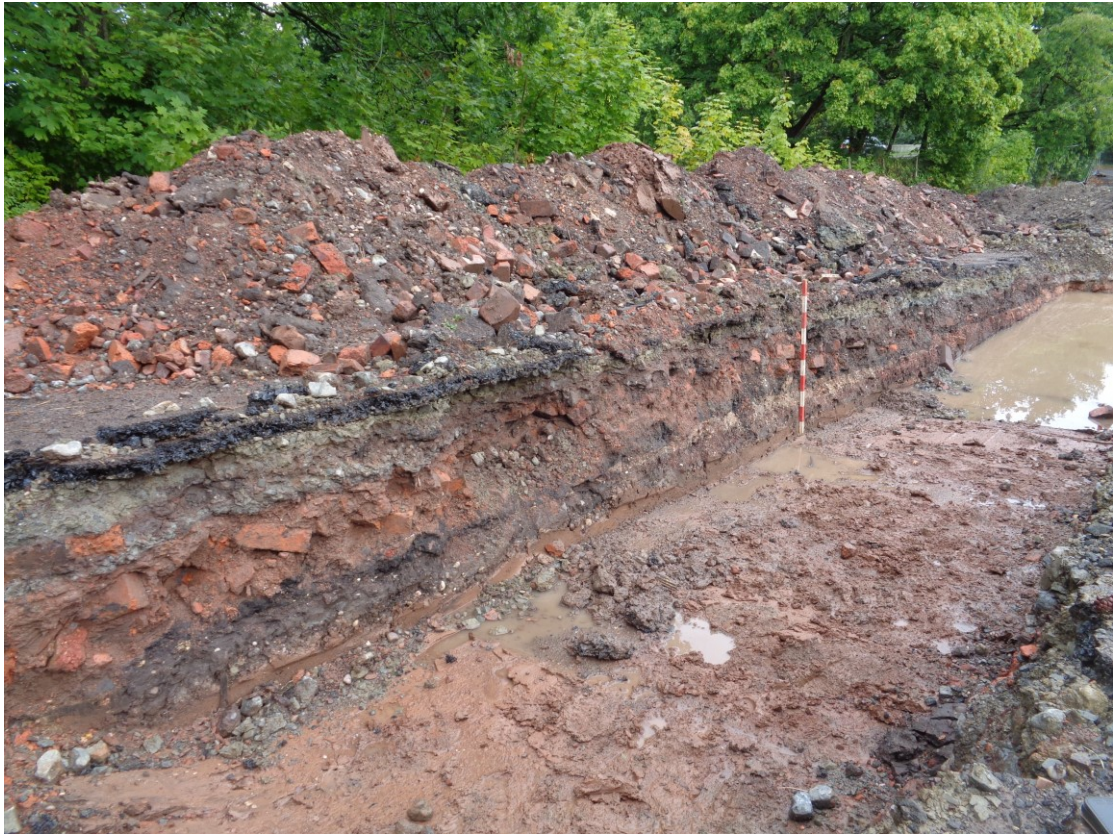
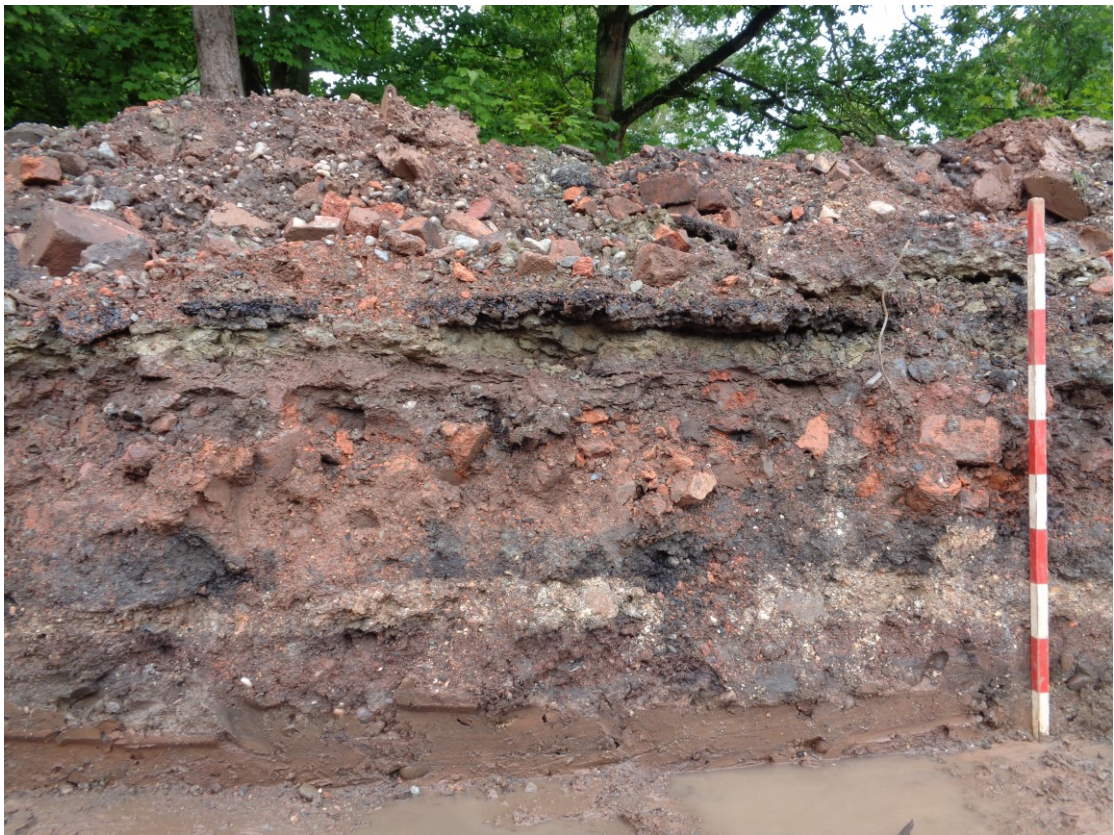
Plate 7: trench 3, view northwest

Plate 8: trench 3, view southeast

Plate 9: section 3a

Plate 10: section 3a, detail

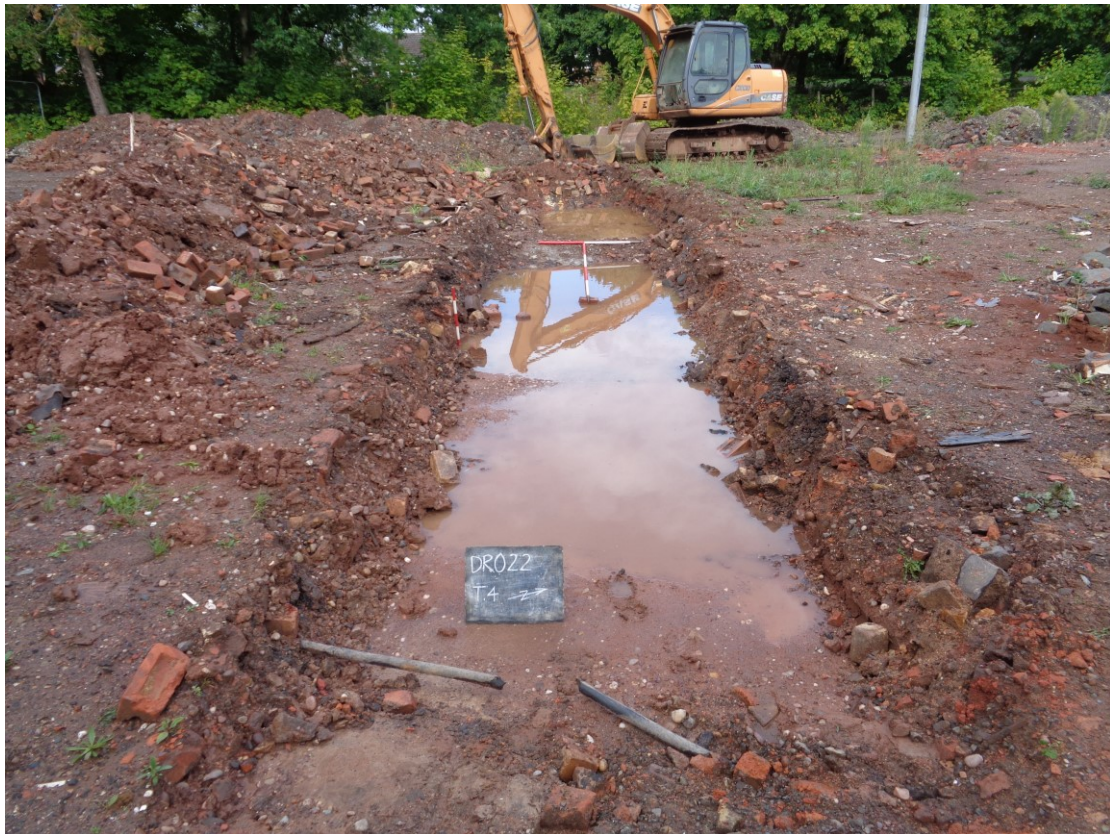
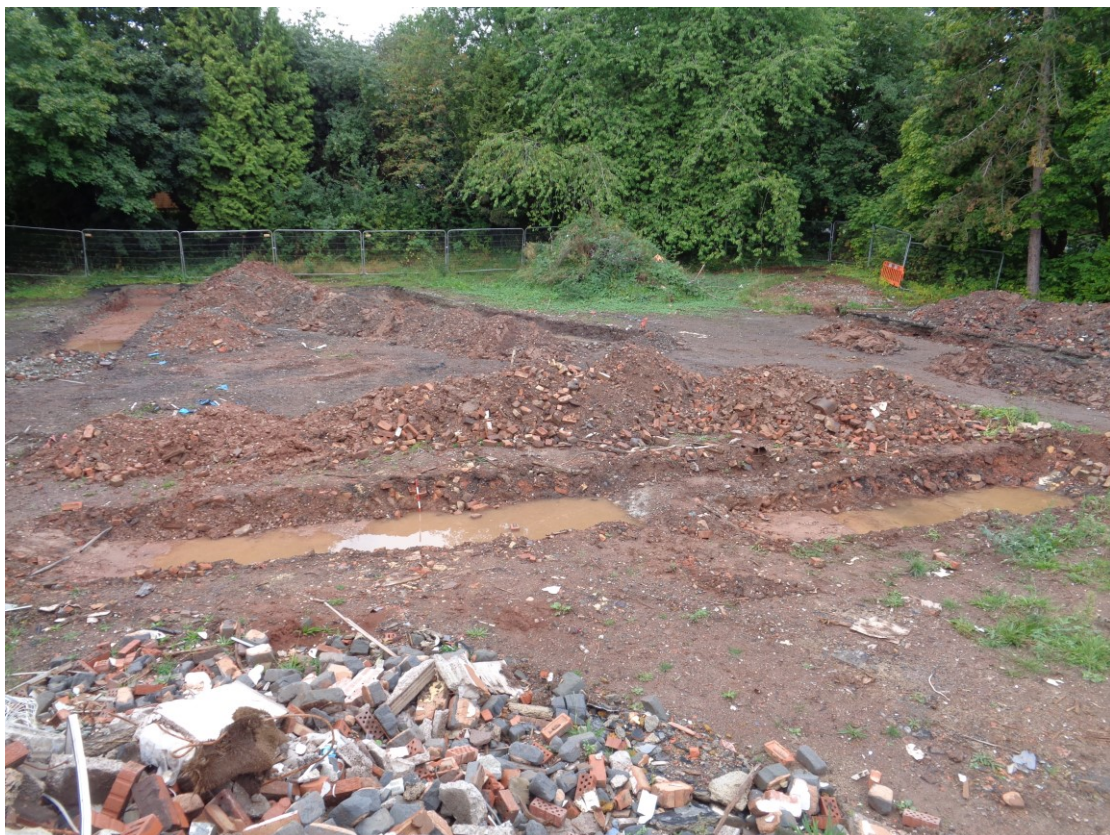
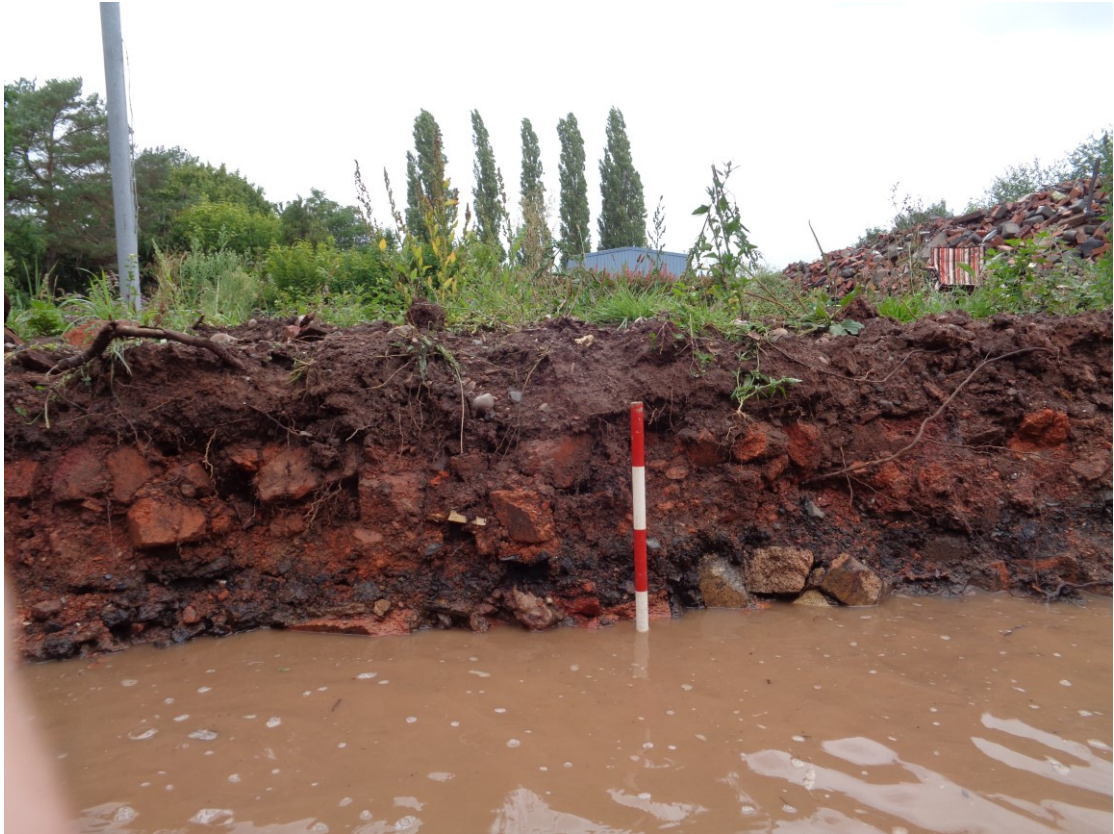
Plate 11: trench 4, view west

Plate 12: trench 4, section, view southwest

Plate 13: detail of trench section

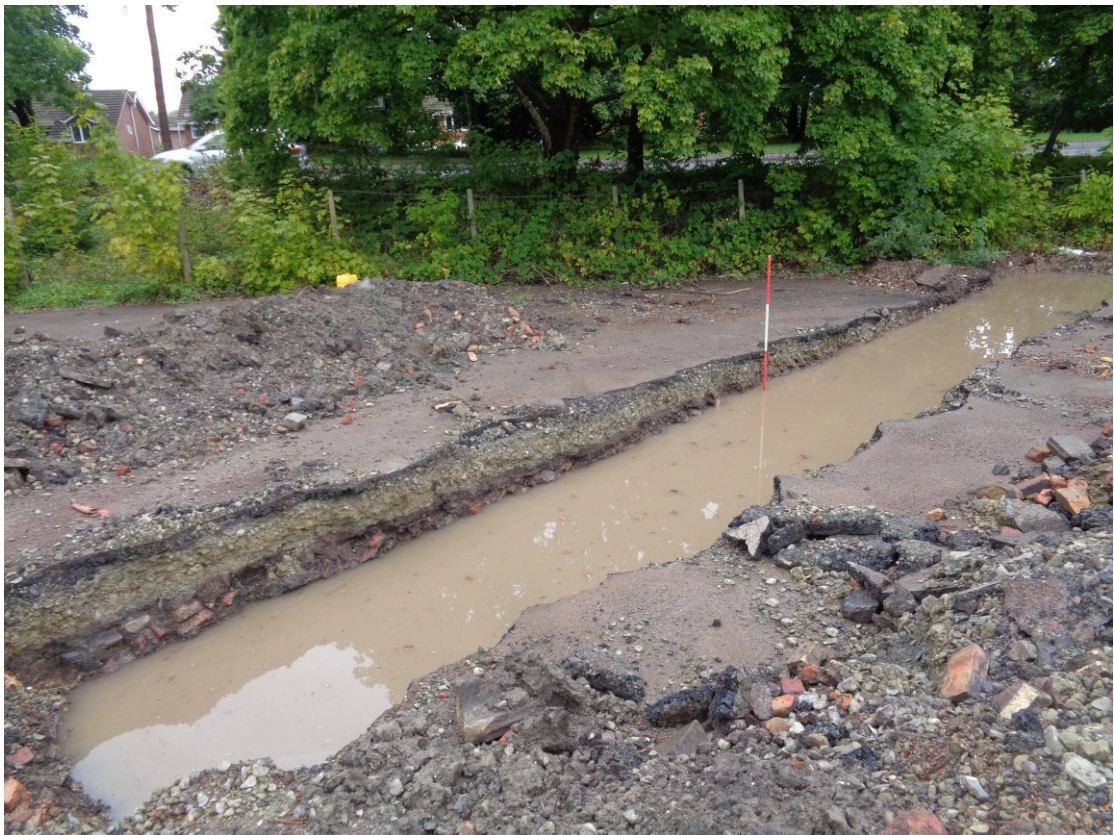
Plate 14: trench 5, view northwest
