EXCAVATIONS AT THE DESERTED MEDIEVAL VILLAGE OF HANGLETON

Part II

By JOHN G. HURST, F.S.A., and D. GILLIAN HURST

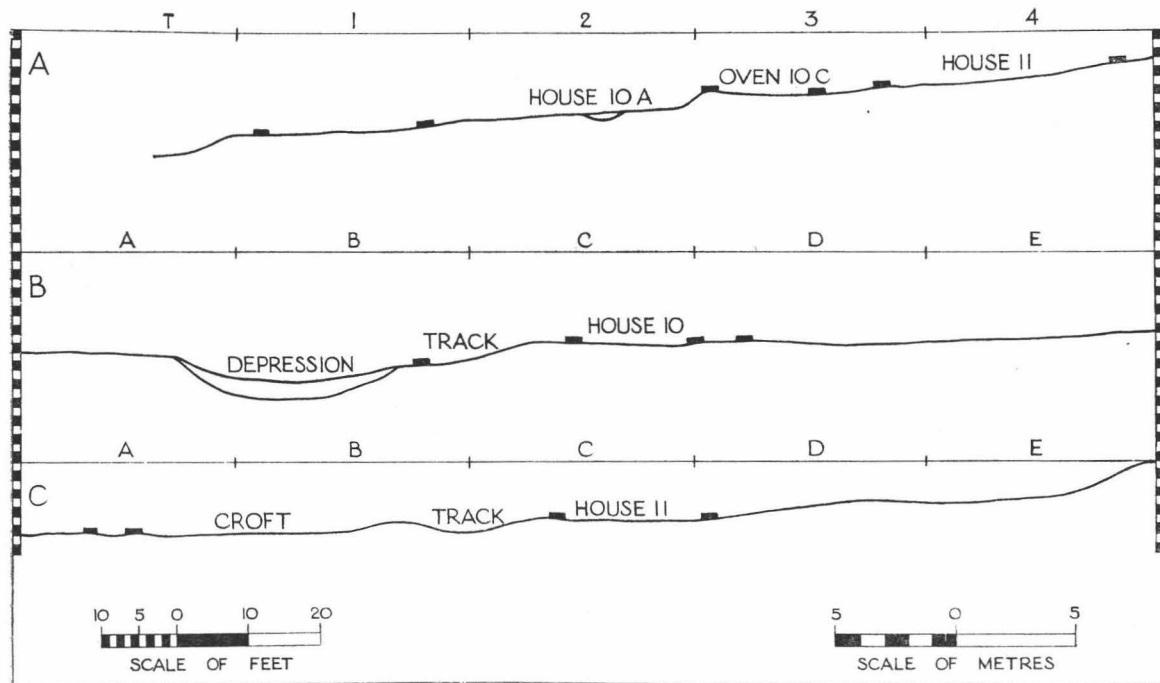
FIG. 2. PROFILES. A, ALONG THE SITE THROUGH BUILDINGS 9E, 10 AND 11 FROM T—4; B, THROUGH THE DEPRESSION, TRACK AND HOUSE 10 ALONG THE 1/2 LINE; C, THROUGH THE CROFT, TRACK AND HOUSE 11 ALONG THE 3/4 LINE.

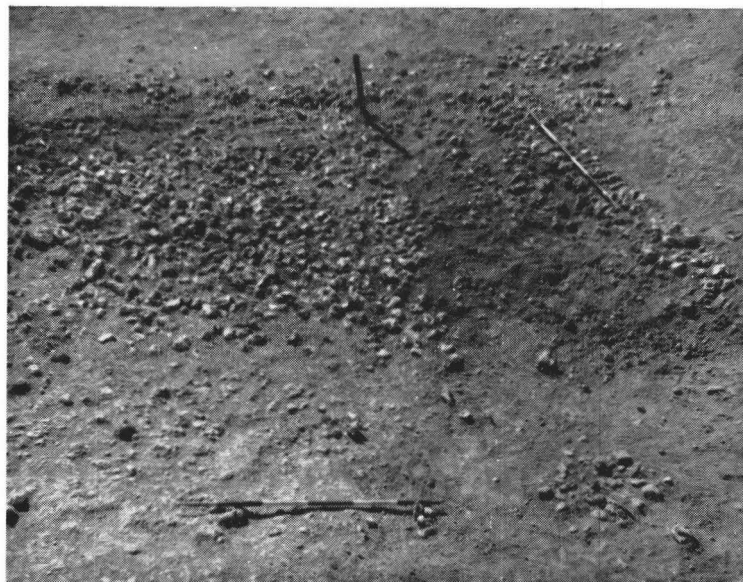
1A. AREA 9 FROM THE EAST SHOWING THE RUBBLE SPREAD AFTER THE TURF WAS REMOVED. THE POLE ON THE RIGHT IS LYING ALONG WALL 1 (p. 97).

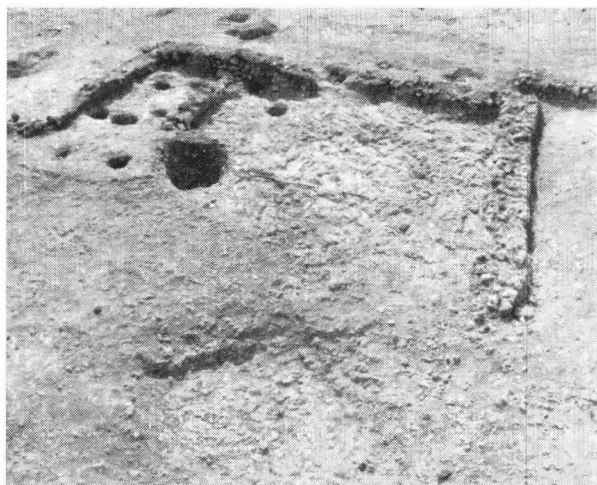
1B. AREA 9 FROM THE EAST SHOWING THE WALLS OF BUILDINGS 9B and 9C WITH THE TIMBER STRUCTURES UNDERNEATH (pp. 100, 103).

Fourteen postholes and two pits were found in this area, (Pl. 1B). They all seemed to be earlier than the flint buildings and to date to the late 12th or early 13th centuries. As in the other areas, though, it was not possible to make a coherent plan out of them, although they were confined to a limited area.

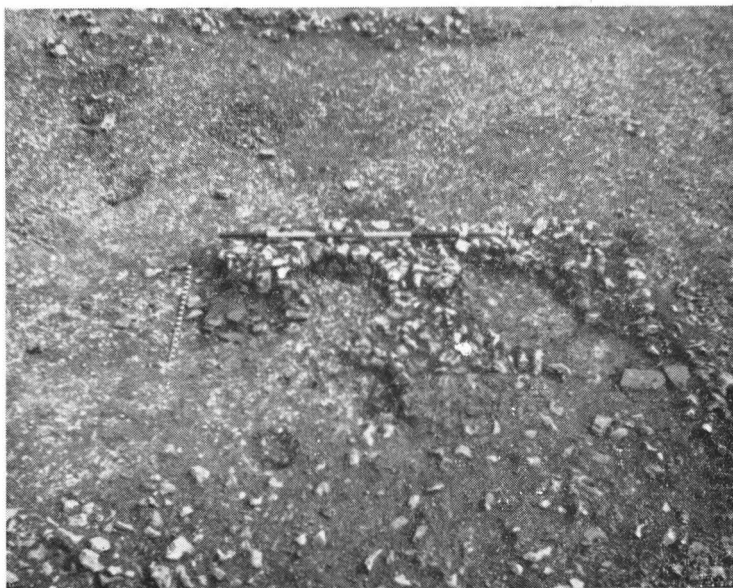
2A. OVEN OUTSHUT 10B WITH HOUSE 10A BEHIND FROM THE NORTH (p. 104).

The purpose of this outshut was clearly to hold the two ovens which were fortunately preserved under the south corner of Building 10D. The eastern one was the best preserved and consisted of a semi-circle $2\frac{1}{2}$ feet across, well constructed of flint headers instead of the random flints of most of the other walls. It did not seem to have been robbed and did not come any further forward. This is confirmed by the two large flat burnt stones forming the rake-back, which were *in situ*. The western oven was larger, over 4 feet across, and its exact form could not be determined as the western part was obliterated by the south-west wall of Building 10D. It was placed further south and was partly placed in the south wall of the outshut. To the north of the ovens the wall was solid and may have supported some form of chimney. This means that the outshut was divided into two quite separate parts with ovens back to back and no access between them. It is not possible to tell for certain, where the entrances were, but there must have been one to each part. All the western half of the south wall was robbed but the very large flint might denote an entrance right against the west wall as far from the oven as possible. Certainly the entrance to the east oven was right in the south-east corner as the wall line survives in the part near to the oven. The scarp was continuous so there must have been a step.

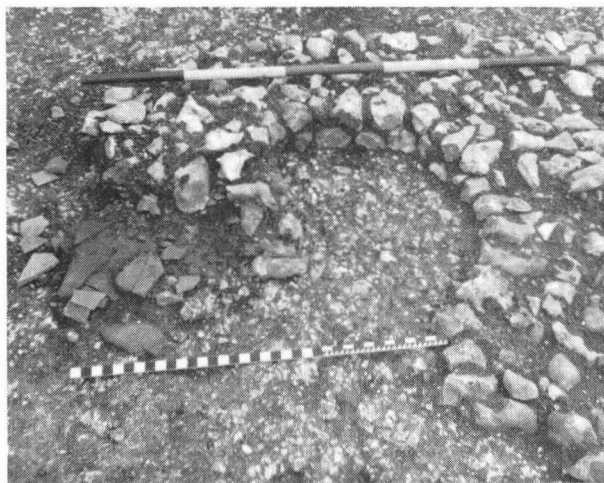
2B. THE EAST OVEN AND RAKE-BACK IN OUTSHUT 10B FROM THE NORTH (p. 104).

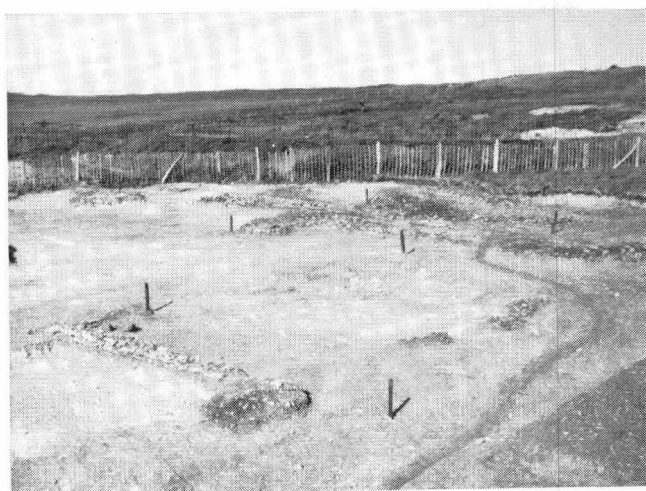
3A. HOUSE 11 AT A LATE STAGE OF THE EXCAVATION WITH HOUSE 12 BEYOND, FROM THE SOUTH-WEST (p. 109).

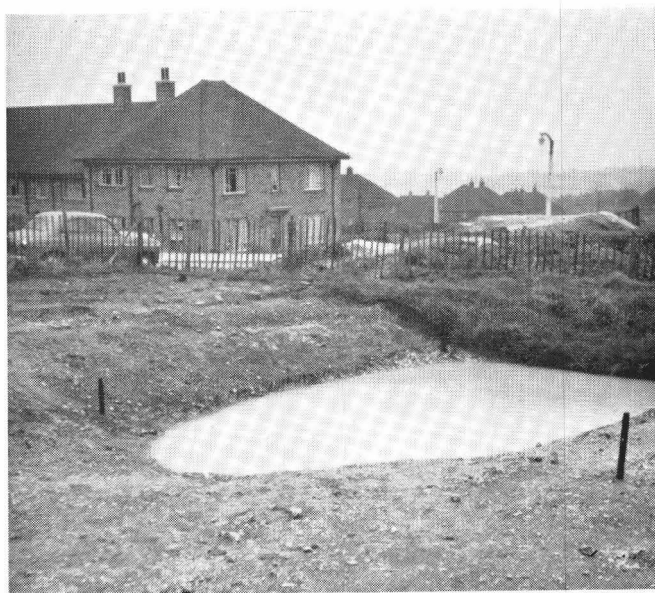
3B. THE DEPRESSION FROM THE NORTH-EAST AFTER RAIN SHOWING HOW IT WAS STILL CAPABLE OF HOLDING WATER (p. 115).

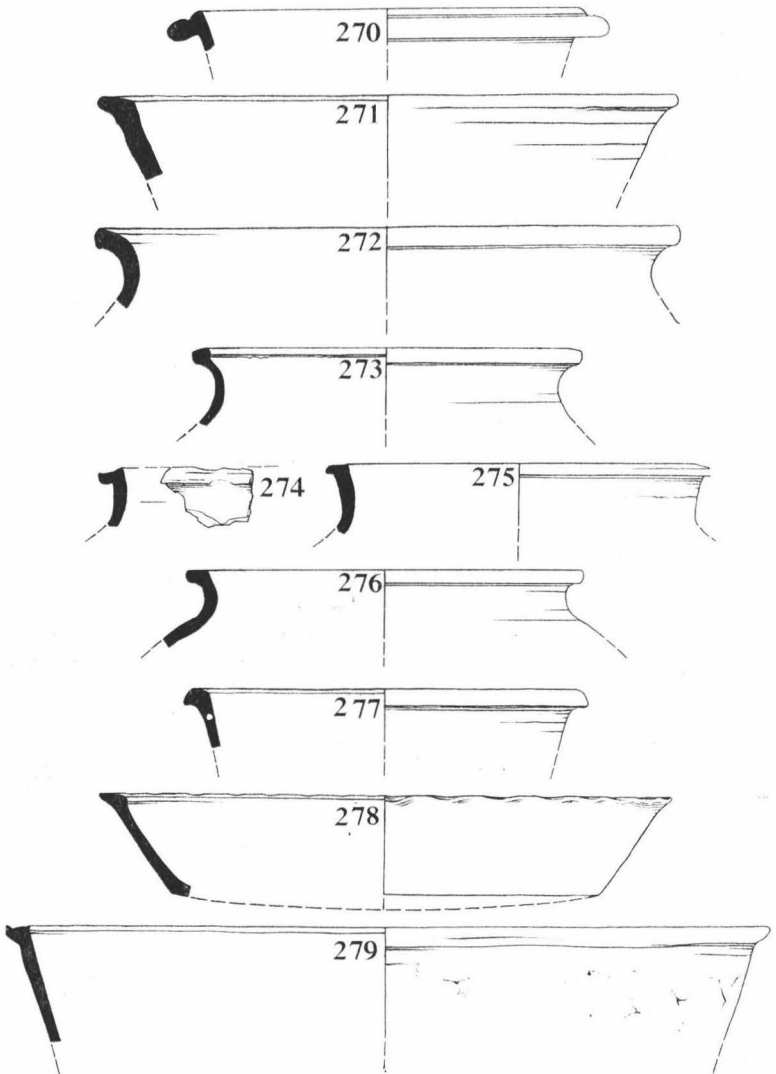
FIG. 7. POTTERY. 270 ROMAN, 271 GROUP *a*, 272-9 GROUP *b*, (‡), p. 121.

(b) A heavy coarse red ware with a heavy laminated core containing much flint grit and some calcite; the surface rough and pitted; probably 1200-1250. Part I, p. 114, Fig. 17.

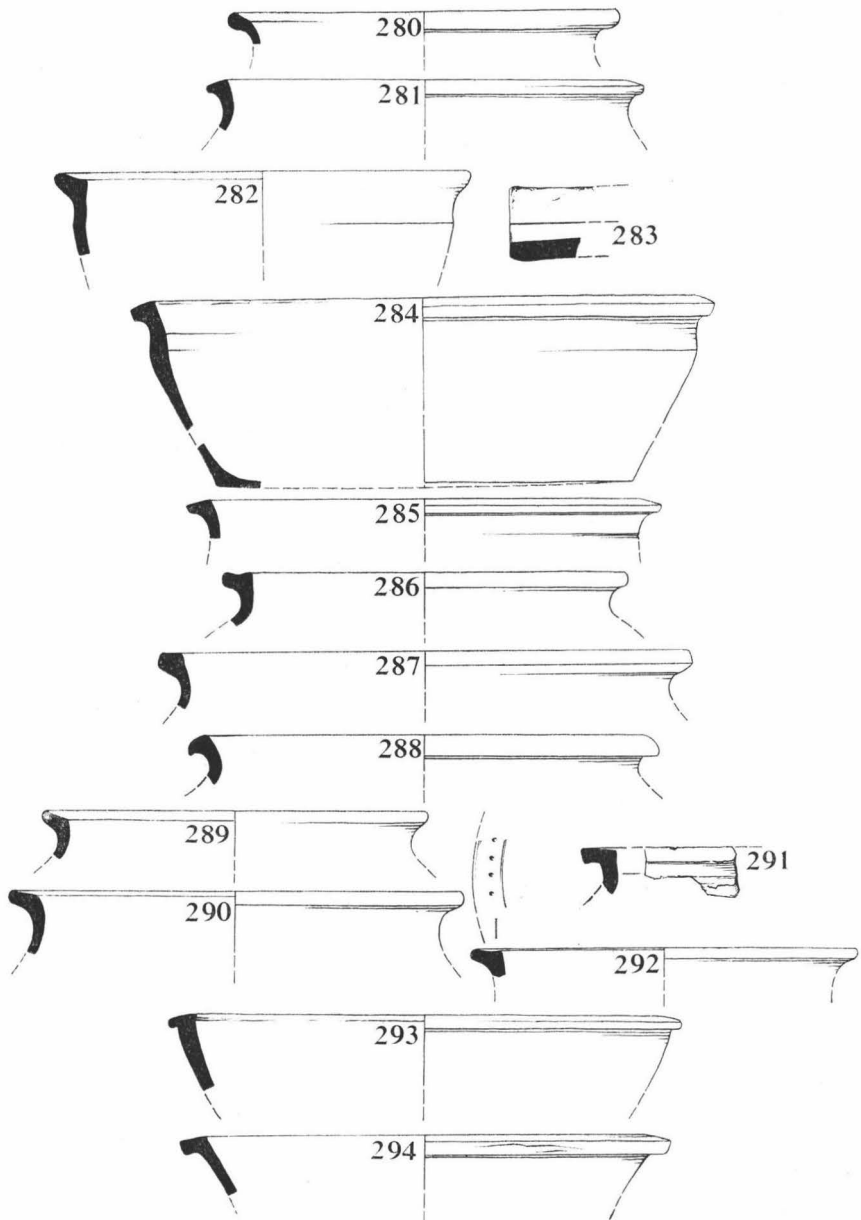
FIG. 8. POTTERY. 280-4 GROUP *c*, 285-7 GROUP *d*, 288-294 GROUP *e*, ($\frac{1}{4}$), p. 123.

288. Cooking-pot with rounded rim sharply undercut outside; from the depression.

289. Cooking-pot with rounded flanged rim, sloping inside; from croft square B3.

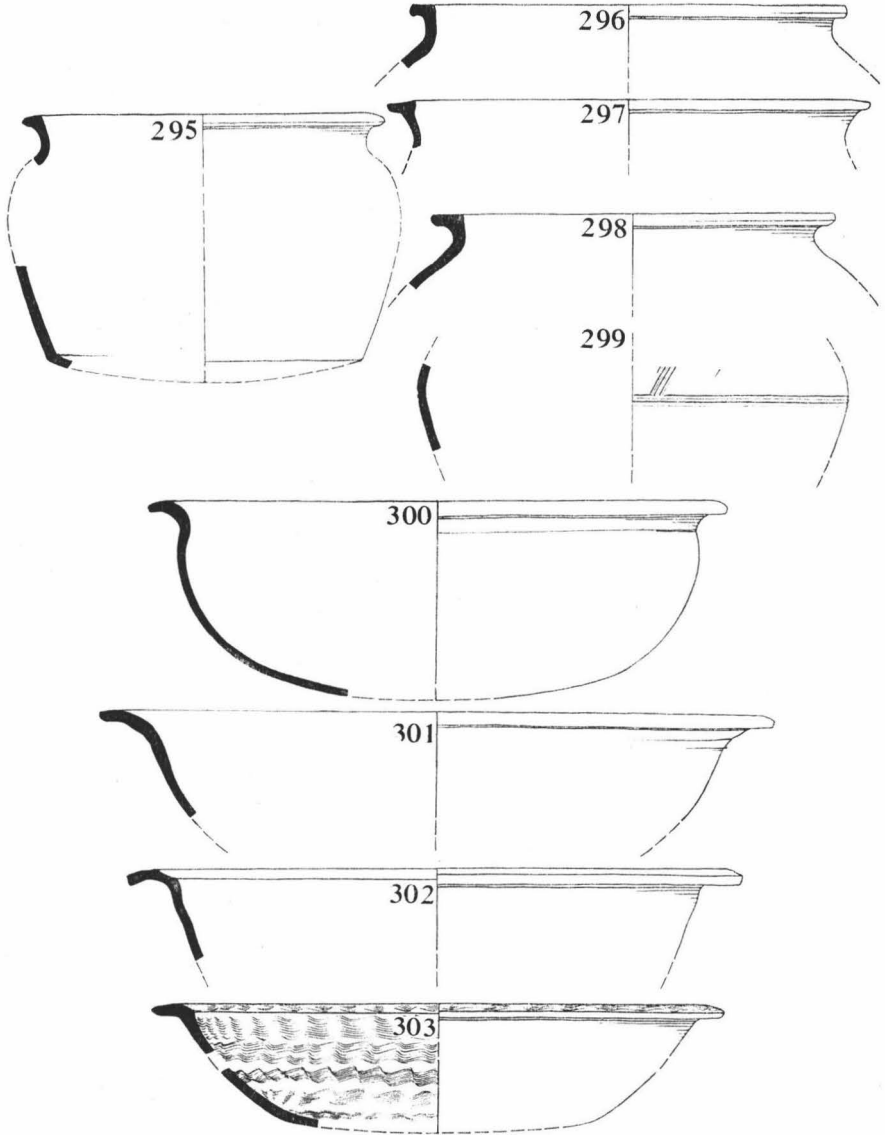
FIG. 9. POTTERY. 295-7 GROUP *f*, 298 GROUP *g*, 299-303 GROUP *i* GLAZED, (‡), p. 125.

299. Body-sherd from a squat cooking pot with comb decoration; from rubble over outshut 12B.

300-303. A group of bowls with thin rounded rims variously moulded. In 303 the basal angle is almost gone and in 300 the base is almost completely

rounded. 303 has an over-all internal decoration of horizontal combed waves. 300-302 from the bank south of area 10. 303 from the south west part of Building 9D.
