# LULLINGTON CHURCH

# EXCAVATIONS AT LULLINGTON CHURCH

By A. BARR-HAMILTON

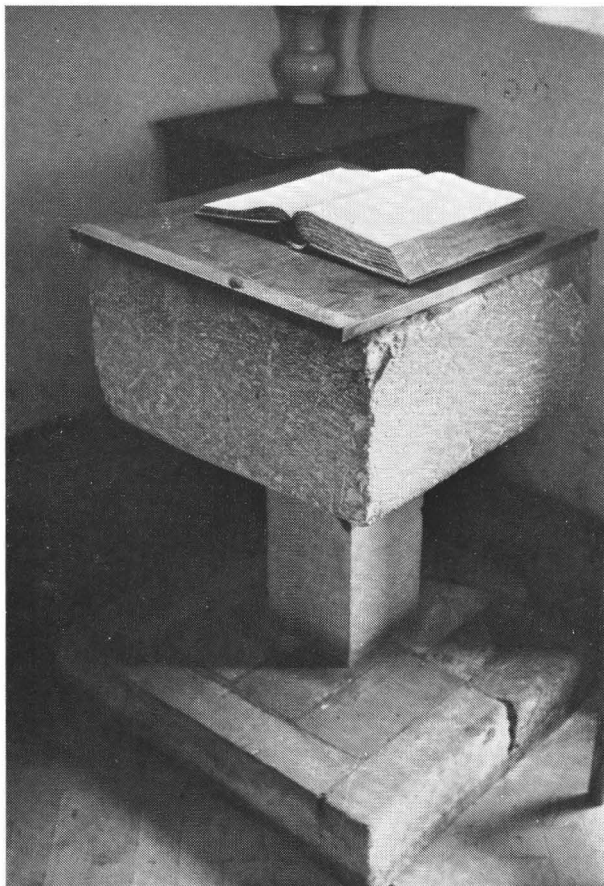
PLATE IV. Font of Building A, in use in the present church. The bowl is of Petworth marble and some original sections of Caen stone remain in the base.

Within the nave area and below the latest floor level, a further footing of chalk, flints and mortar (A2—A5) was found, lying N.-S., between the positions of the doorways; this could not be other than the sleeper footing for the arch of a W. tower (A1—A2—A5—A6—A1; Plate VII) existing before the introduction of these doorways and showed that, when the tower had stood, there had been a smaller nave, of which the N. and/or S. doorways, if any, must have been placed further to the E. It was, perhaps, significant that a rectangular mass of material similar to that contained in footing A2—A5 was uncovered at a point between the approximate positions of such doorways (A21) where one would have expected the font to have rested (Plate VIII); the probability that this mass had been the font base was increased by the discovery, at its W. side, of a circular hole (A22) approximately 12in. wide and 12in. deep, through which the baptismal water could have drained. The font, almost certainly, would have been that in the present church (Plate IV).

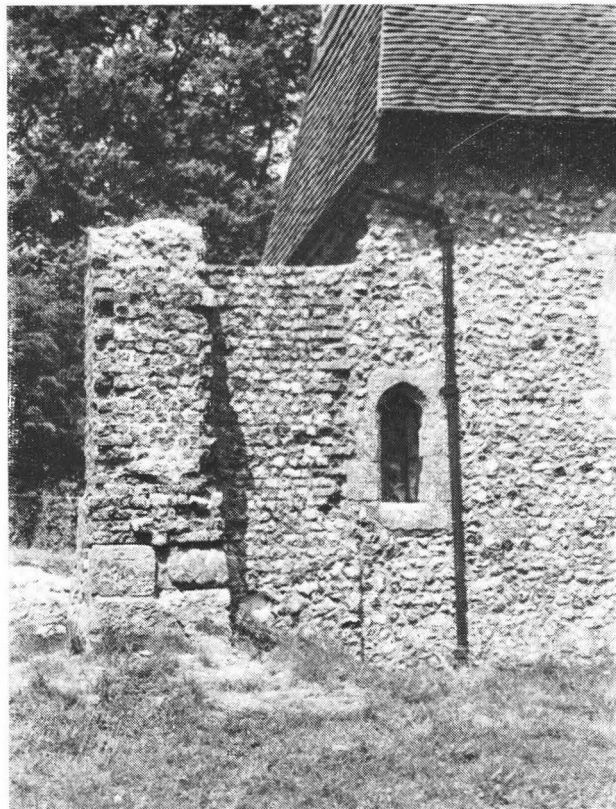
PLATE VI. Standing section of ruined walls of buildings A, B and C, from south. Immediately to the west of south-west angle of present building can be seen low side window of Building B, in green sandstone, with trefoil head and remains of iron grille. To the west of window are the chancel arch buttress and repaired section of south wall of Building C in squared

The porch walls were repaired and the S. wall of the chancel, with external buttress to the arch, was rebuilt, W. of the low-side window, in squared flints faced with bricks thought to be Tudor (Plate VI).

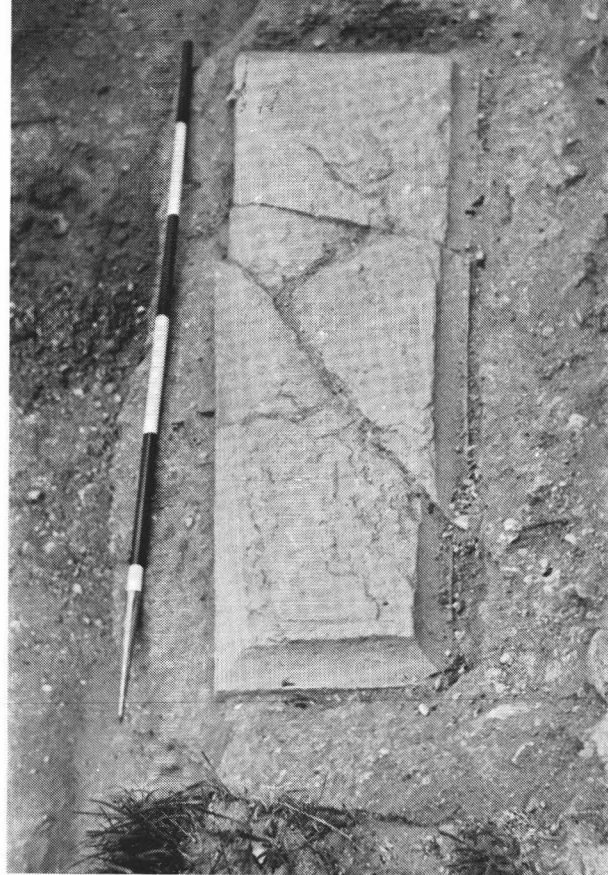
PLATE XII. Grave slab, probably of fourteenth century date, outside north doorway of Building B.

*Note:* Base of stepped cross, in bas-relief.
