# ROMAN TILEWORKS AT ITCHINGFIELD

By T. K. GREEN

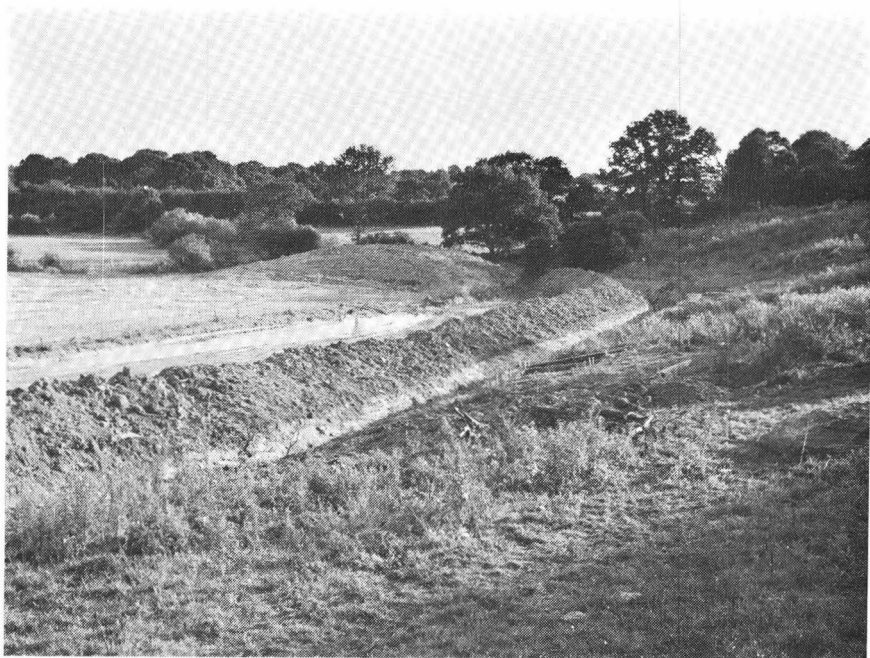
PLATE IA. Baystone Farm Tip, Itchingfield, with Sites 1 and 2 beside ditch: looking SSW.

The site lies  $1\frac{3}{4}$  miles WSW. of Horsham, in the NW. segment of an ox-bow valley cut by the River Arun which now flows northward across the eastern ends. The building is located at TQ14092979 and the clamp-plus-tile-dump at TQ 14062975. The local rock is Weald Clay, mottled bluish-grey and yellow when unweathered, in which beds of fine-grained sandstone occur sporadically. The areas excavated lie on the tail of the northern side, whose slope is markedly steep for a clay feature, and there may have been some subsidence into clay pits or workings since Roman times.
