## A MEDIEVAL AND SEVENTEENTH-CENTURY HOUSE AT WALDERTON, WEST SUSSEX, DISMANTLED AND RE-ERECTED AT THE WEALD AND DOWNLAND OPEN AIR MUSEUM

by F. G. Aldsworth B.A., F.S.A. and R. Harris M.A., A.A.Dip.

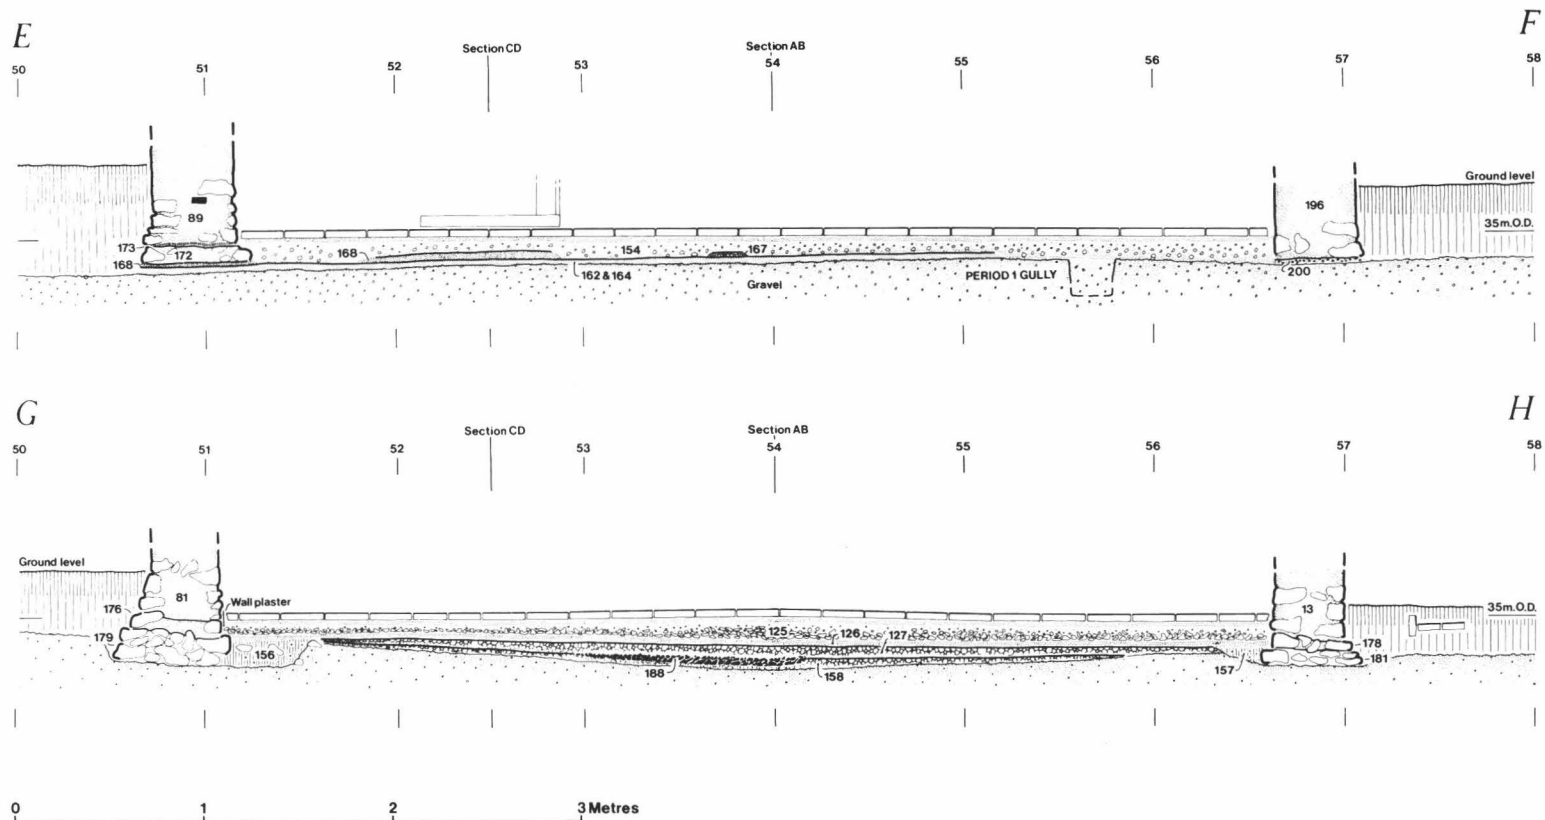
Fig. 5. Archaeological sections, north-south.

The wall, burnt areas and floors were overlaid by a further puddled chalk floor (Layer 127) and this was cut by the foundation trenches of Period 3 wall footings (Figs. 4 and 5). At the bottom of the foundation trenches two postholes, each about 20 cm in diameter, were cut a few centimetres into the underlying gravel. Whilst they may relate to this, or an earlier period, their character and position suggests that they are more likely to relate to a later phase of reconstruction (see p. 62).

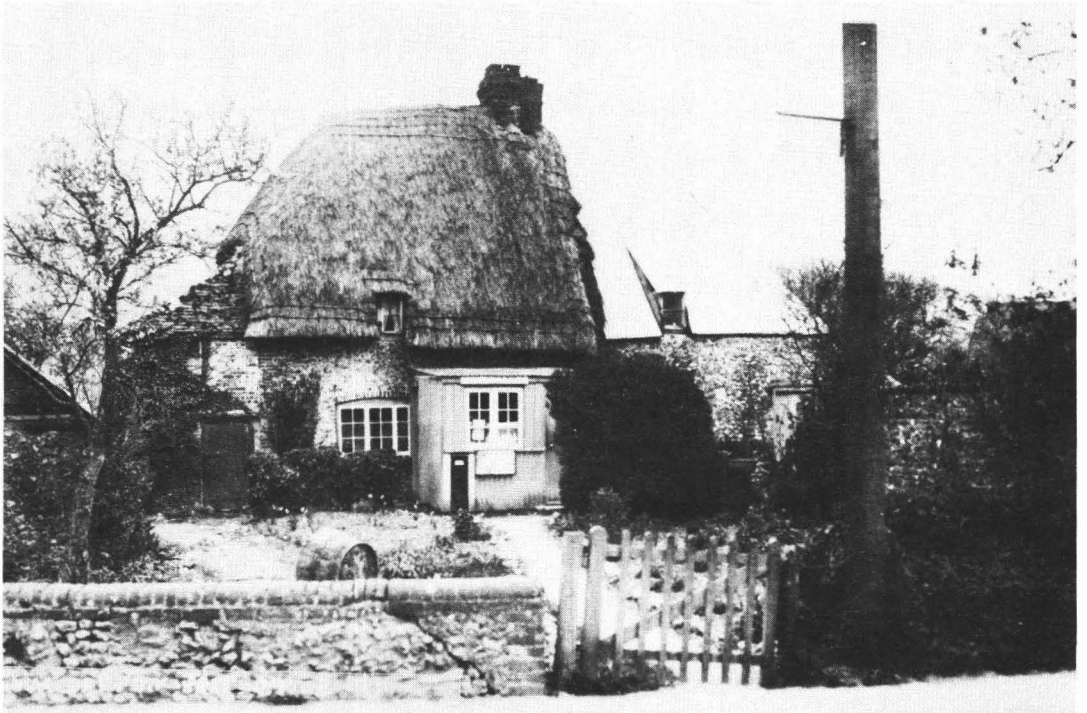
Plate II. Walderton Cottage, a view of the north side in about 1950. This shows the east outshot and the corrugated tin extension in use as a Post Office. Reproduced with the kind permission of Mr. M. Uniacke.

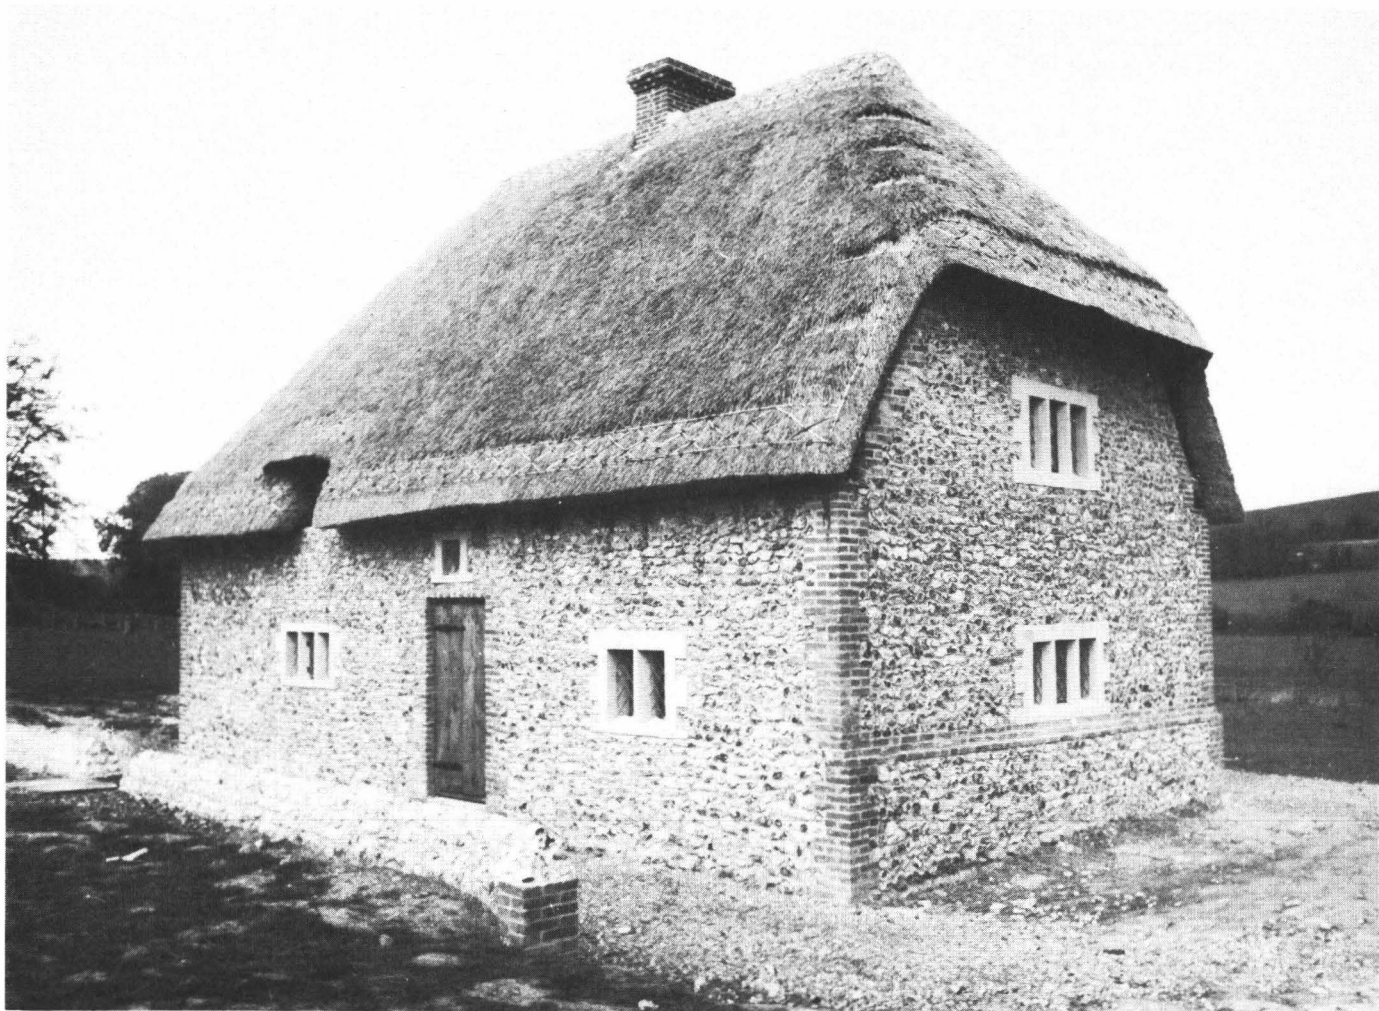
Plate IV. Walderton Cottage; as reconstructed at the Weald and Downland Open Air Museum. South and east elevations.

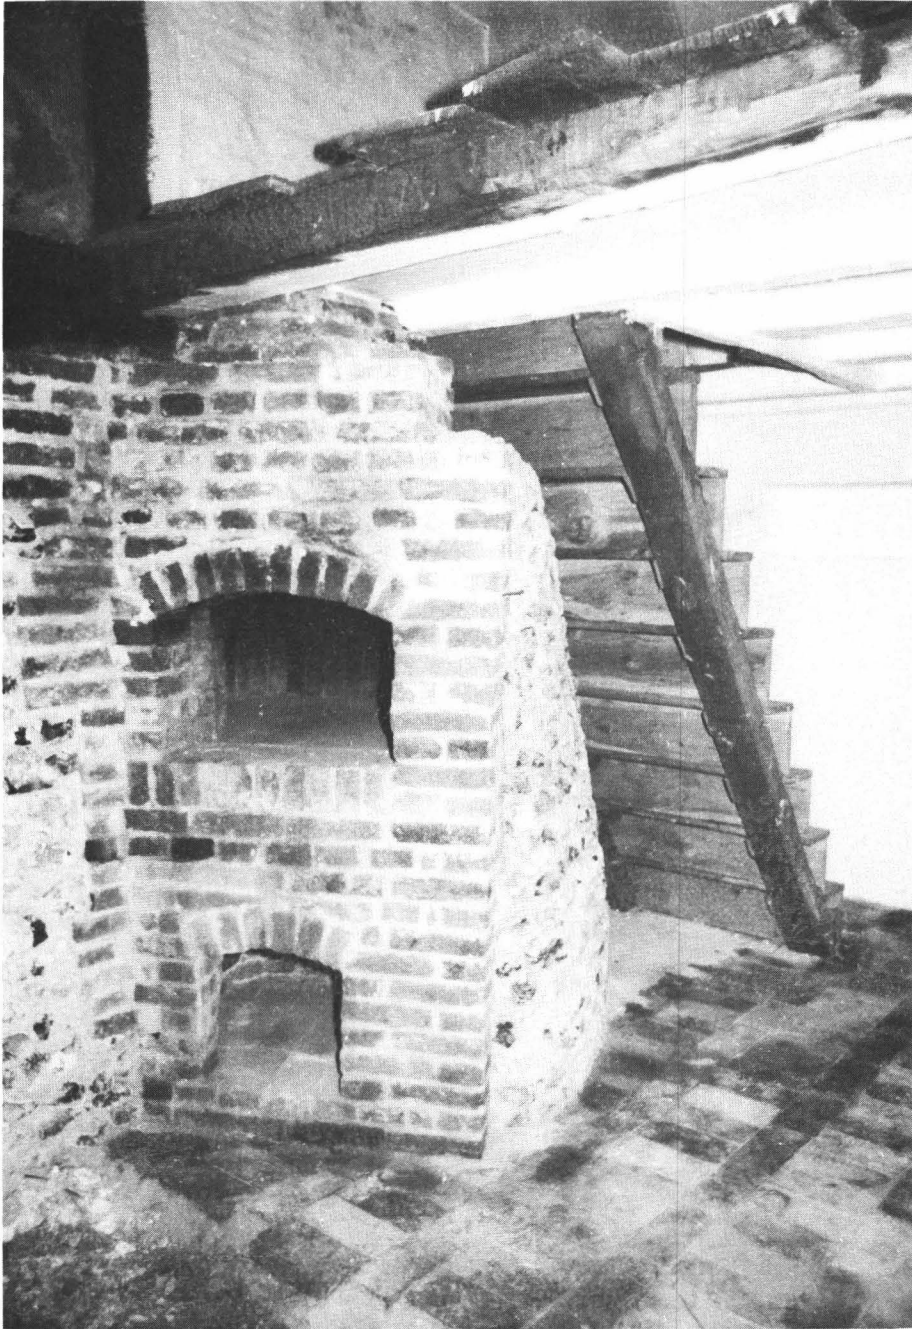
Plate V. Walderton Cottage, the Period 4 oven, as reconstructed at the Weald and Downland Open Air Museum.
