PAINTED GLASS FROM A WINDOW IN THE
CHURCH OF ST. THOMAS-A-BECKET,
BRIGHTLING, SUSSEX.

BY W. C. ALEXANDER.

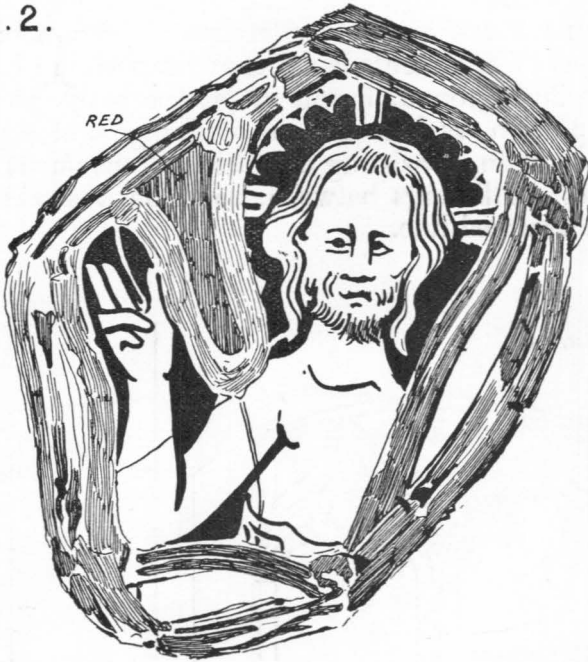
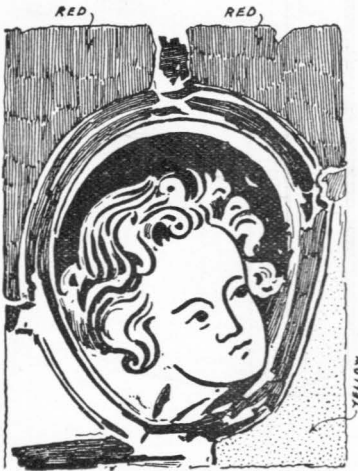
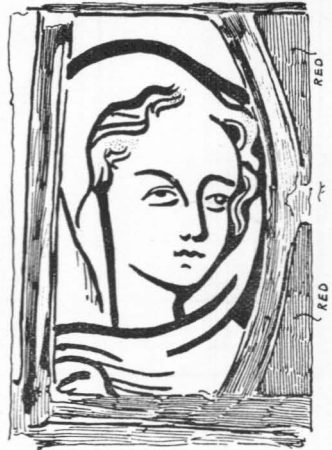
No. 2.

The most interesting fragment is the head of our Lord with the right hand raised in blessing. The head of an angel and that of a woman complete the figure subjects. The sheet of fragments No. 3 shows a portion of a wing on a yellow ground, fragment of a canopy, part of a diaper pattern, various designs of foliage and a pattern on yellow stain, consisting of a beaded ornament with a couple of small rings between, some on a straight and part on a curved line.

The decorated glass is the ordinary white of the period, thick, rough and rather green in colour; flesh-coloured pot glass is used for the two male heads; ruby glass, in which a thin coat of red covers the white glass, usually called flashed glass; yellow pot glass only seen in the fragment of a wing; and white glass with a yellow stain, used on the hair of the woman's head and in ornamental borders.

The drawing, in a deep enamel colour, is bold in treatment. On the reverse side of some of the glass a smear of brown has been used to give depth of colour to the men's hair, a treatment I have not before seen.

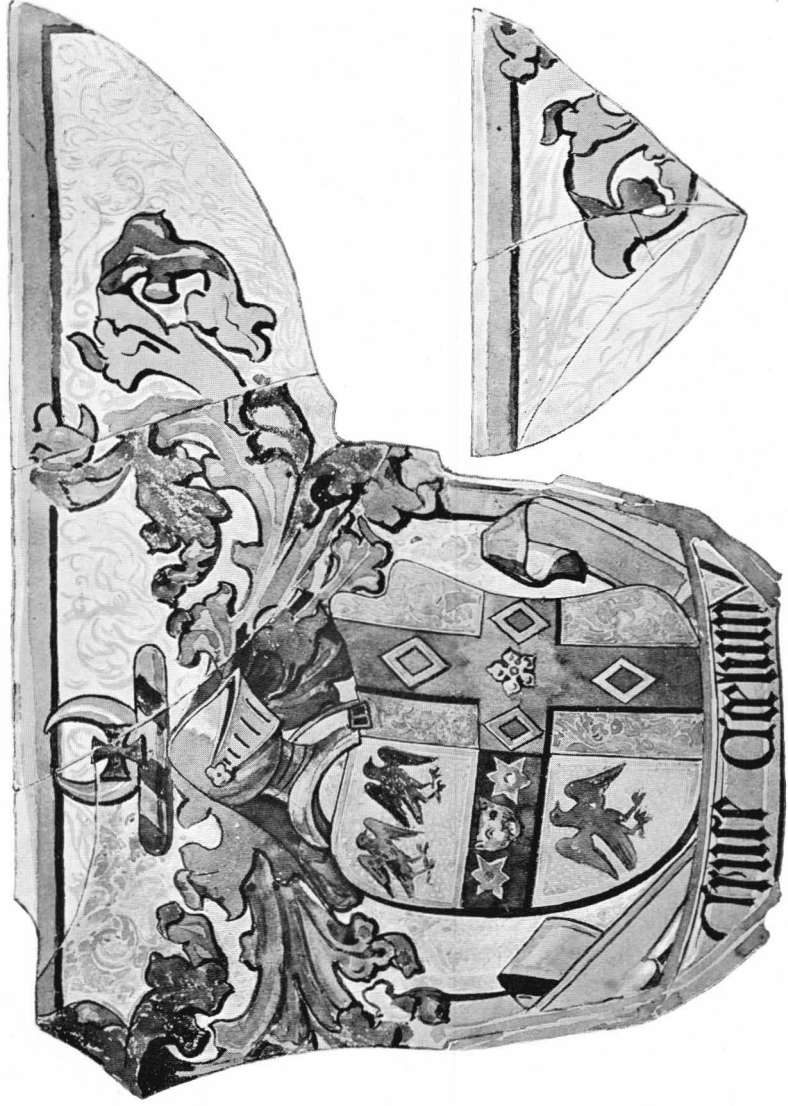
No. 7.

Drawing No. 1 gives the design of the Late Decorated window, and Nos. 2 to 7, inclusive, are copies of all the glass of the same period now remaining. The leading is modern, and the original arrangement has been lost, as seen in drawings 4, 5, 6 and 7. Nos. 4 and 5 have been made up to fit the two spandril lights in the tracery. Plate 7 is heraldic glass of the eighteenth century, made to fit the central tracery in the head of the window.

The late heraldic glass I have copied, as it may be the memorial of a benefactor to the church. It is much broken and portions are missing. It was made to fit the central part of the tracery. The Clerk told me that he had heard it was a copy of earlier glass which had been injured and replaced in this way. Whether this is so or not the story may give a useful hint.
