# ROOD-LOFT PISCINA IN EASTBOURNE PARISH CHURCH.

BY THE REV. W. BUDGEN.

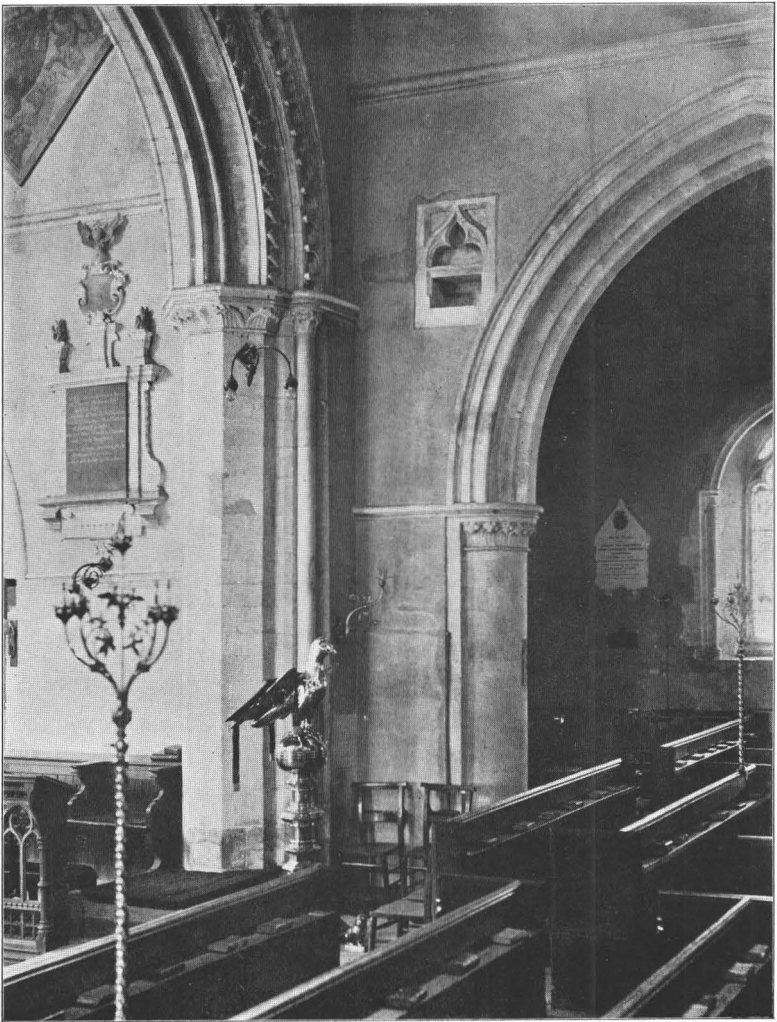
ROOD-LOFT PISCINA IN EASTBOURNE PARISH CHURCH.

A correspondent in "Notes and Queries" in 1863 mentioned such a piscina as being in the church. During the restoration of the church, which took place shortly after this date, the walls were heavily plastered and the piscina was entirely lost sight of. Attention having been called to the supposed position of the piscina by the note above referred to, discoloration was noticed in the plaster at that spot, which seemed to take a definite shape. The plaster was therefore cut away and the piscina was found, filled in with portions of brick and extremely strong cement. Its form will be seen from the accompanying illustration and it is evidently of the same date as the aisles of the church, *i.e.*, the first half of the fourteenth century. The upper portion, with the shelf and trefoil head, and the basin itself, are of Eastbourne greensand stone, of which all the fourteenth century additions to the church consist; while the two side pieces are of Caen stone, the material used in the original twelfth century work. The working of the stone is as clean and sharp as if just completed, but the projecting portion of the basin has, at some time, been broken off and the edge squared up with plaster. In the pier, almost immediately below the piscina, is a cavity reaching to the floor level of the church. Many conjectures have been made as to its use, but though its features have been somewhat altered,

it would appear to have afforded a convenient channel for the drainings from the piscina.

The position of the piscina naturally suggests an enquiry as to the arrangements of the rood-loft, with its altar and other accessories. A turret outside the north wall of the church, entered by a door from the aisle, gives access by means of a staircase 2-ft. 6-in. wide to an enclosed passage over a massive stone arch spanning the aisle. There is no evidence of an original outside door to the turret; traces of doorways exist, but they were, almost certainly, made to provide access to galleries erected about 1820. The passage way over the arch was re-opened at the north end by the Vicar (Canon Goodwyn) in 1906, and the stone jamb and lintel of the doorway leading out to the rood-loft have since been uncovered.

It is possible to form some idea of the general scheme of the rood-loft from the information afforded by various scars and patches in the stonework of the chancel piers and the first arch of the nave arcades. The position of the principal beam above the rood-screen is clearly indicated on both piers at a height of 8-ft. 6-in. from the nave floor level—the chancel floor is six inches lower. On the outer mouldings of the eastern limb of the first nave arch in both arcades, 16 inches above the capital, there is a patch of plaster indicating the position of a beam. This would give the approximate level of the loft floor, agreeing with the level of the doorways. There would be a rise from the top of the screen to the loft floor of some 18 inches, affording space for ornamental coving. Similar traces of repair to the stonework suggest that there were beams spanning the first bay of both north and south arcades. These beams, resting on the capitals of the nave piers at a height of 8-ft. 10-in.,
