Sussex Archaeological Society

WALL PAINTINGS IN SOUTHEASE CHURCH

BY E. CLIVE ROUSE, F.S.A.

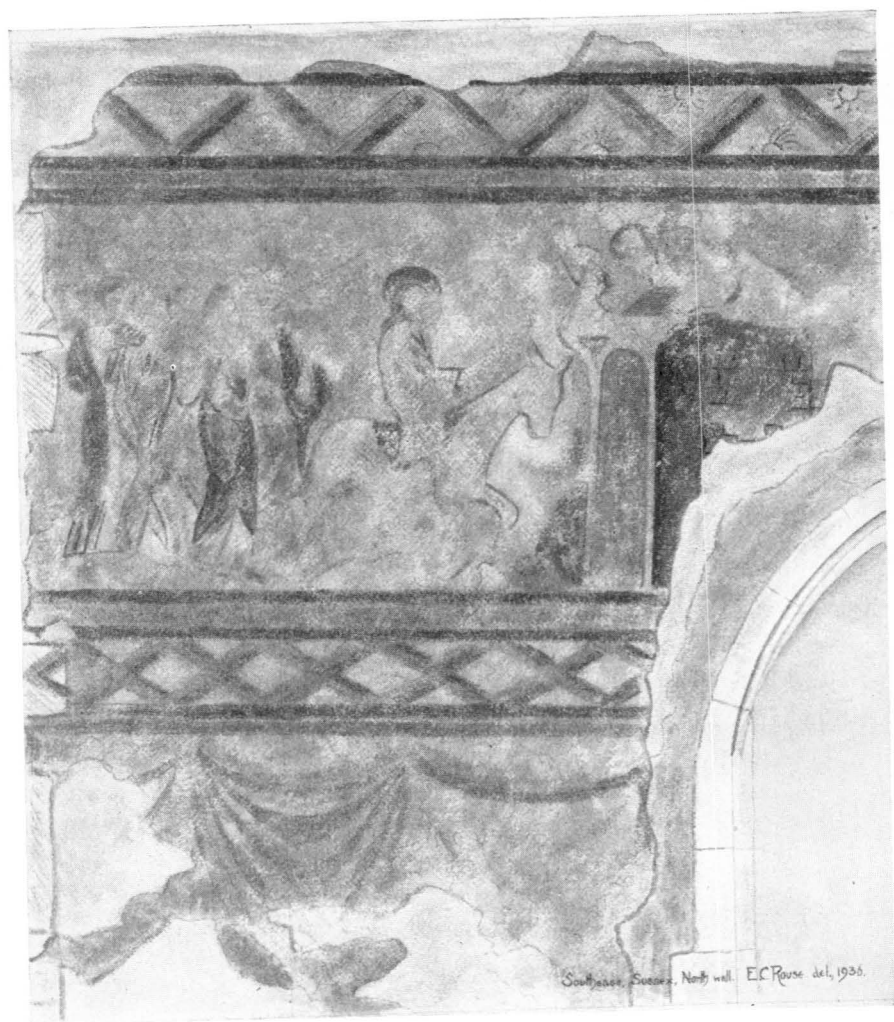
PLATE I. SOUTHEAST. PAINTING ON THE NORTH WALL. THE TRIUMPHAL
ENTRY INTO JERUSALEM.

also there was ornament of some sort in the spaces; but it has nowhere survived sufficiently to be clear. Below this dado band was a painted representation of drapery hanging from it in the usual way. The scheme is best preserved at the west end, where a very good idea of its detail and general effect can be gained (Plate I).

The figure subjects are continuous in one tier, without vertical divisions, and this, in their fragmentary state, adds to the difficulties of identification. The first scene is the Triumphal Entry into Jerusalem. On the left is a group of onlookers, one in the act of throwing down a garment, with good drapery folds. Christ, with a black nimbus and long yellow hair that is employed throughout the series, is in the centre, and is shown riding on a light-coloured donkey towards the gates of Jerusalem, of which some part of the buildings are shown, with an archway and single-line masonry pattern, with towers and ornament above. The scene is well composed and grouped, and in spite of its mutilated condition still makes itself clear in its main outlines and achieves a rich effect of warm colour (Plate I). The next scene is defaced by a modern window. But just above the eastern side of the arch are traces of two figures, one with the dark halo and robe given to Christ in this series, which suggest the Betrayal. It would be in the correct sequence in this position, and one would expect the scene to be shown in this particular instance. Next probably came the scene of Christ before Pilate. A trace of the dark nimbus is again visible on the right, with Pilate's throne on the left and the drapery of a large group of figures in the centre. A fragment of architectural detail of the Judgement Hall may be made out at the top. The Scourging is easily decipherable. Christ, with slightly bowed head, and hair and nimbus as before, is in the centre, presumably bound to a pillar as is usually the case, while on the right the legs, tunic, and lower portion of one of the Roman soldiers, with scourge upraised is clear. Only a fragment of the other tormentor remains on the left of Christ.

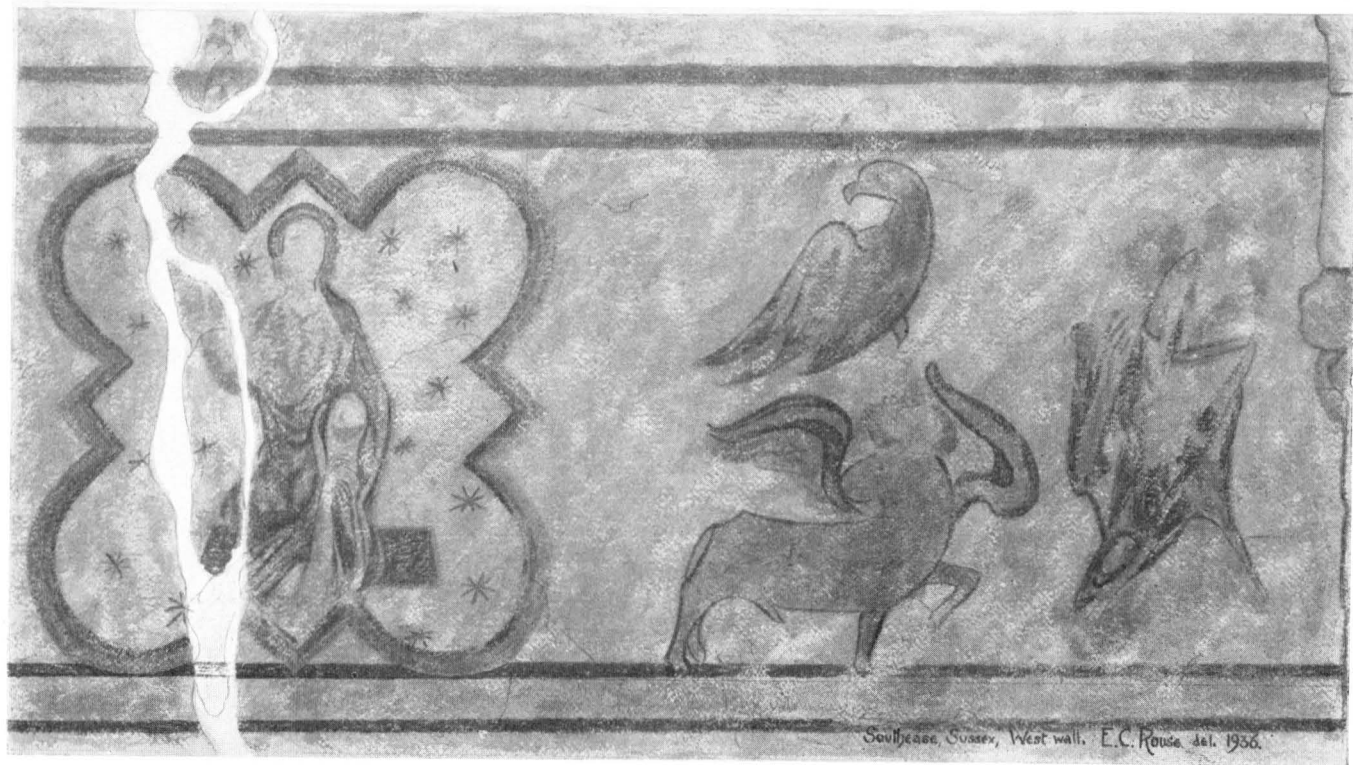
PLATE II. SOUTHEASE. PAINTING ON THE WEST WALL, NORTH SIDE. CHRIST IN MAJESTY, AND THE SYMBOLS OF ST. JOHN AND ST. LUKE.

The west wall was found to be similarly painted high up with subject-matter between two borders of simpler design. The scheme did not, however, prove to be a continuation of the Life of Christ, but was a Majesty within a type of mandorla consisting of a barbed quatrefoil, flanked on either side by the symbols of the Evangelists and a kneeling Angel, probably censuring (Plate II). At the top is a plain frieze of two yellow lines. There was probably ornament or colour between, but it has

perished. At the base is a similar band, the lines in this case being red, and there is evidence that the space between them was filled with black or dark brown. In the centre, between the two borders, which are almost 4 ft. apart, is the figure of Christ seated on a throne, the right hand raised in blessing, the left holding an orb: the drapery is still somewhat formal and stiff, but is elaborate. The background is powdered with stars in red, and the enclosing aureole is composed of equal red and yellow bands with a broader one of black on the outside. On the north side of the wall are the Eagle of St. John above, the winged Ox of St. Luke below, and a fragment of a kneeling Angel with elaborate drapery at the northern edge of the wall. All look towards the central figure. On the south are traces of the Angel of St. Matthew, with the winged Lion of St. Mark below, and some lines and colour at the extreme south end, which is all that remains of the Angel corresponding to that on the north.

The form of the mandorla is interesting, and is of great assistance in dating. In the Canterbury and Winchester Majesties the mandorla surrounding Christ takes the more usual form of a vesica with four foils or lobes in which the symbols of the Evangelists are placed. In another case there is a circle with four attached circles. All these paintings are of early- or mid-thirteenth-century date. The form enclosing the central figure at Southease is typical of the second half of the thirteenth century, and more particularly the last quarter, though it does also occur in the fourteenth century as late as about 1330—e.g. throughout Queen Mary's Psalter, where many of the New Testament scenes are enclosed in such a form. It is found in a painting by Cimabue in the church of St. Francis at Assisi; on the Syon Cope; and in the painting in St. Faith's Chapel, Westminster, all of which can be fairly closely dated in the late thirteenth century. It also occurs in Westminster MSS. up to the middle of the fourteenth century.
