BECKET'S BARN, PAGHAM

(Pagham Rectory)

BY A. H. COLLINS, M.A., AND LINDSAY FLEMING, F.S.A.

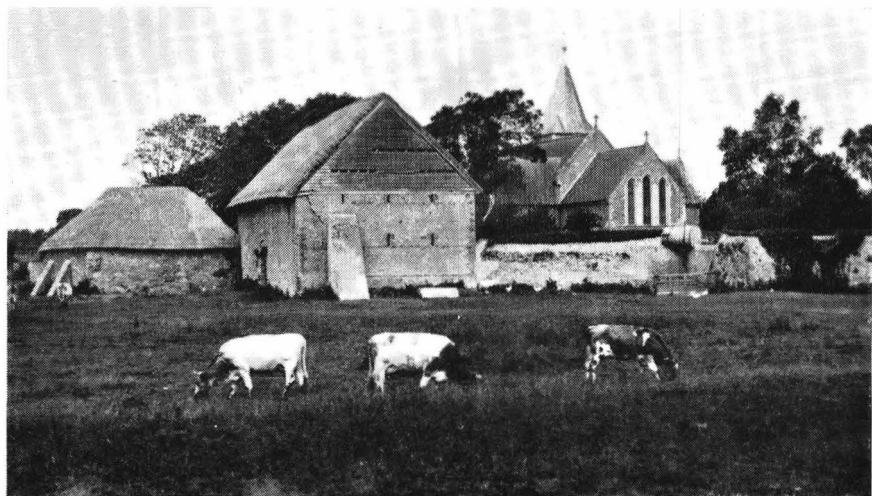
PLATE I. BECKET'S BARN AND PAGHAM CHURCH, early 20th century

In the gable of the west wall are the jambs of two square blocked lights, and, below these, two holes with remains of timber (Plate II). In the north and south walls are central openings. These may have been made when the building was converted to agricultural use. The east wall is a rebuild on the original footings. The south wall is supported by two modern buttresses not shown in the photograph (Plate I).

There are walls to the north of the Barn, those to the east apparently once enclosing a nearly square-shaped, substantial building, and judging from the style of construction, contemporary with the Barn (Plate I). Erections here are indicated on the Plan of 1786 and that of 1854. In them are three culvert heads—or, perhaps relieving arches—two opposite each other at the base of the north and south walls, and one in the base of the east wall. Excavations inside the western and outside the southern arches have revealed no channel or ditch outline nor given any clue to their purpose. A similar arch, here very likely a culvert head, is in the base of the south wall of the building, south-west of the Barn, used in modern times as a cattle shed. This building, now ruinous, is shown on Plate I and retained a thatched roof till about 1930.¹ It was undoubtedly of later date than the Barn.

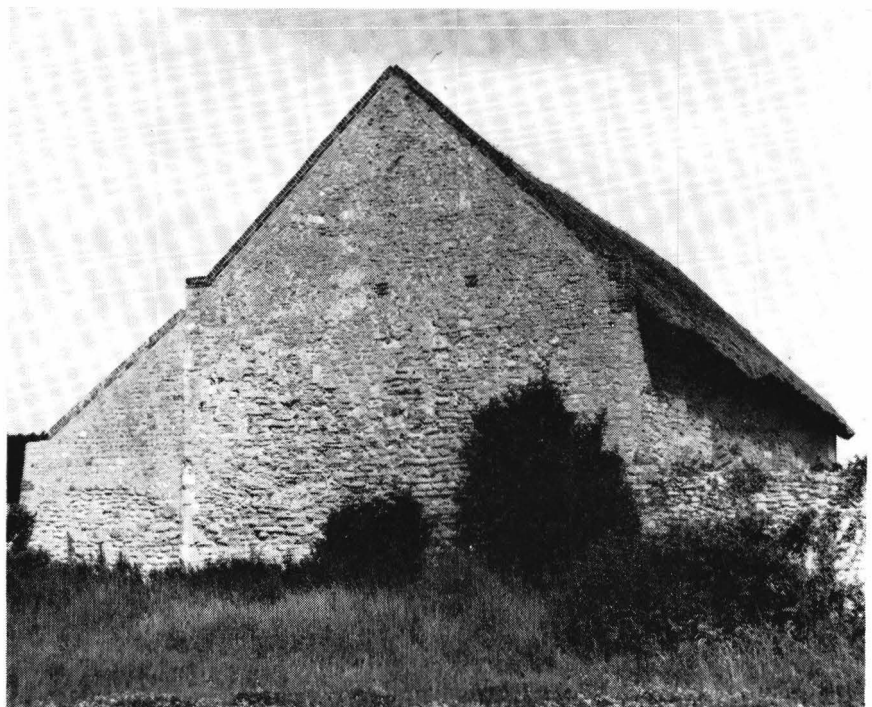
PLATE II. BECKET'S BARN, from the south-west, July, 1956

The erections to be seen above ground now are the Barn, with walls about 2ft. 6in. thick built of stone rubble; retaining walls of a yard adjoining to the north; thick walls of another building once in the north-east corner of the yard, and walls of a building to the south-west of the Barn shown roofed and thatched in a photograph of the early 20th century (Plate I).³ The present aspect of the Barn from the south-west is shown in Plate II. The stone used is principally from the Bognor and Barn Rocks, off the neighbouring sea shore, with some glacier boulders from the same, and the Mixen Rock from the Selsey shore. There are also some worked stones perhaps from Caen resembling stone in the tower of Clymping church; most of these form part of the north-west quoin of the Barn (Plate II).

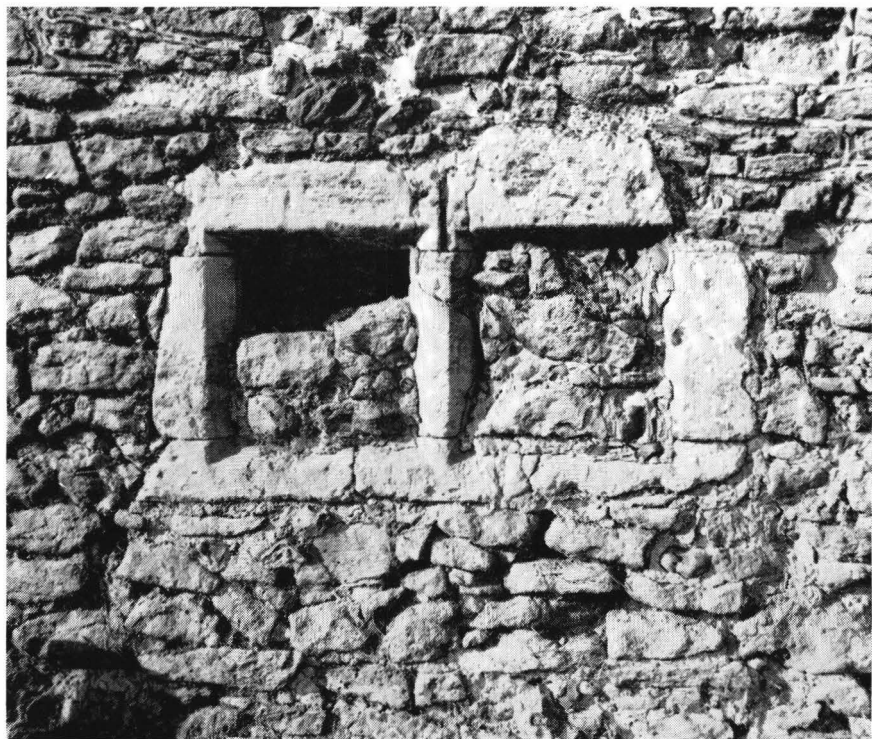
PLATE III. DOUBLE WINDOW OPENING in north wall of Becket's Barn, August, 1956

In the north wall of the Barn to the west, 4ft. 6in. to sill from the ground, is a blocked two-light window with plain chamfered jambs and matching square heads and sills. On the left may be seen part of a wide

internal splay and in the left jamb trace of a socket perhaps for a hinged shutter (Plate III). The window is not visible inside. It is difficult to date this window, and it may be a re-build. To east of it, at ground level, are the plinths, slightly chamfered, and the sill, of a blocked doorway, also not visible inside. At the east end of the north wall is a broken corbel stone, 12ft. from the ground.

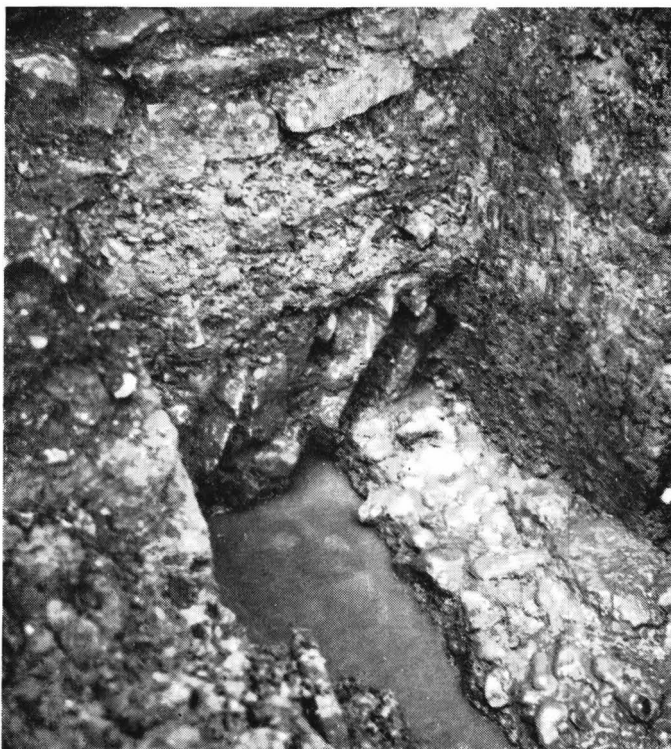
PLATE V. CUTTING ON NORTH SIDE OF BARN showing cobble floor, possibly late Saxon in date, December, 1956

Plate V, besides showing the eastern edge of the cobble, also illustrates a characteristic of the construction of the foundations of the present walls of the Barn—the lowest stone course of the footings having the stones on edge, the courses above being laid flat.

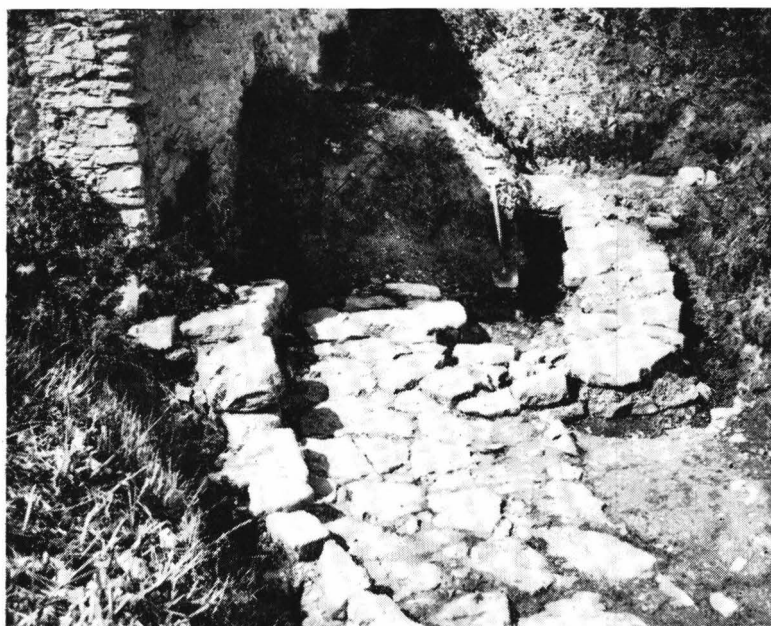
PLATE VI. CORRIDOR AND "PORCH" on south side of Barn, July, 1956

At the southern end of the wall projecting south from the south-west corner of the Barn were foundations of a wall curving south-eastwards, and, inside, flagstones with slighter wall foundations beyond, forming a corridor. This was found to have a clear edge at about 15ft. to the south (Plate VI). A heavy tumble lay beyond the clear edge with an admixture of the blue, sometimes roughly triangular slates also found in cuts inside the Barn.³ To the north the flags of the corridor continued over the return footings between the two north-south walls to form what looked like a porch, and with the offset still visible (Plates VI and I) at the top end, on its east face, of the standing north-south wall, one can visualise an arched entrance here, with, perhaps, a stone stair leading into the main building by the doorway mentioned above.⁴ The boundary wall on the west side of the corridor seems to have been more solid than that on the east, forming perhaps a wind break on the weather side. Economy in the use of stone would be a consideration.

The other foundations discovered were of the eastern retaining wall of the supposed porch (Plate VI), and of a substantial wall running west to east parallel with the south wall of the Barn at an interval of about 10ft. (Plate VII).

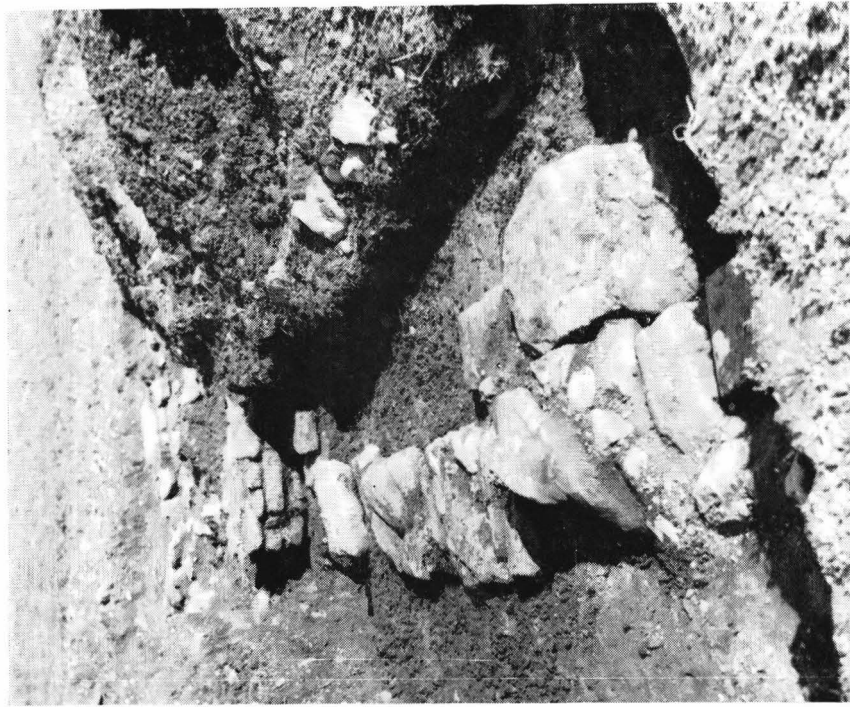
PLATE VIII. NORTH-SOUTH WALL IN RAIL CROFT FIELD, with west end of mortared wall, and, beyond, the "oven" stones, February, 1957

lowest course, as in the case of the Barn, consisted of stones on edge. At right angles to this wall were large stones forming foundations of a slightly curved wall, but these stones were free, in a single flat layer only (Plate VIII). A piece of worked stone was among them, the first stone, in shadow, to be seen in Plate VIII. At the north end the stones were grouped irregularly, some being burnt as though they had formed sides of an oven. There were thus two completely different styles, and perhaps dates, of construction. That there was a domestic building here was evidenced by the discovery of pottery fragments and of a few glazed triangular and rectangular floor tiles. The pottery range indicates domestic use over much the same period as the Barn.¹
