THE EXCAVATION OF BARGHAM CHURCH SITE

Upper Bargham, Angmering, Sussex

BY A. BARR-HAMILTON

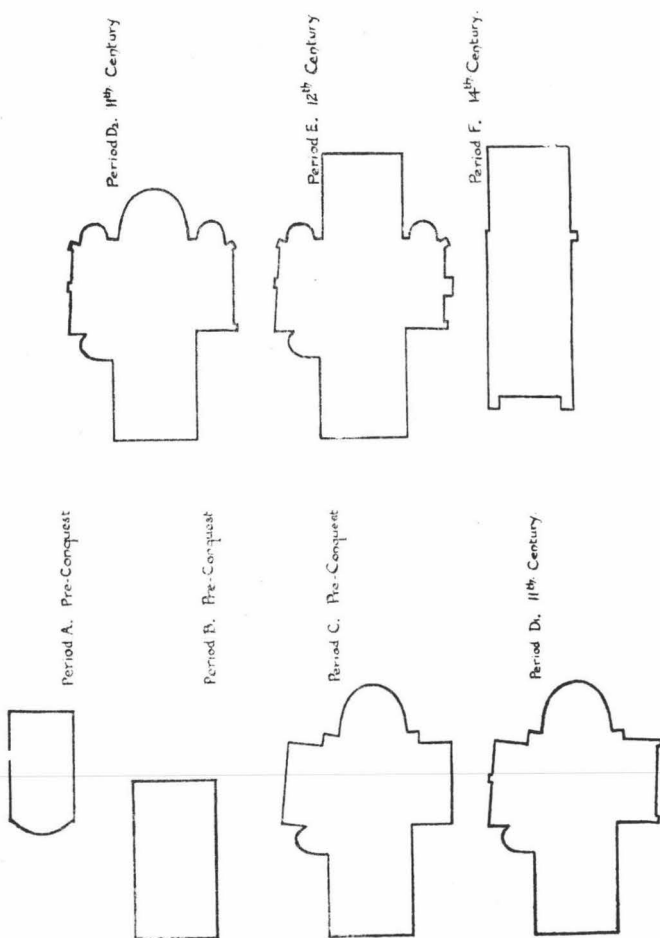
FIG. 2
BARGHAM CHURCH SITE

Probable Evolution of Ground Plans

<i>Chronological Plan Reference</i>	<i>Excavation Progressional Reference</i>	<i>Architectural Evidence</i>	<i>Constructional Detail</i>	<i>Period to which ascribed</i>
D	3	Complete footings (except for minor damage) and lower courses of some walls of cruciform building, having central tower and apsidal chancel, otherwise following known ground-plan of C and in which nave of B appears again to have survived. Transept apses, with angle buttresses, appear to have been later additions. Remains of bases of chancel and transept arches; carved capitals; font; keystone.	Footings of unbroken flints and walls of unbroken flints and ashlar (mainly Purbeck limestone) set in a poor, sandy mortar, bright yellow in colour, when dampened. Shafts and plinths partly of crudely-tooled yellow sandstone (apparently re-used from earlier building) and partly of well-tooled Purbeck limestone. Footings: width, average 48in., except east and west footings of transepts 56in.-60in.; depth, north transept 24in., south transept 22in.; tower, north 16in.-20in., south 29in.-32in.; chancel apse 30in.-32in. All laid on natural clay. Walls: width (average) 29in., except north transept, west wall, 55in.	11th century.

E	2	Footings of rectangular chancel, which replaced apsidal one, and of small porch (or, possibly, of large buttress) to south transept. Whole building D/E destroyed by fire, c. 1300.	Mainly sandy mortar, but some white. Chancel footings, width 48in., depth 29in. Laid on natural clay. Evidence that, at the time of the fire, building D/E was roofed with Horsham slab, had painted glass, ochre murals.	1150-1200.

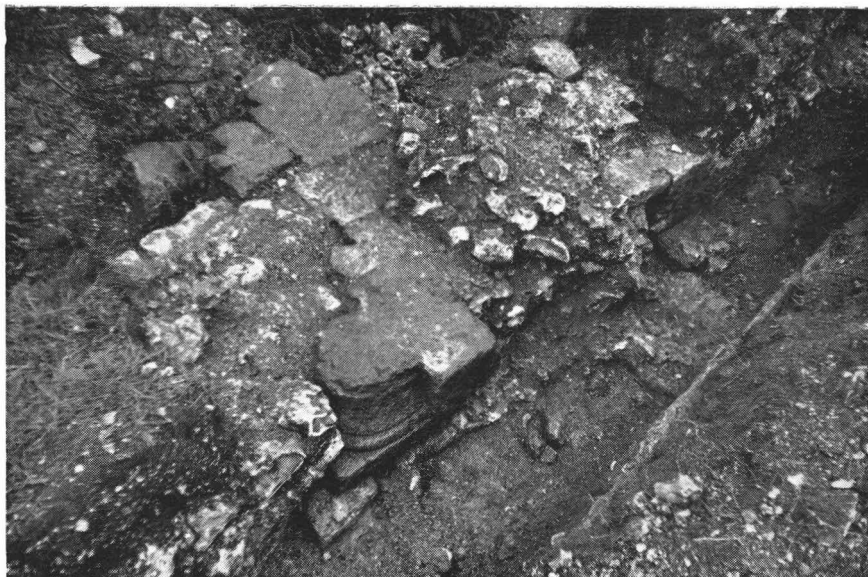
PLATE Ia.

CHANCEL AND TRANSEPT ARCH BASES, South wall of nave, Building 1, on removal of section of earth cap.

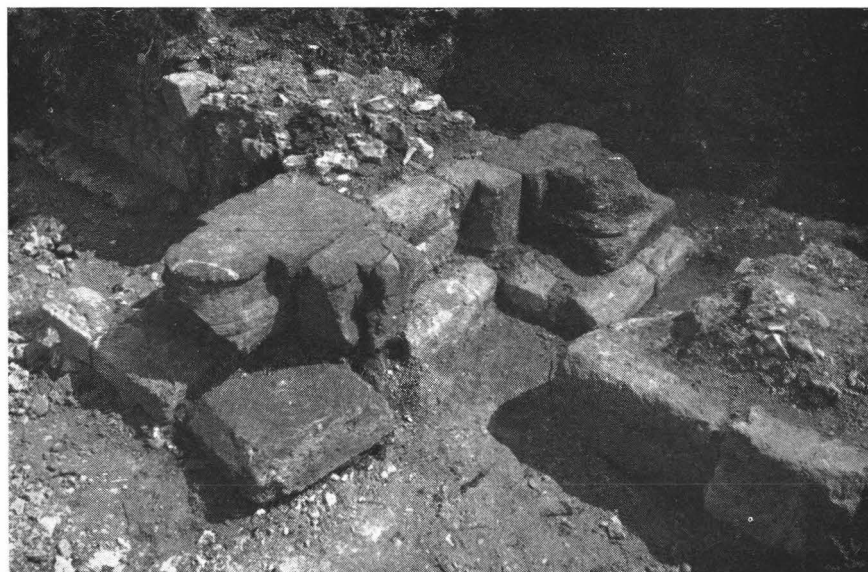
PLATE Ib.

CHANCEL AND TRANSEPT ARCH BASES, after removal of section of South wall of nave of Building 1. The chancel arch base of Building 1, its upper surface repaired, has been re-used from Building 3 (Period D—11th century). Note association of crudely tooled sandstone blocks with neatly tooled stones of Purbeck limestone.

side, however, the base of the central shaft, and that of the western of the two supporting shafts of a compound pier, remained in position (D32, Plate Ib). On both north and south, the sections of wall behind the remains of the arch (D19, D31) were set in a poor, sandy mortar, bright yellow in colour when dampened.

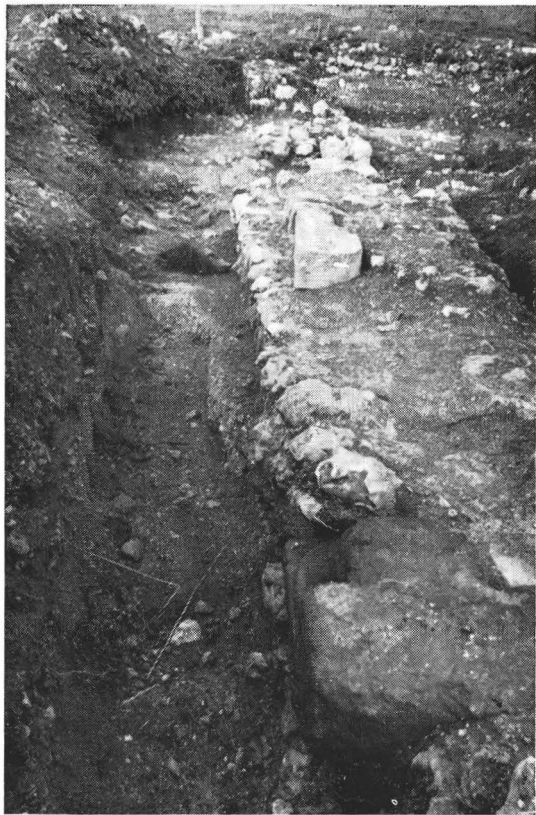
PLATE IIa. *Photograph: Mr. N. E. S. Norris.*

SECTION F 11, SOUTH WALL OF NAVE OF BUILDING 1 (Period F—14th century), made by filling in transept arch of Buildings 3/2 (Period D/E—11th/12th century). Note base of respond in foreground.

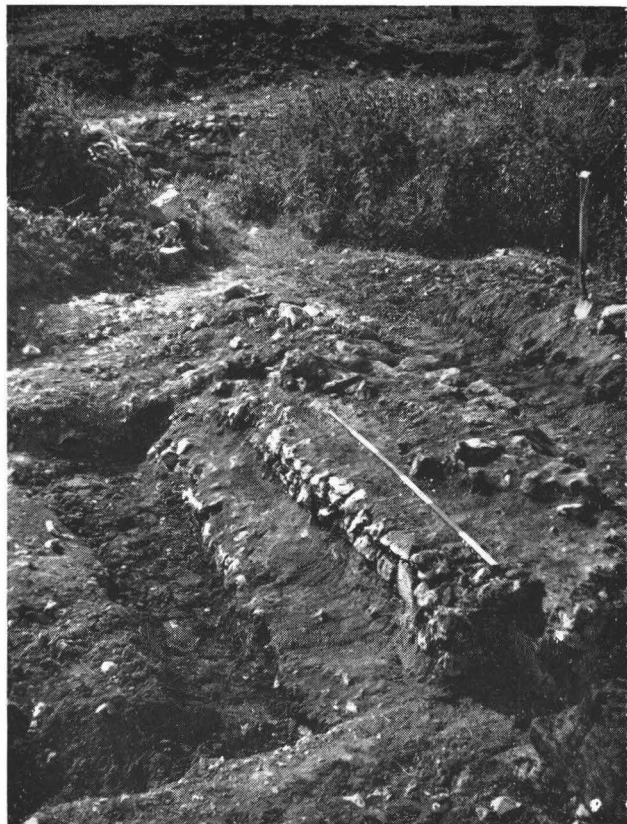
PLATE IIb

SECTION F 11, SOUTH WALL OF NAVE OF BUILDING 1 (Period F—14th century), after exposure of transept arch base (right, foreground). The wall had been laid upon the massive sleeper footing for the transept arch of Building 3 (Period D—11th century).

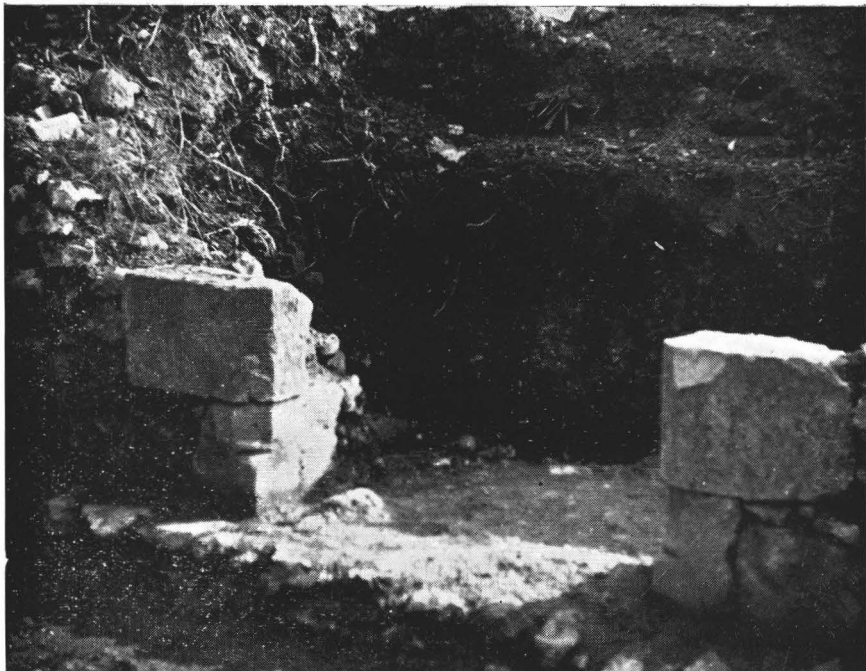
PLATE IIIa
PRIEST'S DOORWAY, SOUTH WALL OF CHANCEL OF BUILDING 1 (Period F—14th century).

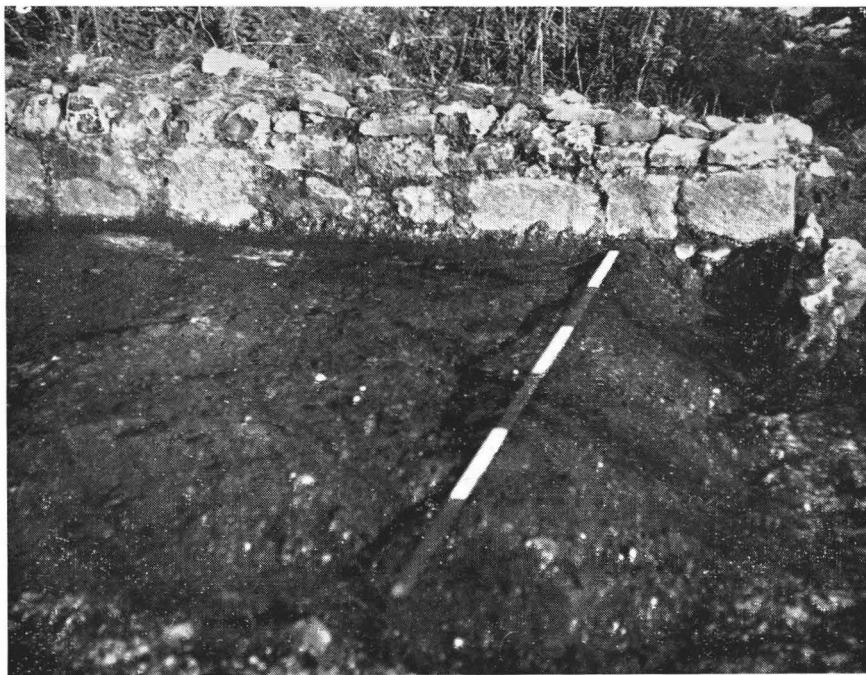
PLATE IIIb
EXTERNAL FACE OF WEST WALL OF NAVE OF BUILDING 1 (Period F—14th century). It is mainly composed of carved stones of Purbeck limestone from Building 3 (Period D—11th century) and broken Roman tiles. In the foreground can be seen the earth floor of the nave of its predecessor, destroyed by fire, c. 1300.

stones of Purbeck limestone, some carved; and contained the greater part of a large grave slab of Petworth marble, with foliated cross, of thirteenth- or fourteenth-century date, which had been broken into sections for use as building material. The corresponding section of the south wall (F11, Plates IIa and IIb) may have been of identical construction, but little remained above the plinth, which consisted, on its internal face, entirely of large, re-used, dressed stones of Purbeck limestone. West of the doorways, the walls (F4, F5, F12) were of a different character, consisting mainly of large, unbroken flints, with a considerable quantity of broken Roman brick, particularly in the west wall, which had, also, a plinth of re-used, carved stones of Purbeck limestone (Plate IIIb). The strong, white mortar had been used throughout.

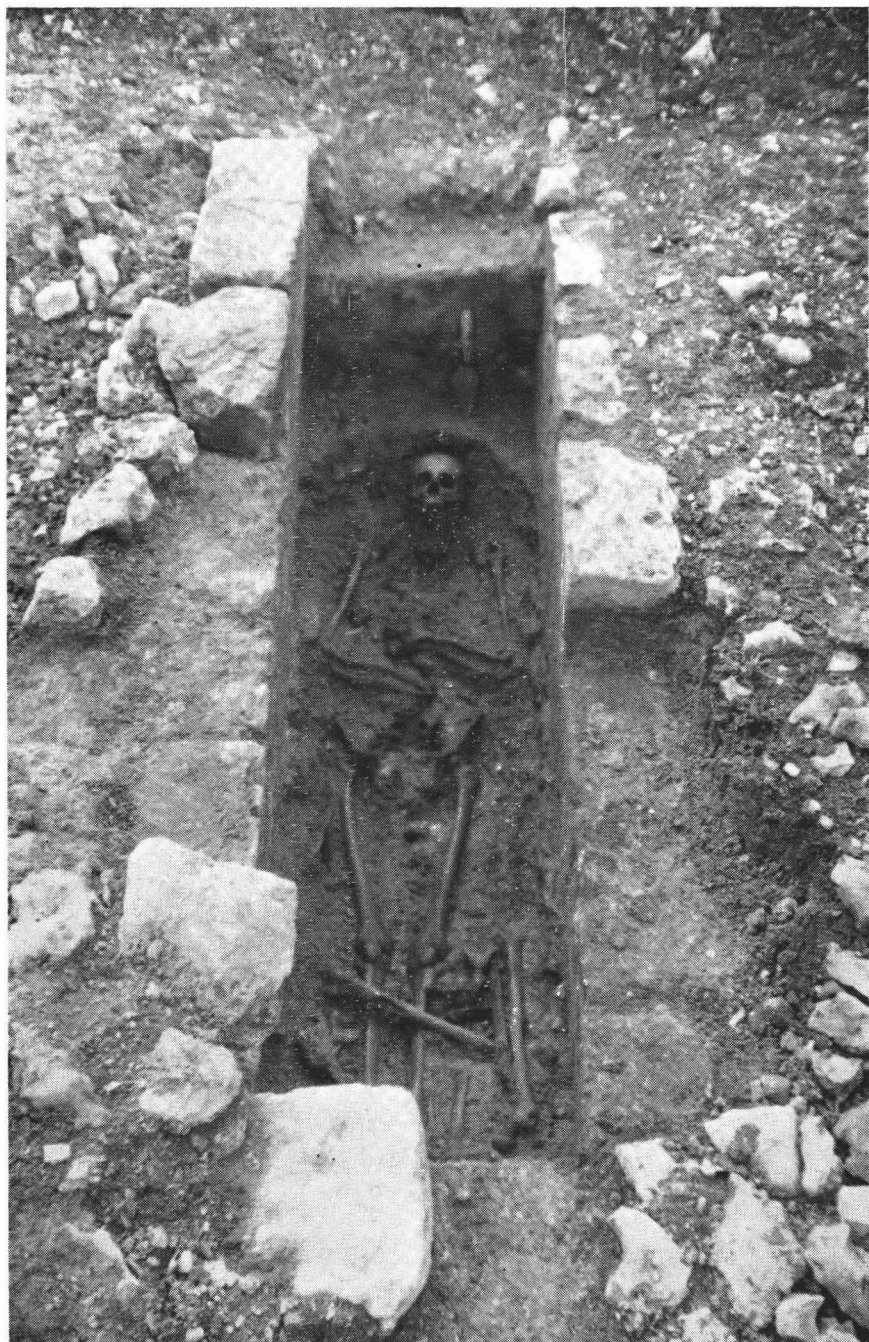
PLATE IV.

STONE-BUILT TOMB IN CENTRE OF NAVE OF BUILDING 1, with the construction of which it appears to be contemporary (Period F—14th century).

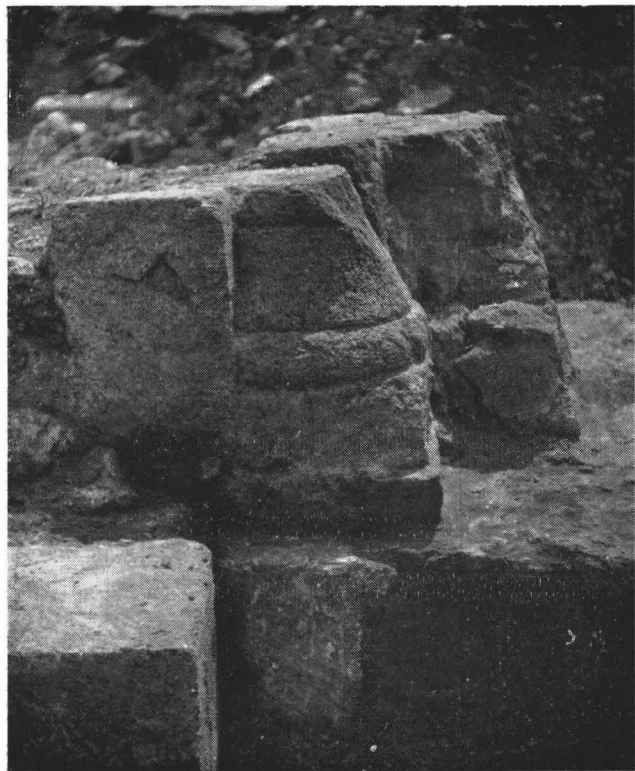
PLATE Va.

EAST BASE, NORTH TRANSEPT ARCH OF BUILDING 3 (Period D—11th century). Note crudely tooled sandstone of plinth and base of main shaft and neat tooling of supporting shaft of Purbeck limestone, the latter resting upon a Roman brick. The whole group has been reddened and splintered by exposure to intense heat.

The removal of the caps of earth from the north and south walls disclosed the bases of two further compound piers (D20, D33, Plates Va and Vb). These consisted of central shaft and, in each case, one remaining base of an original arrangement of two supporting shafts, but, in the northern group, a shaped Roman tile, used as a plinth, marked the position of the second. These two groups were built, one into each wall, adjoining the position of the chancel arch bases; and were also deeply reddened and fractured by exposure to flame. The northern group (Plate Va) consisted of a main shaft, crudely tooled in yellow sandstone and one surviving, supporting shaft, on the north side, neatly carved from Purbeck limestone in a manner which suggested early Norman workmanship. The course of Roman tiles on which this group had been set, including the shaped tile mentioned above, remained in position, and these were laid in turn upon a massive plinth of material and workmanship identical with that of the central shaft base. In the southern group (Plate Vb), the central shaft base resembled its counterpart, described above, but was of larger dimensions. The surviving supporting shaft, again, was neatly tooled in Purbeck limestone. The group was set upon a plinth comprising one large, roughly tooled stone of yellow sandstone and two smaller well-tooled stones, of Purbeck limestone, which clearly had been re-used, since the chamfered edges were not in harmony. Eleven feet westward of these features, in each wall, were found part of the plinths of the responds (D18, D50) made up again of roughly tooled stones of yellow sandstone and neatly tooled stones of Purbeck limestone. Yellow mortar had been used in the construction of each of these features and there could be no doubt that they were the remnant of transept arches of an earlier building (Building 3, see p. 53) of which the transepts, at some time after the fire and, possibly, because of it, had been abandoned; whereupon the arches had been walled-in to complete the nave of this little church (shown black on plan).

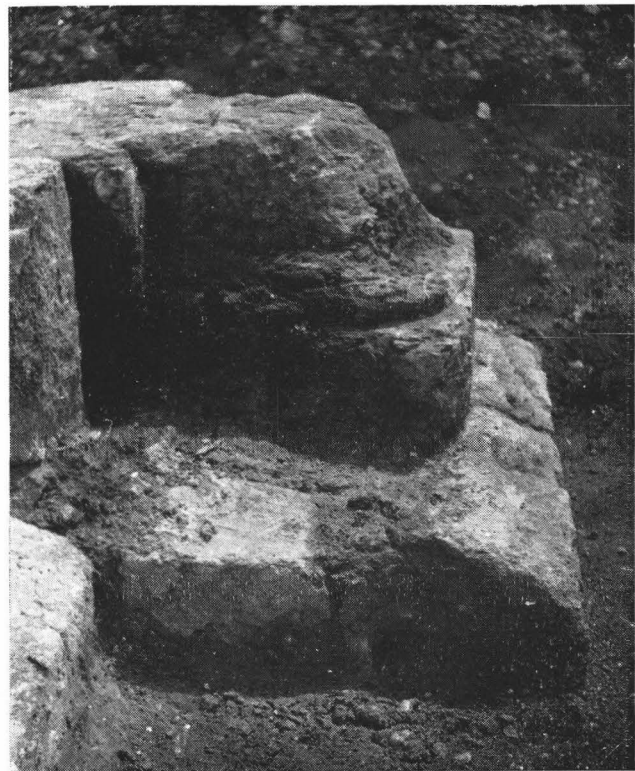
PLATE Vb.

EAST BASE, SOUTH TRANSEPT ARCH, BUILDING 3 (Period D—11th century). Main shaft is of sandstone, the supporting shaft and plinth of Purbeck limestone. The whole group has been reddened and splintered by exposure to intense heat. Note makeshift construction of plinth.

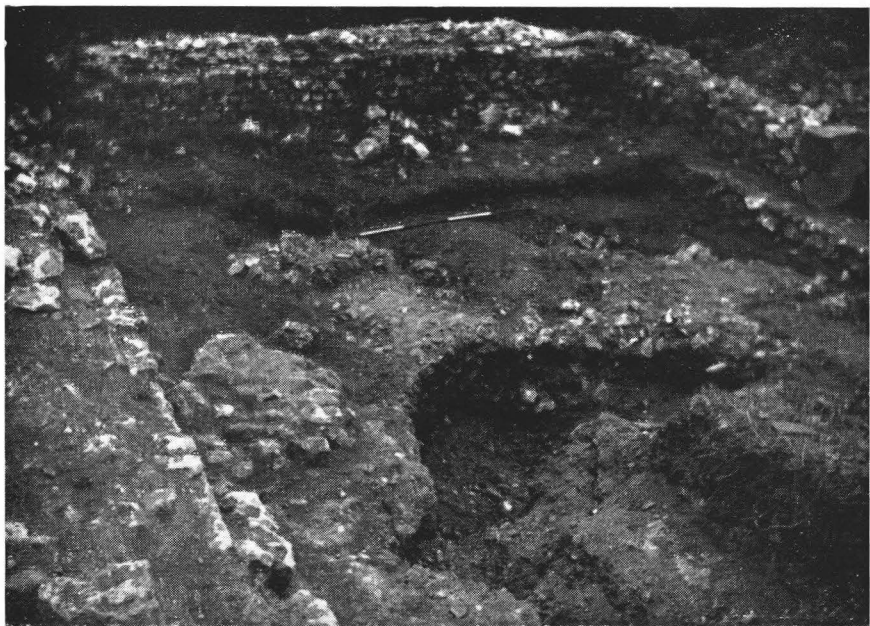
PLATE VIa

THE YELLOW-MORTAR FOOTING OF THE APSIDAL CHANCEL OF BUILDING 3 (11th century), from North, after removal of part of the earth floor of the rectangular chancel of Building 1 (14th century). The slight damage to the inside edge of the footing (foreground) and the three large breaks, indicate the positions of Graves 13, 3, 2 and 1.

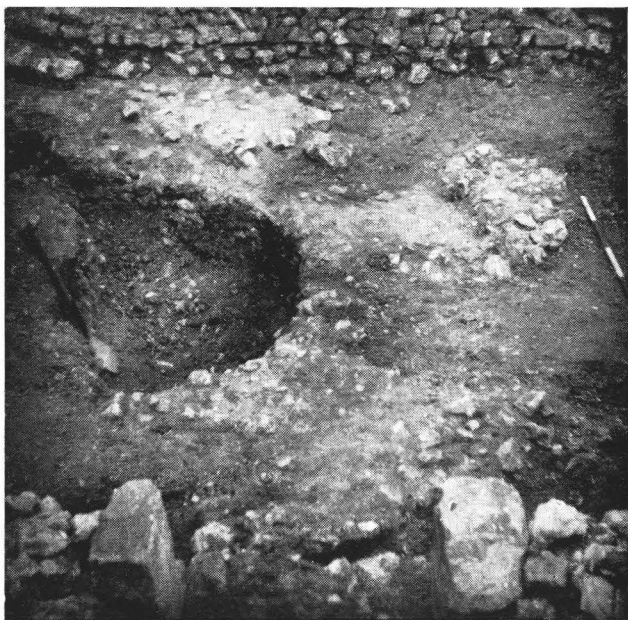
PLATE VIb.

THE APSIDAL CHANCEL FOOTING from South-south-west.

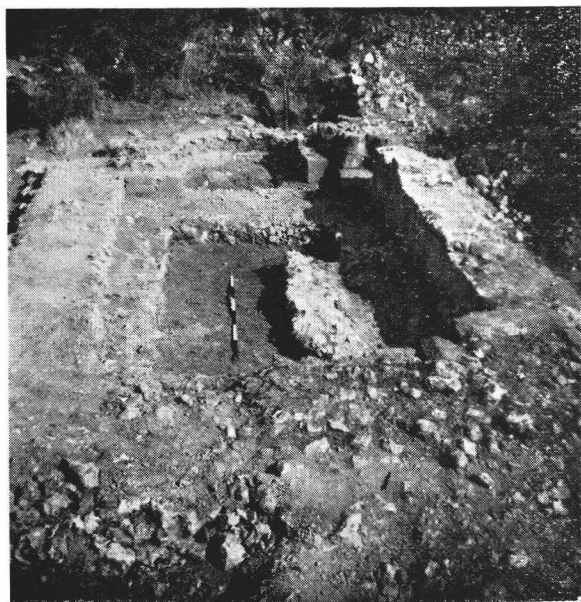
PLATE VIIa.

NORTH TRANSEPT OF BUILDING 3 (Period D—11th century).

1. In foreground, Roman brick mortar footing of turret staircase of Building 5 (Period C—pre-Conquest), abutting and underlying West wall of 11th century transept.
2. Centre, mortar base of 13th or 14th century grave-slab.
3. Centre (right), chequerwork, North wall of Nave of Building 1 (Period F—14th century), between remains of transept arch bases.
4. Background (near), massive footing of East wall of porticus of Building 3 and later apsidal end of transept.
5. Background (right), walls of chancel of Building 1.

The north transept was next uncovered (Plates VIIa and VIIb) when it was found that the lowest courses of the walls (D16, D17, D17a) remained; it had an odd NE/SW inclination from its roughly north-south axis, with the exception of the apse, which had the same orientation as that of the chancel.

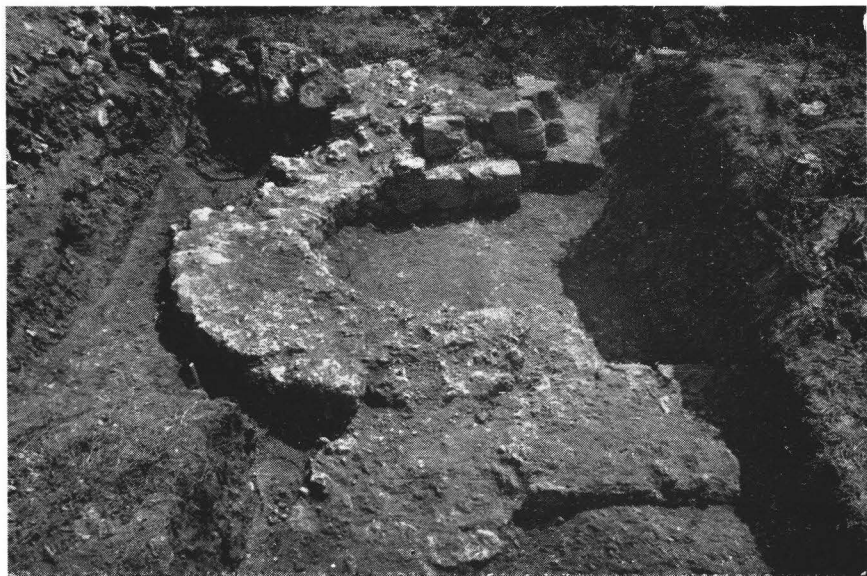
PLATE VIIIb.

NORTH TRANSEPT APSE OF BUILDING 3 (Period D—11th century).

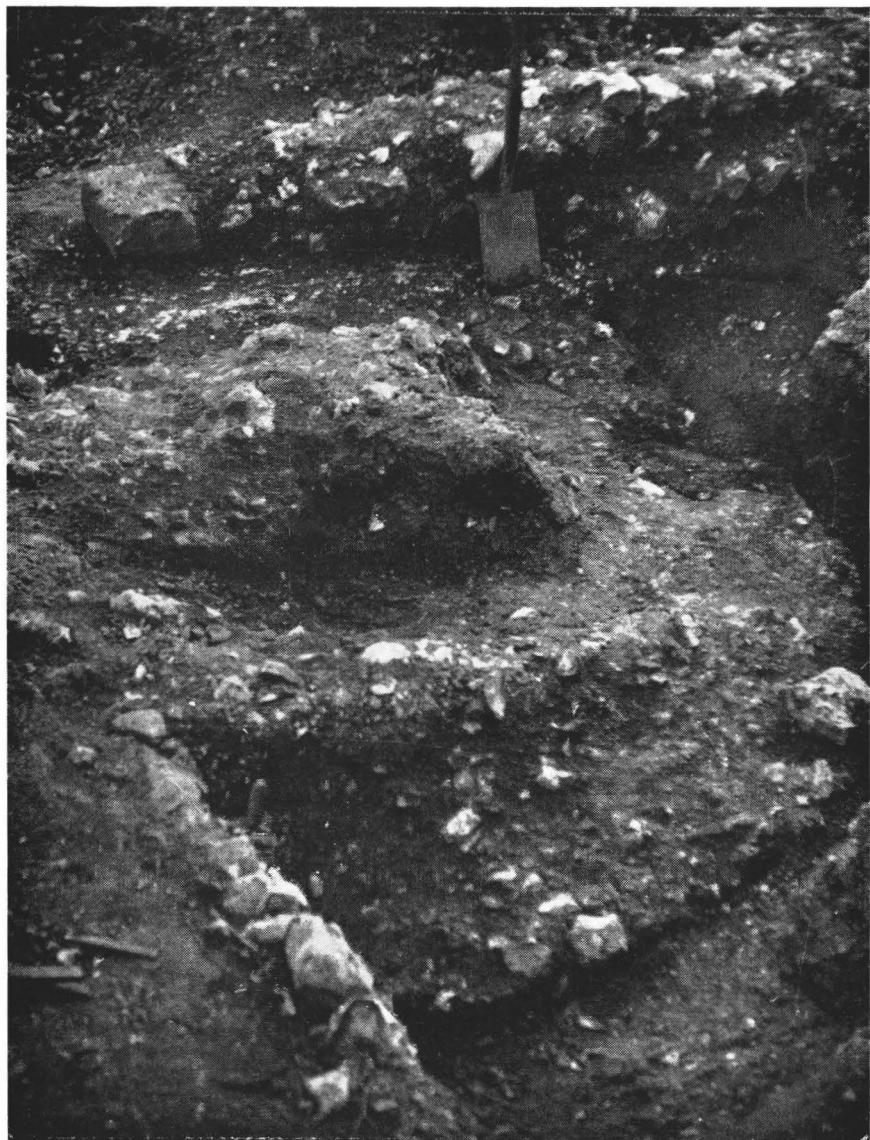
PLATE VIII

TURRET-STAIRCASE FOOTING OF BUILDING 5 (Period C—pre-Conquest).

1. (in foreground). The east wall of the 11th century north porticus (Building 3—Period D) has been laid across it.

2. (in background). Base of W. jamb of doorway of Building 1 (Period F—14th century) and north wall of nave, lying upon chalk footing of Building 6 (Period B—pre-Conquest).

The discovery of the Roman-brick mortar footing C1 (Plate VIII) has been mentioned above. On completion of the excavation of Building 3, attention was turned to this footing, which seemed to represent yet another early building. It was found to abut the chalk footing B1-B2, but to pass under the yellow-mortar footing D1-D3 of the eleventh-century Building 3. A section of the latter was therefore removed, with the result that the remainder of the Roman-brick mortar footing C1—probably that of a turret staircase—was exposed; this footing was found to be joined on the east by a series of others, of similar construction (C2-C5, C6-C9) which, by means of further cuttings, internal and external to the north porticus footings of Building 3, were shown to lie almost exactly beneath the latter.

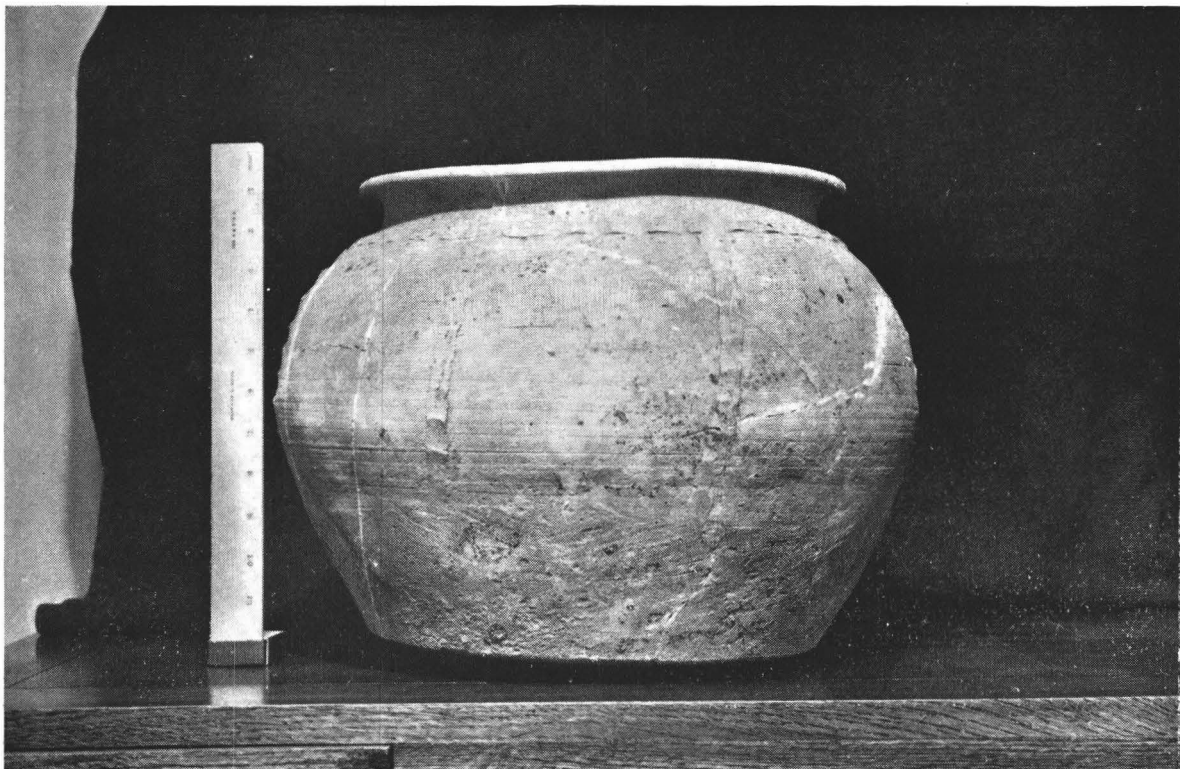
PLATE IX.

13TH OR EARLY-14TH CENTURY STORAGE-VESSEL, WITH APPLIED-STRIP ORNAMENT, SAGGING BASE AND INTERNAL GREEN GLAZING. From area of abandoned north transept of Building 3.

Set into the floor at Y was found a large, earthenware storage-vessel, with sagging base, green-glazed internally and with applied-strip ornament (Plate IX). The rim of the pot was, approximately, at floor level and, since it showed no signs of carbon deposit and contained nothing except earth in-filling, it appears possible that it was placed there, as a water container, by the builders of the last church, in the fourteenth century. The footings of the porticus (D1, D13, D14, D15) were found to rest upon, and slightly overlap, several inches of flints in a white mortar containing pounded Roman brick (C2-C9).

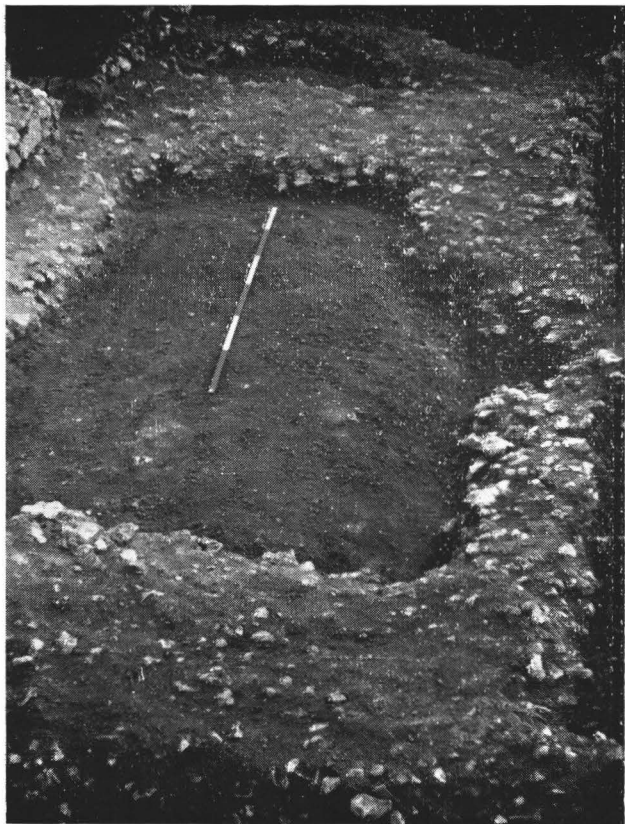
PLATE Xa.
FOOTINGS OF SOUTH TRANSEPT OF BUILDING 3
(Period D—11th century).

Finally, the south transept was uncovered, when the main features of the north transept, other than those which suggested a turret staircase, were found to be duplicated; the footings only remained however (Plate Xa), and these had a corresponding, though less pronounced, NW/SE inclination. The footings were of identical construction with their counterparts, those of the apse and south wall being broken at D39, D38 and D48, probably by burials, while there was evidence of buttresses (D37 and D35), respectively at the east and west angles of the south wall. Instead of a shallow external buttress central to the south wall, there was a larger footing in a different mortar (E9) resembling that of the footings of Building 2 and probably representing a small porch added at some time after the construction of the yellow-mortar building. The massive footings of the porticus (D41-D44), remained complete, with the exception of a section of the south wall (Grave 14).

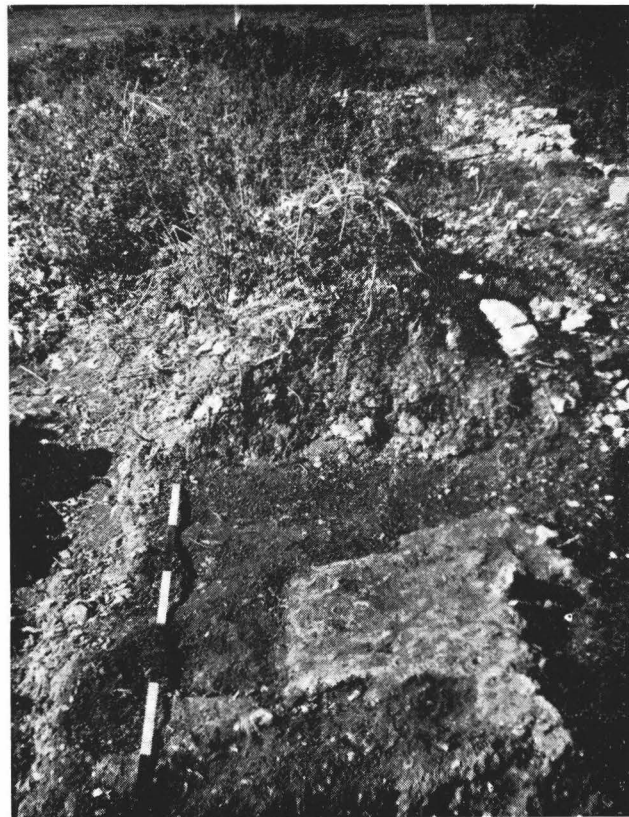
PLATE Xb.
DISTURBED MASS OF ROMAN-BRICK MORTAR (pre-Conquest)
lying within area of apsidal chancel of Building 3 (Period D—
11th century).

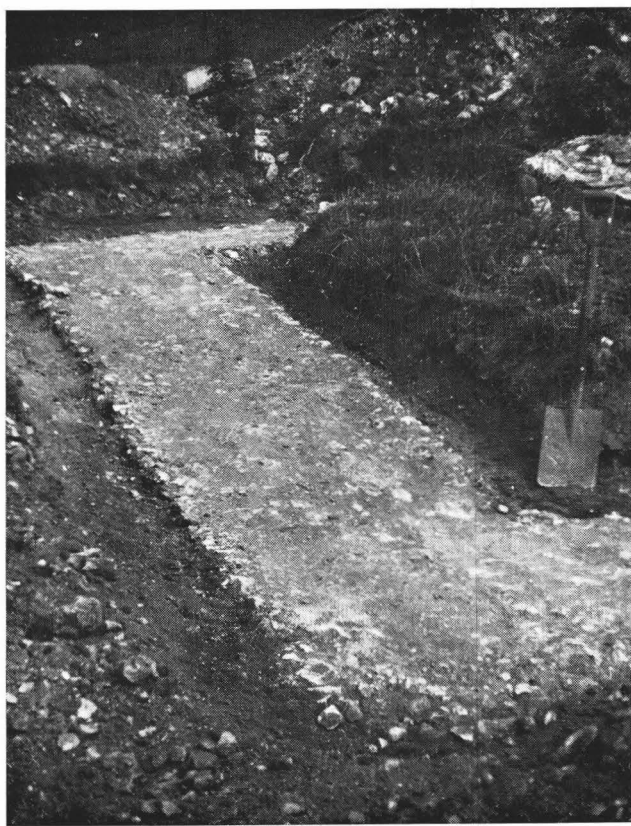
PLATE XIa.

EARLY FOOTINGS, OF RAMMED CHALK, OF WEST END OF NAVE OF BUILDING 6 (Period B—pre-Conquest); in background, right, can be seen part of West wall of Building 1 (Period F—14th century).

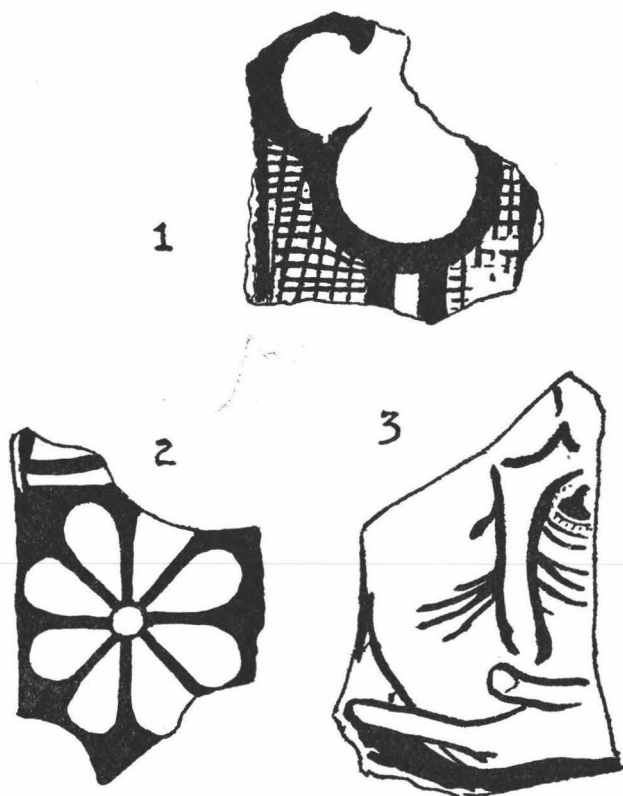
Fig. 4. FRAGMENTS OF PAINTED GLASS (13th or 14th century).

1. From filling of stone-built tomb.

2 and 3. From in-filling below position of east window of Building 1 (Period F—14th century).

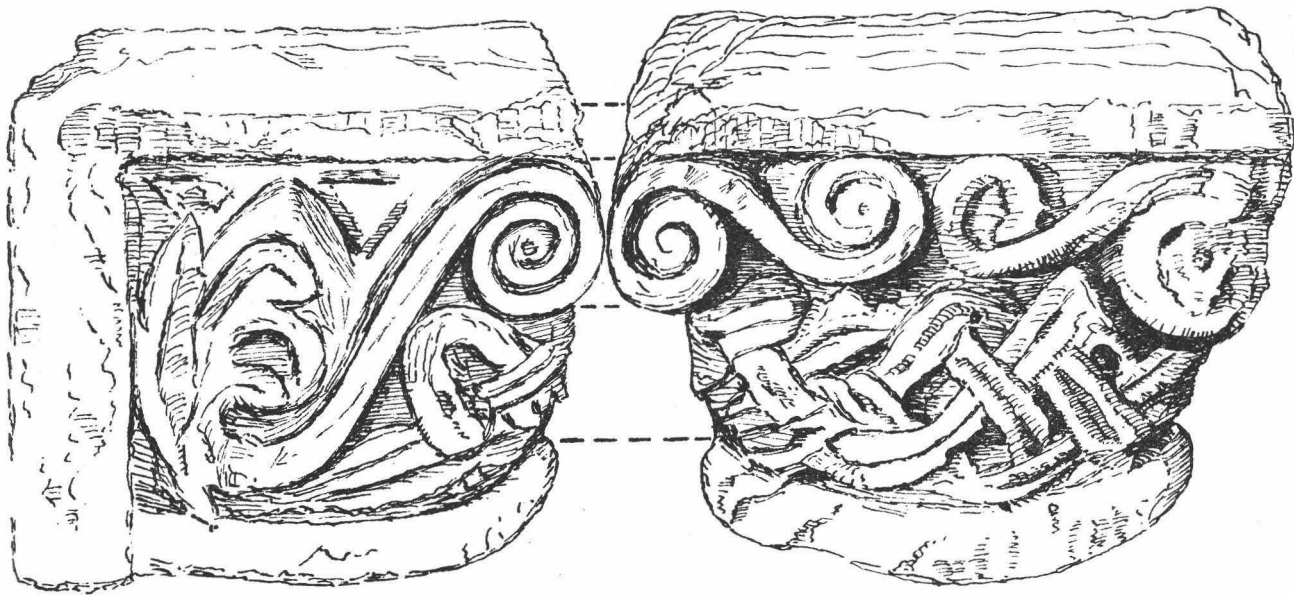
Fig. 5. CARVED CAPITAL FROM BUILDING 3 (11th century), built into nave wall of Building 1 (14th century).
