◆ The spire of Holy Trinity Church, Bosham, West Sussex

by F. G. Aldsworth

The spire of Holy Trinity Church, Bosham, was the subject of study in 1998 whilst the structure was undergoing routine repair and maintenance. It can be demonstrated that, whilst the mast and cross-trees were replaced in 1841 and some other alterations have been made, much of the surviving structure, including most of the rafters, was built in a single phase of construction from timbers felled in the winter of 1405/06 and the summer of 1406. The Romanesque corbel-table at the top of the tower, which supports the spire, is discussed in greater detail than previously but it continues to be ascribed on comparative and stylistic grounds to the period c. 1080–1110.

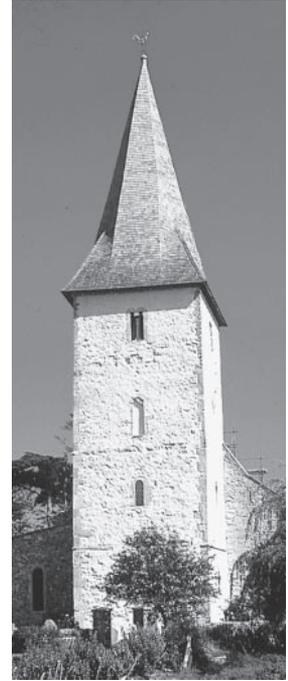
Figs 2a & 2b. The tower of Holy Trinity Church, Bosham, from the west and north after repair in 1988. The remains of the original Anglo-Saxon corbel-table, exposed during repair, can be seen below the uppermost belfry window in both elevations. (Photographs: Fred Aldsworth.)

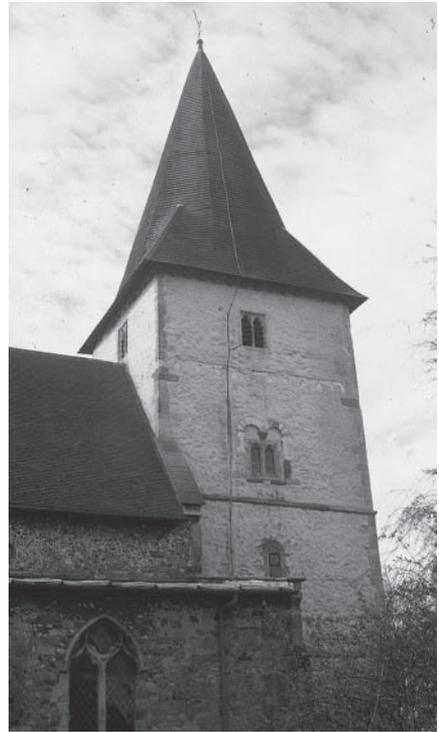
Fig. 1. Vertical section through the tower and spire, looking south.

As previously discussed (Aldsworth 1990, 56–63), the pre-Conquest tower survives in its original form, built on an offset plinth-course, with three storeys separated externally by string-courses (Fig. 1). The tower was capped by a corbelled eaves-course, set in the same distinctive hard pink mortar as the original quoins, which was subsequently cut back to the outer face of the walls, but it was still visible in 1988 and was exposed to view by the repairs undertaken at that time (Aldsworth 1990, figs 3 & 4 and here (Figs 2a & 2b). The structure includes the remains of original belfry windows in the north, south and west sides and a series of openings into the nave in the east side, which indicate that the nave contained at least one, and possibly two, upper floor levels or galleries.

Internally the pre-Conquest tower now contains the remains of one old floor, just below the level of the second string-course and at the threshold level of a round-headed door in the east wall (Fig. 1). This door presumably served a second floor or a gallery level in the nave. The floor is carried by a pair of east–west beams, with braces partly set into the walls and partly supported on Purbeck stone corbels. The floor frame comprises the remains of ten substantial floor joists some of which are later replacements of originals and one is a re-used beam with redundant

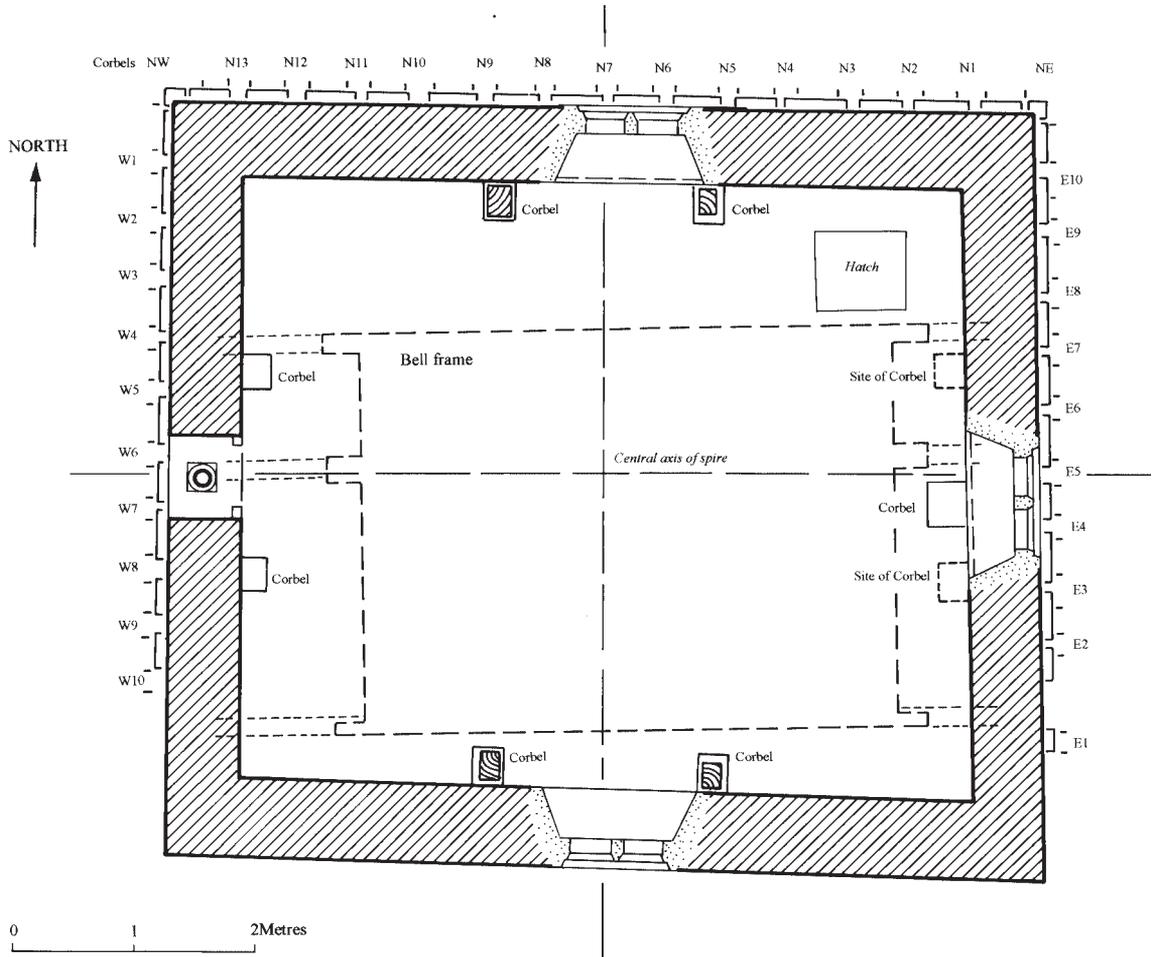
Fig. 3. Plan at Phase 2 belfry stage. The original (Phase 2) masonry is shown hatched diagonally, whilst later insertions are shown stippled.

The height of the tower from the top of the offset plinth-course (at 4.13 m Ordnance Datum) to the top of the corbelled eaves-course (at 21.30 m OD) is 17.17 m. The plan of the tower at wall-plate level is not quite rectangular. Externally the walls measure 6.98 m north, 7.20 m south, 6.30 m east and 6.18 m west, and internally 5.82 m north, 5.98 m south,

4.93 m east, and 4.80 m west (Fig. 3). The walls are approximately 0.60 m thick.

The west wall contains a centrally-placed and original belfry window, comprising a double round-headed opening with mid-wall shaft. The other three walls each contain a centrally-placed and inserted two-light, trefoil-headed window which is probably of 15th-century date. There is a pair of inserted corbels in each of the north and south walls, possibly of Purbeck limestone, which are still used to support the spire and a pair of inserted, but now abandoned, corbels in the west wall. In the east wall there is a centrally-placed corbel which appears to have served no particular function, but on either side of it is a repair indicating the former existence of a fourth pair of corbels, all four pairs having been inserted to support the spire when it was constructed (Fig. 3).

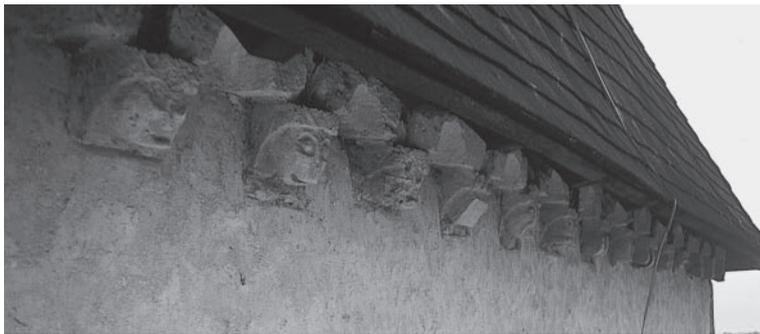
Fig. 4. Holy Trinity Church, Bosham, Romanesque corbels on the north elevation of the tower, photographed in 1988 after cleaning. (Photograph: Fred Aldsworth.)

The corbels were not illustrated in 1990, and so the opportunity is taken here to include a photograph and description of each one as important pieces of Romanesque sculpture, one at each of the north-west and north-east corners (Fig. 3: NW & NE & Fig. 5), 10 on the east elevation (Fig. 3: E1–E10 & Fig. 5), 13 on the north elevation (Fig. 3: N1–N13 & Figs 4, 6 & 7) and 10 on the west elevation (Fig. 3: W1–W10 & Fig. 7); that is a total of 35 in all. It is these corbels and the tops of the early Norman walls that support the spire.

coloured mortar used in the rubble flint wall immediately below it. This indicates either that the corbels have been re-set at some time prior to the erection of the present spire, or that different mortars were used for different building materials in the original construction, as is often the case. The absence of corbels on the south elevation and at the south-west and south-east corners is considered to be due to the effects of the prevailing wind and repairs carried out as a result of weathering. No evidence was observed to suggest the form of the original timber spire on top of the walls.

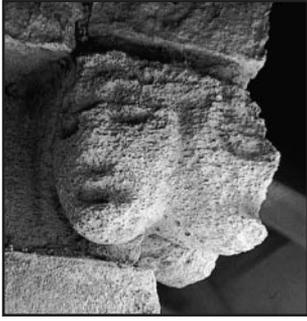
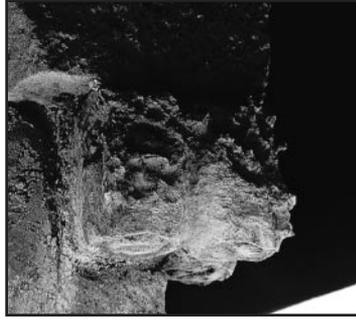
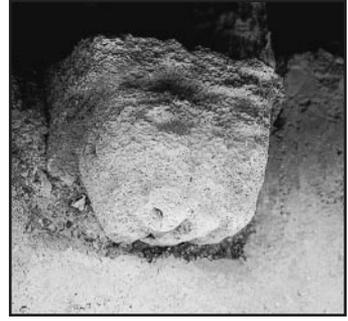
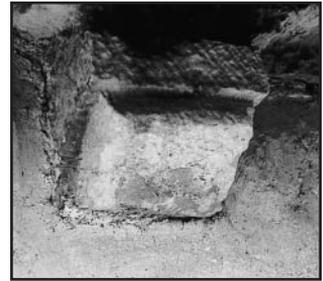
Fig. 5. Holy Trinity Church, Bosham, Romanesque corbels at the north-west corner, north-east corner, and east elevation of the tower. (Photographs: Fred Aldsworth.)

Corbel no.	Subject matter	Stone ¹	Condition
E1	Frontal animal head with muzzle	Q	good
E2	Roll in hollow	FQ	worn
E3	–	Q	damaged
E4	Raised square in hollow	FQ	good
E5	Quadrant	FQ or B	worn
E6	Quadrant	FQ or B	good
E7	Frontal head	FQ	worn
E8	Frontal head	FQ	worn
E9	Frontal human head	Q	worn
E10	Two human heads, facing angles	FQ	good
NE	Three animal heads, one on each angle of the block. These are identified as animal heads because the lower part of each face is shaped like a muzzle rather than a jaw. The underside of each muzzle is carved with a disc containing a bar or cross.	FQ	worn
N1	Frontal human head	FQ	good
N2	Frontal animal head with short muzzle and large mouth	FQ	good
N3	Frontal human head	Q	worn
N4	Raised square in hollow	Q	good
N5	Frontal human head, possibly with moustaches	Q	worn
N6	Frontal animal head (horse?) with muzzle and possibly bridle	Q	worn
N7	Quadrant divided by central, vertical channel (cf. two wheels)	Q	good

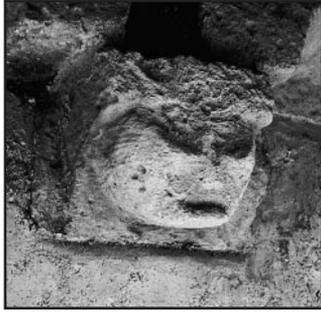
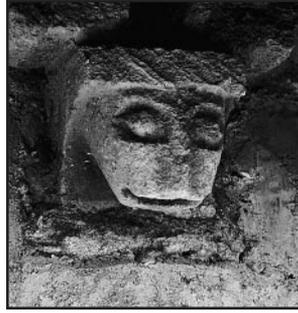
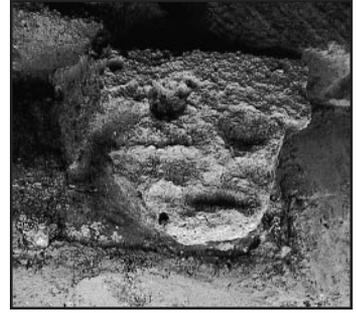
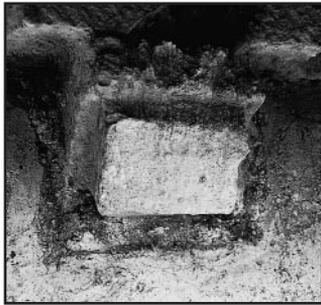
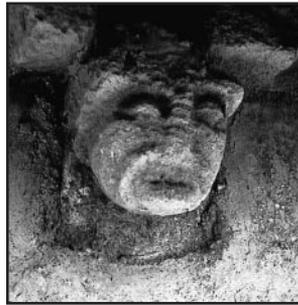
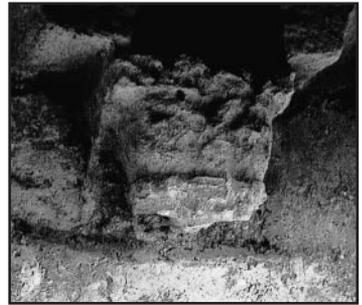
Fig. 6. Holy Trinity Church, Bosham, Romanesque corbels on the north elevation of the tower. (Photographs: Fred Aldsworth.)

N8	Frontal human head	Q	good
N9	Roll in hollow, with flat band around centre	Q	good
N10	Two human heads, facing angles	Q	worn
N11	Triple roll	Q	good
N12	Two human heads, facing angles	Q	good
N13	Roll in hollow	Q	good
NW	Three human heads, one on each angle of the block	Q	good
W1	Raised square in hollow	Q	good
W2	Raised square in hollow	Q	good
W3	Roll in hollow	Q	good
W4	Raised square in hollow	Q	good
W5	Frontal (animal?) head	Q	worn
W6	Raised square in hollow	Q	good
W7	Raised square or roll in hollow	FQ	good
W8	Frontal animal head with muzzle	FQ	worn
W9	Frontal animal head (horse?) with muzzle and bridle	FQ	worn
W10	Raised square in hollow with sphere or pellet in centre	FQ	worn

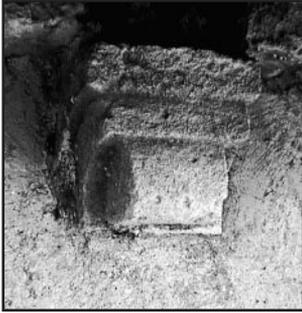
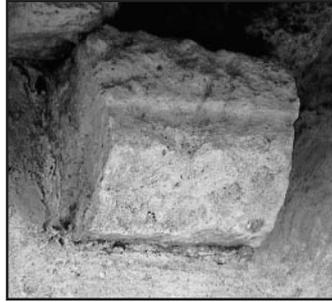
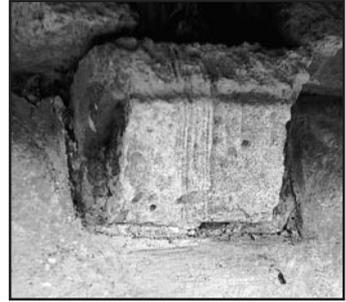
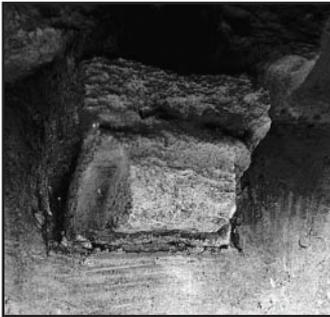
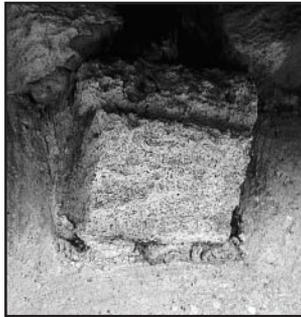
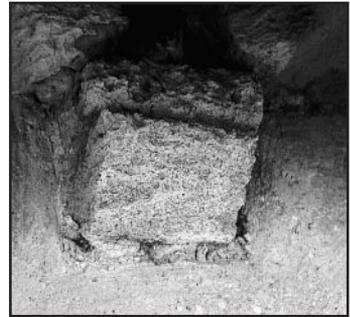
Fig. 7. Holy Trinity Church, Bosham, Romanesque corbels on the north and west elevations of the tower. (Photographs: Fred Aldworth.)

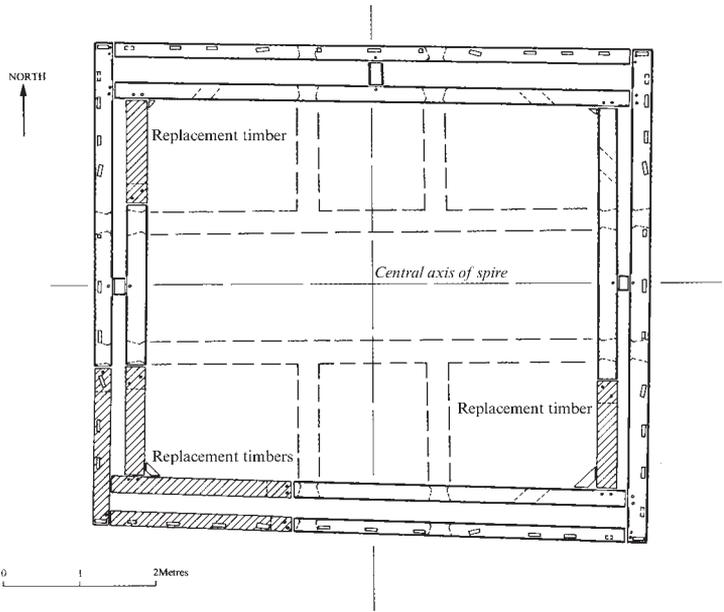
Fig. 8. Plan showing the wall-plates & ties. Replacement sections of original timbers are shown hatched diagonally.

There is a pair of wall-plates on the top of each of the four walls; these are mostly original but six sections have been replaced due to decay, which has been particularly prevalent at the south-west corner (Fig. 8). The outer wall-plates carry the birdsmouth seatings for the rafters. Generally the wall-plates sit flush with the internal face of the wall and flush with the outer face of the corbel-table, except where the latter is missing (Fig. 9). There is evidence, in the form of a mortar change at the very top of the wall internally, to indicate that the wall was repaired to take the wall-plates. The individual wall-plates vary in width, from 180 mm to 280 mm (7 to 11 in.), and in height, from 160 mm to 190 mm (6 to 8 in.). They are joined by pegged mortice-and-tenon joints, with linking pieces at the centre of the north, east and west, but not the south, sides and the whole assembly is in the form of a horizontal frame.

mm (8 in.) deep and 290 mm (11.5 in.) wide. In all six cases they are secured to the tops of both the inner and the outer wall-plates by means of a full-width lap dovetail joint with entrant shoulders (Figs 8 & 9).

Lying or running across each of the four corners formed by the inner wall-plates is a relatively modern corner brace which also supports the base of the rafters forming the octagonal shape of the spire and the ends of the north bell-frame and south frame. These probably replaced the original timbers in the same position. The originals were probably trenched into the upper face of the inner wall-plates, but the evidence for this has been either destroyed by later repairs or is now obscured by the replacement corner braces (Figs 8 & 9).

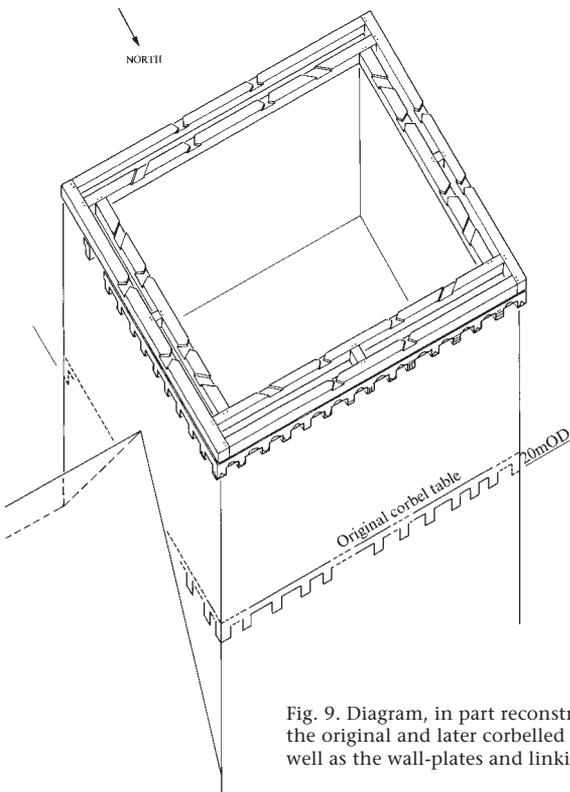
Fig. 9. Diagram, in part reconstruction, showing the original and later corbelled eaves-courses as well as the wall-plates and linking pieces.

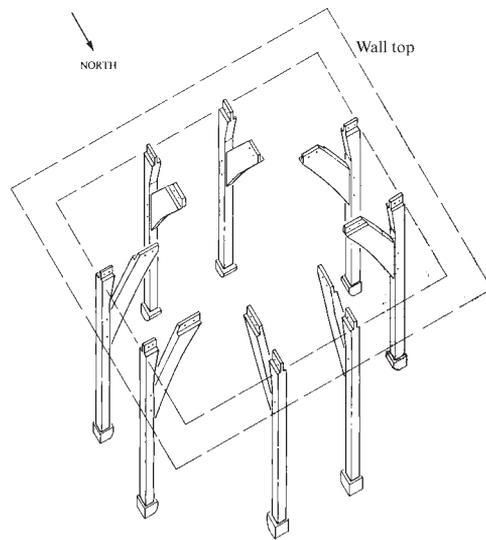
Fig. 10. Diagram, in part reconstruction, showing the posts and braces which support the underside of the main beams.

Eight internal corbels originally supported eight chamfered posts with braces up to the soffits of the main beams (Fig. 10). The posts and braces on the east and west sides are now missing (Figs 11 & 12) but those on the north and south sides survive, and in all four cases the posts have been repaired at their lower ends with re-used timbers, each bearing a variety of redundant pegged mortices (Figs 13 & 14).

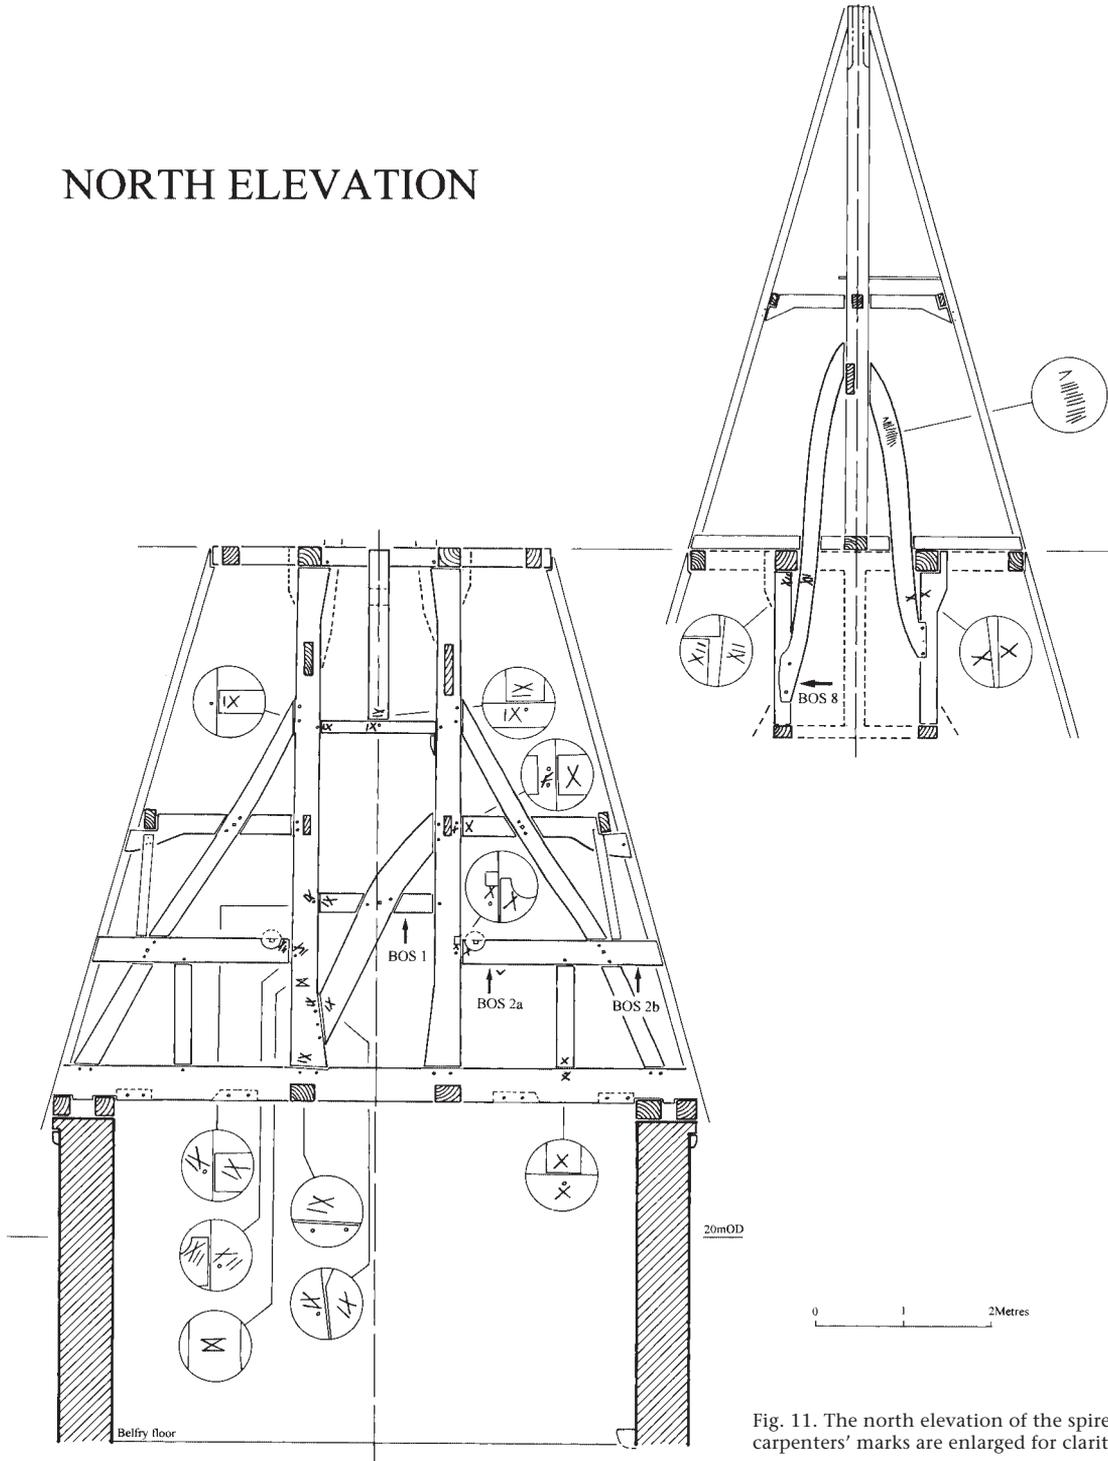
NORTH ELEVATION

Fig. 11. The north elevation of the spire. The carpenter's marks are enlarged for clarity.

tower, measuring 1.92 m east–west by 1.86 m at the base, tapering slightly upwards. It consists of four main posts each 5.72 m long, eight horizontal rails, four diagonal braces, and four shorter intermediate upright posts (Figs 11–14 & 17).

A number of carpenters' marks, both scratched and produced with a race knife, were noted on the timbers and these are shown in their actual locations and enlarged on the elevation drawings (Figs 11–14). However, because of limited access it was not possible to examine all the exposed surfaces and other marks may exist. They include numerals, both in Roman form and with the occasional use of a centred arc — presumably used either as a numeral

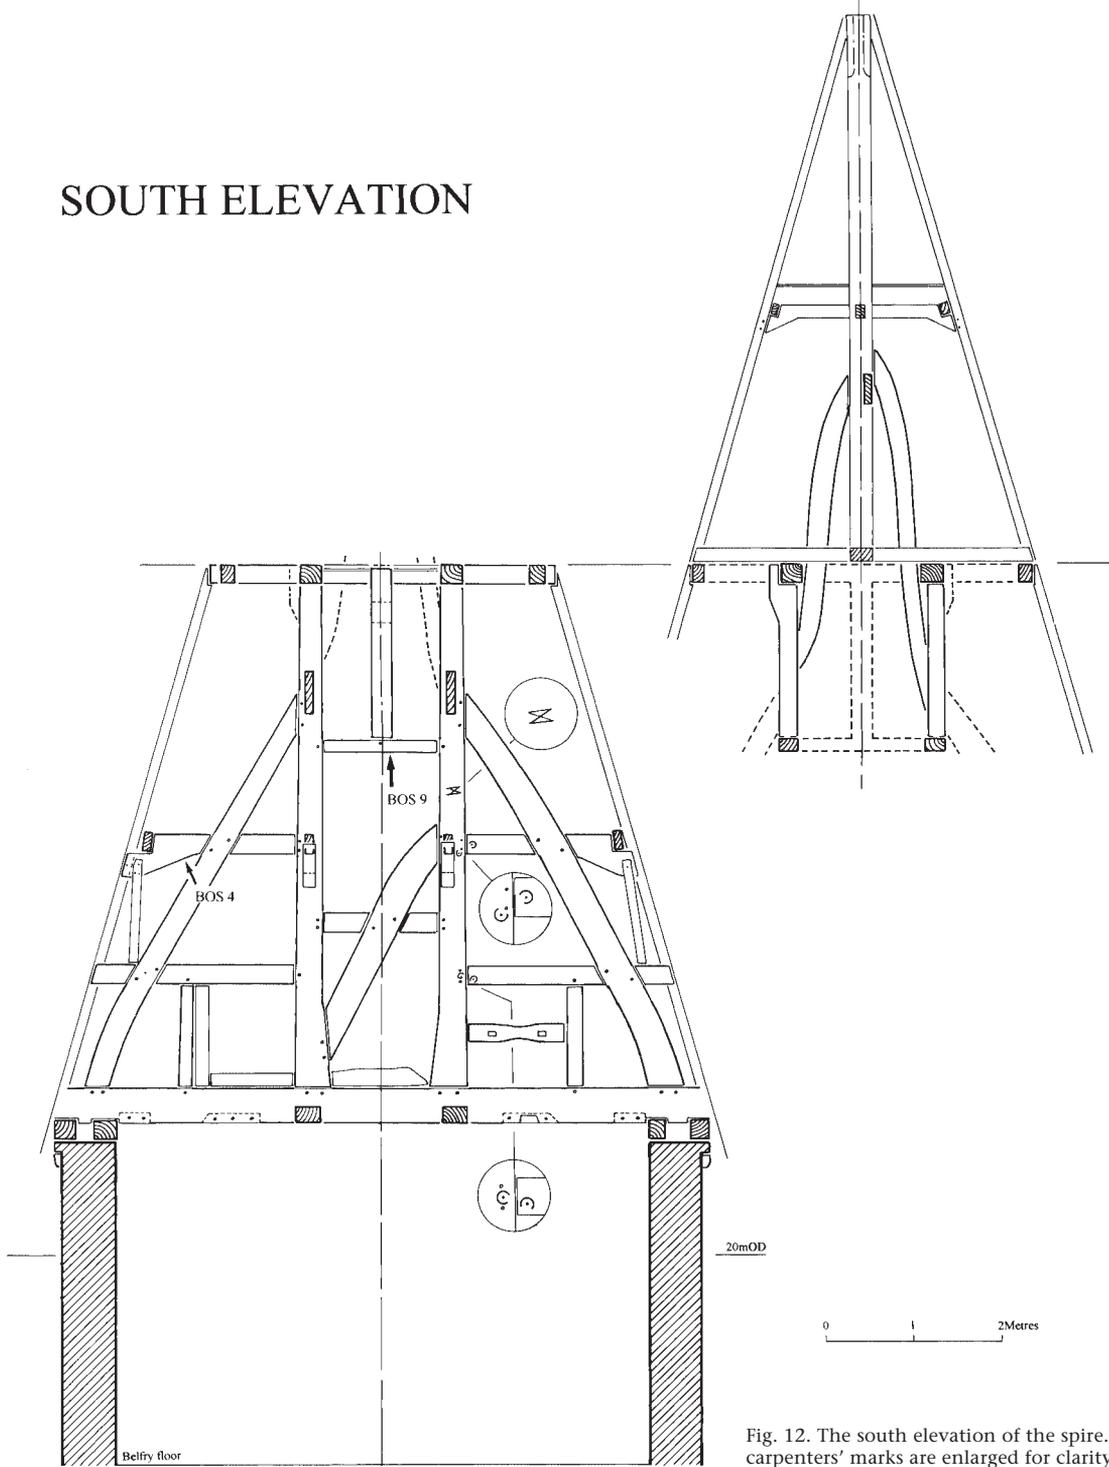
SOUTH ELEVATION

Fig. 12. The south elevation of the spire. The carpenters' marks are enlarged for clarity.

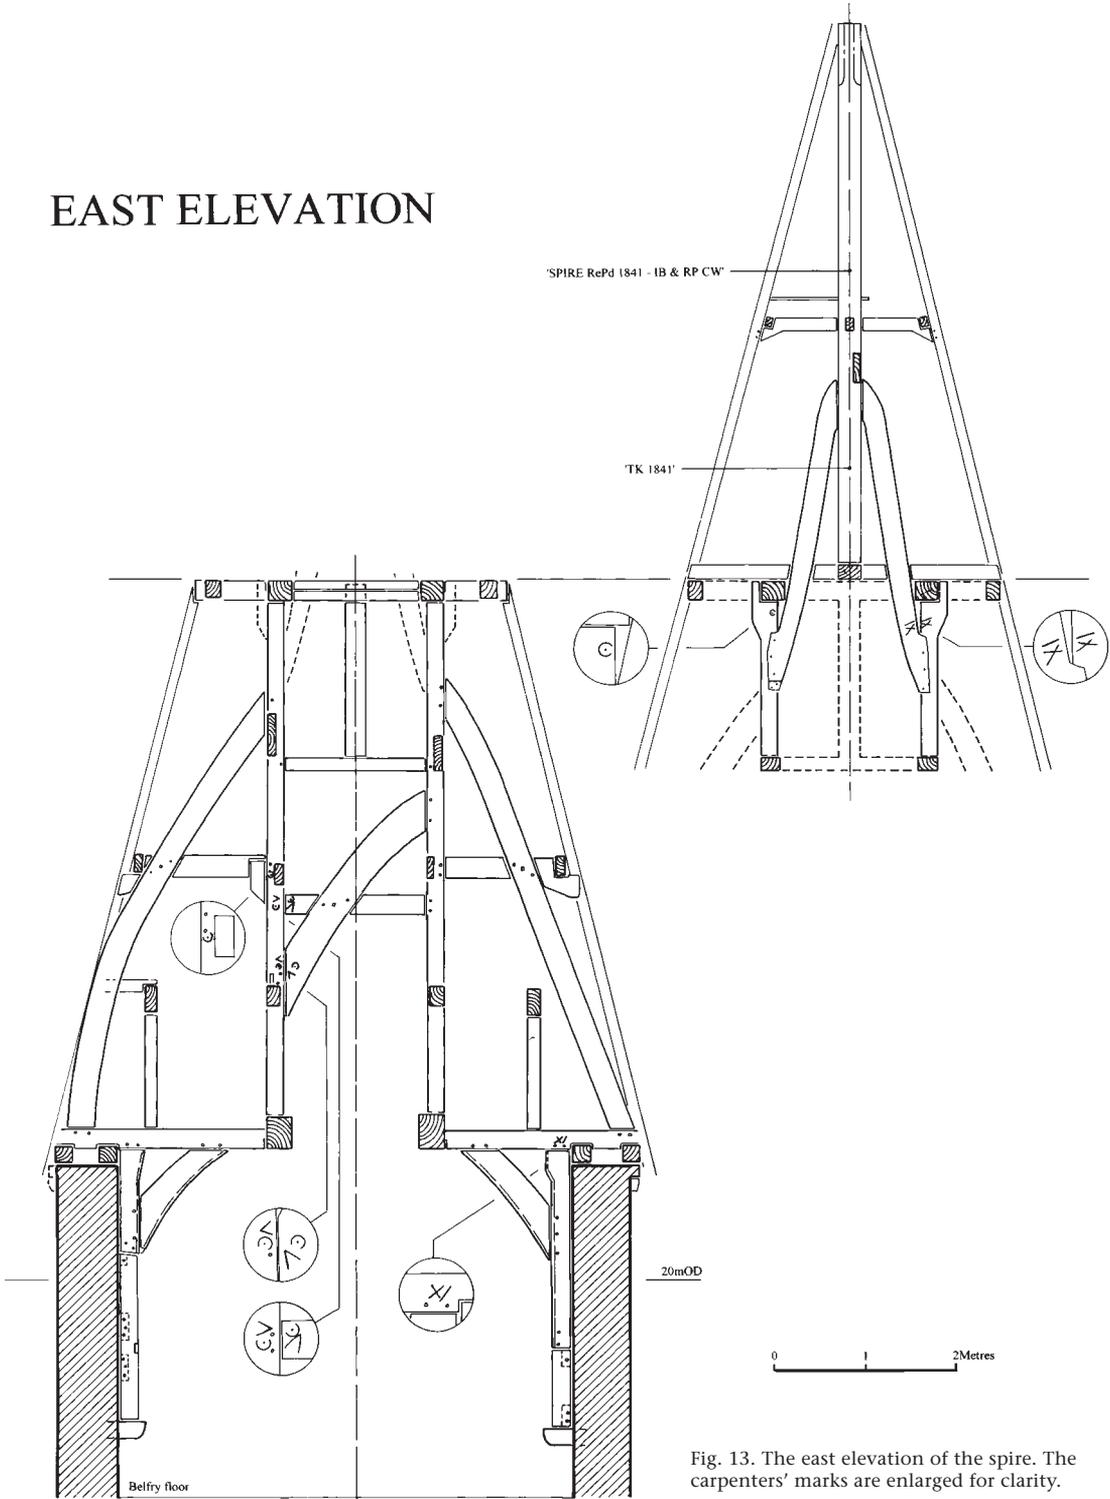
EAST ELEVATION

Fig. 13. The east elevation of the spire. The carpenters' marks are enlarged for clarity.

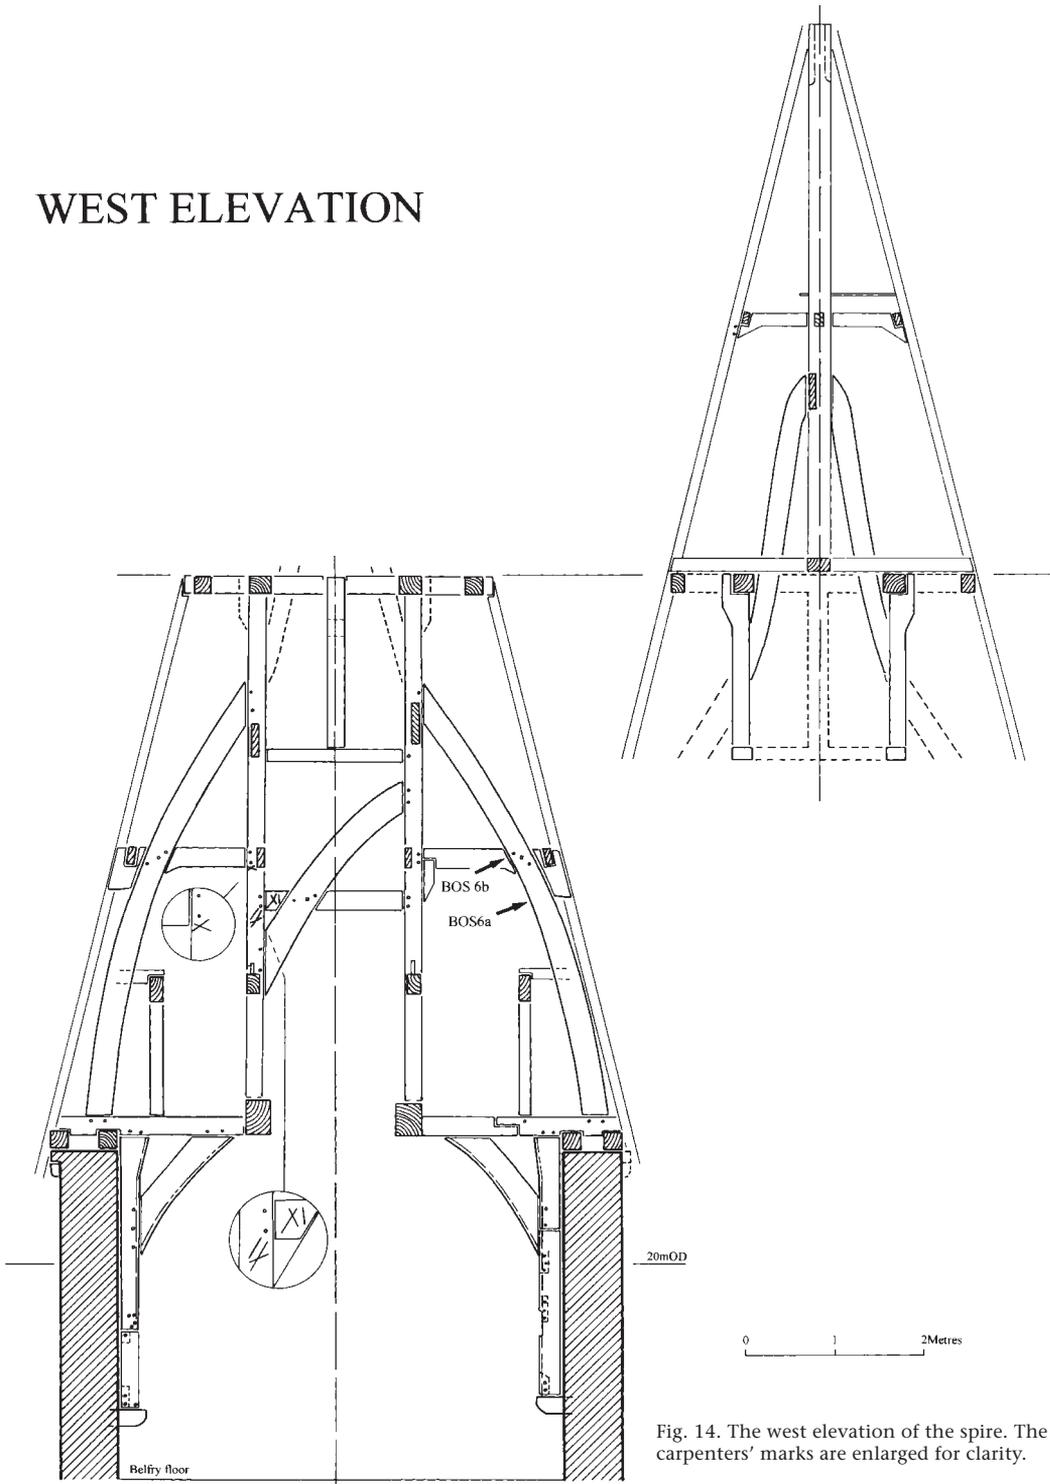
WEST ELEVATION

Fig. 14. The west elevation of the spire. The carpenters' marks are enlarged for clarity.

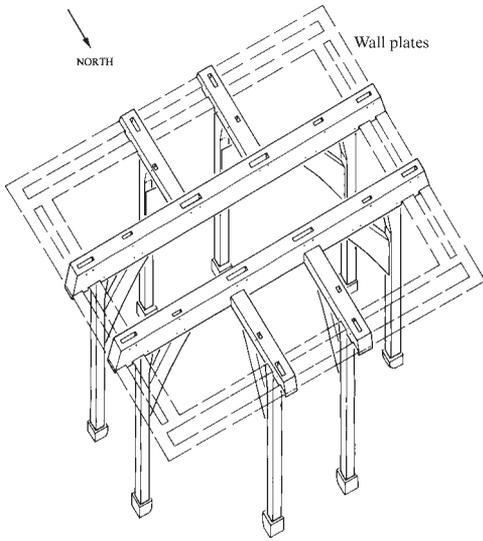
Fig. 15. Diagram, in part reconstruction, showing the main beams and their supporting posts and braces.

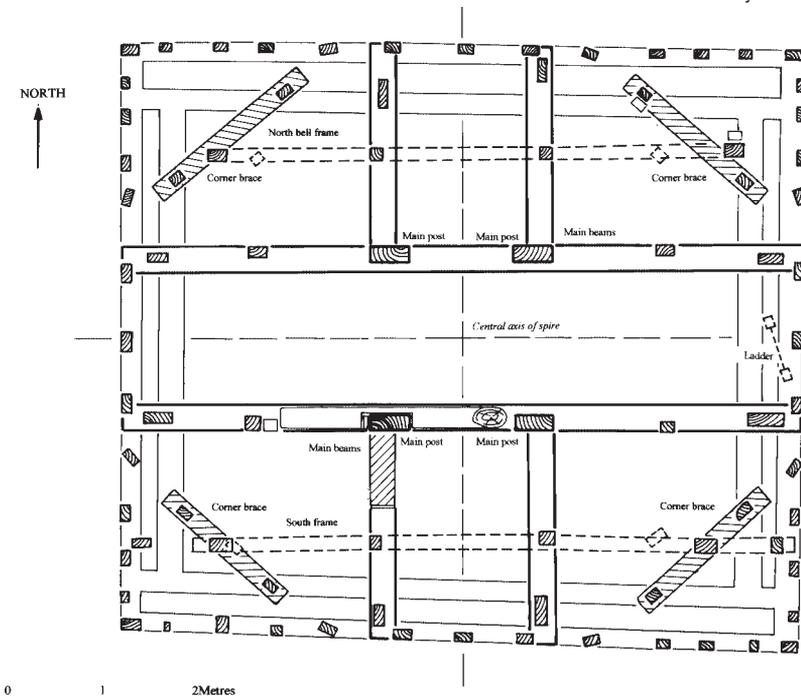
Fig. 16. Plan at the base of the spire, showing the main beams, main posts, corner-braces, north and south frames, and rafter feet. Replacement timbers are shown hatched diagonally.

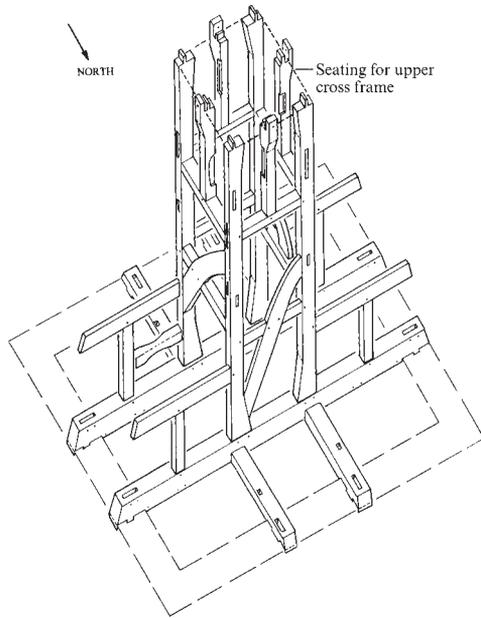
Fig. 17. Diagram showing the main beams and the main frame of the spire.

The four main posts are tenoned into the tops of the east–west beams. Each of the four timbers measures 300 mm (12 in.) wide by 180 mm (7 in.) deep, expanding at the base to 420 mm (16.5 in.) wide and at the tops in the case of the two at the north-east and north-west corners to 350 mm (14 in.) wide. The diagonal braces are halved and pegged over the lower rails and above them a set of four upper rails support four intermediate posts. The four main posts and the four intermediate posts are all tenoned at the top to provide a seating for the top frame. Observations made on site, which were restricted by limited access available to this level, appeared to suggest that the main corner-posts may each carry a T-shaped tenon into the lower members of the top frame. It has subsequently been suggested to me that T-shaped tenons would be unusual and they are more likely to have north–south tenons (Fig. 17). The

intermediate posts carry a tenon and an upstand at the head of an external jowl (Figs 17 & 21).

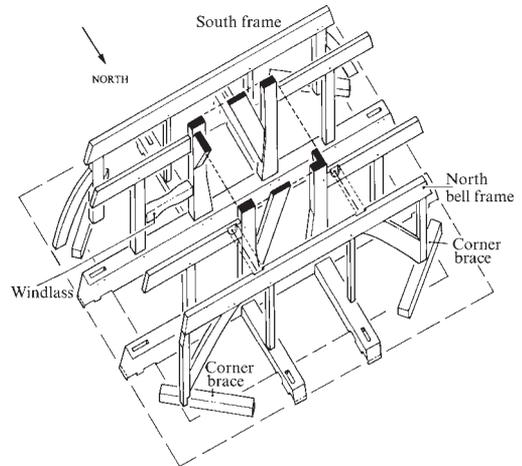
Fig. 18. Diagram showing the base of the main frame of the spire and the north bell frame and the south frame.

Extending east and west from the main frame are the rails and studs which support on the south side the surviving windlass, for raising and lowering the bells, and on the north side one side of a bell-frame. On the north and south sides of the main frames, and supported on the secondary beams and corner-braces, are additional studs, rails and braces. These form the remaining side of a north bell frame, for two bells, and a south frame, which appears to have no particular function other than supporting the feet of rafters (Fig. 18).

The mast (Fig. 19), the top of which rises to a height of 12.75 m above the wall tops (i.e. 34.05 m OD) and which is 230 mm (9 in.) square in section, is seated on a pair of cross-trees. These cross-trees lie in full-width lap dovetail joints with entrant shoulders in the top face of the top frame, in the same way as the main beams are secured to the wall-plates (Figs 18, 21 & 22).

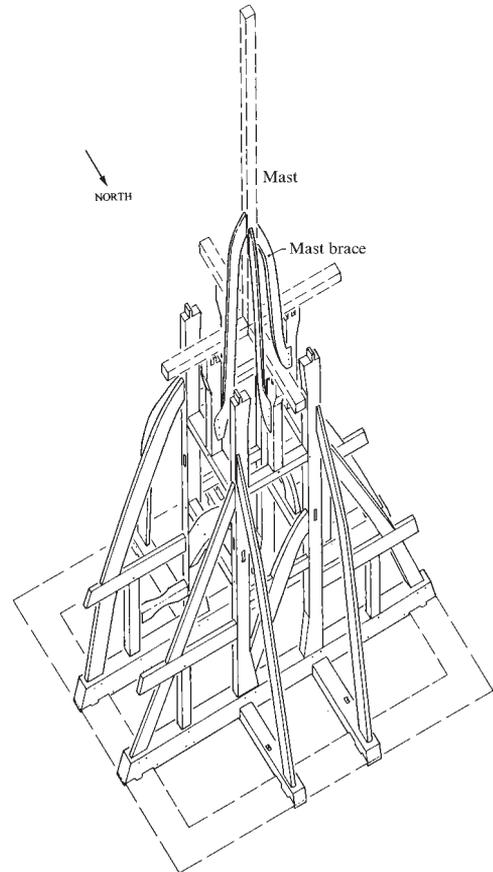
Fig. 19. Diagram showing the main frame of the spire and the shores.

tenoned and pegged at their lower ends into the main and secondary beams of the 'base frame' and into the posts at their upper ends (Fig. 19). The shores on the east and west sides are halved and pegged across the rails of the bell-frames.

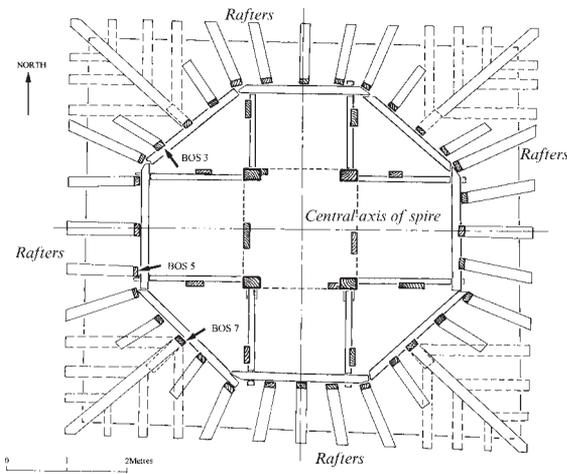
Fig. 20. Plan showing the brackets, purlins or plates, and rafters.

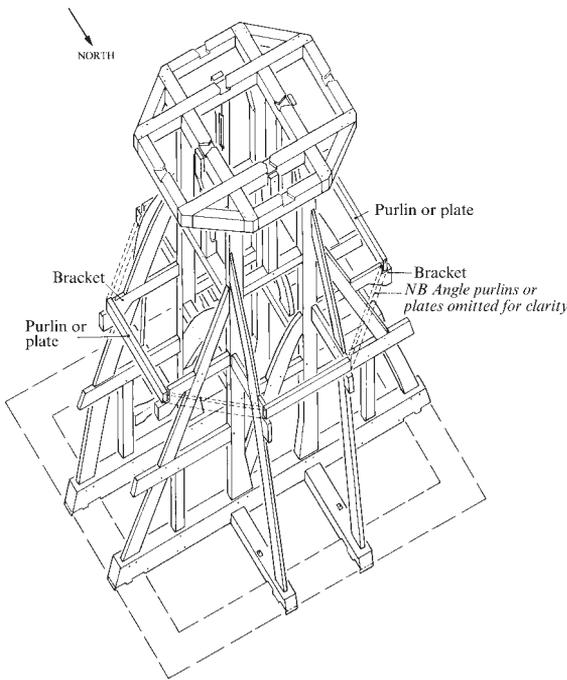
Fig. 21. Diagram showing the main frame of the spire with lower shores, brackets, purlins or plates, and top frame added.

At the top of the main frame the octagonal shape is formed by the top frame (Figs 21 & 22). It comprises two beams extending east–west across the top and beyond the sides of the main frame, and is halved across two similar beams extending in the

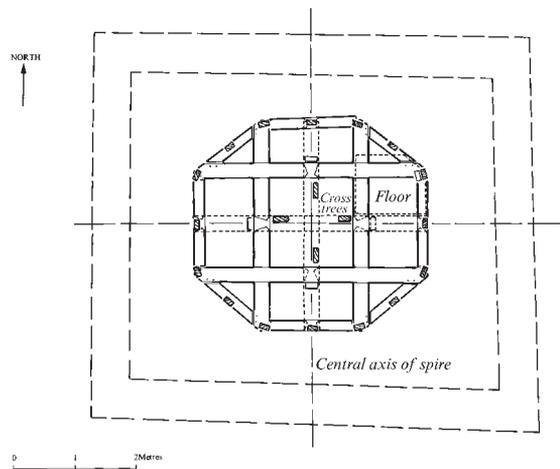
Fig. 22. Plan showing the top frame and purlins or plates.

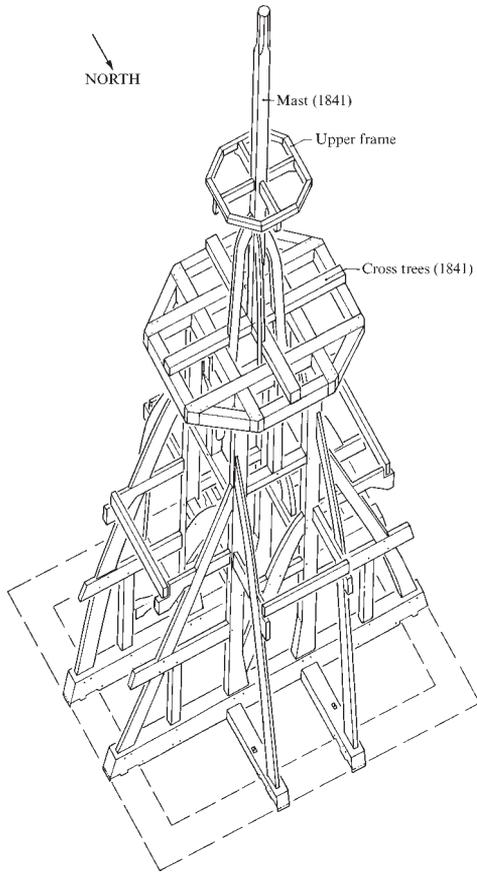
Fig. 23. Diagram showing the complete spire frame, with cross-trees, mast and upper frame added. The north and south frames are omitted for clarity.

small floor area for inspection purposes was also added then as an upper frame (Fig. 23).

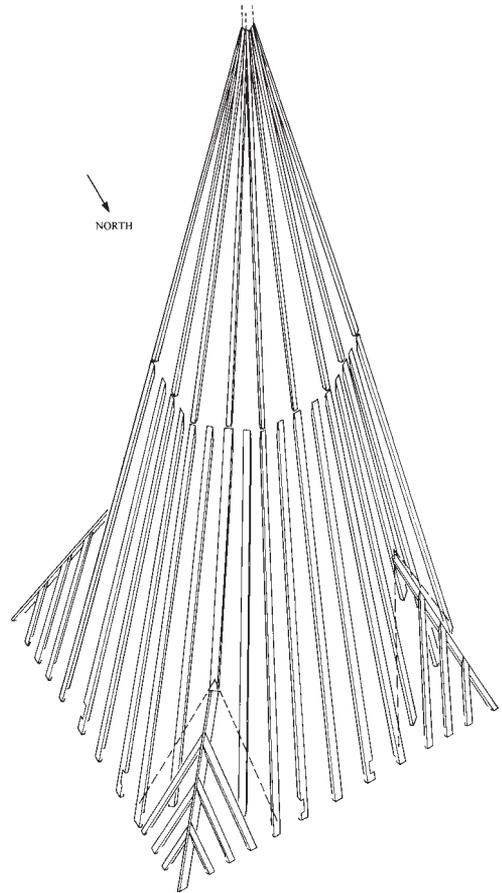
Fig. 24. Diagram showing the arrangement of lower and upper rafters.

The lower rafters which form the four principal sides of the spire extend from the plates of the top frame down to the wall-plates over which they are birds-mouthed (Fig. 24). There are five on each side (north, south, east and west), those at each end being slightly canted. Each of the four angles of the spire, which convert its plan from a rectangle (Fig. 19) to an octagon, is formed by three more rafters. That in the centre of each angle is supported, somewhat precariously, on the upper rails of the north bell frame and the south frame, whilst the remainder are supported on the corner braces. They all derive additional support approximately half way along their length by the intermediate frame of brackets and purlins or plates (Fig. 21). Many of the 32 lower rafters appear to be the originals.

The upper rafters sit on the cross frame and rise to the top of the mast, which is chamfered to take them. They are given additional support by the upper set of brackets and purlins or plates, probably added in 1841. With the exception of three replacements on the east side, all 16 upper rafters appear to be originals.
