# ◆ Archaeological investigations at the former East Grinstead Pottery works, Garland Road, East Grinstead, West Sussex

*Archaeological investigations at the former site of Rentokil House, Garland Road, East Grinstead revealed surviving structural elements of the East Grinstead Pottery works which was established in 1855 and demolished in 1971. The structures identified represent the foundations of the Pottery workshop, including the foundations of the bottle kiln and an extensive yard area with discrete brick-laid flooring around a circular brick-built clay-processing feature. An associated assemblage, including red earthenware products of the Pottery, consisted of flowerpots, large jars, bowls and dishes, which evidence the utilitarian vessels produced during the second half of the 19th and early 20th centuries. The excavated assemblage was compared to the collection of vessels previously collected from the Pottery works and housed at East Grinstead Museum, which has helped to refine the product range, especially towards the end of production.*

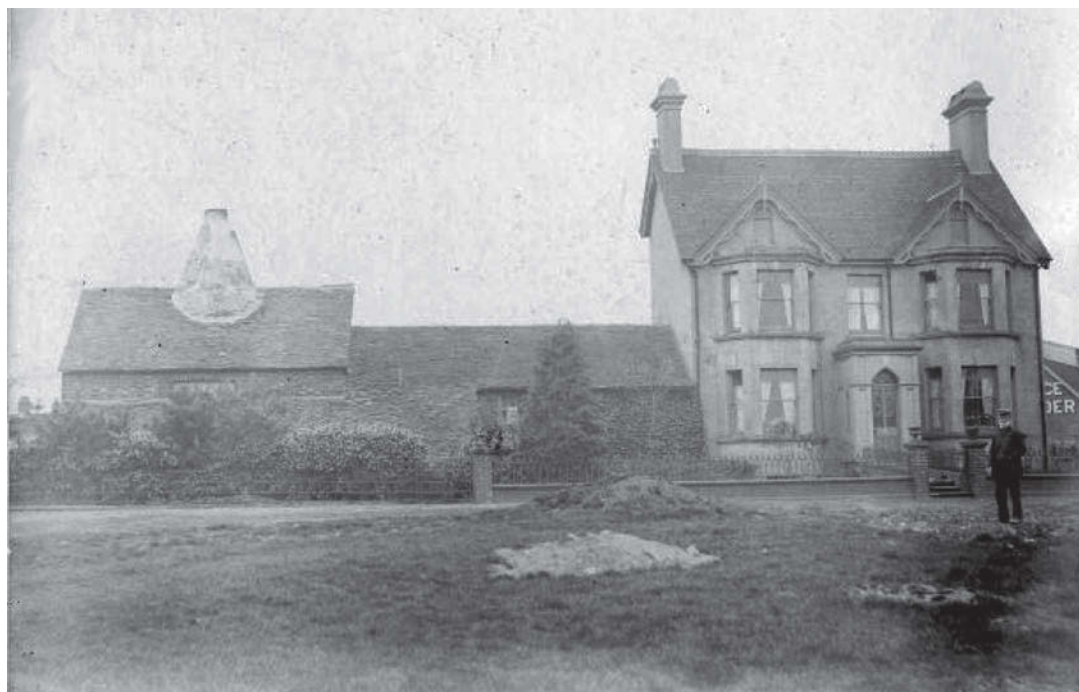
Fig. 3. Photograph of the bottle kiln (left), workshop (centre) and potter's house (right) viewed looking north from Park Road (courtesy of East Grinstead Museum Collection).

The basal course of the foundation of the circular bottle kiln was recorded (Fig. 4). The term 'bottle' refers to the shape of the structure (Figs 3 and 5). The substantial kiln walls were constructed of unfrosted reddish-orange bricks and were 0.8m thick. The kiln has an extrapolated external diameter of c. 5m (approx. 16ft 4ins). Some elements of internal kiln structure were also observed. Bottle kilns were constructed in Britain until the mid-20th century, after which they were replaced in the pottery industry by other types. A surviving photograph shows two firemouths at

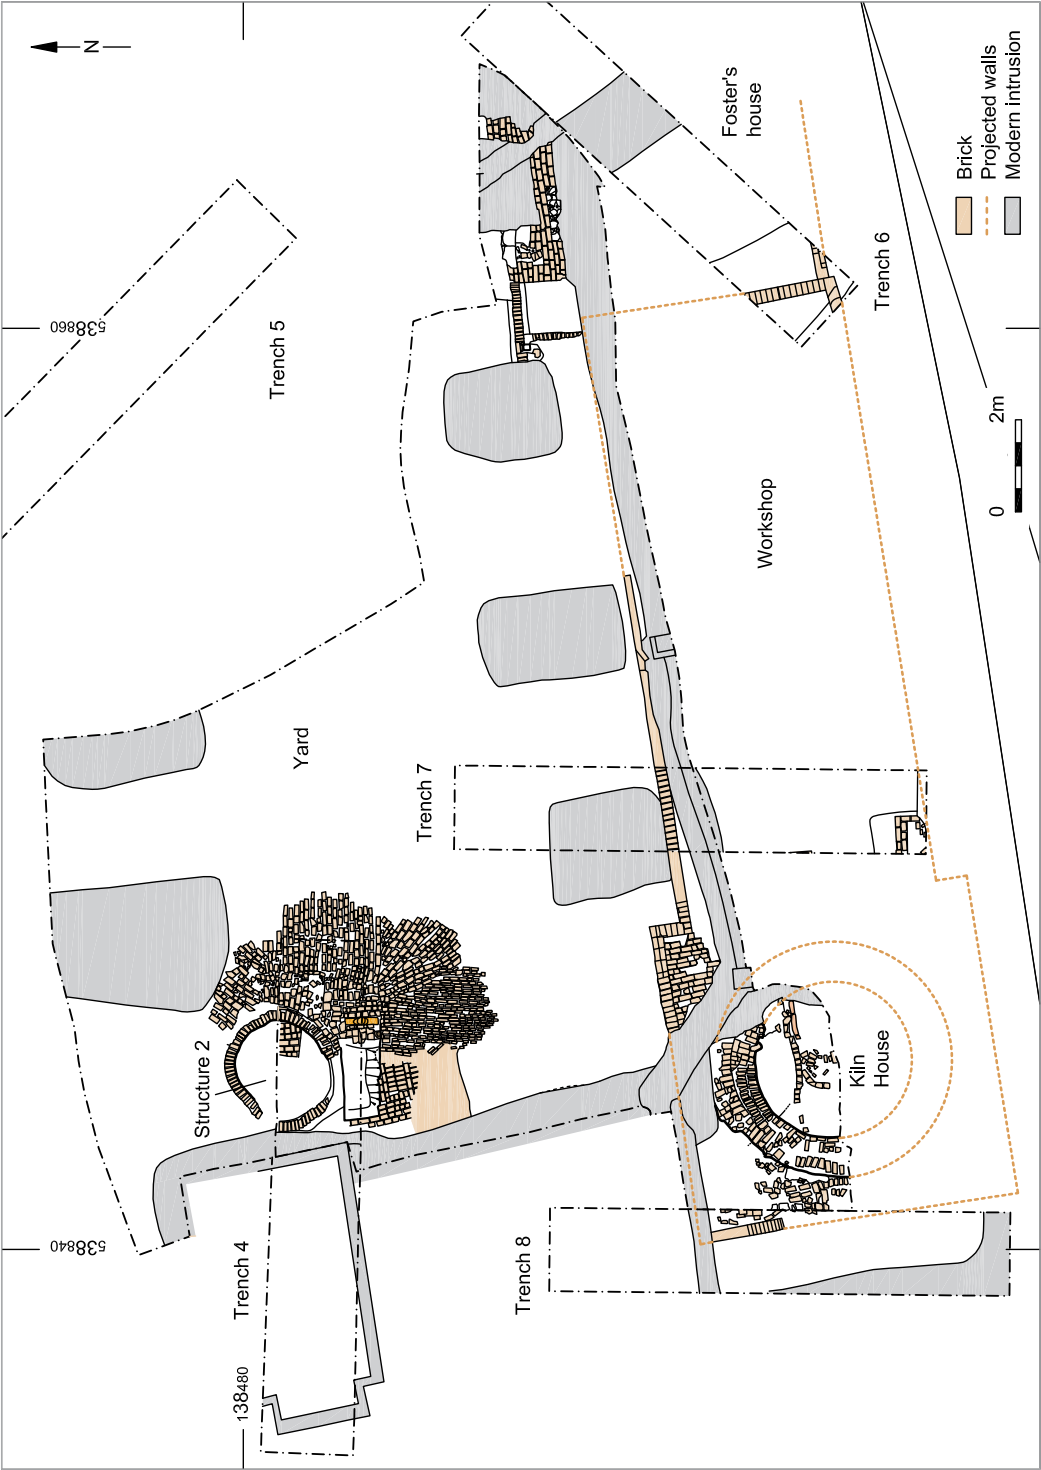
Fig. 4. Plan of excavated features.

The base of the northern part of the kiln house walls and floors survived, suggesting that the building had a single room with an internal width of 6.98m (Fig. 4). Map evidence confirms that this room was roughly square, with the circular kiln structure in the centre (Figs 2 and 3). All the masonry elements of the kiln house were constructed of unfrosted reddish orange bricks measuring 230mm by 110mm by 70mm. The wall foundations were laid on natural sandstone, as either headers or double rows of stretchers, forming a single-skin wall 230mm thick. No indication of a dividing wall between the kiln house and the workshop was found, although one might have existed but not

The central workshop (Fig. 4) measured c. 13m by 5.6m, based on extrapolated wall lines. The workshop was constructed in the same bricks as the kiln house and the bottle kiln. The workshop was largely unexcavated, although the back wall was partly recorded and some internal structures were identified, including masonry elements (in evaluation trench 7) and floor surfaces from the southeast corner of the room (in trench 6). These floor surfaces comprised an asphalt surface overlaying a re-deposited clay bedding layer.

A circular brick-lined pit (Figs 4 and 6) was recorded in the northern part of the yard. This was c. 2.5m (approx. 8ft 2½ ins) in diameter externally and constructed of unfroged bricks. These bricks were laid as headers eight courses deep, and the structure had a brick floor at the base and was filled with soft clean clay with few inclusions. The pit was surrounded to the east and the south by a brick working floor, laid in rough panels that radiated away from the pit and were evidently contemporary with its use. The floor measured c. 6.30m × 4.74m. An earlier brick floor surface was also partly exposed below this during the excavation of an adjacent mechanism (Fig. 6).

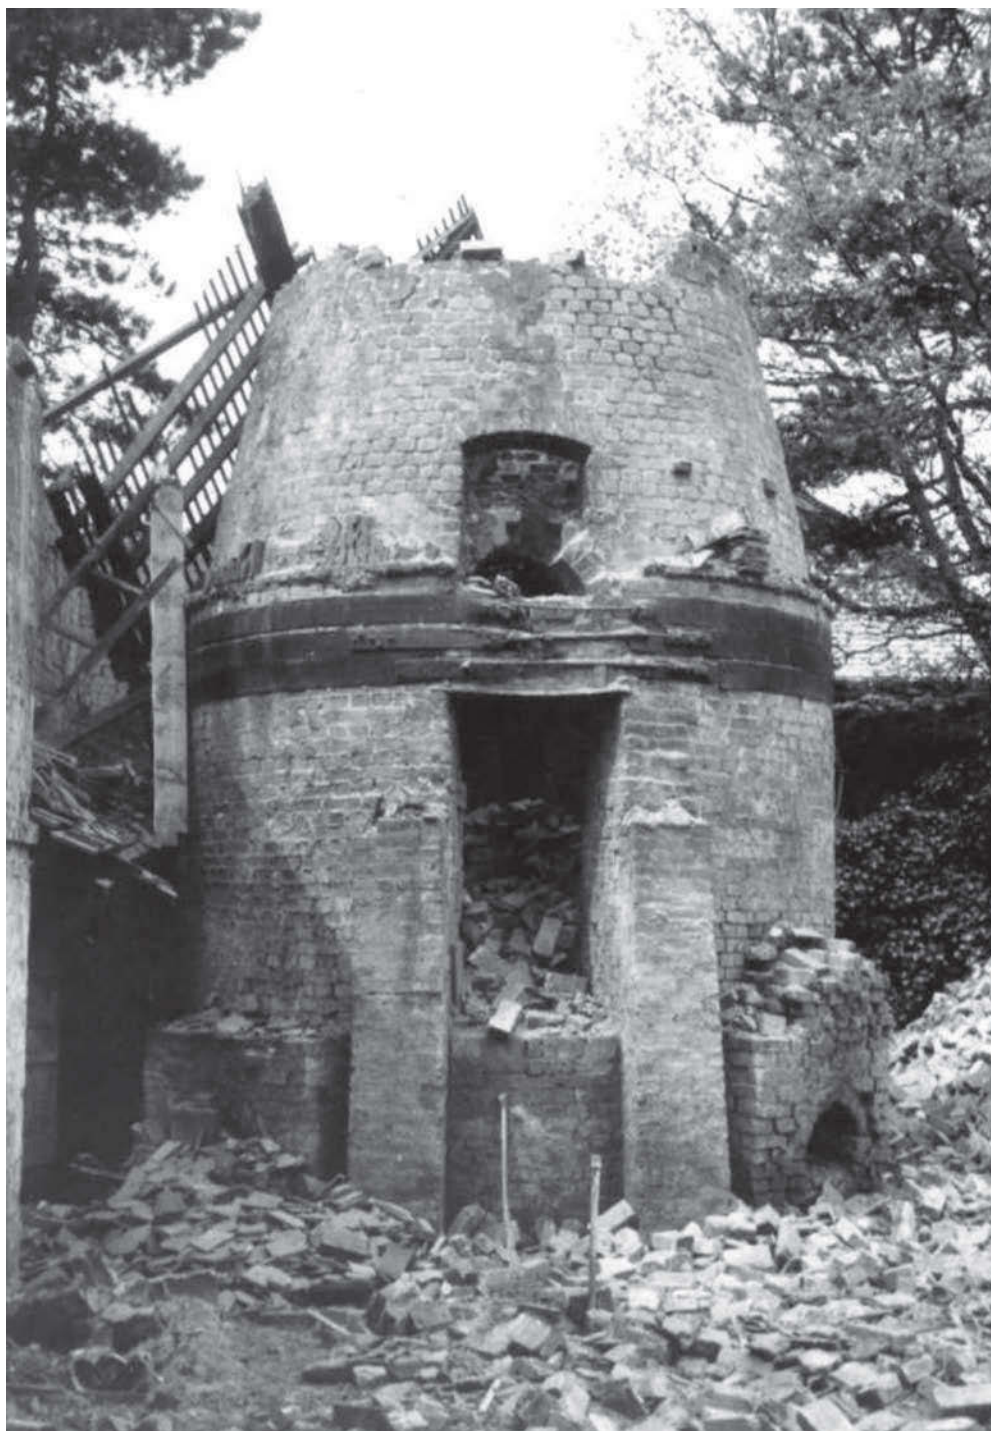
Fig. 5. Photograph of the bottle kiln during demolition in 1971 viewed from the east (courtesy of East Grinstead Museum Collection).

the base of the kiln, the doorway for loading and unloading, and the iron bands that ran around the kiln to strengthen it during contraction and expansion (Fig. 5).

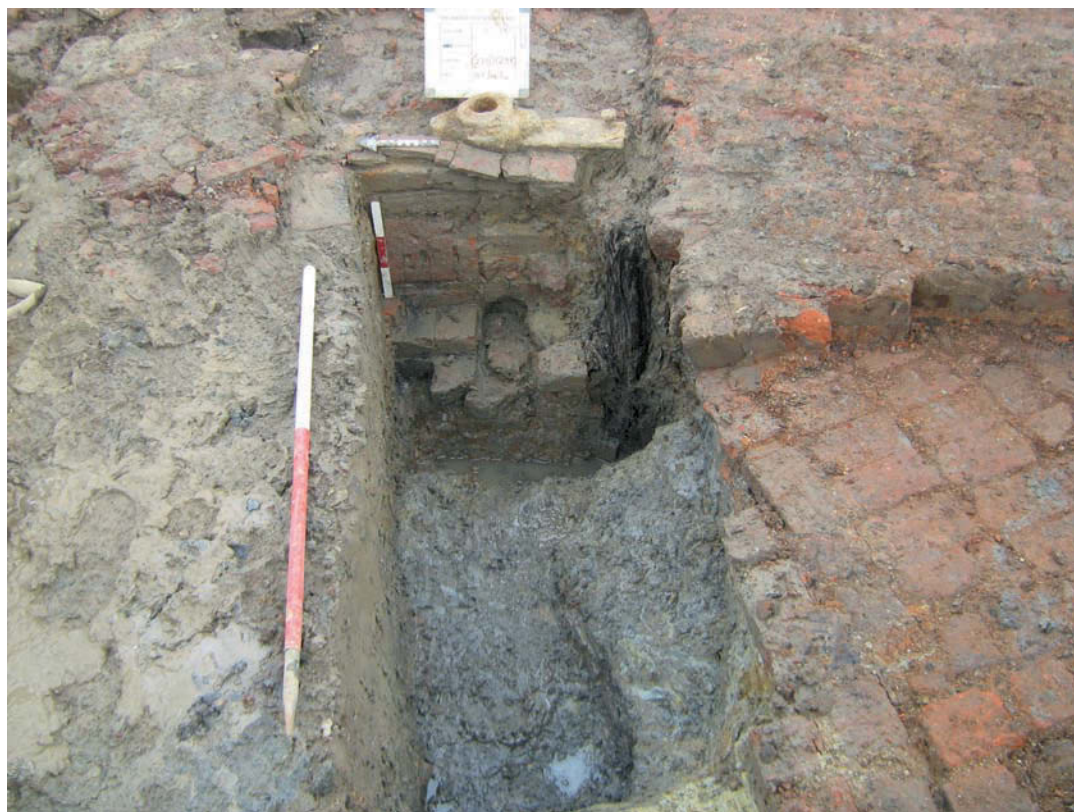
Fig. 7. Mechanism adjacent to circular brick-built structure showing weight-bearing plinth and one of the retaining wooden posts, viewed from the west.

Directly south of Structure 2, a clay-filled gap in the brick floor was visible. Excavation of this revealed a rectangular robber cut, measuring 1.65m × 0.75m × c. 0.75m deep (Fig. 7). At the eastern end of the robber cut, parts of a mechanism could

be seen that had been installed within a separate construction cut that underlay the brick surface; these were a brick plinth with two wooden posts. The plinth was quite substantial, 0.75m wide and 0.55m high. The two wooden retaining posts identified appeared to be quite substantial. One was identified to the southwest of the plinth visible in the side of the robber cut. Set into the top of the plinth was a wooden base plate into which an iron socket had been fixed. The brick surface that surrounded Structure 2 was laid overlying the plinth, leaving the baseplate and iron socket visible. The second wooden post was identified to the northeast of the plinth and socket, seen to be poking up through the brick surface. This structure was clearly designed for, and capable of, supporting a significant weight and allowing circular movement around the iron socket. The rectangular pit to the east of the plinth appears to be a robber cut excavated through the brick surface,

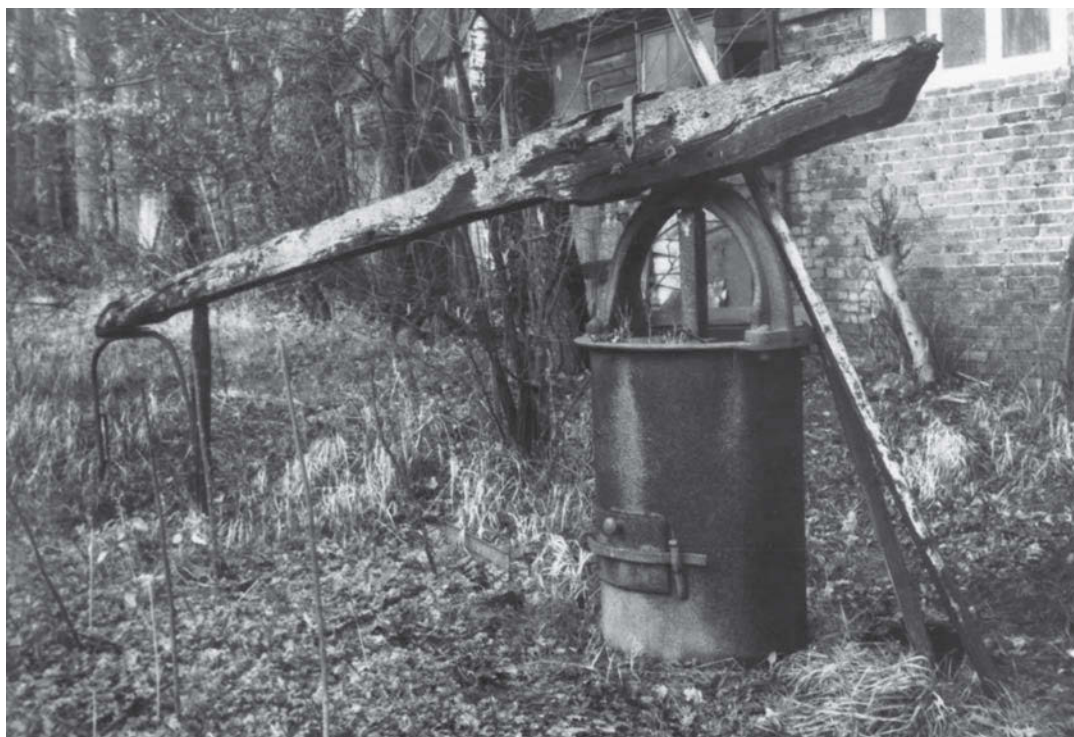
Fig. 8. Photograph of the horse-driven pug-mill, showing the horse harnessing at the end of the wooden arm; taken at the East Grinstead Pottery works (courtesy of East Grinstead Museum Collection).

It is tempting to suggest that the pug-mill shown in the photograph (Fig. 8) is related to the robbed-out mechanism with the iron socket. The socket could have been used to lock the pug-mill barrel to the ground. The proximity of these two features does not fit well with the description of puddled clay being moved 'by wheelbarrow' from one structure to another.

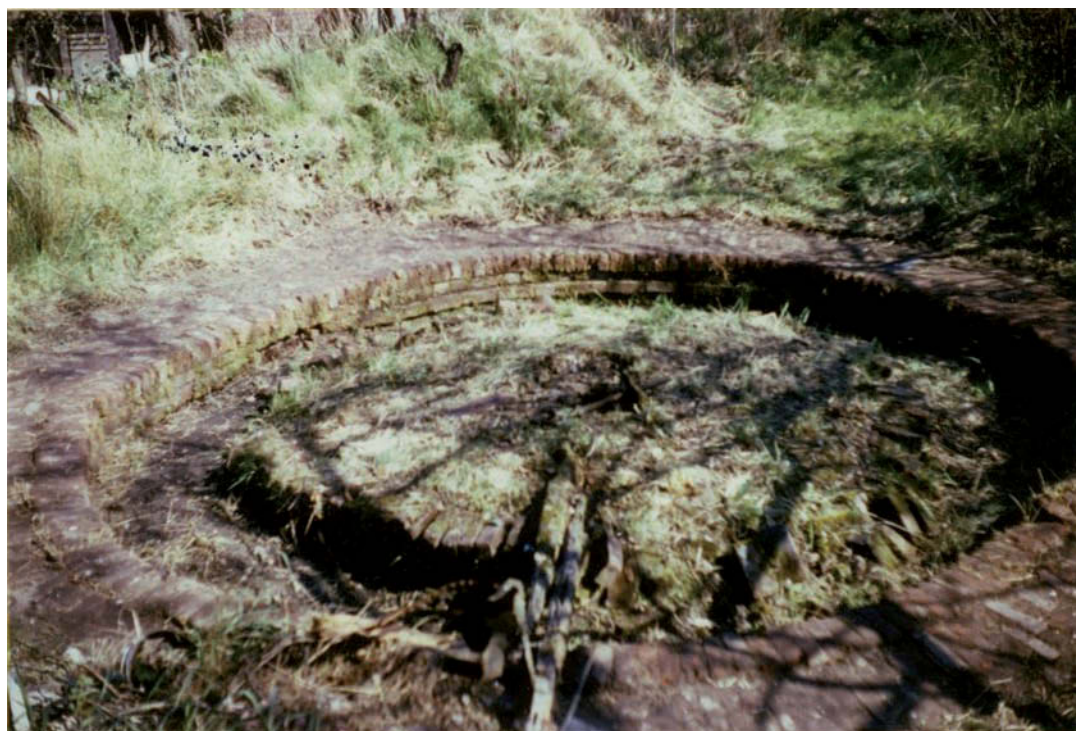
Fig. 9. Photograph of the 'horse gin' from the East Grinstead Pottery showing the inner and outer brick structures around a trough that held unprocessed clay (courtesy of East Grinstead Museum Collection).

was identified on the site, and the photograph gives little insight into its location. The size of the bricks in the photograph suggest that it was in the order of 5.00m in diameter.

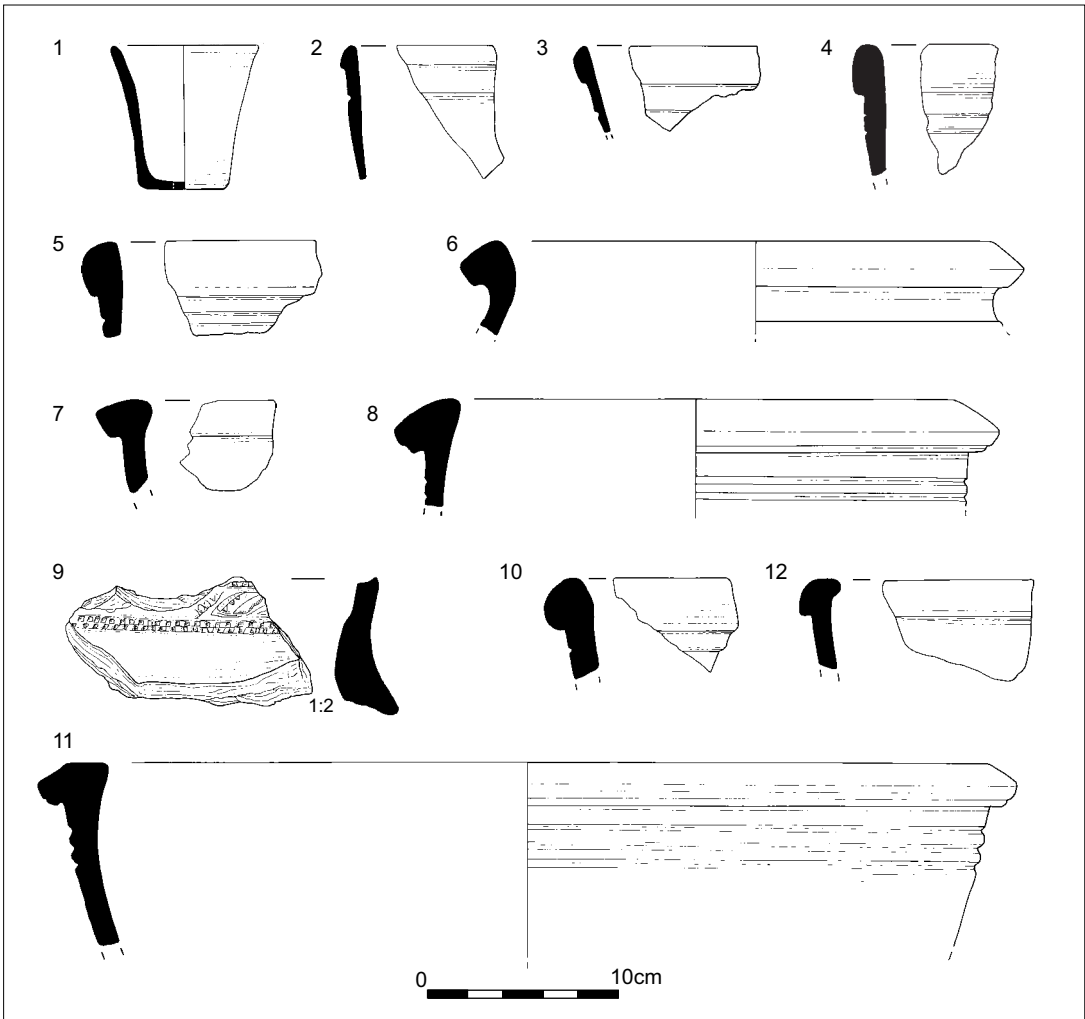
Fig. 10. Selected pottery drawings.

The most complete flowerpots from the site are all small with simple rims. A complete, slightly overfired example (178g) in Fabric 2 is 70mm tall, with base diameter of 48mm and rim diameter of 75mm (Fig. 10, no. 1). A similar example, measuring 75mm tall was uncovered from unstratified deposits. Larger examples are present with rim diameters of 160mm, 200mm and 280mm. These larger vessels typically have thickened rims with either a slightly flattened or convex outer profile (Fig. 10, nos 2–5 and Fig. 11). Although the

types, slightly triangular or square (Fig. 10, nos 6 and 7). The all-over glazed jar has a squared club rim similar to those found on the large bowls, though the body angle shows it to be a jar (Fig. 10, no. 8). At least some vessels appear to have had horizontal handles to aid lifting. Decoration is rare, but where apparent usually consists of one, two or three incised horizontal lines on the vessel exterior. One example has a rouletted band around the unglazed exterior.

These are not as common as large jars, although this may be due in part to the difficulty of distinguishing between the two forms, a task virtually impossible for body sherds and often difficult from small-rim sherds. The rim forms are similar to those of the large jars in being typically squared club types, though one was recovered with a convex-profile thickened type, similar to the flower pots, from an internally glazed vessel (Fig. 10, no. 10). The more typical rim form has a slight internal thickening (Fig. 10, no. 11). Although the rim profile of this internally glazed vessel is similar to that of some of the large jars (Fig. 10, no. 8), the angle of the body differentiates them. As with the large jars, some of these bowls appear to have had horizontal handles, and most are internally glazed. Decoration, consisting of incised lines (Fig. 10, no. 11) and occasionally rouletting (Fig. 10, no. 9), is the same as noted for the large jars.

A single internally glazed F2 dish with thickened 'hammer-head' type rim was recovered (Fig. 10, no. 12). The lack of such vessels may again be because industrialised wares were flooding the market for this vessel type by this time.

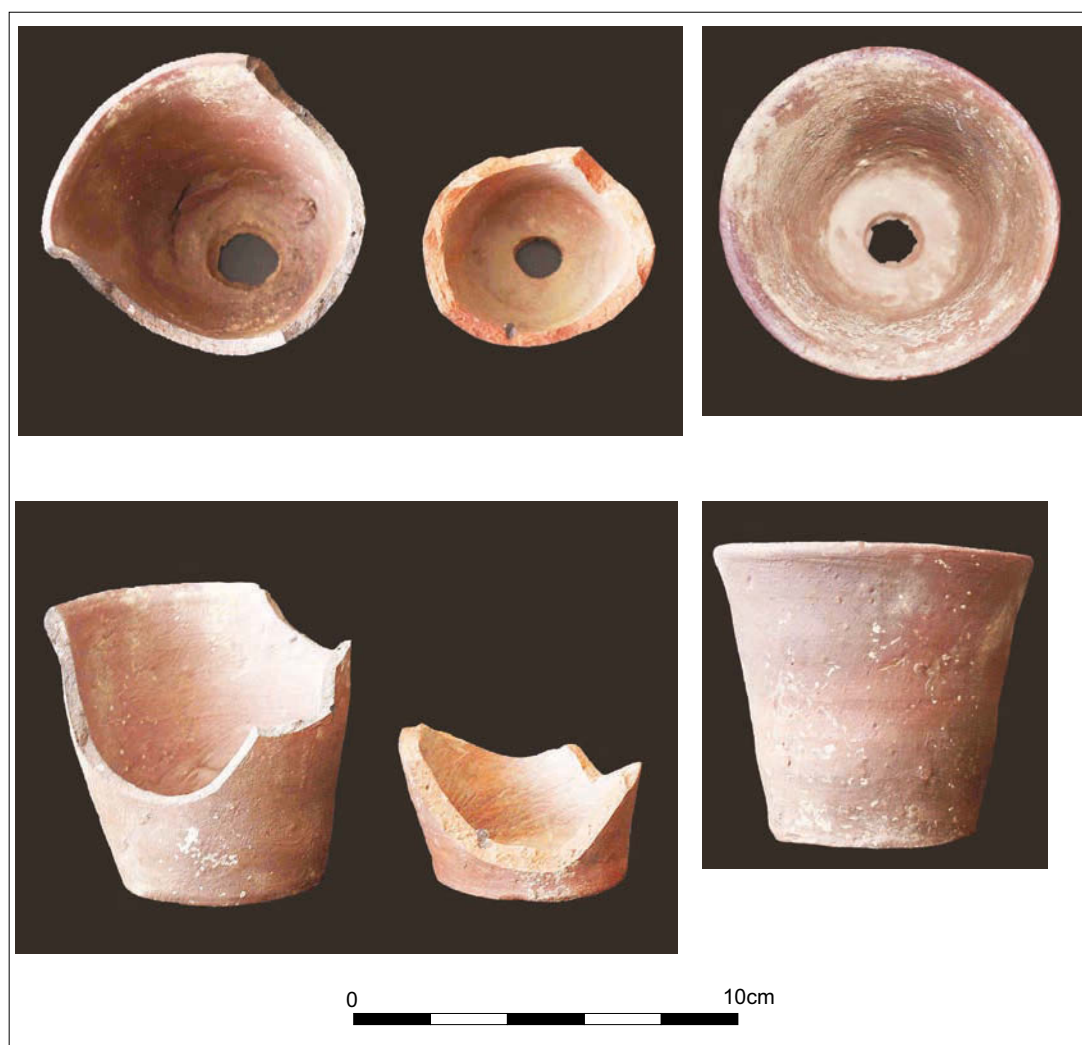
Fig. 11. Selected pottery photographs.
