# ◆ Uppark revealed

## A REINTERPRETATION OF THE HISTORY OF THE HOUSE AND GARDENS IN THE LIGHT OF EVIDENCE REVEALED DURING RESTORATION IN 1989–94 FOLLOWING DAMAGE BY FIRE

By Fred Aldsworth

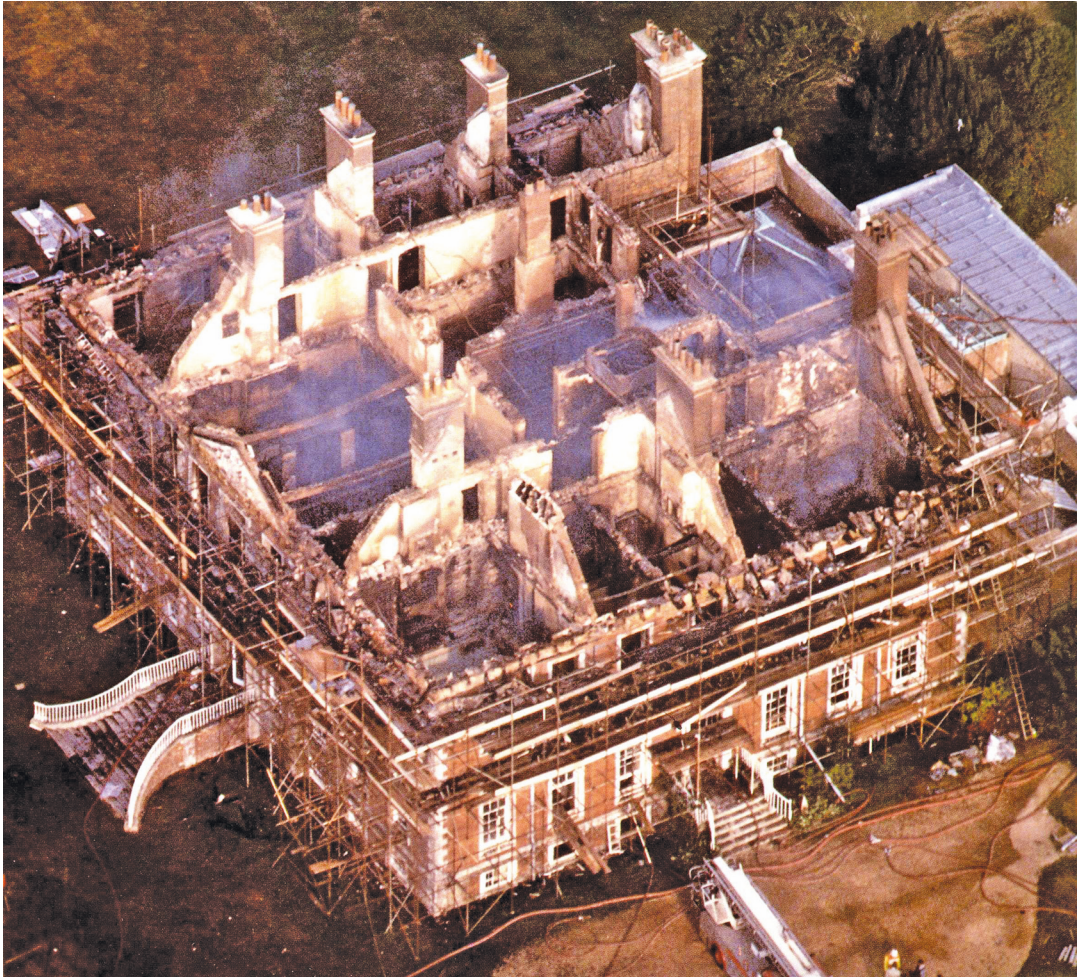
Fig. 1. The house after the fire in August 1989. Photograph by courtesy of Portsmouth Publishing and Printing Ltd.

was damaged by heat, smoke, and water penetration (Fig. 1).

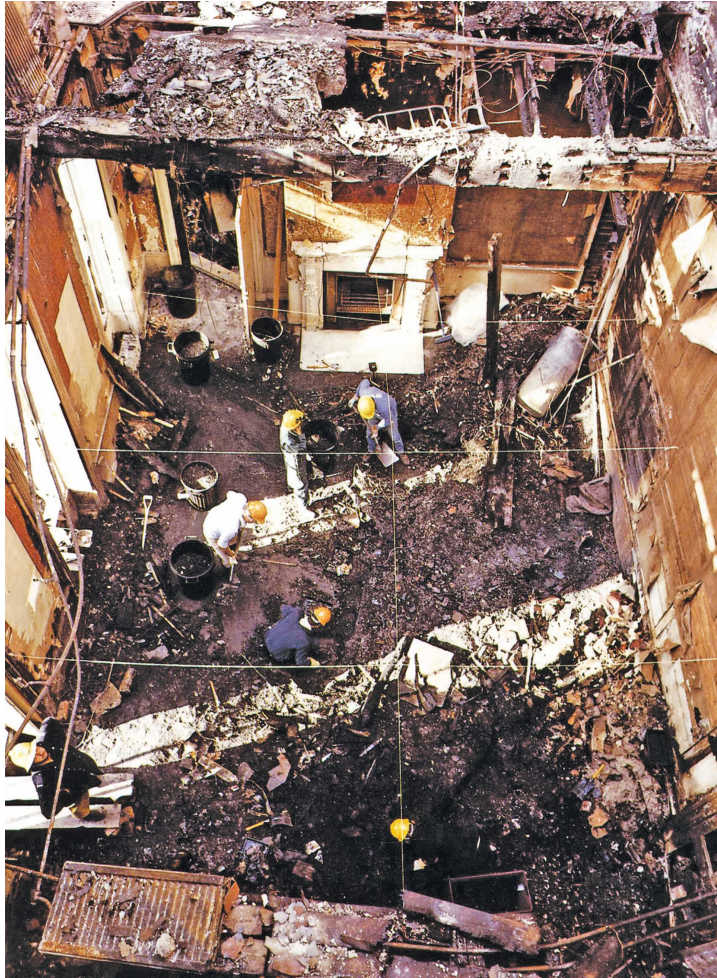
Fig. 2. Salvage excavations in the Red Drawing Room, after the fire. Note the string grid at ceiling level which enabled finds to be located within the space.

The decision to restore Uppark, a Grade I Listed building, not to its original form of c. 1690 but to its arrangement immediately prior to the fire, presented the National Trust with a considerable number of difficulties, not the least of which was the almost complete absence of accurate and detailed records of the building at any time during its life.<sup>1</sup> The Trust immediately adopted an 'archaeological' approach which was to rely heavily on the evidence surviving in the building or contained in the salvaged debris. Structural timbers, surviving joinery and floors were carefully recorded and removed, and the debris was excavated and sieved to recover even the smallest pieces of decorative plaster and metalwork which might aid restoration (Fig. 2).

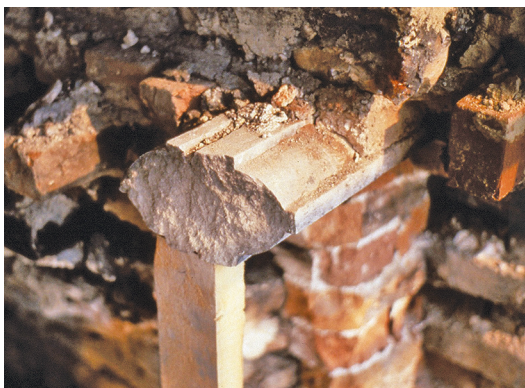
Fig. 8. A reused stone window mullion from another building, incorporated in the original masonry.

When first constructed, some of the internal walls of the house incorporated a number of reused pieces of building stone, some of which had been worked, and either at that time or at a later date several pieces of timber and joinery were incorporated into the walls (see SR 9). These all appear to derive from another building or several buildings in the vicinity,

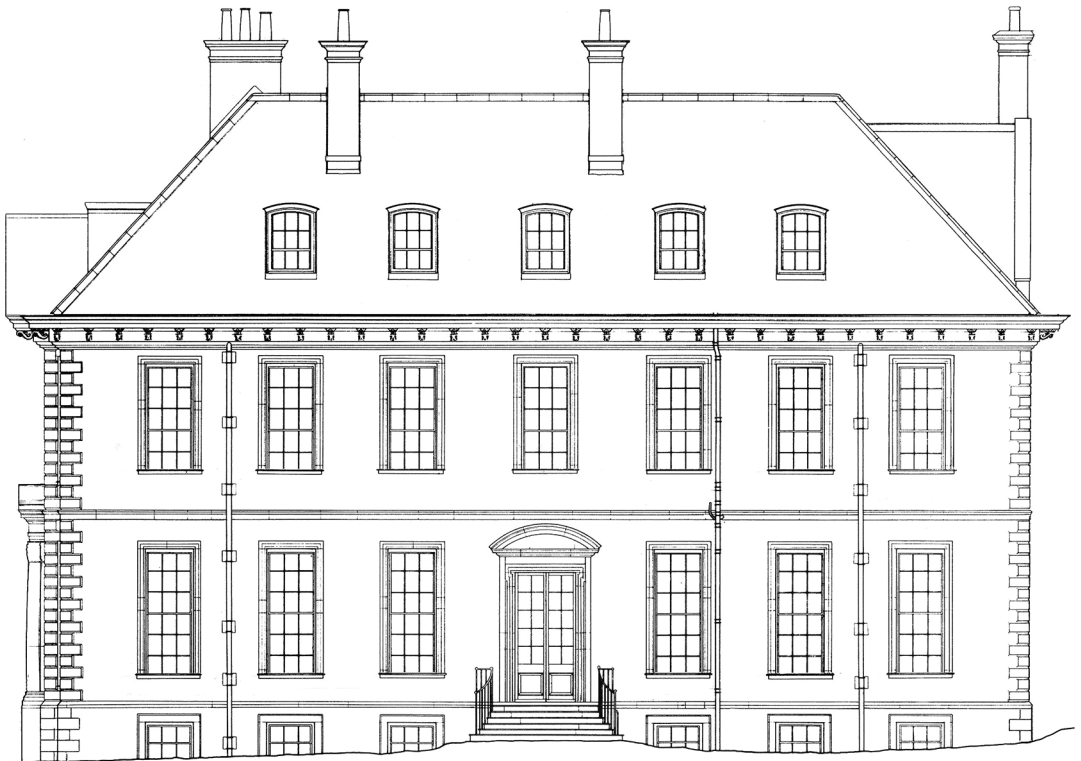
Fig. 16. The original arrangement of the east elevation, as reconstructed from the available evidence.

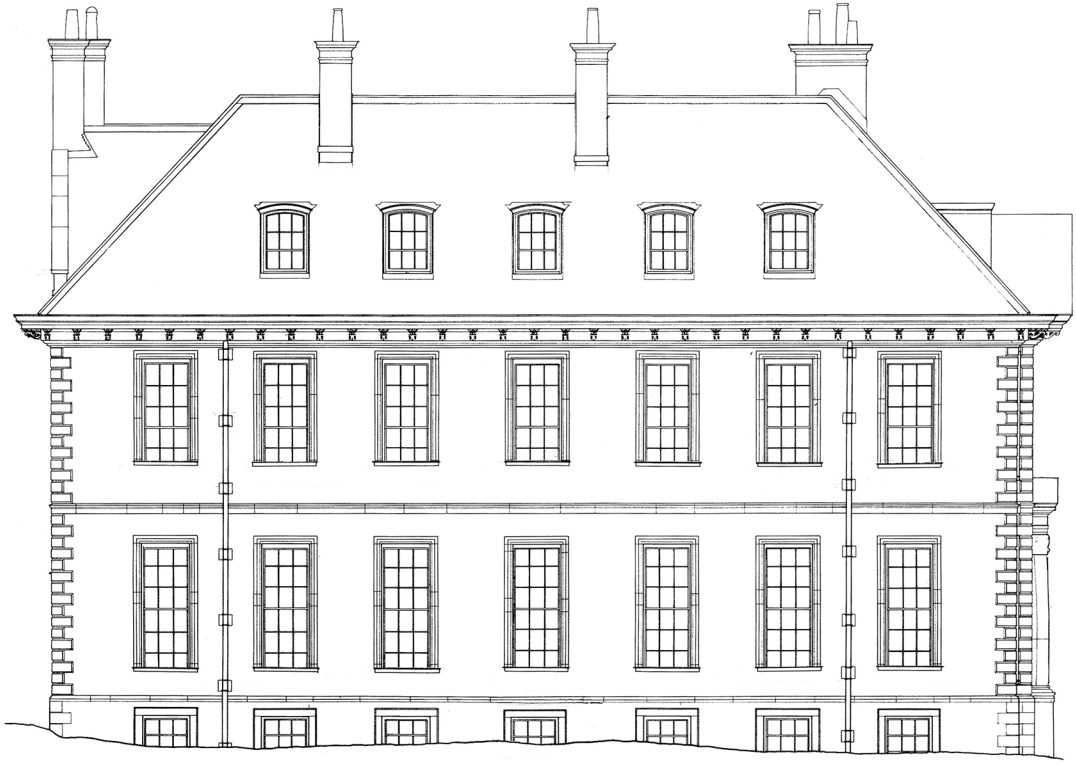
Fig. 17. The original arrangement of the west elevation, as reconstructed from the available evidence.

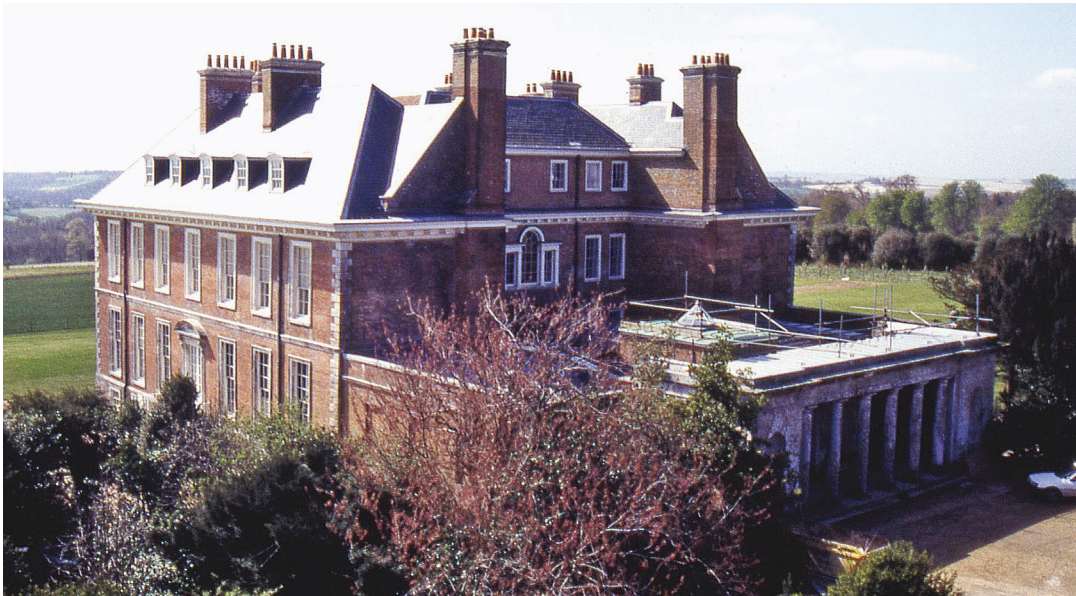
Fig. 18. The house from the northeast, after restoration, with the service wing and Repton portico in the foreground.

The original arrangement of the north elevation is more problematical as this side has been altered and added to more than the other elevations (Figs 18 and 19). The addition of the Fetherstonhaugh service wing shortly after 1746 (Period 2) and the subsequent addition of the Repton portico and entrance (Period 3) have not only obscured or removed architectural features, but they have also made it difficult to reconstruct original ground levels on this side of the house. The evidence of the external and internal masonry, which was partially exposed by the fire damage (Figs 19 and 20), revealed that there were fireplaces in the centre of the north wall of the Stairs Hall (Room 9) at both basement and at first-floor levels, and the flues were carried up to a chimney stack shown on Kip's engraving (Figs 9 and 21, and *SRs* 1.8 and 3.6). There were also windows on either side of the flue which served the Stairs Hall.

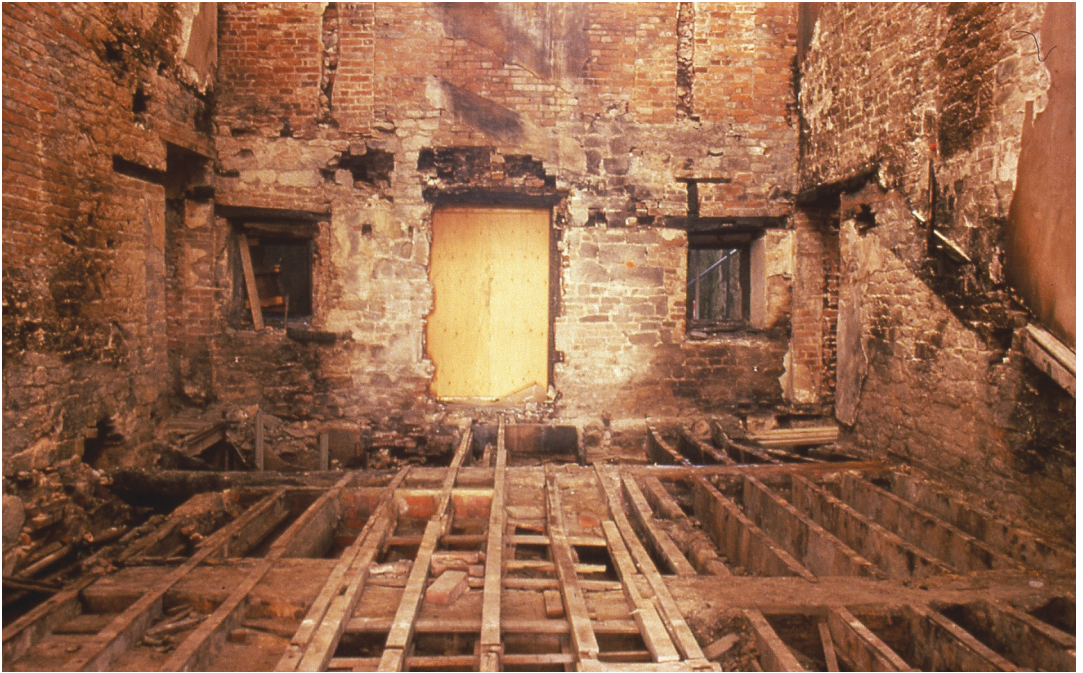
Fig. 20. The north wall of the stairs hall at ground- and first-floor levels, after the fire and the removal of what survived of the staircase, the floorboards and some other joinery.

The earlier arrangement of windows in the north wall of the Stairs Hall (Room 9) was revealed during restoration (*Figs 20 and 21*) and seems to suggest that the arrangement of the staircase may have been modified in this period. This means that the staircase that existed in 1989 was probably not the original (*SRs 1.8 and 3.6*). In its refurbished form the Stairs Hall included the decorative plaster

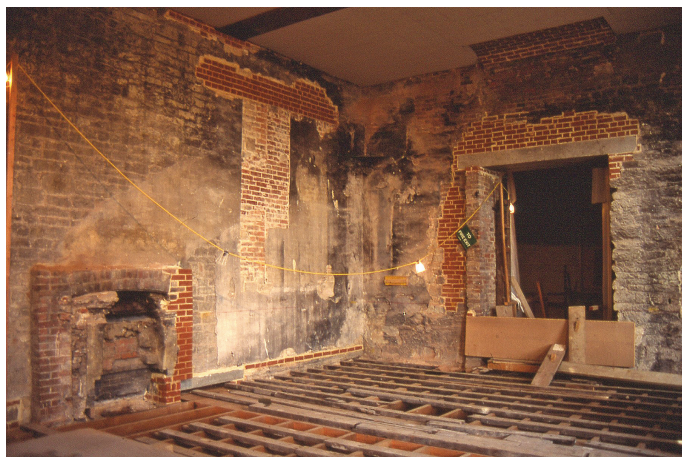
Fig. 23. The Dining Room, looking northwest after the fire and following the removal of the surviving panelling and floorboards. Note the blocked window opening to the right of the fireplace.

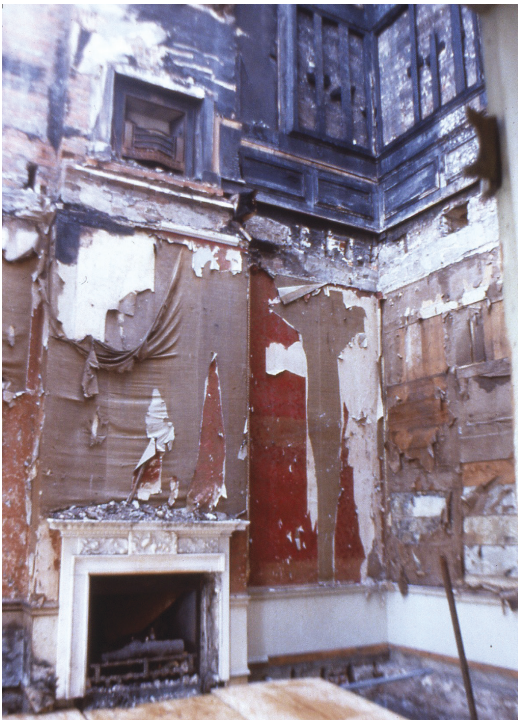
Fig. 27. The Small Drawing Room and part of the bolection panelling in the Prince Regent's Bedroom above it, after the fire.

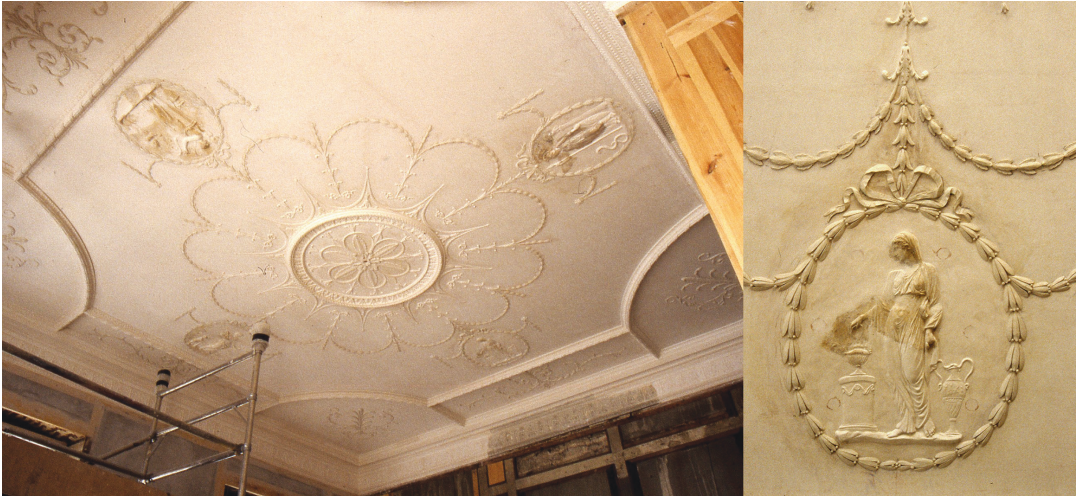
Fig. 30. The Little Parlour ceiling, during restoration, and a detail of one of the four medallions which may have originated in the Dining Room.

There is just a possibility that the four oval plaster medallions now in the ceiling of the Little Parlour (Room 3; Fig. 30) originated in the oval niches of the oak panelling, as close examination during repair indicated that they were later insertions into the existing decoration.

enrichments into which four oval plaster plaques, bearing scenes from Greek mythology, were inserted (Fig. 30). Evidence was found during restoration to indicate that the plaques did not form part of the original design but were later insertions. One possibility is that the plaques had originally been located in the four oval niches in the Dining Room (Room 5) and were reused here at a later date. The room was otherwise finished with painted wallpaper above a plain painted dado boarding (SR 6.45).

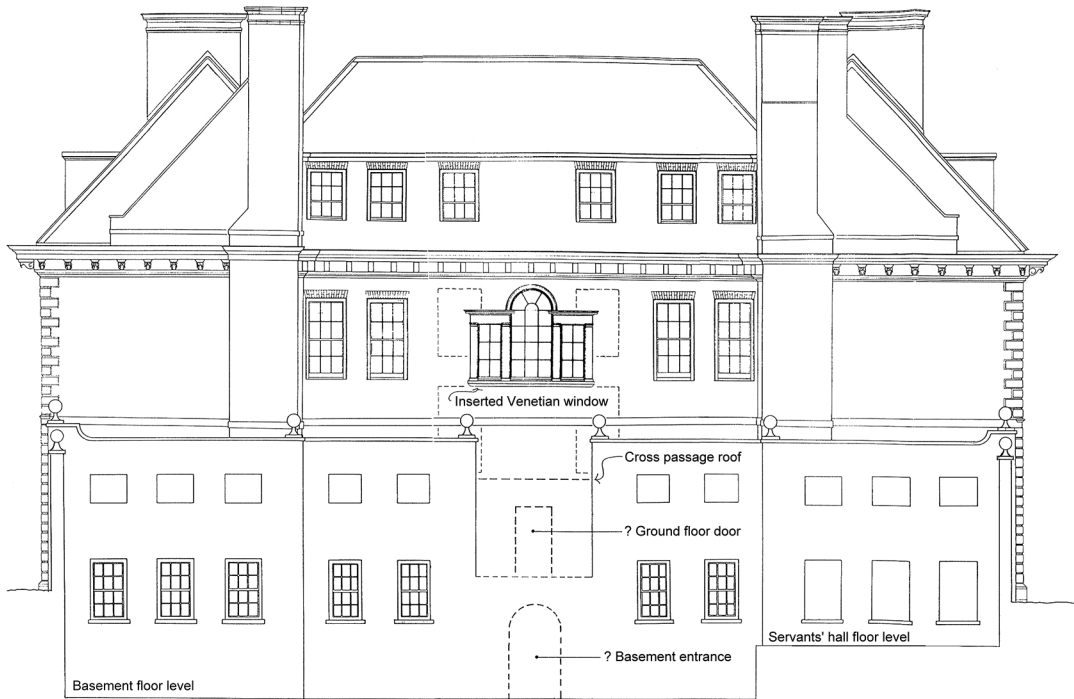
Fig. 40. Reconstruction of the north elevation of the house in 1774, based on the available evidence.

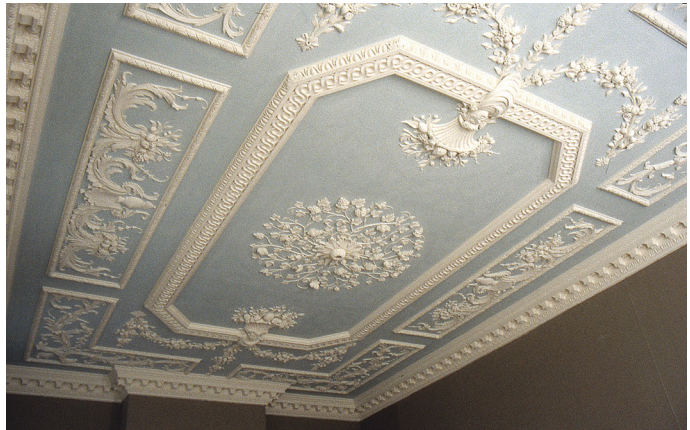
Fig. 43. The restored ceiling in the Red Drawing Room, prior to gilding.

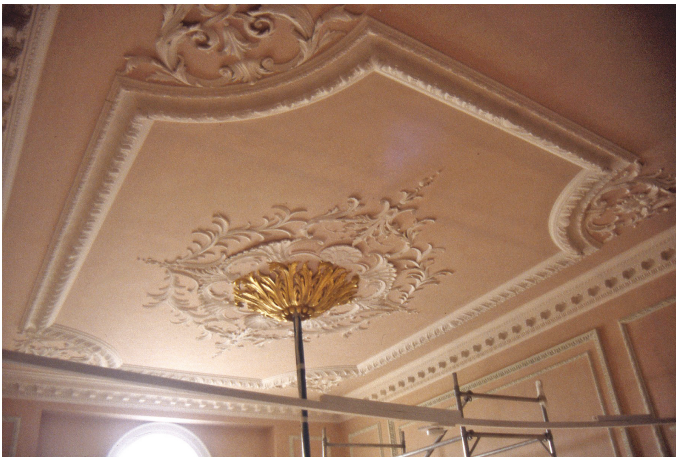
Fig. 45. The restored ceiling in the Stairs Hall.

ceiling, plastered panels and busts at first-floor level, and panelling below, which was later modified to accommodate the new Repton entrance. The former fireplace under the staircase was probably abandoned and small windows were inserted where previously none had previously existed.

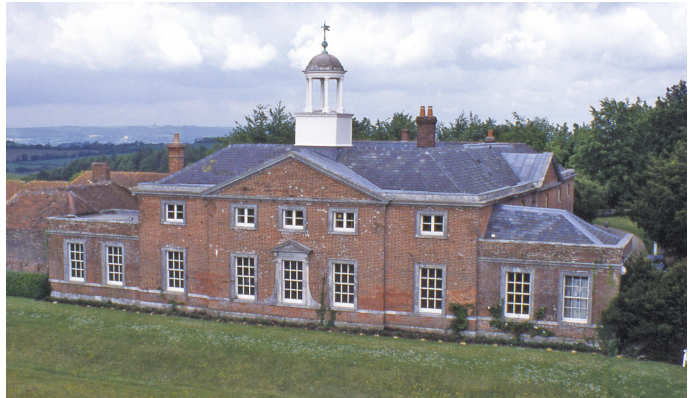
Fig. 50. The Stables from the southeast.

first documentary evidence for building works. In 1723–5 he had new stables built ‘according to a Plan or Model drawn by Mr Jenner’ almost certainly John Jenner, the London bricklayer and builder who was responsible in 1727 for alterations to the earl’s London house in St. James Square (Colvin 1995, 544–5).<sup>10</sup>

The stables to Jenner’s design were presumably one of the two buildings shown on Tillemans’s paintings of c. 1730 (Figs 34 and 35) and James Crow’s plan of 1747 (Fig. 37; see Period 2). They certainly replaced, rather than were formed by additions to the two original outbuildings shown on Kip’s engraving, and foundations of both the new buildings were encountered during ground disturbances (for relative positions, see Fig. 32; Fig. 36 and SR 8.2 Fig. 4).

now the Orangery (Figs 49, 50 and 52). The new service wing was linked to the outbuildings and to the northeast was the walled garden. The principal approach to the house remained from the east, with the existing drive now probably enhanced by a turning circle for carriages.

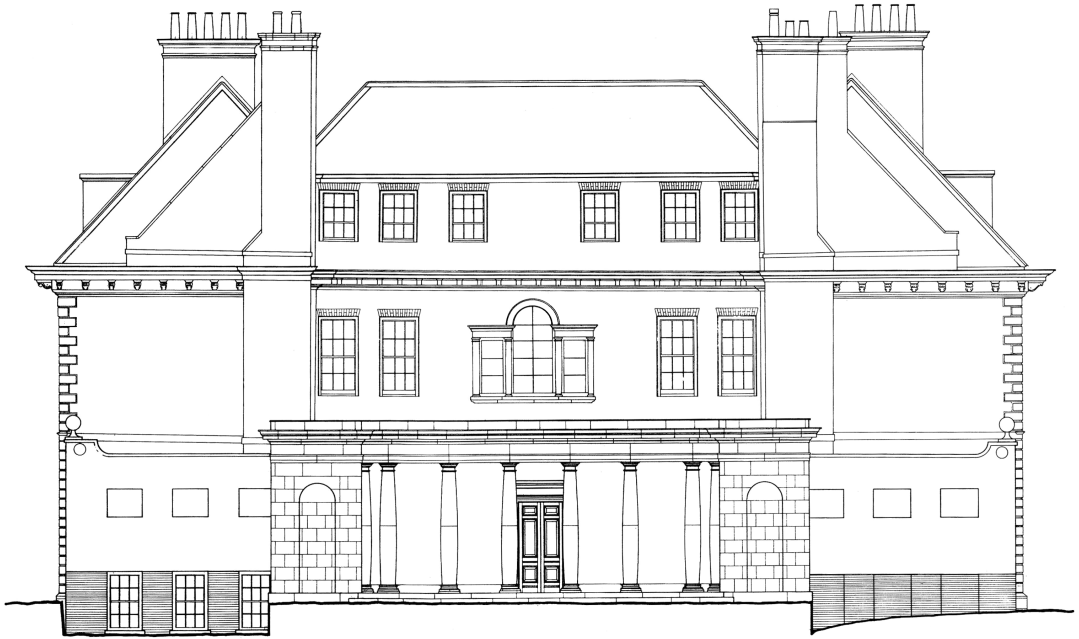
Fig. 54. The north elevation, showing the Repton portico.

Sir Harry adopted some of Repton's recommendations and added a portico to the north elevation, but this was in a much reduced form from what it would have been if the largest of Repton's three designs had been adopted, rather than the smallest (Figs 53–55). Neither did it form a link with the outbuildings, as Repton had envisaged in his view across a new entrance quadrangle which had been produced 'to show how the same sort of skreen which is proposed to the House, may be continued on each side to connect the house with the detached wings.'
