# ◆ Training for war

## PLANS OF THE THREE GREAT WAR DIVISIONAL CAMPS IN SUSSEX

By Luke Barber and  
Justin Russell

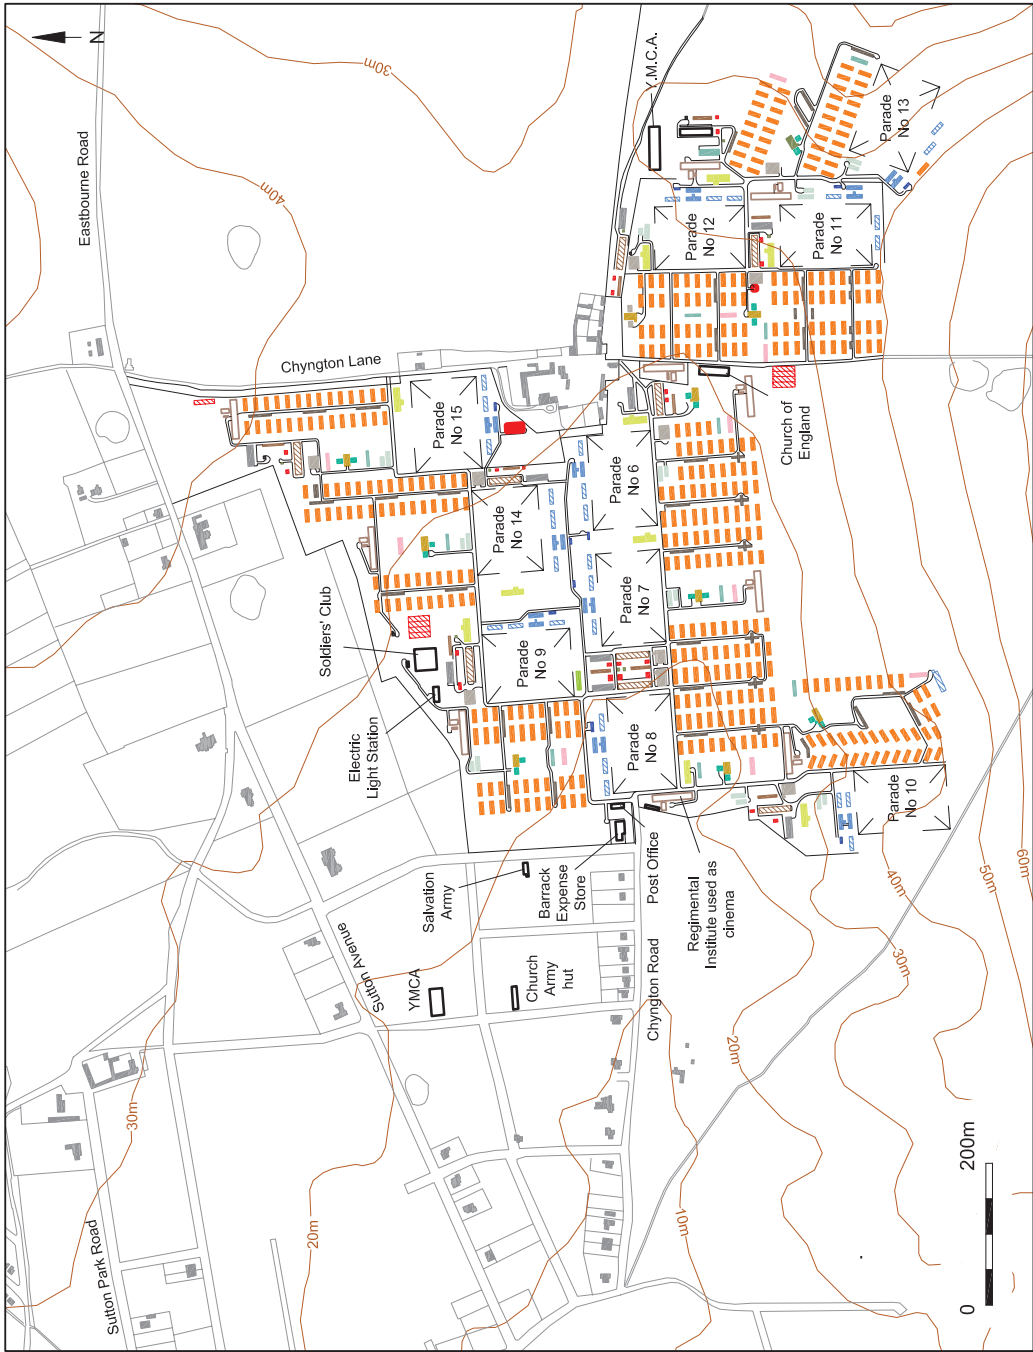
Fig. 4. Plan of Seaford's South Camp (for key, see Fig. 2).

To what extent the tented area at Seaford's South Camp (as well as the other camps) remained in use after the hutted camp was built is uncertain. The 1916 South Camp plan does not depict tents to the west of the hutted area but does clearly show some of the more permanent buildings in this area such as the YMCA, Salvation Army and Church Army huts (to the west of the camp area depicted on Fig. 4). Several postcards depict the large area of original tented accommodation as still standing when the hutted camp to the east was nearing completion (Fig. 7). It may be that these photographs were all taken early in 1915 when the huts were nearly finished but the tents had yet to be taken down. Alternatively the tents may have remained to provide additional summer accommodation but, being so temporary, were not added to the 1916 plan.

and slag from burning coal in the cookhouses and huts, as well as from the incinerators for refuse, provided another source of hardcore for surfacing both roads and open yards. At Seaford, field survey has found many of the camp roads around Parade No. 13 (Fig. 4) covered in this slag. Pre-war guidance on 'military hygiene' required refuse to be incinerated before being dumped outside the camp's perimeter (initial survey work by the authors suggests disused quarries were often used where available).<sup>19</sup> Although all three camps appear to have had incinerators, only a small proportion of the ceramics and glass in refuse from Seaford's South Camp shows signs of burning. Guidance which may have been enforceable on a small professional army was unenforceable in a civilian army of considerably larger size.

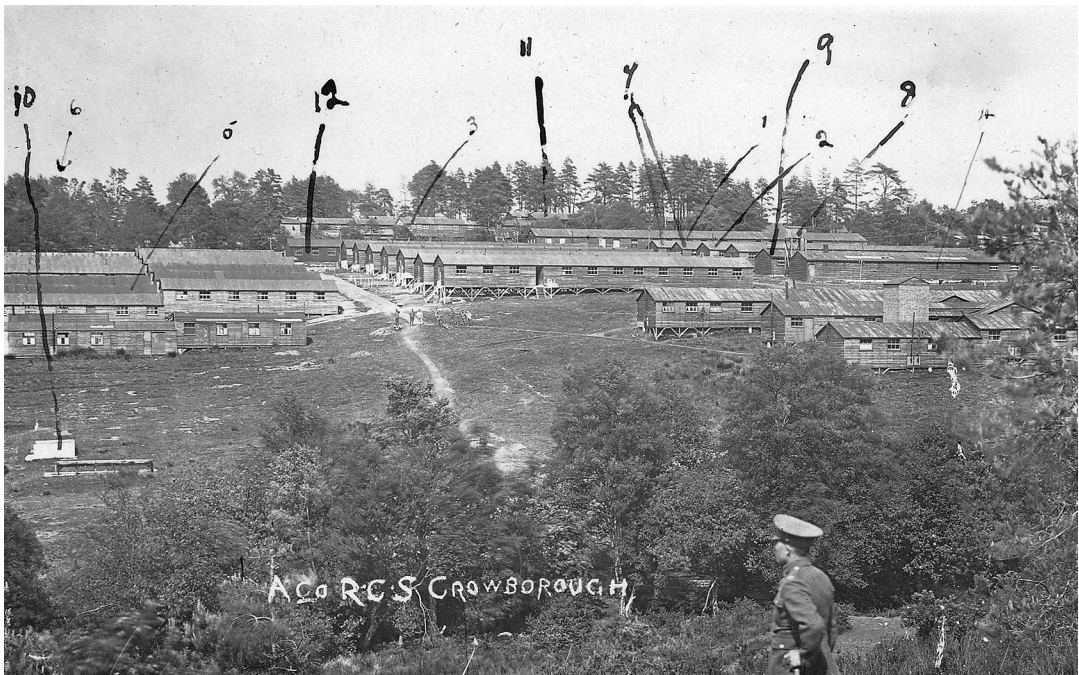
Fig. 8. View of some of the huts at Crowborough. Note the double-length huts (central) and close-set standard huts (left) (Luke Barber's collection).

Crowborough's parade grounds have notably fewer accommodation huts. However, as depicted on the plan (Fig. 5), the huts are notably longer than those at the other camps and this may have made up the needed accommodation space on a somewhat restricted site. The presence of these abnormally long huts and the close-set nature of the standard type are clearly shown on contemporary views (Figs 7 and 8). The huts were usually prefabricated and set on level platforms provided by brick/concrete piers, timber piles and/or terracing, depending on the slope. In one area of Seaford's South Camp a double row of huts had a distinctive herringbone layout, again to counter the slope in the area (Fig. 5, Parade No. 10).<sup>11</sup> These huts were not sited in the more usual position on the south of Parade No.

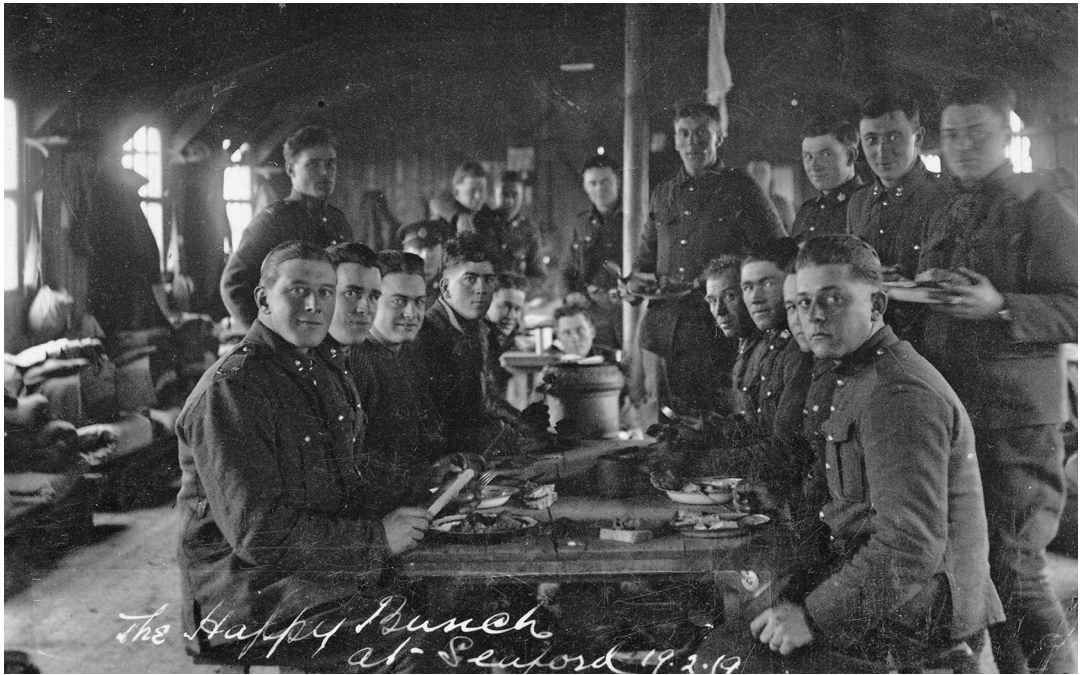
Fig. 9. View of Canadian troops dining in their hut at Seaford while waiting to go home, February 1919. Note the stove beyond the table and folded-up beds by left wall (Seaford Museum, John Eastlake/Jim Marsh Collection).

Each battalion had a cookhouse and two 'wash-ups', located beside or among the barrack huts. Crowborough varies again in that the cookhouses tended to be situated near the top of the slopes, adjacent to the inner perimeter track, presumably for the ease of supply. The original Armstrong designs for divisional camps included large central communal eating halls. These are apparently missing from the three camp plans, probably as a result of Kitchener's cuts to the camp building programme implemented in the winter of 1914/15.<sup>15</sup> It appears that the barrack huts also acted as the men's dining rooms, as certainly borne out by contemporary images (Fig. 9). The camps were
