◆ West Chiltington church

STRUCTURE AND WALL PAINTINGS

By Robin Milner-Gulland,
John F. Potter and
Pamela Tudor-Craig

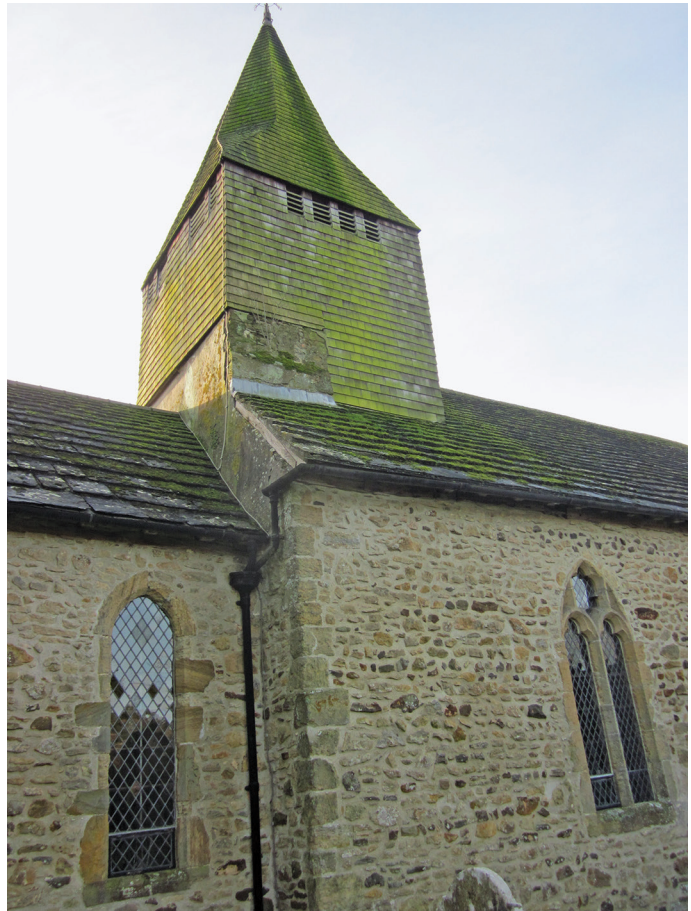
Fig. 3. View of West Chiltington church from the north-east: the central tower and spire are visible. The masonry on the east side once supported an earlier bell-turret. The north-east nave quoin created in Pulborough Stone is also visible and the slightly more pronounced, centrally placed, stones are set in Anglo-Saxon style.

The church today consists of a nave and chancel onto which have been constructed both a lean-to south aisle and a chantry chapel; these are connected, and together extend to the full church length (Fig. 2). Unusually, the church nave together with the chancel arch supports a central bell tower (perhaps originally a bell-cote), to which the wooden broach spire is believed to have been added in 1602. The masonry of the earlier, smaller, single-bell turret supports the east side of the later

North-east nave quoin (*see* Fig. 3): all discernible stones of Pulborough Stone; with stones 2, and possibly 10, **BVFR**, and stones 8, 9, and 12, **BVFL**.

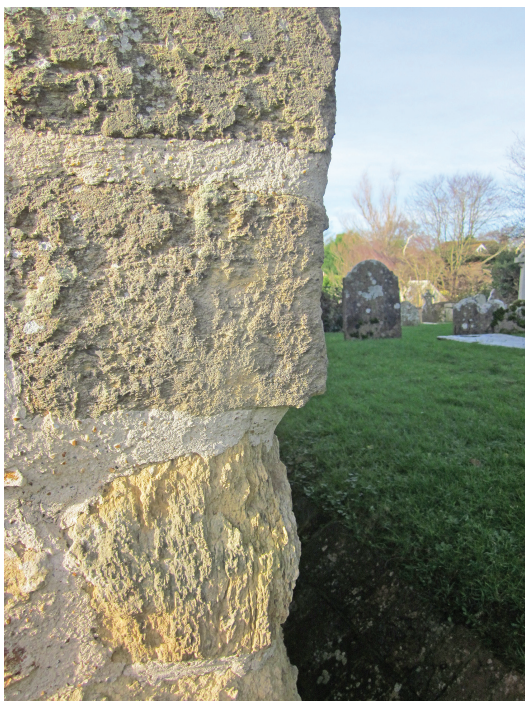
Fig. 5. Stones 4 (top only), 5, 6, and 7 of the north-east chancel quoin are of Pulborough Stone, here sufficiently enlarged to read something of their Anglo-Saxon orientations as **BVFL**, **BVFR** (the most obvious), **BH**, **BH**.

The north-east chancel quoin at West Chiltington clearly betrays its Anglo-Saxon origins (Fig. 5). The stones in the quoin rise from the brick gully at its foot as follows: Stone 1, Bedded Horizontally (**BH**) of Caen Stone; 2, **BH**, Caen Stone; Stone 3, **BH**, Caen Stone; Stone 4, Bedded Vertical with Face to the Left (**BVFL**), Pulborough Stone; Stone 5, Bedded Vertical with Face to the Right (**BVFR**), Pulborough Stone; Stone 6, **BH**, Pulborough Stone; Stone 7, **BH**, Pulborough Stone; Stone 8, **BVFL**, Pulborough Stone; Stone 9, **BH**, Pulborough Stone; Stone 10, orientation uncertain, Caen Stone; Stone 11, **BVFL**, Pulborough Stone;

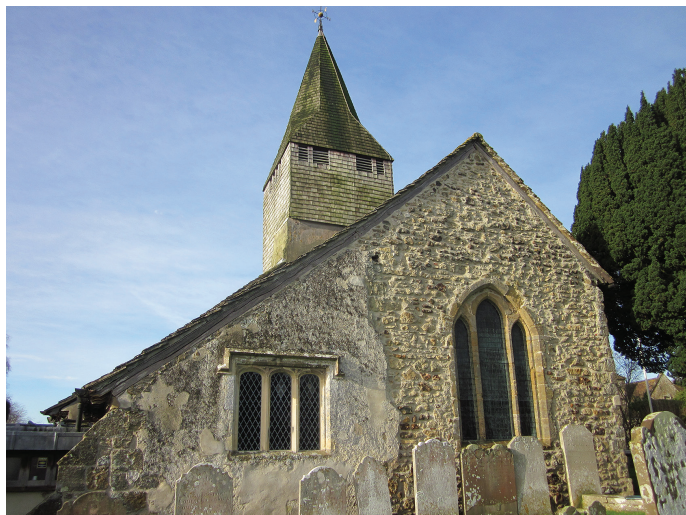
Fig. 6. The east face of the church is partially covered with render, largely removed to the north of the south-east chancel quoin (of which a few stones only are visible).

South-east chancel quoin (east face only visible): the quoin is variously covered in render (Fig. 6) with all obvious quoin stones of Pulborough Stone. The bedding orientation could be determined for the four stones apparent below the end of a sleeper timber beam of an earlier nave roof; they are placed in descending order **BVFR**, **BVFR**, **BVFR**, **BVFL**. There is rather more than two metres of render cover before the lowest, partially reset, quoin stones are perceptible.

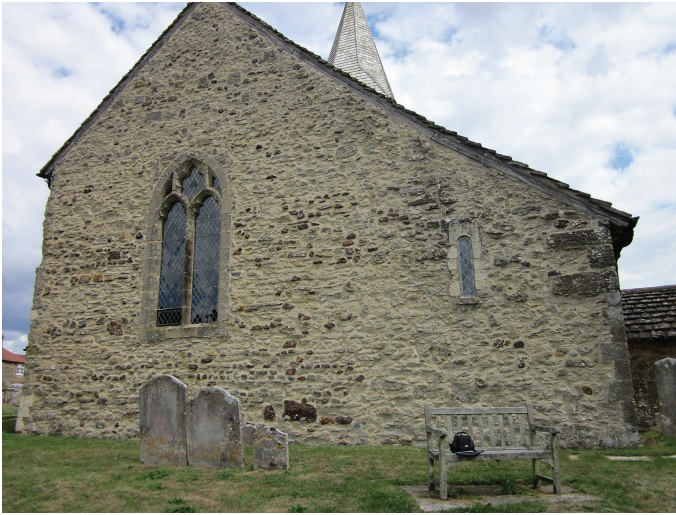
Fig. 7. The west faces of the nave and south aisle at West Chiltington. Only the top three quoin stones of the south-west nave quoin remain. The darker stones in the Hythe Beds walling are mainly of Folkestone iron-rich sandstone. The aisle west window is largely created in Caen Stone in Norman style, and the darker patch of iron-rich sandstones above and to the north of the window marks the position of the one-time gallery doorway.

South-west nave quoin (West face only visible): only the top three stones below the original roof line could be distinguished (Fig. 7); each is of Pulborough Stone. In ascending order they are placed **BH**, **Bedded Vertical** (direction uncertain) and **BVFR**.

The visible wall fabric seen in the north and west nave (Fig. 7), and north and east chancel walls is almost entirely constructed of a rubble of local, often bioturbated, Hythe Beds, which is softer than the Pulborough Stone. Up to 15 per cent. of the fabric consists of probably field-picked, irregular pieces of ironstone from higher horizons in the Lower Greensand such as the Folkestone Sands. This is particularly evident in the rebuilt east gable of the upper chancel wall. Disruption to the wall fabric may be observed particularly where 14th-century windows have been inserted.

The grey-green, Hythe Beds ragstone, which has weathered brown, on the exterior of the west end wall of the aisle (see Fig. 7), is somewhat different in appearance and age to the walls elsewhere. The south jamb of the blocked round arched external entry to the 17th-century galleries is still visible in this wall, to the north of the late Norman-period west window. It has been suggested (anonymously) that it is depicted, but as blocked, in a painting of 1892 by G. de Paris; we have not been able to locate this painting. Internally, there is now barely any evidence of the doorway. This single entry point may have been presumed to have also served the nave gallery. If it did, there is only very limited indication of the nave south arcade wall being

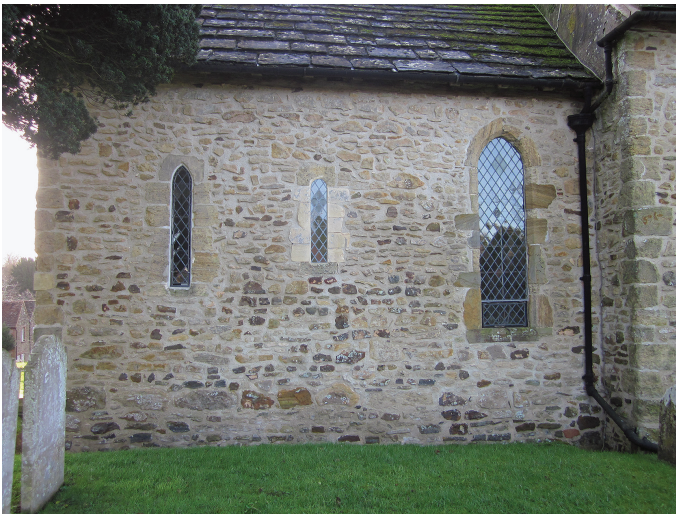
Fig. 8. On the north wall of the chancel there are three windows. The smaller central window is of Norman character and probably replaces an earlier Anglo-Saxon window. There are traces of this earlier window where Pulborough Stone remains in use, but most of the window is now built of Caen Stone.

been used extensively and probably much more recently, for repairs. There is a third, smaller window (Fig. 8) between the two 14th-century lancet style windows in the north chancel wall. This window is of Norman character, although it probably replaces an original Anglo-Saxon window which occupied the same position. In this, the sill and lintel stones are of Pulborough Stone (the single lintel stone being placed with its bedding vertically orientated but parallel to the wall surface) and the jambs are of Caen Stone (all **BH**). In the church interior, all the chancel windows have been repaired.

The chancel, together with the chantry chapel built alongside it, have a slight weep to the north (Fig. 8). In other churches displaying weep, the chancel typically exhibits evidence of having been rebuilt (much more rarely the nave is the component that has been rebuilt). It is suggested that weep occurs when, in order to maintain the use of the church as long as possible whilst the chancel (for instance) is being rebuilt, the nave would be sealed off. The new chancel rebuilding would then commence with its eastern extremity in order to delimit the size required. The subsequent building of the chancel's north and south walls to meet the nave may result in a weep. In the instance of West Chiltington this rebuilding of the chancel would have occurred during Anglo-Saxon times as shown by the stone emplacement in the quoins.

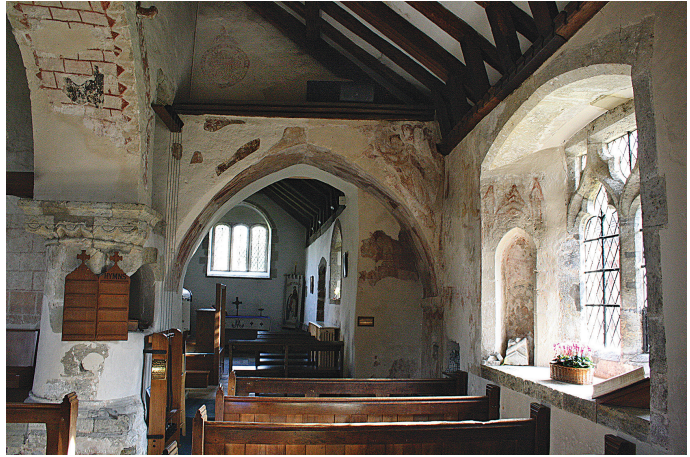
Fig. 11. E. end of S. aisle: Angel [A]; masonry pattern [B] on arch to nave (left); decorated niche in S. wall [E].

[A] Figs 11–14. This, though much of it is lost or hard to decipher, is a rare and remarkable example of mature Romanesque art. The 'polished' quality and good preservation of the surviving paintwork makes one suspect that it is largely or wholly in true fresco, alone among the church's paintings (only laboratory testing could definitely confirm this). With true fresco, painting proceeds day-by-day on freshly-applied plaster; the pigment, suspended in lime water, bonds permanently with the wet plaster in a chemical process called carbonation (secco painting, on dry plaster, is less stable but more flexible – sometimes painters worked in secco on a frescoed background). Fresco technique died out in England during the 12th century, and would not have been employed after c. 1200. The wall paintings related to the arch at the aisle's east end would have surrounded and embellished the aisle's altar. This arch was later broken through to the chapel. It is pointed, in 'Transitional' manner, which would have been very unlikely before 1150 (probably, rather later). Whatever the scenes originally depicted, we can clearly make out figures of prophets or other holy figures on either side of the arch (on the north side, one, possibly St Paul,

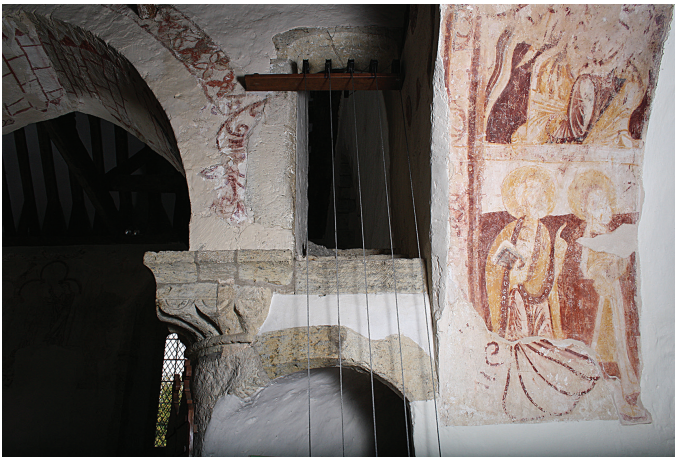
Fig. 14. E. end of nave arcade viewed from aisle, with patterning [B]; entrance to rood loft and squint; holy figures in soffit of aisle arch [A]; below, indeterminate lines [?E].

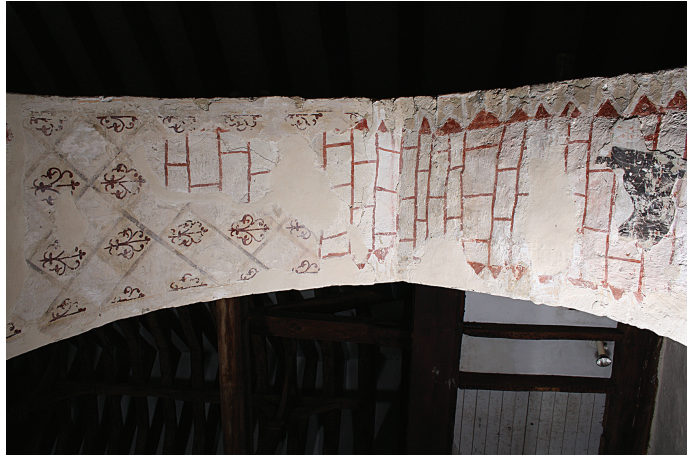
Fig. 15. Soffit of E. arch of S. nave wall, with masonry pattern [B] overlaid with later patterning [E].

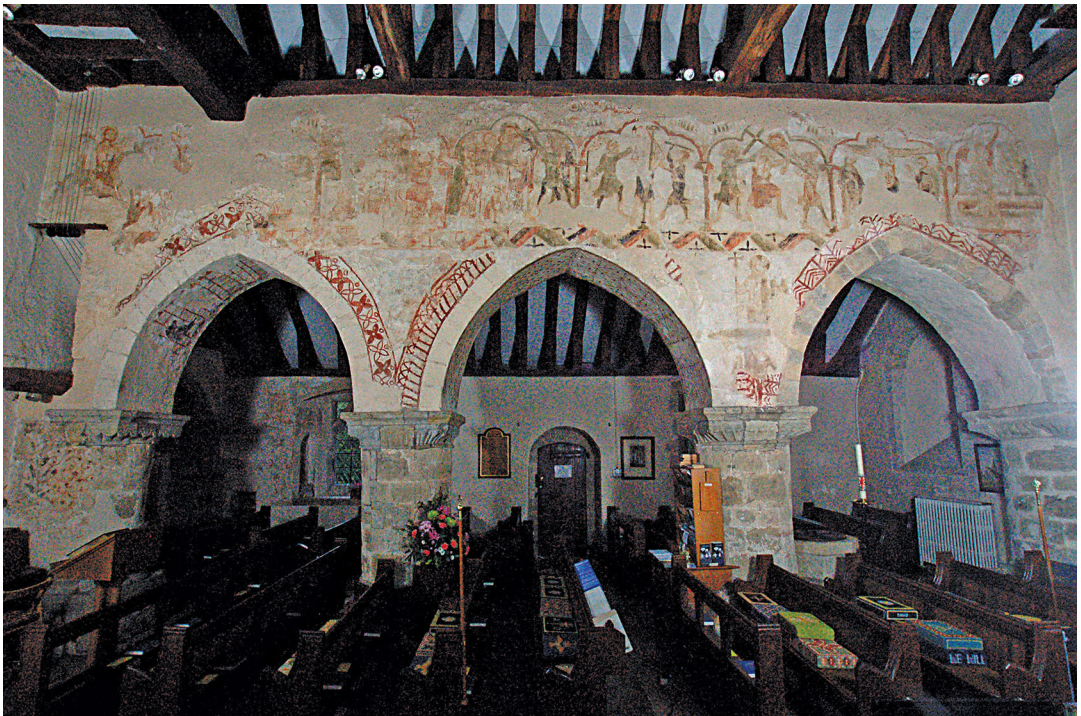
Fig. 20. Nave S. wall arcade with Passion cycle [D] above, superimposed on pattering [B]; foliage design [E] to left.

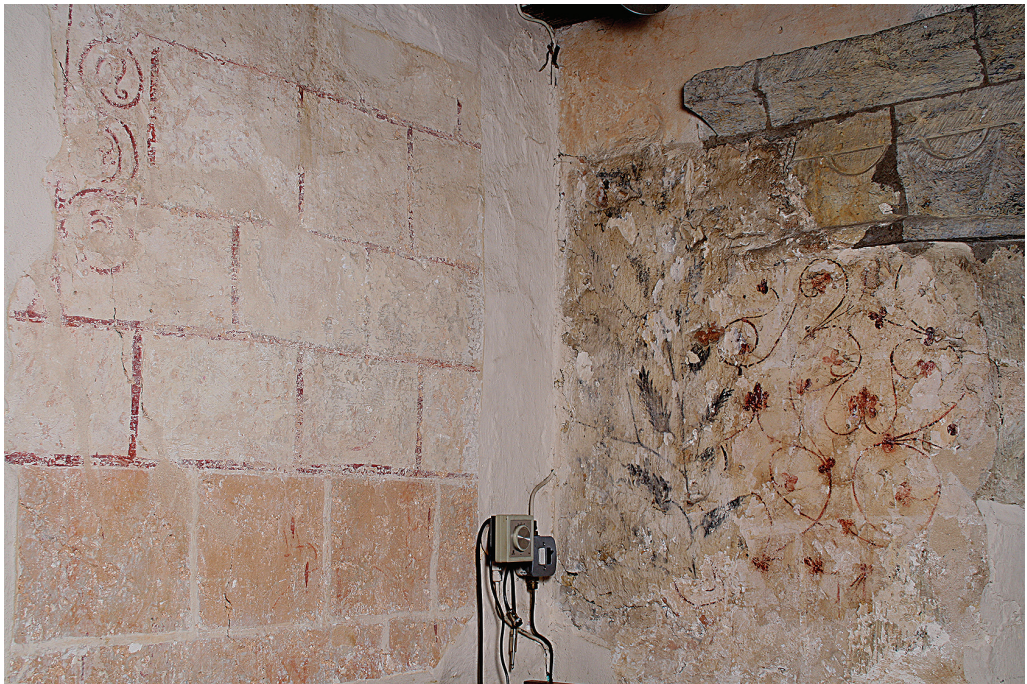
Fig. 24. Nave S. wall and part of chancel arch wall, with masonry pattern and foliage scrollwork [E].
