# ◆ An archaeological investigation of a Roman villa in the parish of Elsted with Treyford cum Didling, West Sussex

By Jonathan Dicks

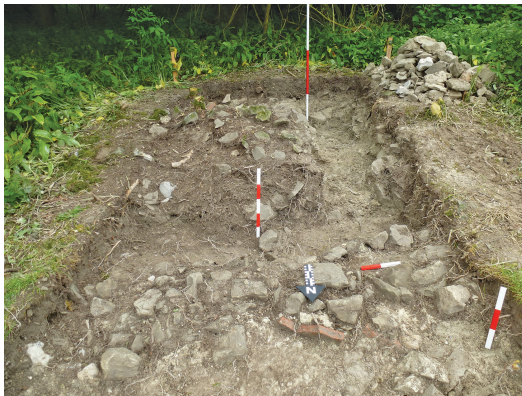
Fig. 2. View of trench A looking south. Scale: 200mm; 300mm; 500mm; 2m.

The random nature of the tiles and stones did not suggest any form of structure and probably represents the dumping at the edge of the field of material collected by farmers over time (Fig. 2). The bank at the southern end of the trench, just in the wooded area and originally thought to be a wall, was possibly an old boundary.

Trench A was excavated to a depth of 0.6m without finding any *in situ* archaeology. There were, however, large amounts of Upper Greensand stone blocks and large flints which could have been used as building material and may have come from a demolished building. Additionally, there were numerous large ceramic tiles with several examples of the different standard sizes of Roman brick commonly used in hypocausts, but which could also have been used in ordinary walling.

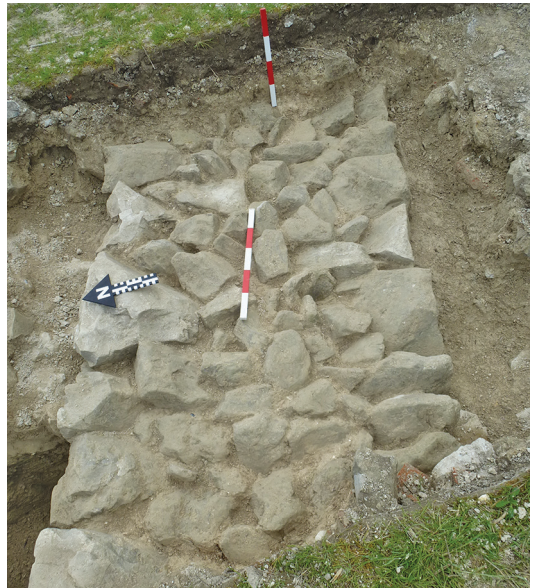
Fig. 4. Wall in trench B [201]. Scale: 400mm; 500mm.

but time did not allow for it to be fully excavated. It was constructed from large, roughly 280mm by 300mm square Upper Greensand mortared stone blocks and excavated to a depth of six courses (Fig. 4).

The wall in trench B was constructed from blocks of malmstone (a local form of the Upper Greensand), a grey, fine-grained calcareous siltstone. Amongst the demolition rubble within the trench were many more malmstone blocks, as well as Horsham Stone roof tiles. Horsham Stone is a calcareous, flaggy sandstone (Birch 2006) and was used extensively during the Roman period in Sussex and Hampshire for roofing. Several of the malmstone blocks had been shaped and the chisel marks were still evident (Fig. 9). Their shape suggested that they may have been used to form an arch, or part of a barrel-vaulted roof.

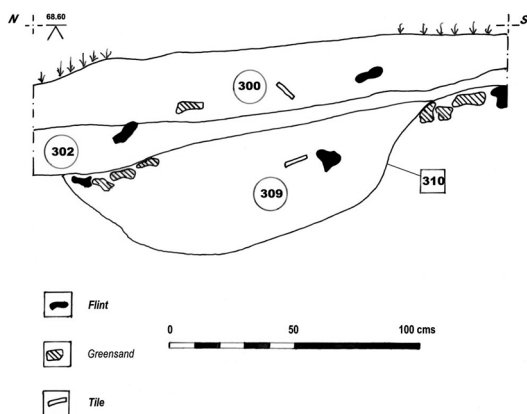
Fig. 6. Section of ditch 309/310.

Wall [307] had been cut by a ditch running east-west across the trench. It was 0.95m wide and 0.75m deep (Fig. 6). The ditch fill (309) was dark brown, firm, silty clay, the upper part of which contained 18th- and 19th-century pottery. The 1840 Treyford tithe map (WSRO TDW129) shows that the site was in fact two fields separated by a boundary running east-west. The ditch found in trench C probably represents the field boundary between the two fields. This would explain the presence of post-medieval pottery and glass in the top fill.

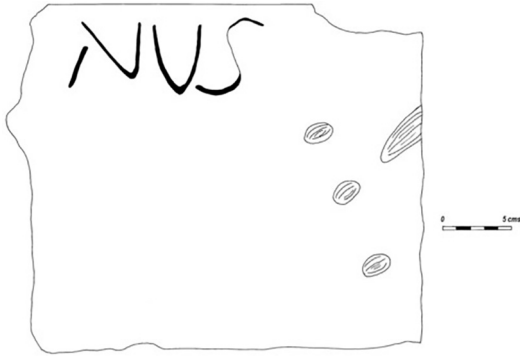
Fig. 7. Graffito on a bipedalis.

An almost complete *bipedalis* recovered from trench C (context 305) had been marked with the letters NVS prior to firing (Fig. 7). This may well have been the initials or name of the tile maker.

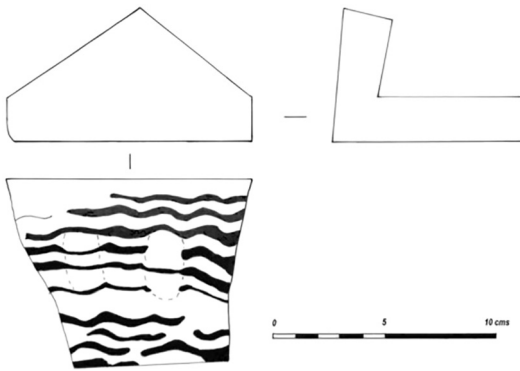
Fig. 8. Hypocaust flue tile vent.

There were triangular hypocaust flue tiles present (Fig. 8). Similar tiles have been recorded at Chilgrove 1 (Down, 1979, 177).

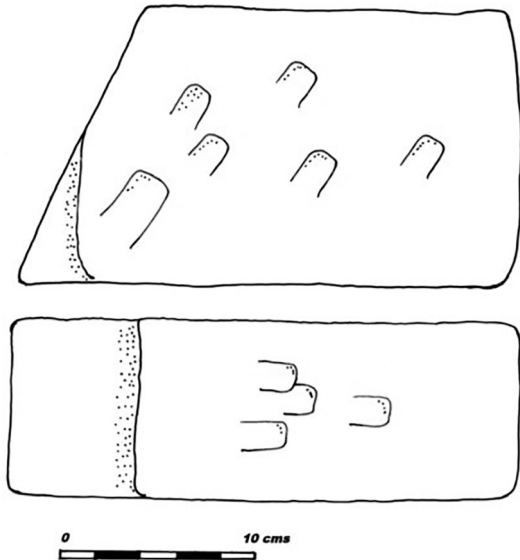
Fig. 9. Worked Greensand block.

Again, as in trench A, there were ceramic flue and roof tiles, both *tegulae* and *imbrices*, as well as several large Horsham stone roofing tiles. The angle of the stone tiles, which were roughly hexagonal in shape, suggested that they may have slid from the roof of a building. There were several examples of *pedalis*, *bessalis* and *lydion* brick tiles in the rubble. Four shaped, Upper Greensand blocks recovered from the rubble were probably part of an arch or vaulted roof (Fig. 9).

The substantial wall recorded in trench B could signify the presence of the remains of a large building. The shaped Upper Greensand blocks recovered from the demolition rubble suggest that at least part of the building contained an arch, or may even be part of a barrel-vaulted roof. The Horsham Stone also recovered would seem to indicate that at least part of the building had a stone-tiled roof. This would account for the need for substantial stone walls.
