# Excavations at Stanmer: new insights into the development of the manorial holding and country house

by Andrew Margetts  
and Alice Thorne

*During the summer of 2011, Archaeology South-East (UCL Institute of Archaeology) carried out a complex phase of excavation at Stanmer House, Stanmer, East Sussex. The fieldwork, commissioned by ABIR architects, took place in advance of construction of a new rear wing to the building. This occupied the footprint of the earlier northern wing of Stanmer House which had been demolished in the 1960s. The excavations revealed archaeological evidence largely supporting the known historical development of the building. Remains included an Elizabethan or Jacobean manor house, a country residence built in the reign of Queen Anne and details of the Palladian rebuild designed and overseen by the architect Nicholas Dubois.*

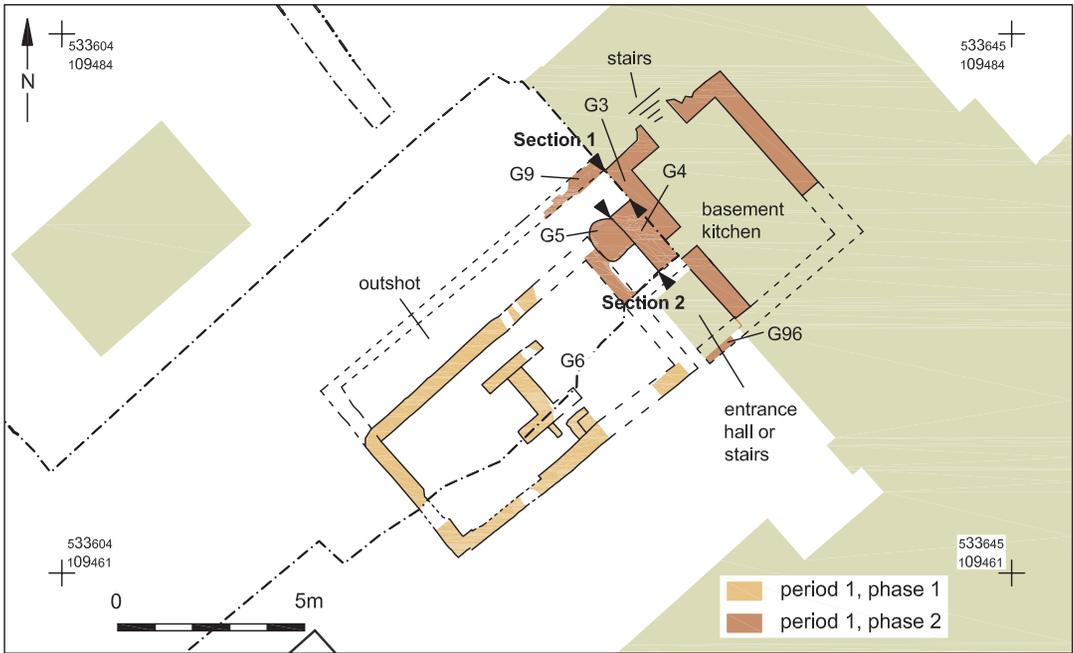
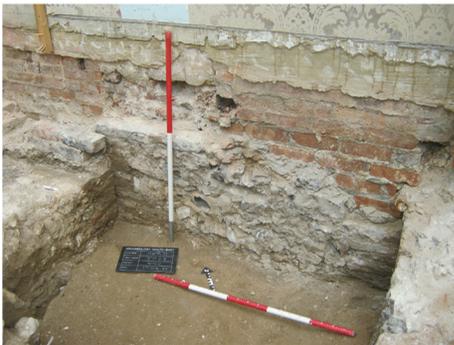
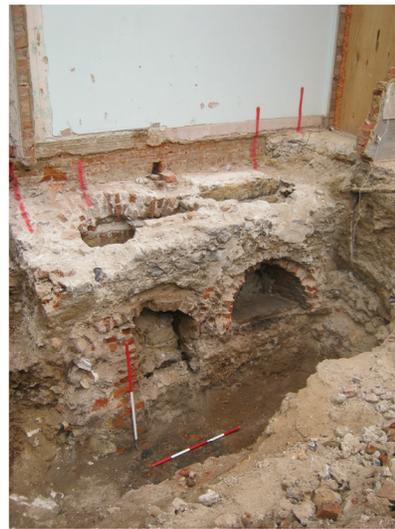
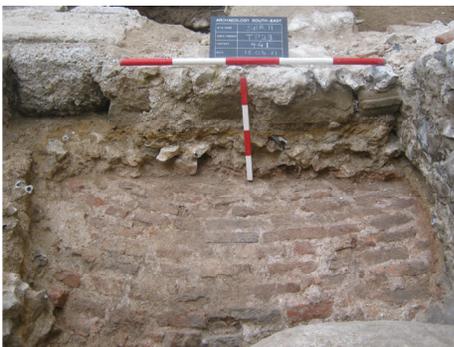
Fig. 10. Photographs and site plan, Period 1, Phase 2.

G3 facing east

G4, 5 and 23 facing east

G5 oven (left) partially overlain by later oven GR23

A substantial fireplace with twin flues was encountered to the west of the cross-wing walls (Fig. 10, G4). This was observed during the 2011 excavation adjoining the cellar levels below Stanmer House. Constructed of roughly coursed flint nodules, this fireplace included occasional bricks, internal partitions and quoins. Fragments of door pintles, a bracket for tying-in an iron bar to masonry and a smaller, L-shaped bracket for securing a fireback to the wall were recovered (see ASE 2012). Served by the north-western flue was a substantial oven built of 16th to 17th century brick with a partially flattened dome (Fig. 10, G5).

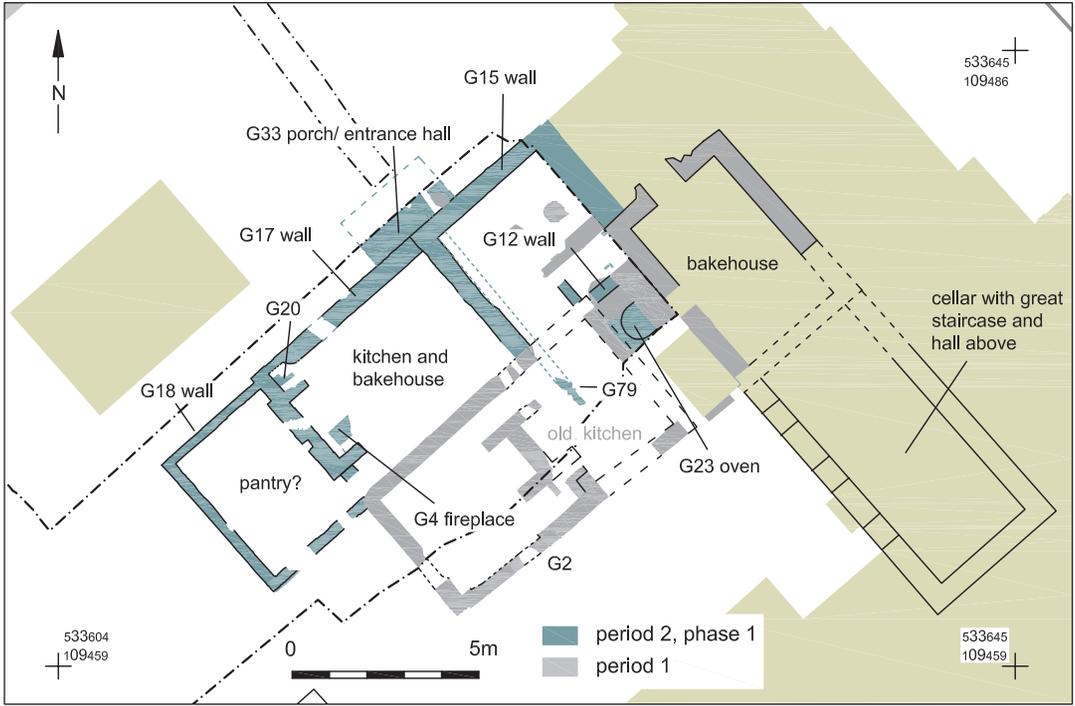
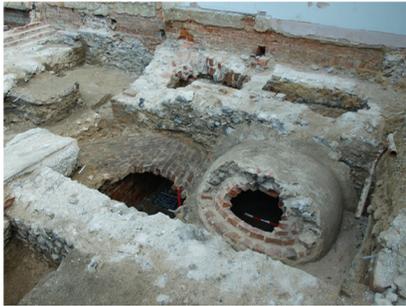
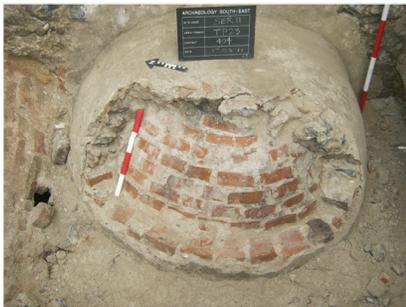
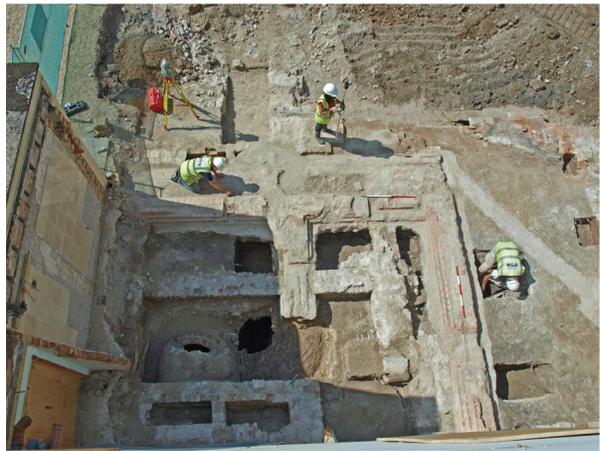
Fig. 13. Site plan and photographs, Period 2, Phase 1.

G23 Oven facing north east

Area of 'old kitchen' from above

During post-excavation analysis it was found that Gott's phase of construction can be detected through the sequence of wall phasing (Fig. 13). A significant extension was found to post-date the 17th century house and predate the construction of much of the kitchen range (1721–1725).

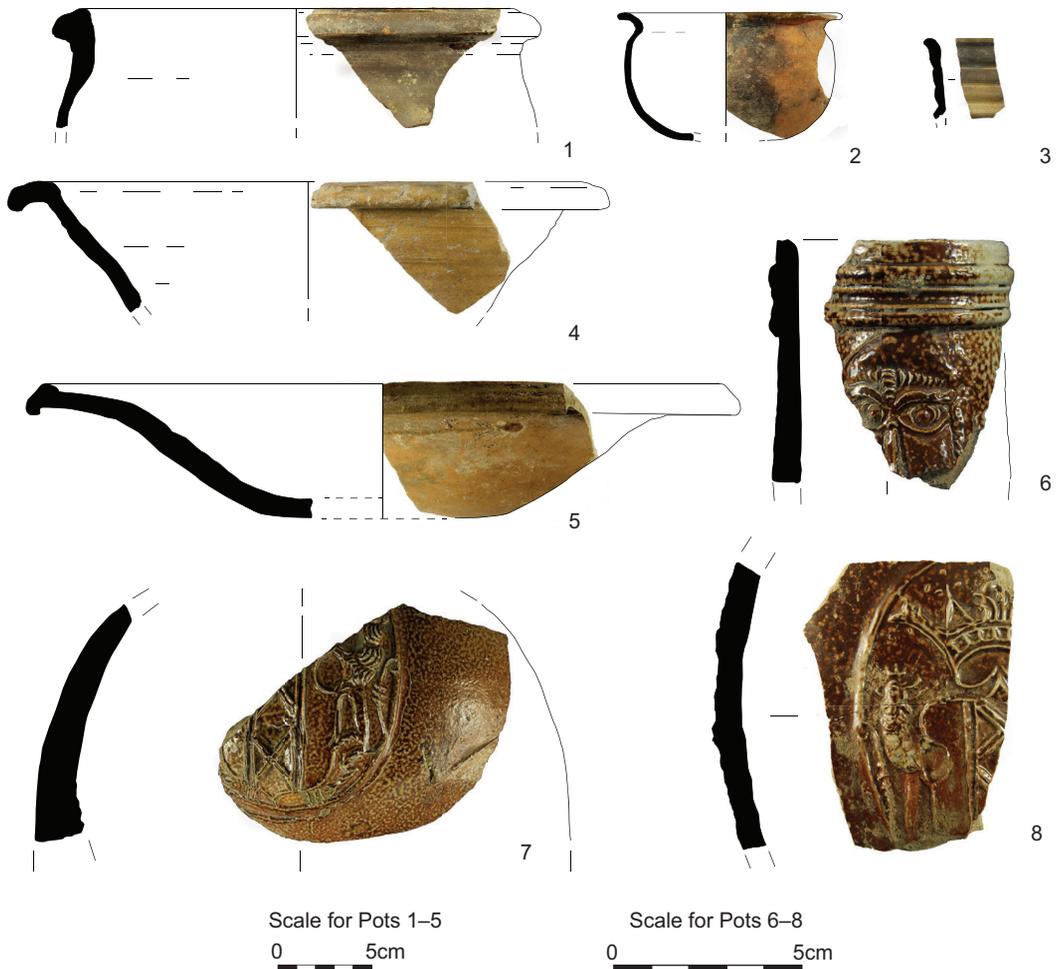
Fig. 18. Selected post-medieval pottery. **1.** Heavy jar with beaded club rim. Brick-red with dark grey inner margin and exterior surface. Black internal glaze. GRE 1. Fill [479] of oven [441] (G24, Period 2.2). **2.** Pipkin with tapering, everted rim. Dull orange with internal mid-grey margin. Internal dull green glaze. Exterior sooted. GRE 1. Fill [479] of oven [441] (G24, Period 2.2). **3.** Bowl with simple out-turned rim and exterior horizontal grooving. Buff/light grey with iron-flecked, pale green internal glaze. GRAF 1. Backfill [418] (G11, Period 2.1). **4.** Bowl with curved rim. Buff/light grey with iron-flecked pale yellow/green internal glaze. GRAF 2. Fill of pit [433] (G74, unphased). **5.** Large dish with hooked club rim. Light grey with buff exterior surface and iron-flecked, dull green internal glaze. External sooting under rim. GRAF 1. Backfill [420] (G11, Period 2.1). **6.** Frechen stoneware partial facemask from Bartmann bottle. FREC. Backfill [418] (G11, Period 2.1). **7.** Frechen stoneware medallion from Bartmann bottle depicting coat of arms of Amsterdam. FREC. Backfill [418] (G11, Period 2.1). **8.** Frechen stoneware medallion from Bartmann bottle depicting coat of arms of Amsterdam. FREC. Backfill [418] (G11, Period 2.1).
