◆ The excavation of a post-medieval site at Herstmonceux Castle, 1998–2003

By Philippa Whitehill,
David Martin and
Barbara Martin

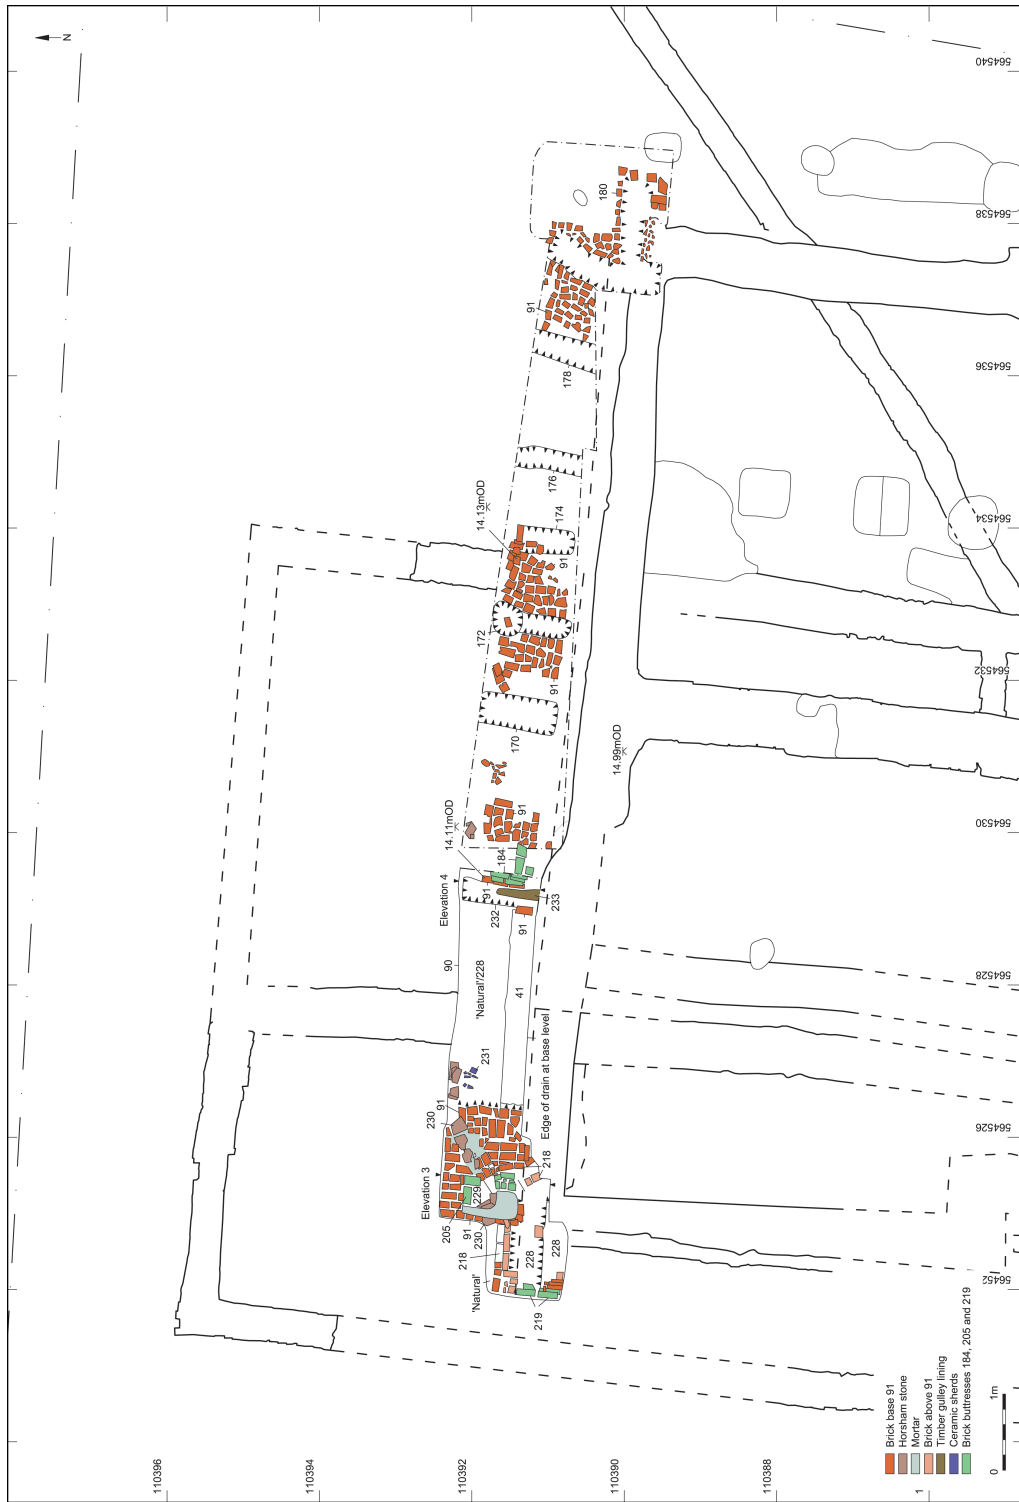
Fig. 10. Plan of drain.

The only other sections of Phase 2 brickwork to remain are buried fragments of buttresses built against the northern face of the north wall (see Fig. 10). These were left *in situ*, but isolated, when the foundation of the northern wall (within robber trench/context 40) was grubbed out to its full depth.

A second method of drainage was noted: a series of small gullies (contexts 170, 172, 176, 178, 180, 228, 229, 232; Fig. 10), randomly spaced and north-south aligned along the bottom of the brick paved area, the most complete of which was located at the north-western end of the big drain area, below context 205. It is unclear whether they were dug just prior to the backfilling of the drain/paved area or were there when it was open and in use, but when discovered it was obvious that they had remained open and in use beneath the backfill, as they appeared not to have been filled in.

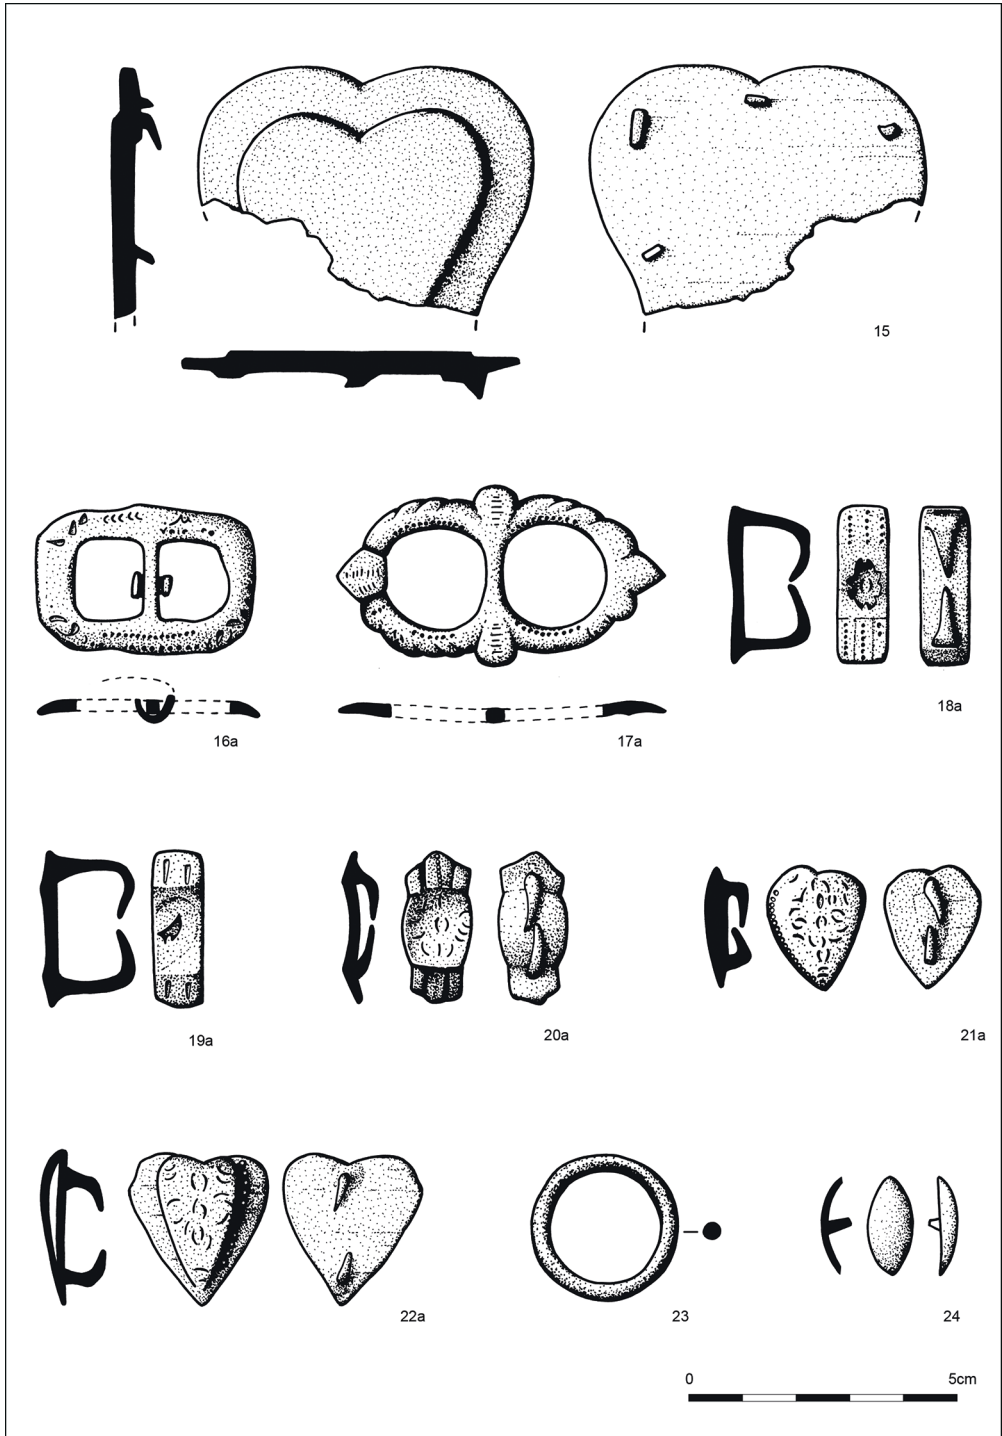
Fig. 14. Metalwork. 15–24: horse brass, bridle buckles, bridle rings, strap fittings and studs.

Despite the variable condition of some of the assemblage, most of it was identifiable as to form and function and included relatively large groups of iron and copper-alloy equestrian equipment and dress accessories (Figs 14 and 15), including farriers' nails for shoeing, horse shoes, spur fragments, harness buckles, strap guides, a harness ring and chain fragments.

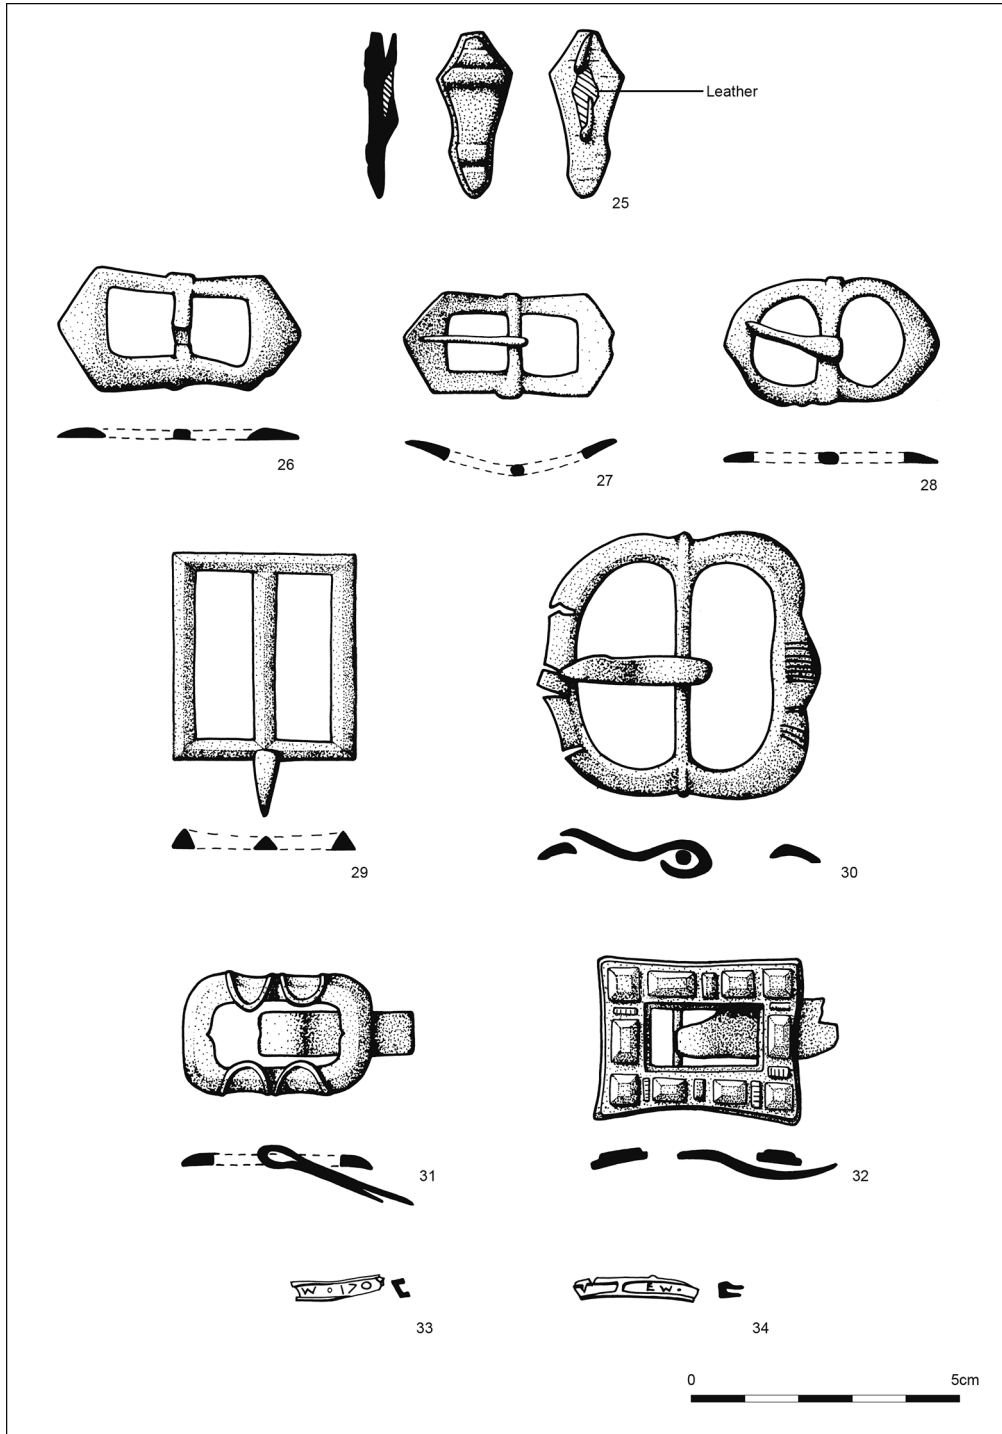
Fig. 15. Metalwork. 25: copper alloy leather fixings; 26-32: dress accessories; 33 and 34: lead window comes.

In keeping with the window glass, a fairly large assemblage of lead came was also found on site, several of which presented with a date and maker's stamp on what would have been the underside of the came strip into which the glass pane was fitted (Fig. 15, 33 and 34).
