THE EXCAVATION OF A POST-MEDIEVAL SITE

AT HERSTMONCEUX CASTLE,

EAST SUSSEX, 1998 - 2003.

Report by Philippa Whitehill MA, PCIFA and David and Barbara Martin; University College London Institute of Archaeology, based on excavations directed by Jenny Compton.

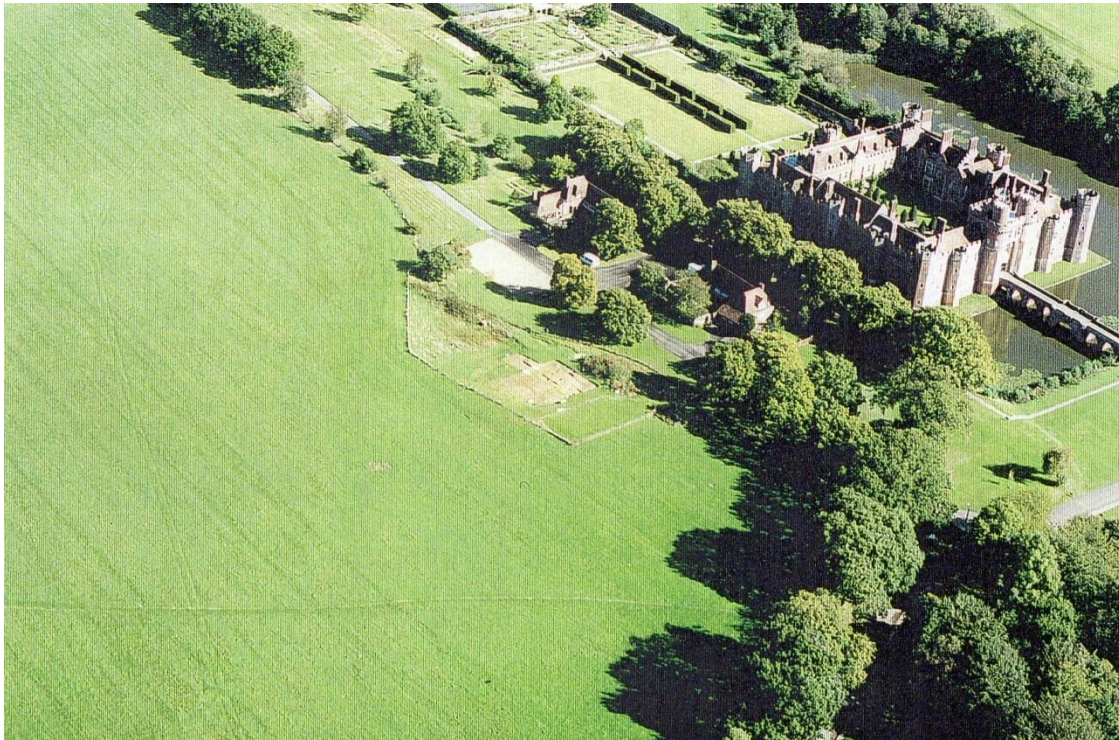
Frontispiece: aerial view of the excavation site from the south west (Monica Pellet and David Mitchell)
