◆ A late-medieval house at 26 and 27 Cliffe High Street, Lewes, East Sussex: the documentary and archaeological evidence

David Gregory with
David and Barbara
Martin, and
Christopher Whittick

Renovation in 1987 of two cottages at 26 and 27 Cliffe High Street, Lewes, East Sussex, revealed remains of a late 15th-century house, with number 27 an open hall and number 26 floored with a first-floor chamber which may have extended over a culvert. In the 16th century a floor and a ceiling were inserted in the hall, and a ceiling added to the upper room. Several decades later a small, heated, two-storeyed range was built at the rear. In the mid-17th century, possibly in 1673, a second rear range was added, enveloping the 16th-century chimney. The house was divided into two cottages in 1708. In the course of road widening in 1829, the front two-fifths of the 15th-century structure were removed.

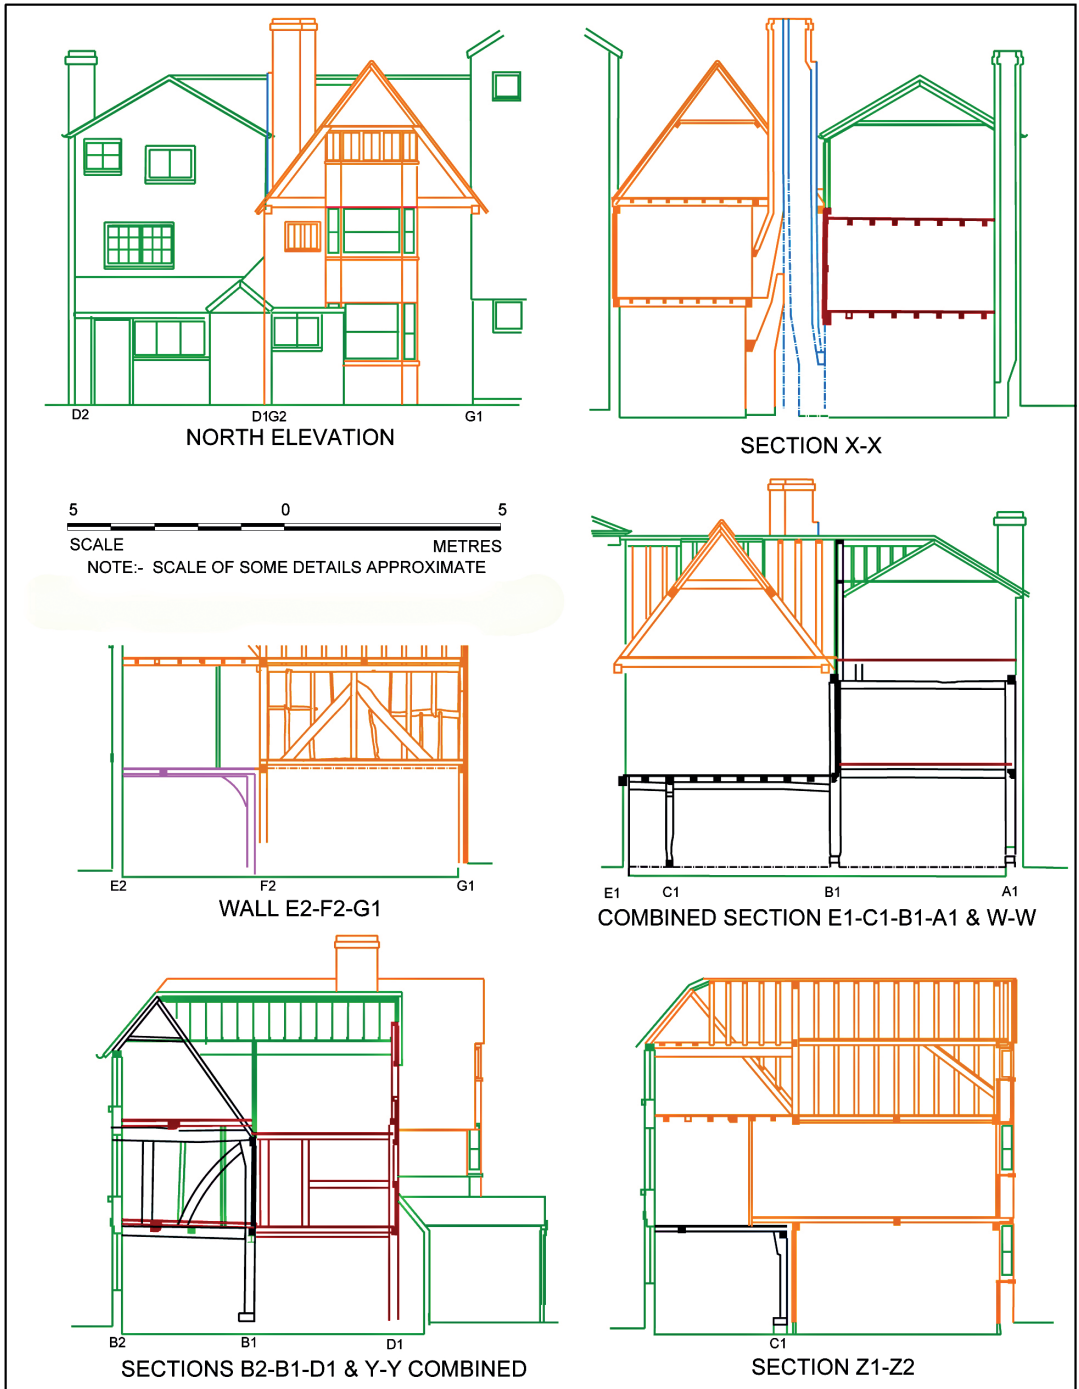
Fig. 3B. Interpretation of the architect's drawings made prior to renovation in 1987, B: north elevation and sections.

The structure of this article, reflected in Figs 3A and 3B, is as follows:

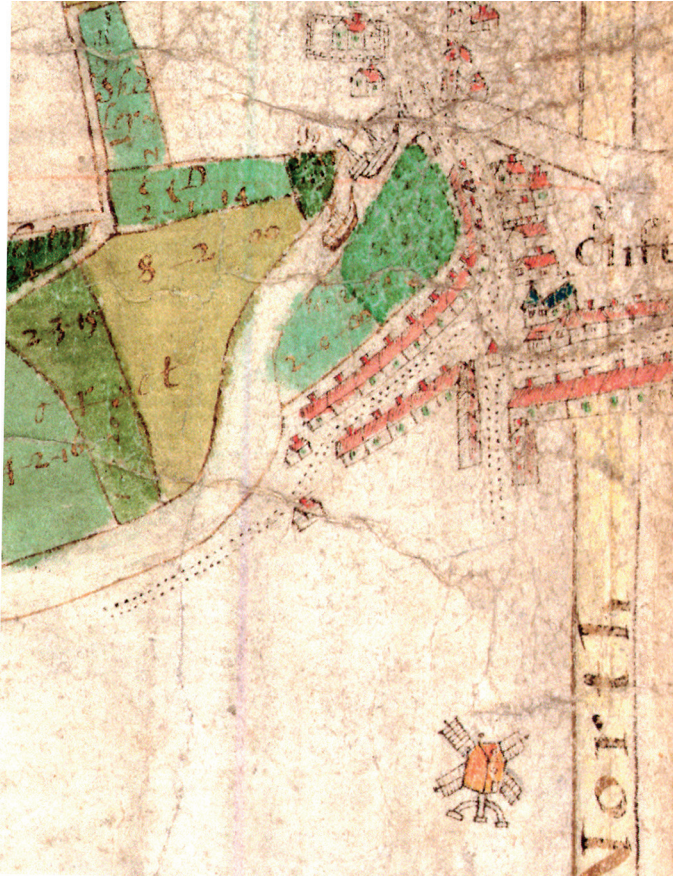
Fig. 5. Detail of the map of Lewes Levels by John de Ward, 1620 (ESRO ACC 2187).

in the vicinity by the end of the 12th century. It was probably during that century that the causeway which would subsequently form Cliffe High Street was laid out over the brookland between the Ouse and the foot of Malling Hill, where the earliest settlement lay.⁵ The archbishop's rental of 1285 lists 52 messuages, four shops and three kilns in Cliffe, an almost certain indication of the development of Cliffe High Street by that date.⁶ The marshes which underlay the settlement still needed to be drained, and a network of sewers, apparently mostly open until culverted by the Cliffe Improvement Commissioners under a private act of 1828, ran north-south between many of the buildings from the great sewer to the Ouse; one of them formed the west boundary of number 26 (Fig. 4).⁷ Two maps of 1620 show that housing was already dense in each of the suburb's four streets (Figs 5 and 6).⁸

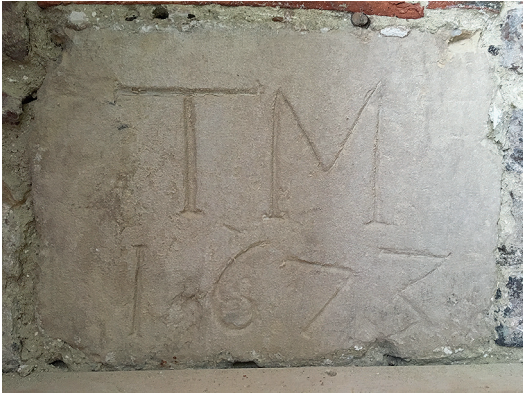
Fig. 7. Date stone, 'T M 1673', in the north face of the Phase 3 chimney (Photo Nicola Smith).

During repairs following extensive flooding in October 2000, a date stone 'TM 1673' was uncovered in the north face of the chimney (Fig. 7). That is a slightly unusual place for a date stone and it could have been refixed or inserted into an existing section of brickwork. But, as shown above, 'T M' can be identified as Thomas Mosely who bought the building in 1672 and do allow the second phase of improvements to be dated to the mid-17th century. Then a second rear range was added, replacing the west outshut and enveloping the Phase 2b chimney, against which two west-facing fireplaces were now added (Figs 21 and 28). This range is slightly longer than its Phase 2 neighbour, measuring 4.80m, with a width of 4.95m. As with the adjacent Phase 2b range, the new range incorporated a single ground-floor heated room, but in this instance the chamber above was also heated. Furthermore, the roof over the earlier west (Phase 1) bay was removed and that of the new range extended forward over the bay to give the impression, from the street, of an (assumed gabled) cross-wing. Whether or not the Phase 1 west chamber overshot the culvert, this new range did. Beneath the Phase 3 range was incorporated a cellar beside the culvert,²⁴ and a quality garret room was formed within the roof, lit by a bay window in the rear gable. This bay window extended down to ground level where, in 1987, the builders revealed the top part of the entrance to the

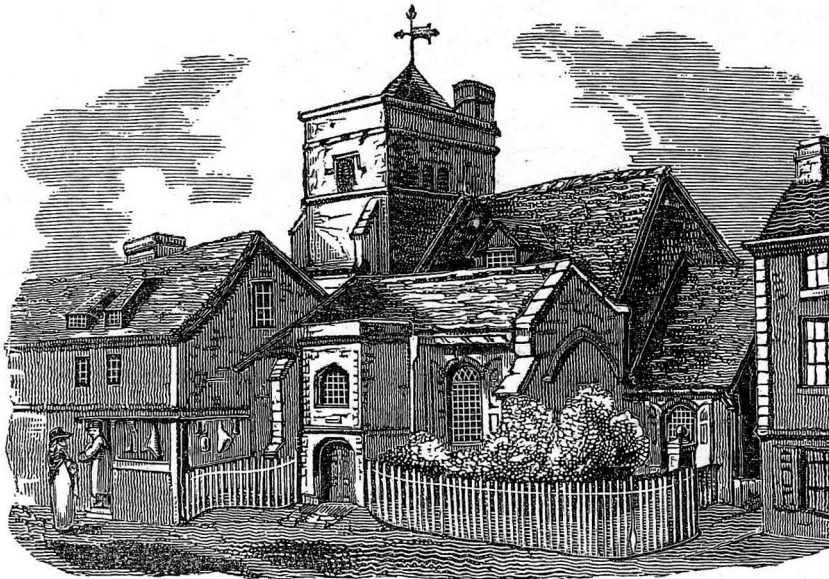
Fig. 8. Engraving of St Thomas à Becket church and the grocer's shop to its west, c. 1820.

west portion of Cliffe Church (Fig. 8).¹⁸ The *Sussex Weekly Advertiser* of 8 December 1828 reported a public meeting of the inhabitants of the Cliffe which in response to the application of 'many respectable graziers and farmers' for land on which to establish a market, 'most cheerfully offer that commodious piece of ground behind the church', and resolved 'that for the greater convenience of the market, arrangements be made with Mr Venus for the immediate pulling down the house now in his occupation'. His landlords the Feoffees received £120 in compensation.¹⁹

- ¹⁷ ESRO PAR 415/12/1, AMS 6469, LEW C/10/1/2.
- ¹⁸ Shown in an engraving published in 1824 (Fig. 8): T. W. Horsfield, *History and antiquities of Lewes and vicinity* **1** (Lewes: J. Baxter, 1824), 288; the author observed that the church 'is so much crowded by the neighbouring houses, that its beauty is in a great measure lost'.

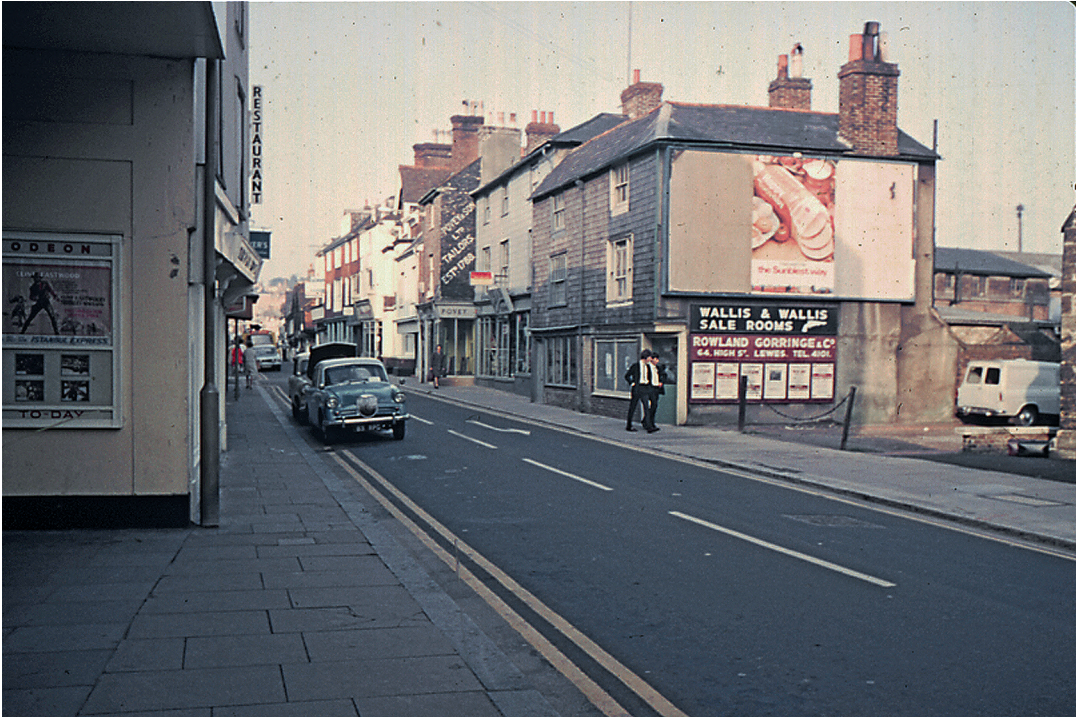
Fig. 9. Photograph of 26 and 27 Cliffe High Street, c. 1970 (ESRO DL/A 24/1/46).

lavatory.²² When photographed in about 1970 by the Lewes Borough Surveyor, Douglas Cyril Race (1929–2003), along with much of Cliffe High Street the buildings were in a dilapidated condition (Fig. 9).

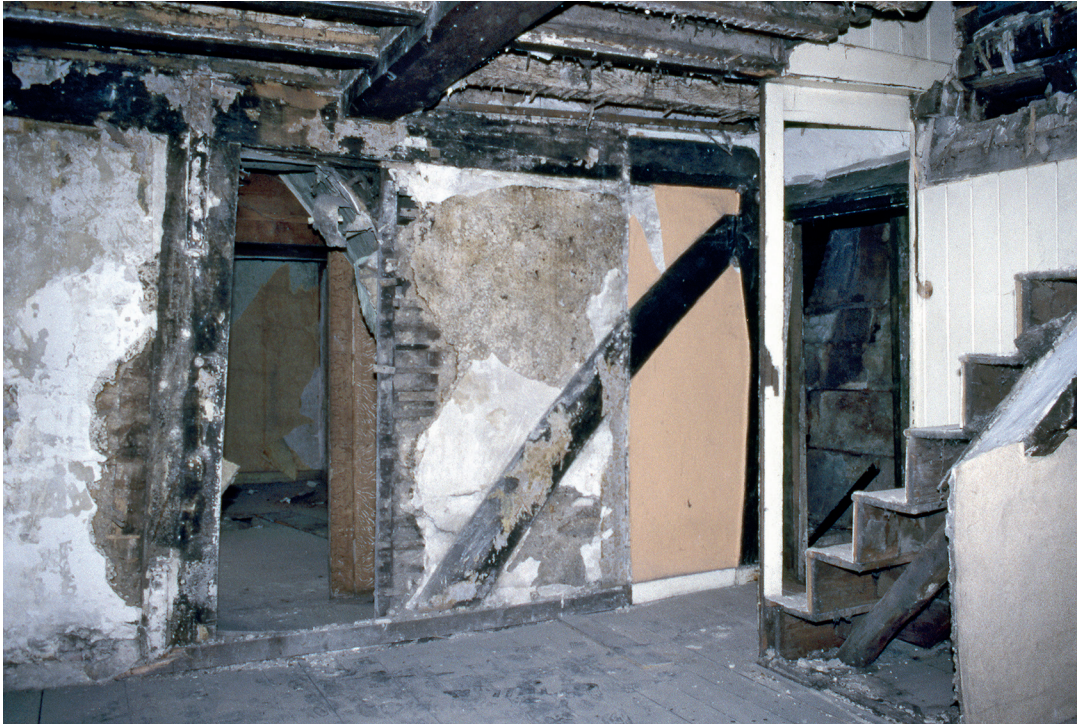
Fig. 10. Truss B-B: foot-brace to post B1 (right) and central stud (left).

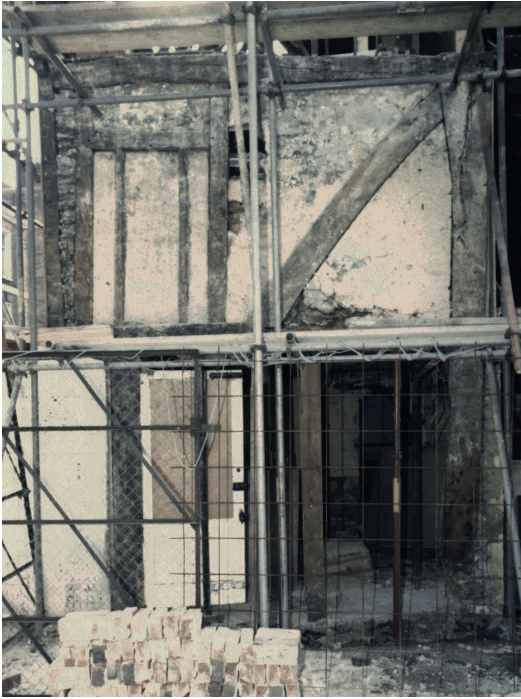
Fig. 11. Truss A-A: east elevation showing foot-brace (upper right), and blocked hall window (upper left).

Only one window is evidenced. It survives blocked, fully intact save for its central mullion, positioned immediately above the crossbeam in the east end wall (Truss A-A; Fig. 11). Not only is its location in the end wall of a hall unusual, but also its ornate detailing. It is of standard close-mullioned unglazed type, but instead of the mullions being of diamond-section profile, they are square in section and incorporate neatly chamfered leading edges. Furthermore, on the external face, the jambs, head and cill are also chamfered, those on the head and cill being neatly stopped on either side of each mullion (Fig. 12). Windows of similar design were found in the front elevation of Portland Cottages

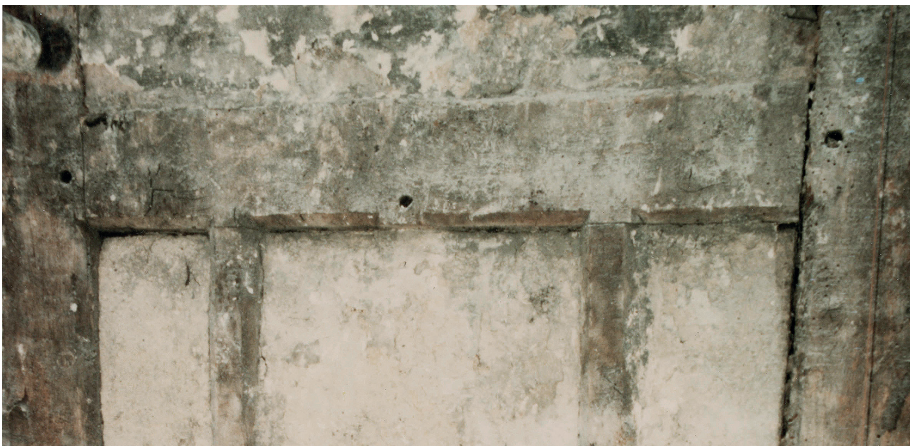
Fig. 12. Truss A-A, blocked hall window: detail showing stopped chamfers on window head and jambs, plus two surviving chamfered mullions.

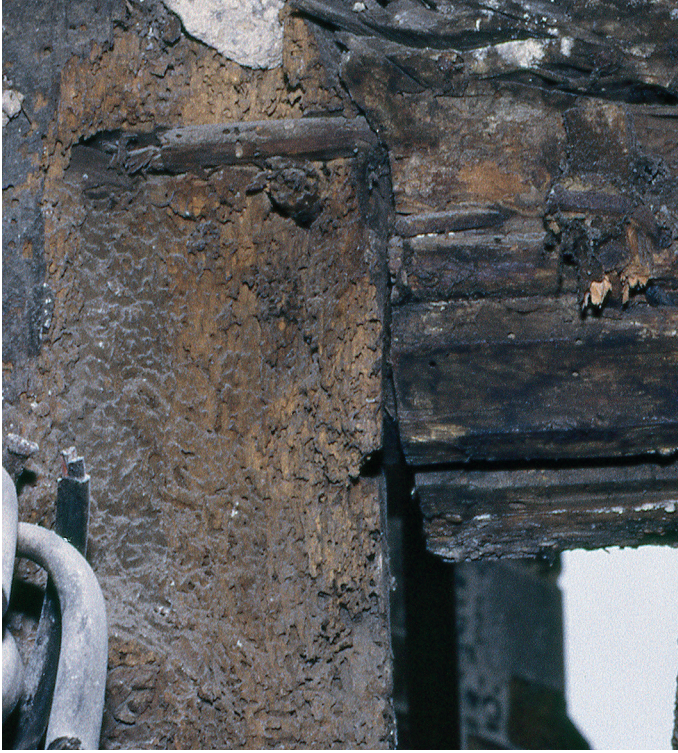
Fig. 13. Crossbeam truss A-A (right) and principal post A1 (left).

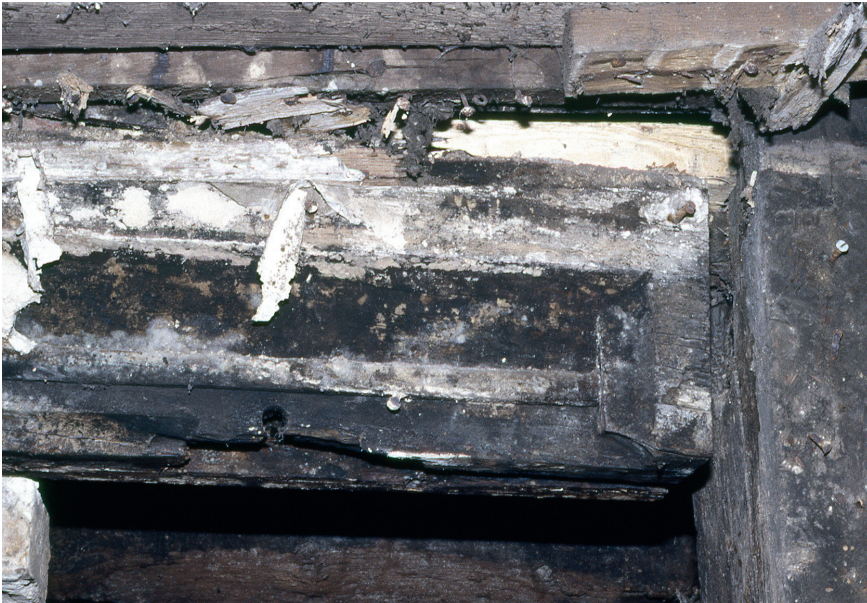
Fig. 14. Crossbeam truss B-B with principal post B1 to right.

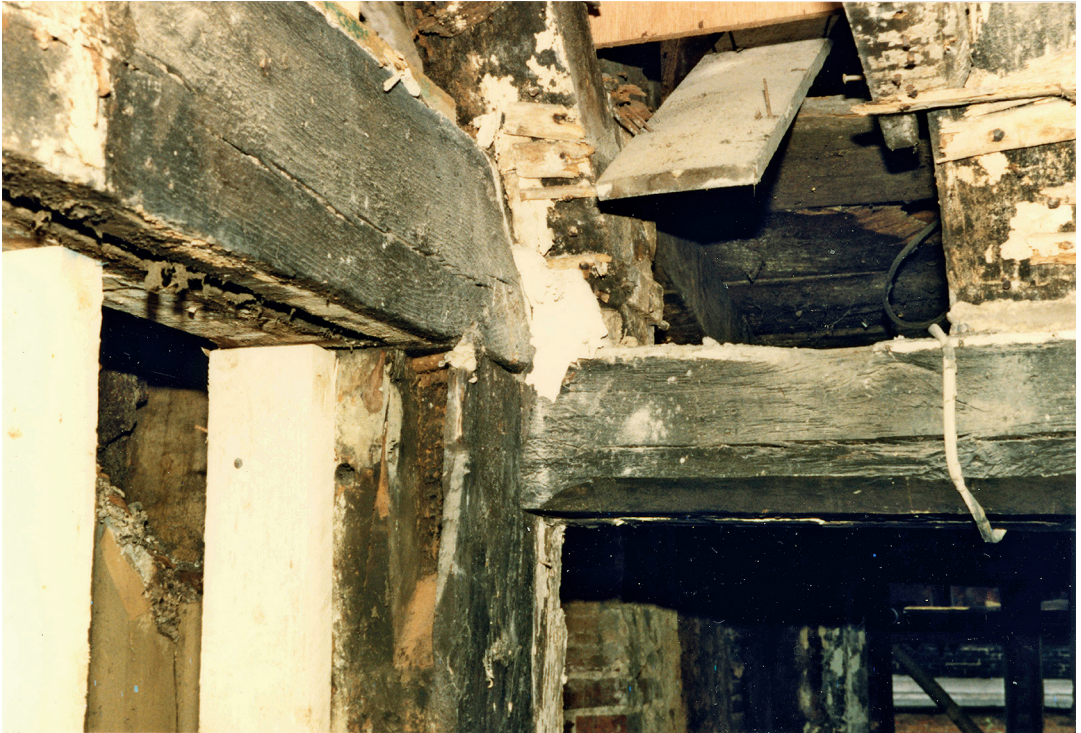
Fig. 15. Tie-beam B-B, head of principal post B1, and wall-plate to bay A-B, the latter supporting a few surviving Phase 1 rafter fragments. That on the left is part of the surviving rafter pair and is halved over the east face of the tie-beam.

the front rafter) and the feet of others remain within bay A-B (Fig. 15). These vestiges are sufficient to give the pitch of the roof and the spacing of the rafters. The surviving rafter pair shows the roof to have been of paired-rafter-and-collar type and indicates the level of the collars. What it does not indicate is whether there were crown-posts. The archaeological drawings of the timbers of both trusses A-A and B-B made in 1987 do not indicate pegs or peg-holes for crown-posts or associated crown-post braces, suggesting that crown-posts were lacking. Given the relatively narrow span of the roof, that is to be expected.

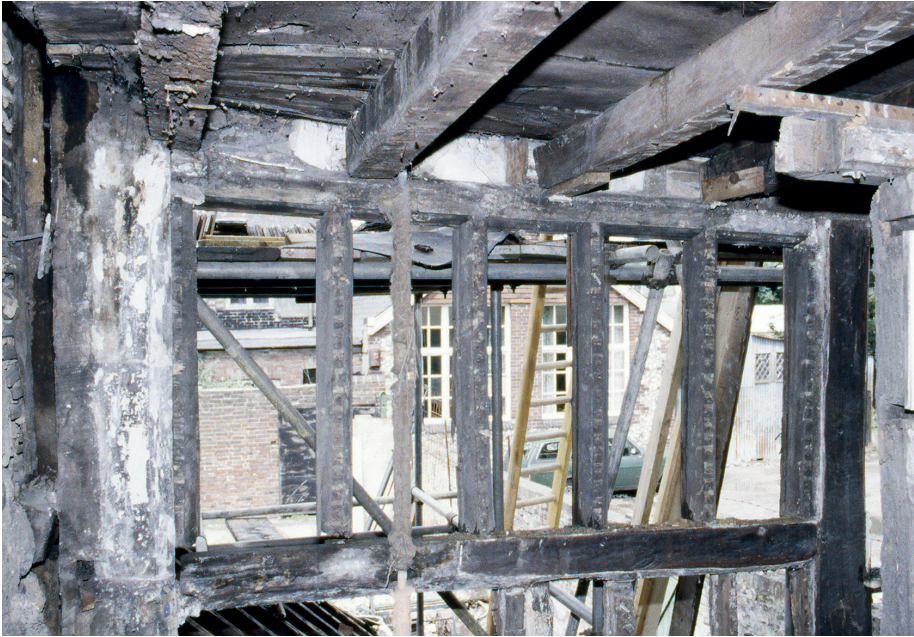
Fig. 17. West five panes of the frieze window which extended across the full width of the Phase 2b north elevation. The window's cill doubles as the wall's midrail, whilst the joists supporting the garret floor are supported on the window's head.

In the north wall, although that half of the ten-pane frieze window to the east of the central stud has been removed, that to the west still survives, though blocked. It is of ovolo-moulded design, a type used extensively throughout the late 16th and first half of the 17th centuries (Fig. 17). Above this window, in the roof gable, can be seen the jamb of another glazed window, probably of three panes.

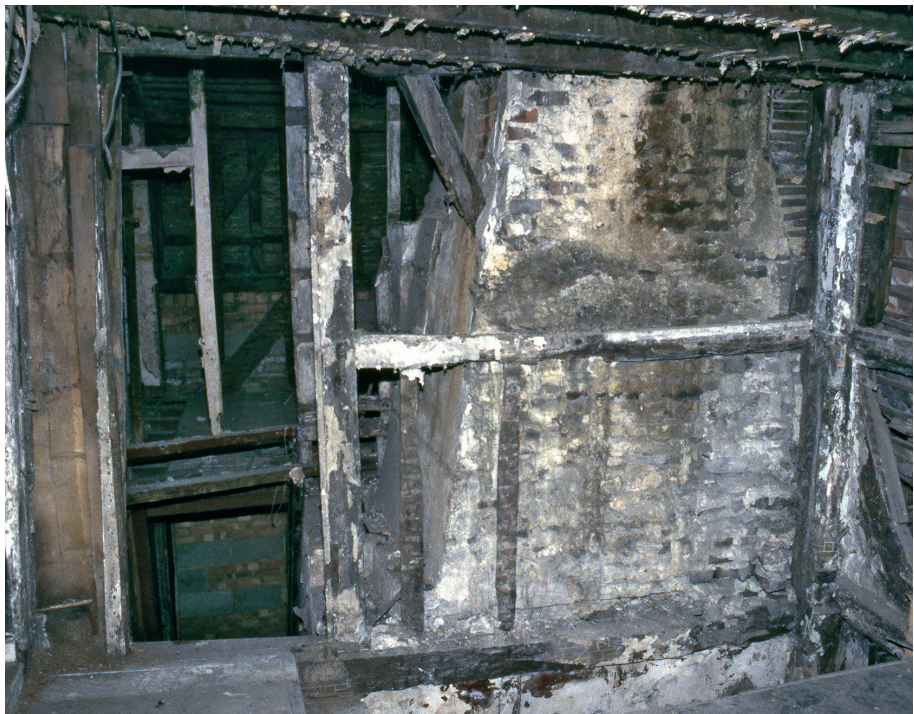
Fig. 18. West wall of Phase 2b range: note doorway at south (left) end.

In 1987, only one doorway survived within the new range; on the first floor at the south end of the west wall. It is entirely plain and uses the wall's upper side-girt as its head (Fig. 18). The visible details of the present chimney now located within the east part of the adjacent Phase 3 rear range are mostly of Phase 3 date, but a blocked-up fireplace

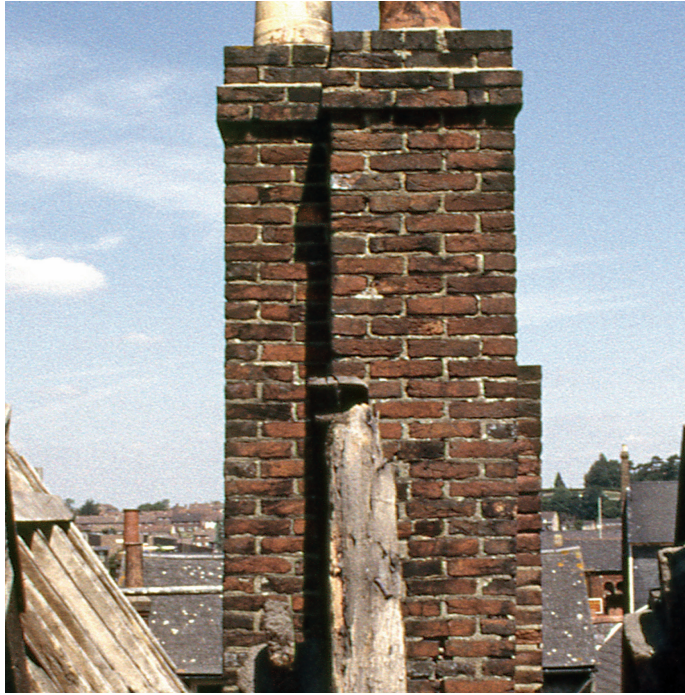
Fig. 19. Phase 3 chimney cap from south showing likely Phase 2b flue projecting from east (right) face.

serving the Phase 2b east rear range is evidenced by a third flue within the chimney cap. Furthermore, the details of the cap where it passes through the roof makes it almost certain that this fireplace and its flue pre-date the remainder of the chimney and represent a single-flue stack incorporated into the later chimney (Fig. 19). How much of the fireplace survives behind the present brickwork of the range's west wall is impossible to say.

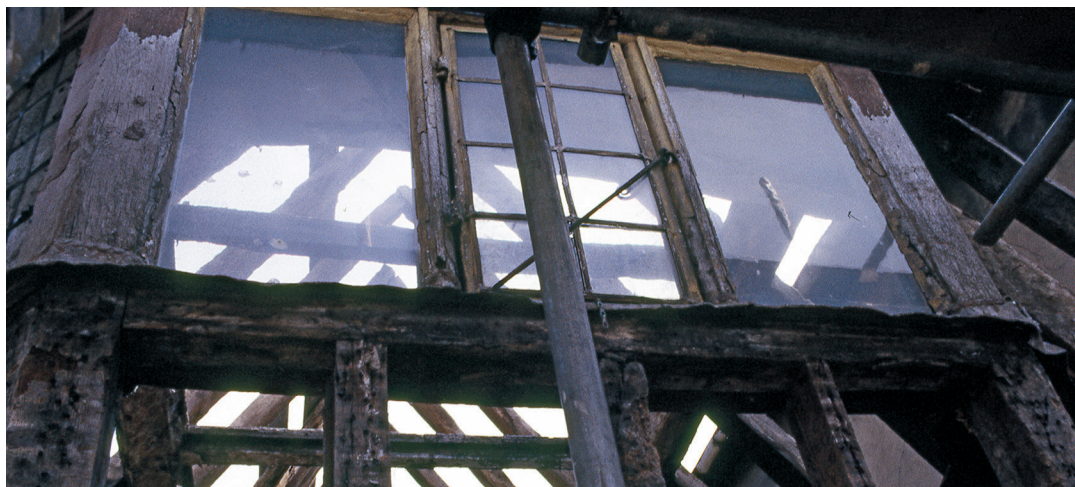
Fig. 22. Garret window at head of bay window.

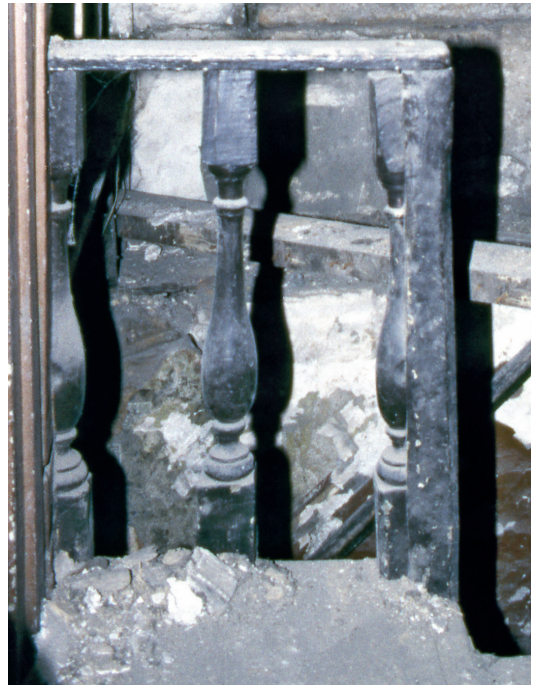
Fig. 23. Balustrade to first-floor landing.

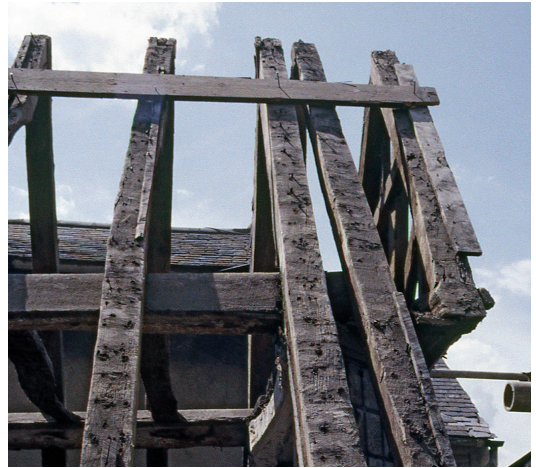
Fig. 24. Detail of projecting gable head.

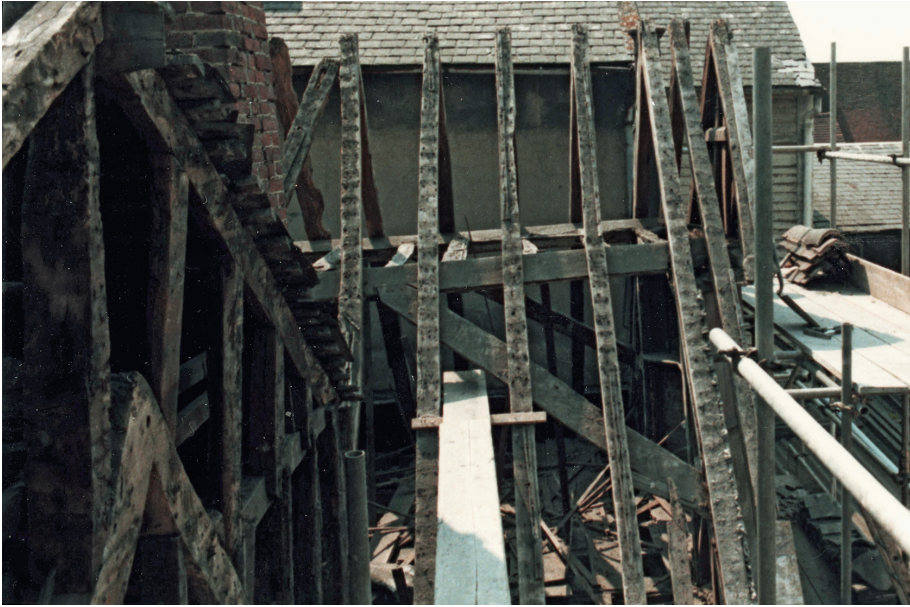
Fig. 25. North end of roof viewed from east.

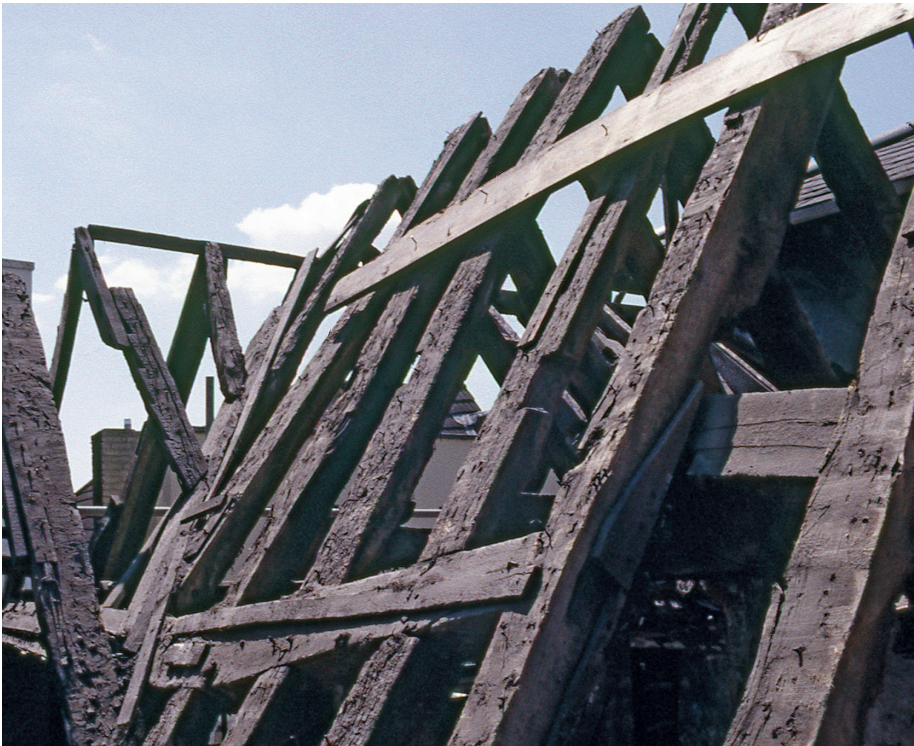
Fig. 26. Intersection of roof with that over main range (left). Note butted side-purlin to north (right) of principal rafter and butt purlin interrupting the common rafters to the south (left).

The new range is capped by a single-bay roof of side-purlin construction with continuous common rafters and long, straight windbracing to the north gable. At this point the pair of principal rafters forming the truss reduces in depth and there is a collar which clasps the side purlins, allowing them to project beyond the gable so as to form a projection weathering the top of the bay window beneath (Figs 24 and 25). In contrast to the arrangement over the new rear range's north gable, the collar truss at the south end of the bay incorporates principal rafters of consistent deep profile throughout their length, with the south end of the side-purlins jointed into them. The reason for this variation between the north and south trusses is to allow the new roof to be continued southwards, effectively requiring the Phase 1 roof over the main range's west bay (B-C-E) to be rebuilt in modified form. Deep butt-purlins joint into the south face of the truss and extend southwards across the full width of the Phase 1 street range to a (now destroyed) south gable in the street facade (Fig. 26).

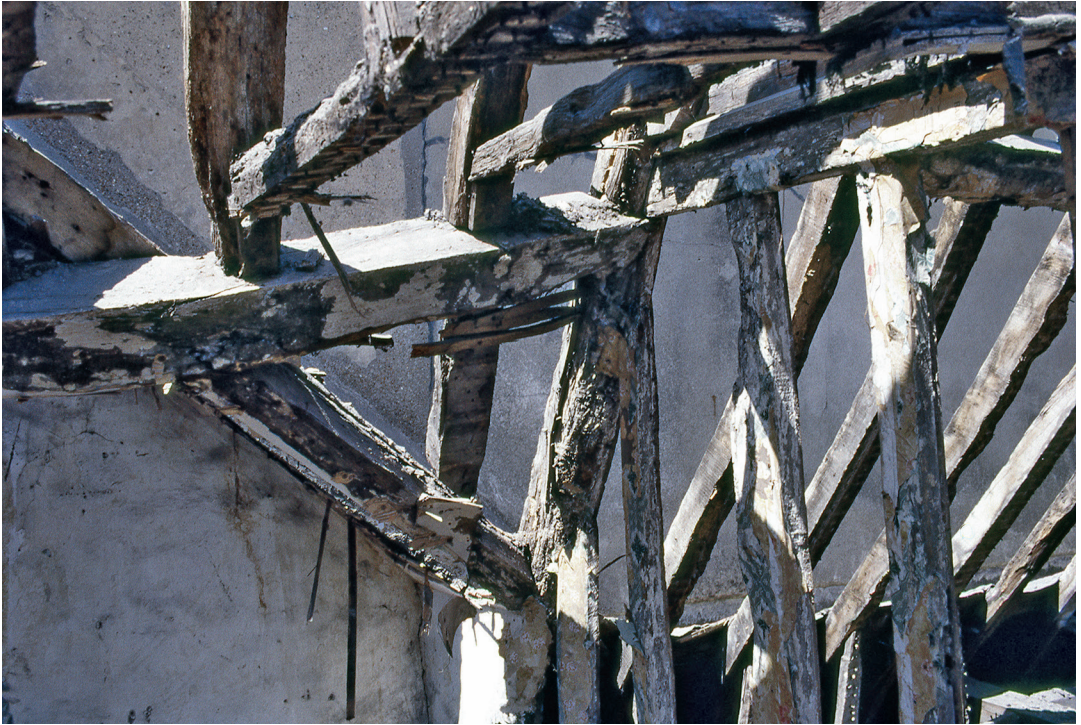
Fig. 27. North end of west butt purlin at roof truss F1-F2, with *in situ* valley rafter and jointed-in jack rafter filling the gap between valley and purlin.

but evidenced by mortices. Where they remain towards the north, lay boards nailed over their upper faces support the jack rafters carrying the roof tiling which flank the new roof as it crosses the range. Contrasting with this arrangement, valley rafters (one of which is shown in Fig. 27) are jointed into
