**A Record of the South
Stand, City Stadium,
Filbert Street, Leicester**

Birmingham University Field Archaeology Unit
Project No. 1078
June 2003

by
Malcolm Hislop

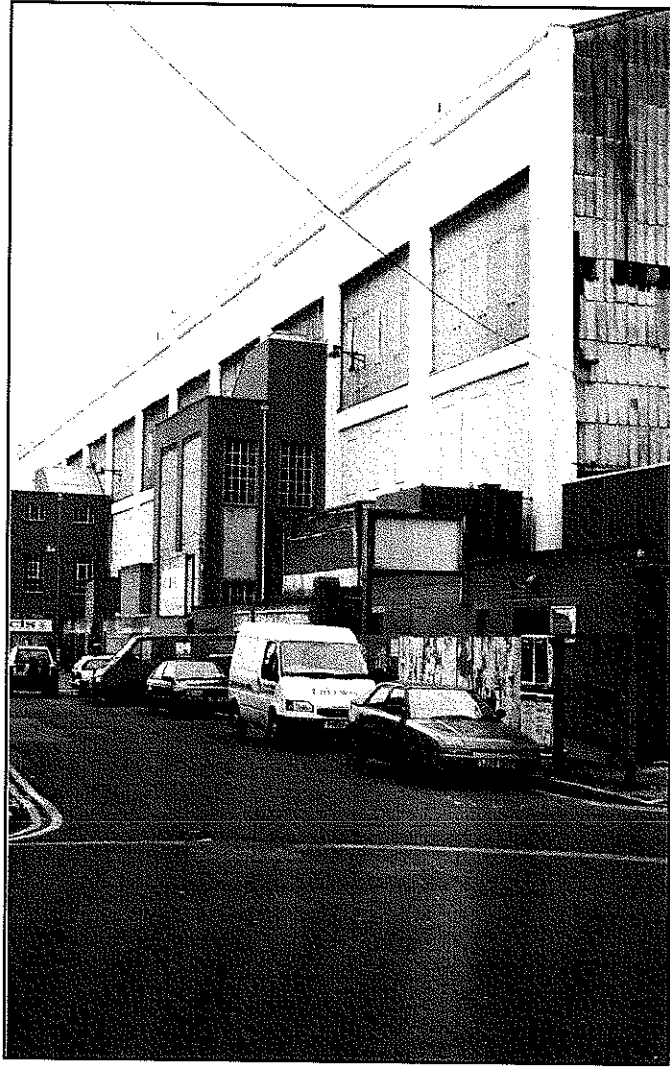
Plate 1

The style of the outer (south) elevation was rooted in classicism but had modernist leanings (Plate 1). It had four tiers of panels reflecting the internal floor levels, namely ground level, gallery behind the lower terrace, gallery beneath the upper terrace, and the uppermost tier of the upper terrace. The front was divided into twelve bays (here numbered 1 to 12 from west to east) by pilasters with corrugated edges and fluted quasi-capitals (Plate 2). There were turnstiles in bays 4, 6, 7 and 9, and tall small-pane windows in all the bays of the second tier, those of bays 2, 6, 7, and 11 being truncated owing to the lavatories for the lower terrace being situated in these positions inside. The third tier was covered latterly with corrugated iron, and the upper tier was blind.
