Standing Remains of the Former Lace Works, Emerys Road, Gedling, Nottinghamshire

An Archaeological Building Record, 2004

P.N. 1259 January 2004

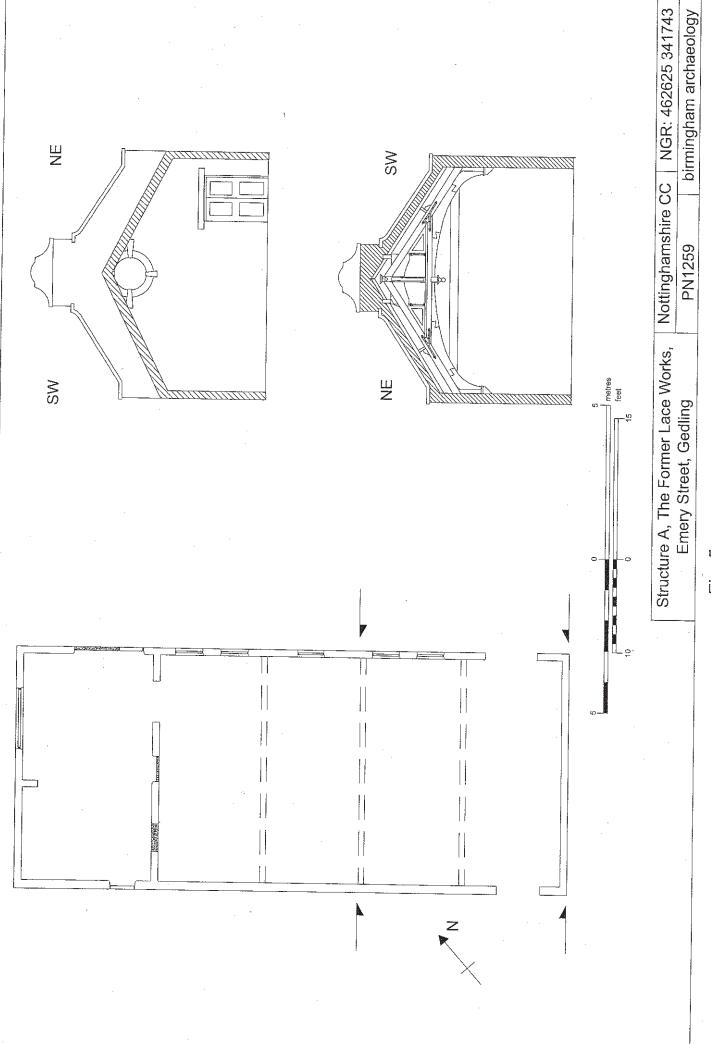
Fig. 5

Structure A: The Dye House (Fig. 5, Plate 1, 4, 5)

A free-standing pitched roof factory building, orientated SE-NW. The southern part of the building was open plan with the northern quarter split into a two storey room.

The principal façade faced north-east onto the factory compound. Two wide openings were located, one at either end of the building with five segmental-arched windows with 12-pane casement frames inbetween. The gables were ostentatiously decorated each with a shaped-pediment at the apex, flanked by stone coping. The north-western gable had a single window at ground floor level, and a lunette flanked by two square lights at the first floor. The south-eastern gable had a single high circular light. The rear, south-western façade was plain and the eaves were undecorated. The roof was pitched and had been recently replaced with corrugated iron.

The principal room within the interior was open to the roof trusses (Plates 4 & 5). The floor was of concrete with discontinuous survival of patterned quarry tiles. The walls were constructed of glazed bricks running to just above the sill level in a green-glaze before continuing above in white-glaze. The window surrounds had moulded decoration. The smaller northern room was plain with vehicular openings to the north-east and pedestrian entrance to the south-west. A beam that ran SE – NW supported the low

ceiling. The first floor was of two varying levels suggesting it was altered at a later date. Access was via a narrow central opening and a ladder. Access between the two rooms was originally by a central doorway but had been altered by a later cut-doorway.

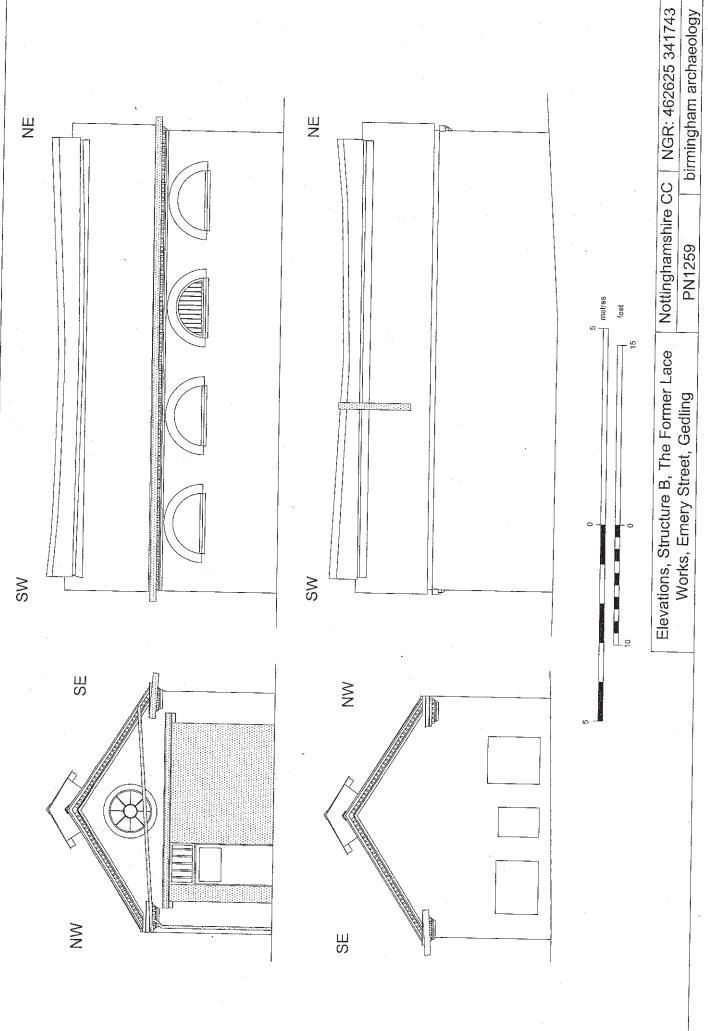
Fig. 7

Structure B: The Engine House (Fig. 6 & 7, Plate 2)

Another free-standing pitched roof factory building orientated NE - SW. The building was constructed in the same form as Structure A. The plan was a single room and entirely open.

The main entrance was via the south-west facing gable, a single large gateway entrance that had subsequently been in-filled by a steel shuttering. A single circular light with casement frame was located centrally above. The eaves were decorated with a moulded terracotta dentil design as seen in Structure A (Fig. 10C). The opposing gable mirrored this but had three low openings at the base. The south-east facing elevation had four half-moon lights with open grills in each and the eaves decoration continued from the gables. The rear, north-west elevation that faced the railway track was plain. The roof was pitched and of grey slate. Along the roof line was a raised vent-stack.

The interior was plain and undecorated. All fittings had been stripped from the interior. The roof was supported by three trusses. These were of a plain king-post design with braces either side.

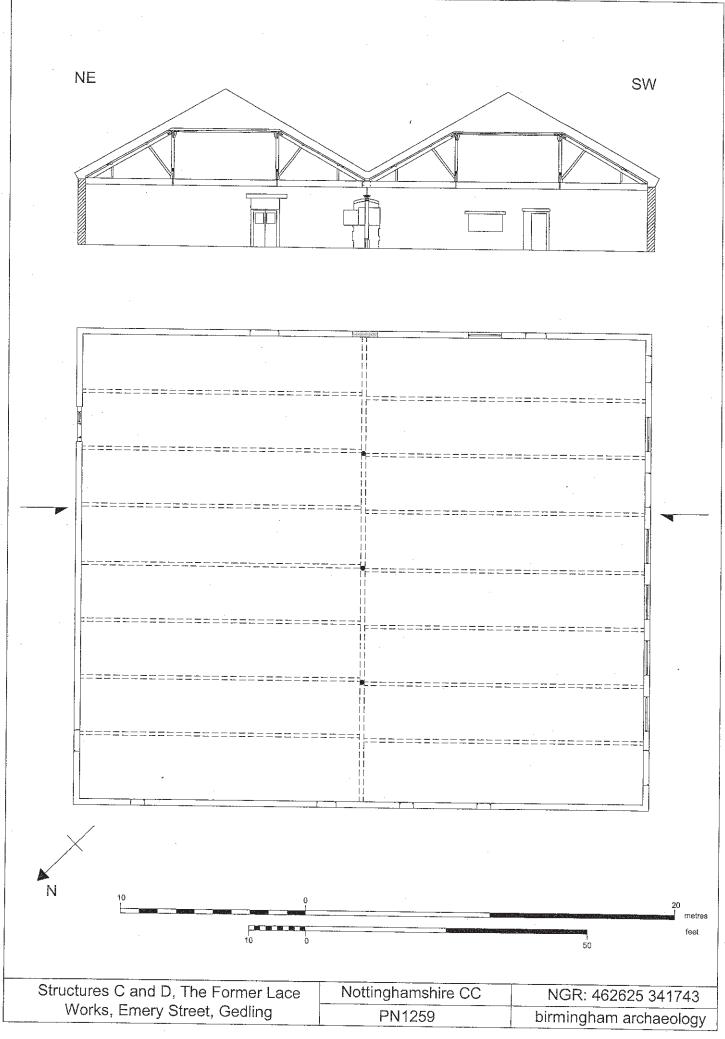
Fig. 8

Structure C/D (Figs. 8 & 9, Plates 3 & 6)

A large twin factory building with its principal façade to the south-east and facing the road. The building was constructed of red brick in English bond with eaves decoration that was identical to Structures A and B. Although the structure comprised two parallel ranges the entire interior was open plan.

The south-eastern façade consisted of twin gables that were undecorated. The opposing façade was identical in form. A large lunette with casement frame within dominated each gable with high circular lights either side that acted as vents. At the apex of the gable a small rectangular opening would appear to have been a pigeon loft. At ground level the façade had been obscured by the construction of modern toilets. The south-western and north-eastern elevations were of pier and panel construction. The piers were sloped and acted as buttresses to support the weight of the roof trusses above. Between the piers of the south-western elevation were three double-doorways and five large segmental-arched windows with 30-pane casement frames.

The interior was a large open space. Access to the building was via a double-doorway entrance and blocked access to Structure E in the south-eastern façade. To the south-west where three double-doorways that faced Structure A. A segmental-arched single-doorway led to the rear of the building. Later-cut doorways led to the toilet blocks at the rear of the building.

The roof of each structure was supported by seven roof trusses. These were in line with the buttress piers at the exterior walls and were supported in the centre by a large central I-Beam that ran north — south. Three cast-iron columns with octagonal bases and moulded capitals supported this (Fig. 10B). The trusses were constructed in pine and of simple queen-post design with the principal joints strengthened using iron straps.

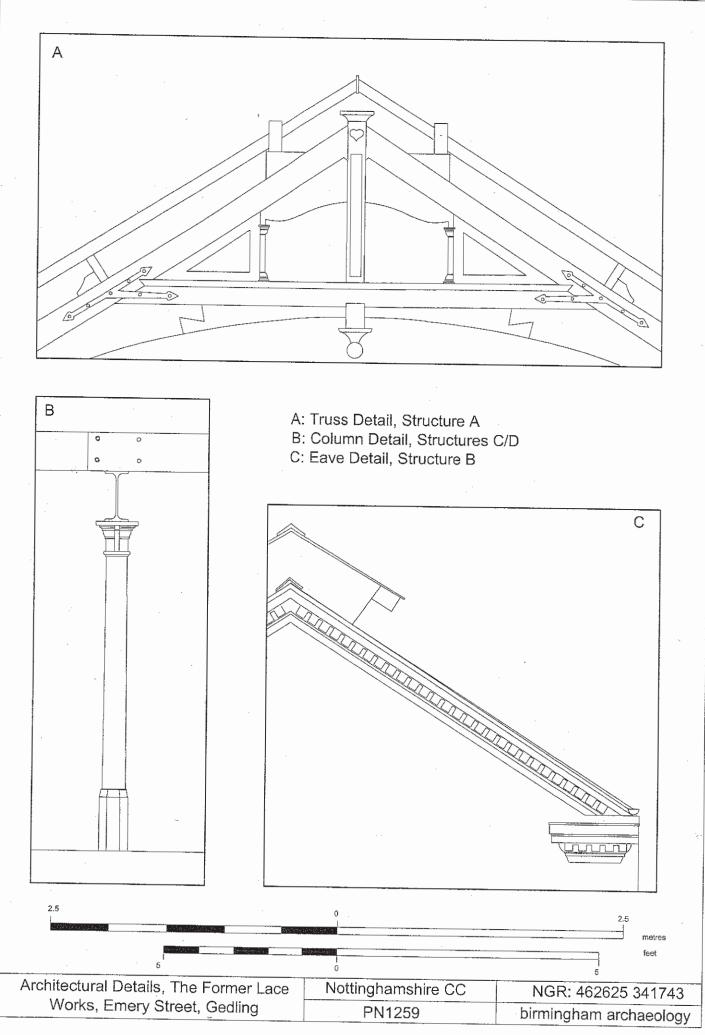
Fig. 10

The roof of Structure A was supported by three ornamented trusses (Fig. 10A). These were of king-post truss design with large arch braces and collar the strength augmented by a further tie-beam. The king-post was decorated with heart motif and globe pendants, and flanked by mock-columns on either side. The arch-braces were supported at the wall by sandstone corbels.

The constructional development of the buildings was also interesting. In the first instance construction is in brick with wood roof trusses. In the case of Structure A these are highly ornamented, particularly in view of the status of the building. This suggests that the facility to dye the lace in-house was a relatively recent development and therefore a prestigious element of the factory. By Phase 2 the use of steel trusses began to be used. These were stronger and lighter therefore allowing greater spans whilst reducing stresses on the load-bearing walls. By Phase 3 these had been abandoned completely and girder posts were being used removing the majority of the load from the brick-wall and reducing this to a shell for the construction of the factory building. These were the early examples of the box-girder construction buildings that are common today.

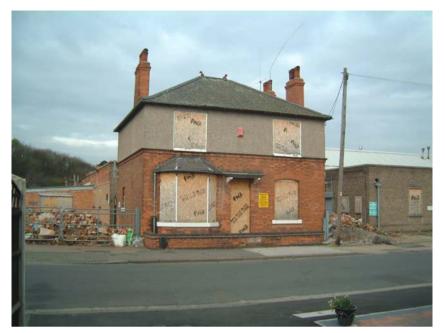
Plate 7

Two-storey Edwardian period house that faces Emerys Road. Constructed in red-brick in Flemish bond, the upper storey was pebble-dash rendered. Access to the building was unavailable so the plan is unknown. Principle façade faced the street and consisted of two bays with a central doorway. The ground-floor openings were a hipped-roof bay window, the central doorway with projecting roof-hood and a segmental-arched window with terracotta voussoirs. The first floor had two windows both boarded. The roof was hipped with three tall chimney stacks, two pots on each stack. The other façades were plain with minimal decoration.

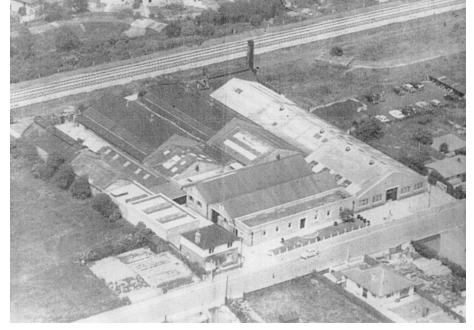
Plate 8 Plate 9

The site was taken over by Speedo International Limited in the late-1960s and began to produce swim-wear (Plate 9). They expanded the site until it incorporated its present size.
