# EXCAVATIONS AT BEESTON CASTLE 1975-1977

by P. R. Hough, B.A.

Excavations on behalf of the Department of the Environment have taken place at Beeston Castle (N.G.R. SJ 537593) to expose the causeway wall to the inner ward and to investigate the filling in of the inner ditch. Several phases of collapse and repair of the wall during medieval times have been identified. Civil War deposits have produced a small but useful group of pottery and clay pipes.

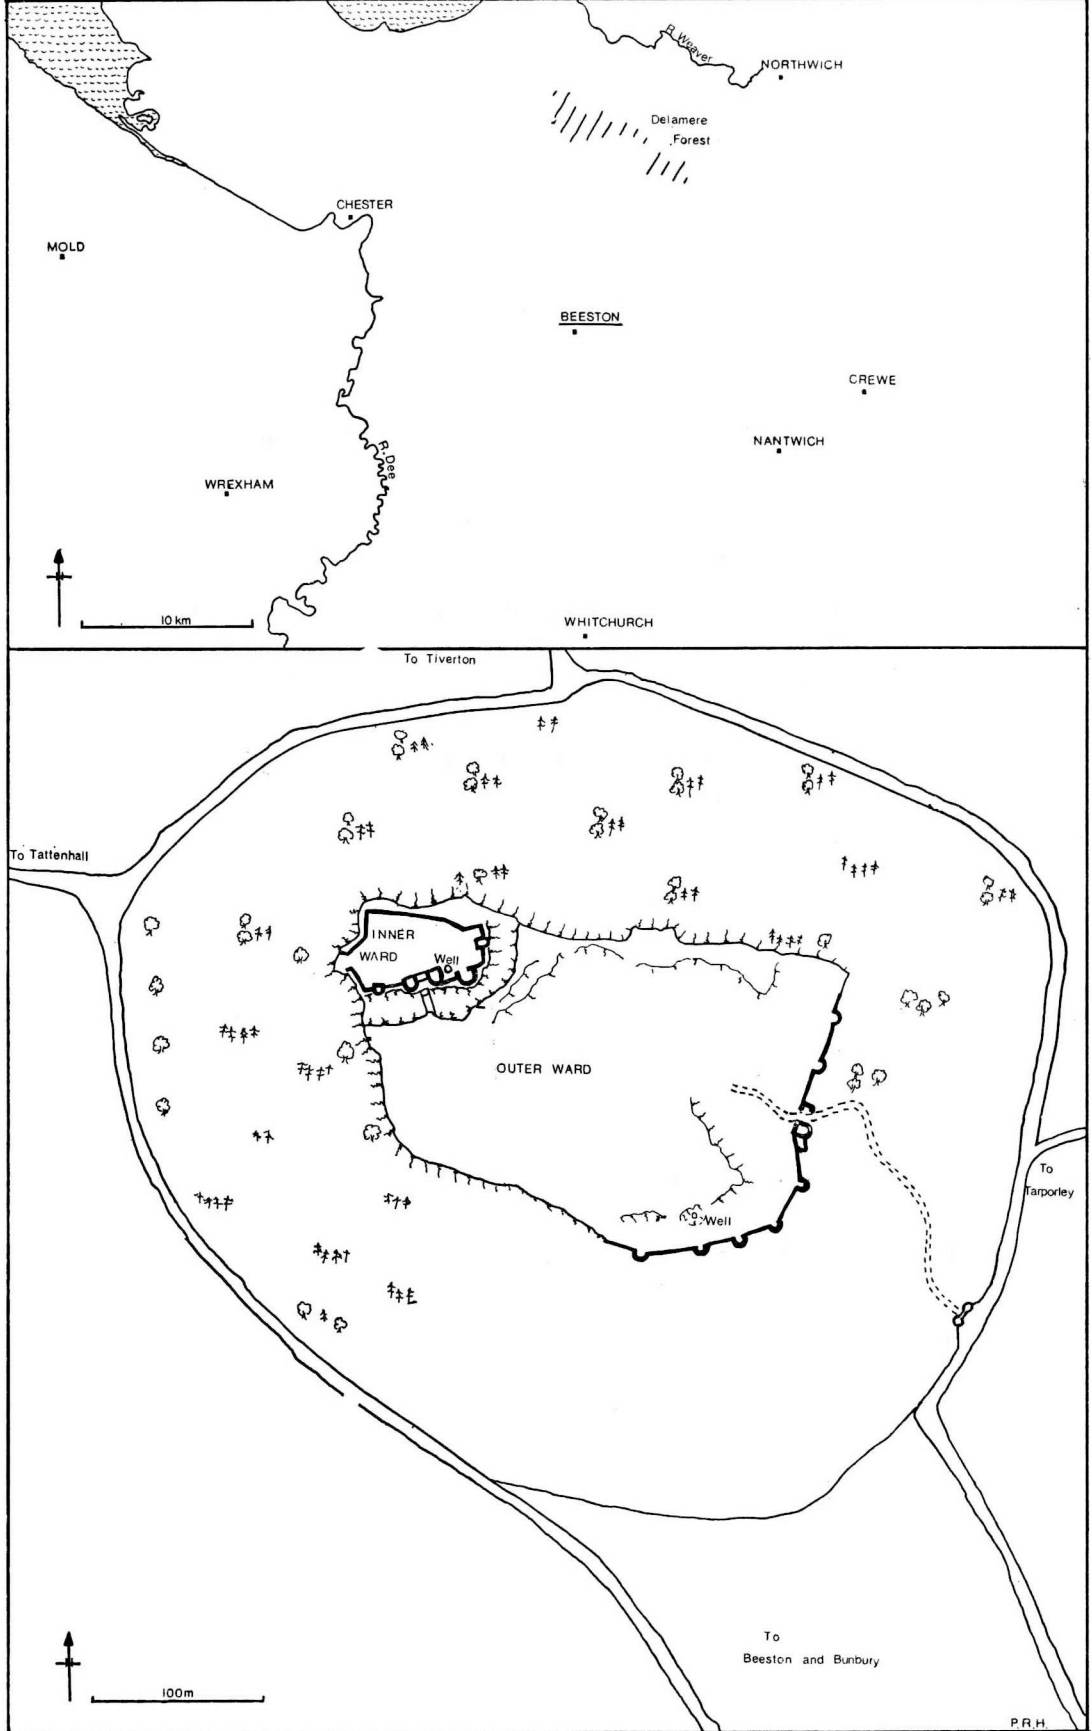
Fig. 1 — Site location map and plan of the castle

Beeston Castle is situated on a sandstone crag at the northern end of the Peckforton Hills, some twelve miles south east of Chester. It is in an excellent strategic position, providing distant views across the surrounding countryside in almost every direction, and has exceptional natural defences. To complete the defence of the hill the medieval castle incorporated an inner and an outer curtain wall, each with a deep rock cut ditch. The castle forms an imposing focus in the landscape, placed precipitously some 90m above the immediate countryside, a total of 140m above sea level (fig. 1).

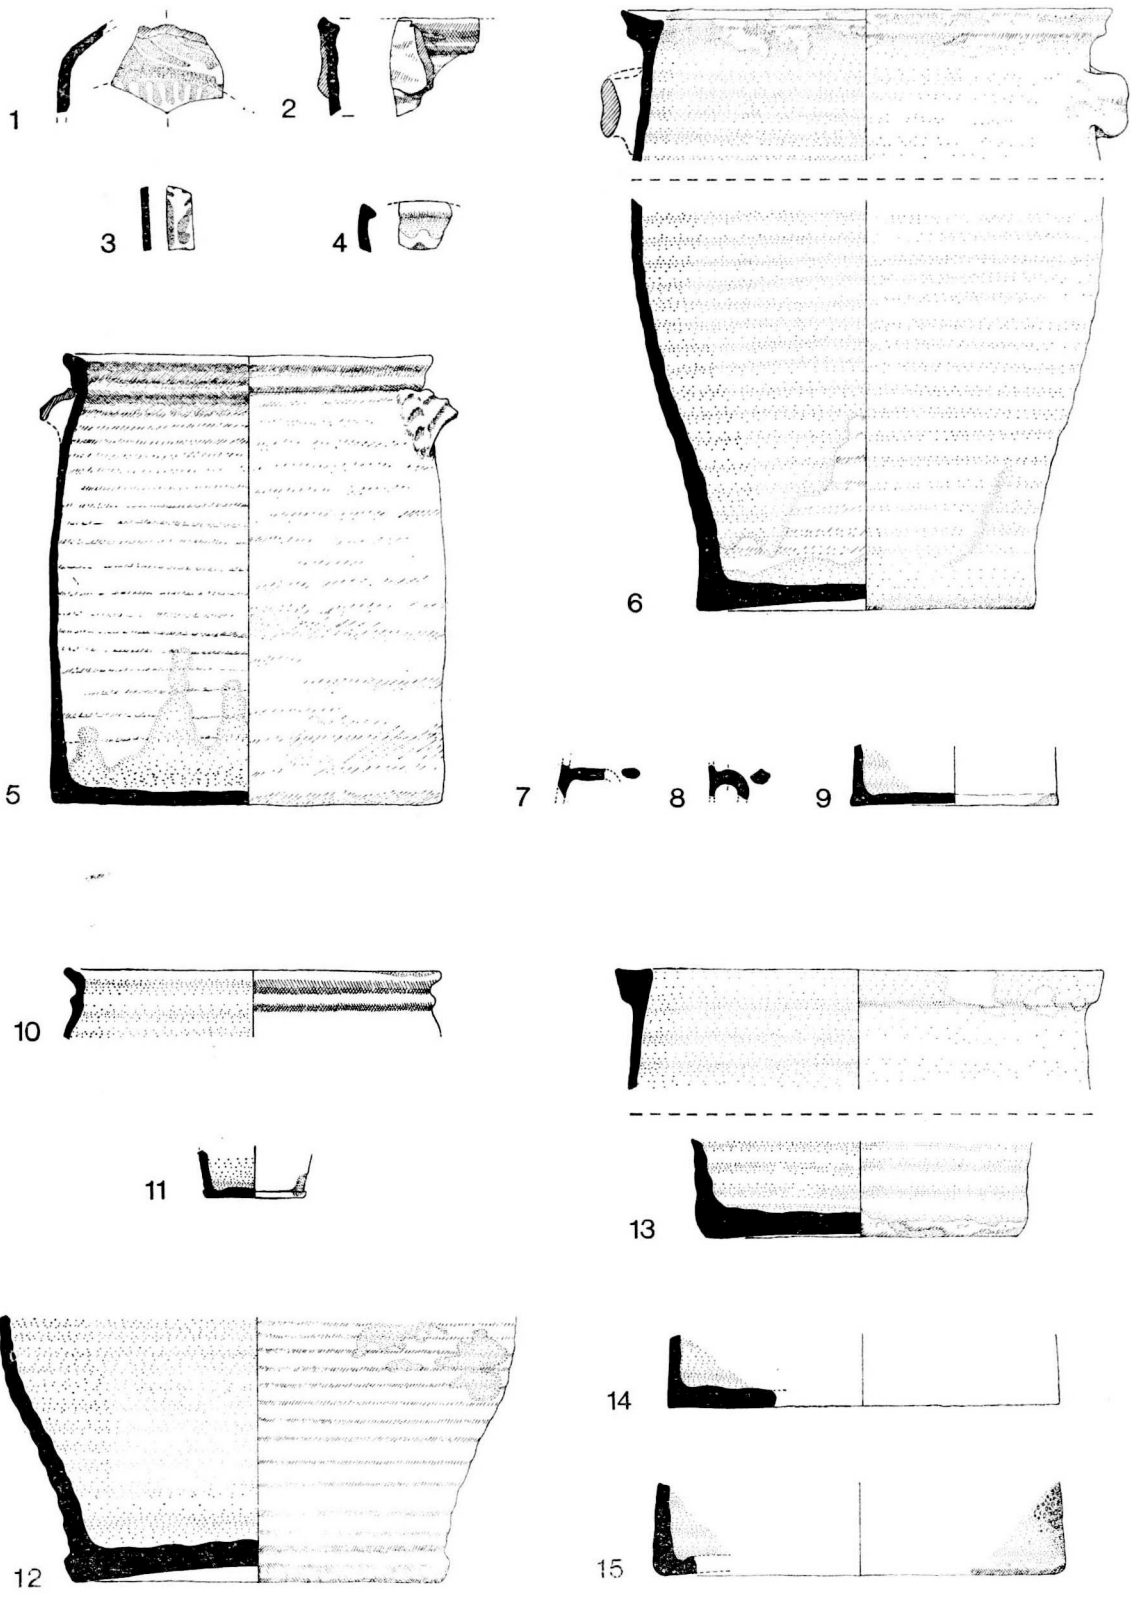
Fig. 1 — Post medieval pottery.  
 Nos. 1-9 Civil War occupation; Nos. 10-15 Civil War demolition ( $\times \frac{1}{4}$ )

- (i) Civil War occupation layers, including layers thought to be associated with the refurbishing of the defences of the castle (fig. 1, nos. 1-9).
- (ii) Civil War demolition layers (fig. 1, nos. 10-15).
- (iii) Upper Civil War demolition layers. These include layers which may have been disturbed (fig. 2, nos. 16-19).
- (iv) Post Civil War levels. These include pottery from later layers, and sherds which are unstratified, but from these layers only pottery of a similar type to the main Civil War group has been illustrated or described (fig. 2, nos. 20-33).

'Butter' or 'bread pot' (fig. 1, nos. 2, 5, 10, 14, 15; fig. 2, nos. 16, 18, 21, 25, 26, 31, 32)

Two nearly complete vessels exemplify this type (nos. 5 and 16). These were of a very hard, highly fired fabric, with an internal iron glaze and two applied handles.

*Two Handed Storage Vessel* (fig. 1, nos. 6, 12 and 13; fig. 2, no. 20)

Four vessels were identified. Two were almost complete (nos. 6 and 13). One was identified by a single rim sherd (no. 20), and another by large fragments of its base (no. 12).

Fig. 1, no. 9: a base sherd similar in form and fabric to the 'butter' or 'bread pots' but smaller. It had an internal brownish glaze on the base over a purple slip and was of a fine orange to grey dense fabric.

Fig. 1, no. 7: a handle sherd of a small glossy iron glazed vessel of a well fired dense orange to brown fabric.

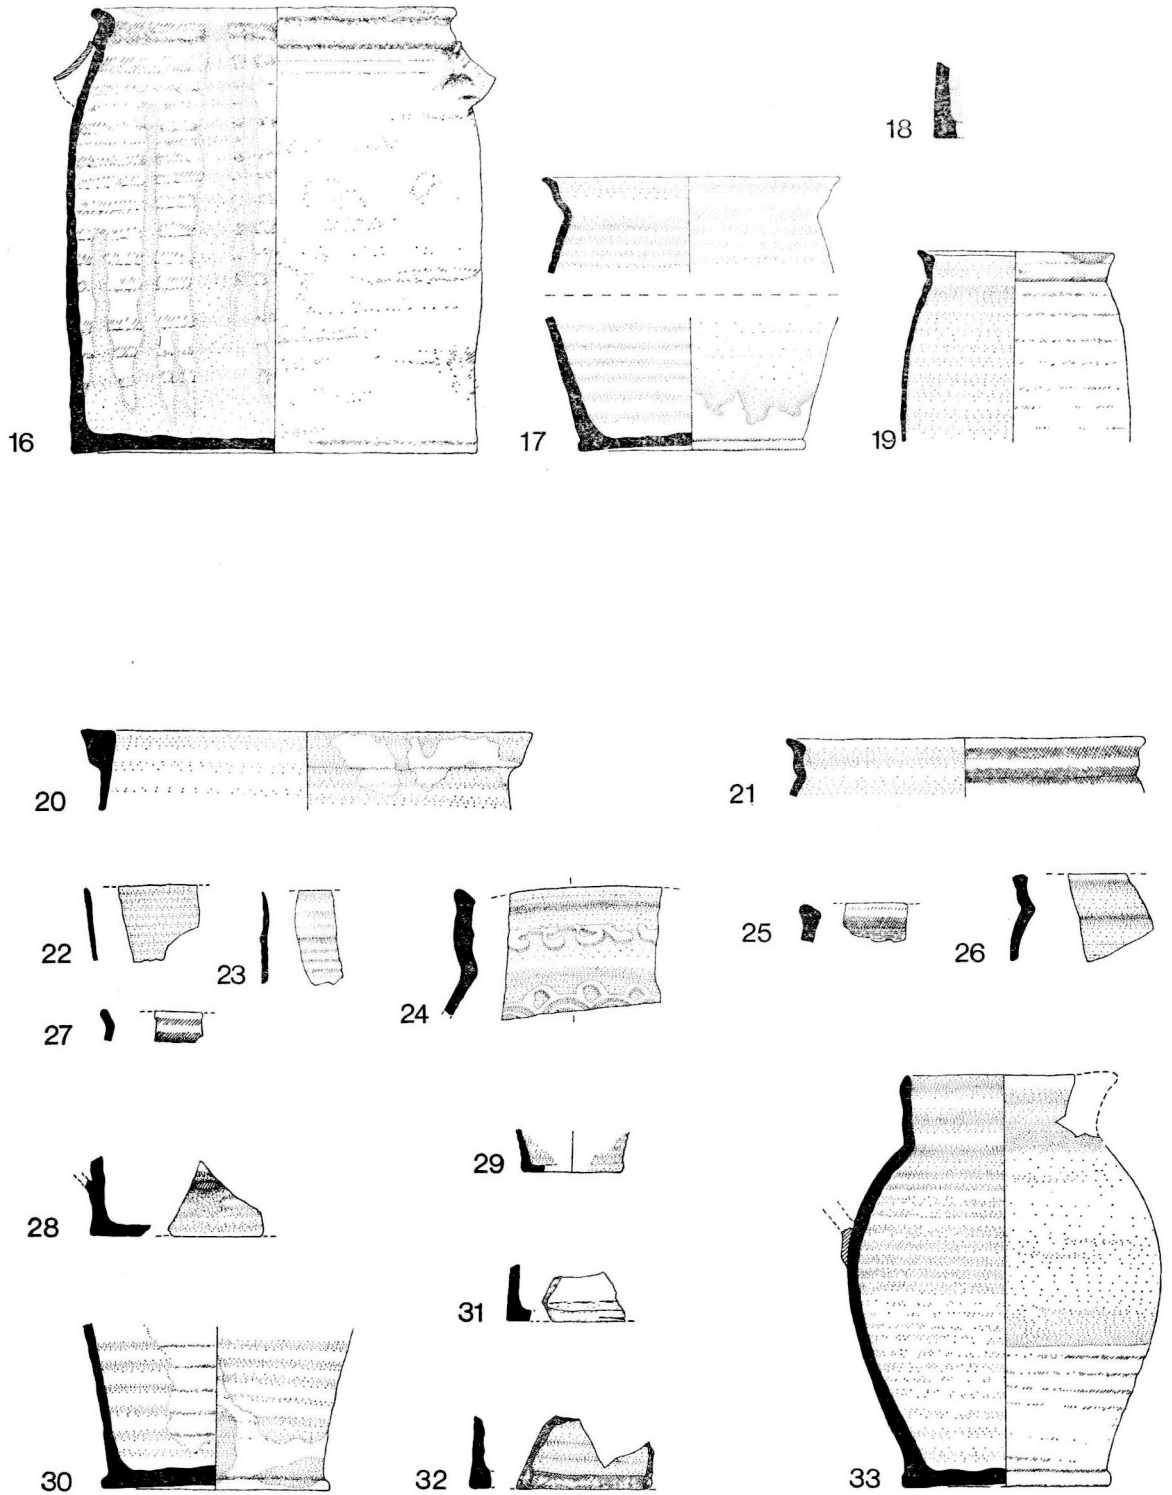
Fig. 2 — Post medieval pottery.  
 Nos. 16-19 Upper Civil War demolition; Nos. 20-33 Post Civil War ( $\times \frac{1}{4}$ )

*Small Jar* (fig. 2, nos. 17 and 27)

Two examples were identified by their rim form and fine all over iron glaze. One of these was represented by a single rim sherd (no. 27). The more complete vessel had a rounded profile and an everted rim. The glaze had been evenly applied but had a slightly mottled appearance. The purple to brown fabric was highly fired and very hard and pure.

Fig. 2, no. 19: a rim sherd similar in form and fabric to the 'butter' or 'bread pots', but smaller. It was finely finished with a thin walled body, an internal purple slip and a patchy brownish glaze. It was of a fine hard orange fabric.

#### *An Iron Glazed Jug* (fig. 2, no. 33)

shoulder of the vessel, were missing. The fine glaze was glossy and thickly applied internally and externally, although it stopped approximately 80mm short of the base on the outside. The light brown to orange fabric was highly fired with occasional streaky impurities.

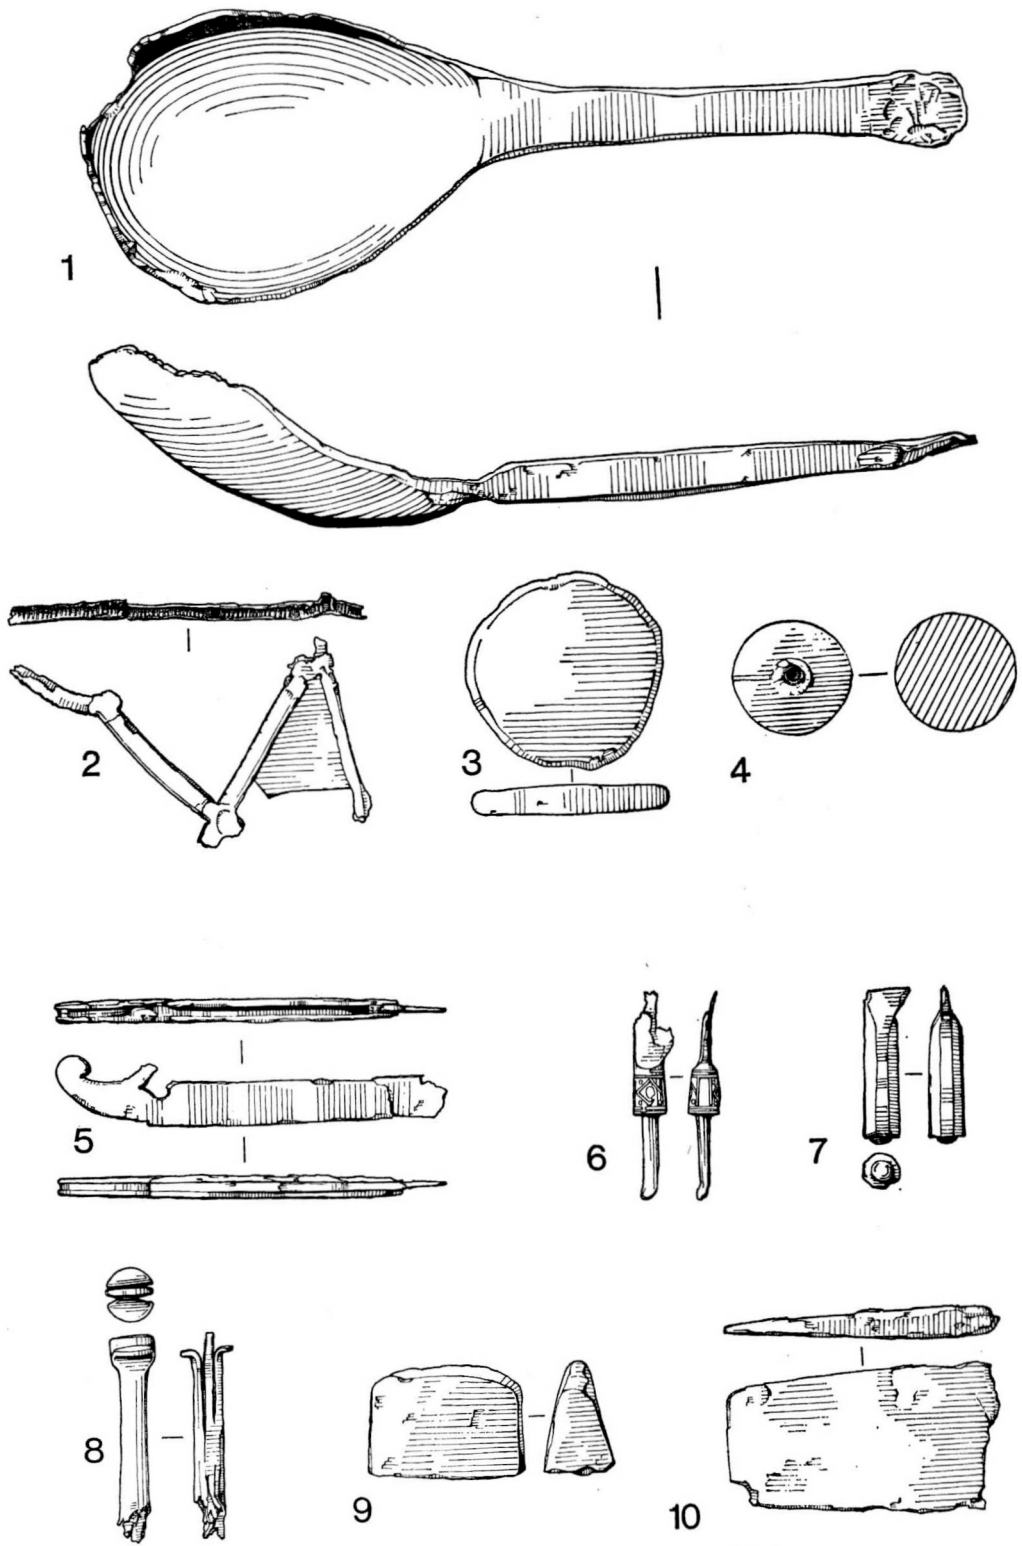
Fig. 1 — Nos. 1-4 Lead ( $\times 1$ ); Nos. 5-10 Iron ( $\times \frac{1}{2}$ )

1 Crudely made lead spoon. It appears to have been made from a sheet of lead roughly cut to shape, leaving an elliptical section for the handle which was folded over and hammered into a rectangular cross section. Context: top of Civil War demolition.

2 Window lead including a small piece of green opaque glass fitting into one corner. The glass is nearly 2mm. thick. The lead is H sectioned and machine made, with marks of the mill teeth in the web. The quarry would have been approximately 50 by 50 by 70mm., forming a right angled isosceles triangle. The adjacent piece of glass would have been approximately 50mm. square. Context: top of Civil War demolition.

- 3 Crude lead disc, 31mm in diameter and 3-4mm thick. Context: Civil War occupation level.
- 4 Lead musket ball, 18mm in diameter, weighing 39g. It has a prominent casting sprue and mould line, and has not been fired. Context: top of Civil War demolition.

- 9 Thin iron wedge. Context: upper causeway collapse.
- 10 Iron wedge or broken hammer-head. Context: earlier medieval levels.
