THE DEFENCES OF ROMAN CHESTER:
DISCOVERIES MADE ON THE EAST WALL, 1983

by T. J. Strickland, M.A., M.I.F.A.

THE EAST WALL CHESTER 1983

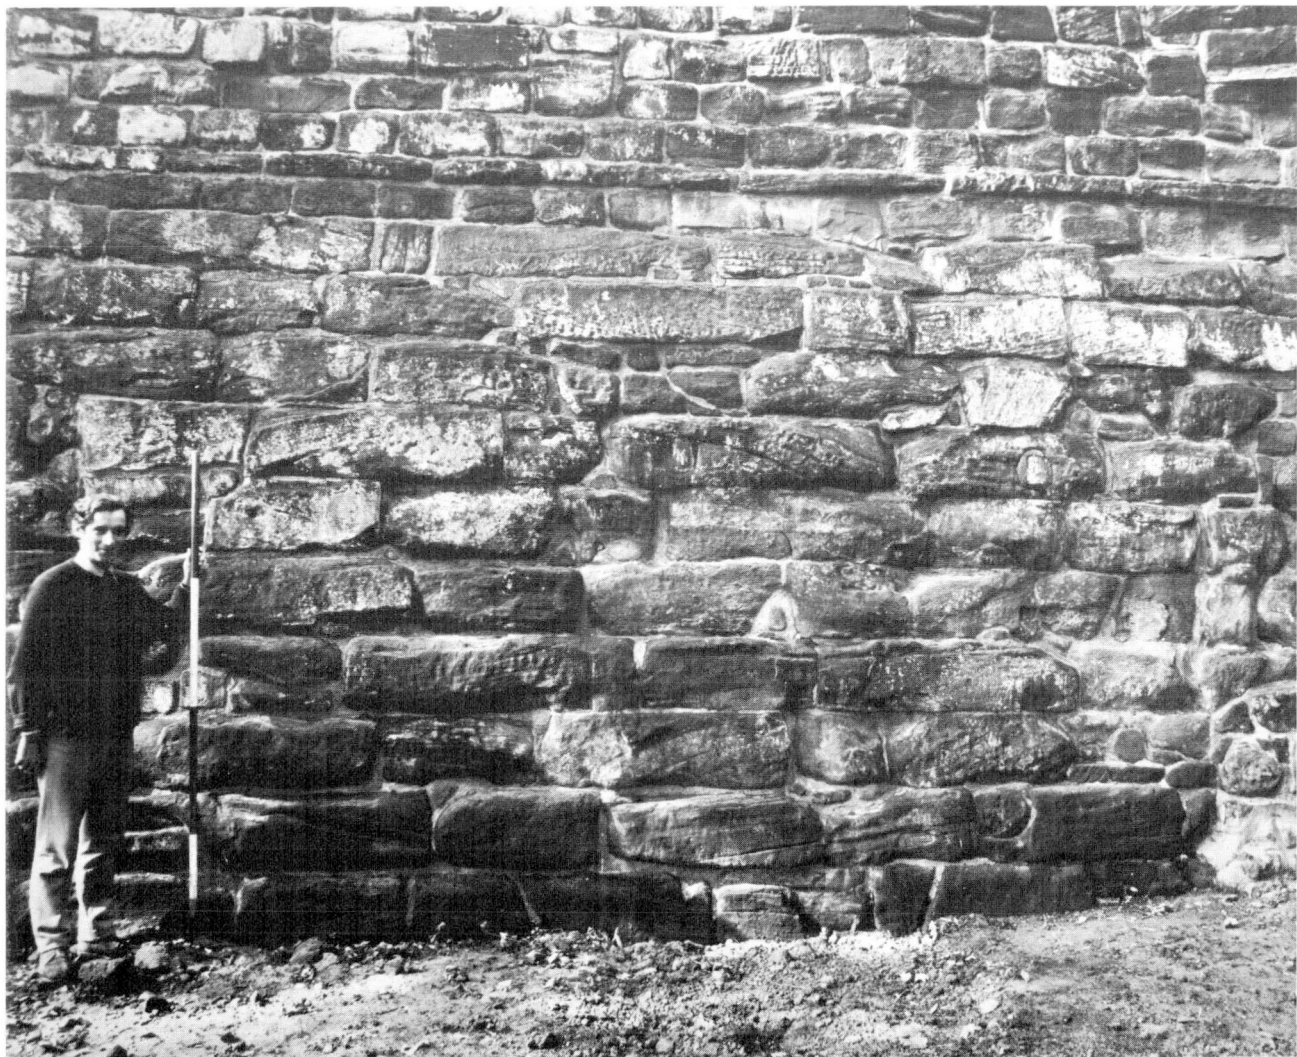
Plate 1 — The East face of the City Wall approximately fifty metres North of the Kaleyad Gate. Although worn, damaged and subsequently repaired in modern times, the characteristic Roman masonry is clearly visible. (Two metre scale).

Approximately fifty metres to the North of the Kaleyad Gate, and visible above ground in the outer face of the City Wall, are ten courses of Roman masonry identical to that present in the North Wall and already described by the author (Strickland, 1982, 26-32). The trench subsequently excavated against the base of the wall revealed an additional three courses of the same masonry, set on the well known chamfered plinth and base course. Like the masonry in the North Wall, this also has slipped backwards but can be seen, at a glance, to have been vertical originally. On this occasion, examination of the rear face of the structure, where it lies buried within the top of the City Wall, confirmed that the facing blocks are only about 0.70m thick, somewhat narrower than was suggested in 1982 (Strickland, 1982, figs. 1 and 2, 26-27). Excavation to the rear of No. 6 St. John Street in 1973 had already shown that the wall facing blocks in that area were similar to those North of the Kaleyad Gate (e.g. Strickland, 1982, pl. 4). It must, therefore, be supposed that, in general, the wall was far too narrow to be anything more than a stone facing constructed at the front of the earlier rampart, which was simply adapted to accommodate it.

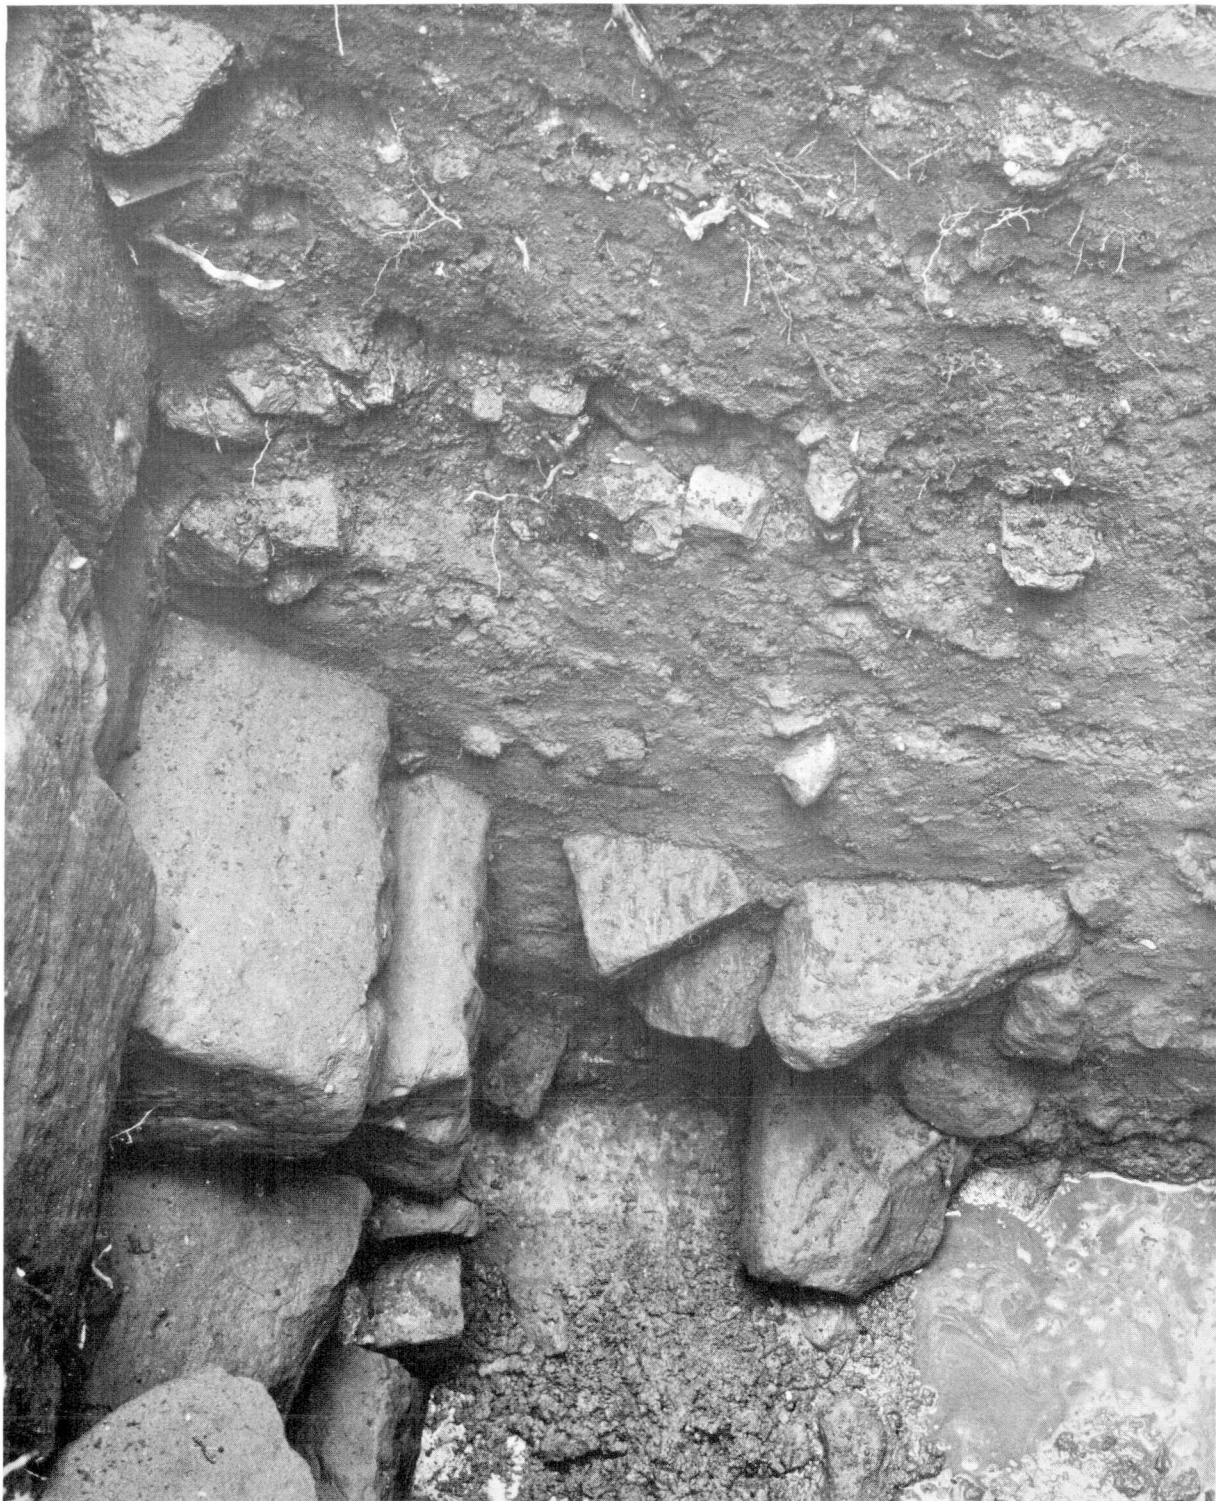
Plate 2 — Close up view of the lower courses of Roman masonry (at left) exposed in a trench fifty three metres North of the Kaleyad Gate. Note particularly the chamfered plinth base course, the earliest visible berm surface below, and the reused Roman masonry incorporated in the raised berm, contemporary with the chamfered plinth.

That the new berm was contemporary with the existing Roman wall is strongly suggested by its level, which coincides with the top of the base course for the wall; precisely the level at which one would expect it to have been constructed. This is confirmed by the unweathered condition of the wall masonry below, whereas above this level the upper surface of the base course, adjacent to the plinth, is worn from use and exposure to the weather. Further, the uppermost surfaces of the reused rubble, where they coincide with the surface of the new berm, are also worn from the same causes. On this interpretation, then, the existing wall, and hence also the earliest visible Roman masonry in the North Wall, must have been constructed after c. A.D. 150. Thus it remains possible to argue that the date of construction of this particular curtain wall was c. A.D. 200 as the writer has already suggested (Strickland, 1982, 34-35).⁴

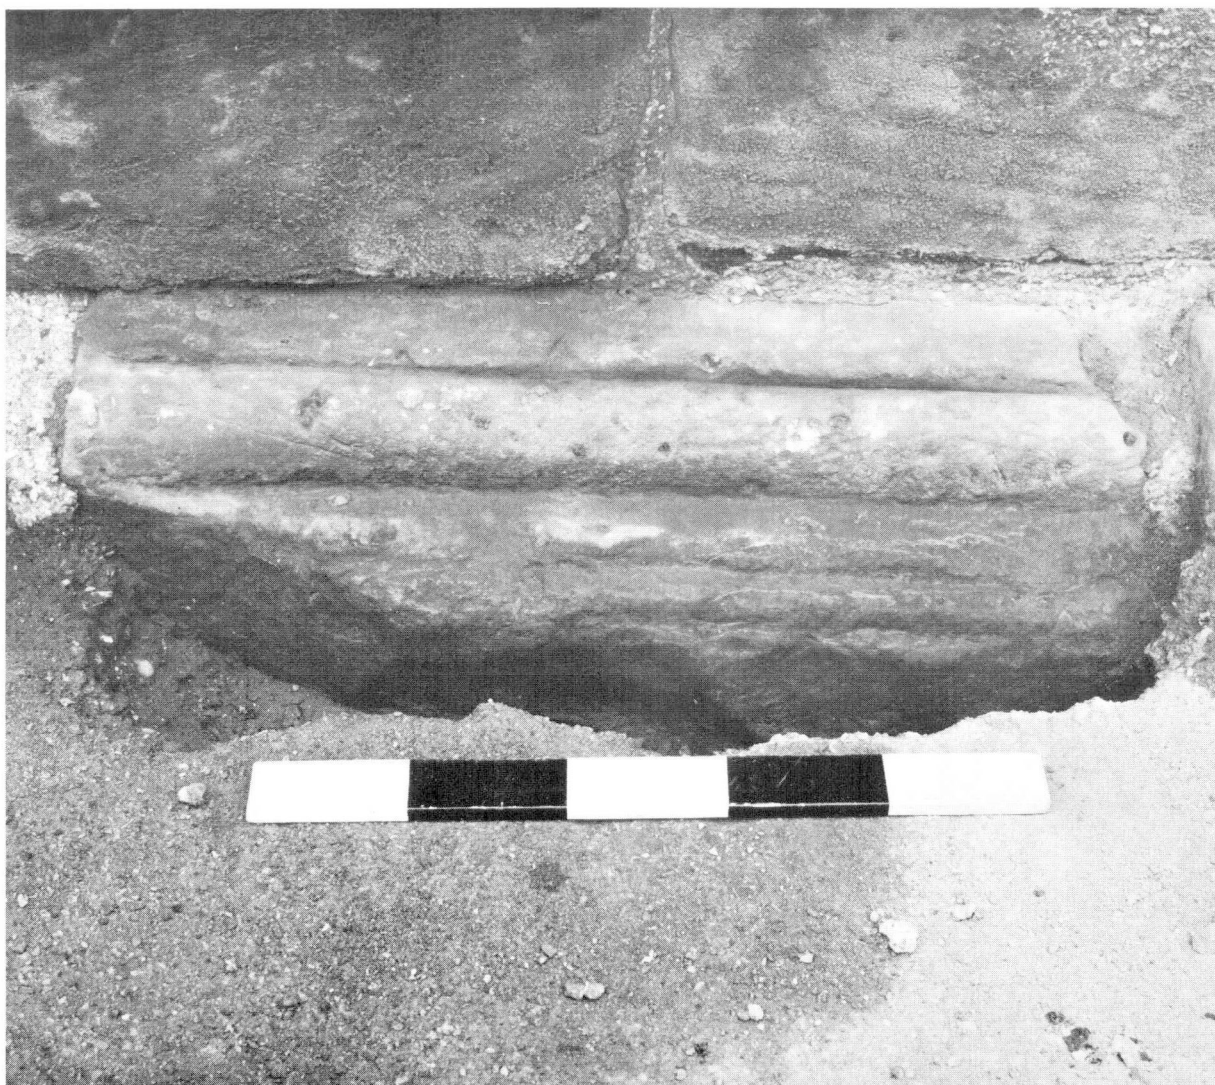
Plate 3 — Damaged cornice fragment, originally from the Roman wall and reused in the footings of the City Wall (Point B on Fig. 1). (Half metre scale).

On the North Wall it was possible to demonstrate that the Roman decorative cornice and parapet structure were set on thirteen courses of masonry and it may, therefore, be assumed that the identical masonry in the East Wall (also thirteen courses excluding plinth and footings) lacks only the cornice and parapet. Fortunately, a fragment, recognisable as wall cornice, was found close by, reused in the inner face of the City Wall. This is identical to the cornice which remains *in situ* in the North Wall, near the Northgate, and its discovery makes possible the conclusion that the East Wall was of similar design.²
