WATLING STREET SOUTH OF CHESTER

by A. C. Waddelove, B.A., and E. Waddelove

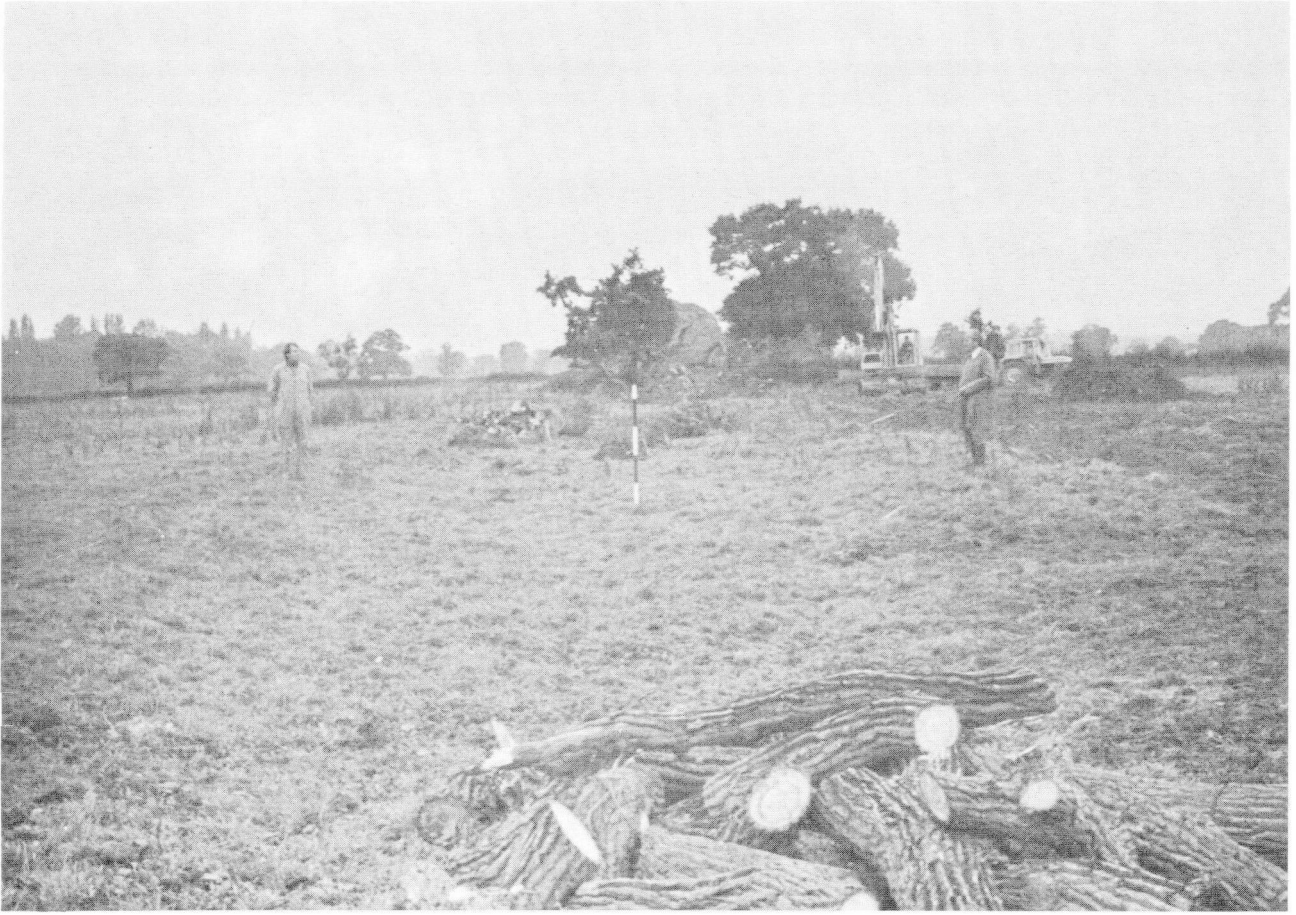
Plate 1 — The two causeways looking North (imperial scale).

The excavation was located at grid reference SJ 42995691 where there had been little disturbance by the recent operations. The field had been thrown up into rigg and furr in an approximately North East to South West direction, with one rigg running across the ends, parallel to the causeway of the road and more conspicuous than it. A slight depression, in which the oaks marking the western side had been growing, separated the two (Plate 1).

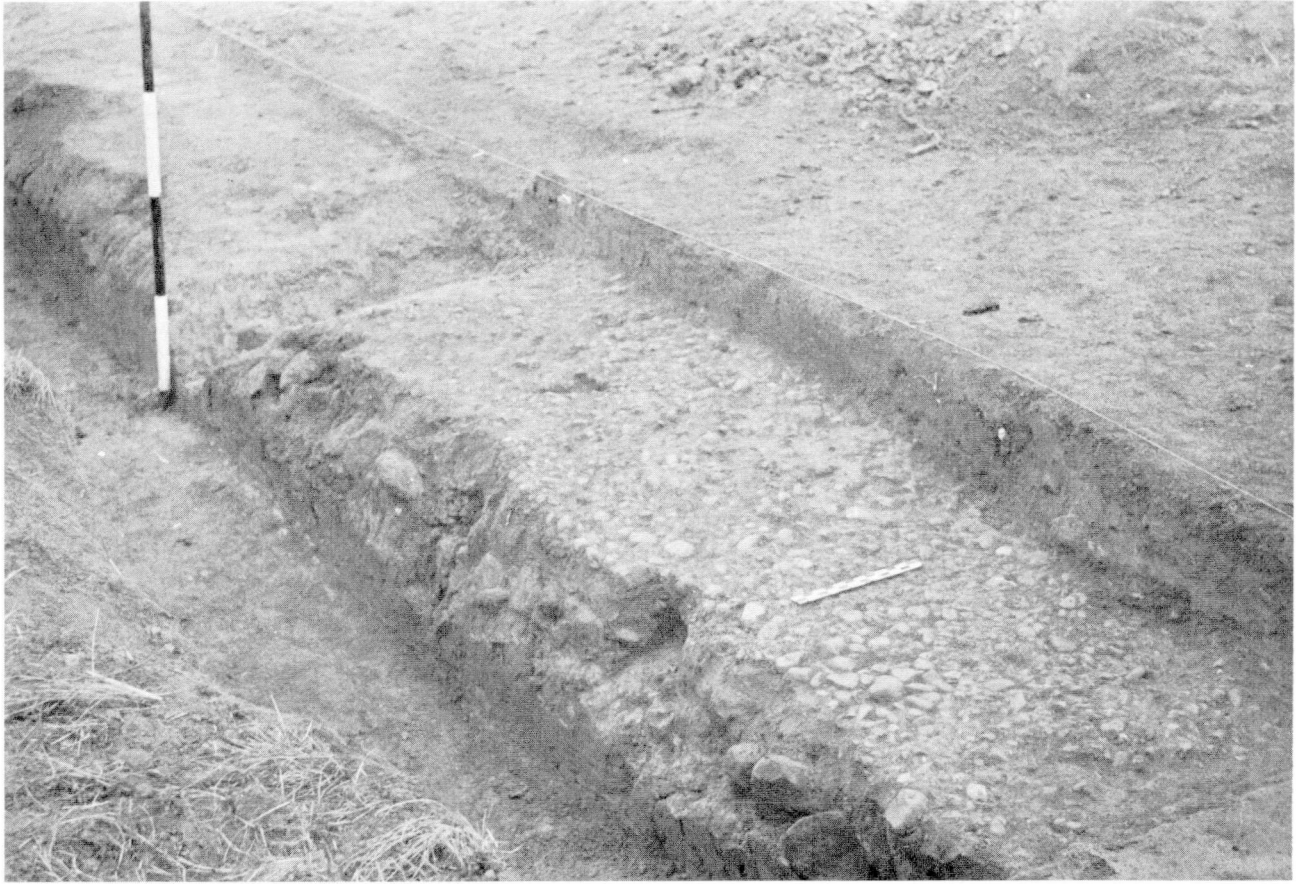
Plate 2 — The pebble surface of Road II on the sandstone blocks (imperial scale).
