III: Archaeological Investigations at Tilston's Yard, New Crane Street, Chester

by George Nash, Pete Owen and Gerry Martin

Introduction: A Very Busy Place

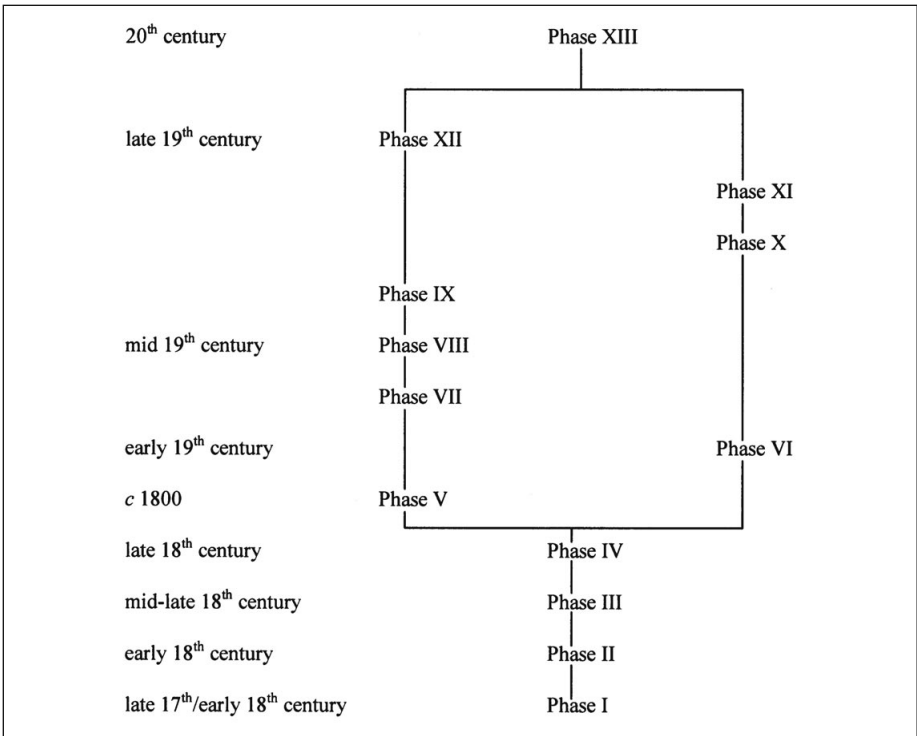
III III. 2: Development of the site from the late seventeenth/early eighteenth century (Phase I) to the twentieth century (Phase XIII)

It was clear from the archaeological deposits, features and structures recorded within the bounds of the site that a complex stratigraphic sequence of construction and refurbishment events was present. Thirteen phases relating to the use and occupation of the site were revealed by the excavation, starting in the late seventeenth/early eighteenth century (III. III.2). Complementing this sequence was a small, but significant, artefact assemblage.

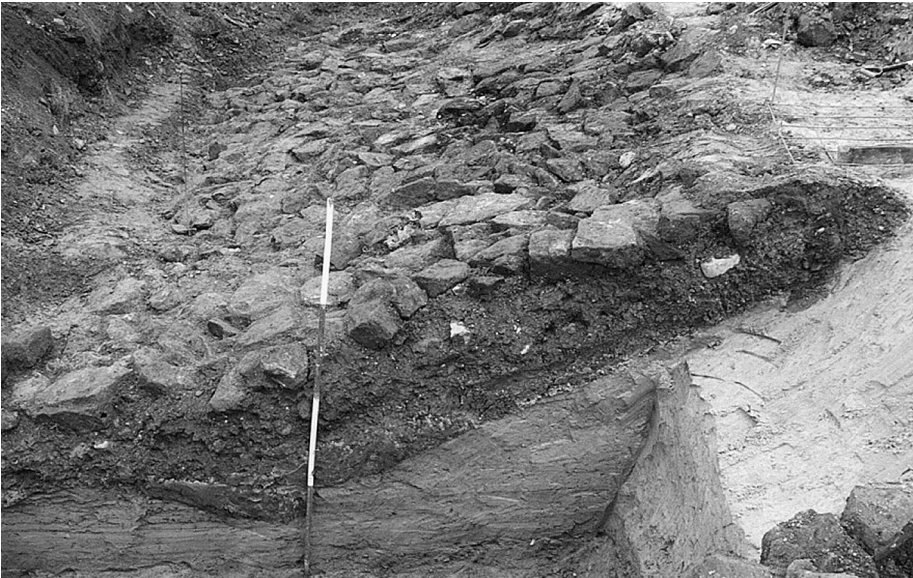
Ill. III.5: View of the Cop and sub-surface deposits in the northern section (see Ill. III.4, Section A)

In the northern section (Ill. III.4) a sandstone facing (143), consisting of roughly hewn interlocking sandstone blocks, up to 0.9m long, at a pitch of approximately 40 degrees was revealed (Ills III.5 and III.6). The blocks were grouted into a clay membrane (144) and (154). The existing river bank had been partially excavated (145) in order to accommodate this defensive work. The sandstone facing stood to a height of 5.8m OD and at its lowest reach was 4m OD, accommodating the tidal range. The clay membrane, (144) and (154), probably formed a water-proof lining and prevented the undermining of the structure. The stone facing (143) was incorporated into the wharf construction (Phase VIII), which helps to explain its preservation. In the southern section the Cop consisted of an earthen bank with only vestigial traces of a sandstone casing. A capping membrane of clay, forming a dome above up-cast silts and sands (67), (87) and (90), stood to a height of approximately 5.8m OD.

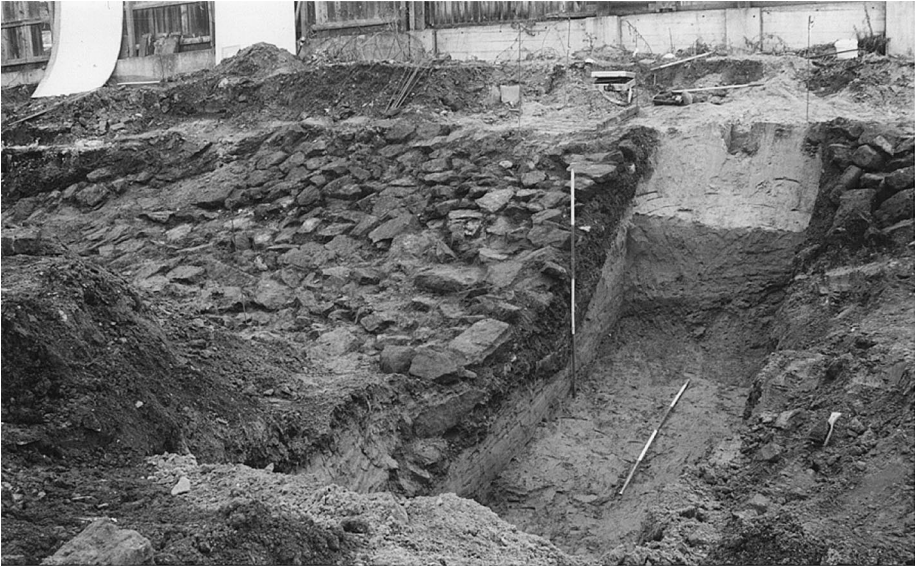
III. III.6: View of the Cop and sub-surface deposits looking east

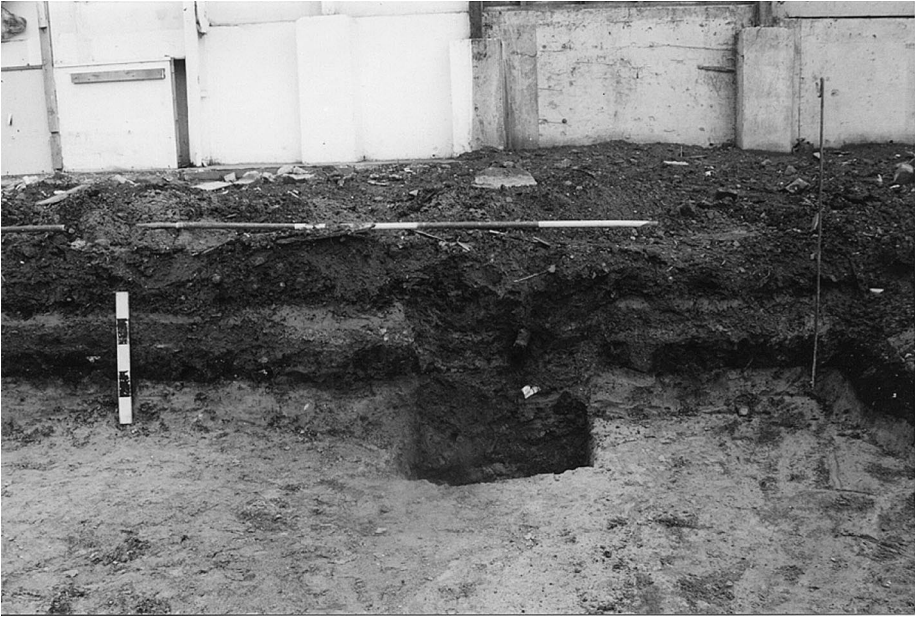
III. III.7: View of trench section looking east with post hole (12) and contexts (33) – (38) showing mid to late nineteenth century building activity

Located within the southern area of the site were the slight remains of a possible structure. It was represented by a clay layer (35) measuring at least 7m by 11m, with its long axis orientated east-west, and a single remaining post hole (40). The full extent of this structure within the excavated area could not be established as the clay layer was partially removed during the site clearance by a mechanical digger. The clay surface appeared to respect the line of a later trench (19) (Phase IX) and probably continued to the edge of Dee Lock, just beyond the limit of excavation. This structure was probably destroyed by a flood, represented by a deposit of silty sand (34) and a spread of slate debris (33). This layer of slate

was cut by post-holes (12) and (31) (both from Phase XIII) and trench (19) (from Phase IX) (III. III.7).

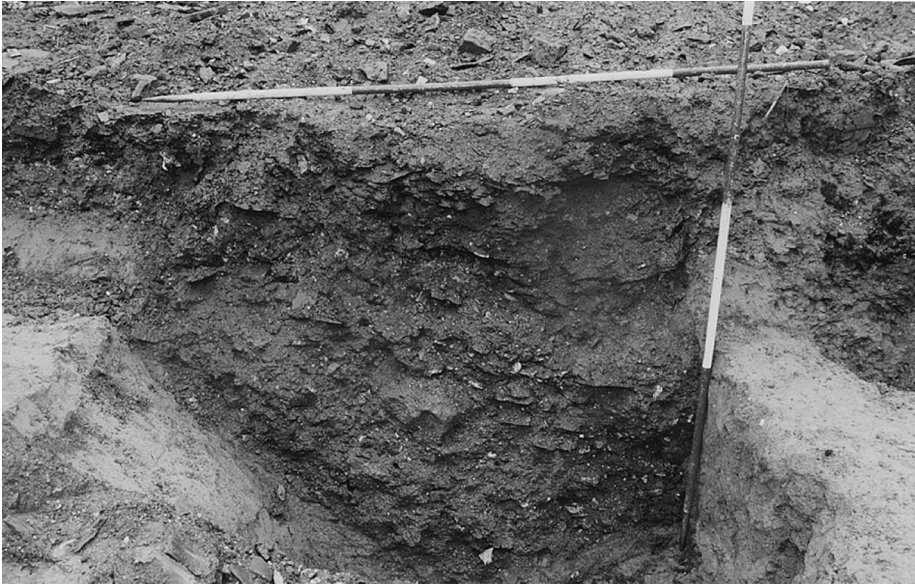
III. III.8: East facing view of (23) showing an extensive pottery deposit

Located in the southern part of the site was an east-west aligned trench (19), considered to be a drain, which had probably been timber-lined (revetted by planking and fastened by upright timber posts) and an open feature. Its course terminated at, rather than running directly into, the river. Any wood lining had been removed when the feature was backfilled in the mid nineteenth century. A large assemblage of pottery was found in one of the fills, comprised of black gritty sand (23) (III. III.8).

or insecure contexts, in particular, the assemblage from context (23), which derives from a dumping deposit and is, therefore, not within a primary *in-situ* layer (III. III.8). A small number of residual Roman sherds were also recovered.

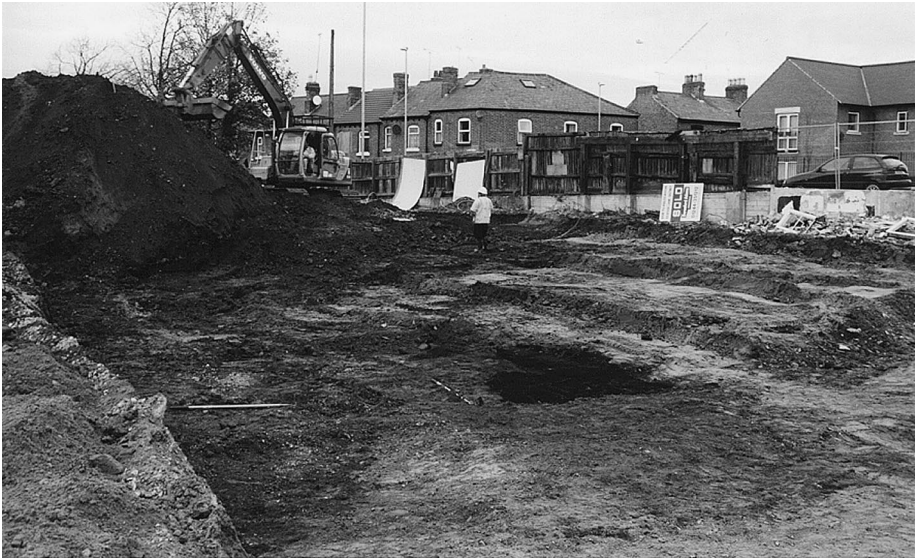
III. III.9: The build-up of debris over the wharf/slipway

Beneath the site demolition clearance level (1) (Phase XIII) evidence was found of the systematic infilling of the wharf/slipway, represented by layers (128)–(140). These deposits consisted mainly of dumps of building rubble from neighbouring slate yards and demol-

ished brick buildings, together with a deposit of coal and ash (136) (III. III.9). Much of this material was dumped from the road to the east. Some of the building rubble appears to have come from elsewhere in the city because of the inclusion of Roman pottery.

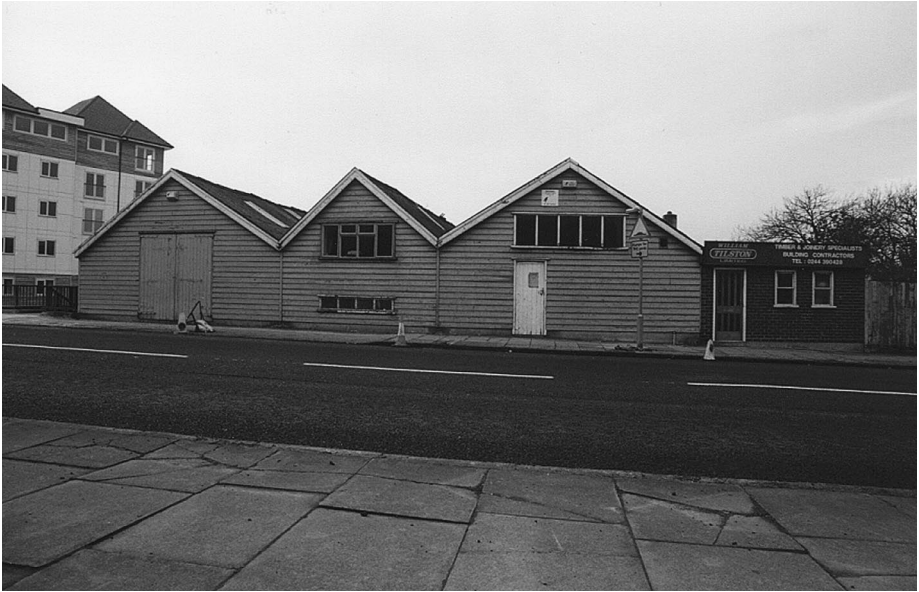
III. III.11: The New Crane Street frontage of Tilston's Boat Yard

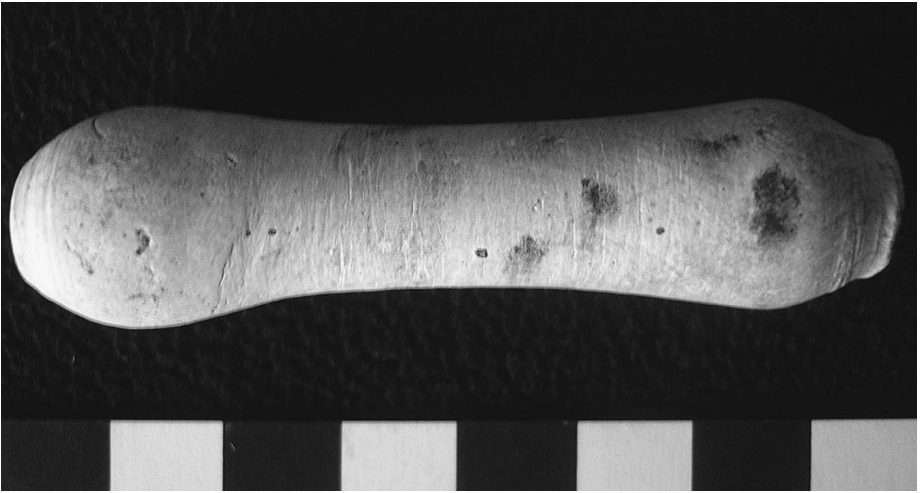
III. III.12: Mid to late eighteenth century ceramic wig curler

The other notable element of the assemblage was a group of eleven complete wig curlers from context (6). All of these curlers were of ‘dumb-bell’ shape, but none bore makers’ marks or stamps. By analogy with previous finds from Chester they are likely to date to c.1750–80 (Rutter & Davey 1980, 263–266). It is possible that all of these curlers are derived from a single wig, which did not survive in the archaeological record (III. III.12).
