## IV: The River Dee, Roodee Cop and the Workhouse: Recent Excavations

by Blair S. Poole

Between 2001 and 2005 L-P: Archaeology investigated a series of sites in the old port and Roodee areas of Chester, extending from the Grosvenor Bridge in the south to the Cop Recreational Ground at Sealand Road in the north. These investigations have contributed significant information about the changing course of the River Dee, the city's attempts to control the flooding at the port and Roodee areas and the construction of port installations. In addition, considerable light has been shed on the structural remains of Chester's first workhouse, which lay adjacent to the port.

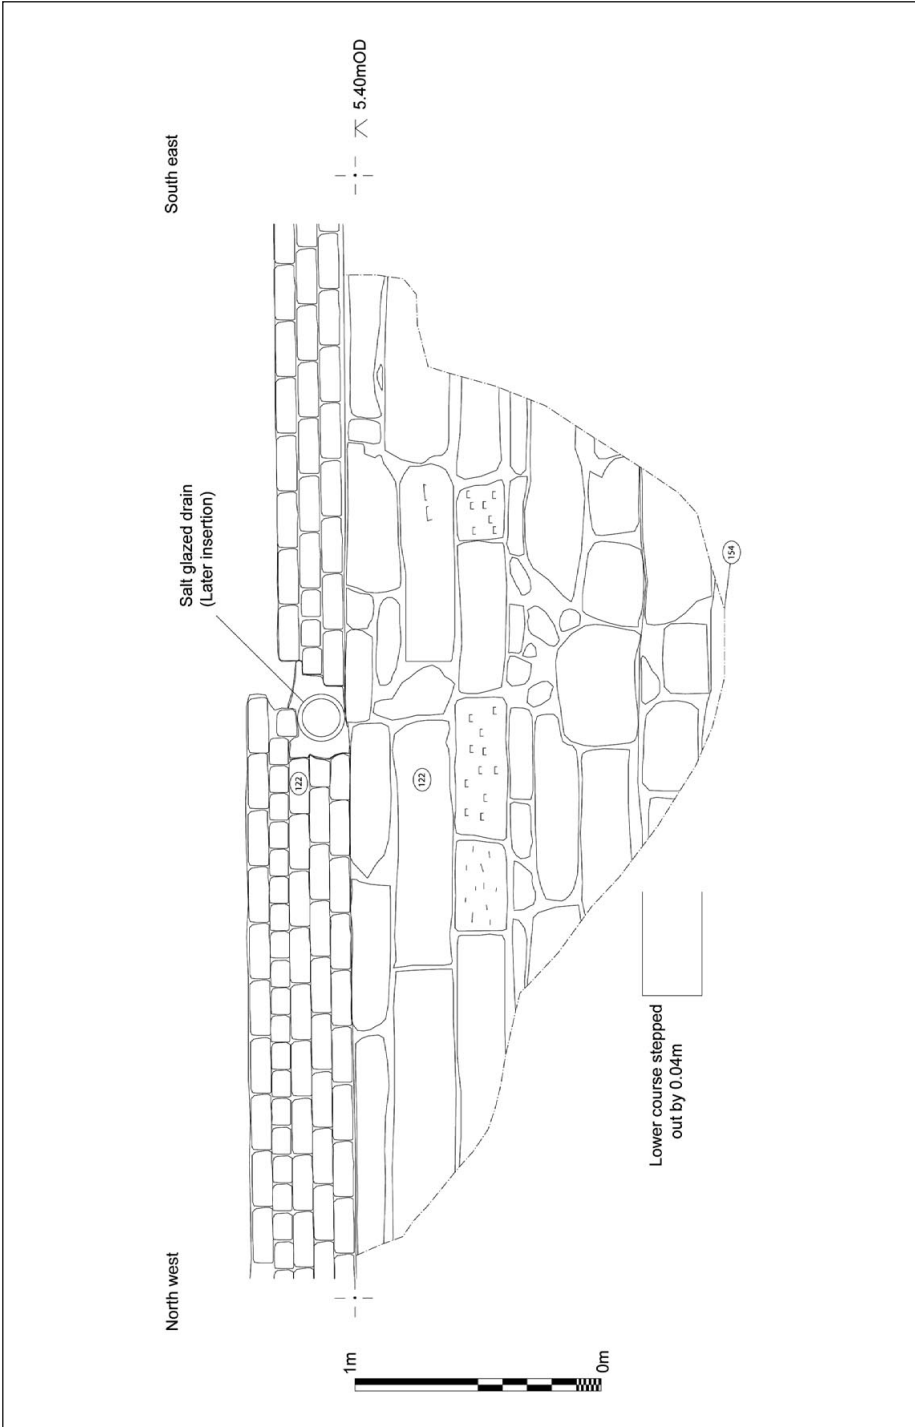
III. IV.8: Elevation of the workhouse foundation

Walls (122) and (123) formed the inner and outer walls of this wing. Like the main structural walls reported above, they were brick-built (standing up to five courses high) and overlay sandstone block footings, cutting a light yellow grey re-deposited alluvial silt (154). Wall (122) was recorded in section to reveal the foundation, extending 1.5m below the lowest course of brick, equating to 3.9m above Ordnance Datum. The lowest course of the foundation was slightly offset from the main line of the wall and several blocks employed in the construction displayed tooling marks. Several ceramic drains had been inserted through these walls. Areas of brick flooring, (121) and (131), were revealed. Within floor (121) an area 0.45m wide had been renewed. This alteration and the insertion of the drains date to the late nineteenth/early twentieth century when the workhouse was used for the production of confectionery and preserves.

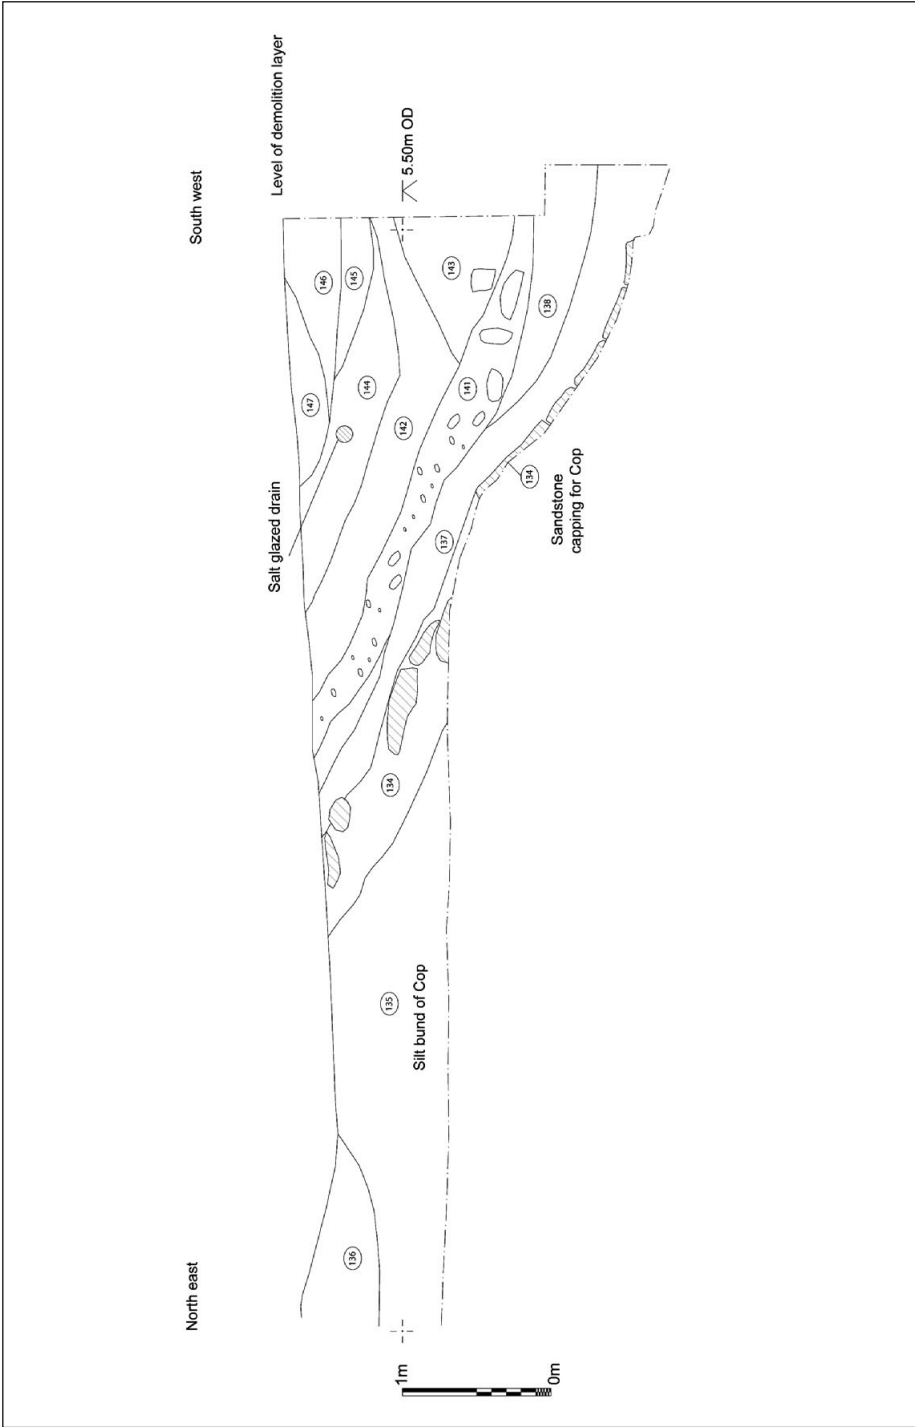
III. IV.9: Section through the Cop

A section of the Cop, forming part of the later re-alignment around the workhouse, was identified to the south of the building, running roughly southeast–northwest (Ills IV.1, IV.6, IV.7 and IV.9). The uppermost part of the south face had been capped with large, irregular, sandstone block fragments (134). These sandstone blocks were roughly shaped and of varying size, between 0.4m and 0.6m in length, and lay directly on an earthen bank, or bund, approximately 3m in height with steep sloping sides. This earthwork was composed of light brown redeposited silty sand with varied laminations indicative of flooding activity (135). Root activity identified within indicates that the mound had a turf layer covering it, if only for a short period of time. Below this deposit, at a depth of 5.50m above Ordnance Datum, a series of three naturally deposited layers were encountered: a silty sand with distinct laminations (199) indicative of flooding activity; beneath which was a further, but unlaminated, silty sand (200); and at the base of the trench, at a depth of 3m above Ordnance Datum was a mid grey coloured sandy clay loam (201), which is likely to have been laid down during the migration of the River Dee prior to the construction of the Cop. The upper part of layer (201) shows evidence that it was once an exposed surface; however, the shell inclusion and laminations of the lower part of the deposit indicate that it was formed within a flowing water environment.

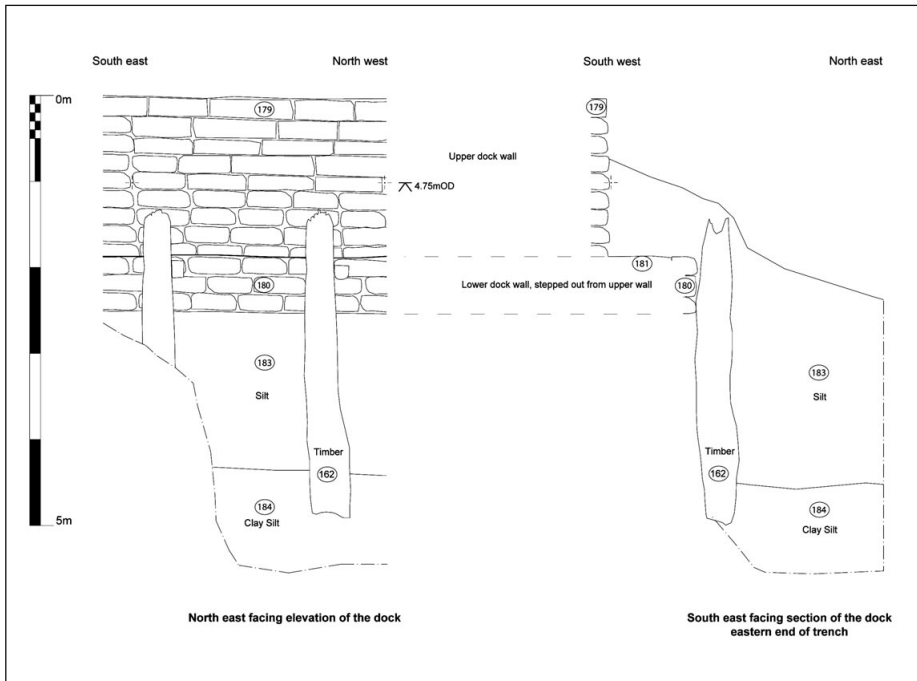
III. IV.11: Elevation and section of dock

Located to the west of the site, to the southwest of the workhouse, a small portion of a sandstone dock was uncovered (Ills IV.10 and IV.11). This comprised a large block sandstone wall with associated walkway and timber posts. The dock was positioned within a narrow inlet first shown on Hunter & Weston's map of 1789, which matches the location of a small inlet apparent on the first and second edition Ordnance Survey maps (published in 1875 and 1899, respectively). A possible path is shown on Stockdale's map (1796) linking the inlet to the iron foundry, which would suggest that the inlet was intended as the dock for the foundry.

The dock wall (179) was excavated to a depth of 1.8m (equating to 2.6m above Ordnance Datum). The north facing elevation of this wall had been finished to a high standard, implying that this was a face of the wall to be displayed. Tooling could be seen on the blocks,

which had been squared off to an approximate size of 0.7m by 0.2m. A small walkway (181), approximately 1m wide and constructed of sandstone fragments, ran alongside wall (179) where a lower sandstone wall (180) continued down into the natural silt layer. The lower sandstone wall was constructed of the same material as the upper wall (179) and extended down approximately 0.65m below the walkway. This was built into the natural alluvial silt deposit (183) at the base of the trench. Two upright timbers (162) had been driven through the alluvial silt (183) into the underlying silty clay (184) and appear to be mooring posts. Alongside, two timber sleepers ran under the walkway, through the lower wall (180) to support the walkway. The form of the dock and the deposition of silt within it would suggest that boats could sail into the area at high tide, secured to the mooring posts, and at low tide the boats would be left on the dry silt bed.

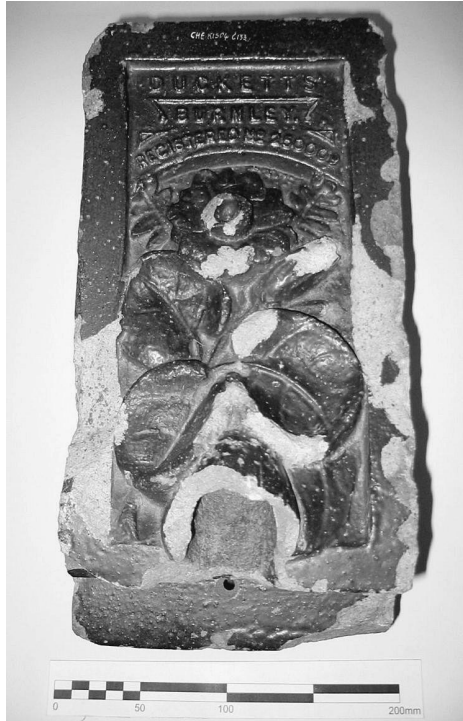
III. IV.15: Architectural water spout from Roodee workhouse excavation

A ceramic water spout was recovered from context (133), the later demolition spread across the site. It measured 310mm by 115mm by 160mm and was produced by Ducketts of Burnley. The exposed face has a brown glaze and is decorated with flowers and leaves, the water spout representing the stem for the flowers (Ill. IV.15). Due to the nature of the context it is not clear if this came from the later workhouse remodelling, although it is unlikely that such a decorative item would have been included in the workhouse.
