**Report on Archaeological Monitoring**  
**St Mary the Virgin Church, Gamlingay,**  
**Cambridgeshire**

CHER ref. ECB 4364

**Prepared for Gamlingay PCC**

July 2015

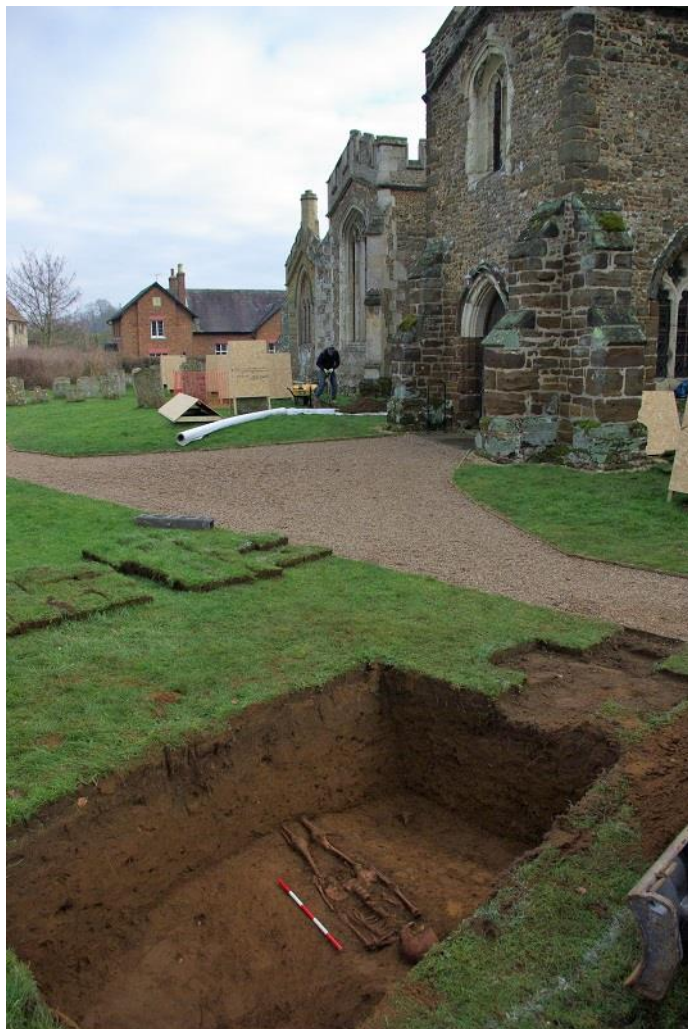
Plate 1: Trench [1], skeleton [4], looking NW, 0.5m scale

Slightly to the south of, and cutting, grave [13] was grave [5] (Fig. 3B and C, Plate 1). The sides of the grave cut were not distinguishable until skeleton [4] was reached at the very shallow depth (at skull) of only 0.45m from the surface. The remains were those of an individual of quite small stature and the long bones were unfused at their epiphyses; these factors suggested that the remains were of an older juvenile or young adult. The presence of iron nails showed that a coffin was used for this burial.

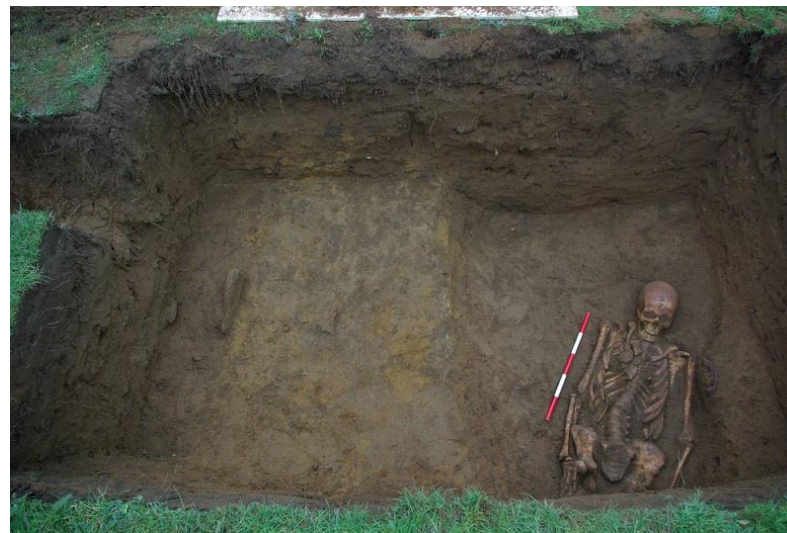
Plate 2: Trench [1], skeleton [12], looking W, 0.5m scale

In the north-eastern part of the trench was grave [10] (Fig. 3A and C, Plates 2 and 3). It had a very well-defined almost vertical north side which represented the position of a coffin; an iron coffin handle was found *in situ* next to the left humerus. The south side of a coffin was indicated by some nails but the south side of the grave was less certain; a well-defined steep slope ran across the trench but was misaligned with the burial itself and was not fully understood; it may have been a natural slope or, perhaps have related to the deeper area recorded as [79] (see above). The likely south side of grave [10] was recorded only in section (Fig. 3C). Adult skeleton [12] lay at a minimum depth (at skull) of 0.76m. Two sherds of medieval coarseware, two fragments of probably post-medieval roof tile and a piece of 17<sup>th</sup>- or 18<sup>th</sup>-century clay pipe stem were found in the fill of grave [10].

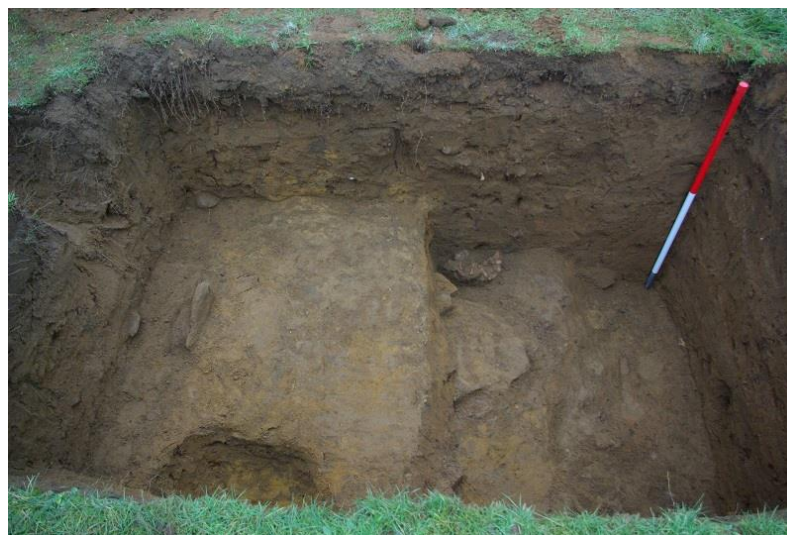
Plate 3: Trench [1], graves [13] and [10] excavated, grave [78] and skeleton [18] visible to left and rear respectively, looking W, 1m scale

Grave [13] was of relatively early date. This just extended into the side of the trench near its south-east corner (Fig. 3A, and visible in bottom left of Plate 3). It had a slightly rounded end and its hand-excavated part was 0.25m deep (although it probably

At the west side of the trench the east end of another grave extended just into the trench [16] (Fig. 3A, Plate 3). Its south side corresponded with the slope running across the trench. The hand-excavated lower part of grave [16] was 0.30m deep. At its base was some black glassy material; the 'pitch' lining/sealant of a coffin [19] (see also Trench [2]; [22] below). The feet of skeleton [18] lay upon this and were recorded at a depth of 0.95m.

At the south end of the trench another grave remained unexcavated [78] (Fig. 3A, Plates 2 and 3). One or two thin fragments of sandstone lay on their sides against the north side of the grave; they may, perhaps, have been placed (or fallen) alongside a coffin. The trench was extended very slightly at its north end to allow the space required for the soakaway and grave [78] was undisturbed by the drainage works.

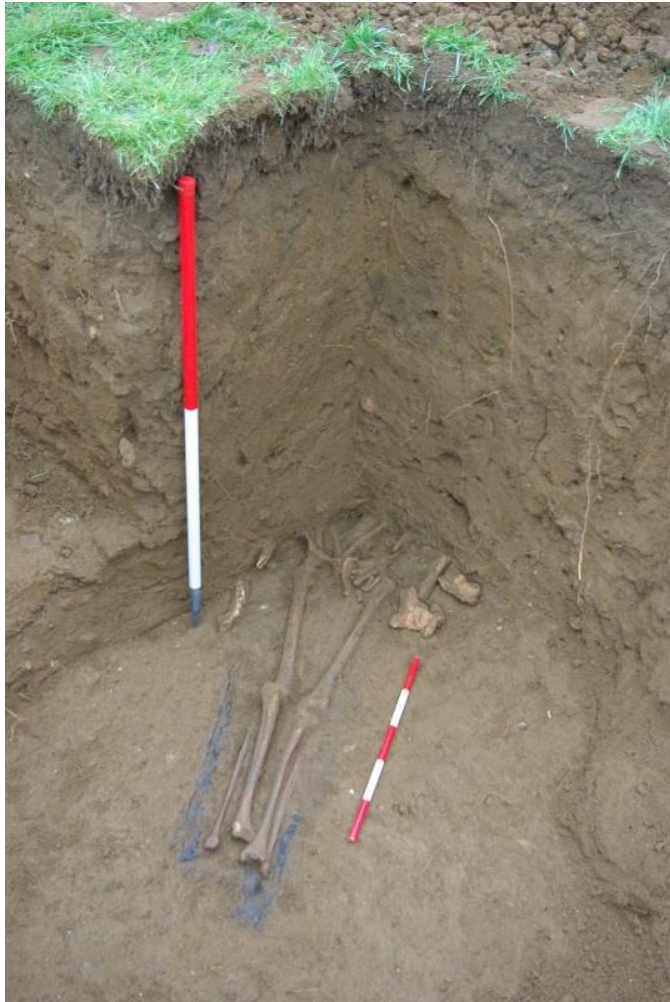
Plate 4: Trench [2], skeleton [23], looking W, 1m and 0.5m scale

Grave [20] was orientated east to west and just over half of it was revealed in the east corner of the trench at a minimum depth (at pelvis) of 1.12m from the surface. The surviving/identified part of the grave was barely more than a very shallow scoop in the underlying deposits but within this were significant traces of a black glassy deposit which, along with several evenly spaced large nails, defined the base of a coffin [22] (Fig. 4, Plates 4 and 5). The black deposit was 'pitch' used to seal the adjoining planks of the coffin. Skeleton [23] lay upon the coffin base; its legs, part of its pelvis and left hand were exposed within the excavated area.

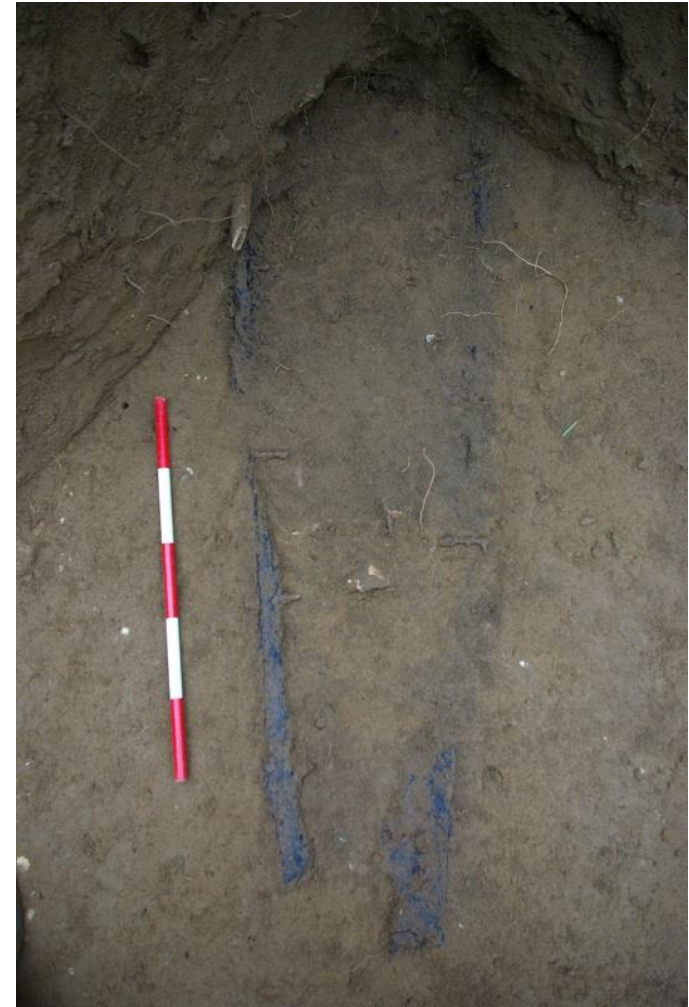
Plate 5: Trench [2], coffin [22], looking W, 0.5m scale

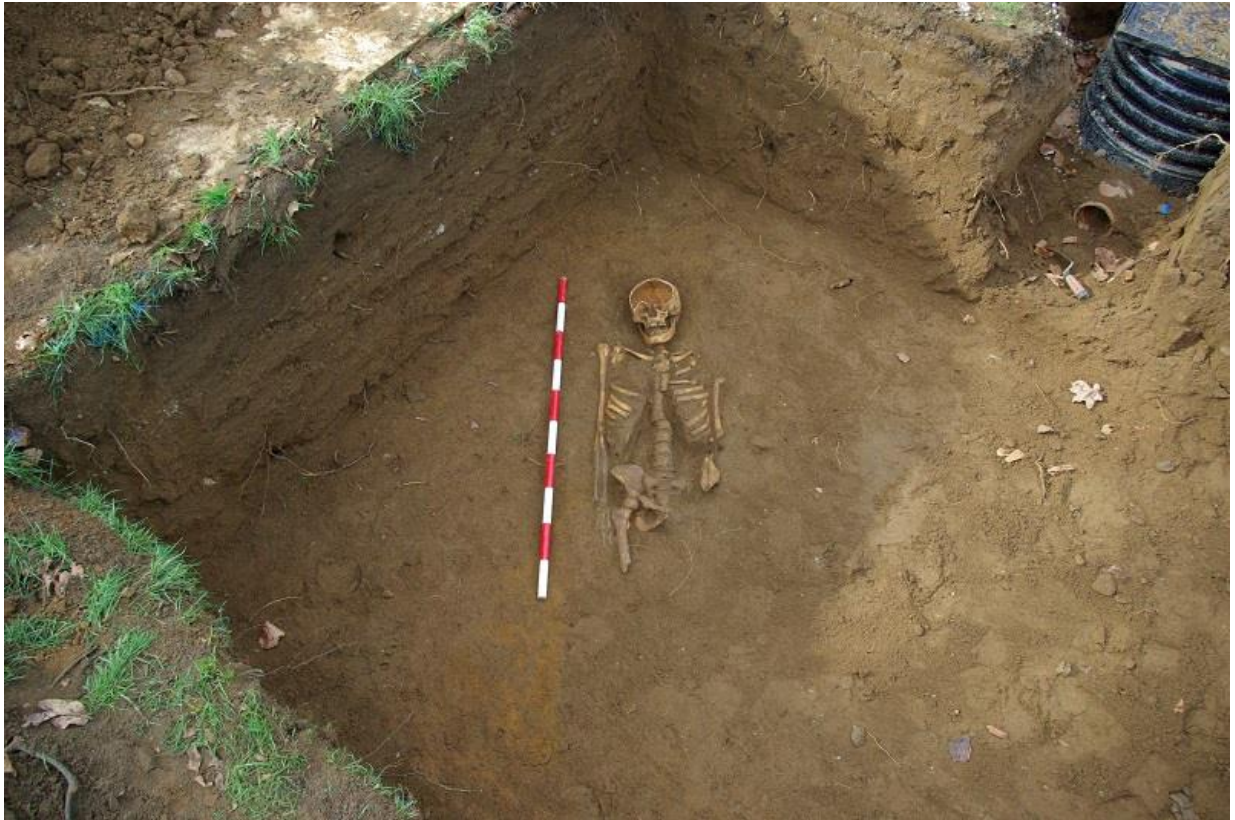
Plate 6: Trench [3], skeleton [29], looking W, 1m scale

The earliest burials are represented by truncated skeletal remains in three east to west orientated graves (Fig. 5 Trench 3 plan A). Grave [27] was located towards the southern end of the trench. Within it adult skeleton [29] was revealed at a depth of only 0.75m (at skull) from the surface and, as such, was the first burial encountered during excavation (Plate 6). The skeleton was truncated across its left side and leg bones by later graves ([46] [40] and [30]) and at its east end by grave [33] but most of its upper part and its feet survived. To its north-west the lower left leg and feet of adult skeleton [68] survived in the east end of grave [66] at a depth of about 1.15m. The right leg of this skeleton was truncated (probably by grave [46]). The third east to west burial [76] was recorded to the east of grave [66] and was truncated to its west and east respectively by graves [62] and [75]. Only the torso and some arm bones of skeleton [65] (again at a depth of about 1.15m) survived. The bones were small (child-sized) and unfused. No coffin nails were found with any of these three burials and no other finds were associated with them. The regular spacing of these graves as well as their shared orientation and stratigraphic position showed that they were roughly contemporary.

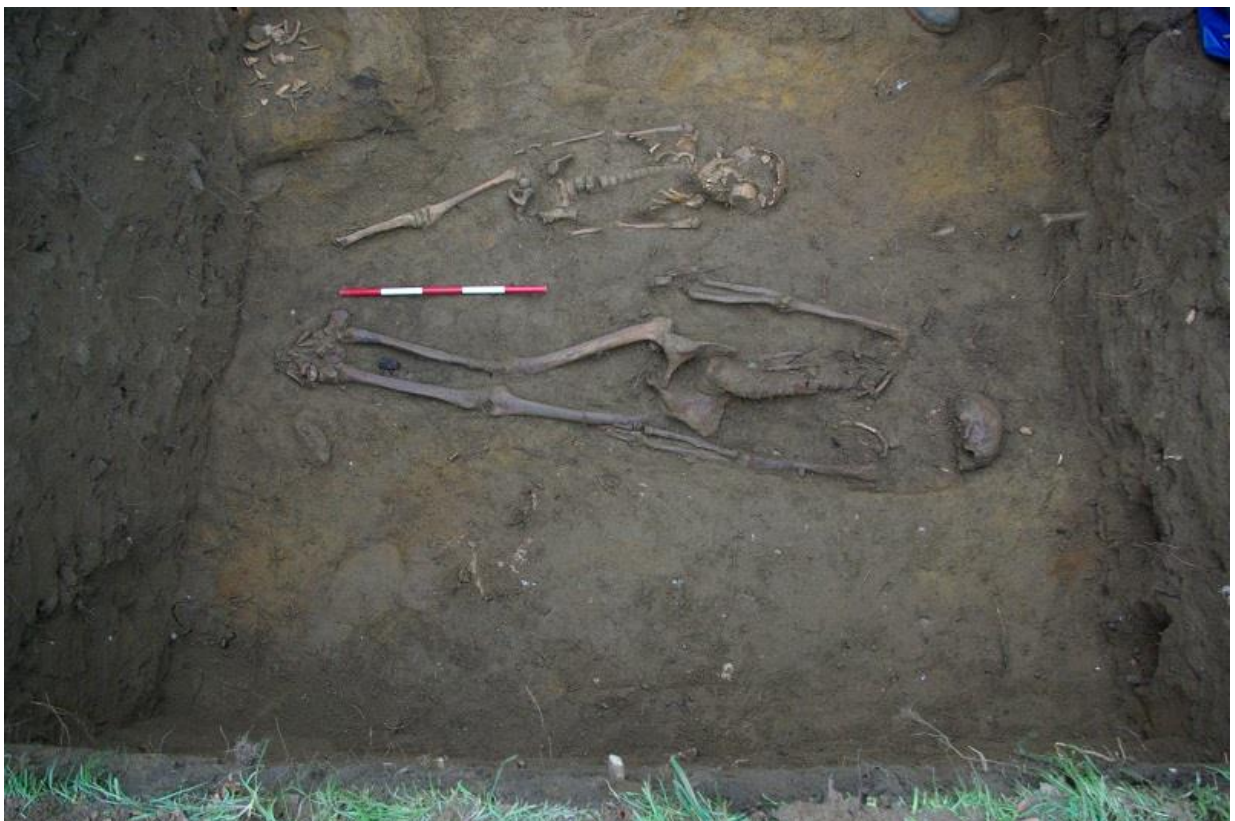
Plate 7: Trench [3], skeletons [61] and [64], looking SW, 0.5m scale

To the north, the skeleton of juvenile [61] (indicated by its size and the unfused nature of the bones) was recorded in grave [59]. No coffin nails or fittings were found with the skeleton. Grave [59] was cut to its north by grave [62] which contained adult skeleton [64] which had been buried in a coffin (evidenced by coffin nails) (Fig. 6, Trench 3 plan B) (Plate 7). The bones of this skeleton were rather degraded and had a blackish colouring to their surface. A very small fragment of medieval window glass was found in the grave fill. Another juvenile burial appeared to post-date grave [62] to its north; grave [52] was not well defined but its skeleton [53] (the small bones of which were relatively well-preserved) was at a slightly higher level than the much larger skeleton [64] (Plate 8). Clearly the relative depths are not evidence of relative date but their very close proximity suggests that, had the larger grave been dug subsequently, it would have disturbed the remains of the child. The different preservation of bone of the two skeletons and the presence of the coffin nails with skeleton [64] strongly suggests that the two were not buried together.

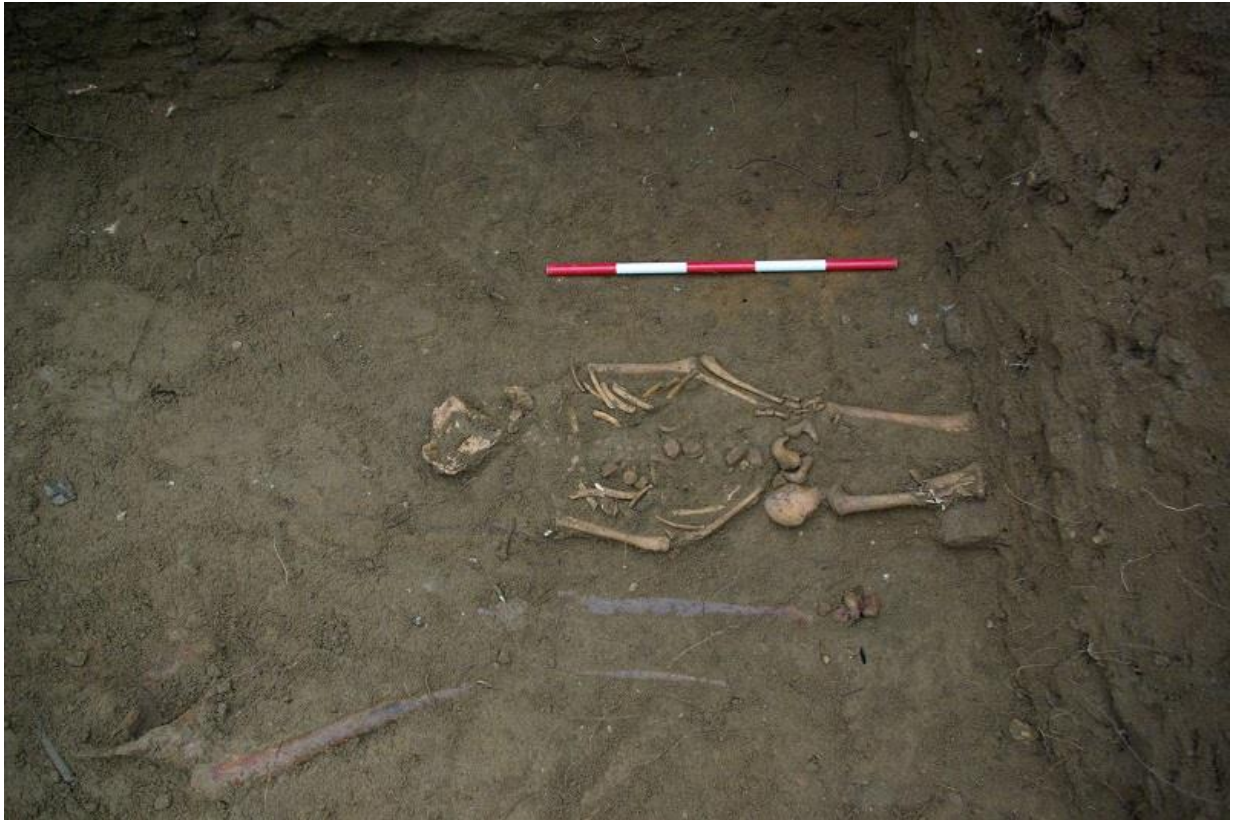
Plate 8: Skelton [53] with (probably later) skeleton [64] partly exposed looking NE, 0.5m scale

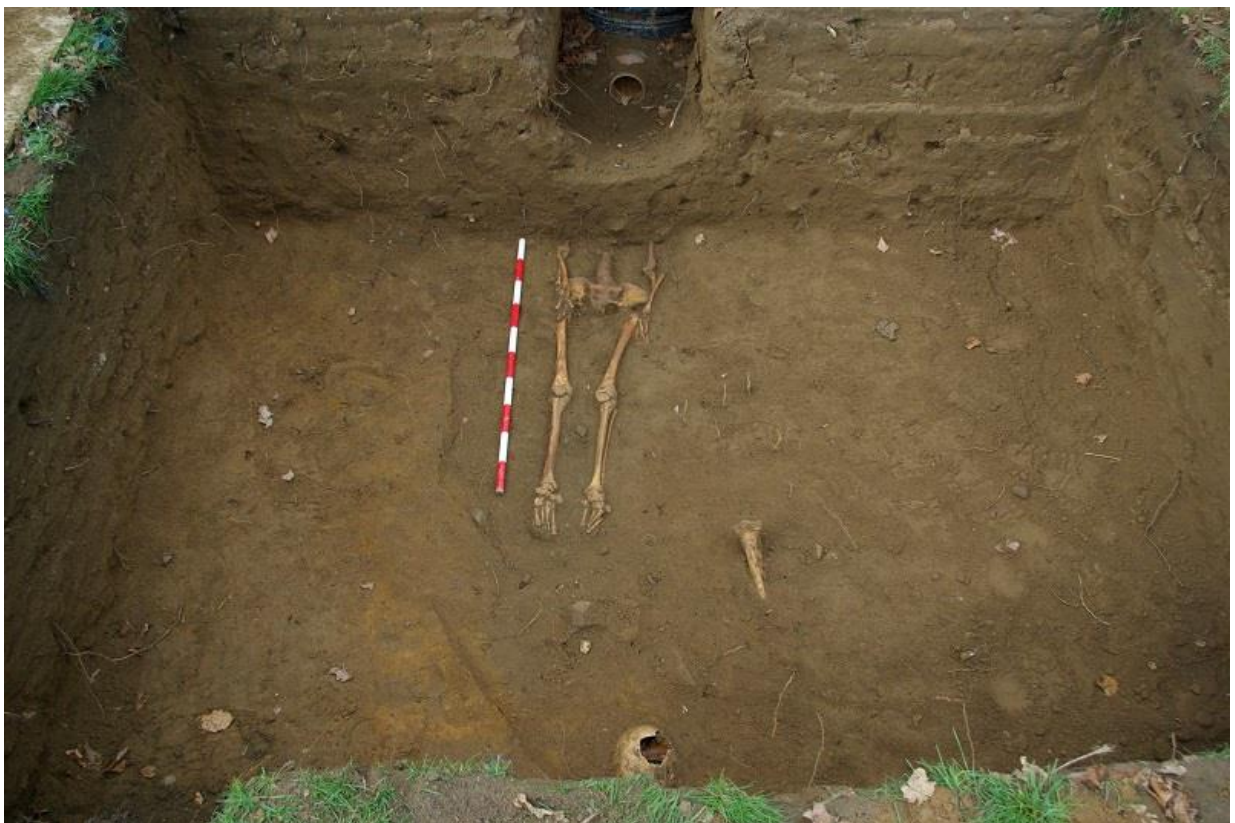
Plate 9: Skeleton [32] looking NW, 1m scale

The latest burials in the area are shown in Figure 6 Trench 3 plan C. Graves [30] and [43] both extended beyond the east side of the trench and contained the lower parts of well-preserved skeletons ([32] (Plate 9) and [45] respectively). In both graves coffin nails indicated the method of burial (although these were not recorded in plan). A piece of probably post-medieval roof tile was found in grave [43]. Probable grave [49] extended into the extreme south-west corner of the trench; no burial evidence was revealed within it but its position suggested that it could be contemporary with the two graves to its north. In the north-east corner of the trench grave [75] was also of relatively late deposition. It probably cut grave [52] to its south and clearly overlay the child burial [74] described above.

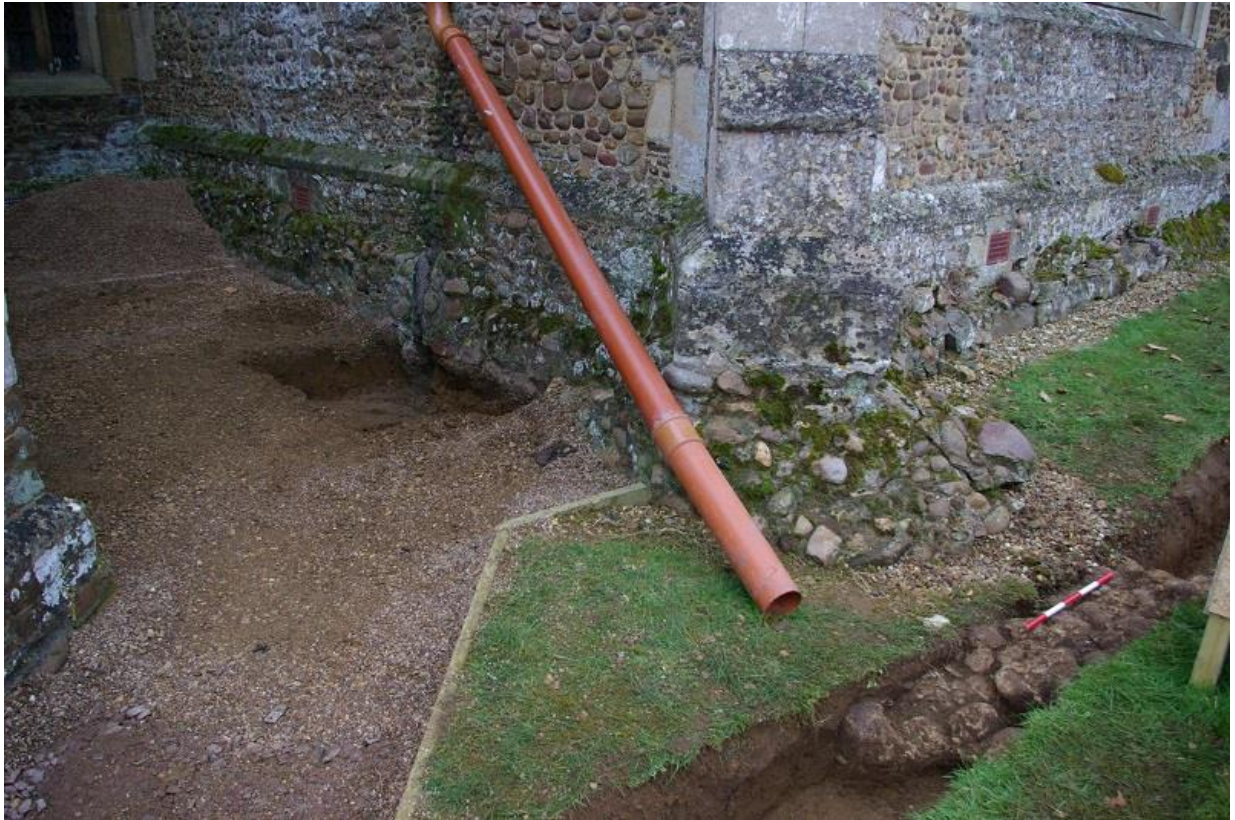
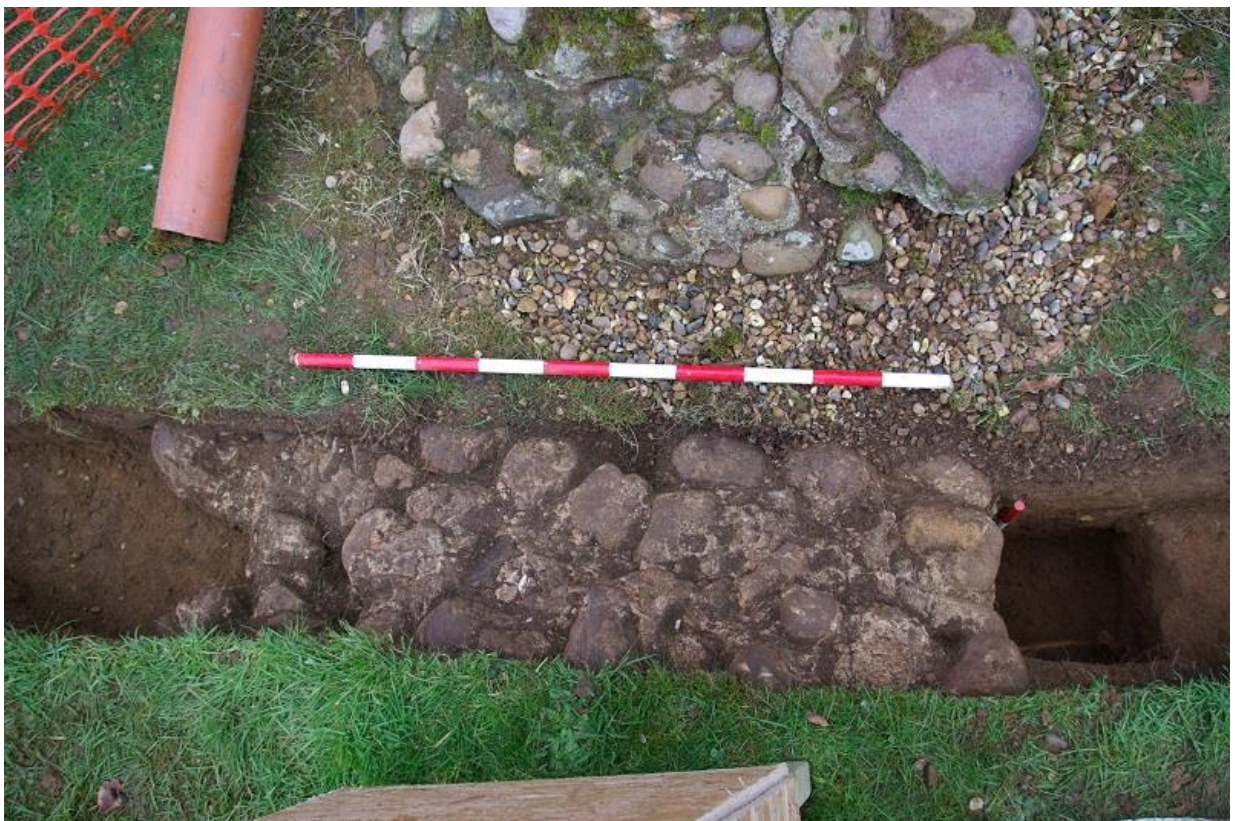
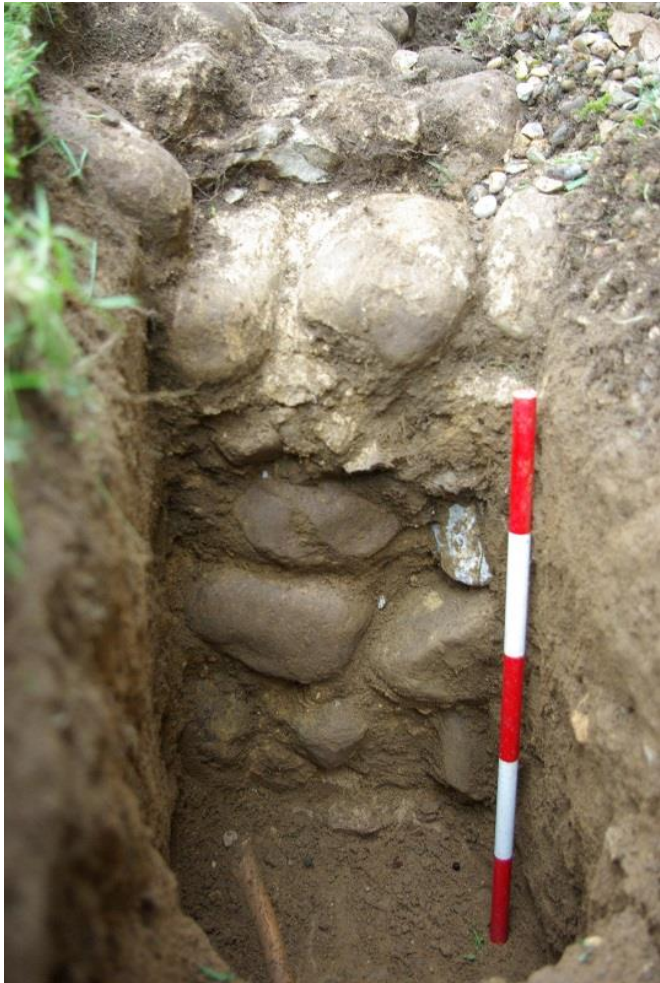
Plate 10: Wall [9] looking SW, 0.5m scale

Plate 11: Wall [9], from above, looking SSW, 1m scale

Plate 12: Wall [9], looking ESE, 0.5m scale

Just to the north-east of the north transept chapel a masonry wall and footing crossed the drain trench approximately from north to south [9] (Figs 2 and 7). It was 1.37m in total maximum width and comprised stone cobbles in hard cream-coloured lime mortar. The stones in its west face were fairly large (<0.18m in size) and were coursed. The core of the wall consisted of irregularly placed smaller stones (<0.11m in size) and occasional flint fragments in mortar. The maximum depth/height of the observed wall was 0.70m with the upper 0.25m being bound ('almost faced') with mortar and, below this, the large cobbles having little mortar between them (Plates 10-12). The bottom of the footing was not reached. The putative 'faces' of the wall are shown as a heavy line in Figure 7. The wall formed a continuation northwards of some rough stone-work beneath the footings for the existing angled buttress and east wall of the north transept. This rubble masonry ran, however, on a very slightly different (NNE to SSW) orientation and was slightly to the east of the east wall of the existing transept chapel (Fig. 7).

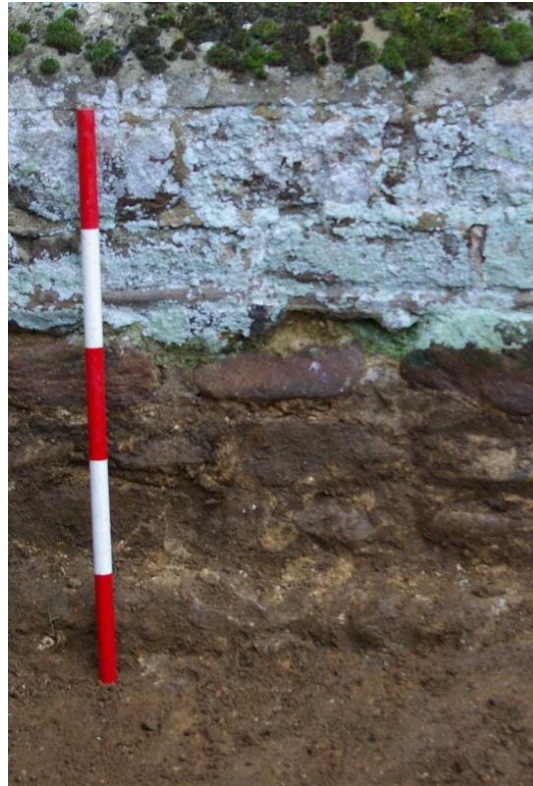
Plate 13: Gully trench [25], vestry wall footing, looking WNW, 0.5m scale

Plate 14: Gully trench [24], chancel wall footing, looking SSW, 0.5m scale

Trenches for new gullies to the east of the vestry and south of the chancel were observed. In both of these coursed footings were revealed to a depth of 0.30m below the existing ground level (0.60m below the top of the chamfered plinths). In trench [25] the lowest course of stone cobbles in dark cream-coloured lime mortar protruded from the wall by 80mm at a depth of 0.50m from the top of the plinth (Plate 13). Another course of cobbles was flush with the face of the bricks above. In trench [24] the lowest exposed part of the footing was of quite large blocks of chalk and sandstone the bottom of which was not seen at the depth reached (Plate 14). Above these were stone cobbles which were beneath the brick wall plinth. All of the exposed part of the footing was flush with the face of the plinth.
