Report of Work under Archaeological Supervision and Control

Church Farm, Caston, Norfolk Construction of new cattle shed

NHER ENF 145635

**Sarah Bates, Report no. 46
August 2019**

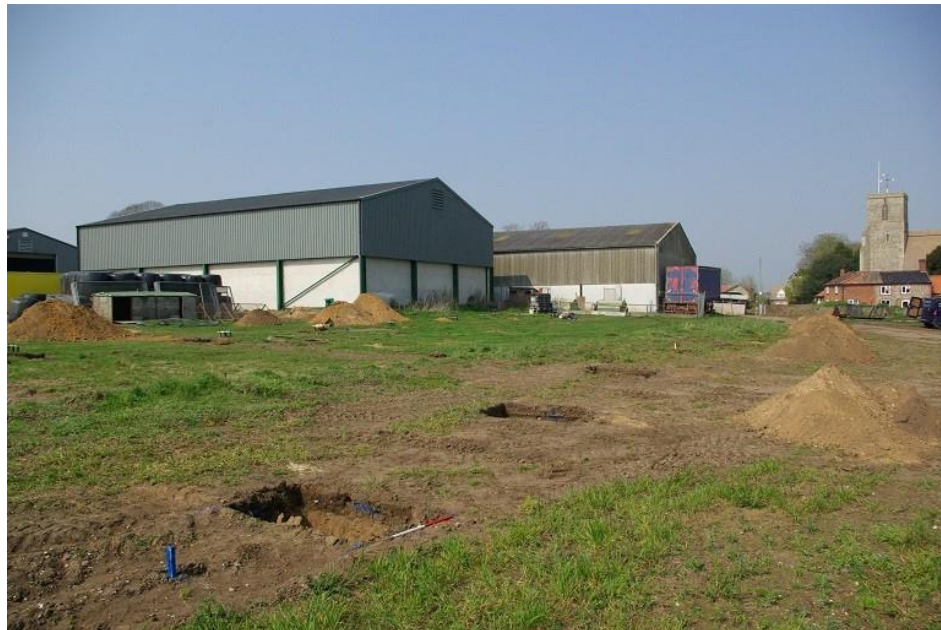
Frontispiece: Area of new cattle shed from the south-east, stanchion trenches visible

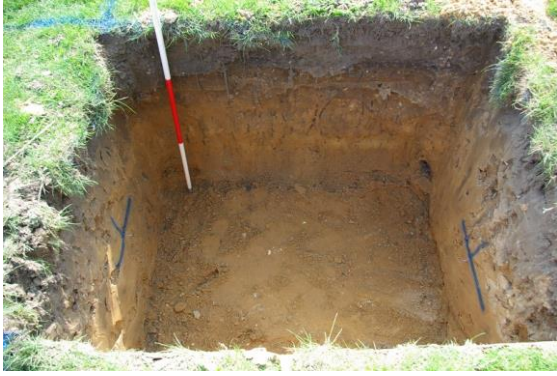
Trench 2: 1.70 x 1.210m, 1.40m deep (Plate 1)

Deposit	Thickness	Description
Topsoil	c. 0.50m	Brown very fine sandy silty loam, occasional small flints, firm but soft
Subsoil	c. 0.35m	Orange brown silty sand, occasional small flints
Natural subsoil	-	Yellowish orange fine sand, some cream/light yellow sand patches

Plate 1: Trench 2, looking SSW, 1.5m scale

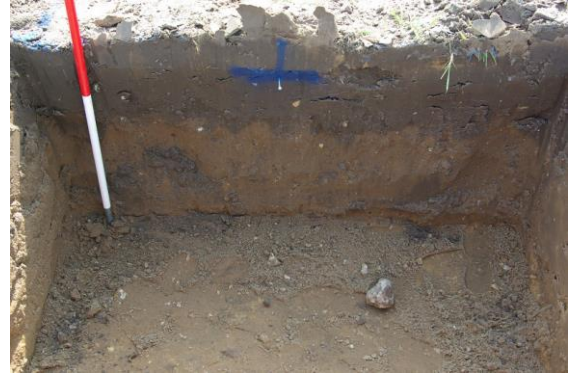
Trench 8: 1.60 x 1.20m, 0.80m deep (Plate 5)

Deposit	Thickness	Description
Topsoil	c. 0.30m	Dark brown sandy loam, occasional small flints, rare medium flints
Upper subsoil	c. 0.50m	Brown silty sand, moderate small flints, occasional medium flints
Lower subsoil	c. 0.15m	Orange brown silty sand, moderate small flints, occasional medium flints
Natural subsoil	-	Very clean yellowish sand, occasional flint gravel

Trench 8 was within the area of recently cultivated field. The soil was darker-coloured and loamier. The upper subsoil represented deep ploughing.

Plate 5: Trench 8, looking SSW, 1m scale

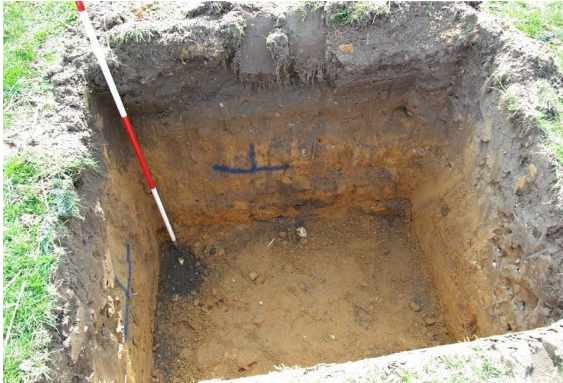
Trench 4: 1.70 x 1.20m, <1.40m deep (Plate 2)

Deposit	Thickness	Description
Topsoil	c. 0.40m	Brown very fine sandy silty loam, occasional small flints, firm but soft
Subsoil	c. 0.45m	Orange brown silty sand, occasional small flints
Natural subsoil	-	Brownish yellowish orange sand, occasional/moderate fine flint gravel

Plate 2: Trench 4, looking SSW, 1.5m scale

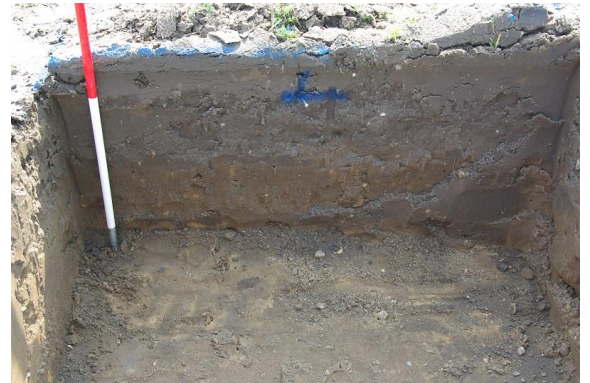
Trench 10: 1.60 x 1.15m, <0.75m deep (Plate 6)

Deposit	Thickness	Description
Topsoil	c. 0.35m	Dark brown fine sandy loam, occasional small flints
Subsoil	c. 0.40m	Brown silty sand, moderate small flints, occasional medium flints
Natural subsoil	-	Light yellow brown sand only slightly exposed in base of trench

Trench 10 was situated at the junction of the cultivated field and the 'yard'/trackway. The trench was relatively shallow and mostly within the topsoil and upper part of brown subsoil.

Plate 6: Trench 10, looking SSW, 1m scale

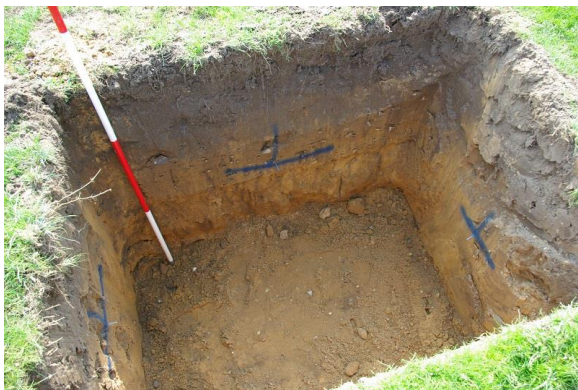
Trench 6: 1.70 x 1.30m, 1.30m deep (Plate 3)

Deposit	Thickness	Description
Topsoil	c. 0.50m	Brown very fine sandy silty loam, occasional small flints, firm but soft
Subsoil	c. 0.60m	Orange brown silty sand, moderate small flints, occasional medium flints
Natural subsoil	-	Yellowish orange sand, rare small flints

Plate 3: Trench 6, looking S, 1.5m scale

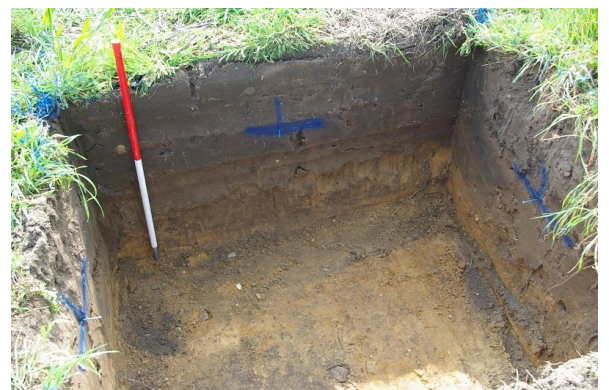
Trench 13: 1.60 x 1.10m, <0.95m deep (Plate 7)

Deposit	Thickness	Description
Topsoil	c. 0.35m	Dark brown sandy loam, occasional small flints
Upper subsoil	c. 0.45m	Dark brown fine silty sand, occasional small flints, only slightly lighter-coloured than topsoil
Lower subsoil	c. <0.15m	Yellowish orange brown silty sand
Natural subsoil	-	Orange mottled yellow sand occasional small flint gravel

Trench 13 was situated in an area of rough grass between entrance tracks to the field and the farmyard. The loamy topsoil and upper subsoil together were notably deep here.

Plate 7: Trench 13, looking S, 1m scale

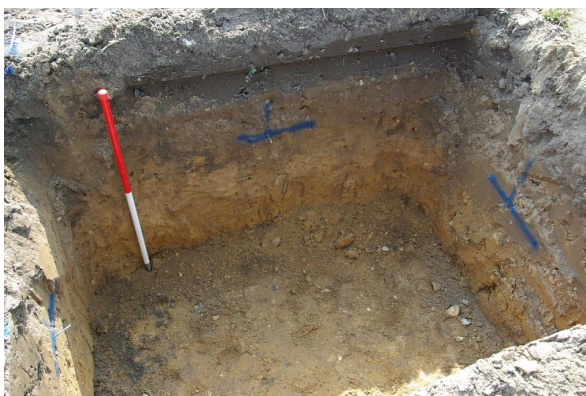
Trench 7: 1.70 x 1.30m, <1.15m deep (Plate 4)

Deposit	Thickness	Description
Topsoil	c. 0.40m	Brown very fine sandy silty loam, occasional small flints, firm but soft
Subsoil	c. 0.55m	Orange brown silty sand, moderate small flints, occasional medium flints, becoming sandier with depth
Natural subsoil	-	Very clean yellowish sand, occasional flint gravel

There was a slightly browner more silty area in the north-facing section, its top at a depth of 0.50m and 0.45m in width, which was initially thought to be a possible feature of some kind. Hand-cleaning, however, revealed no clear interface between the different coloured deposits. The patchy soils may have been caused by animal burrowing.

Plate 4: Trench 7, looking S, 1 scale

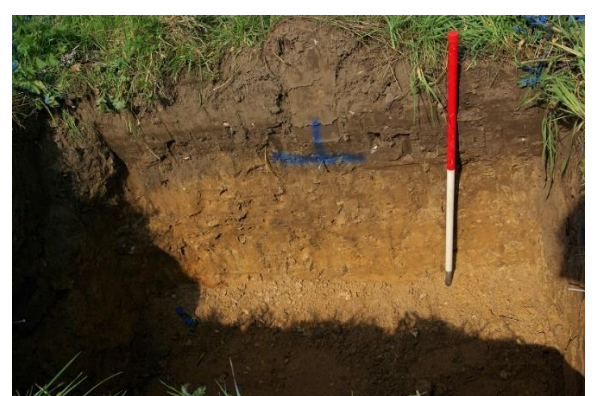
Trench 14: 1.60 x 1.20m, 0.90-1.10m deep (Plate 8)

Deposit	Thickness	Description
Topsoil	c. 0.40m	Dark brown sandy loam, occasional small flints
Subsoil	< 0.50m	Brown and lighter orange brown fine silty sand, with, in its upper part, a concentration of quite large flints in S part of trench
Natural subsoil	-	Light yellow with orange patches, sand and occasional gravel patches. Notably more gravelly than in other trenches

A slightly browner area in the south-facing section was ill-defined and may have been the result of animal burrowing (Plate 8).

Plate 8: Trench 14, looking NNE, 0.5m scale

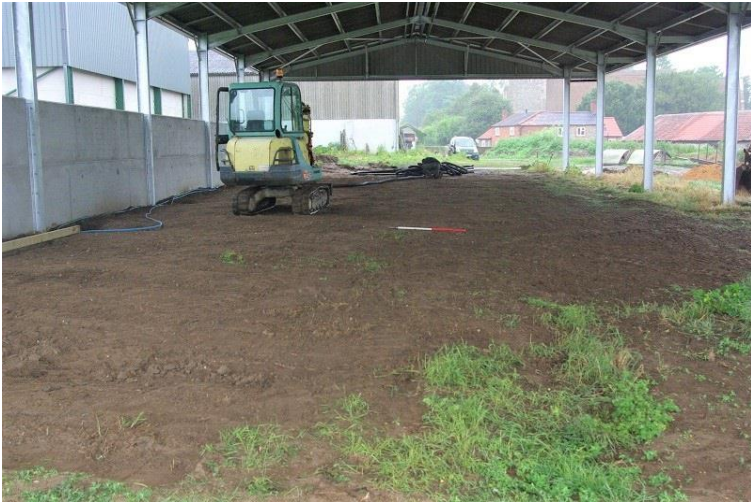
Following construction of the cattle shed topsoil was scraped from across the area within it by the landowner and in the presence of the archaeologist (Fig. 2, Area 17, Plates 9 and 10). The natural slope of the ground meant that, to achieve the required level floor, more soil was removed (a maximum of 0.30m) from west side and south-west area while to the north-east no soil need removing.

The area was metal-detected during and after the soil removal but nothing of interest was found.

Plate 9: Area 17 within new cattle shed, looking NNW, 1m scale

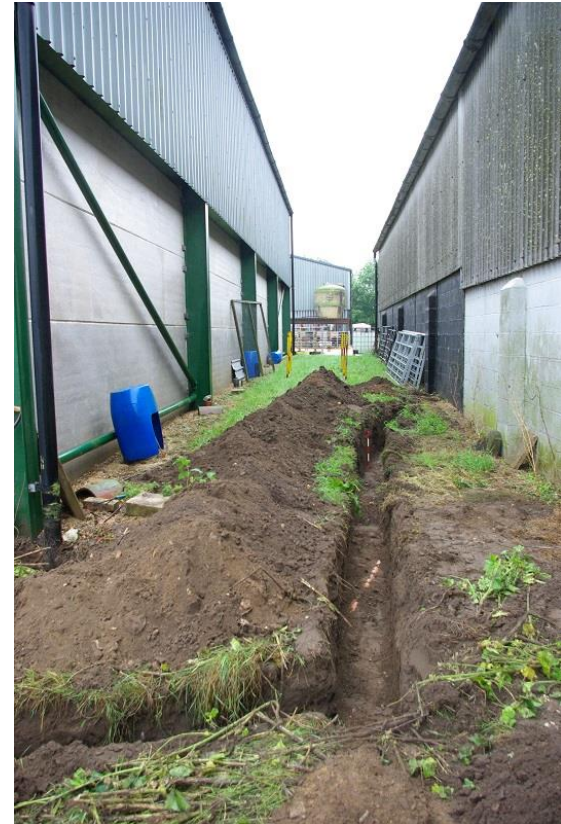
Trench 15 ran from an electricity supply at the existing barn to the north-west corner of the new cattle shed (Fig. 2, Plates 10 and 11). At least two existing drain pipes were encountered along its northern part; the ground had clearly been disturbed previously. Nothing of archaeological interest was seen.

Plate 11: Trench 15 between existing buildings, looking W, 0.5m scale

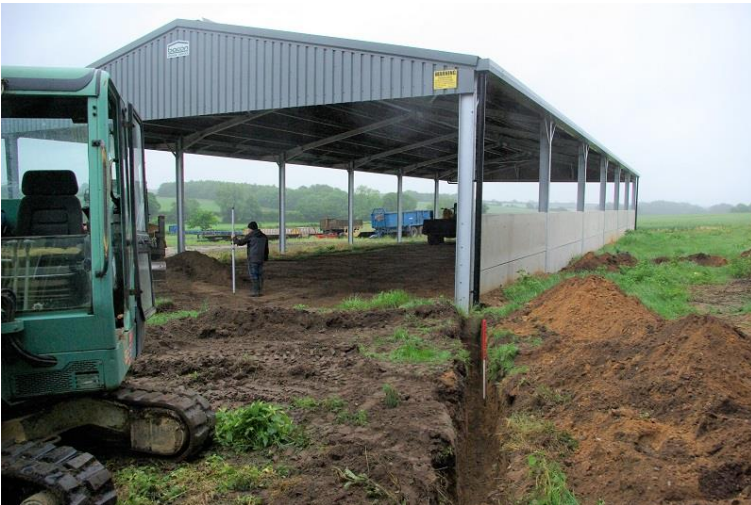
Plate 10: New cattle shed, trench 15 in foreground, looking SE, 1.5m scale

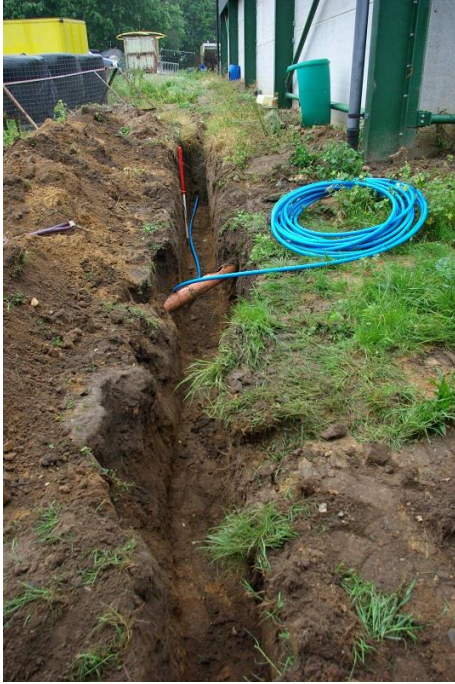
Trench 16 ran from an existing water supply to a point at the north-west side of the new shed. It was 0.85-0.95m deep (Fig. 2, Plate 12). Light brownish yellow natural sand with occasional gravel patches was seen at a depth of about 0.60m. One existing drain was exposed. Nothing of archaeological interest was seen.

Plate12: Trench 16, looking W, 1m scale

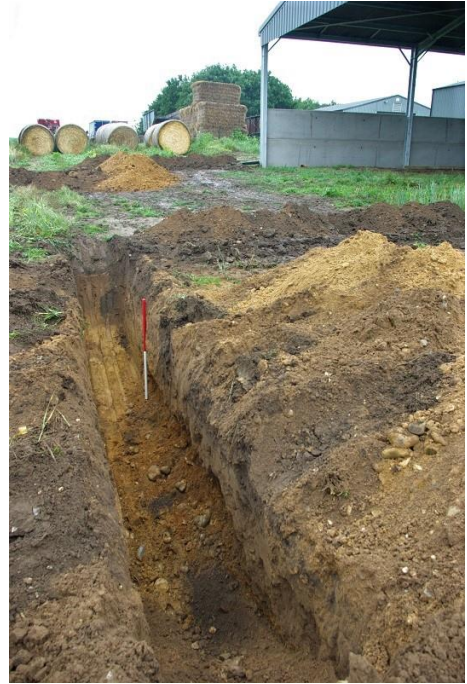
Trench 20 was positioned near the south-east corner of the area of the new shed. It was 5.40 x 6.0 in size and 1.15m deep (Fig. 2, Plate 14). Fine yellowish orange natural sand included an area of large flints. Otherwise the deposits were similar to those seen in the other trenches and nothing of archaeological interest was seen.

Plate 14: Trench 20, looking W, 1m scale

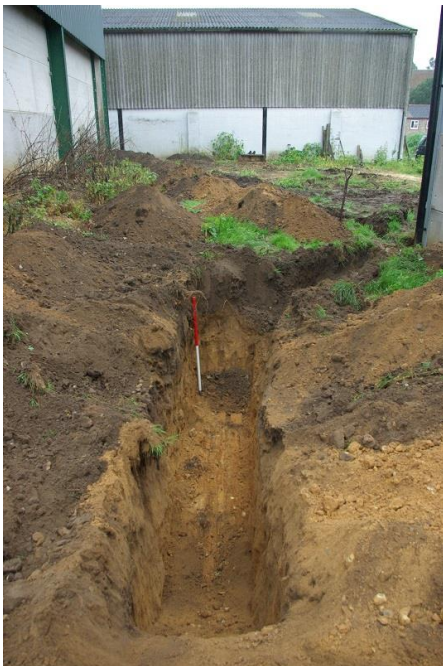
Trench 19 was positioned to the north-west of the area of the new shed. It was 5.40 x 0.70m in size and 1.35m deep (Fig. 2, Plate 13). Natural sand was exposed in the bottom of the trench with occasional flints becoming larger with depth. The sand was overlaid by subsoil and topsoil (as Trench 2). Nothing of archaeological interest was seen.

Plate 13: Trench 19, looking N, 1m scale

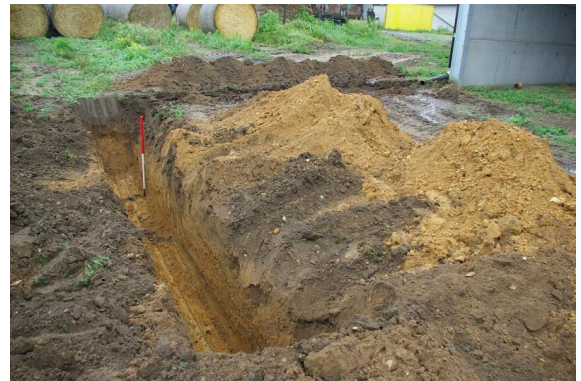
Trench 21 was positioned near the south-west corner of the area of the new shed. It was 5.20 x 0.90m in size and 1.10m deep (Fig. 2, Plate 15). Natural orange sand with sparse fine gravel was exposed in the bottom of the trench overlaid by the subsoil and topsoil. Nothing of archaeological interest was seen.

Plate 15: Trench 21, looking W, 1m scale
