THE ARCHAEOLOGY CO.

House Farm, Thistleton
Historic Building Survey

March 2015

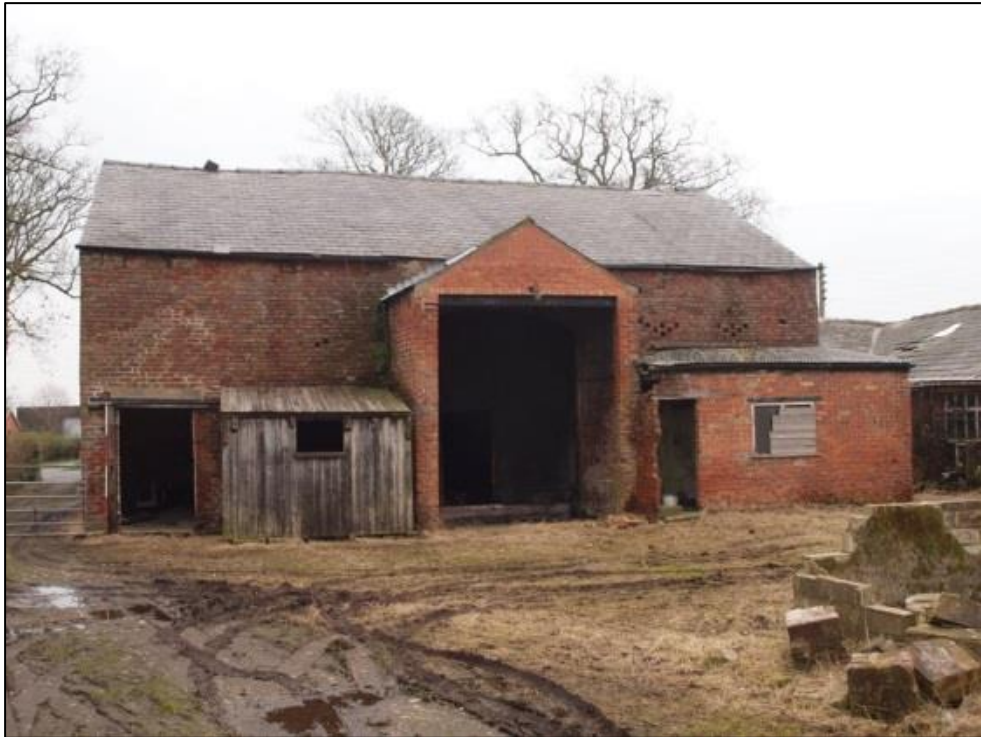
Plate 10: Front (west) elevation

6.2 West elevation (Plate 10). This forms the main front of the barn. In the centre of the face is a large projecting porch built of an orange brick and has a double pitched roof. Within this lies the large barn door, with depressed arch lintel and sandstone keystone (Plate 11). A pair of large timber doors is hung. To the north of the porch is a stable doorway at the northern end of the face. This has a heavy sandstone lintel. Above, is a patch of repair, suggesting the doorway is a later insertion. Between this doorway and the porch is a small timber lean-to. To the south of the porch, the face is obscured by a single story brick lean-to, in a very bad condition. A timber framed window lies in the centre of the face with a doorway to the north, and the asbestos sheet roofing has begun to collapse. Above this the face of the barn is blank with the exception of two sets of triangular vent holes in the brickwork. The bricks of the barn are a reddish brown, hand-made and measure $8 \frac{1}{2} \times 2 \frac{1}{2} \times 4$ ".

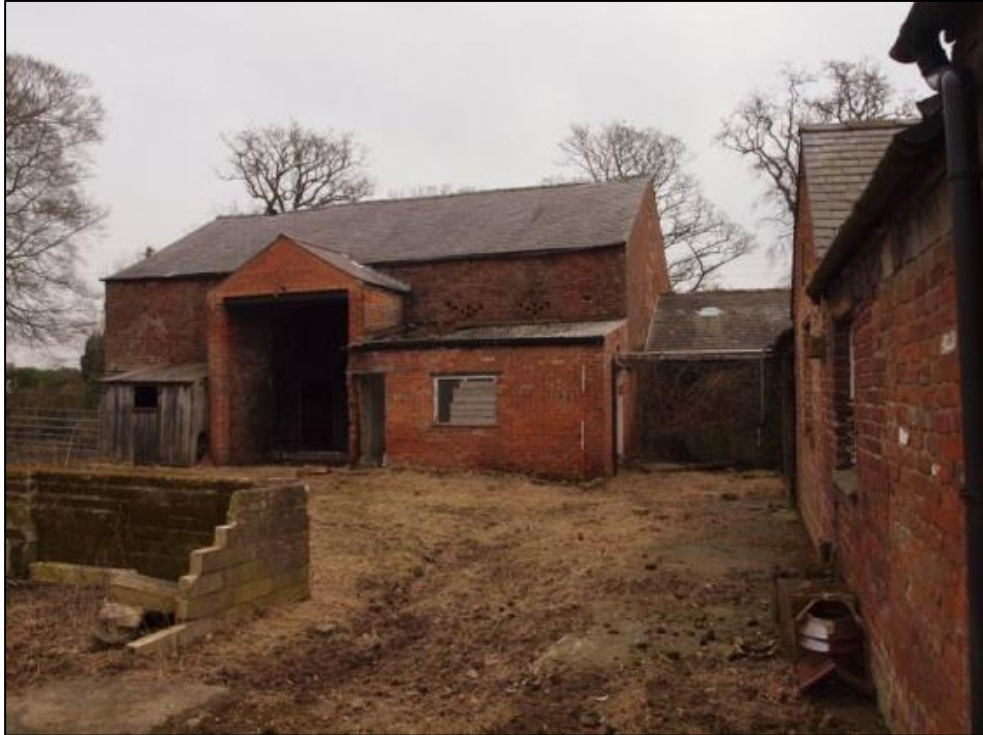
Plate 12: West elevation and southern gable

6.3 South elevation (Plates 12 & 13). This forms the gable end of the building. The ground floor is obscured by the attached shippon. Above this the face is visible and featureless with the exception of small patches of rebuilding.

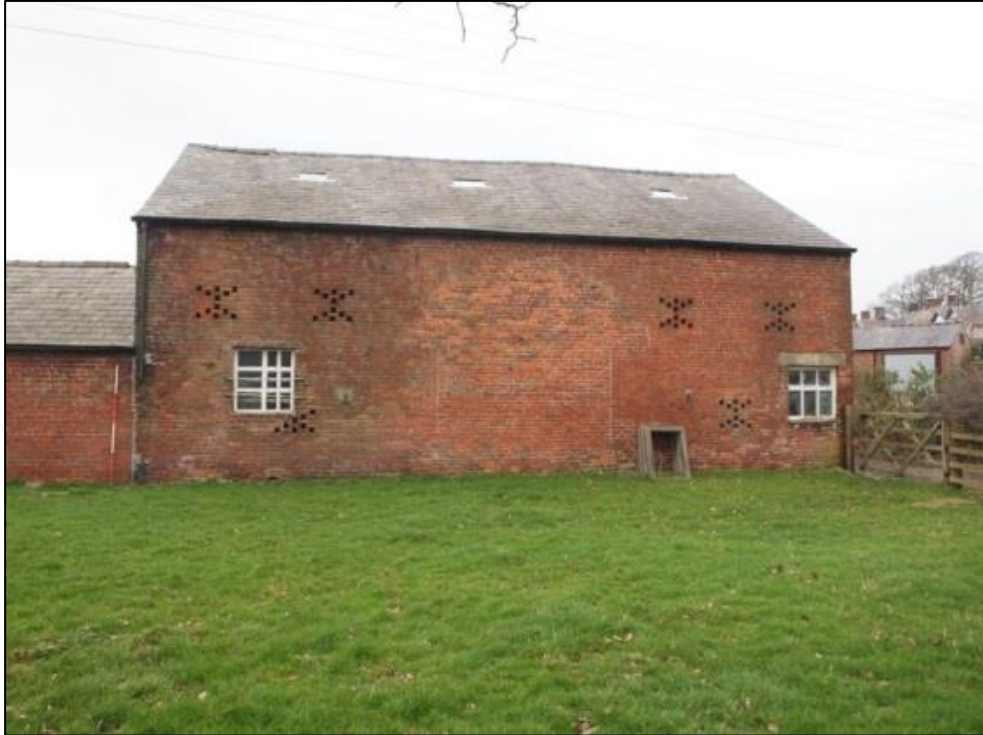
Plate 14: East elevation showing blocked doorway and inserted windows

- 6.4 East elevation (Plate 14). This forms the rear of the building, facing towards Thistleton Road. In the centre of the face is a large blocked barn door, with straight joints marking its location (Plate 15). To the north and south of this the face has a pattern of three sets of vent holes within the brickwork. In the southern end, these holes have been partially blocked by the insertion of a timber framed square window, the rebuilding around it quite evident. At the northern end of the barn is a similar timber framed window, although this has a heavy sandstone lintel and has been inserted to replace the previous doorway (Plate 16).

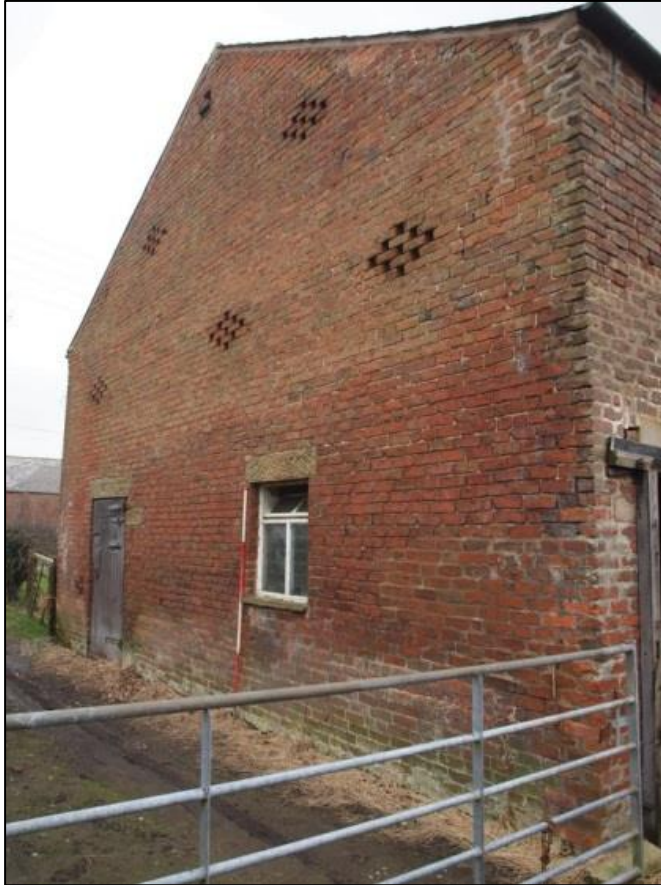
Plate 18: Northern gable

- 6.5 North elevation (Plates 17 & 18). This forms the other gable end of the building. At the northern end is a stable door hung with a heavy timber door. To the south of this, slightly south of centre, is a timber framed casement window. Both have heavy, dressed sandstone lintels. Above these are a series of 5 diamond pattern vent holes, and an owl hole close to the apex.

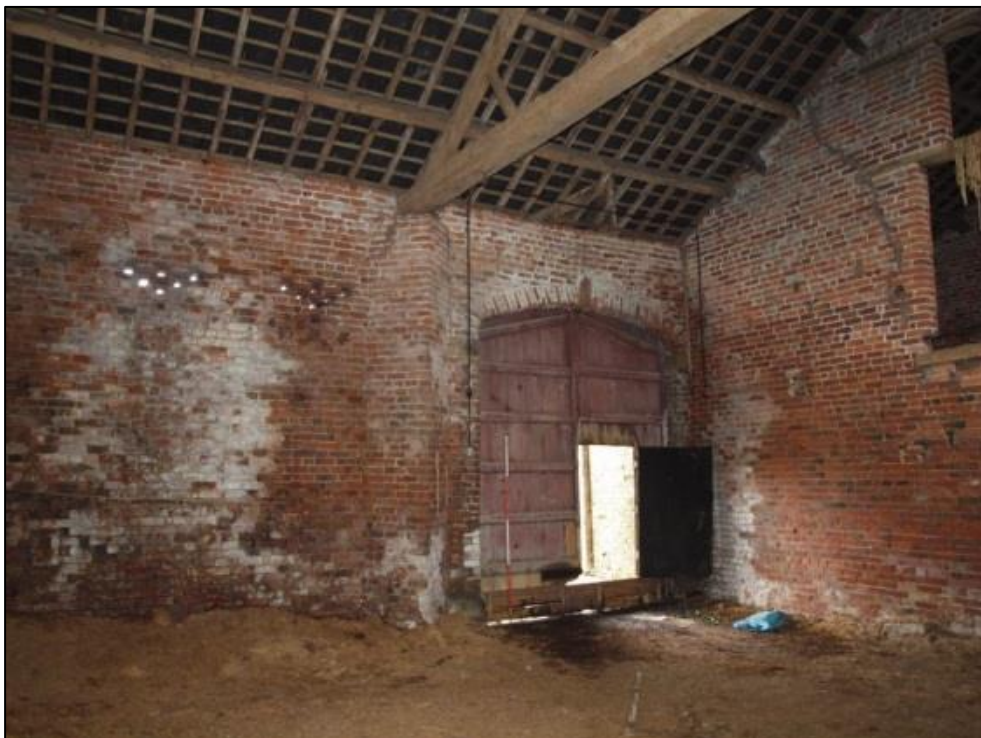
Plate 19: Interior of barn showing barn door

- 6.6 The main barn area (Plates 19 – 26) has an earth floor, bare brick walls and the ceiling is open to the rafters. A large hand cut timber king post truss supports the roof to the southern side with an internal wall supporting the roof to the north. This wall contains a blocked doorway at ground floor level to the east side and two large openings at first floor level, leading to a hay loft above the northern stables. The truss is supported to the east and west by large brick built triangular pillars projecting from the walls. The eastern contains a small niche with a pointed lintel formed of bricks. To the north of this a pair of straight joints are visible in the wall, marking the blocked barn doorway. Opposite this is the main barn door entrance. At the base of each of the jambs lie sandstone blocks, each containing a groove into which a timber board has been inserted. At the southern end of the east wall is an inserted window and at the eastern end of the southern wall a doorway has been inserted leading through to the shippon.

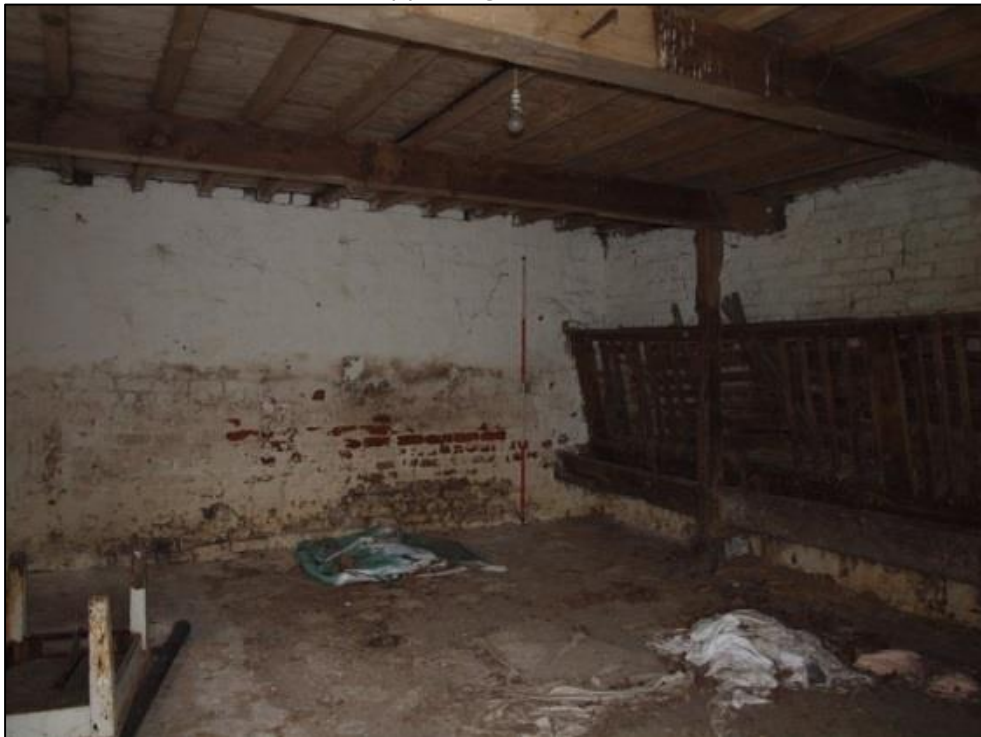
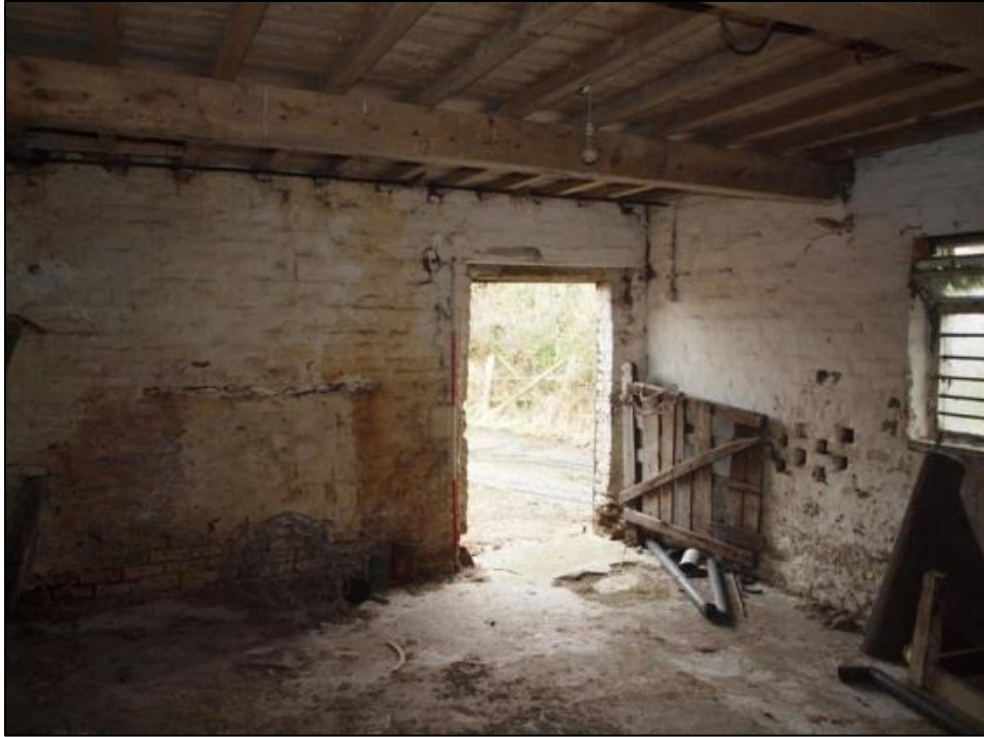
- 6.7 The western stable room (Plates 27 – 29) is accessed via the doorway in the west elevation. The floor has been concreted, the walls whitewashed, and the ceiling

replaced with modern timber. Two large machine cut timber beams span the room north – south, with soffits close to the centre. Timber posts lie at the eastern end, well worn by horses. Finally, in the northern wall is a timber framed casement window. To the east of this room is a small store room (Plate 30), accessed via the doorway in the north gable. This likewise has a concrete floor and modern timber ceiling. The walls have been whitewashed, although in the southern wall a blocked doorway leading into the main barn is still visible. In the north end of the east wall is a timber framed window, which has been inserted in place of a door. The brick built lean-to on the west elevation of the barn was badly damaged, but the interior showed plaster board walls and ceiling and a concrete floor (Plate 31).

Plate 27: Interior of west stable room

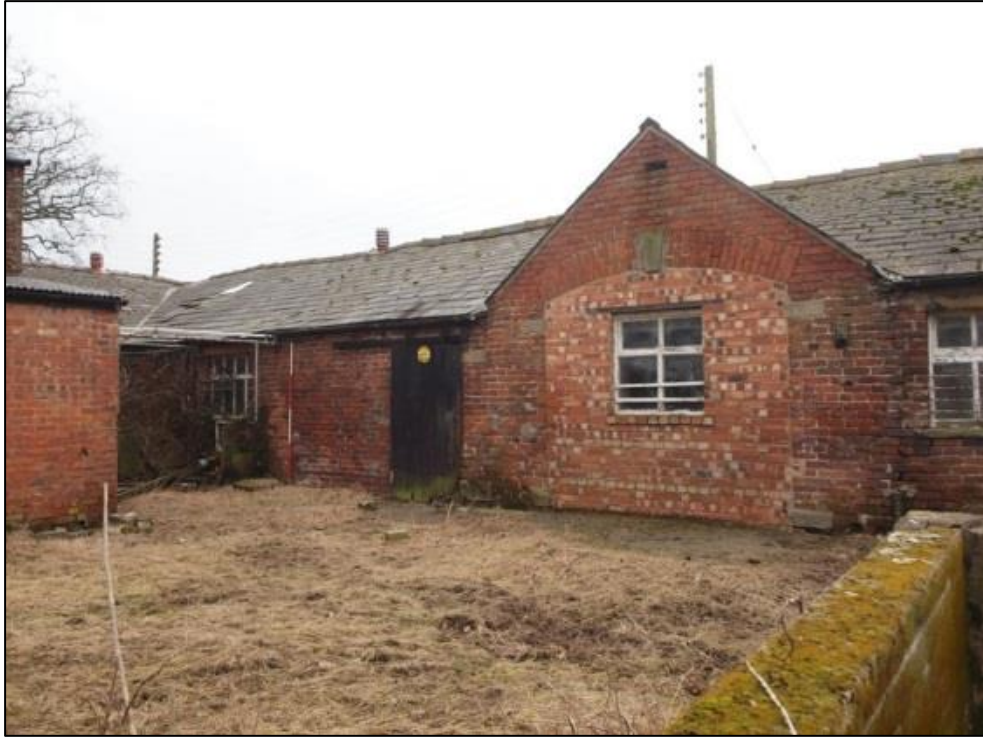
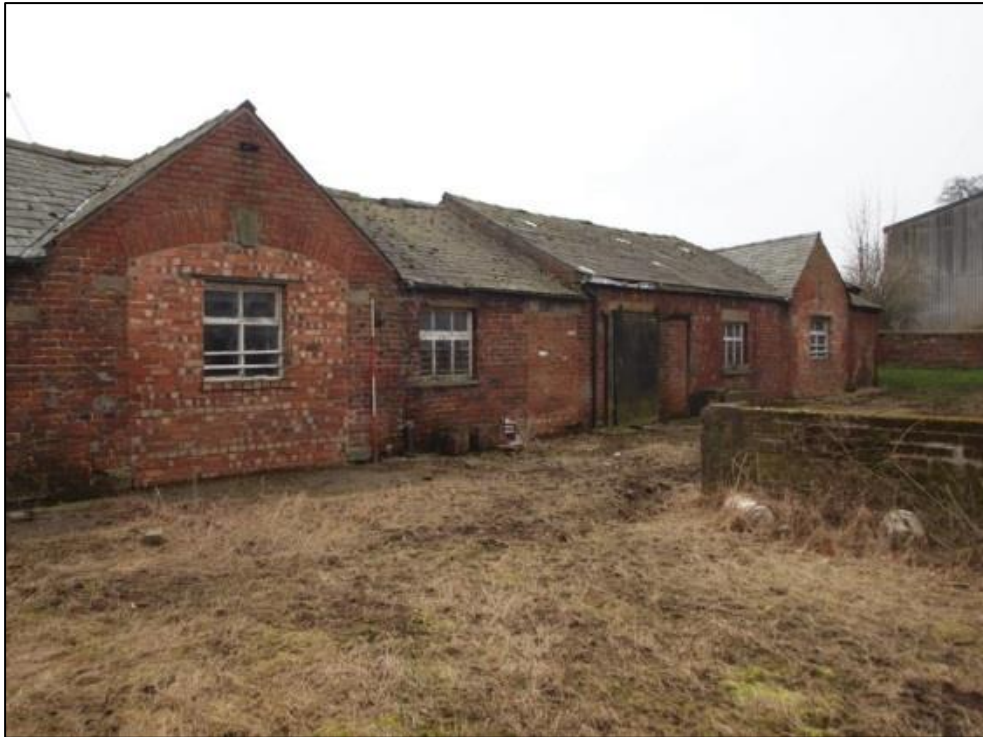
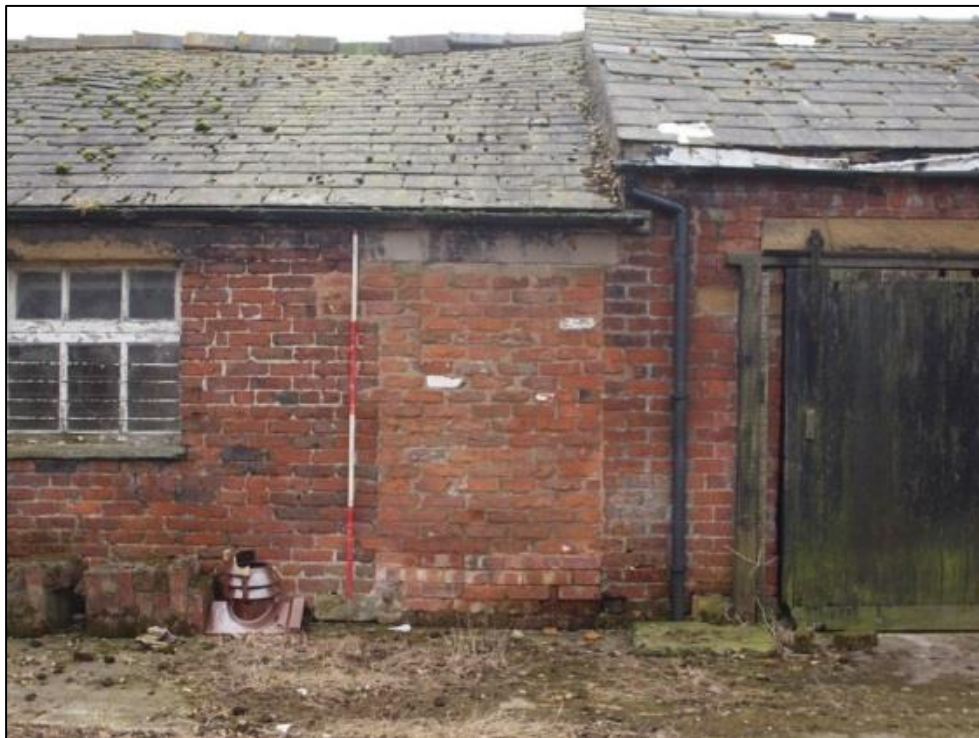
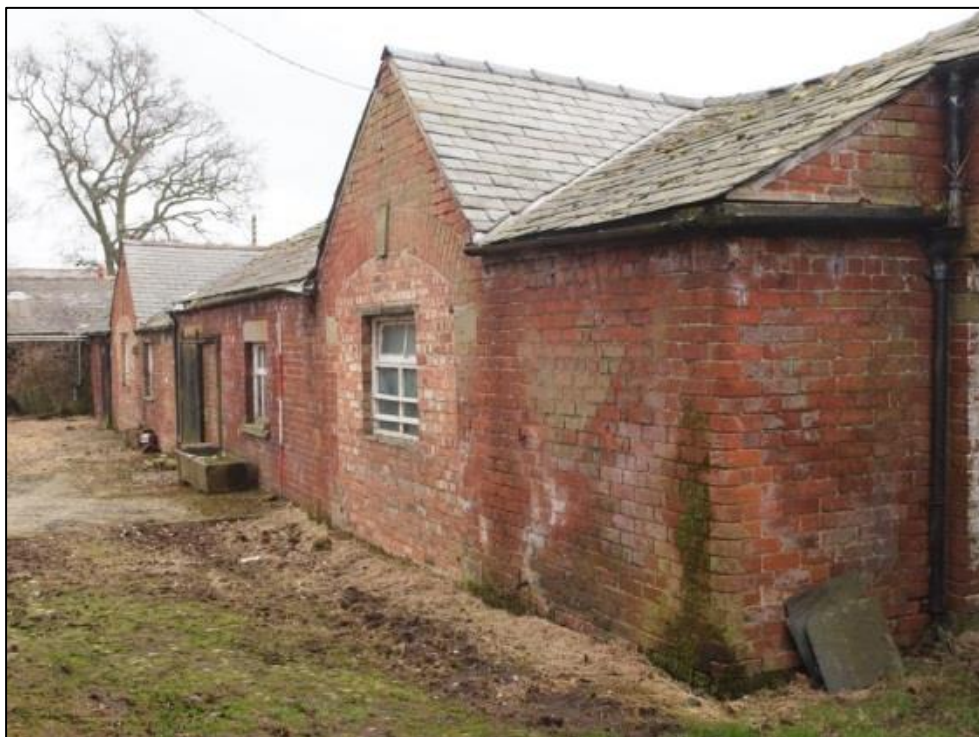
6.8 North elevation (Plates 32 - 36). This forms the main long frontage of the shippon. At the eastern end, within bay 1, is a square timber framed window with sandstone cill and lintel, with a cattle doorway to the west of it in bay 2. This doorway has sandstone blocks in the jamb and is hung with a timber sliding door. West of this again is bay 3, where a gable has been formed with large blocked cart door opening in the centre. The lintel of this is a depressed arch formed of bricks with a sandstone keystone, and two sandstone blocks lie in each of the former jambs. A square timber frame casement window has been inserted in the centre of the former opening. Bay 4 contains a further window, similar to the first, with a blocked doorway to the west of it. Immediately west of the door is a rough joint in the brickwork and the roof line steps up, showing the end of the shippon and the beginning of a later extension. This is also shown in the bricks, with those to the east having similar form and measurements to those of the barn, whereas the western bricks are larger (9 $\frac{1}{4}$ x 3 x 4 $\frac{1}{2}$ "") and pressed. Bay 5, begins this extension with a cattle doorway, hung with sliding door and a sandstone lintel above. A square timber framed window lies to the west of this in bay 6, likewise with sandstone lintel and cill. Within bay 7 a gable has once again been formed, to match that in bay 3. It likewise contains the large blocked cart door opening with inserted window and the cart door surround matches that of the previous. Finally,

bay 8 is recessed from the rest of the face. This contains a personnel doorway in the east end with a heavy dressed sandstone lintel. Immediately to the west of this is a small timber framed portrait window with sandstone cill and lintel. The lintels of the door and window differ, which may suggest that the window is a later insertion, although the brickwork does not suggest such.

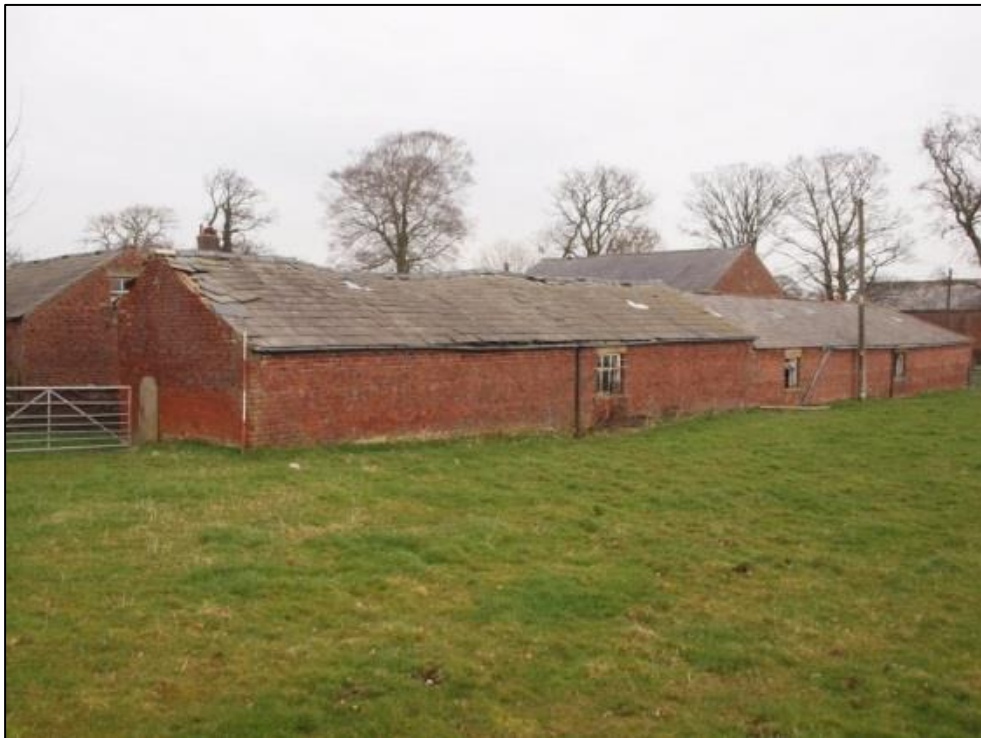
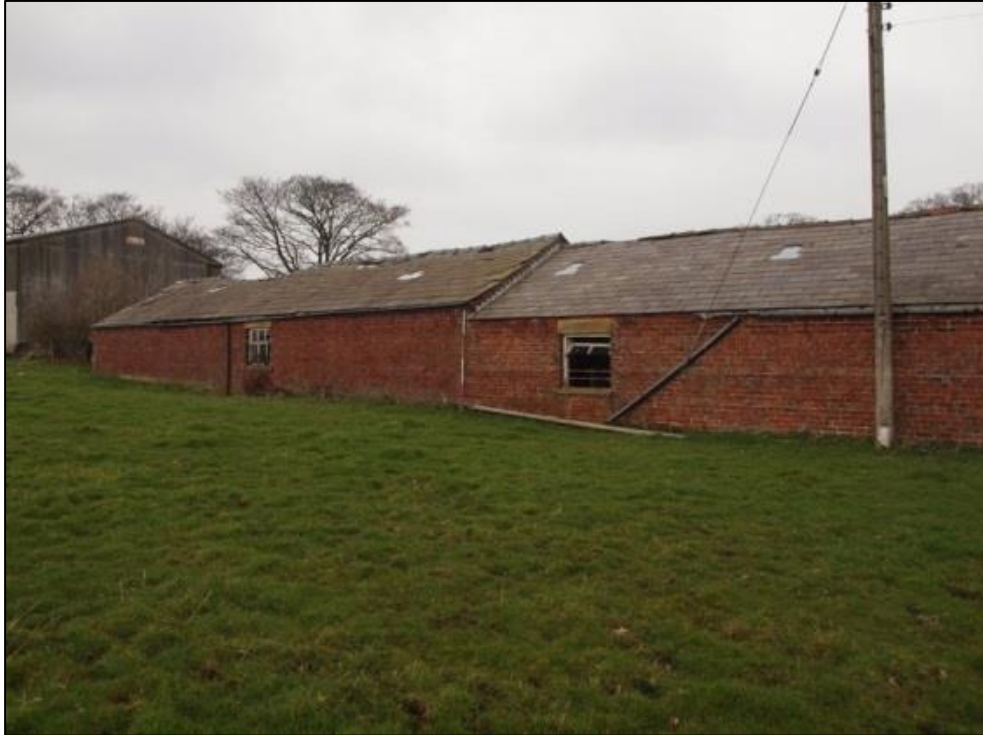
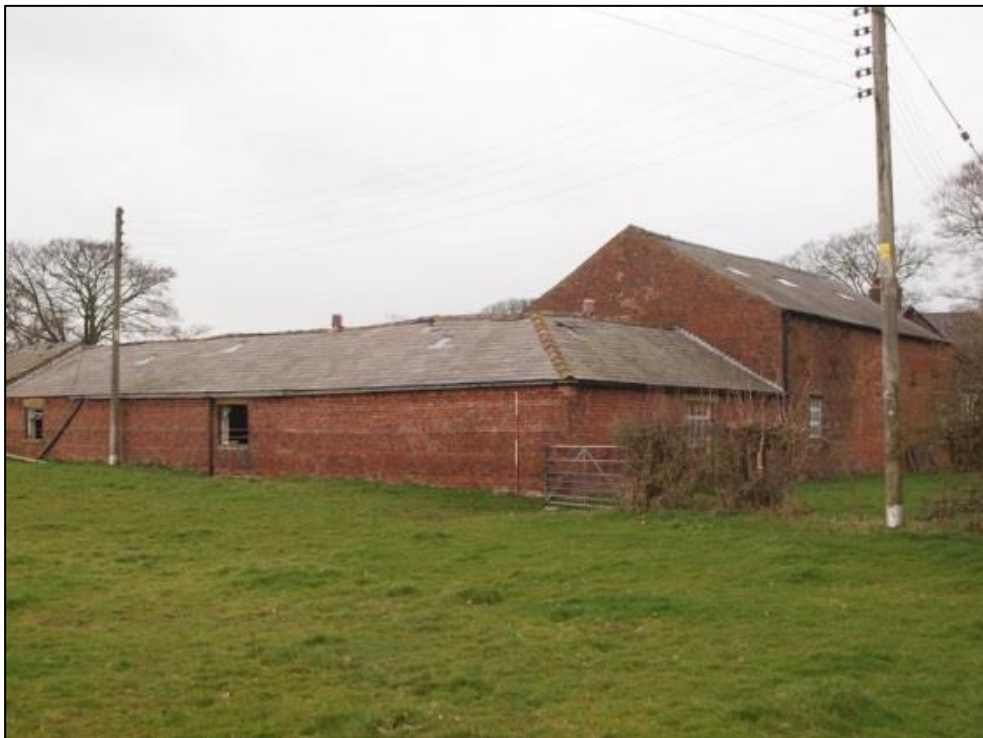
- 6.10 South elevation (Plates 37 - 39). This forms the rear of the shippon. It is relatively featureless and a straight joint runs down the face near the centre, marking the beginning of the later western extension. The western end contains a single timber framed square window towards the eastern side, whereas the eastern half has two such windows. In line with the straight joint the roof line is also raised, further demarking the extension.

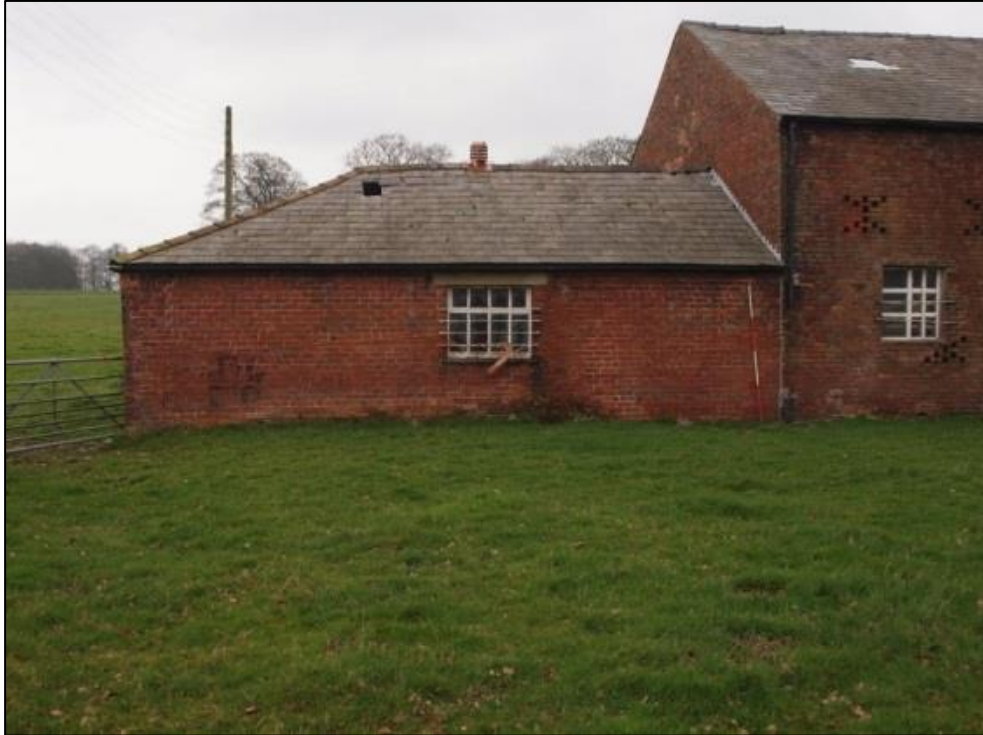
Plate 40: East elevation with faint rough joint to the left

- 6.11 East elevation (Plate 40). This section of the elevation faces onto Thistleton Road and joins the barn to the north. In the centre of the face is a large timber framed casement window with sandstone lintel and cill. The face is otherwise featureless, with the exception of evidence of rebuilding at the southern corner. At the north end a straight joint shows where the shippon butts the barn.

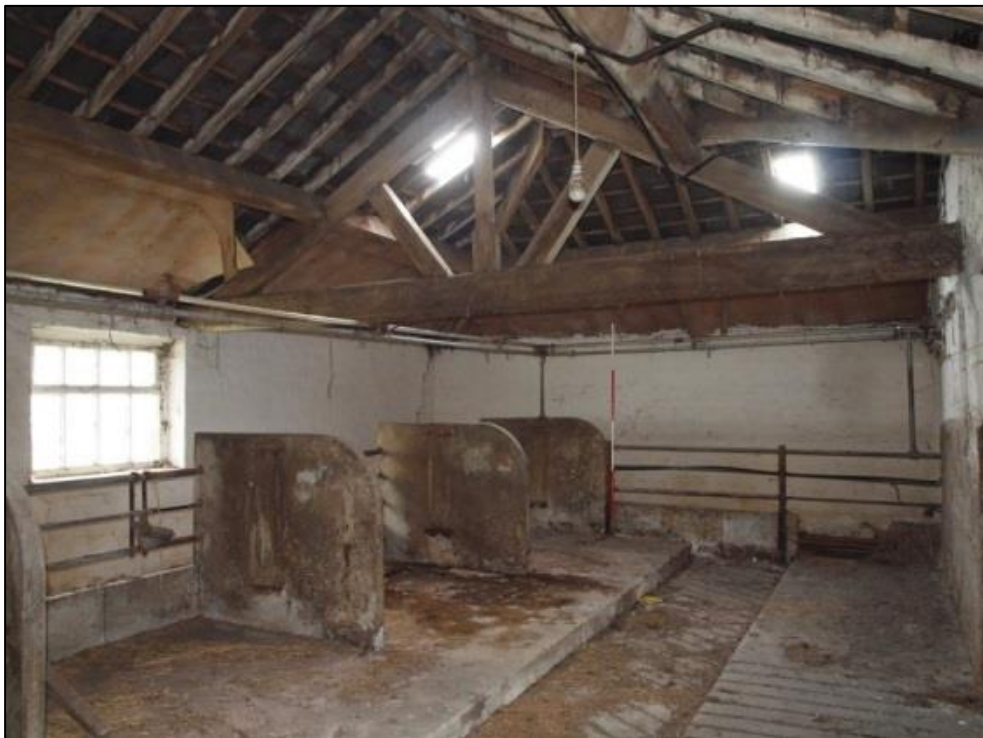
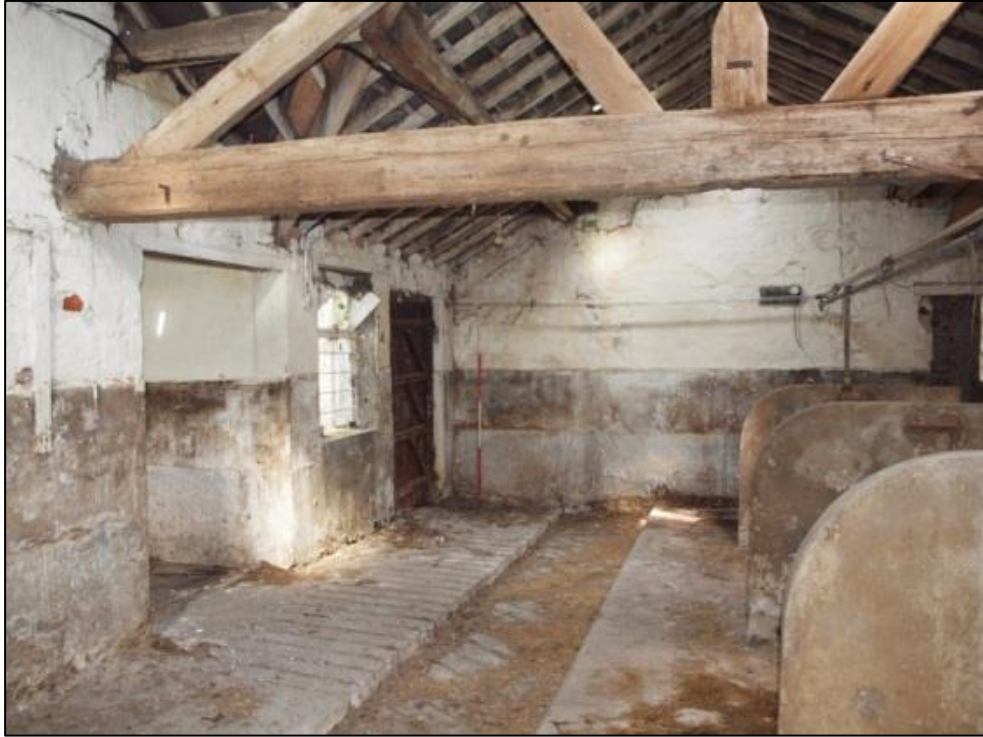
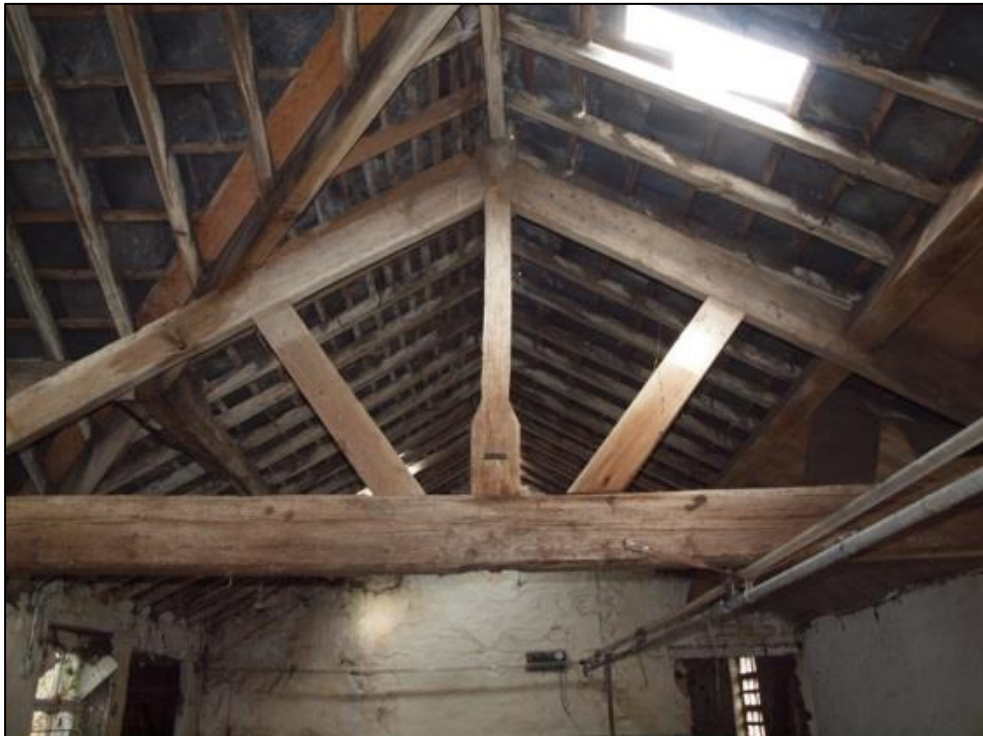
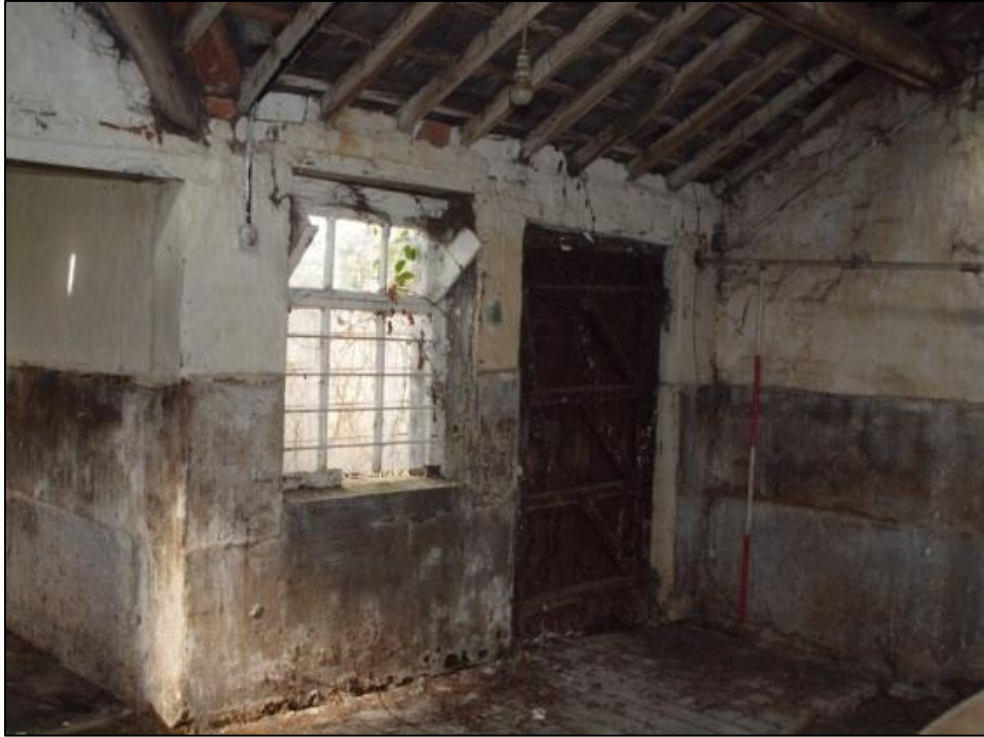
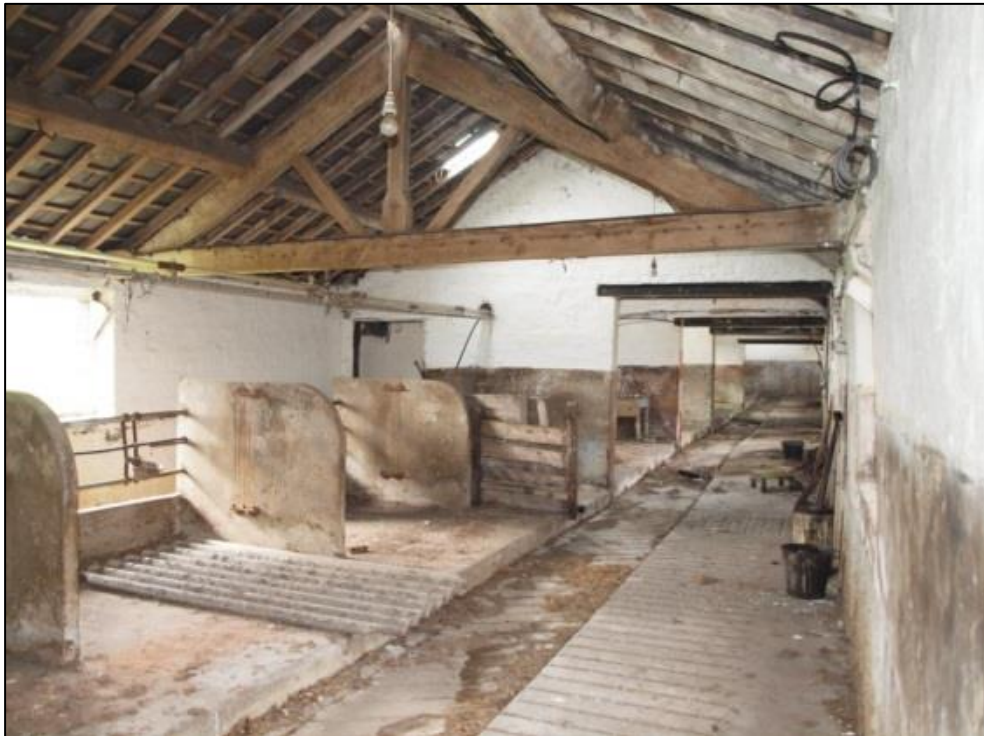
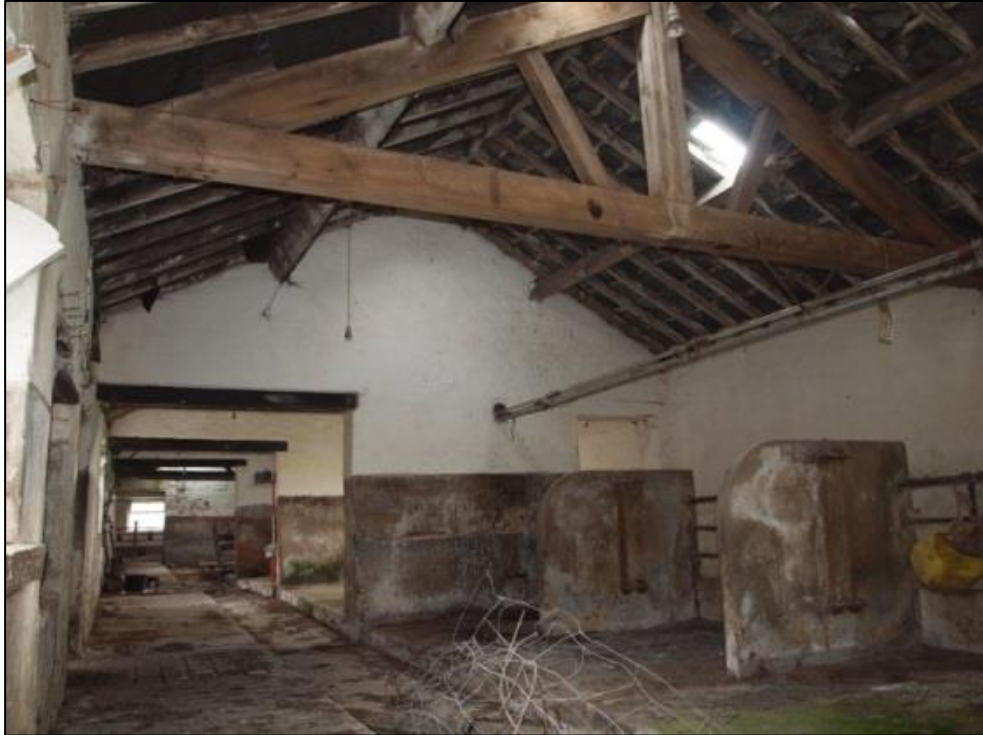
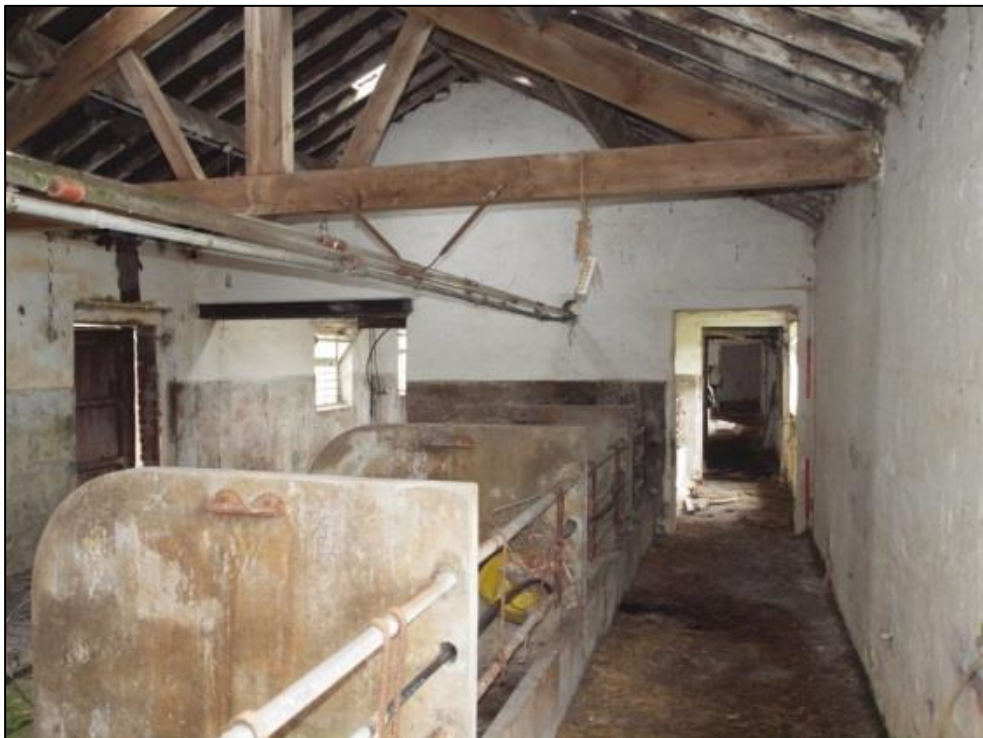
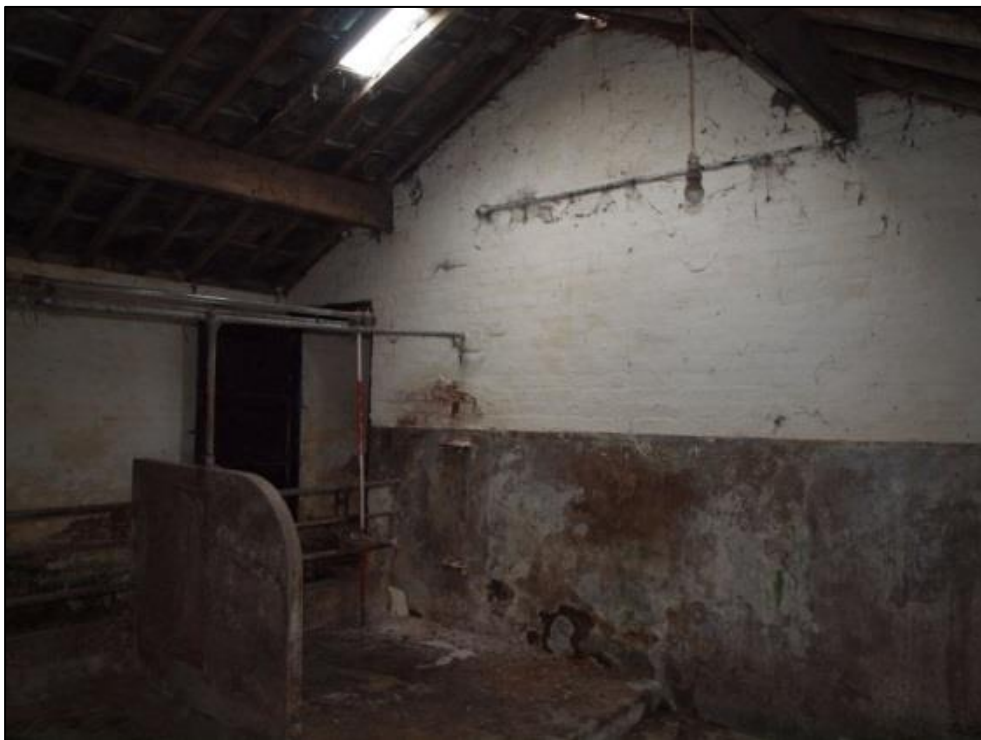
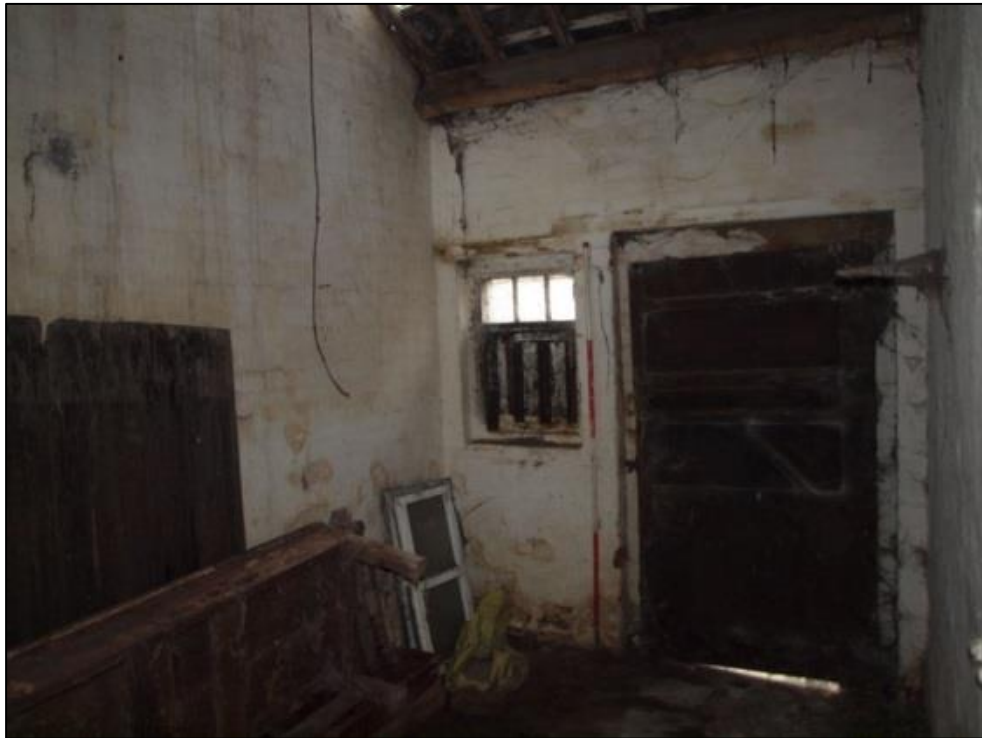
- 6.12 The whole of the shippon interior (Plates 41 - 50) had been modernised, with concrete floor, containing a drainage channel and concrete boskins throughout. The ceiling was open to the machine cut timber rafters. At the eastern end, to the south of the barn, a machine cut timber king post truss supports the roof. Within this area, a doorway lies in the north end of the west wall, with a timber framed casement window to the south of it. These were obscured by vegetation on the

exterior. The feeding passage runs south along the east wall before turning to run west along the south wall.

- 6.13 To the west of this, bays one and two are combined with a machine cut timber king post truss supporting the roof in the centre and contains three concrete boskins. Bay three is separated by brick walls, with openings inserted within to allow the feeding passage to continue and to create a continuous shippon. Bay four likewise has brick supporting walls. The western of these walls was the end of the shippon, prior to the extension, although now openings have once again been inserted to allow the feeding passage to continue and the shippon to be continuous. Bays 3 and 4 each contain a single boskin. To the west bays five and six match 1 and 2, being open with a king post truss supporting the roof in the centre. West of this is bay 7 which is identical to bay 3, both having the gable in the north wall and inserted openings in the east and west walls. Finally, bay 8 is accessed via a personnel doorway at the western end of the feeding passage from bay 7. This is raised, with a step down at the northern end, to match the external ground level. The room itself is small, with a doorway and window in the north wall. Throughout the whole of the shippon, the walls have been whitewashed and rendered at low level.

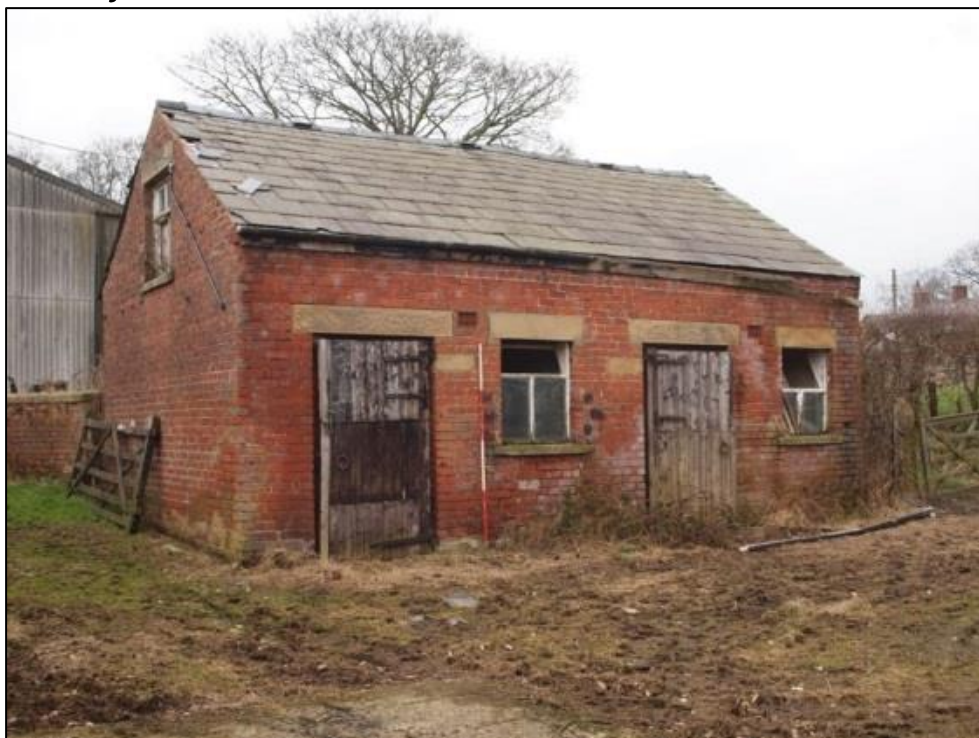
Plate 51: East (front) elevation

- 6.14 East elevation (Plate 51). This forms the front elevation of the two story stable with a stable door at the southern end in bay 1 and a timber framed window to the north of it. Both have sandstone lintels and the window has a sandstone cill. The north jamb of the door also contains a sandstone block. Bay 2 is identical to this, although the sandstone block is in the southern jamb. The bricks are wire cut and measure $9 \times 3 \times 4 \frac{1}{4}$ ".
- 6.15 South elevation (Plate 52). This forms the gable end of the building. The face is featureless save for a timber framed portrait window with sandstone cill and lintel at first floor level.

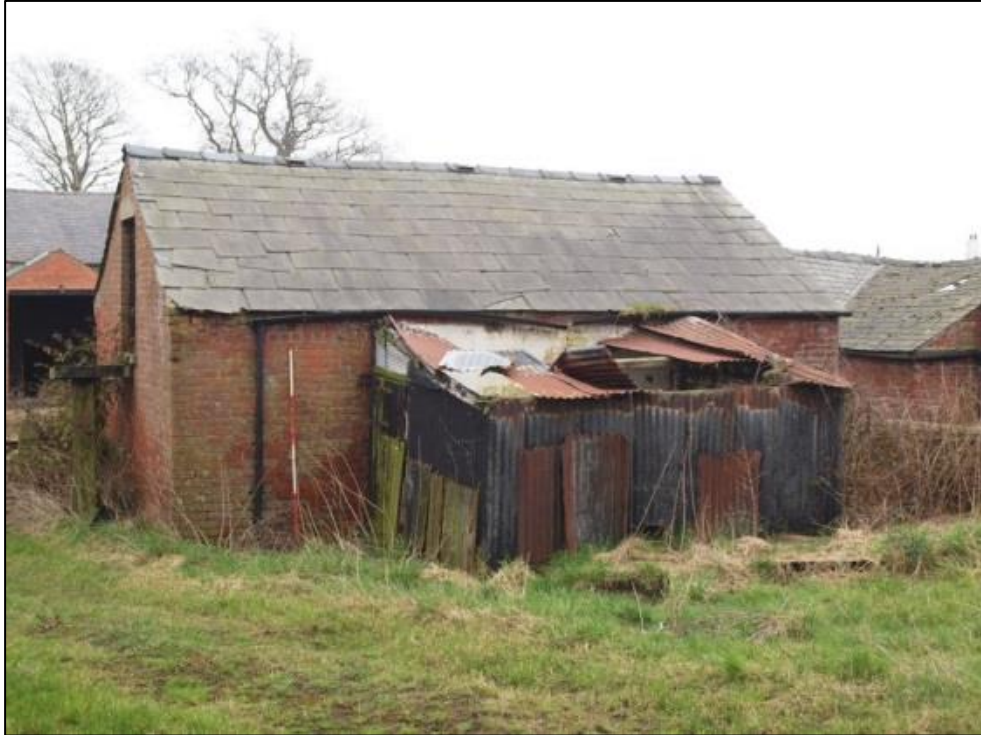
Plate 53: West (rear) elevation with dilapidated lean-to.

6.16 West elevation (Plate 53). This elevation is featureless although the majority of the face is blocked by the corrugated metal sheet lean-to, which was partially collapsed.

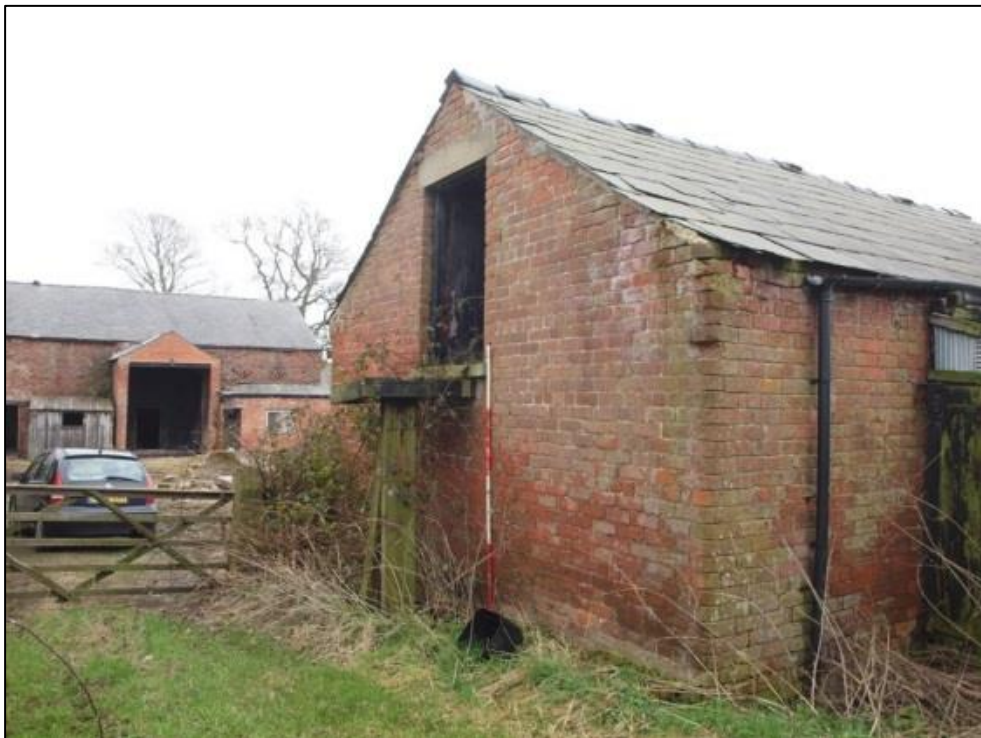
Plate 54: North gable with first floor doorway

6.17 North elevation (Plates 54 & 55). This forms the other gable end of the building. It is once again featureless although a doorway with sandstone lintel lies at first floor level. In front of this are the timber remains of the landing of a staircase, which has since perished.
