THE ARCHAEOLOGY CO.

House Farm, Thistleton
Historic Building Survey

March 2015

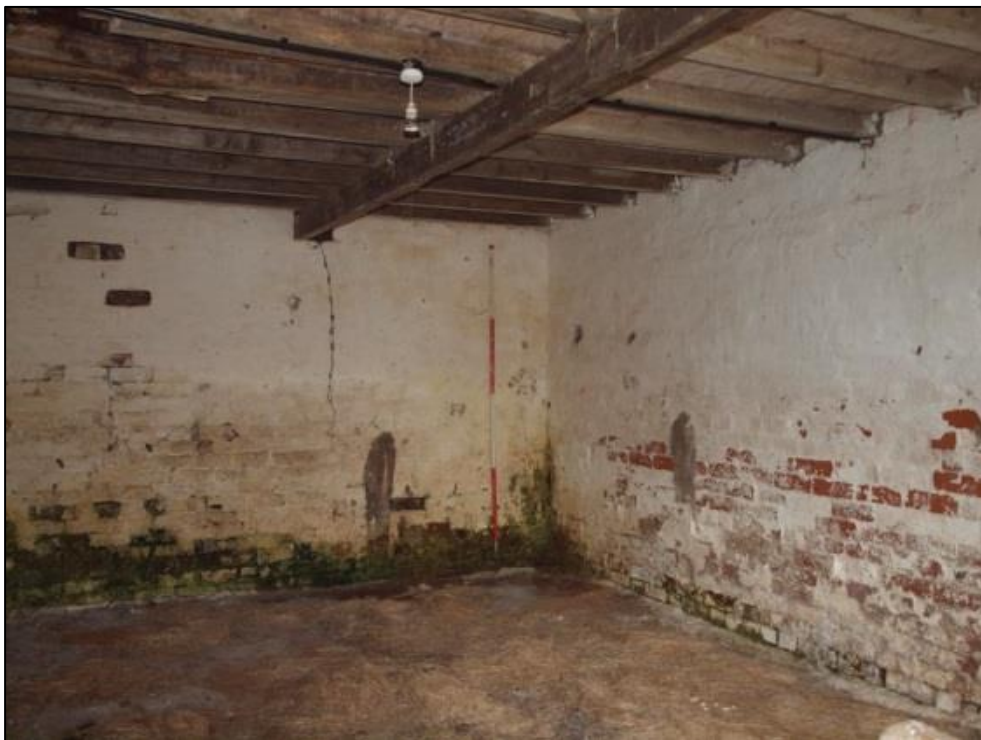
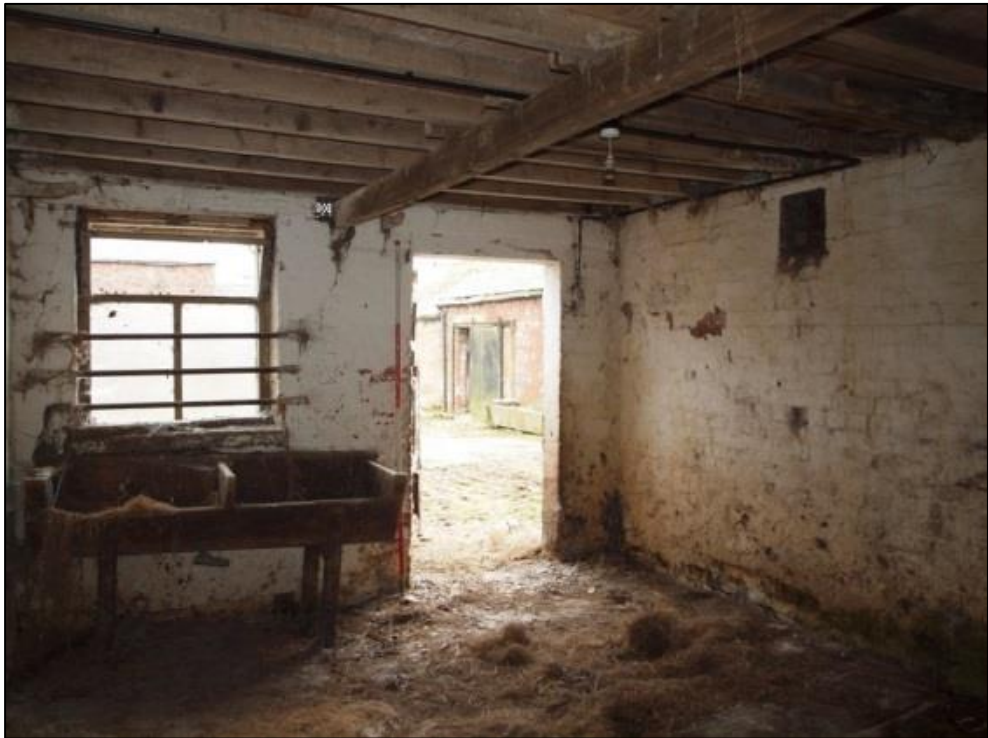
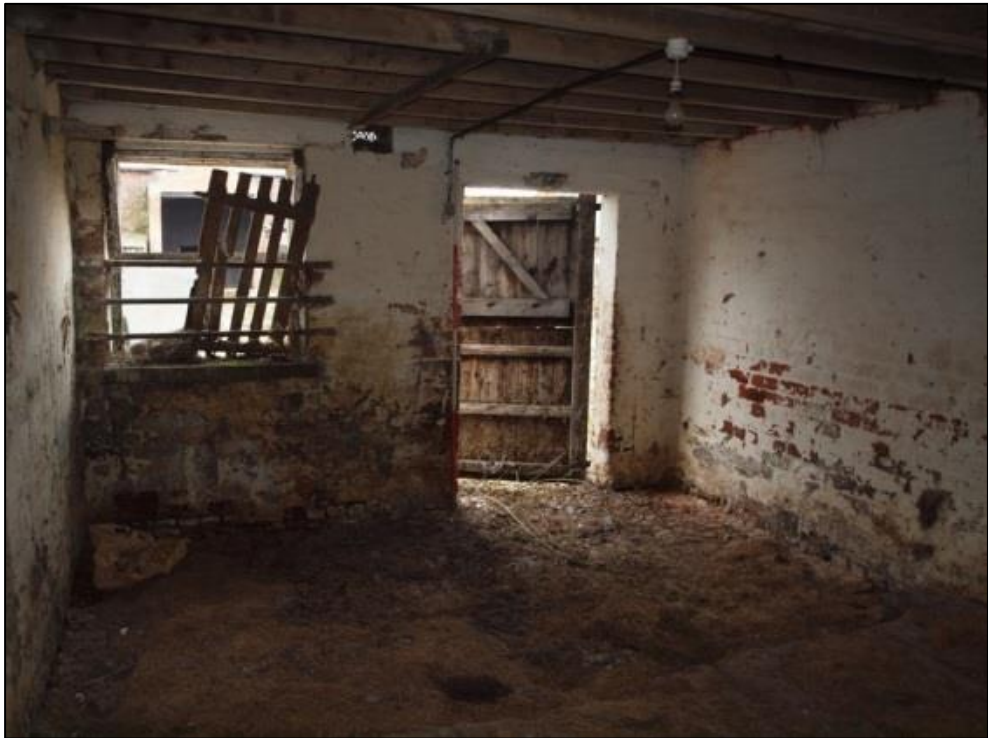
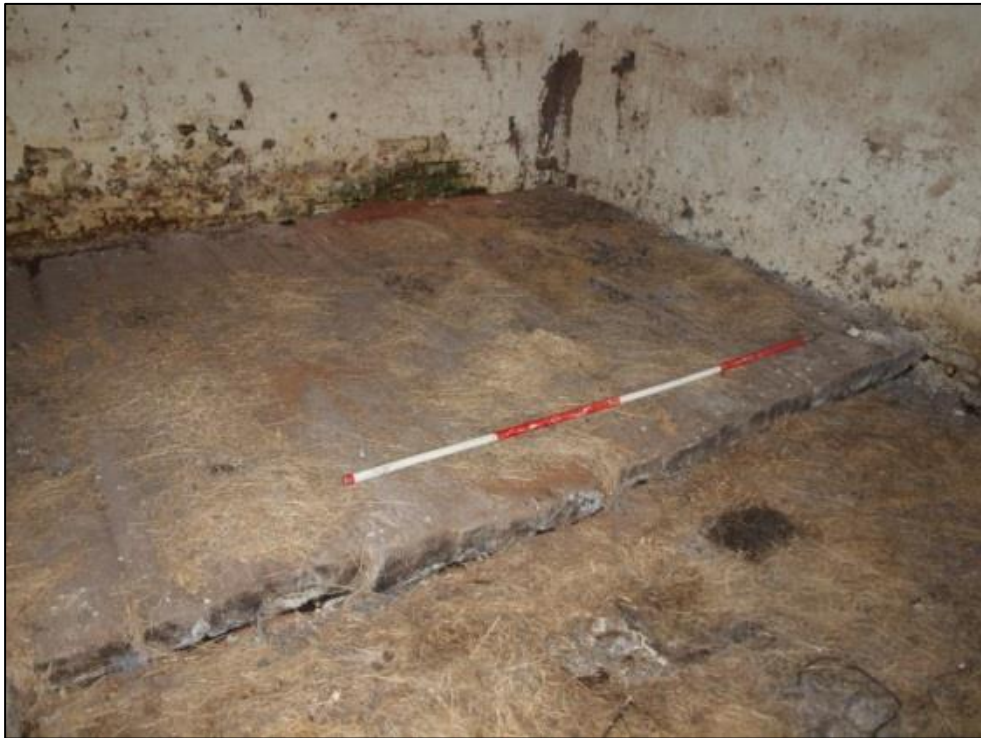
6.18 The interior of the stable (Plates 56 – 59) is divided into two rooms separated by an internal wall. Both sides are similar, with a door and window in the east wall, machine cut timber ceiling and whitewashed brick walls. The floor of the each is of bricks, although within the northern room large timber sleepers have created a raised floor at the west side. The first floor hay loft was inaccessible.

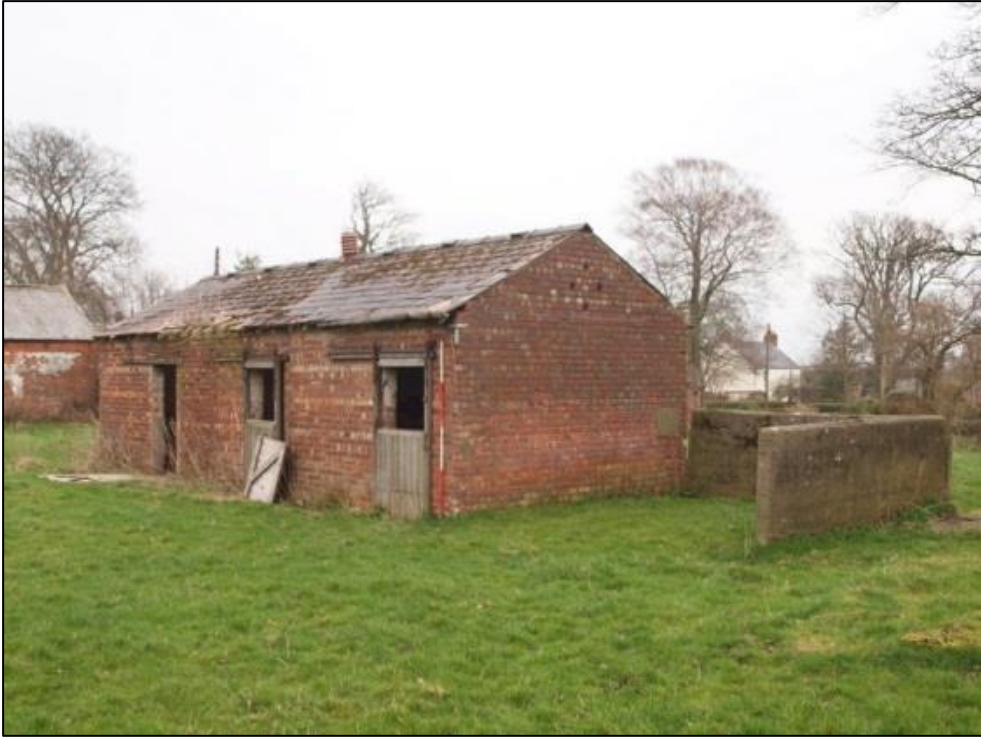
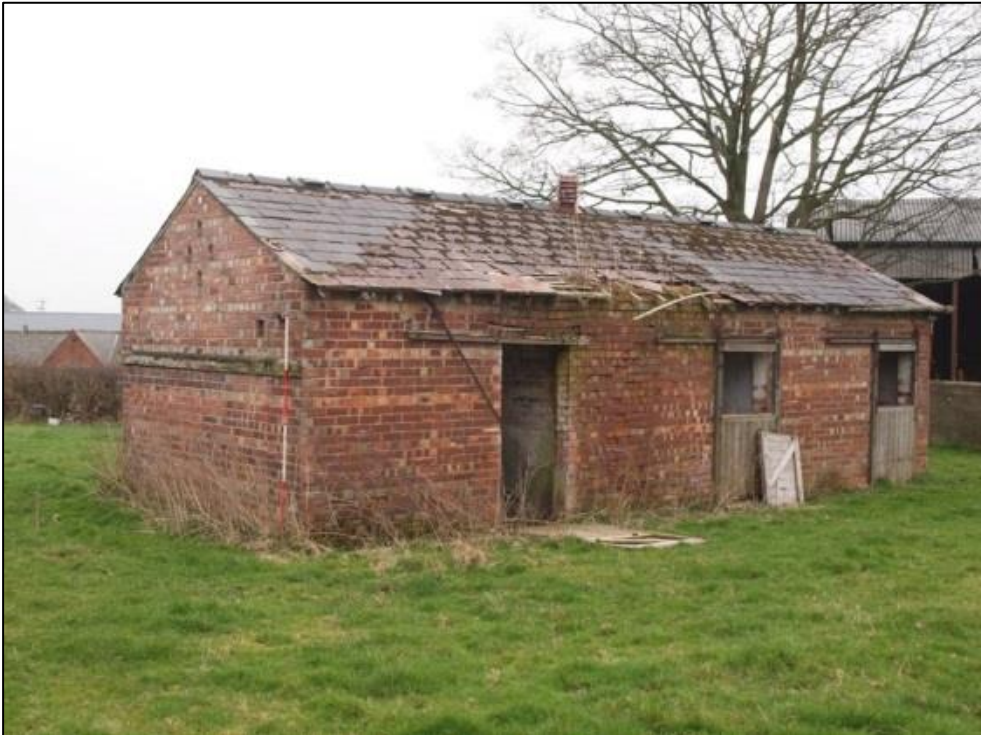
6.19 West elevation (Plates 60 & 61). This forms the front of the 3 bay stable. Stable doors lie at the southern end of each of the bays, although the door itself has fall off from the northern bay. The face is otherwise featureless and the bricks are machine made.

6.22 South elevation (Plates 60 & 63). This forms the other gable end of the building and is identical to it. A concrete wall projects south from the eastern side of the face before turning to the west, to form an 'L' shaped enclosure to the south of the building.

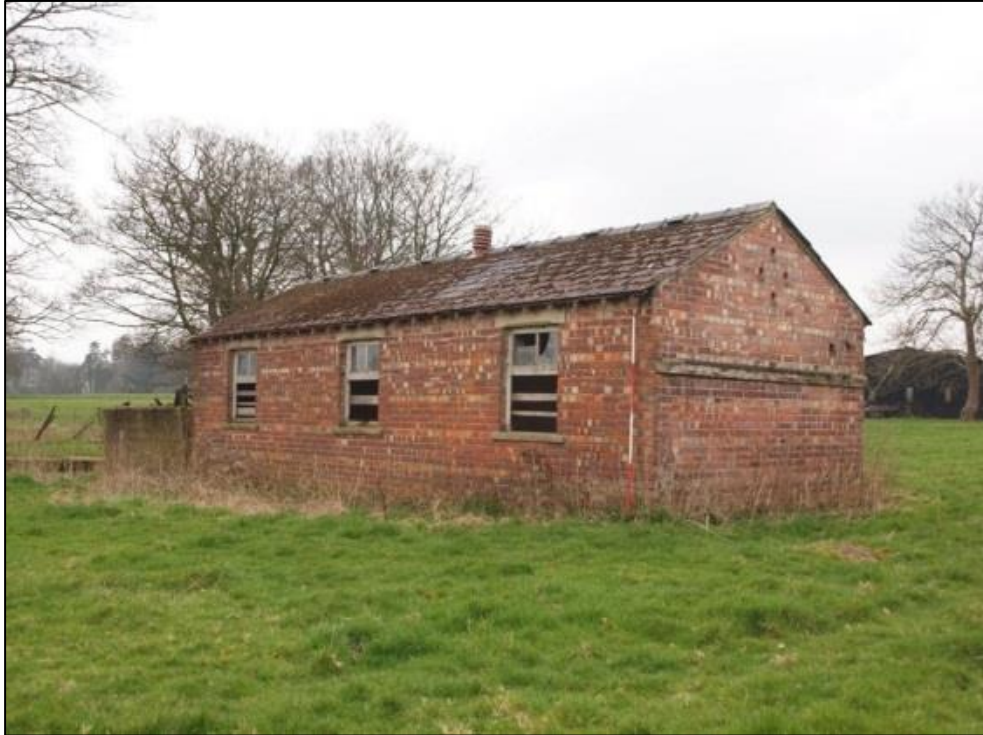
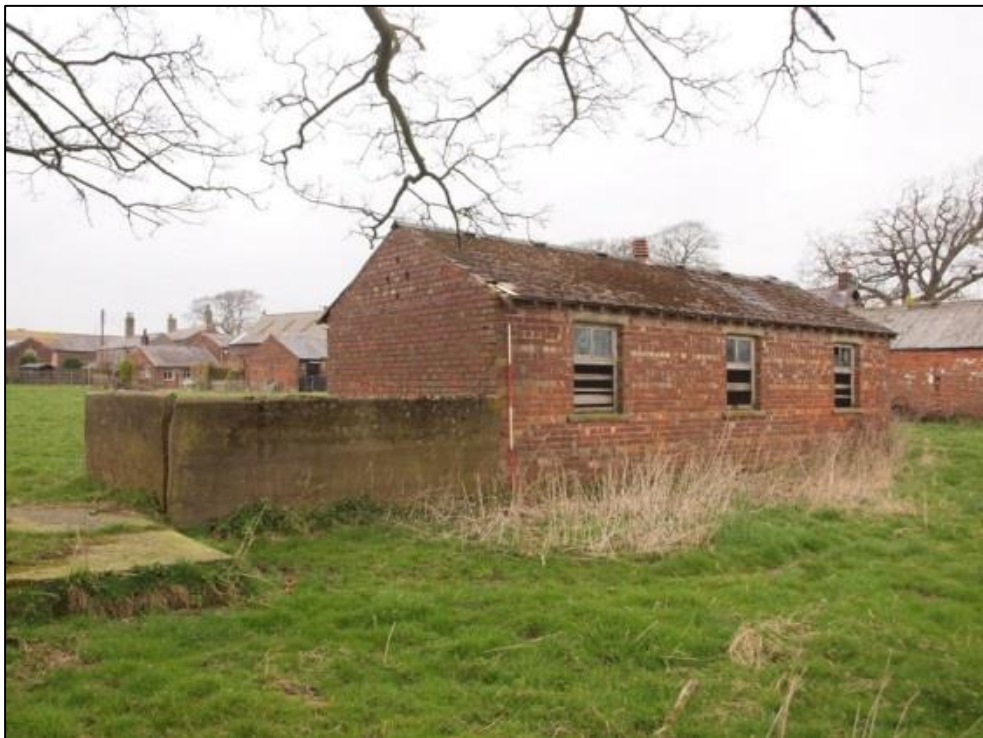
6.20 North elevation (Plates 61 & 62). This forms the gable end of the building and is featureless with the exception of a few vent holes formed through the insertion of ceramic pipe, towards the apex.

6.21 East elevation (Plates 62 & 63). This forms the rear of the building. A timber framed windows lies in the centre of each bays, each having a sandstone cill and chamfered lintel.
