**THE ARCHAEOLOGY CO.**

Kermincham Hall Barn  
Historic Building Survey

June 2017

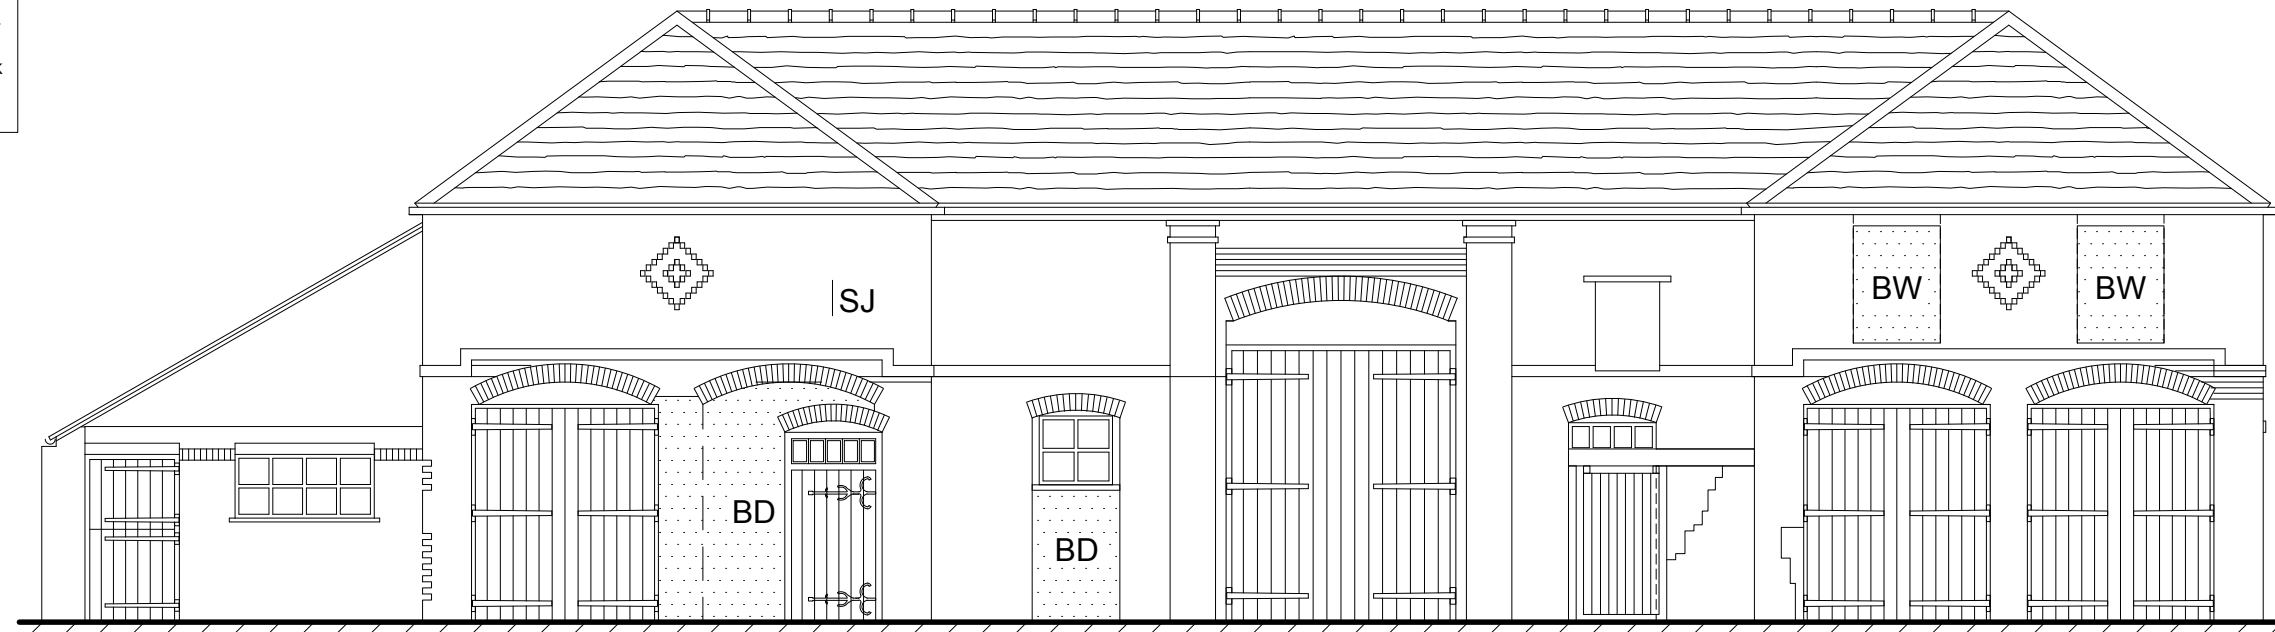
North Elevation

6.2 North elevation (Plates 1 - 4). This forms the main frontage of the building with the two projecting bays at the east and west sides. The western bay contains two large openings at ground floor level, each with double timber doors hung. The lintels of each are depressed brick arches. The brick around these is an orange red, rather than the browner red found on the rest of the building, suggesting that they may have been inserted. The string course has also been raised to accommodate the doorways. Above the string course are two blocked portrait windows. To the east of this is the central face of the barn, set back from the flanking projecting bays. This contains a large barn door in the centre with flanking brick columns. These bisect the string course and the doorway reaches up to first floor level. The lintel of the door is a depressed arch of bricks. To the west side of this door way is a personnel doorway with timber doors hung and four lights above set in a timber frame. The lintel is once again a brick depressed arch. A rough joint to the right side of the door suggests that this may be a later insert. Above this at first floor level is a portrait window, although with no frame, cill or lintel. On the eastern side of the door is a timber framed square window of 4 lights with a depressed arch lintel. Below this blocking is visible where it had once been a doorway. Above this the face is blank, although blocked vent holes are evident. To the east of this face is the eastern projecting bay. This matches that to the west. However, the western doorway has been infilled and a smaller timber framed personnel doorway inserted. Above these doorways the blocked windows are not evident, although

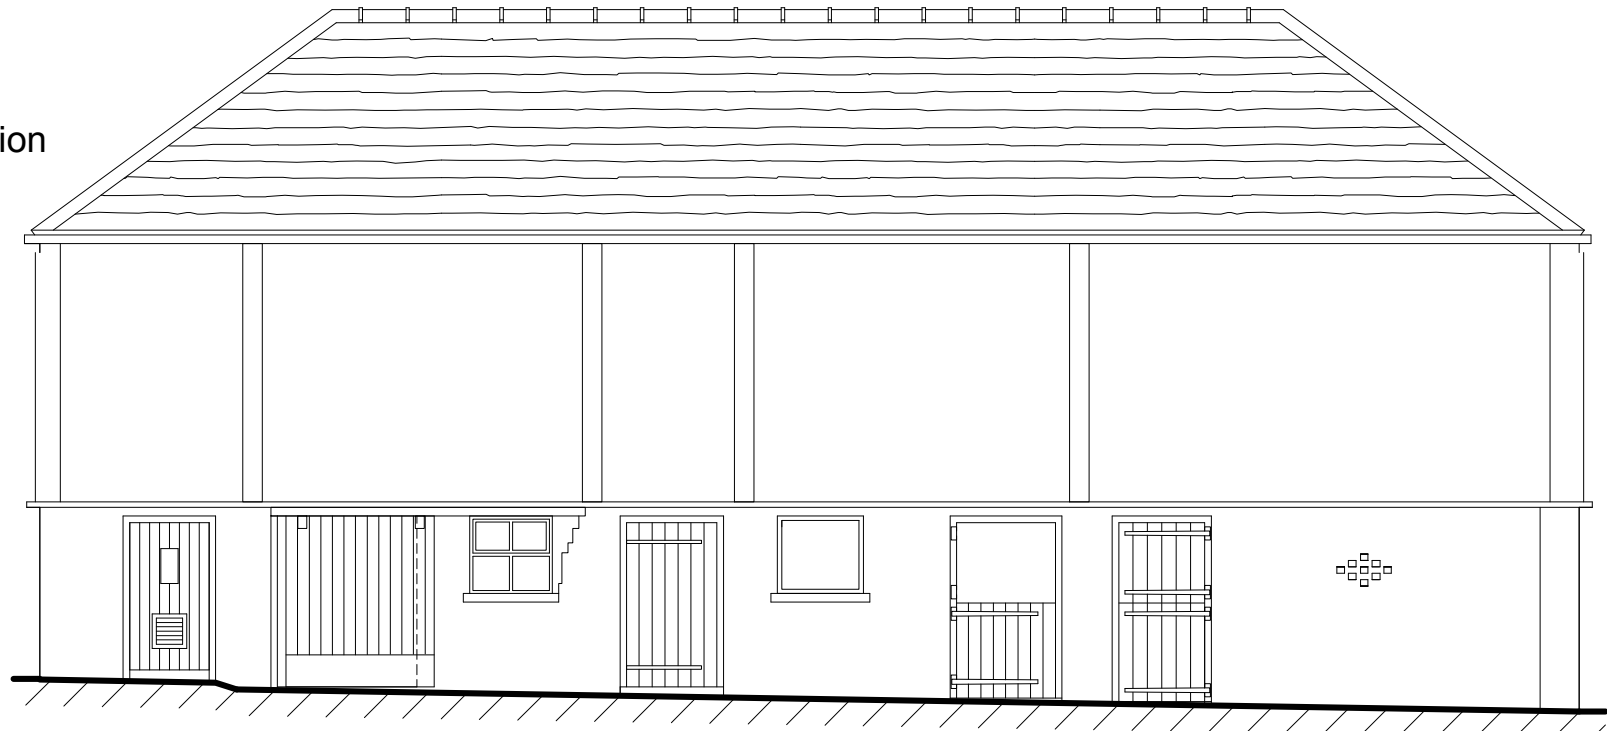
East Elevation

6.3 East elevation (Plates 5 & 6). This forms the front of the single story lean-to and is constructed in English Garden Wall bond. Two personnel doorways lie towards the northern end. The doors have been removed but the southern retains part of the timber frame. To the south of these is a further matching doorway, flanked by a pair of timber framed square windows. The northern has been removed, but the southern is a timber casement of four lights. South of this is a further pair of doorways, once again with no door remaining. The northern of these has been widened into a larger opening, whereas the southern is a personnel doorway.

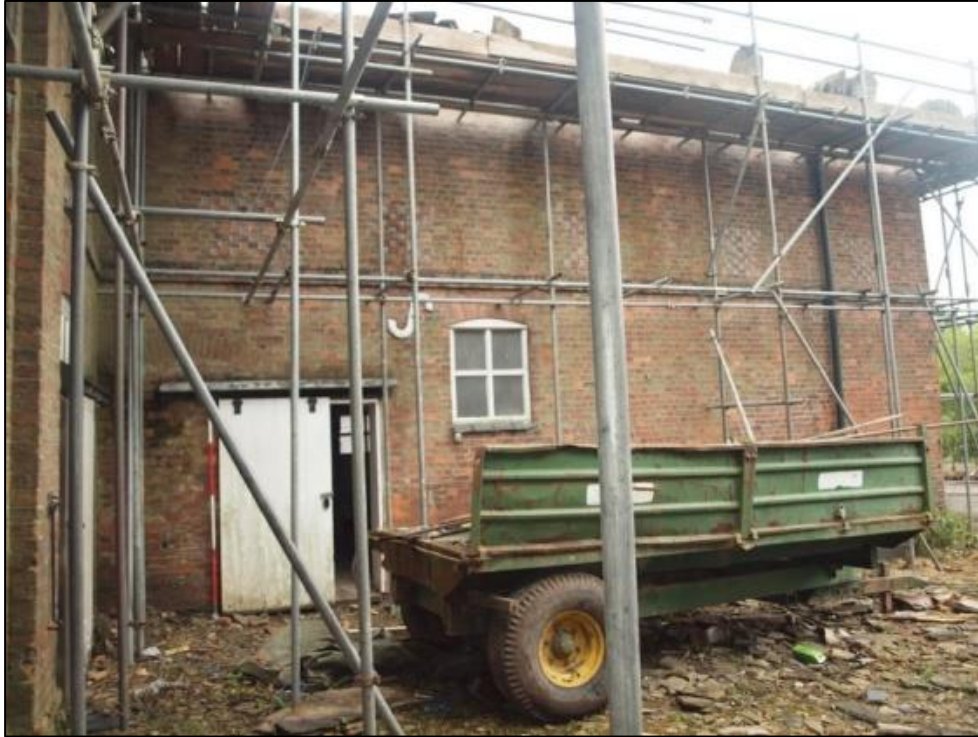
Plate 14: Internal east elevation

- 6.5 Internal East elevation (Plates 13 - 15). The northern end of this face is blank, with the exception of a blocked personnel doorway at ground floor level. South of this is a timber framed 4 light window with depressed arch lintel. South of this again, close to the junction with the north elevation is an inserted personnel doorway with sliding timber door hung, inserted through a blocked doorway.

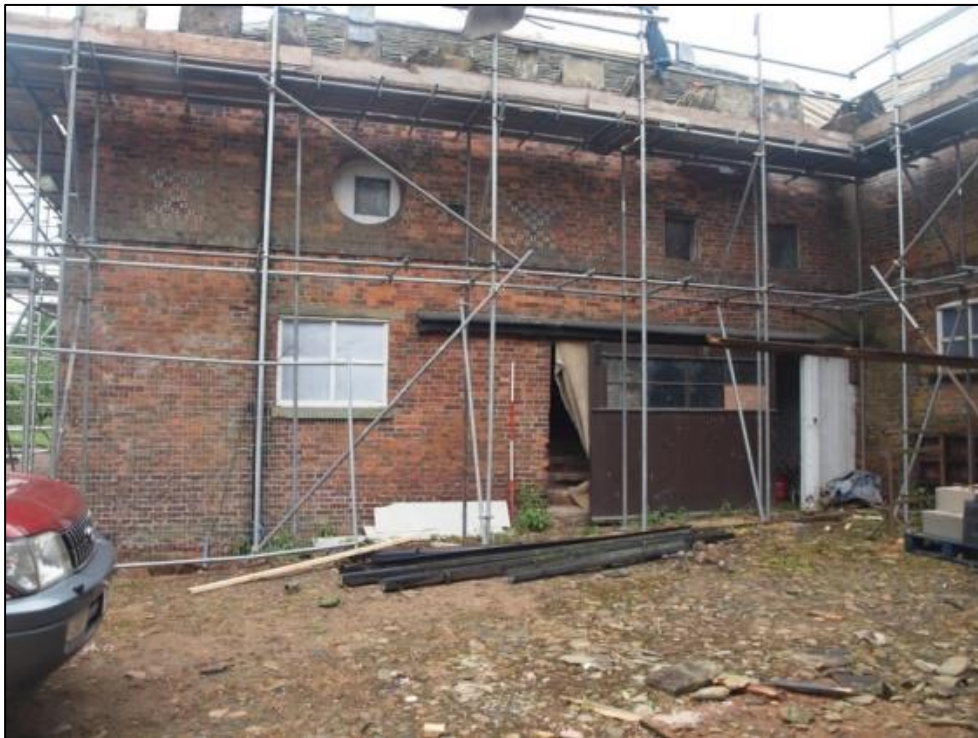
Plate 16: Internal west elevation

- 6.5 Internal West elevation (Plate 16). At the northern end is a four light timber framed window with sandstone cill and lintel. Above this at first floor level is a circular pitching eye. In the centre of the face at ground floor level is a doorless opening with steps leading up to first floor level. South of this is a large timber sliding door. This lies over a large opening with a depressed arched lintel spanning the gap. At the southern end the jamb is formed from a short timber wall. At first floor level above this opening is a pair of inserted single light windows.

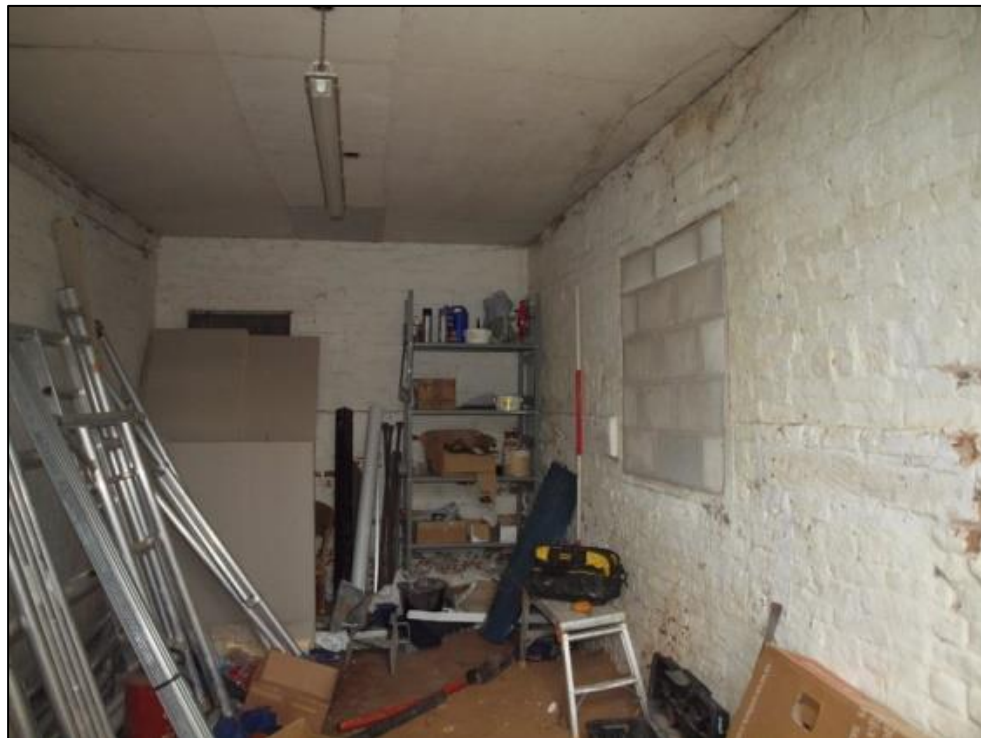
Plate 17: Room 1, southern side

- 6.6 Room 1 (Plates 17 - 19). This is accessed via the large doorways in the north wall. The floor of this room is earth, although some cobbles remain towards the

northern end, and the ceiling is modern ply. The walls are whitewashed brick and an inserted wall running north – south divides the room. In the southern external wall a blocked window is evident and in the external north wall a blocked doorway is also present. A doorway in the south wall leads through to room 2.

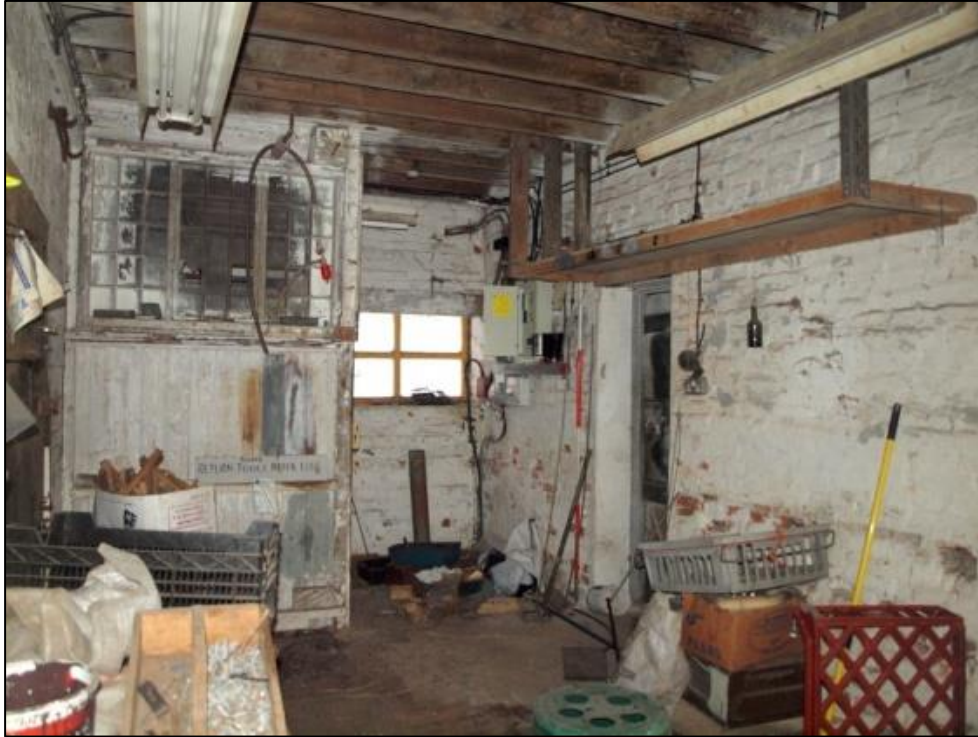
Plate 20: Room 2 looking west

- 6.7 Room 2 (Plates 20 & 21). The room is accessed externally via a doorway in the southern end of the internal east elevation. The floor is concrete and the modern timber joists are visible in the ceiling. The walls are again whitewashed. A doorway in the northern wall leads to room 1 and a four light timber framed window lies in the west wall. A timber stud wall has been erected running north from the south wall. In the east wall, below the window and north of the door, is an alcove with a timber lintel.

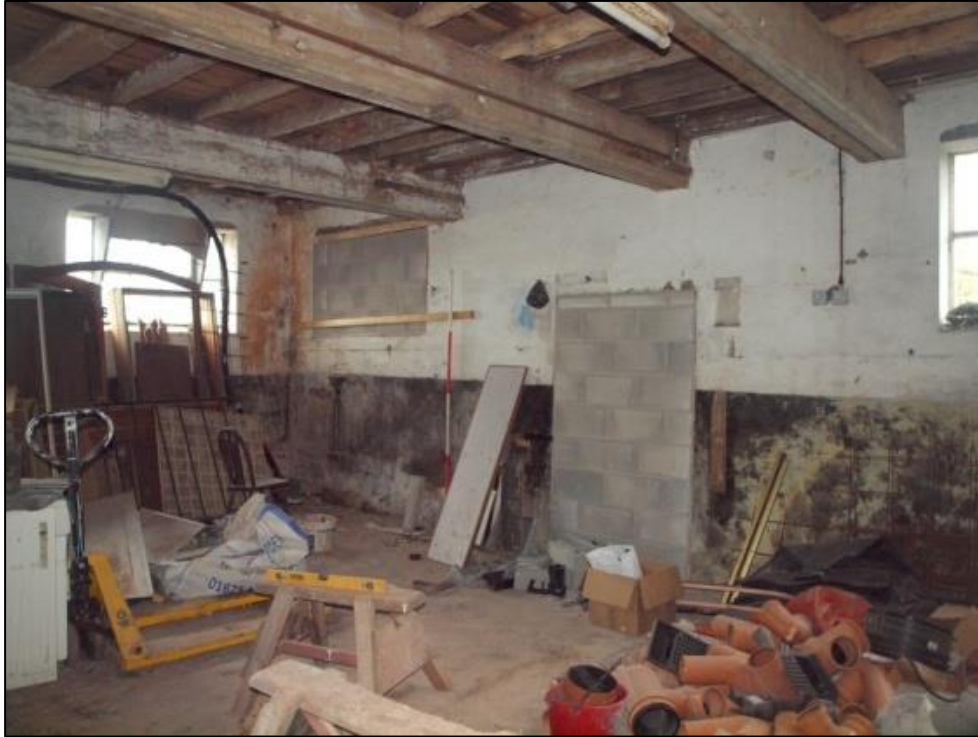
Plate 22: Room 3 looking west

- 6.8 Room 3 (Plates 22 & 23). The room is accessed via a wide inserted opening in the east wall, from room 4, with a large timber lintel above. The floor is concrete and three large machine cut timber beams support the floor above. The joists are of hand cut timber, with some modern timber replacements. The walls are whitewashed brick and a blocked window and doorway are visible in the western wall.

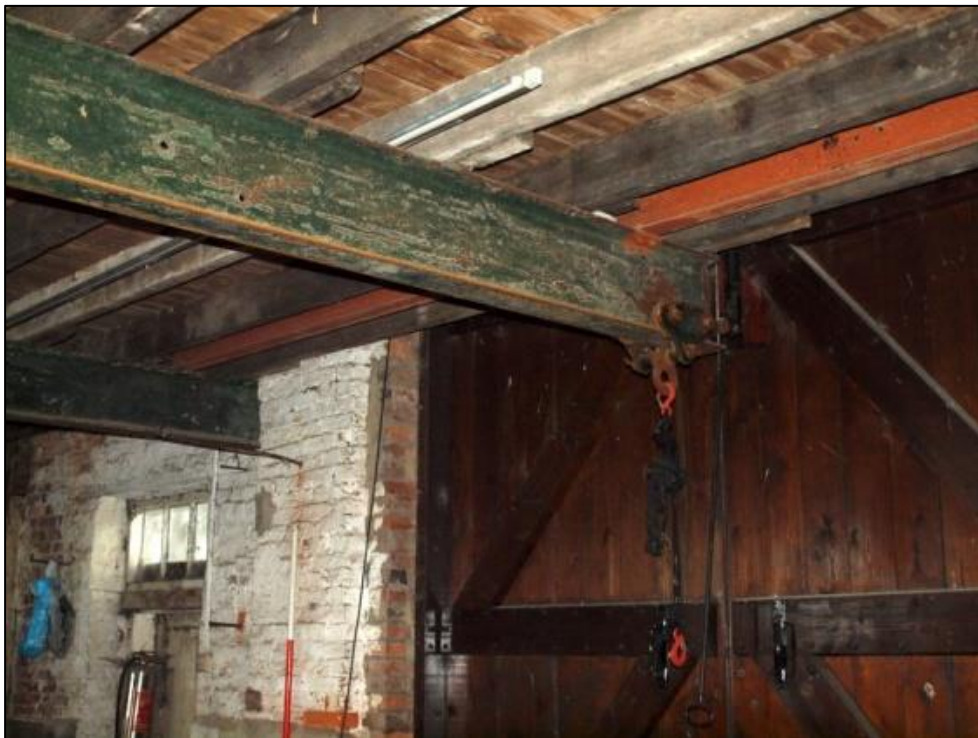
- 6.9 Room 4 (Plates 24 - 28). This is accessed via the barn door in the north wall, or via the smaller doorway opposite in the south. The jambs of both doorways have been rebuilt. Flanking the northern doorway is a personnel doorway to the west and a timber framed window to the east. A Jacobs Ladder is attached to the wall to the east of the window, leading up to a hatch. Flanking the southern doorway are two inserted windows to the east and a window to the west. Between this western window and the door is a further Jacobs Ladder. An inserted opening leads to room 3 in the west wall and the east wall is featureless. The floor of the room is concrete at the ceiling supported by five RSJ beams aligned north south. Above these the modern timber joists are visible.

Plate 25: Room 4 showing barn door and RSJ beam

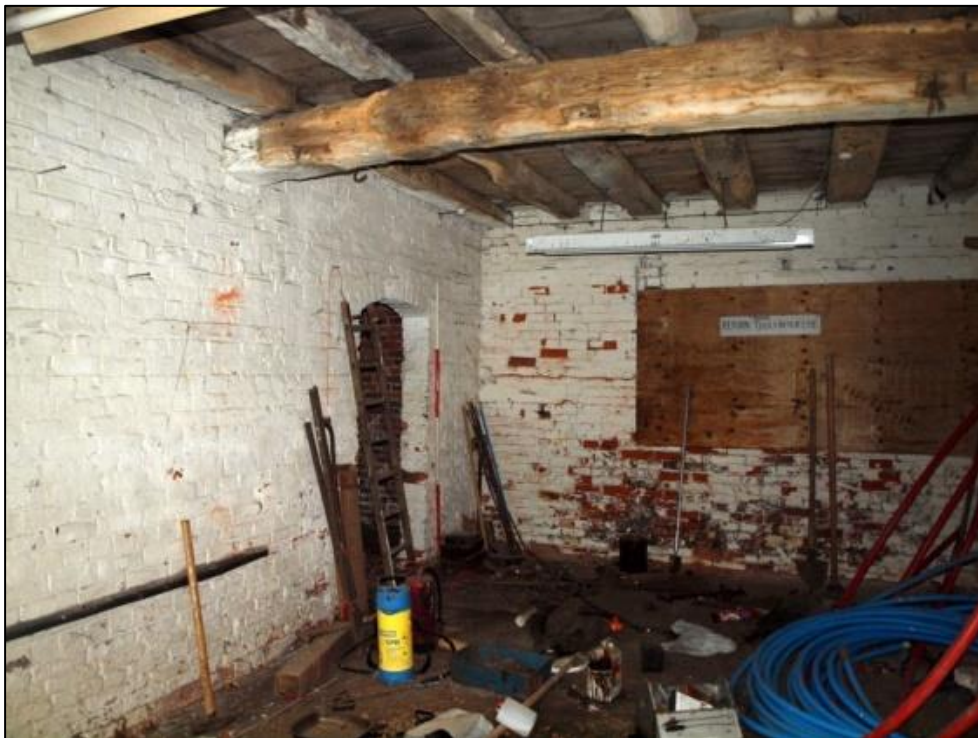
Plate 29: Room 5 looking east

- 6.10 Room 5 (Plates 29 - 32). This room is accessed via the large opening in the west wall, the lintel of which is a single hand cut timber. The floor is concrete and a single hand cut timber beam supports the ceiling. The joists are also visible and are

likewise hand cut, with some modern replacements. The walls are whitewashed brick and have no features except for a doorway in the east wall leading to a storage space below the stairs (room 6).

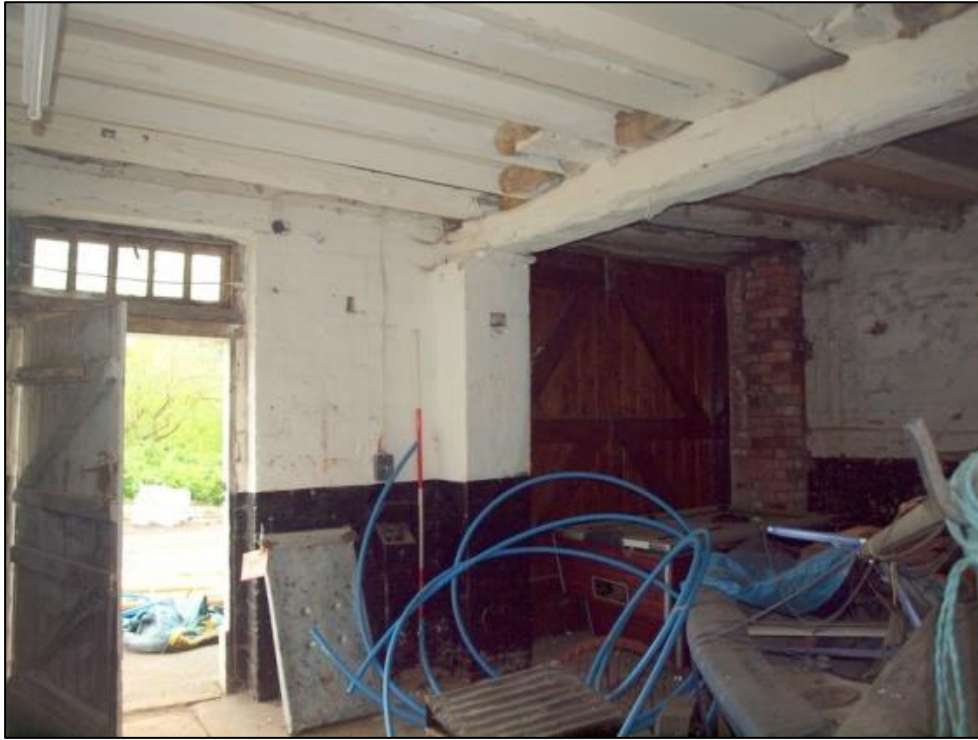
Plate 34: Room 7 looking north

- 6.12 Room 7 (Plates 34 & 35). The room is accessed via the doorways in the northern face. The floor is concrete and the roof is supported by a hand cut timber beam running north – south. Above this several of the joists are also hand cut timber, although some modern replacements are evident, more notably on the west side. The walls of the room are whitewashed brick and the eastern jamb of the eastern doorway shows signs of rebuilding/repair.

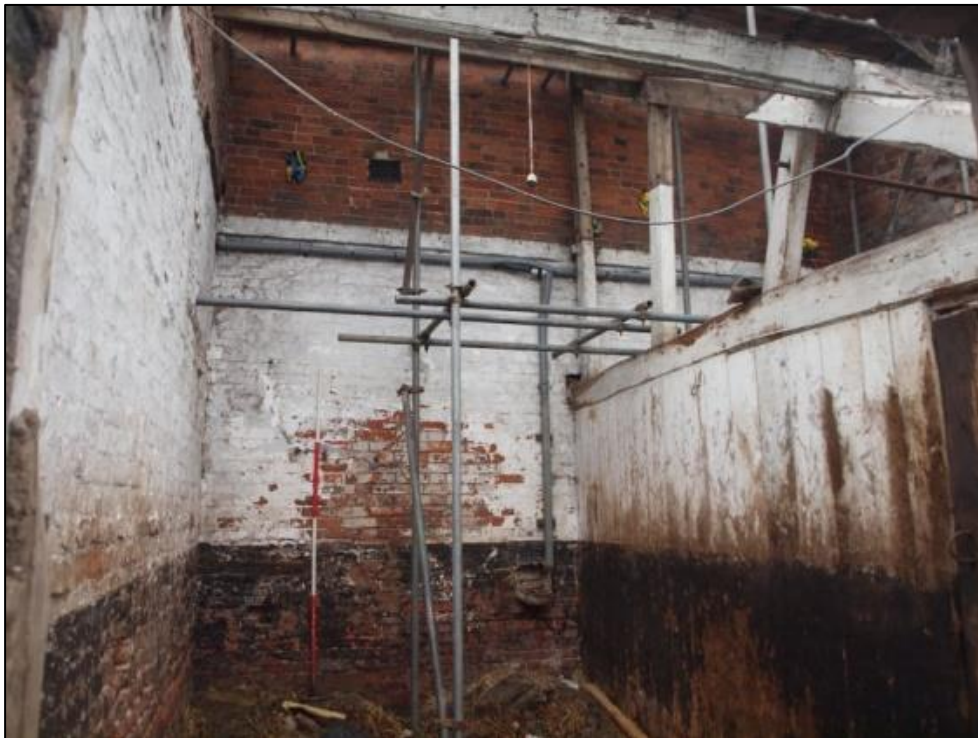
- 6.13 Rooms 8 – 13 (Plates 36 - 42). All of these rooms have no ceiling, whitewashed walls and earth floors, with some traces of cobbles. Room 8 has a timber dividing wall within it. Room 10 is a narrow corridor with three blocked windows in both the north and south walls. These are also visible from the adjoining rooms 9 and 11. Rooms 8 and 9 also contain small feeding troughs fixed to the western wall.

Plate 37: Room 8 showing feeding trough

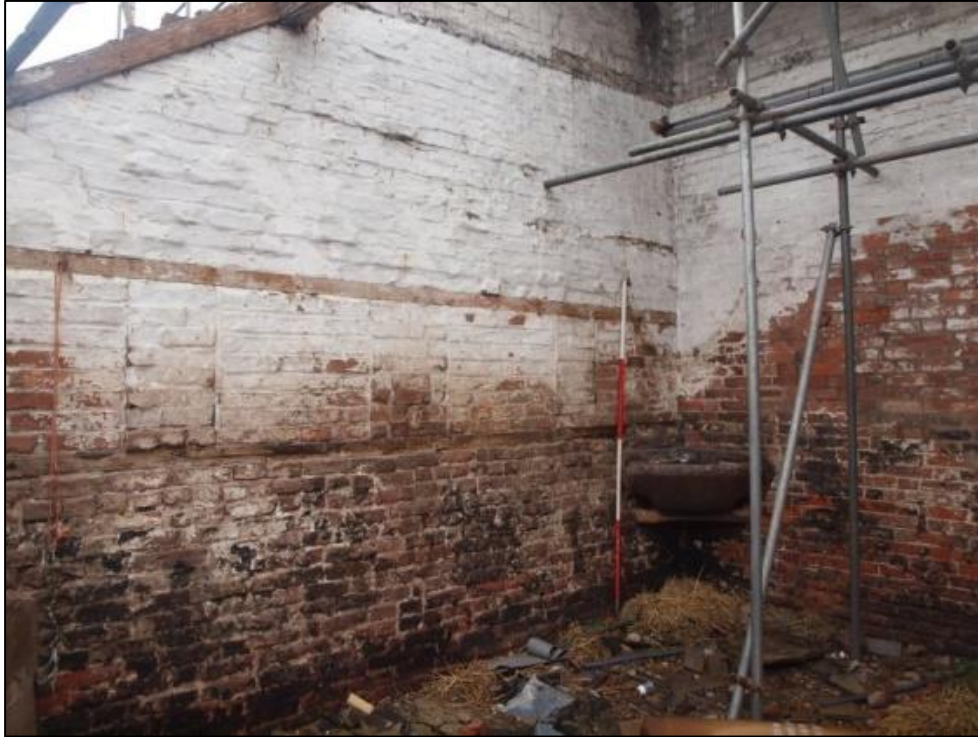
Plate 38: Room 9 showing corner trough and blocked windows

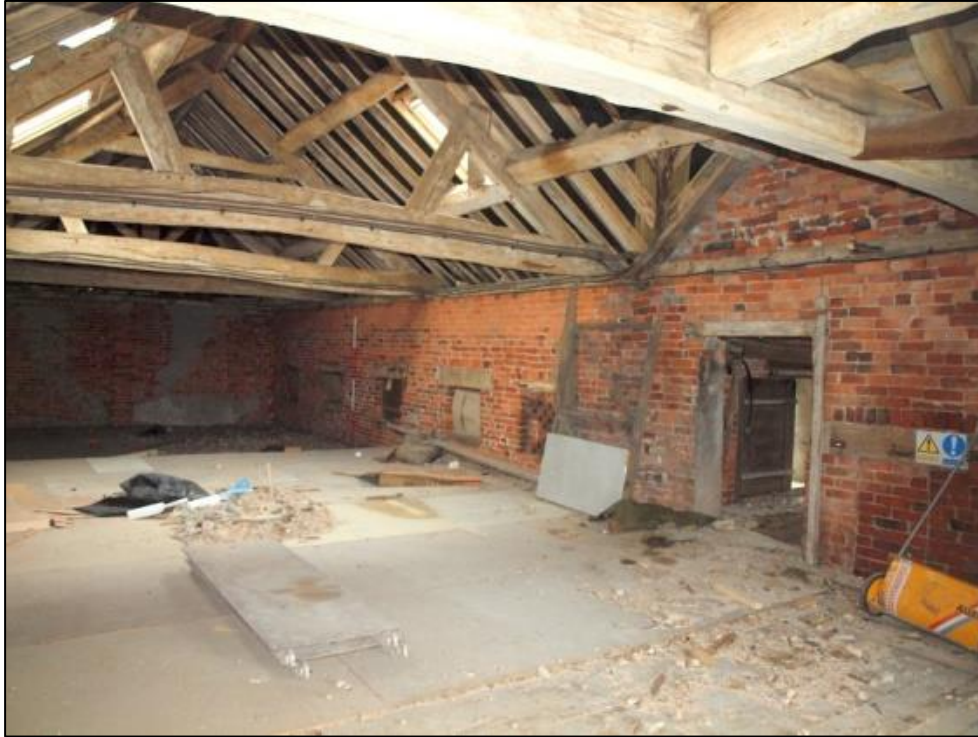
- 6.14 Room 14 (Plates 43 - 50). This room lies over the western end of the building and is accessed via an inserted doorway in the southern end of the east wall. The doorway is low and has no frame. A blocked opening lies to the south of the doorway and to the north are a series of 5 alcoves. Each has a large timber lintel above and, where visible, contains the vent holes to the outside. The western wall contains six matching alcoves with two pitching eyes also. In the southern wall a personnel doorway leads to the exterior and in the northern wall are two blocked portrait windows. The floor is ply, and is stepped down at the northern end. The roof is open to the rafters and supported by 4 hand cut timber trusses. The trusses are not uniform, with the northern most being a King Post truss followed by an Angled Queen Post. South of this is a further Angled Queen Post, followed by a final King Post. The roof is supported by hand cut timber purlins, two on each side

Plate 44: Room 14 blocked alcoves east wall

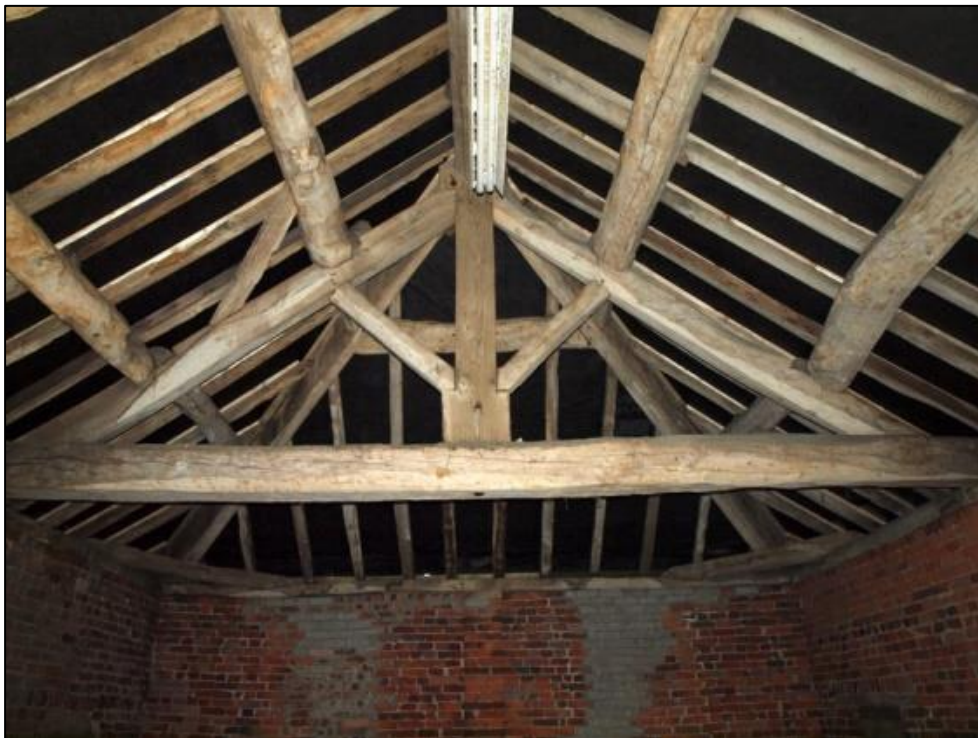
of the ridge post, and at the southern end a bracing truss helps to support the turning roof line.

Plate 47: King post truss at north end

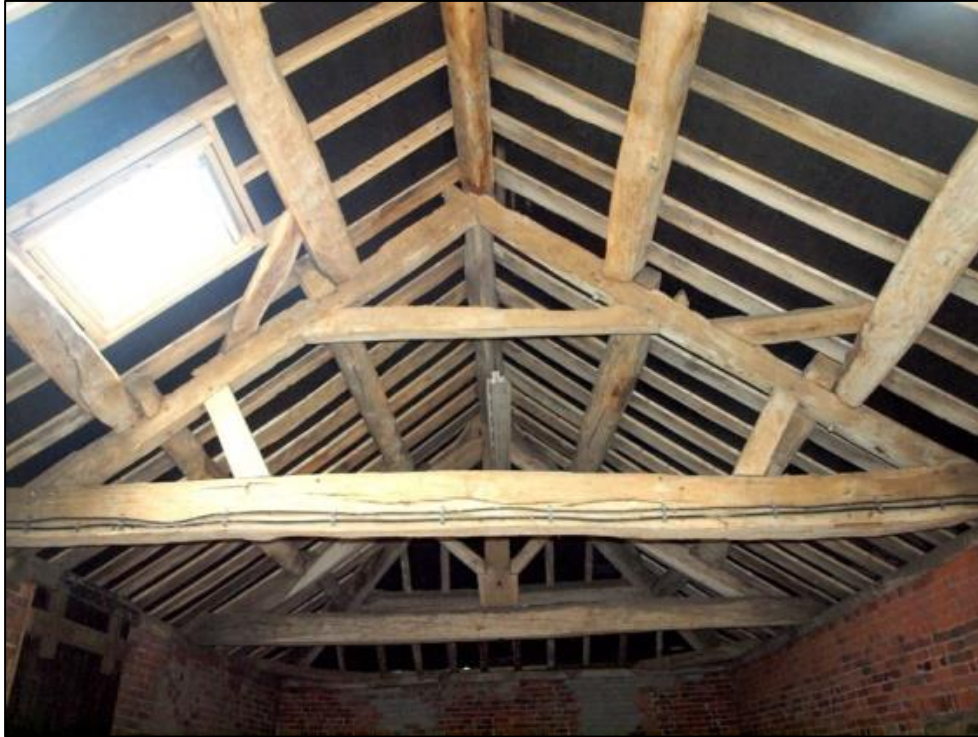
Plate 48: Angled queen post truss

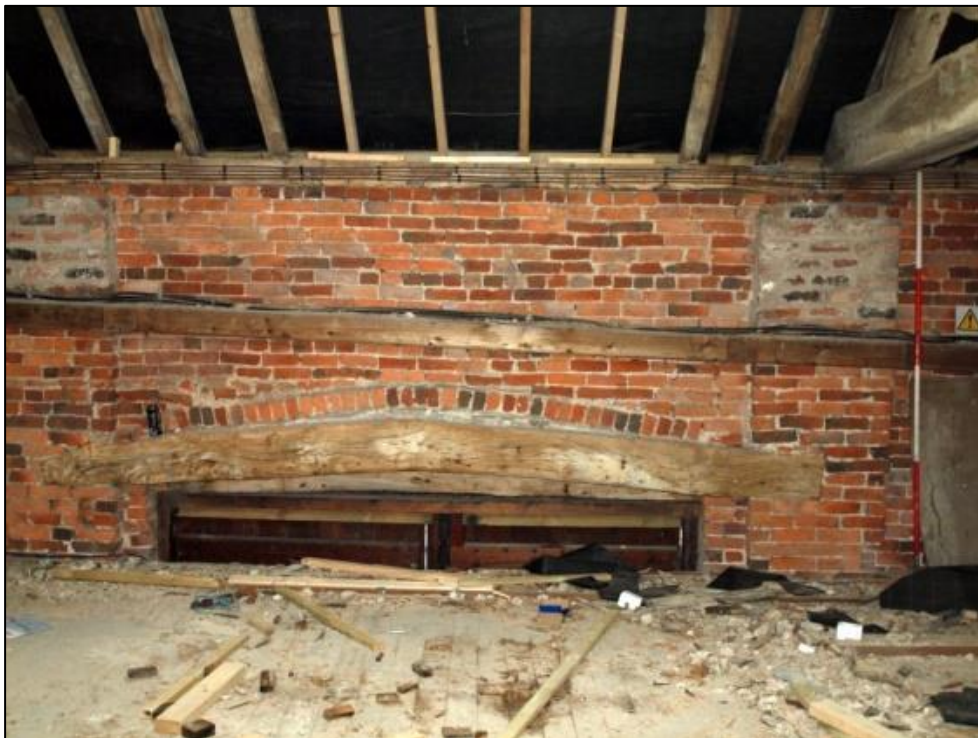
- 6.15 Room 15 (Plates 51 - 60). This room lies at the southern end of the building, accessed via an inserted doorway in the east end of the north wall. Opposite this is an inserted doorway to the exterior. In the centre of the north wall is the top of the external barn door, flanked by brick piers. The lintel of the doorway is a large, curved hand cut timber, with brick arch above. West of this is an inserted window. In the centre of the southern wall a large timber beam marks the lintel of the former doorway. The floor is modern ply and the roof supported by four hand cut timber trusses. At the western end is a modified Queen Post. This has four uprights, rather than two, with a further tie beam and pair of uprights above. To the east is a matching truss with an Angled Queen Post to the east of this. The final truss is a king post, with a bracing truss behind. Hand cut timber purlins also support the roof.

Plate 53: Detail of barn door lintel

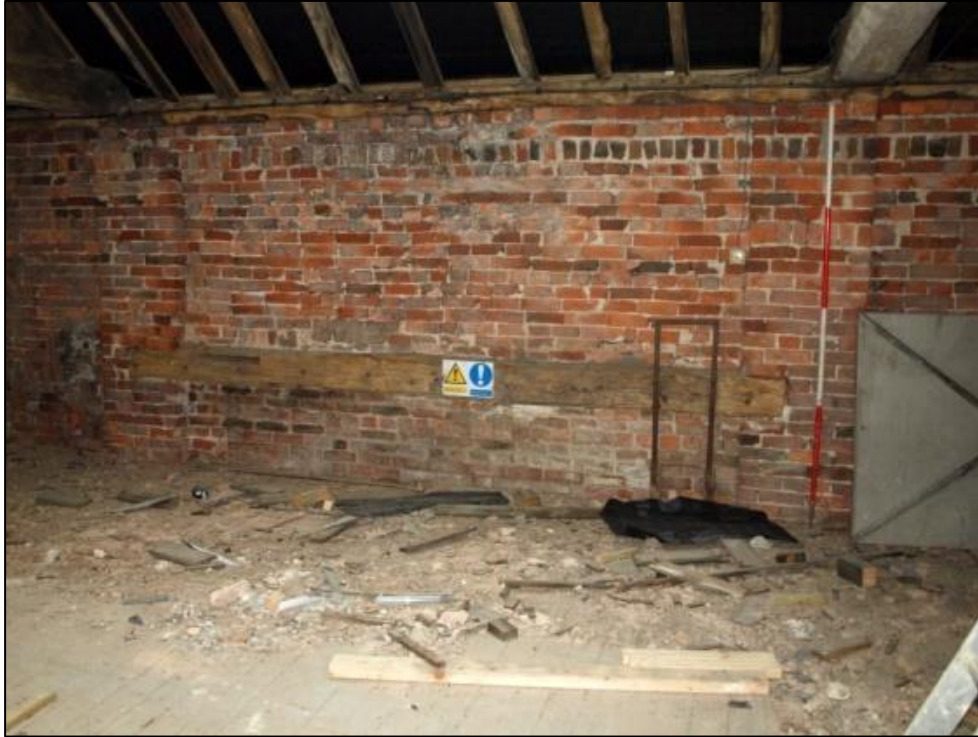
Plate 56: Detail of beam in centre of south wall

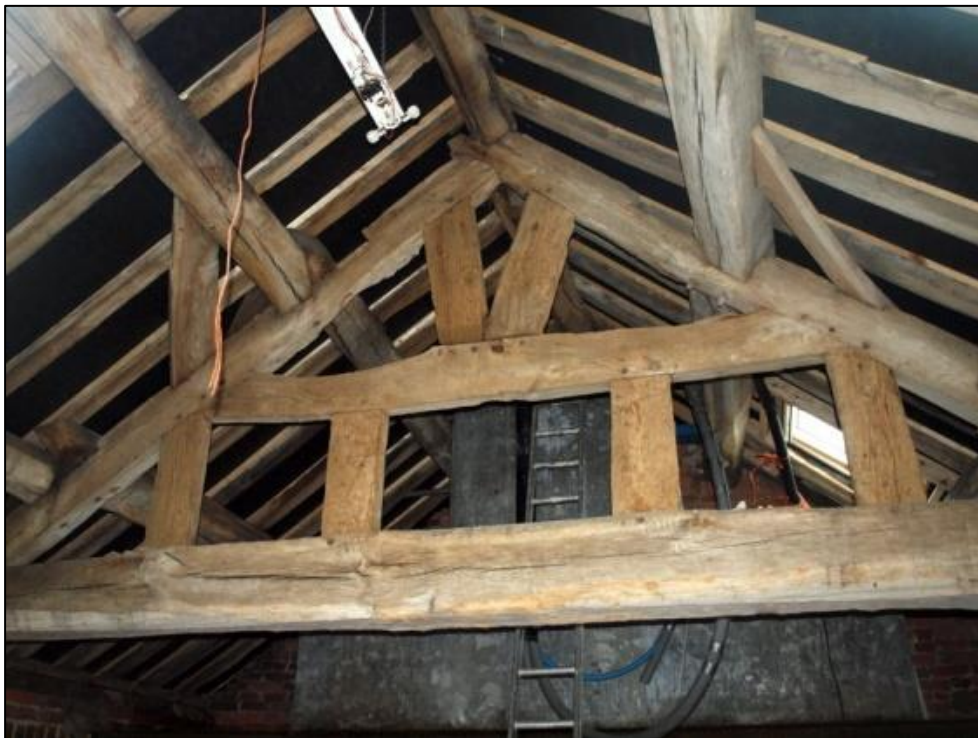
Plate 57: Modified queen post at west end of room 15

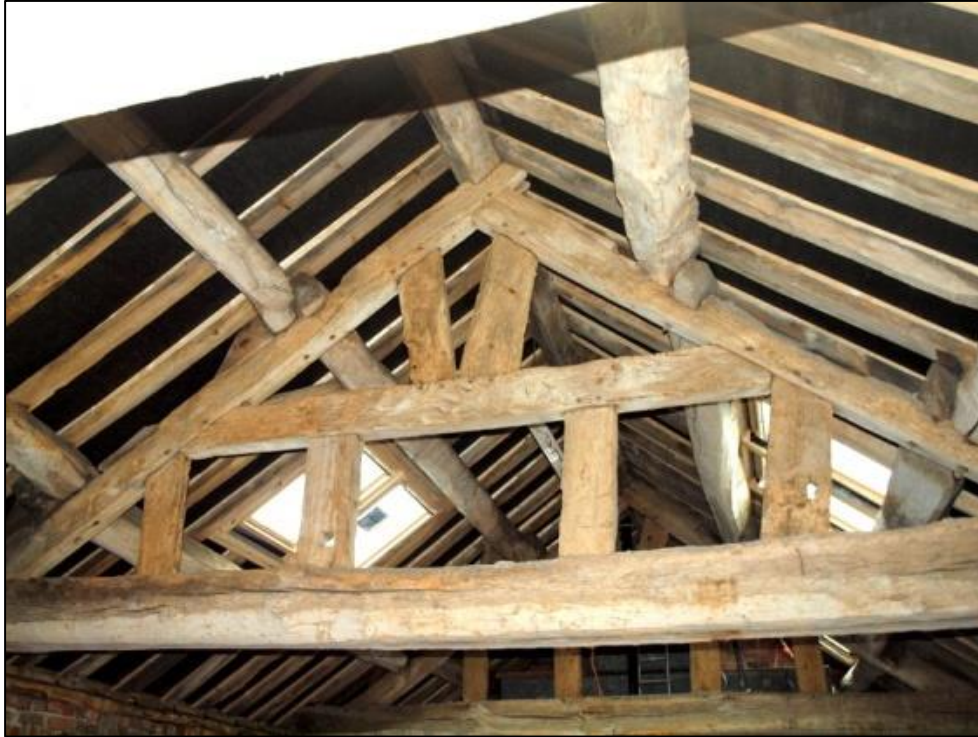
Plate 58: Modified queen post in room 15

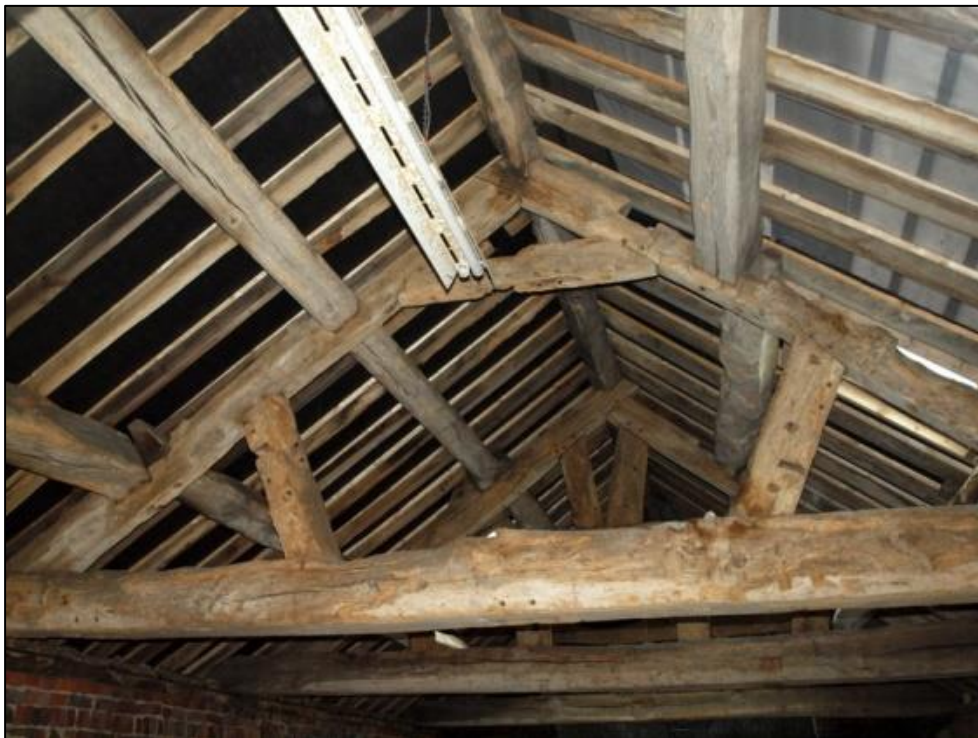
Plate: 59 Angled queen post in room 15

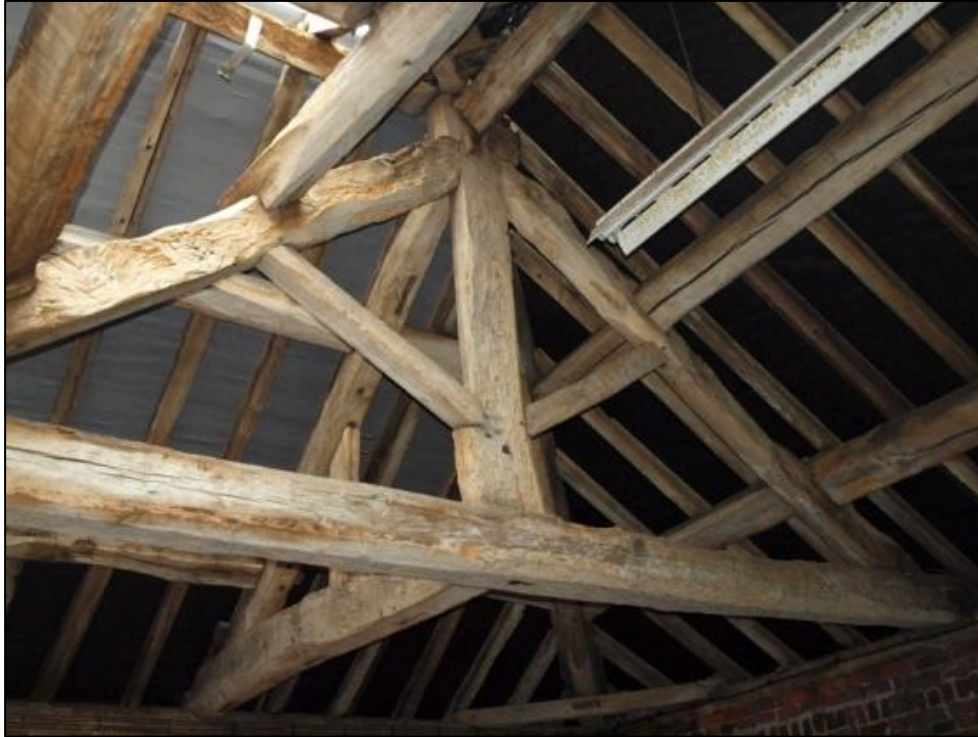
Plate 60: King post truss at east end of room 15

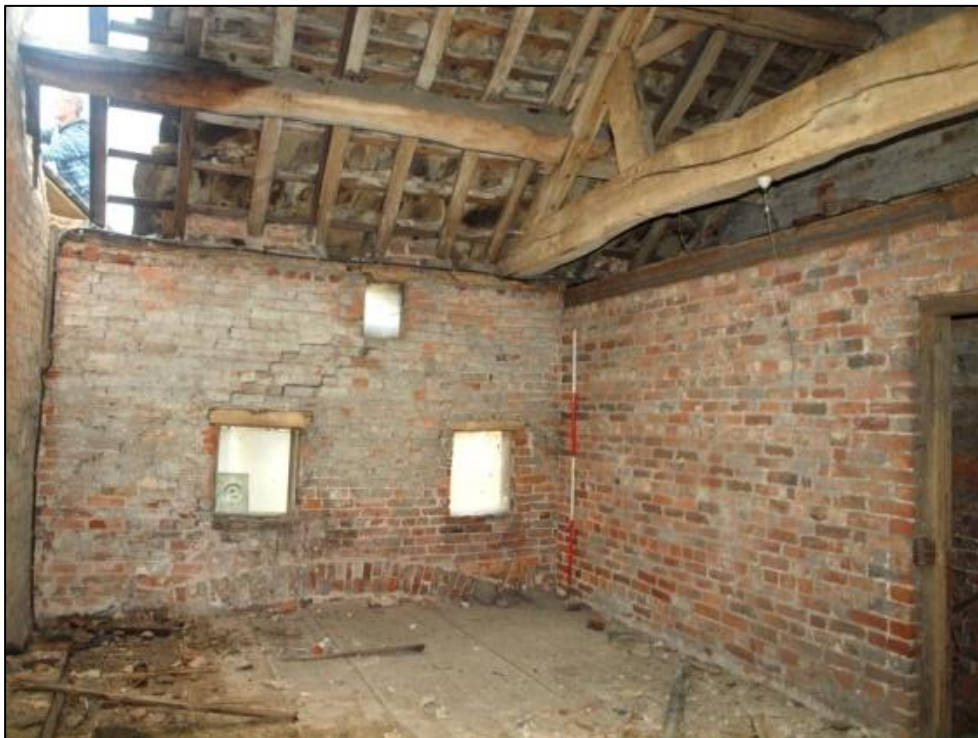
Plate 61: Room 16 looking west

- 6.16 Room 16 (Plates 61 -63). The room is accessed via the doorway in the inserted north wall from the staircase. In the south wall two timber steps lead up to the inserted doorway to room 15. In the southern wall are two inserted windows with a third between them, at the level of the eaves. Below them the large arched lintel of the doorway below is visible. The floor in the room is ply and the roof supported by an Angled Queen Post of hand cut timber. Hand cut timber purlins also support the roof.

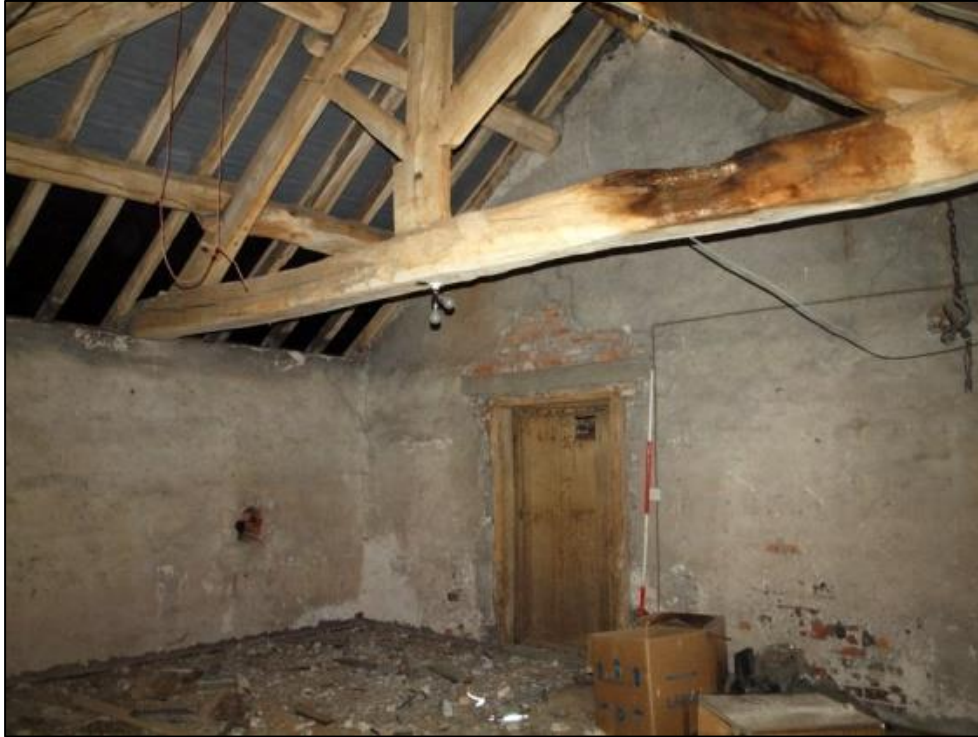
Plate 64: Room 17 looking south

- 6.17 Room 17 (Plates 64 - 67). The room is accessed via the personnel doorway in the south wall. This has a timber frame and a handcut timber door hung. The walls of the room are rendered, with the exception of the north wall. The floor is ply and the roof supported by a hand cut timber king post truss, with hand cut timber purlins.
