THE ARCHAEOLOGY CO.

Black House Farm, Ellel
Historic Building Survey

September 2017

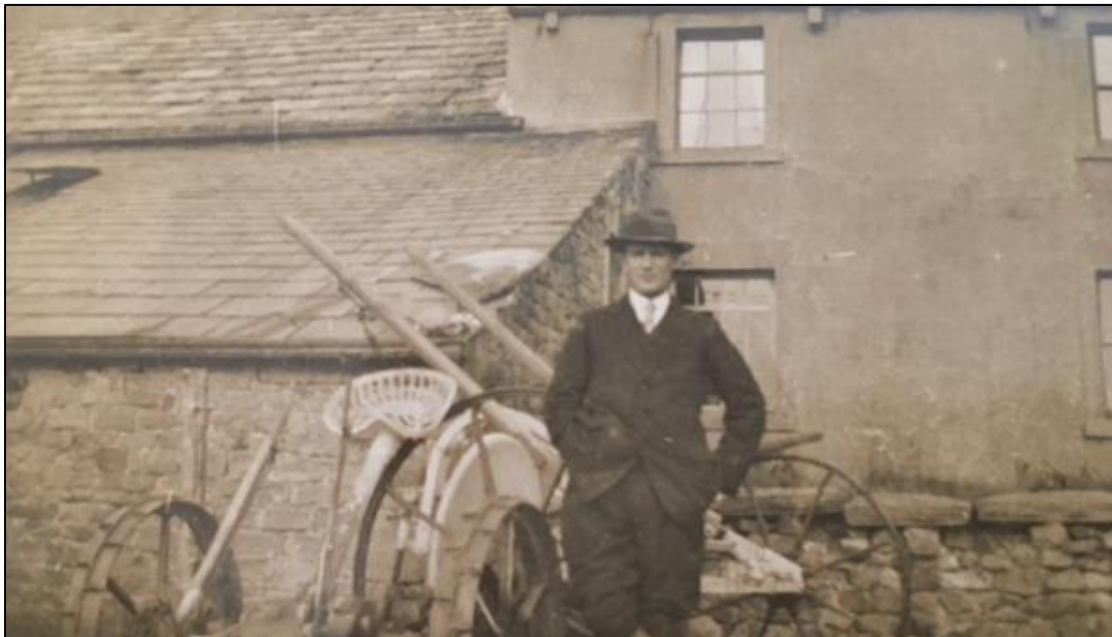
Figure 8: Photograph showing the southwest elevation of the house c. 1900. Note the nine paned window at first floor level which has since been replaced

They also employed a general servant and an agricultural labourer. Photographs taken from around the turn of the century show that the house was rendered by this time. By 1911 William was no longer listed, and neither were any servants, with the two sons working on the farm of 100 acres. The 1910 OS map shows no changes to the building.

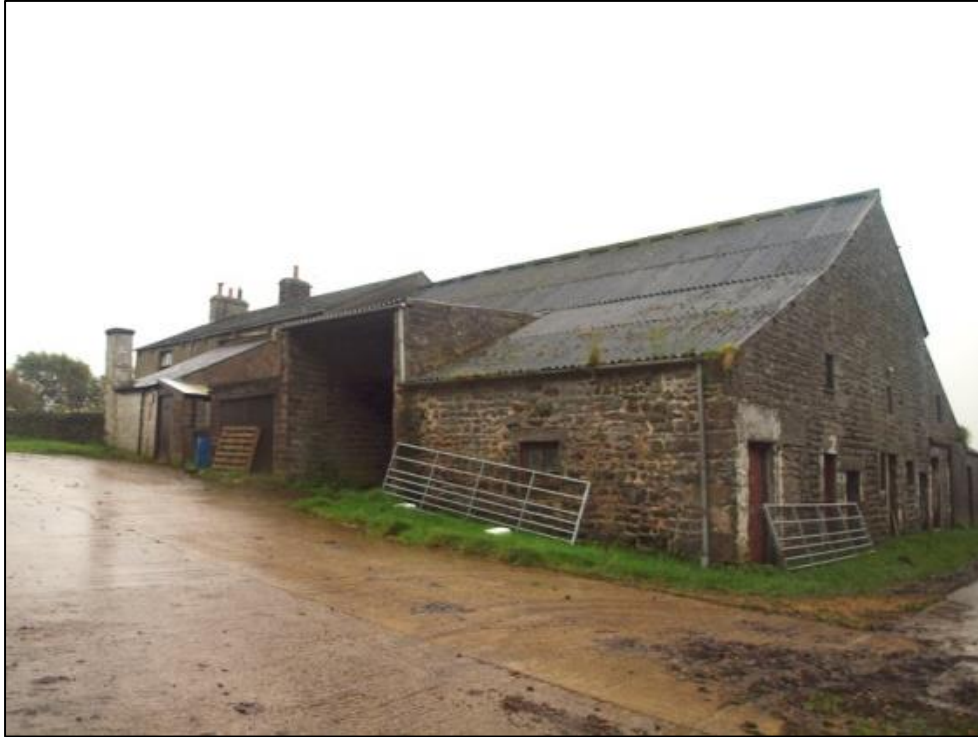
Plate 1: General shot showing the whole farm building from the north

6.1 (Plates 1 & 2) The house forms the southeastern end of a range of buildings aligned northwest – southeast, with the barn and additional buildings to the northwest side. The house is of two stories, three bays wide and constructed of stone with a slate roof. A chimney stack lies at the southeastern end with three pots and a central chimney is also present with a single pot. The stone construction of the latter is visible, whereas the former is covered with render.

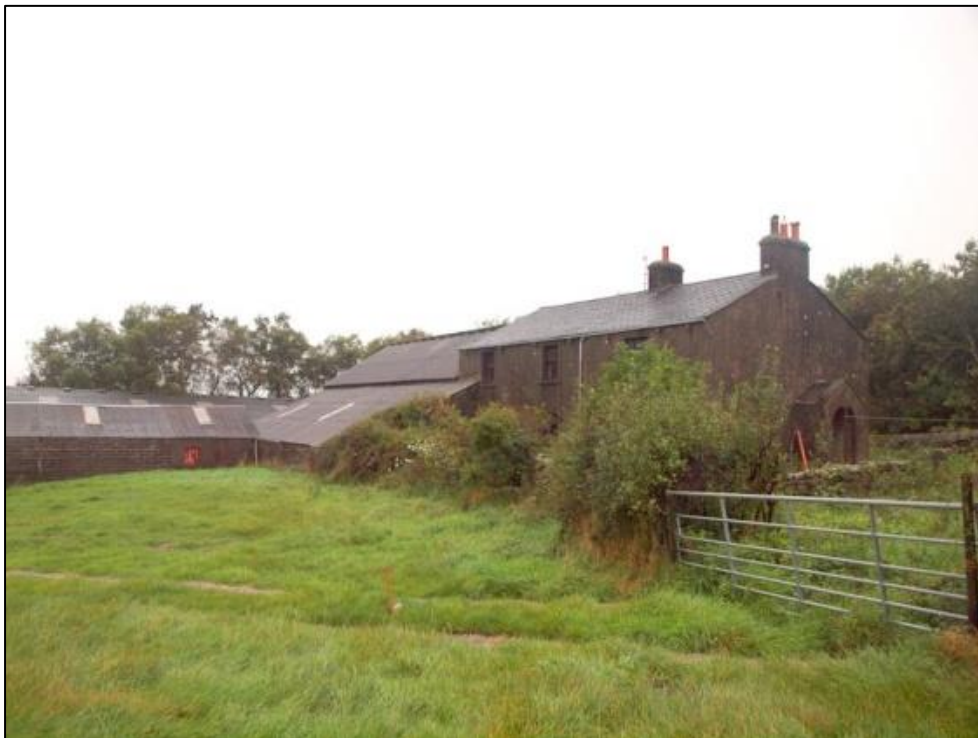
Plate 2: General shot showing the whole farm building from the south

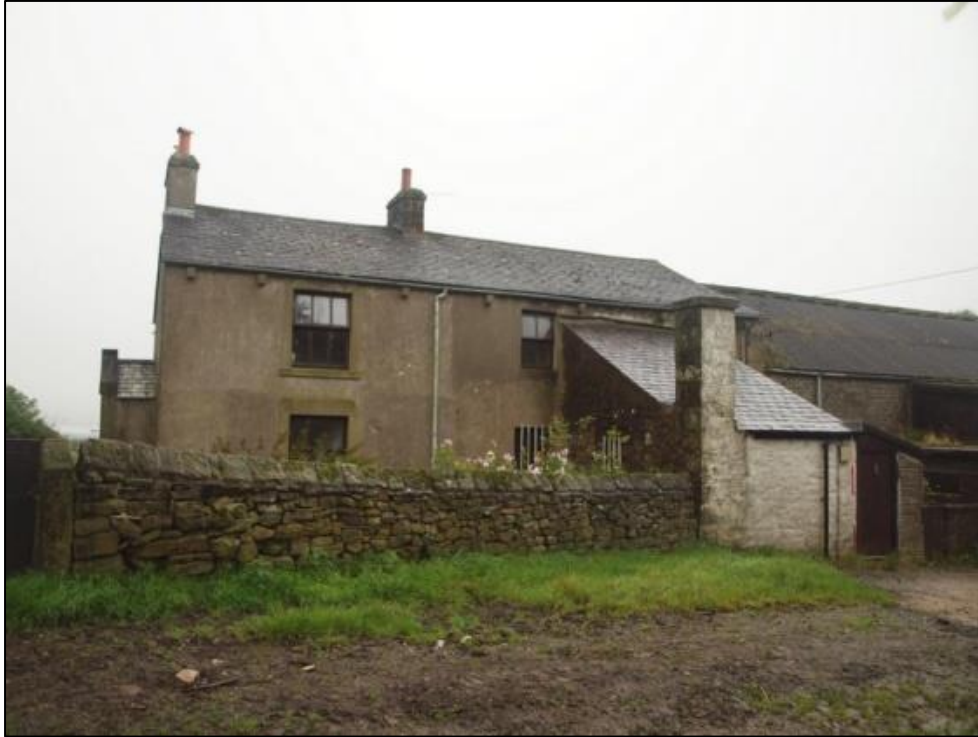
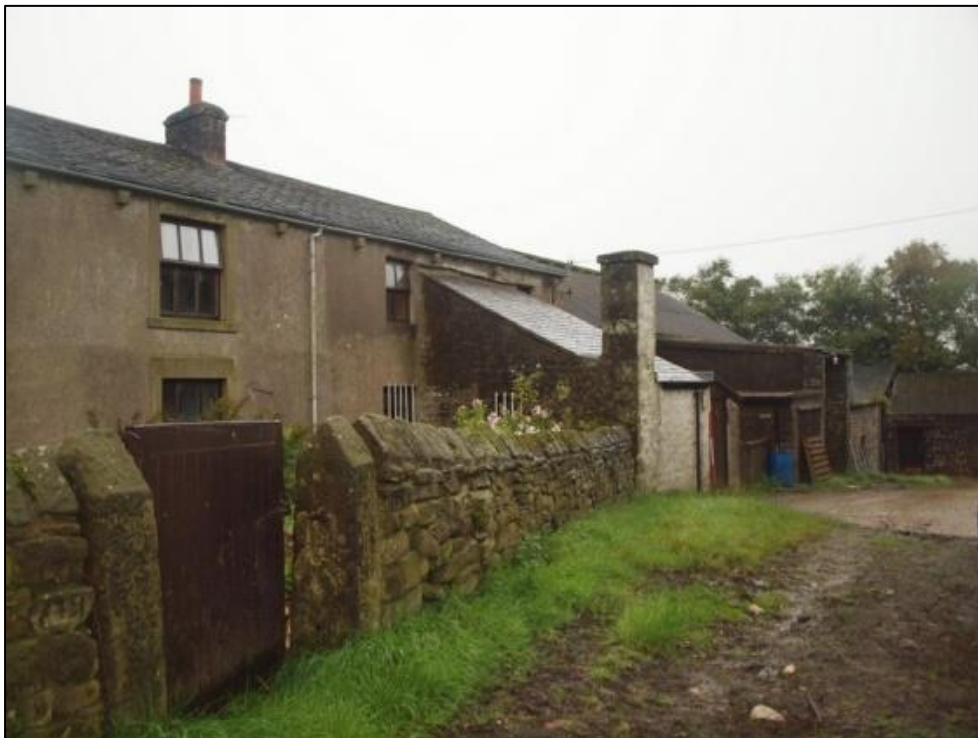
Plate 3: Northeast elevation

Plate 4: Northeast elevation

6.2 Northeast elevation (Plates 3 - 7). This face is three bays wide with an extension covering the third and part of the second bays. The face is rendered, obscuring the stonework beneath. At the southeastern end, in bay one, are large, timber framed casement portrait windows, one at each floor level. Both have heavy sandstone surrounds. Bay two contains similar windows, although much smaller and lacking the sandstone surrounds. The ground floor window also has bars covering it. The utility extension projects from this face, immediately adjacent to the northwestern jambs of these windows. The face of the extension is featureless whitewashed stone, with a chimney stack at the southeastern corner. Northwest of this is a simple timber framed personnel doorway to the modern porch. This masks the third bay at ground floor level, although at first floor level the window is visible, matching that at bay two at first floor level. Here the render has decayed on the face and some of the stone construction is visible, including quoins at the corner.

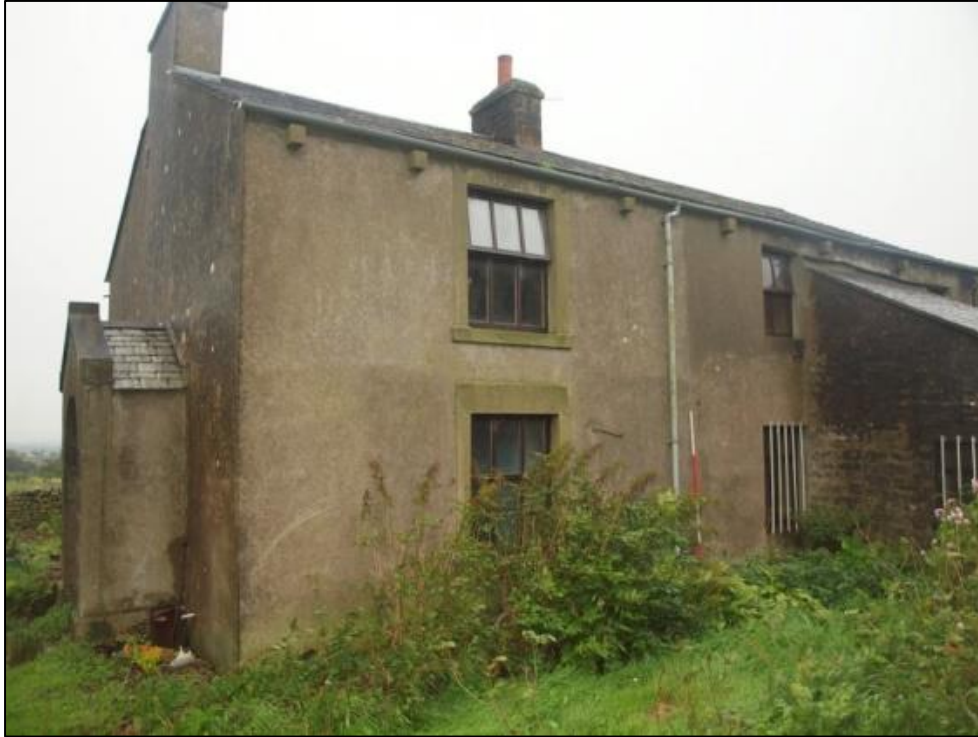
Plate 5: Detail of southern end of northeast elevation

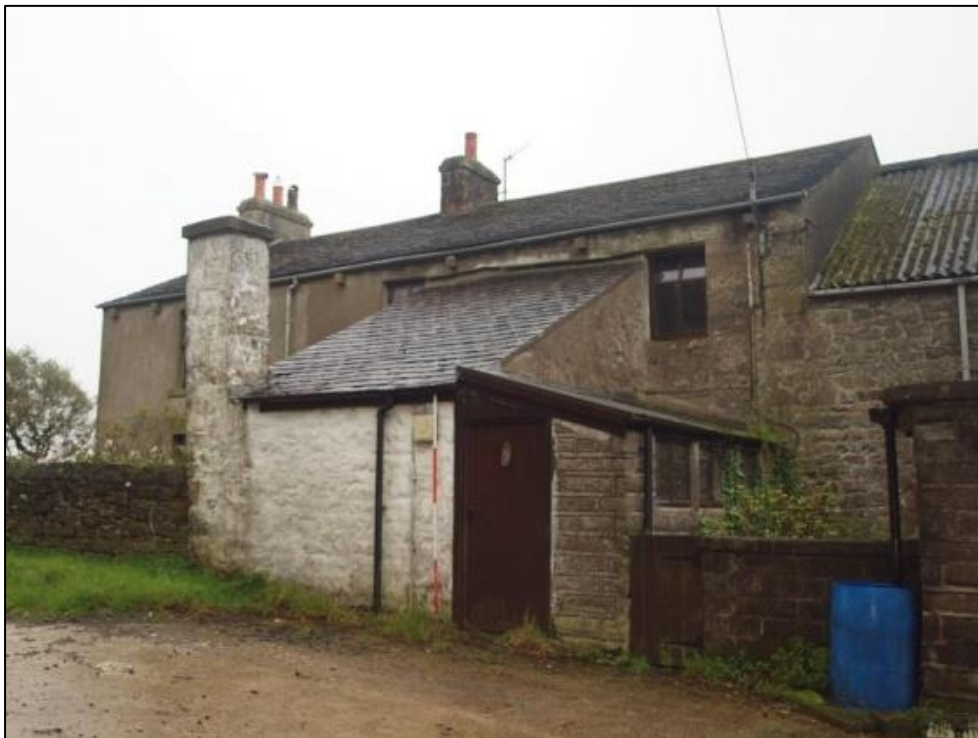
Plate 6: Detail of northern end of northeast elevation

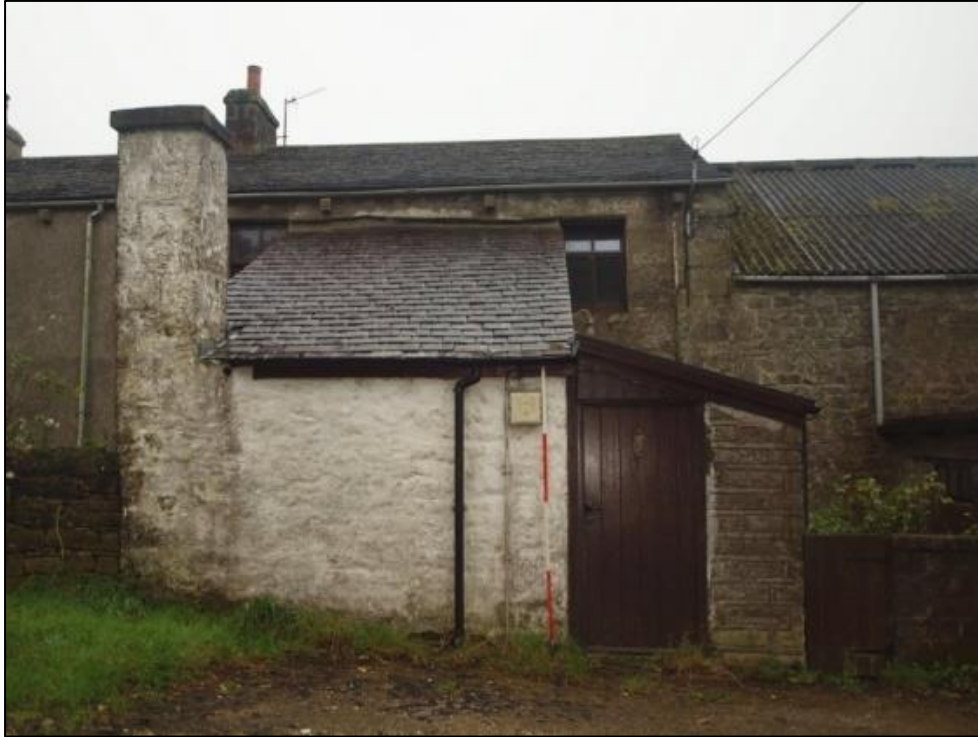
Plate 7: Detail of utility and porch extensions

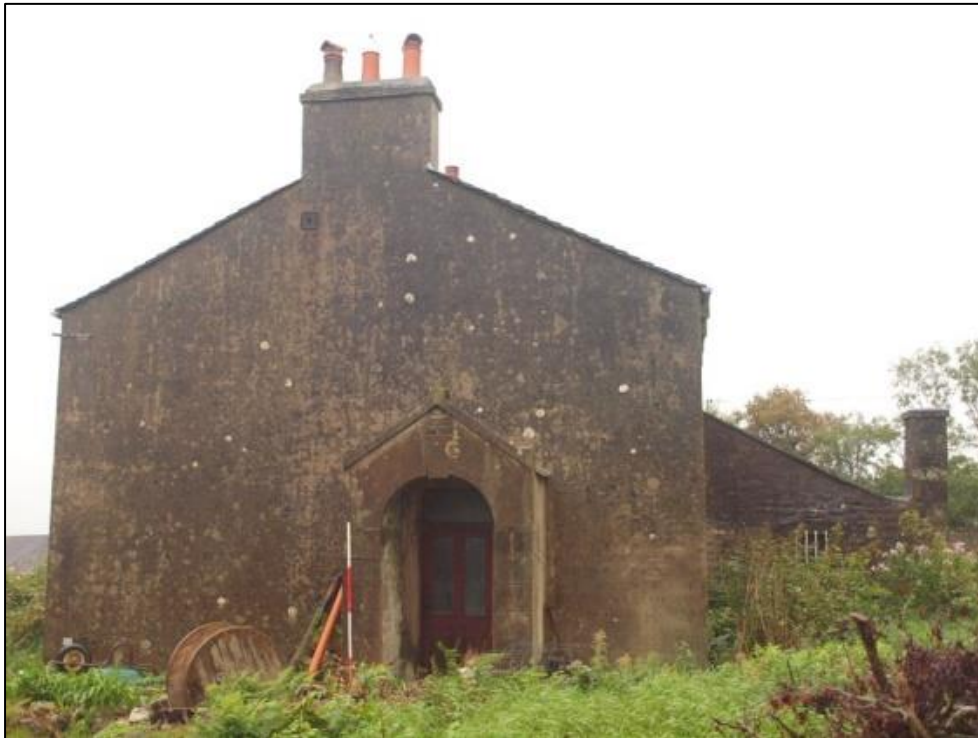
Plate 8: Southeast elevation

6.3 Southeast elevation (Plates 8 - 10). This forms the gable end of the building and been rendered across the whole, including the chimney stack. The only feature is the stone build porch and doorway set slightly north of centre. The porch has large sand blocks forming the entrance with a large arched sandstone lintel with keystone above. The floor of the porch is tiled and the timber panelled door set within a simple sandstone surround with light above. To the northeast is the face of the extension. This shows the single pitched slate roof running down from first floor level of the house to a single story. The chimney stack is visible at the

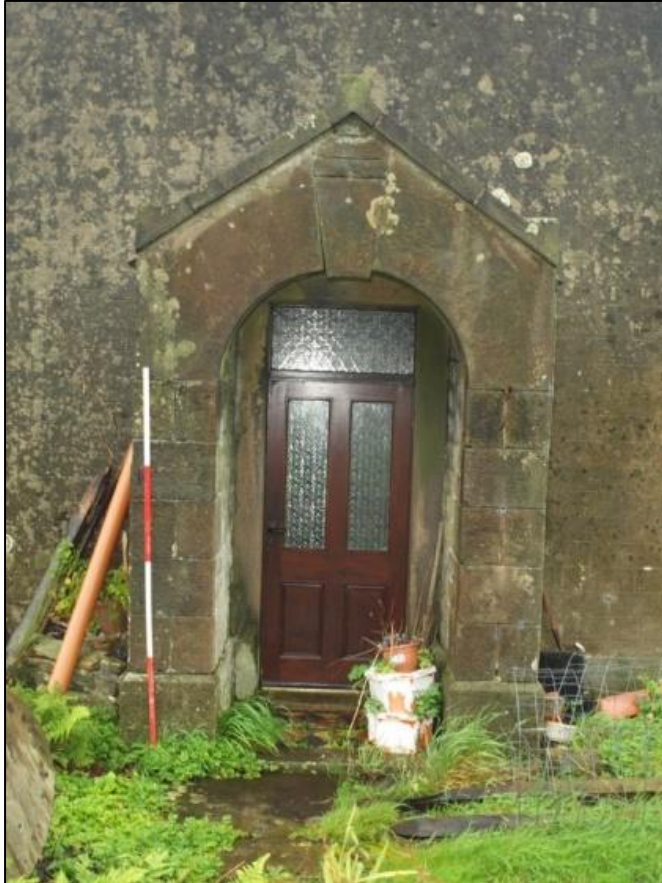
Plate 9: Detail of porch and doorway

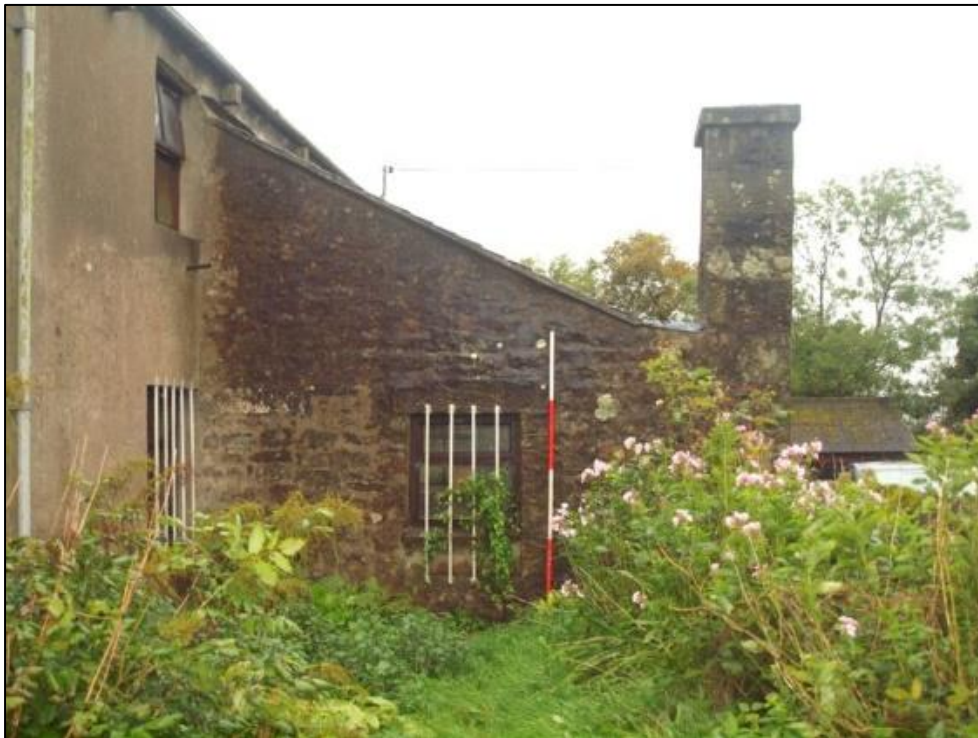
Plate 10: Southeast elevation of utility extension

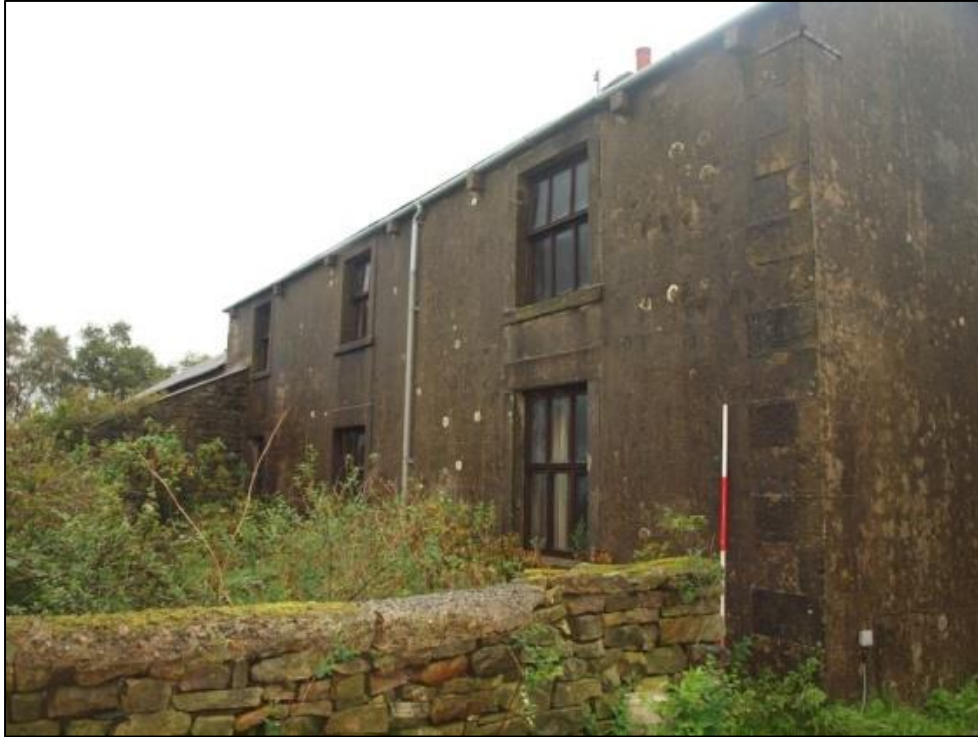
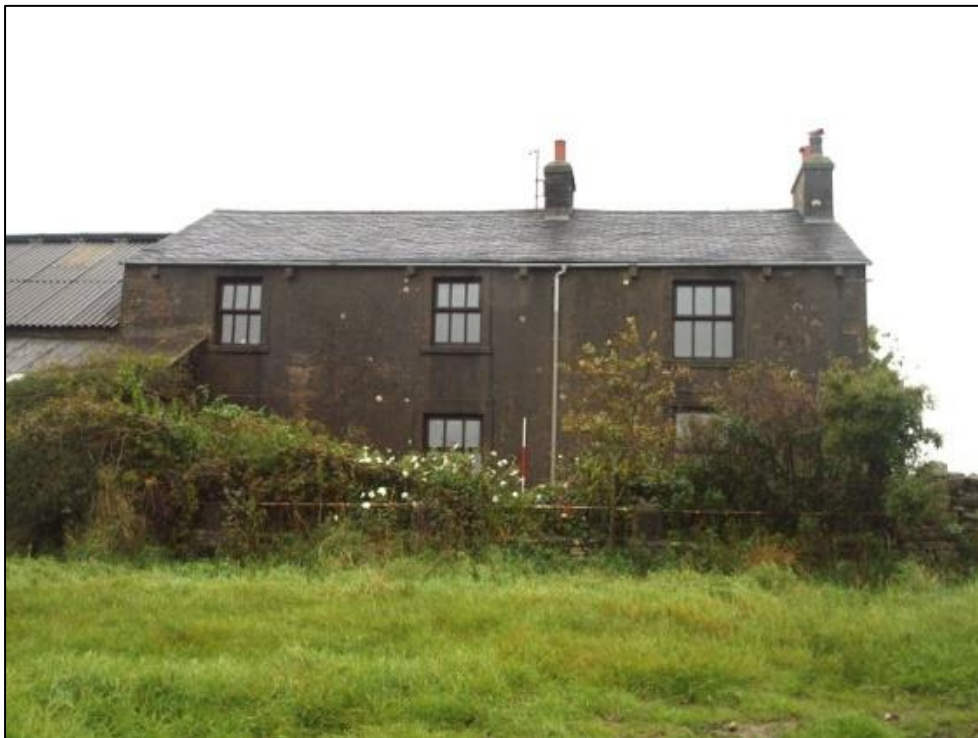
Plate 11: Southwest elevation

Plate 12: Southwest elevation

- 6.4 Southwest elevation (Plates 11 & 12). Bay one to the northwestern end contains windows at each floor. Both are timber framed casement windows of 6 lights with heavy sandstone surrounds, although the upper window is slightly smaller. The second, bay is identical to the first. The third bay is again similar, although the windows are larger. The whole face has been rendered to match the gable, although the quoins have been left visible at the southeastern corner

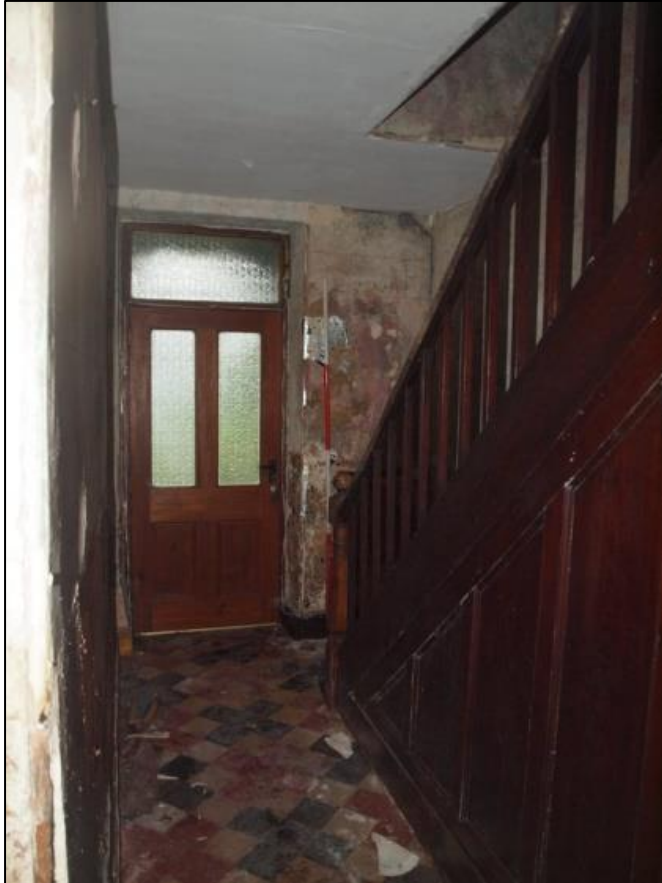
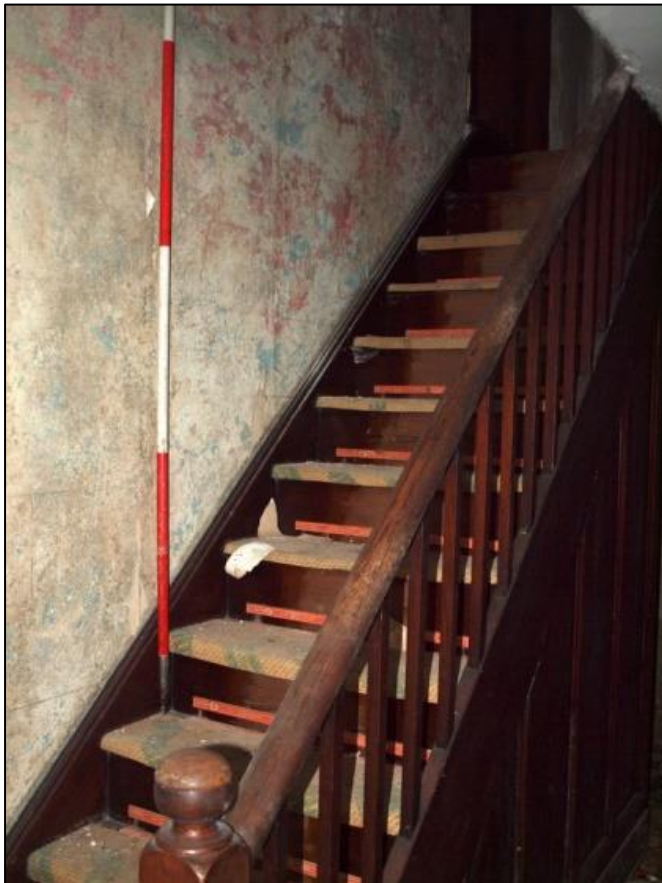
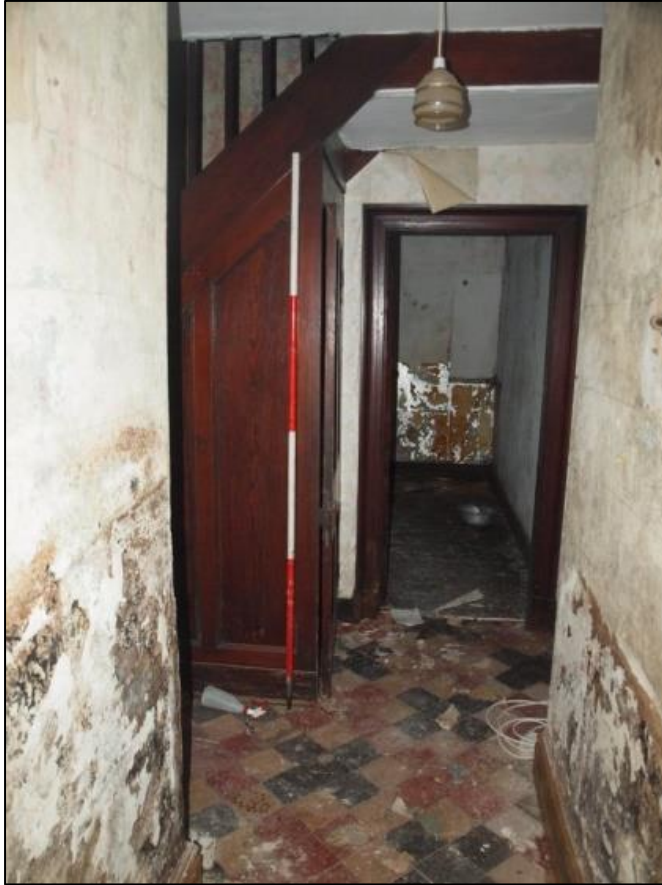
Plate 13: Ground floor tiled corridor

Plate 14: Staircase to first floor

Plate 15: Northwest end of corridor looking towards living room

- 6.5 The building is accessed via the porched doorway in the gable wall which leads to a corridor (plates 13 – 15). The floor of the area is tiled and a timber panelled staircase runs up the first floor on the southwestern side. The walls of the corridor are brick, although plastered over and the ceiling plastered. At the northwest end a section of the northwestern stone wall protrudes, suggesting an earlier fireplace. The corridor leads through to the living room (plates 16 & 17) to the southwest and a bathroom to the northeast. The living room has a floor of bare timber boards and plastered walls and ceiling. In the southeastern wall are a pair of alcoves with cupboards below and arched lintels above. A 20th century tiled fireplace lies between them. In the southwestern wall is a timber framed casement window. The doorway to the room is timber panelled with a large latch.

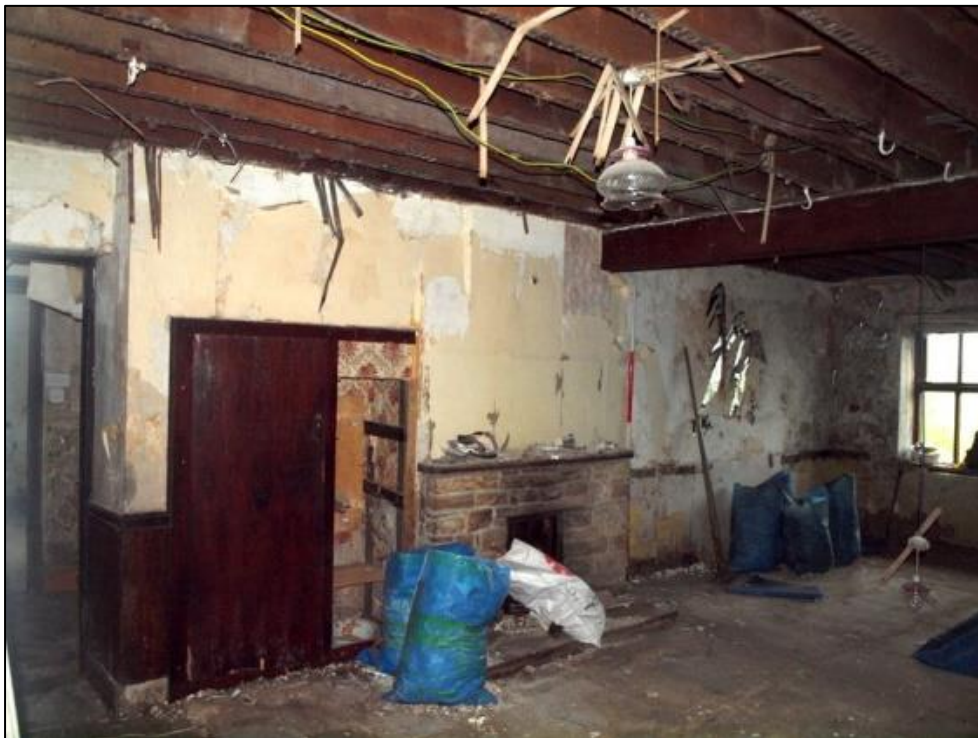
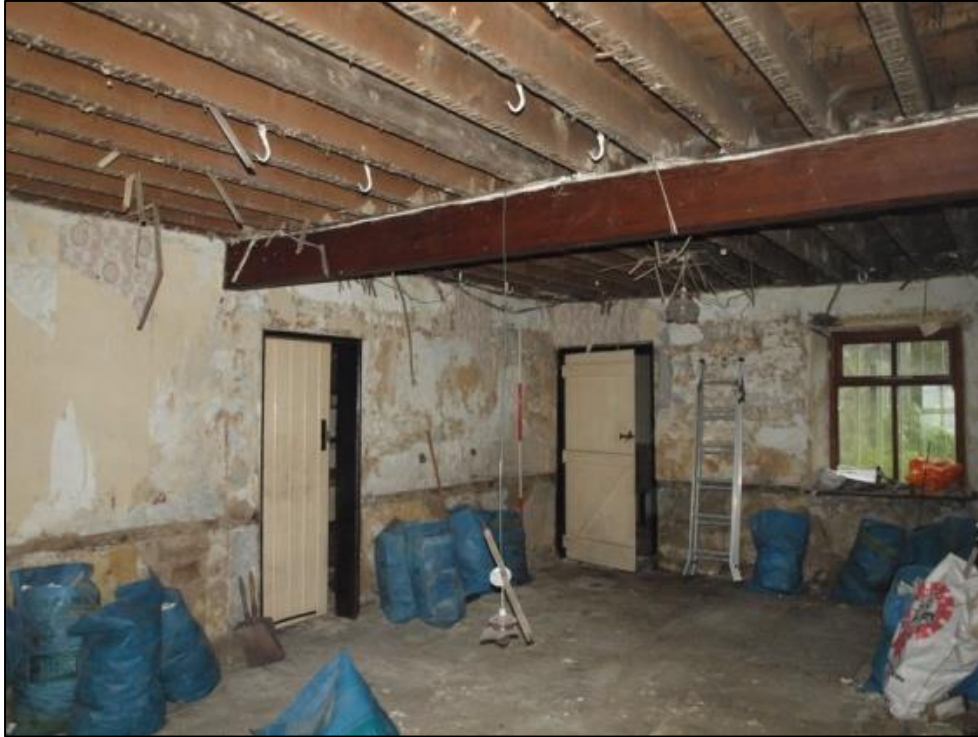
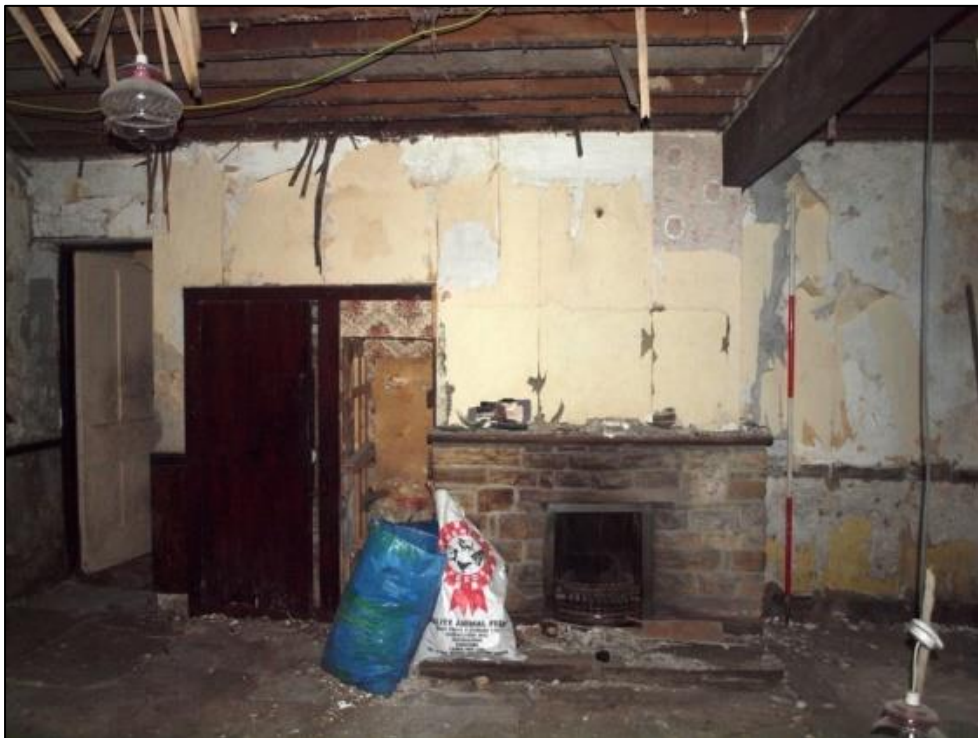
Plate 18: General shot of dining room

Plate 19: General shot of dining room

Plate 20: Southeast wall of dining room showing fireplace

- 6.9 At the northeastern end of the corridor a doorway in the northwestern wall leads into the dining room (plates 18 – 20). This has a flagged floor and the ceiling is open to the modern machine cut timber joists with a machine cut timber beam spanning the room northwest to southeast. In the southeastern wall is a fireplace with a pair of timber framed cupboards to the northeast side. The timber panelled door to the corridor lies to the northeast of this. The northeast wall contains a timber framed casement window, with a timber framed doorway hung with a braced timber door and simple latch, to the northwest of it. This doorway leads

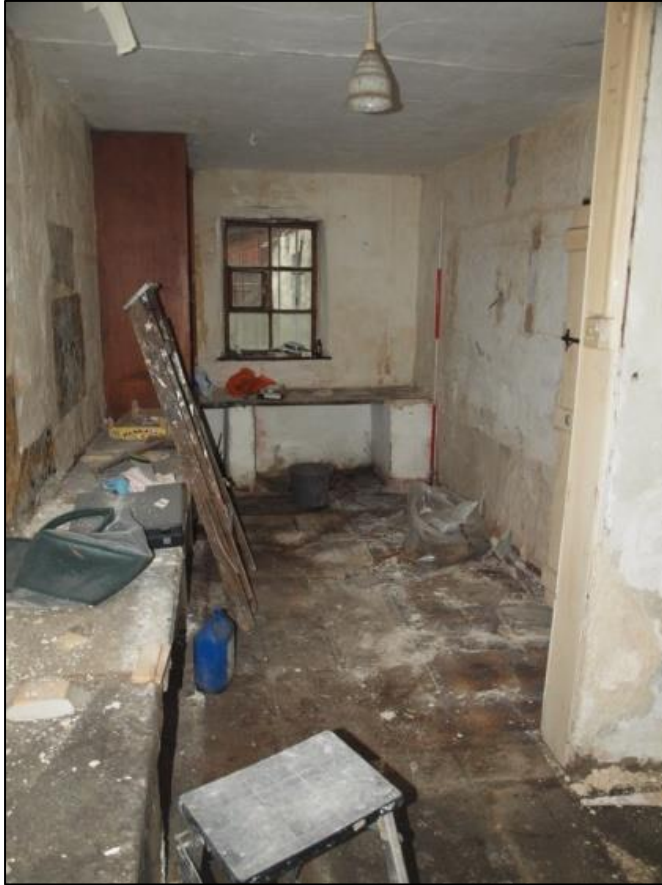
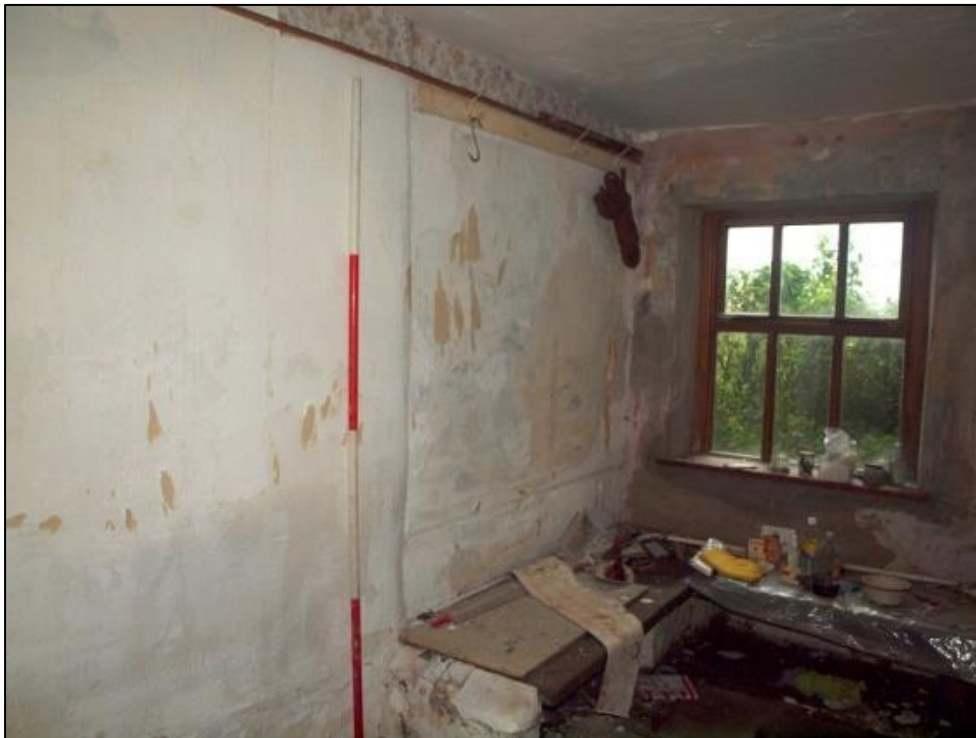
Plate 21: General shot of pantry

Plate 22: Southeast wall of pantry showing change in thickness

6.10 The pantry (plates 21 & 22) also has a flagged floor and a stone thrall runs along the northeast and northwest walls. This has a stone top and the supports are rendered and whitewashed. A further thrall lies along the southwest wall, inserted later. The southwest wall contains a timber framed casement window, visible from the exterior and opposite this is a further timber framed casement window. This is not visible from the exterior, looking directly into the porch. The lathe and plaster section of the southeast wall is more noticeable in this room, with the thickness of the wall reduced on this side. The ceiling and walls are plastered and a hatch lies in the ceiling to the southwest of the door.

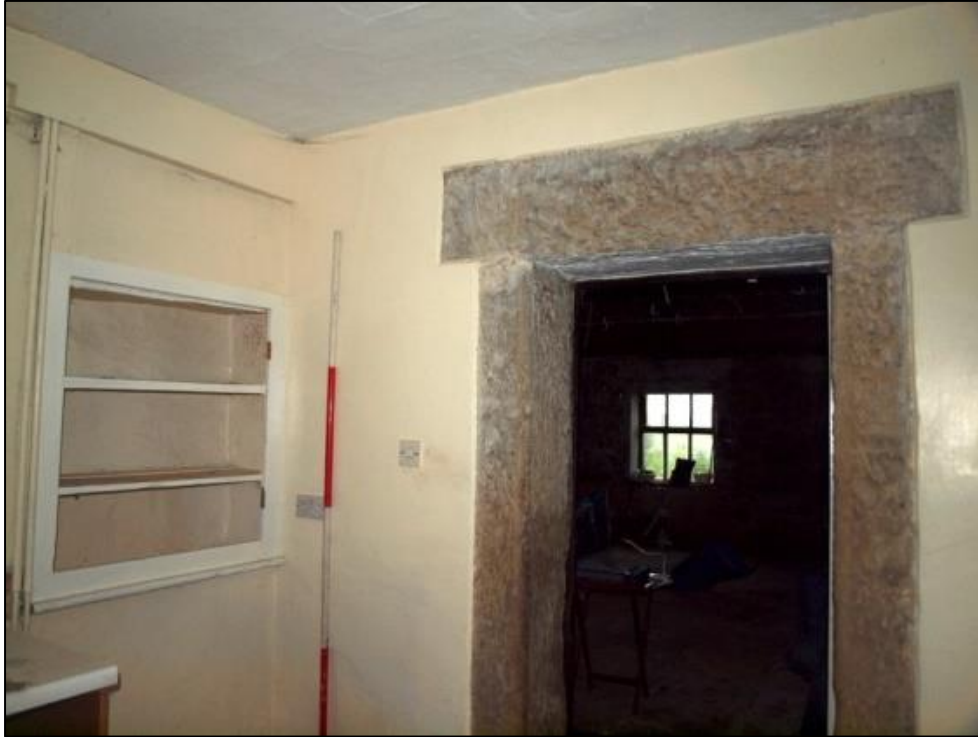
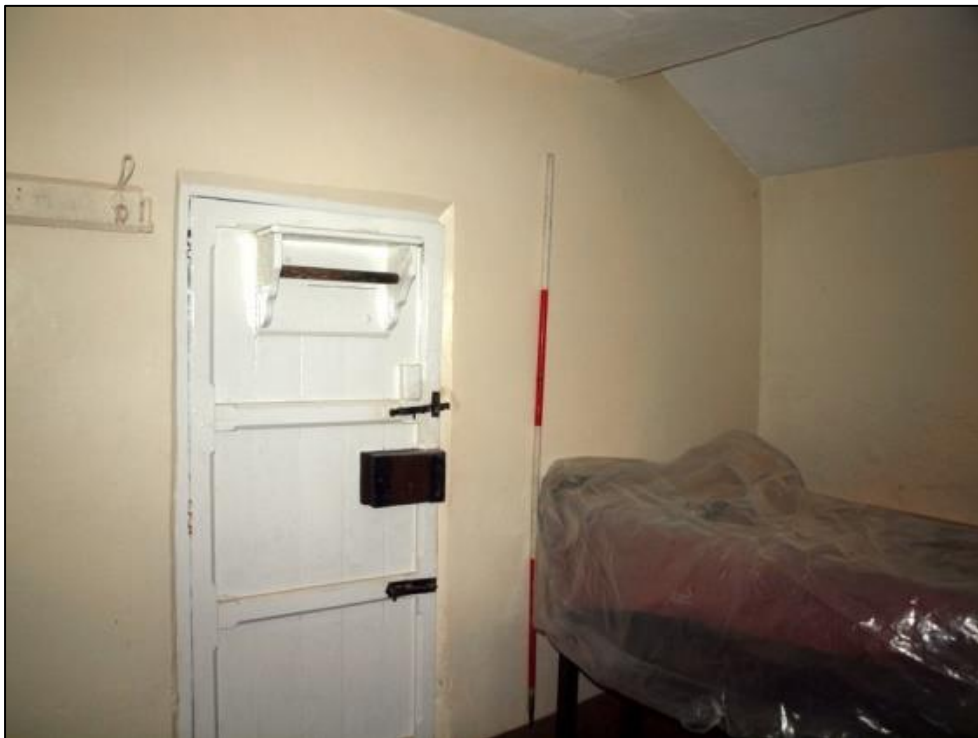
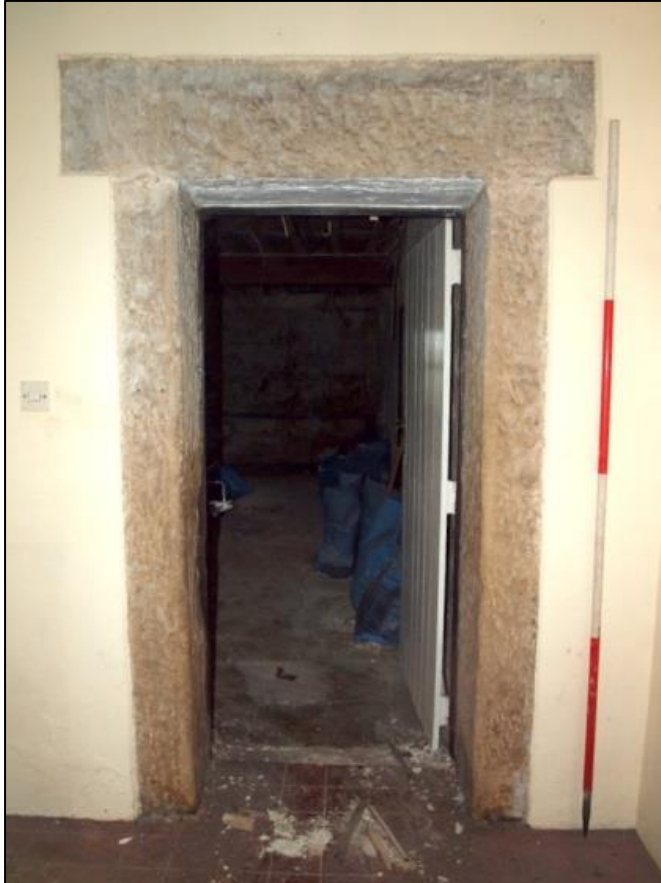
Plate 23: Utility extension doorway to dining room

Plate 24: Utility extension doorway to porch

Plate 25: Detail of doorway to dining room

6.11 The utility (plates 23 – 25) is accessed from the dining room and lies to the northeast side of it. The doorway between them has heavy sandstone jambs and lintel. The floor is tiled and the walls and ceiling are plastered. The southeastern wall contains an alcove in the centre with a timber framed casement window to the southwest side. Southwest of the alcove is a recessed cupboard. Opposite these, in the northwest wall is the timber battened doorway to the porch. The floor of the porch (plates 26 & 27) is tiled matching the utility and the southern walls are whitewashed stone. The northern walls are plastered and the roof is modern corrugated plastic. A window in the southwest wall looks through to the pantry and opposite is the timber door to the exterior.

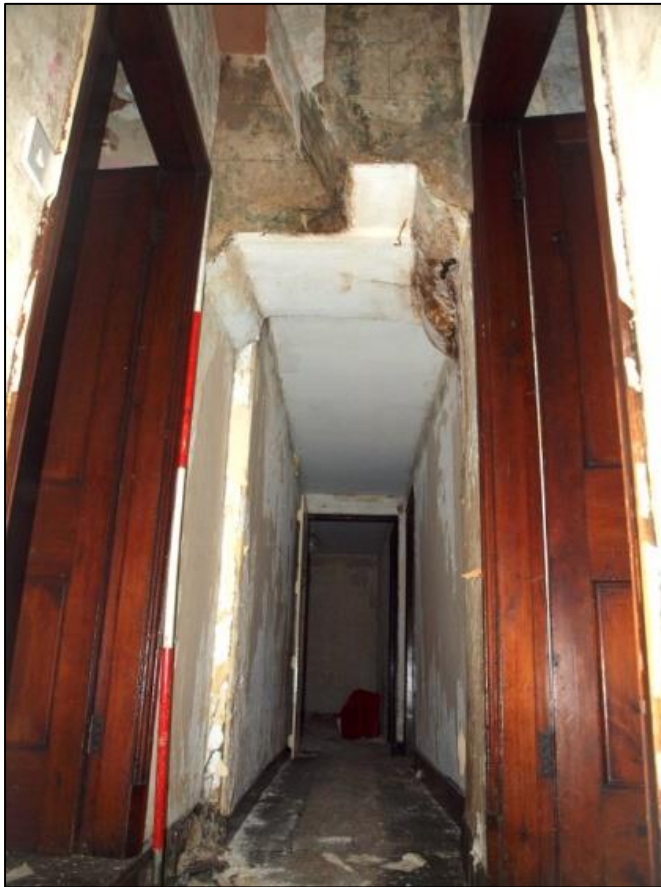
Plate 30: Central corridor of first floor showing cut through chimney stack above

6.13 The central landing (plate 30) is not straight, but is shifted slightly to the north when running through the central wall. The four bedrooms (plates 31 – 34) at this end of the house are simple, with the central rooms having fireplaces in the eastern wall. The southwestern of these rooms has a simple surround whereas the northeastern room has had the fireplace blocked up, although the hearth stone is still visible. The other bedrooms show no evidence of fireplaces. Each of the rooms contains a timber framed casement window in the external walls and have no other features of note. The ceiling throughout is plastered, as are the walls and the floor is timber boards. At the northwestern end the corridor widens out (plate 35) and a hatch lies in the ceiling giving access to the attic space of the northwestern end of the house. A further hatch lies at the top of the staircase to give access to the southeastern part.

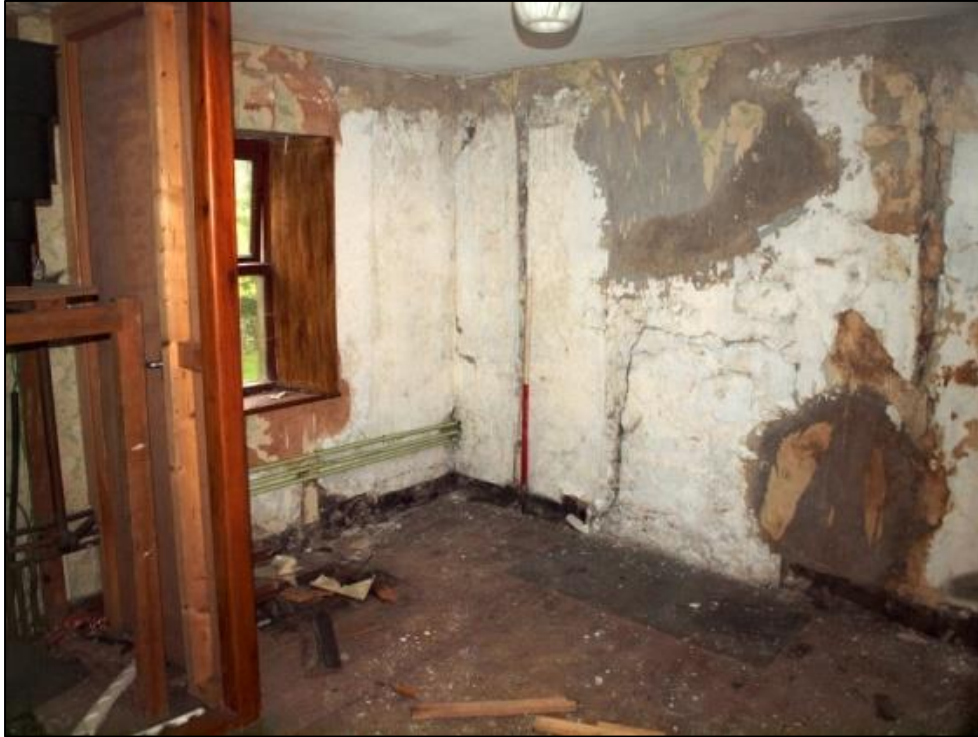
Plate 31: Blocked fireplace in central bedroom on north side

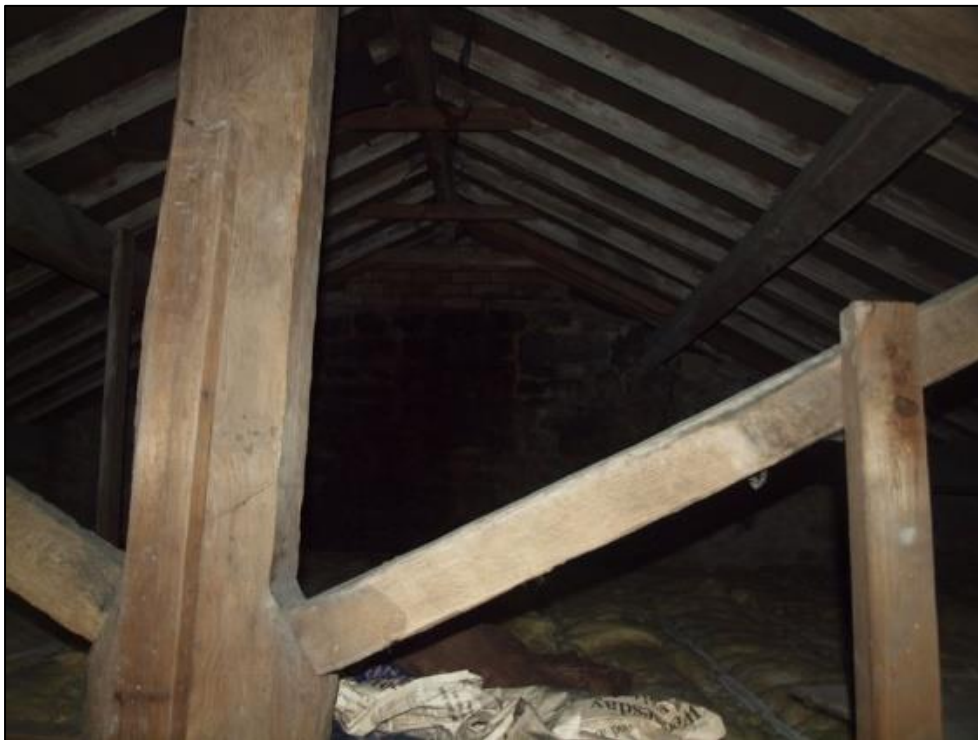
Plate 36: King post truss of machine cut timber

6.14 The attic of the northwestern end (plates 36 & 37) shows modern timber beams and purlins with a machine cut timber king post truss. In the southeastern wall a blocked opening is visible, with brick infilling above. The surrounding stonework is rough rubble occasionally coursed. The southeastern attic (plate 38) shows a similar situation, although there is no truss and the blocked opening is not visible.

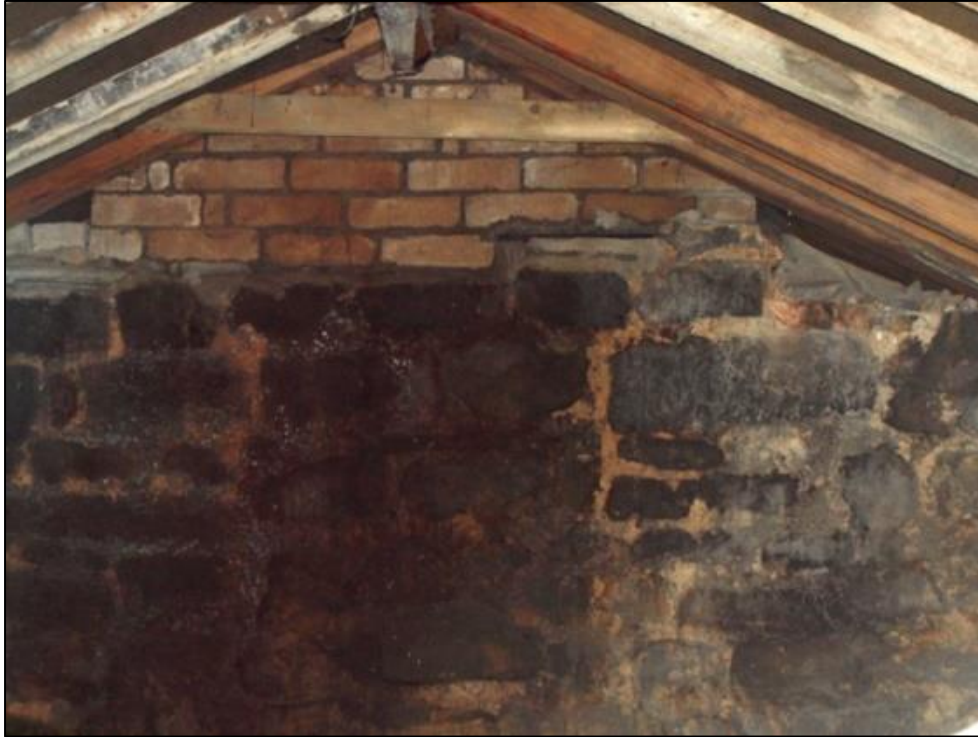
Plate 37: Possible blocked opening in stone cross wall
