THE ARCHAEOLOGY CO.

Barn 1, Rose Farm, Lunt
Historic Building Survey

June 2018

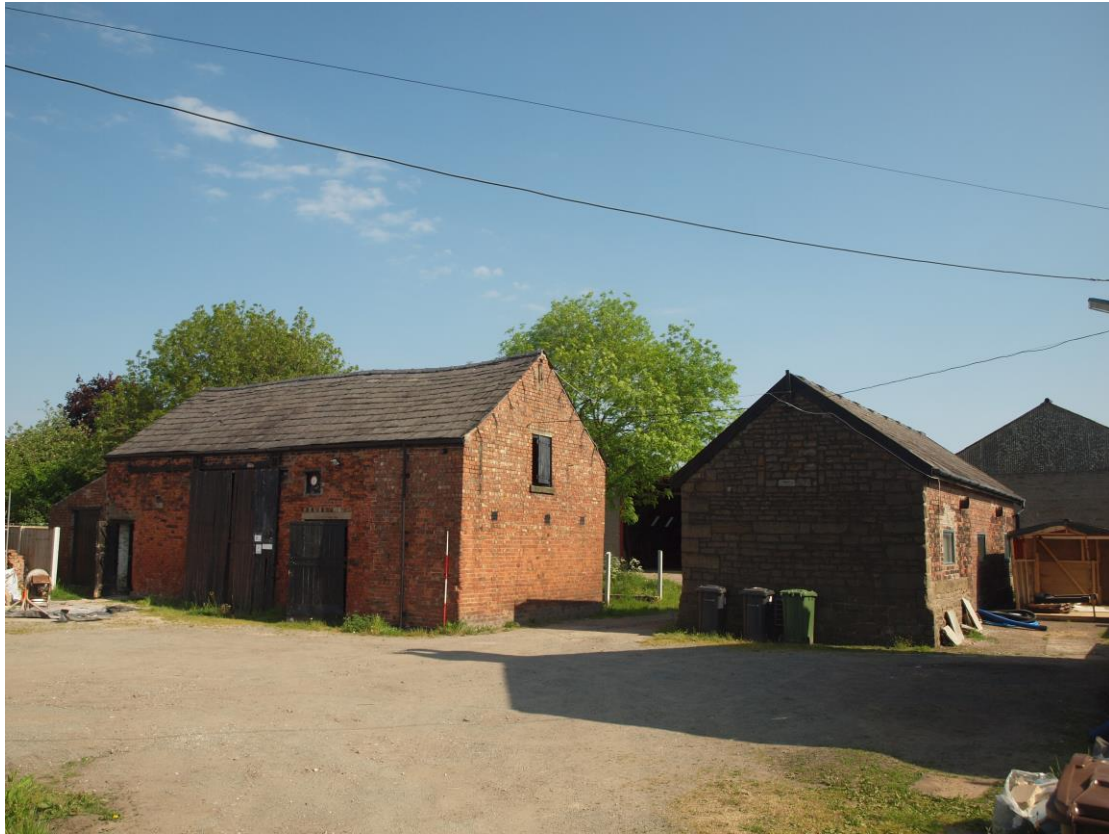
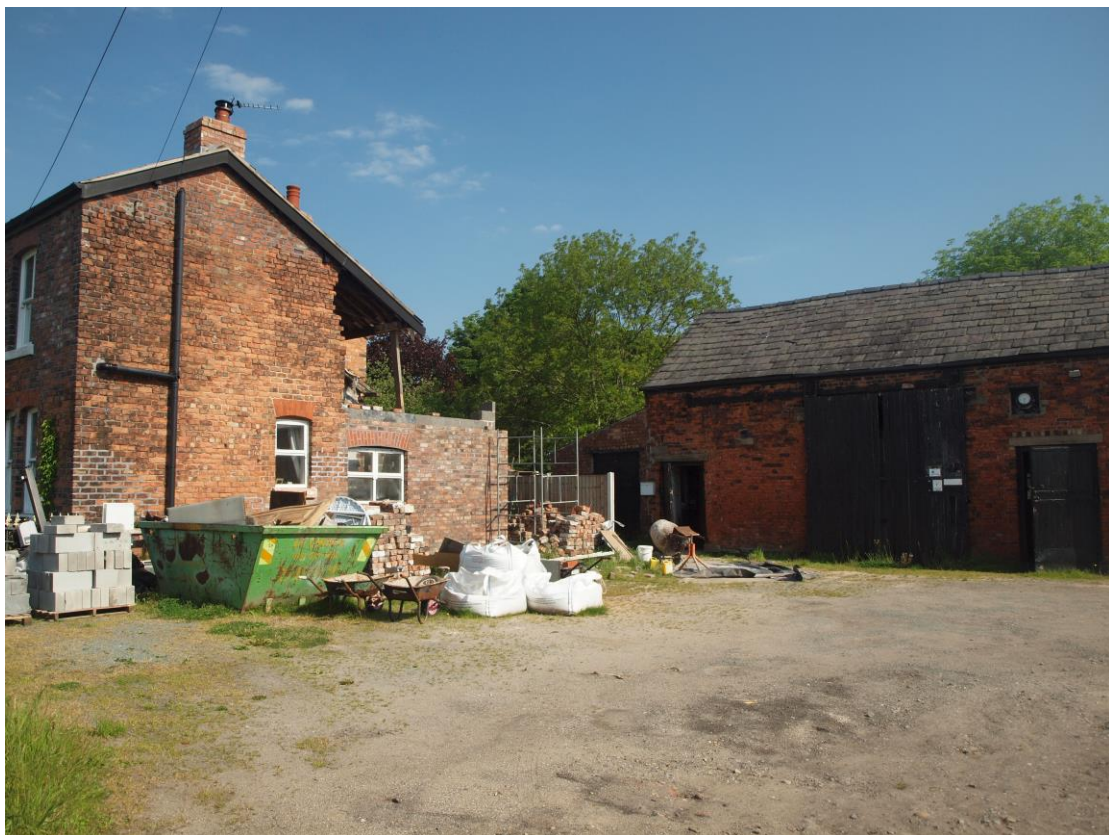
6.1 (Plates 1 & 2) The building is a rectangular four bay brick built building, aligned east – west. It is two stories high with a double pitched roof of slate. The majority of the building is constructed in a red brick measuring 9 x 3 x 4". A single story brick lean-to lies against the west side. Internally the building is divided into four rooms at ground floor level and three at first floor level.

Plate 1: General shot of barn 1 (left) in relation to barn 2 (right)

Plate 2: General shot of barn 1 (right) in relation to the farmhouse

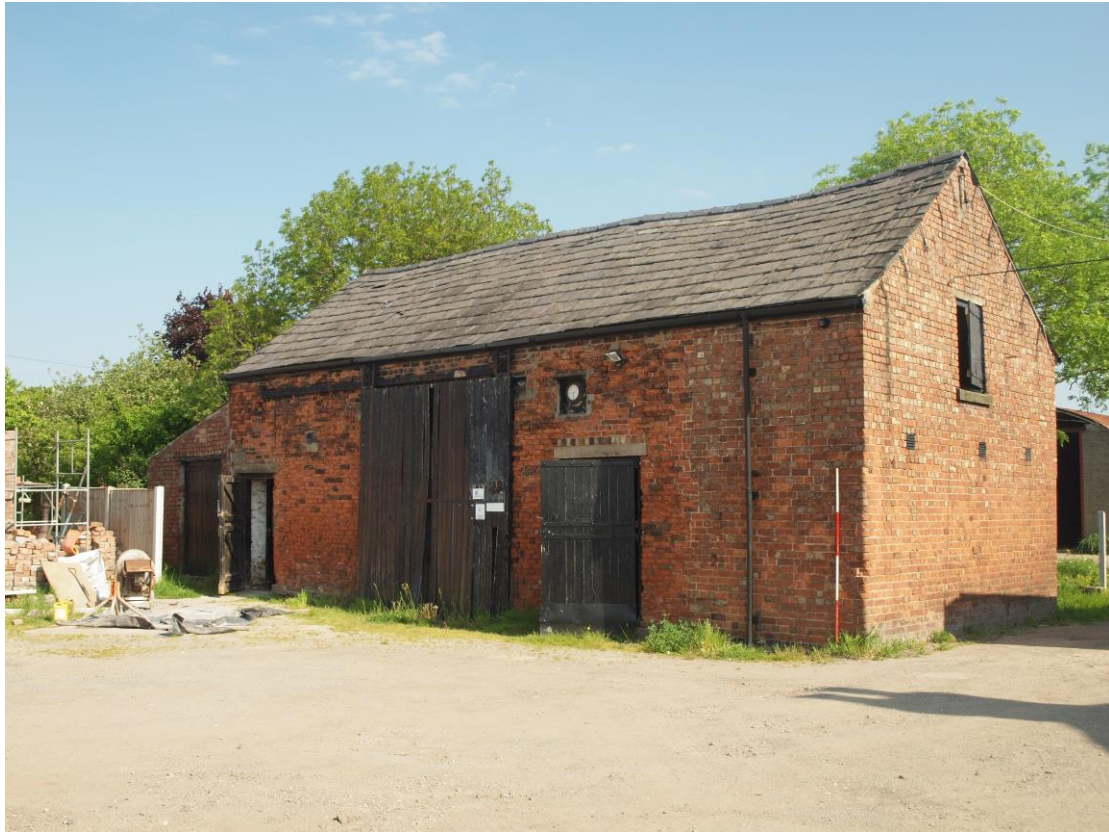
6.2 South elevation (Plates 3 & 4). This forms the main frontage of the building, facing towards the road. It is constructed in stretcher bond, with headers occasionally inserted. At the western end is the south face of the lean-to. This contains a wide doorway hung with a timber door with timber lintel above. To the east a rough joint runs up the face, marking where the lean-to joins the main building. Bay 1 of this contains a timber door with sandstone lintel above. The first floor level is featureless, with the exception of a sandstone block within the brick wall. Bay 2 contains the large barn door hung on a rail above, which allows it to slide to the west. This rises up to the first floor level. Bay 3 contains a wide inserted doorway with concrete lintel above. Above this a small clock is set within an alcove. A rough joint runs up the face, to the east of the door, showing the eastern end of the bay having been rebuilt in a browner coloured brick, measuring 9 x 3 1/4 x 4 1/4". The brick bond differs here, being built in English Bond. The bay is otherwise featureless.

Plate 3: South elevation

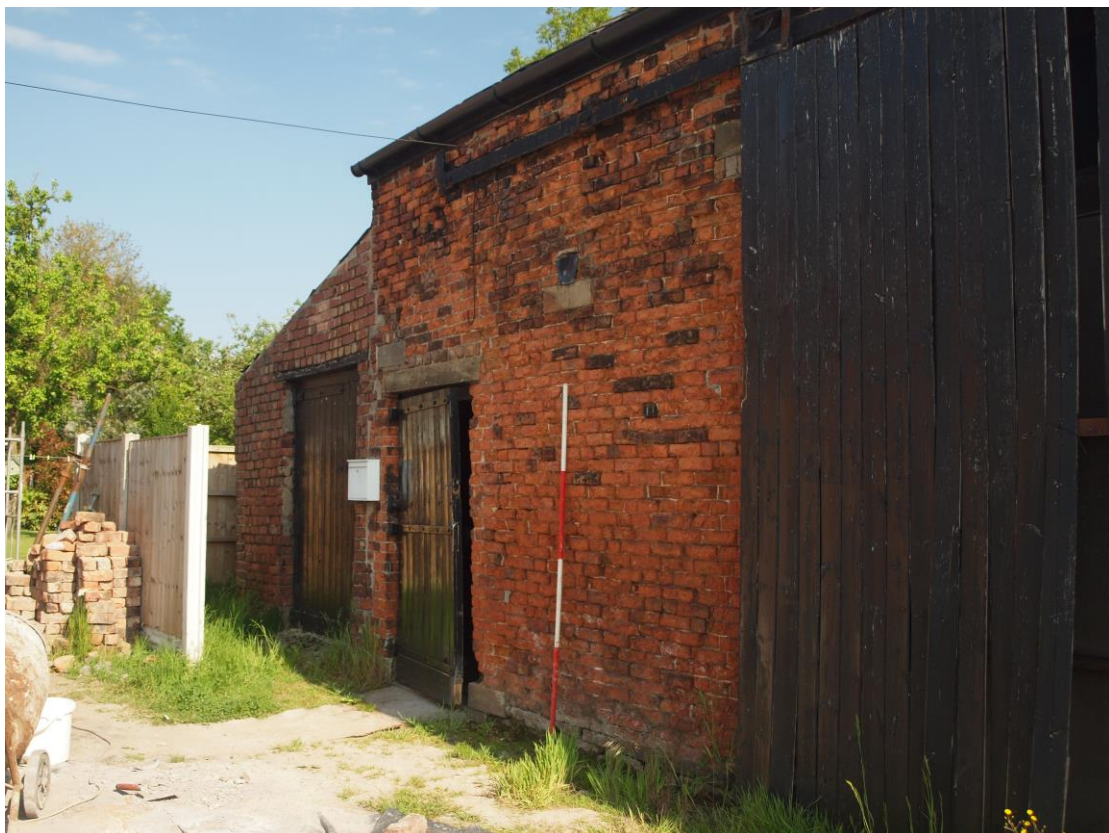
Plate 4: Detail of west end of south elevation

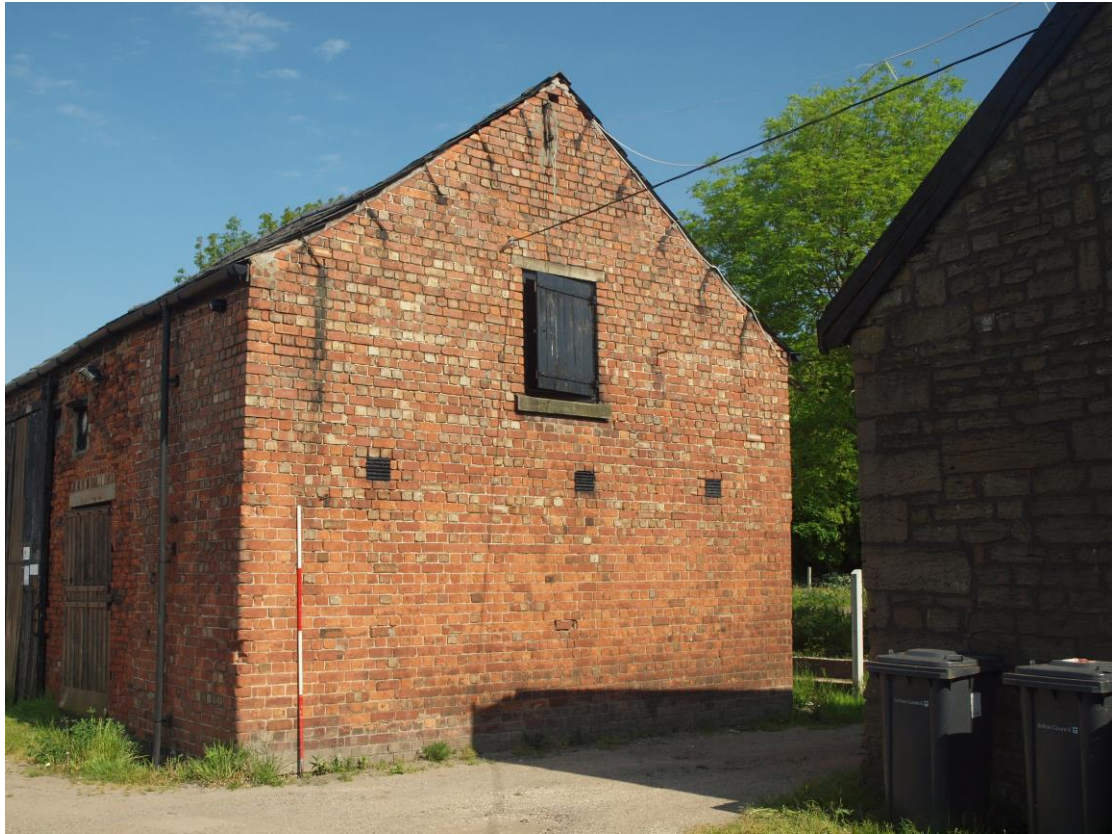
6.3 East elevation (Plate 5). This constitutes the gable end of the building and the English bond of bay 3 continues as the whole face has been rebuilt. The bricks are more regular than those found in the other faces and machine made. The ground floor level is featureless, although at first floor level in the centre of the face is a timber framed window with sandstone cill and lintel and fitted with a timber door. Three modern air bricks are located below.

Plate 5: East gable

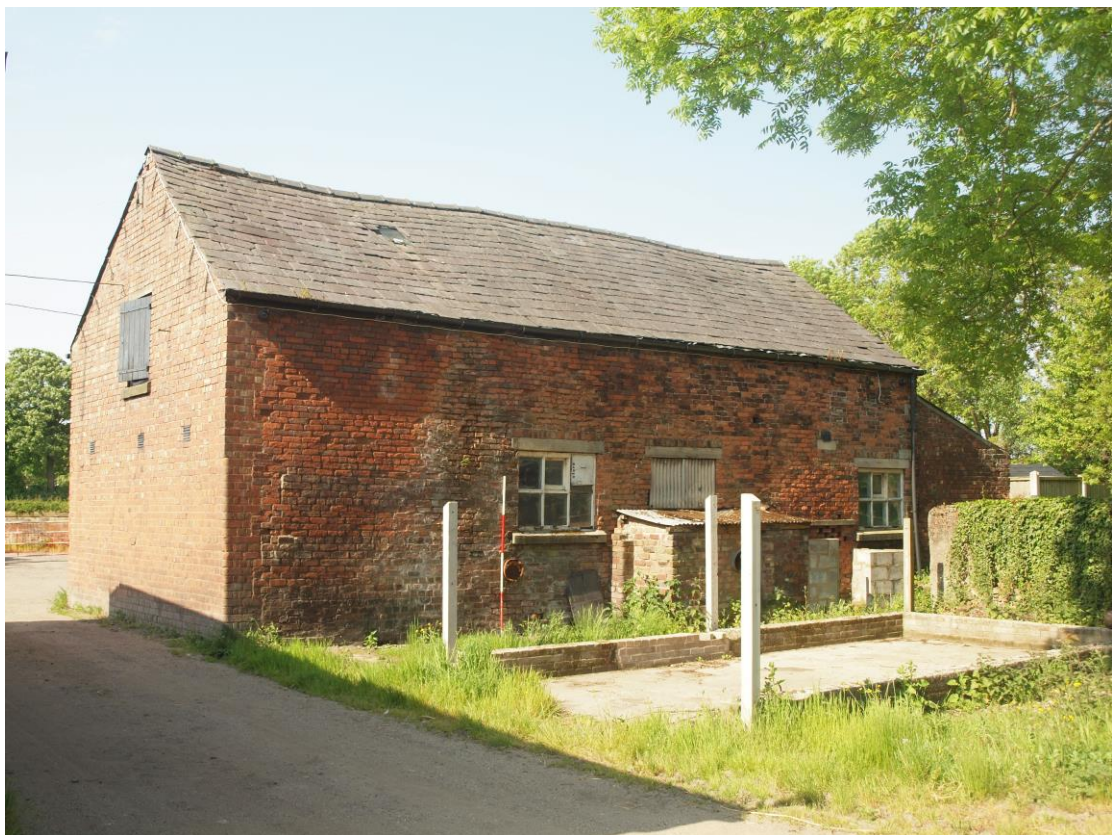
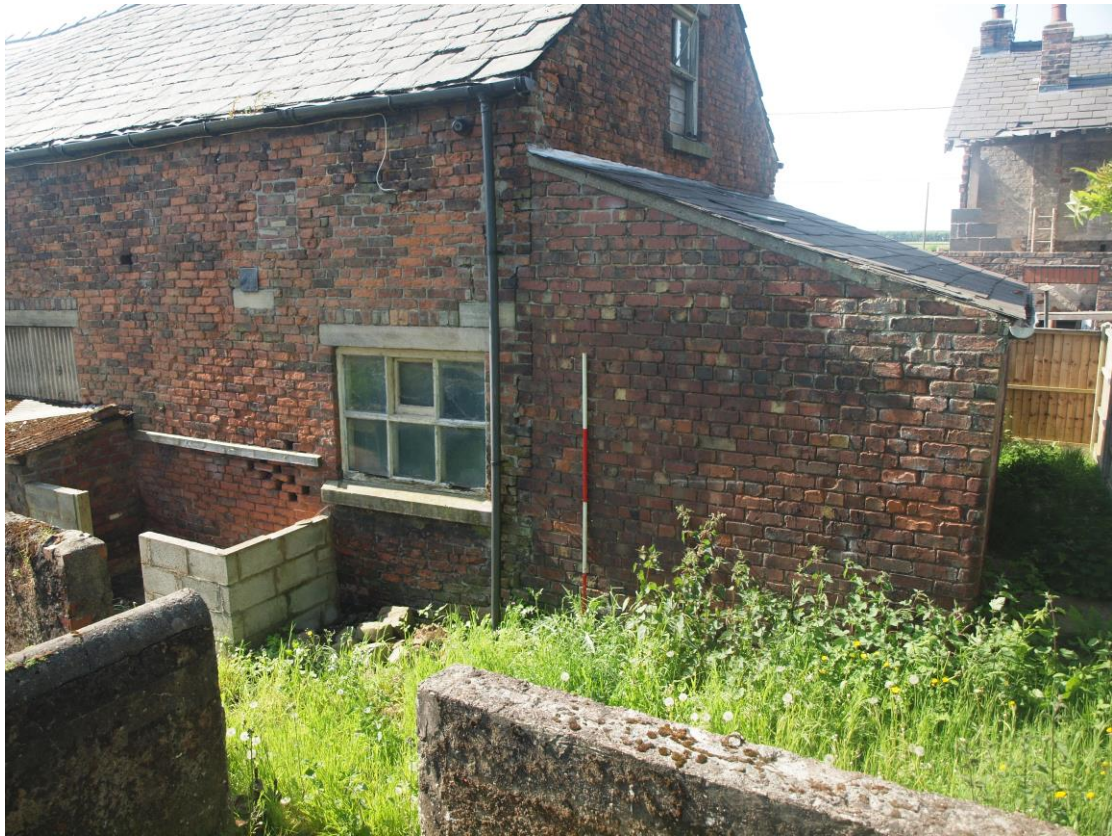
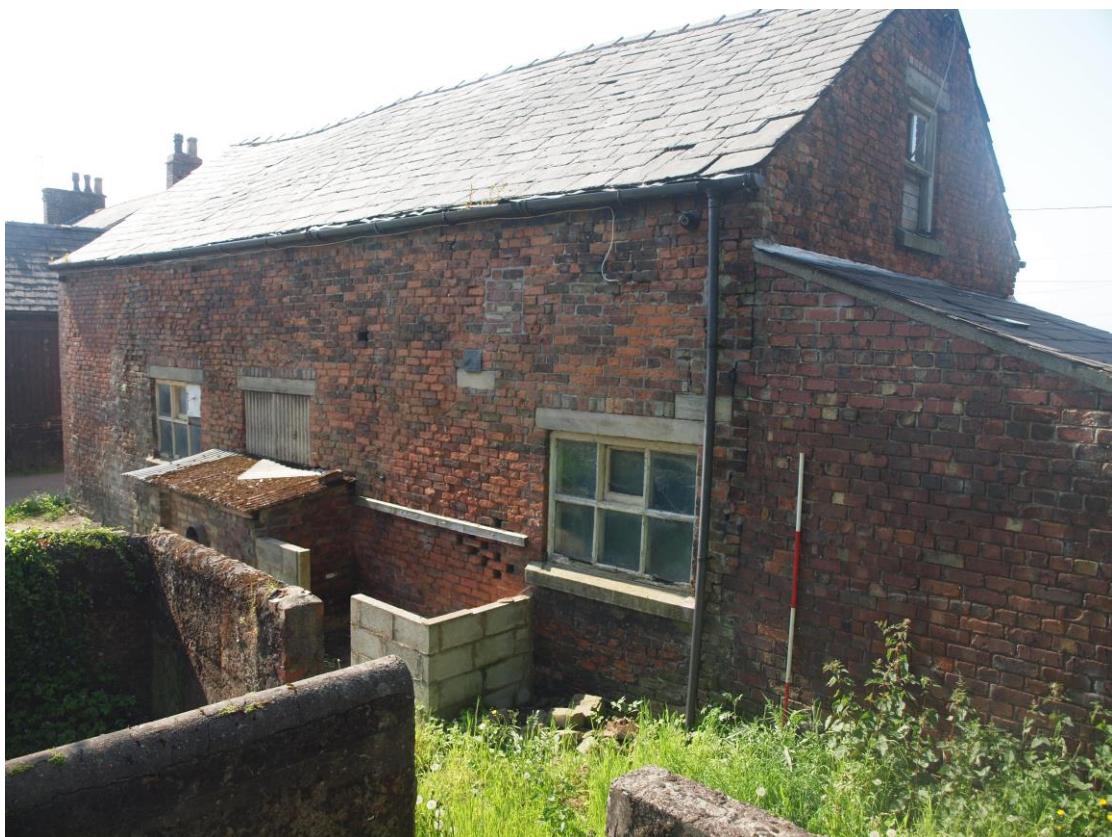
- 6.4 North elevation (Plates 6 - 8) Bay 3 shows the rough joint at the eastern end, marking the end of the rebuilding of the gable. The brick bond here is shown to be English Garden Wall (1:5), but is not uniform across the face. Bay 3 contains an inserted 6 light timber framed landscape window at ground floor level with concrete cill and lintel. The first floor is featureless. Bay 2 is similar, although here the inserted window is blocked. In front and covering the lower part of the window a low brick extension has been added with a corrugated asbestos roof. Bay 1 matches that of bay 2, with a 6 light inserted window, although above this and to the east is a small blocked opening. On the east side of the window a diamond pattern set of breathers are located, the window blocking off the western end. To the west end of the elevation a rough joint marks the location of the adjoining lean-to, which is featureless. This is constructed in a brown brick in English Garden Wall bond (3:1).

Plate 6: North elevation

Plate 7: Detail of lean-to at north elevation

Plate 8: North elevation

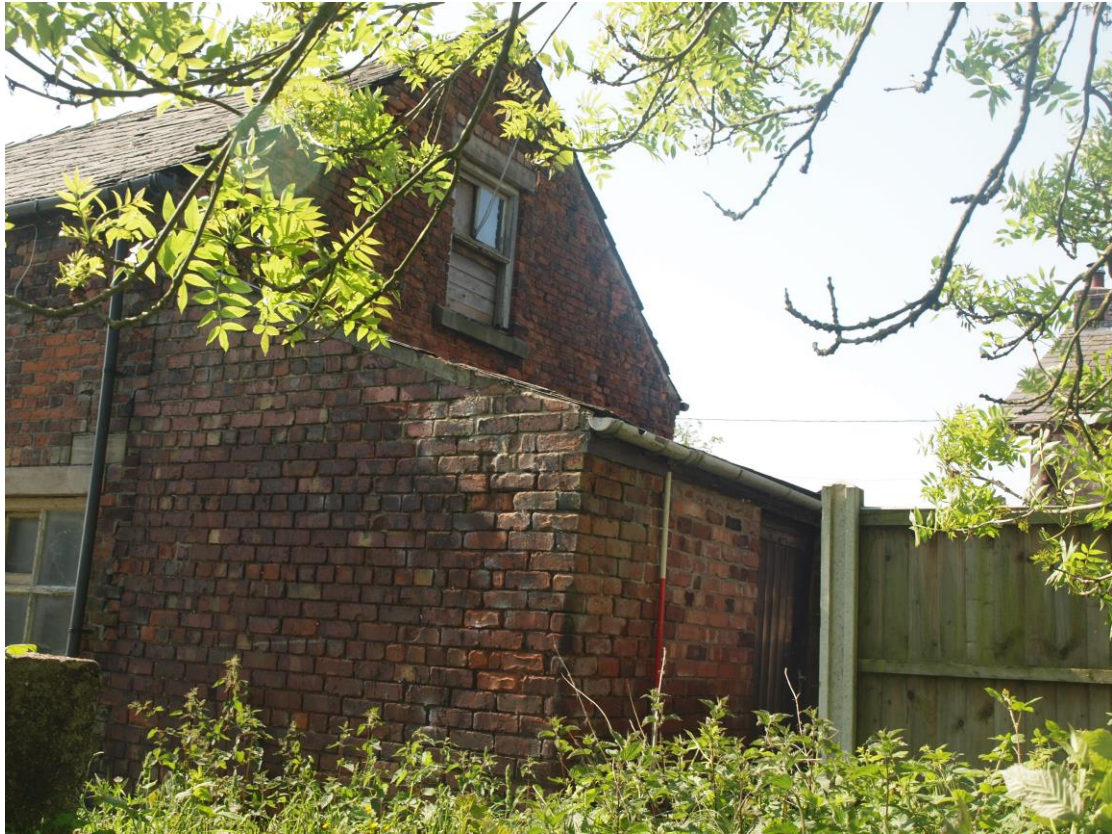
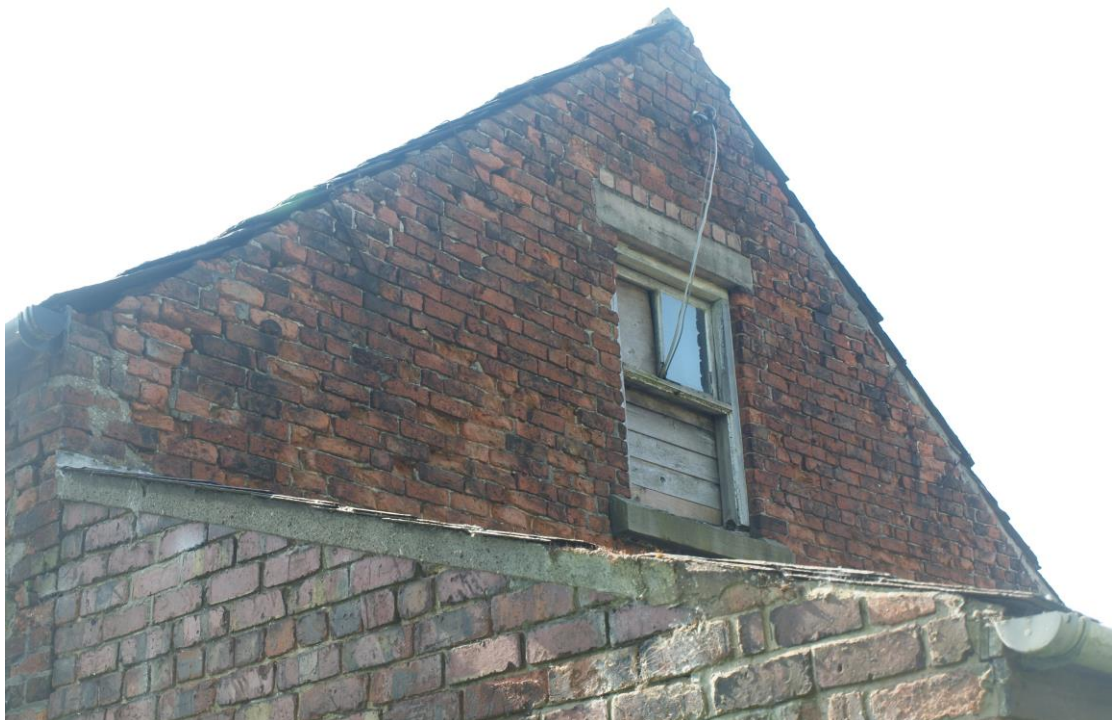
- 6.5 West elevation (Plates 9 & 10). This forms the other gable end of the building. At ground floor level is the face of the lean-to. This has a doorway hung with a timber door, slightly north of centre, with a blocked landscape window to the southern end. At first floor level, in the centre of the gable is an inserted timber framed window, with concrete cill and lintel.

Plate 9: East gable

Plate 10: Detail of window in east gable

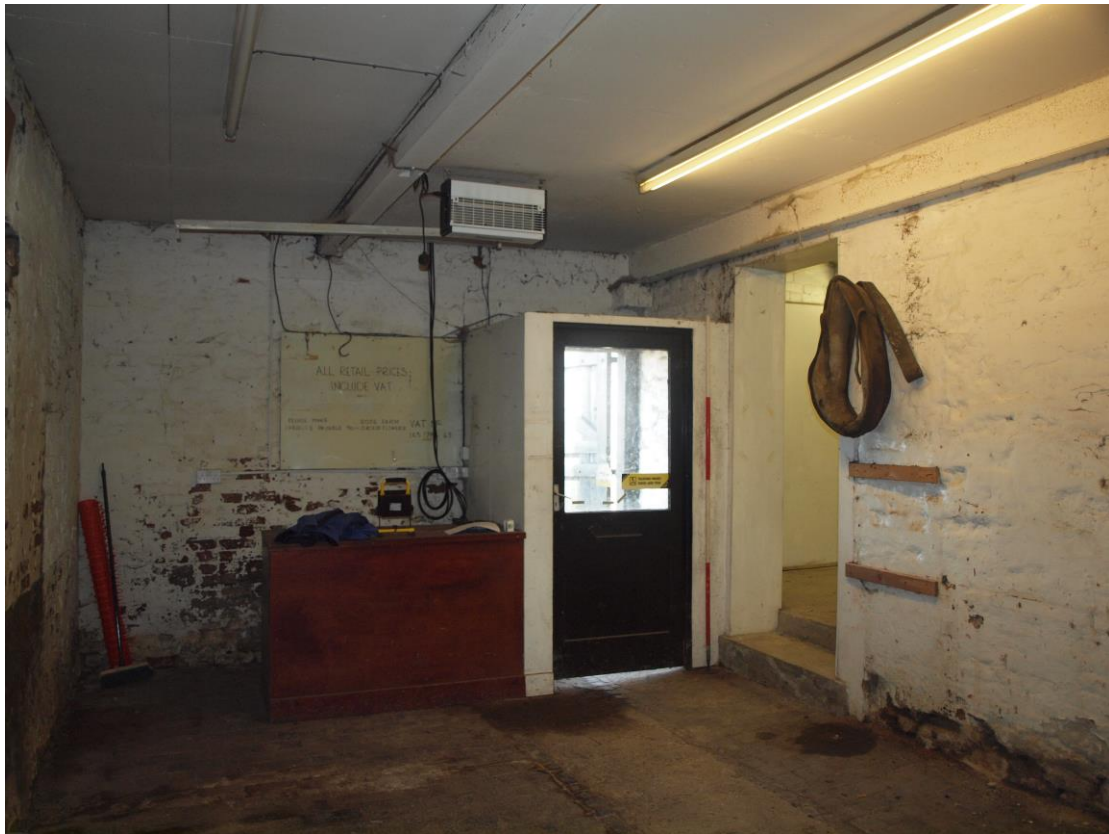
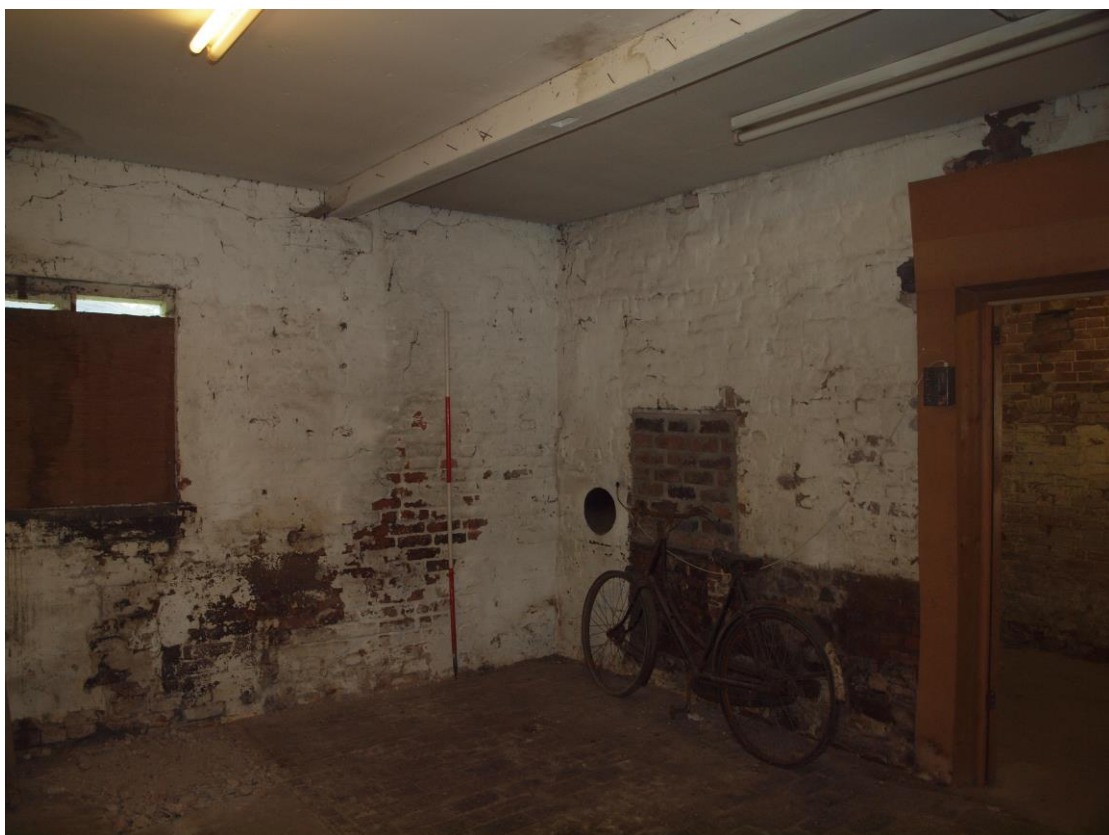
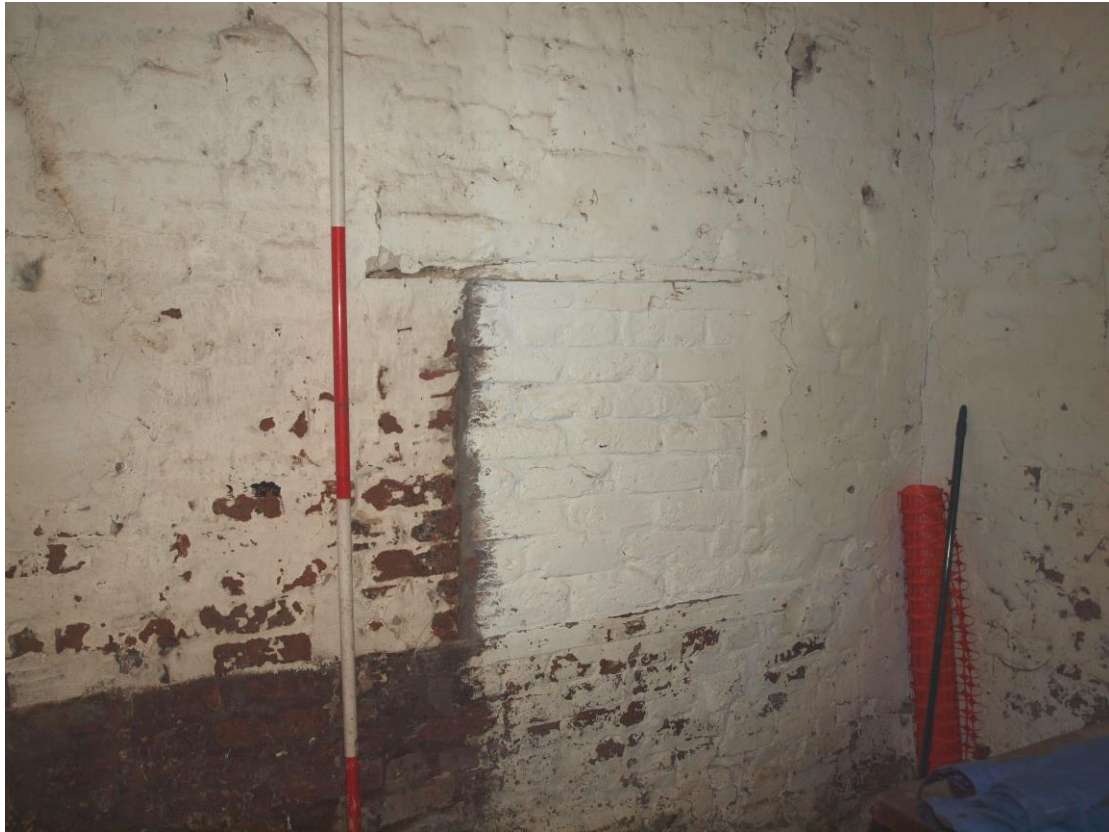
- 6.6 Room 1 (plates 11 - 13) is accessed externally from the door in bay 1 of the southern elevation. A small timber porch has been erected in front of this. The floor of the room is brick, with an infilled drain running from the north wall to the south. The ceiling has been plaster boarded and a machine cut timber beam runs north - south across the room, with a pair of soffits on the underside. In the west end of the north wall is an inserted window and to the east an inserted doorway lies in the centre to room 2, flanked by a pair of blocked windows. This eastern wall shows cracks at the southern end, showing it to be a later insertion. The west wall has an inserted doorway in the southern end, leading into the lean-to and the wall itself shows a sandstone base below the brick wall.

Plate 11: Room 1 showing timber 'porch'

Plate 12: Room 1 showing blocked window and doorway to room 2

Plate 13: Detail of blocked window

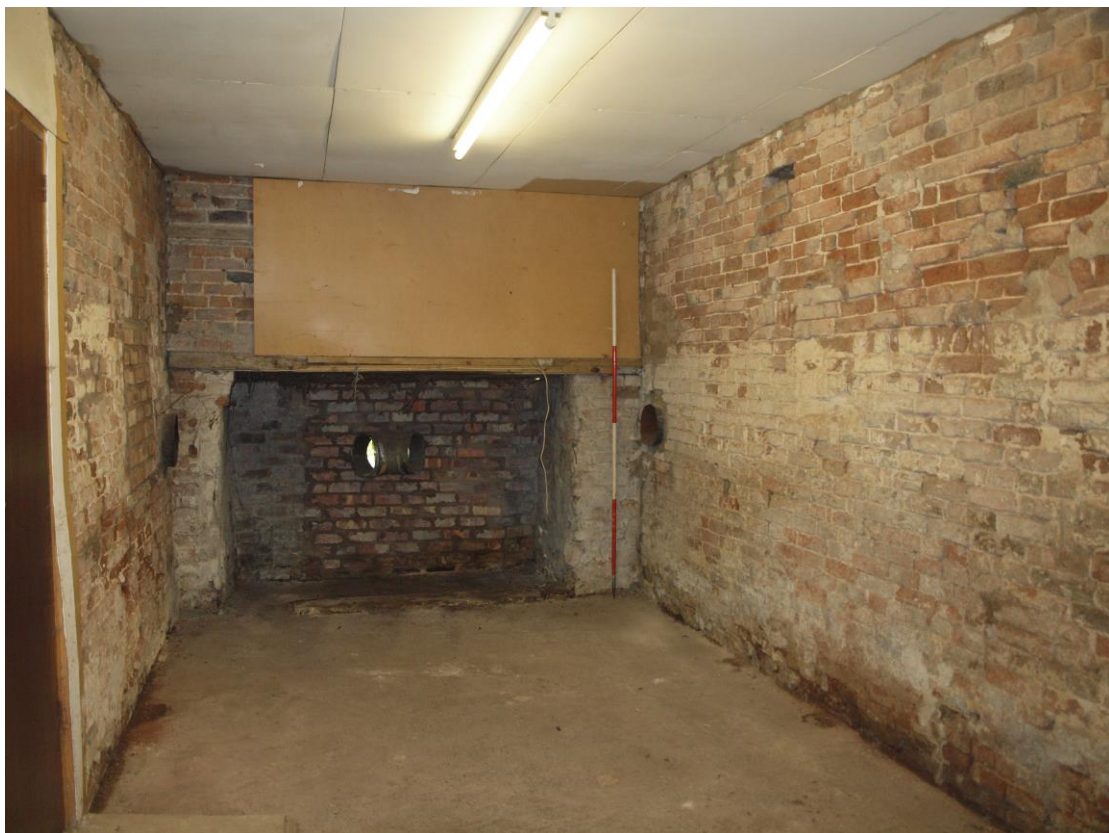
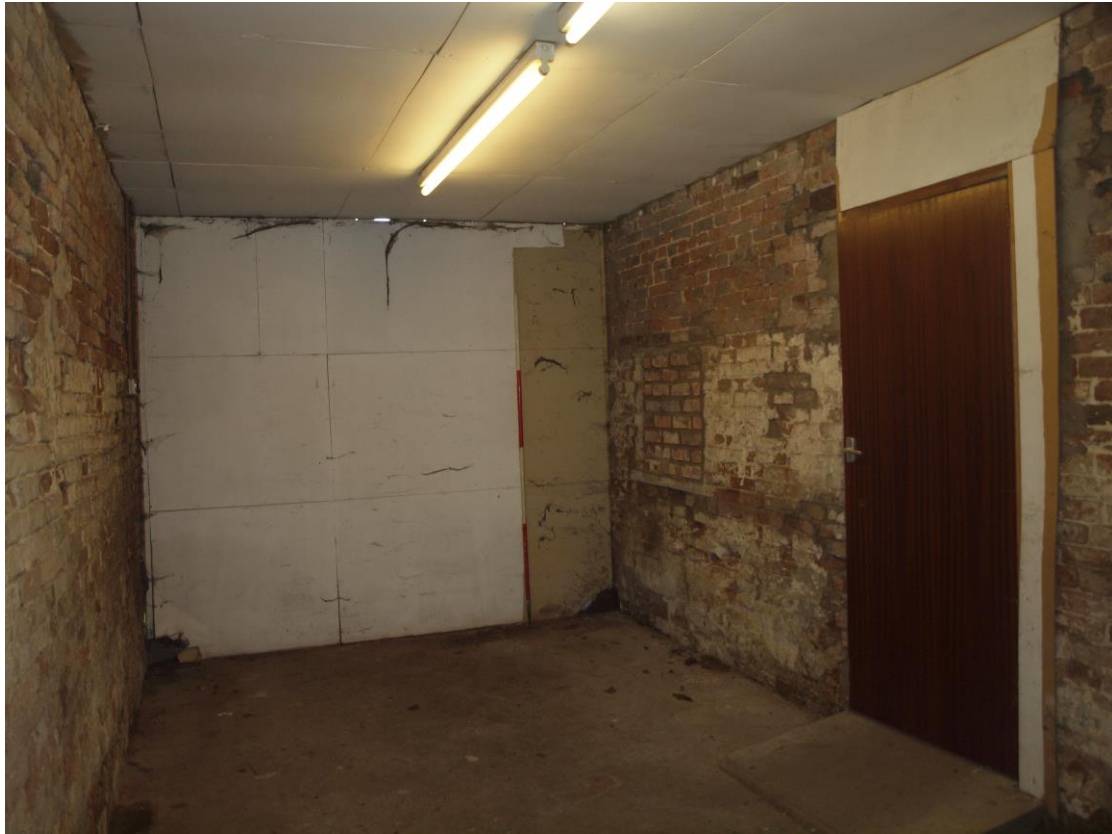
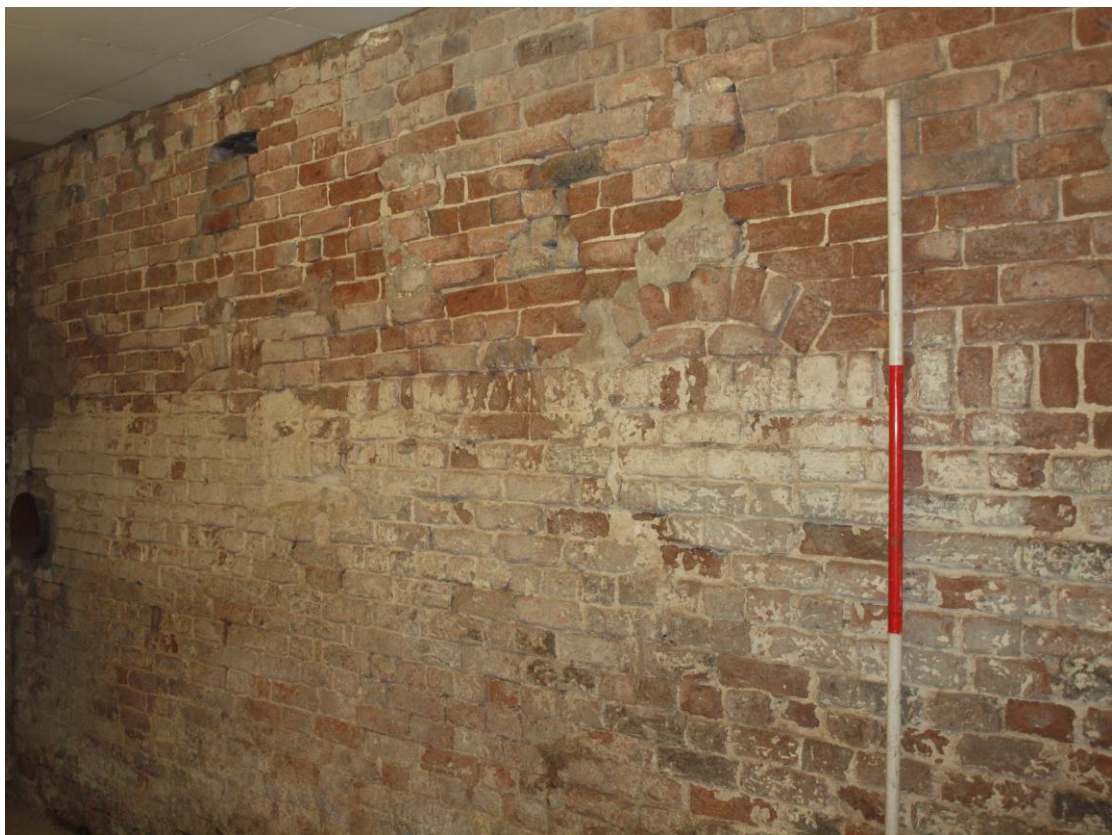
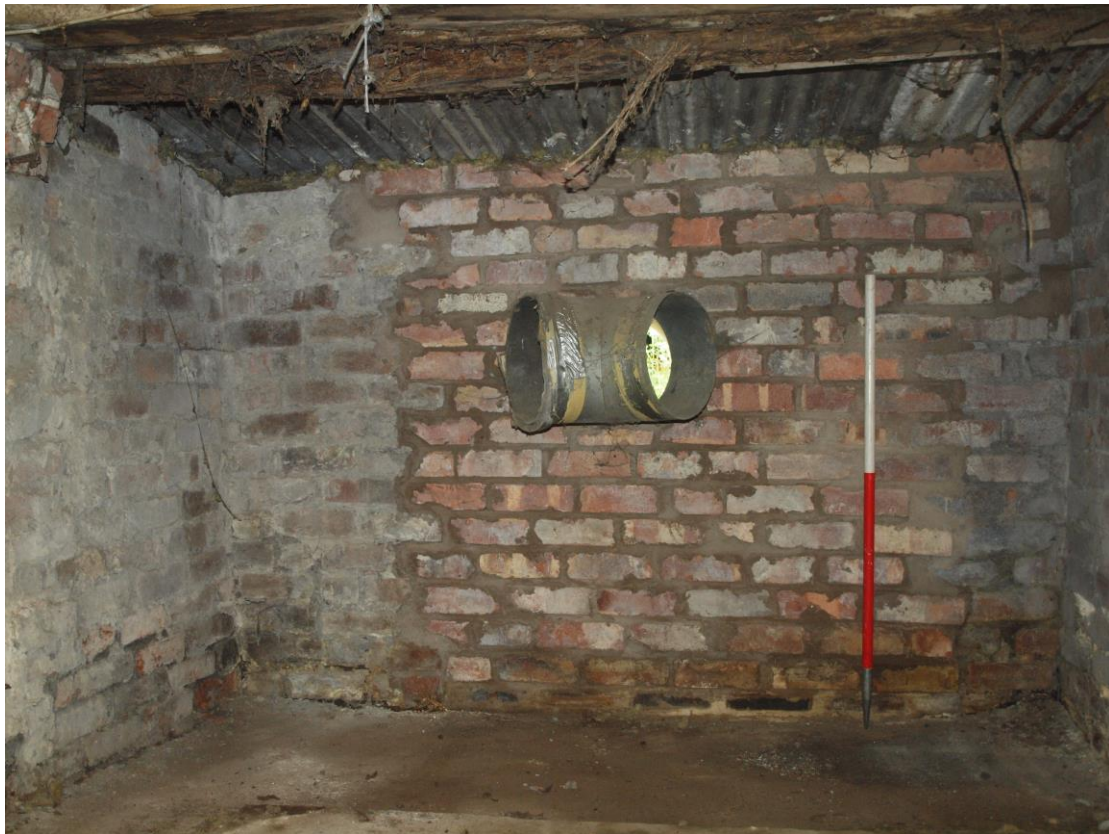
- 6.7 Room 2 (plates 14 – 17) is accessed only via the doorway in its west wall, from room 1. The flanking blocked windows are also visible. The floor in the room is concrete and stepped down from room 1, whereas the ceiling is much the same. The south wall is formed of ply sheeting, completely hiding the large barn door visible from the exterior. In the north wall an opening has been inserted at a low level giving access to the low extension visible externally. A vent pipe has been inserted and the central section of the extension rebuilt. The lintel of the inserted opening is timber. The east wall contains a pair of small blocked windows within it. Unlike those opposite, these have depressed arched lintels of brick.

Plate 14: Room 2 showing inserted opening and low extension

Plate 15: Southern wall blocking the barn door

Plate 16: Blocked window detail in east wall

Plate 17: Detail of low extension interior

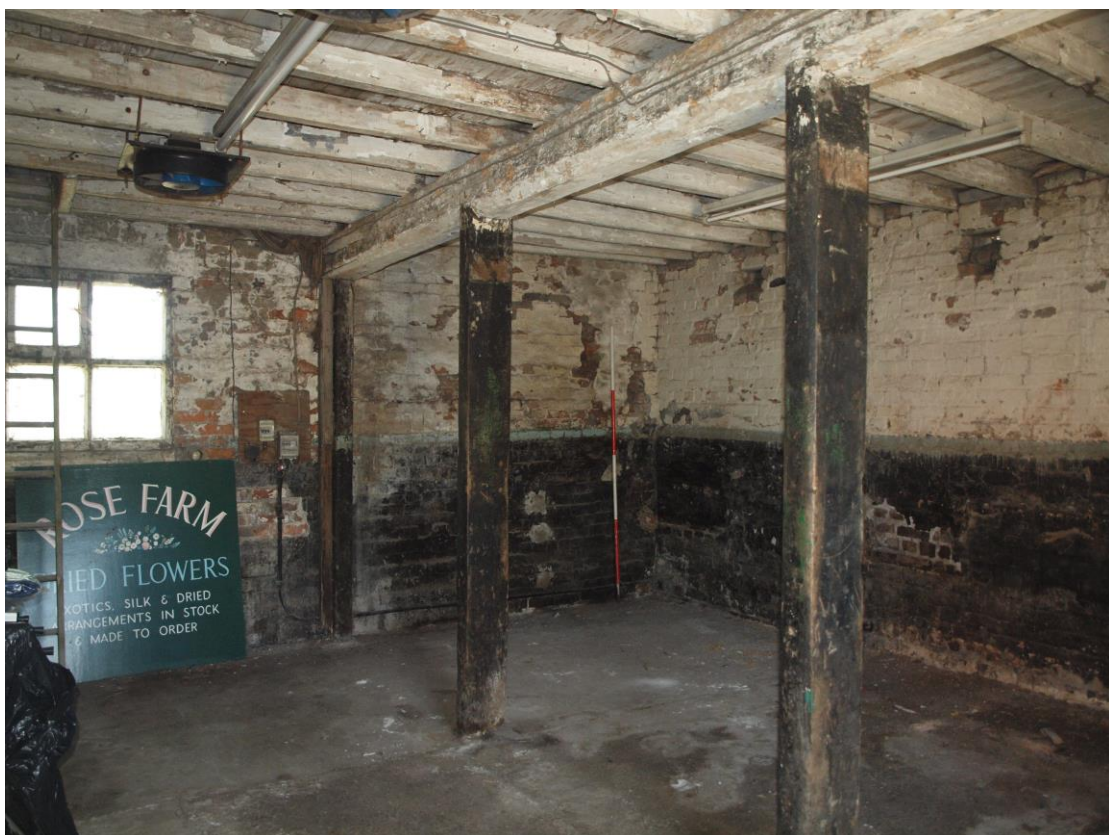
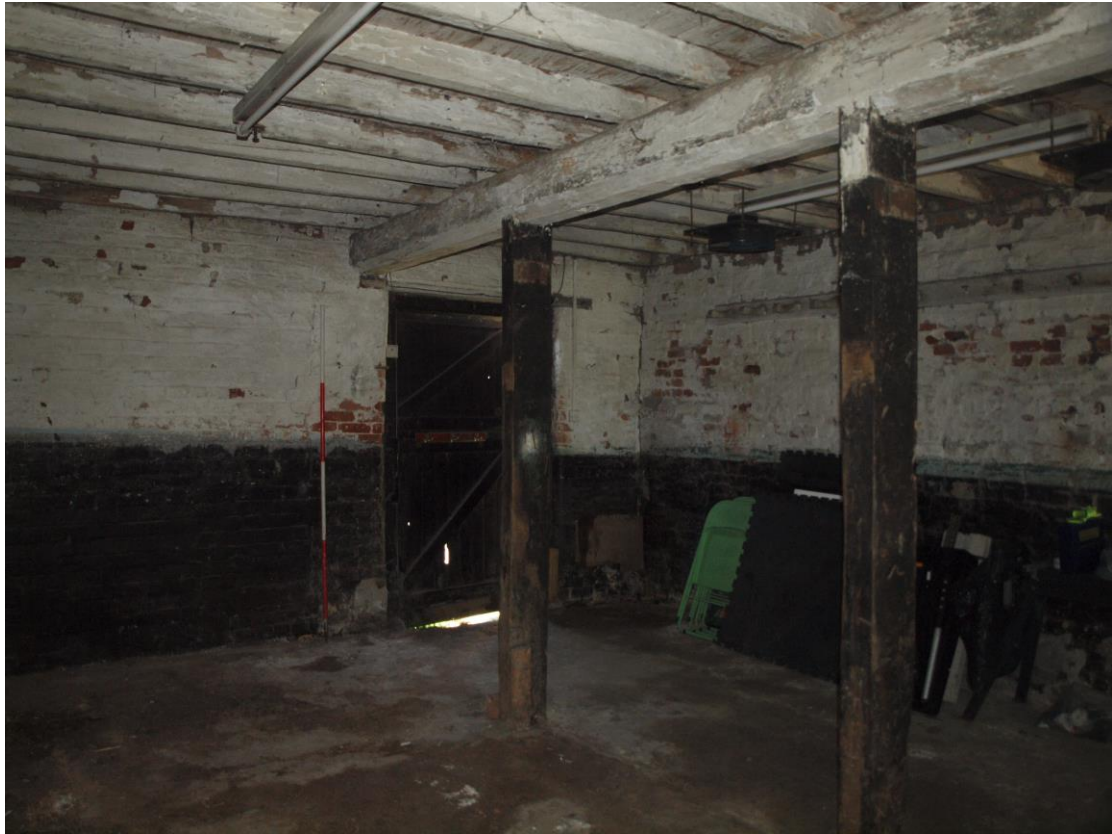
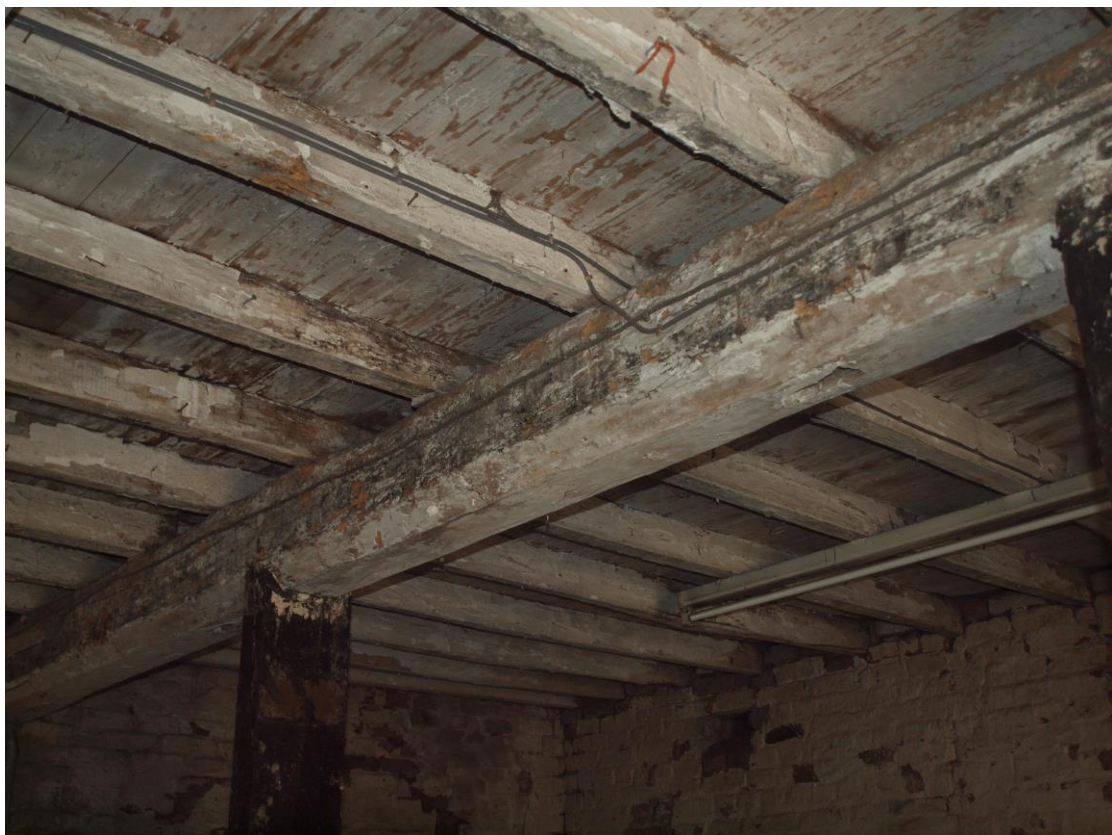
- 6.8 Room 3 is (plates 18 – 20) formed of bays 3 and 4. The room is accessed via the doorway in bay of the south elevation. The floor is concrete and the ceiling is open to the joists above. A north - south machine cut timber beam runs across the room, with soffits on the underside. This beam is also supported by three machine cut timber upright posts. The rough joints visible externally and marking the area of rebuilding around the gable are also visible internally, although the bricks have been painted. The inserted window is visible in the north wall and a hatch lies in the northwest corner of the ceiling, with a ladder set against the west wall, giving access to the first floor. The inserted windows in the west wall are not visible due to the render, although a crack at the southern end shows that this wall is a later insertion.

Plate 18: Room 3 showing timber uprights

Plate 19: Room 3

Plate 20: Beam detail

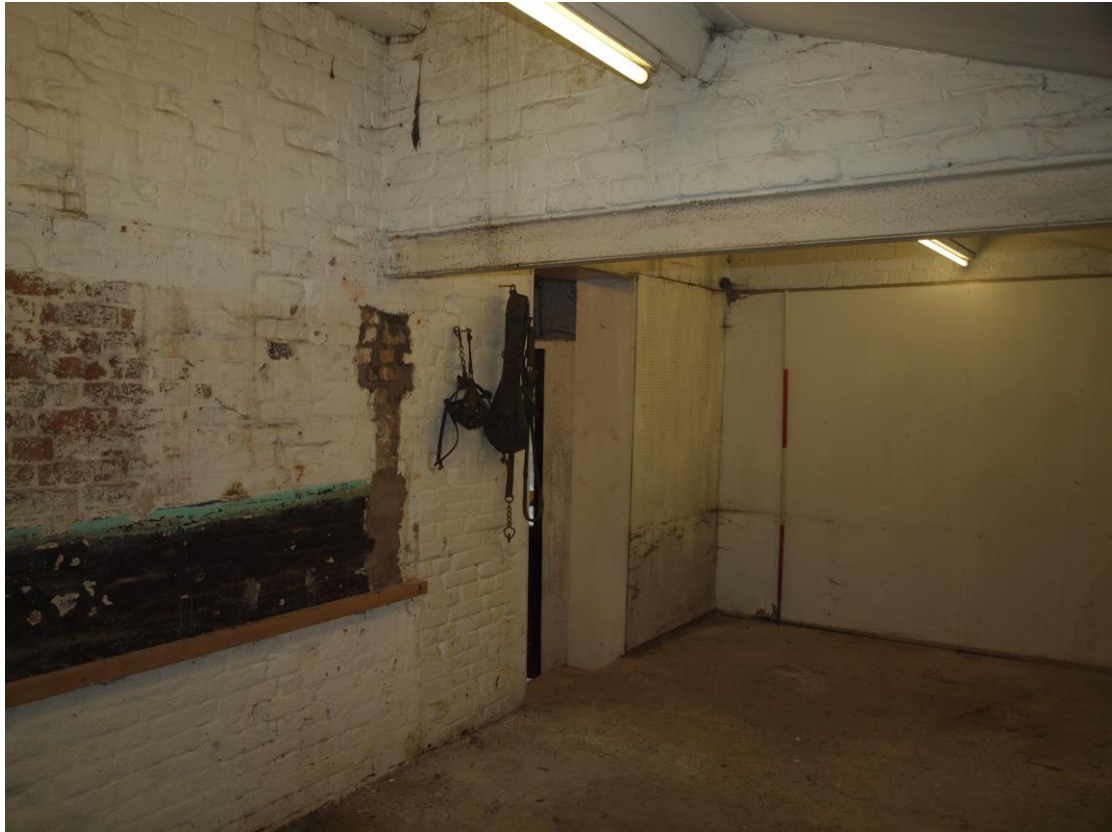
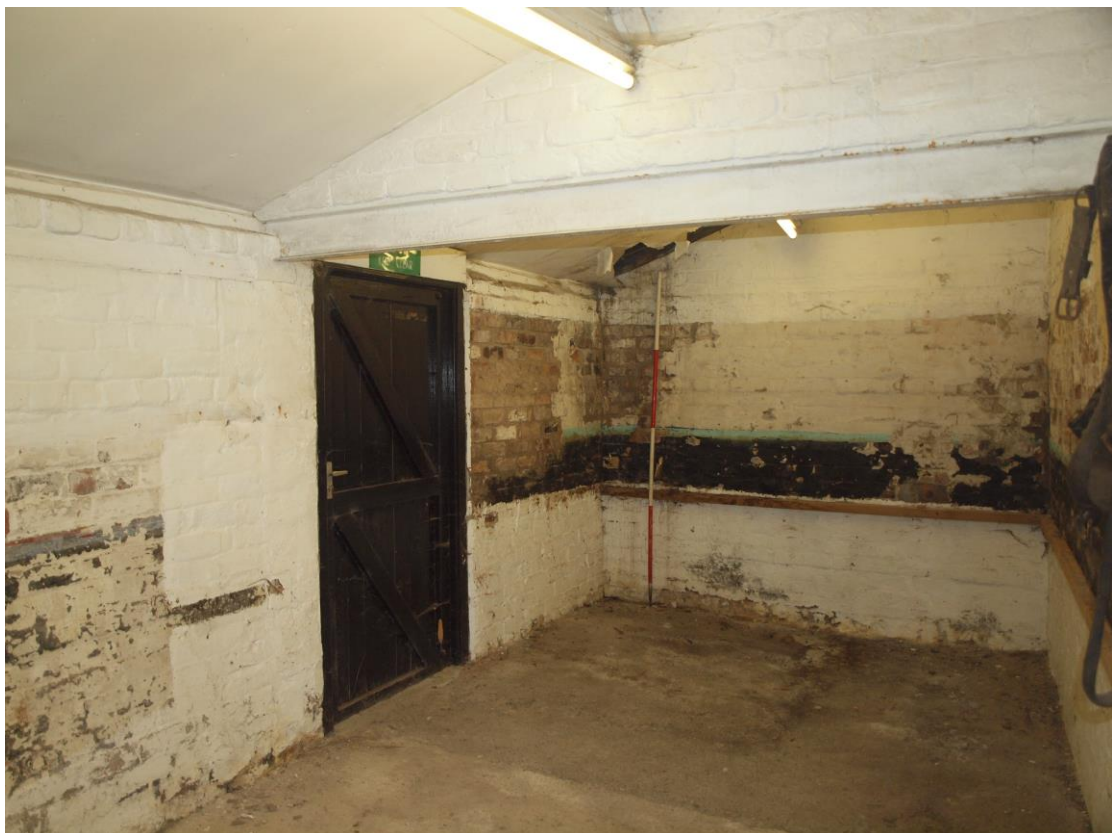
- 6.9 The lean-to (plates 21 & 22) is accessed via room one with the concrete floor set at a higher level. The south wall has been covered with ply sheets, masking the door in the southern elevation completely. The ceiling is covered with plaster board and matches the slope of the pitched roof. An RSJ beam runs across the room centrally, with brick above it.

Plate 21: Lean-to interior looking south

Plate 22: Lean-to interior looking north
