THE ARCHAEOLOGY CO.

Barn 1, Rose Farm, Lunt
Historic Building Survey

June 2018

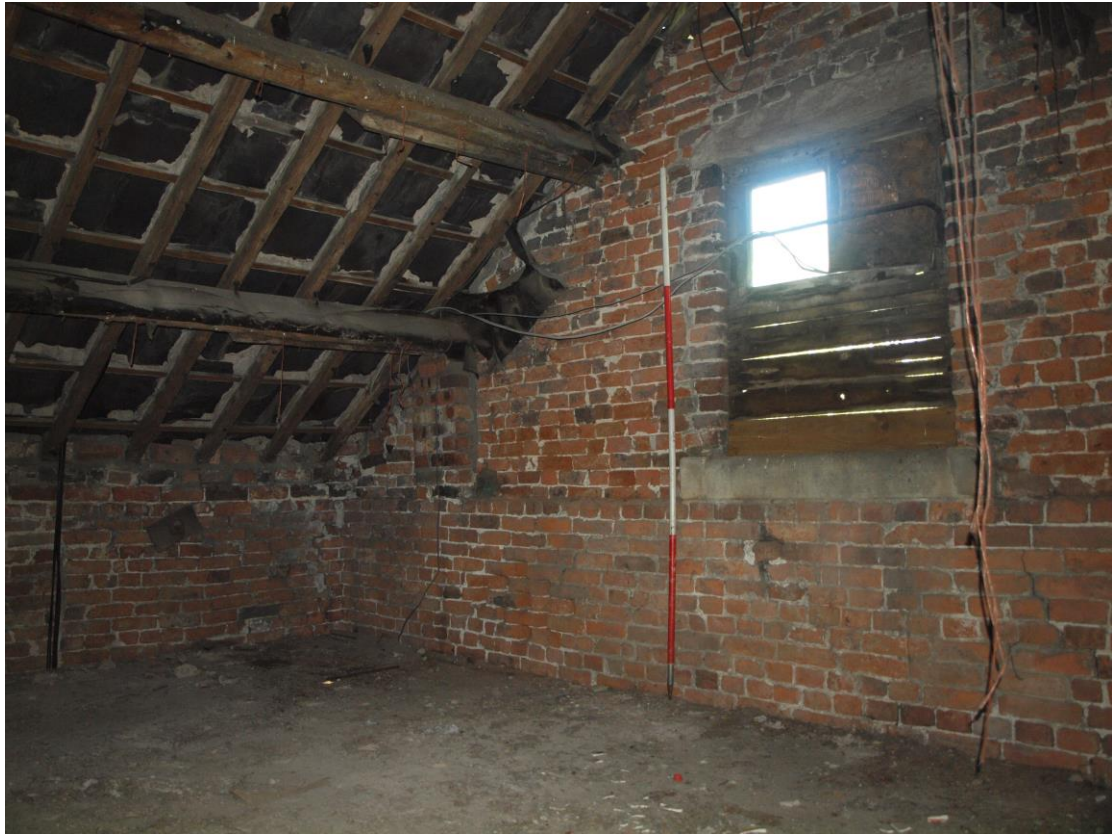
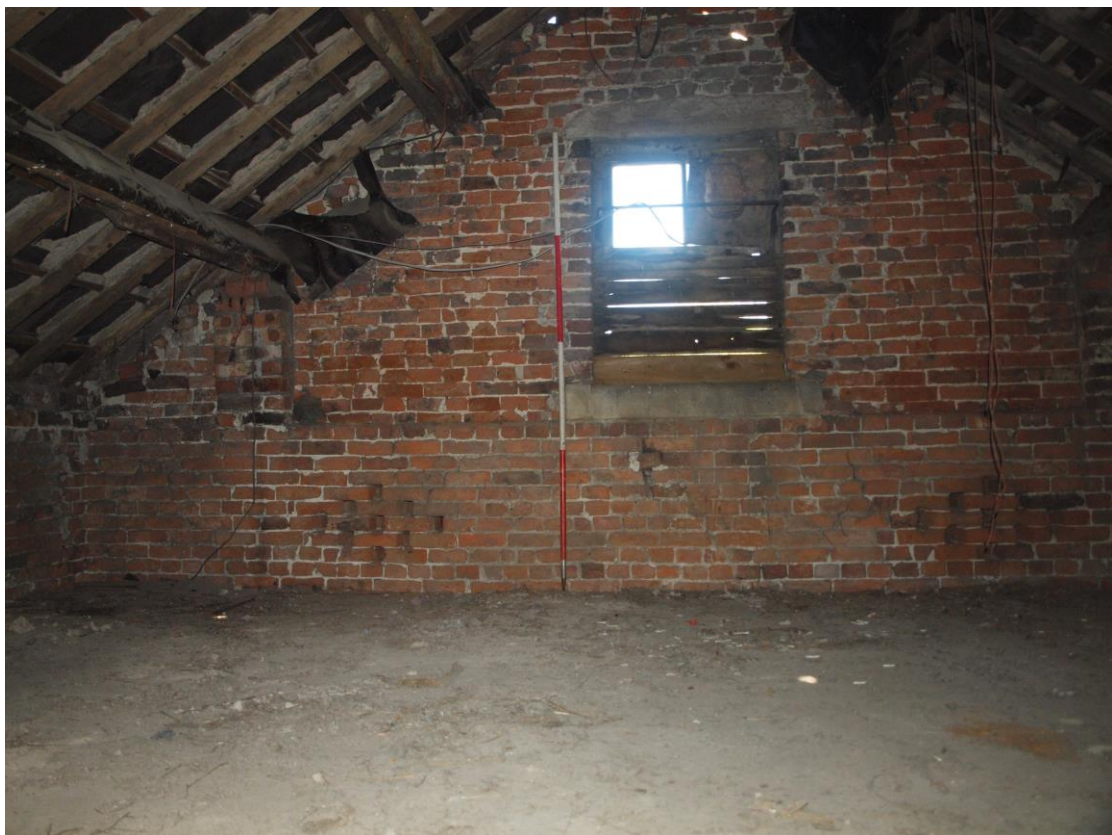
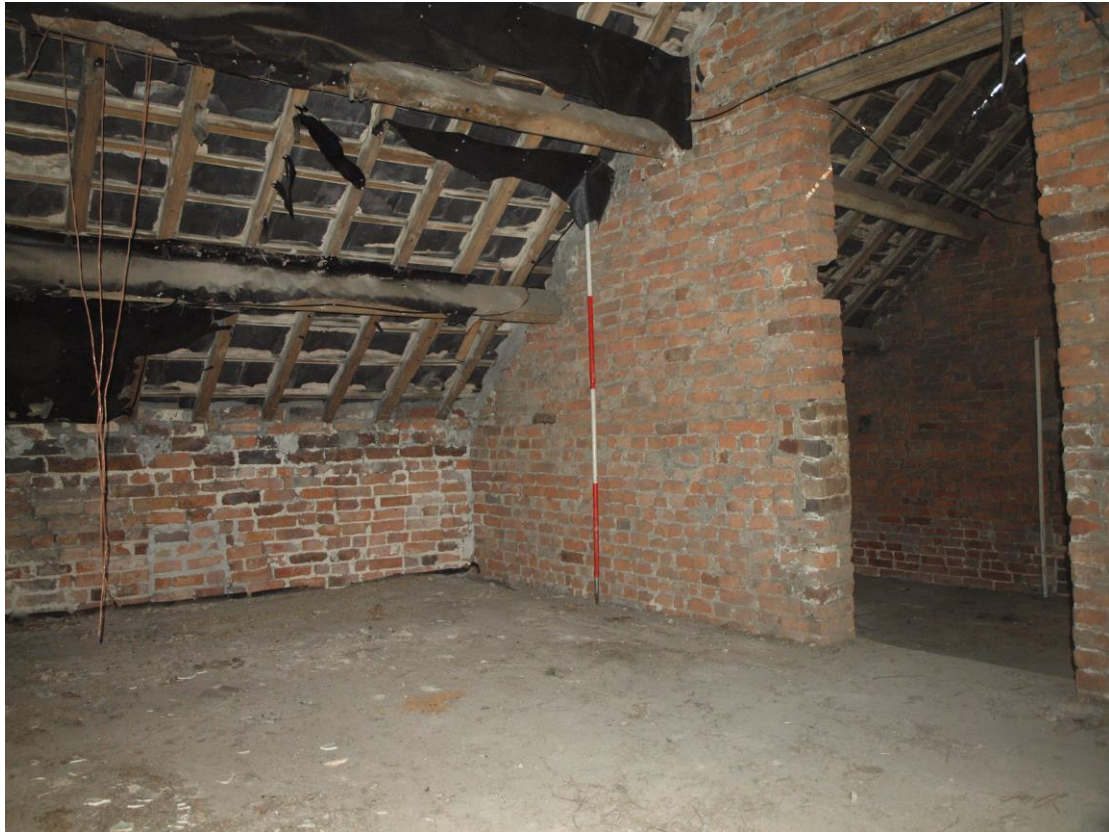
- 6.10 The first floor matches the room arrangement of the floor below, with the internal walls rising up to create three rooms. Room 1 (plates 23 – 25) lies at the western end. An inserted window is located in the centre of the western wall flanked by a pair of inserted brick piers supporting the lower purlins. Opposite the window is a doorway into room 2. The doorway has a timber lintel and shows evidence of

having a lower lintel removed, suggesting that it was a lower doorway with opening above. In the north and south walls there are low blocked openings. No truss is present and the purlins are of machine cut timber. The floor is timber boards.

Plate 23: First floor room 1

Plate 24: Window and flanking piers

Plate 25: Doorway to room 2. Note the notch in the jamb where a former lintel has been removed, suggesting a lower door with opening over.

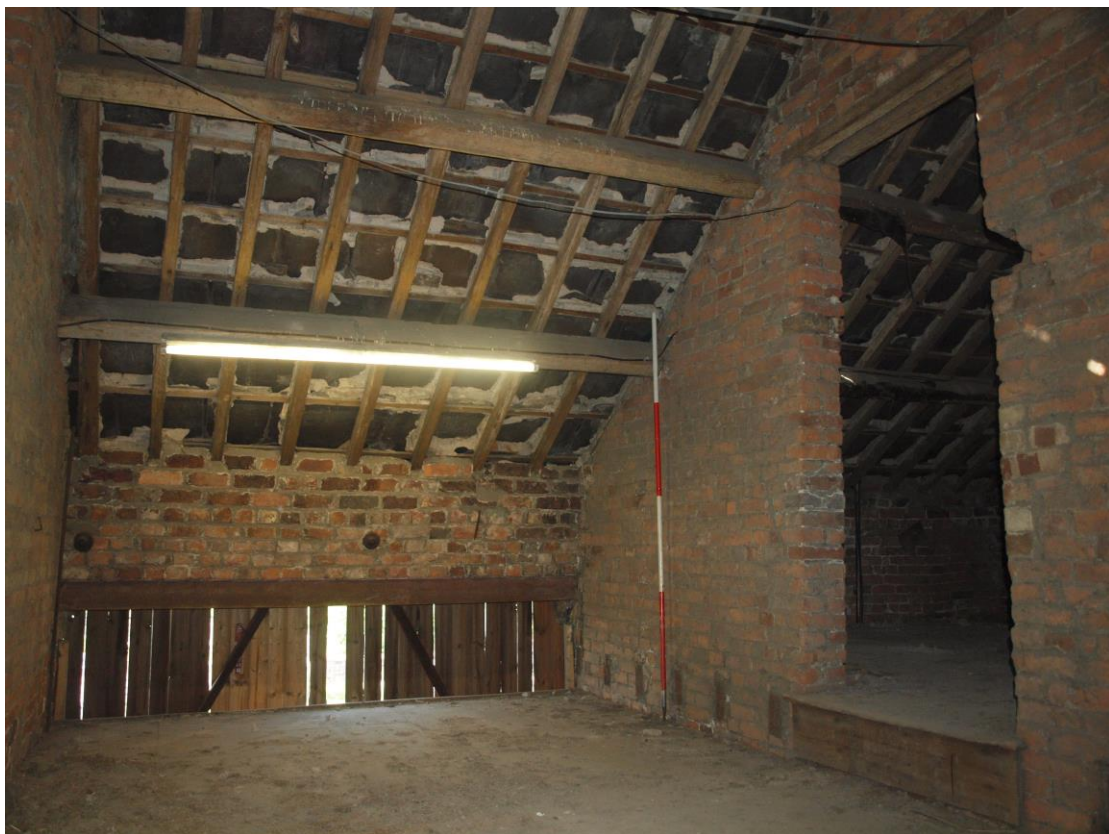
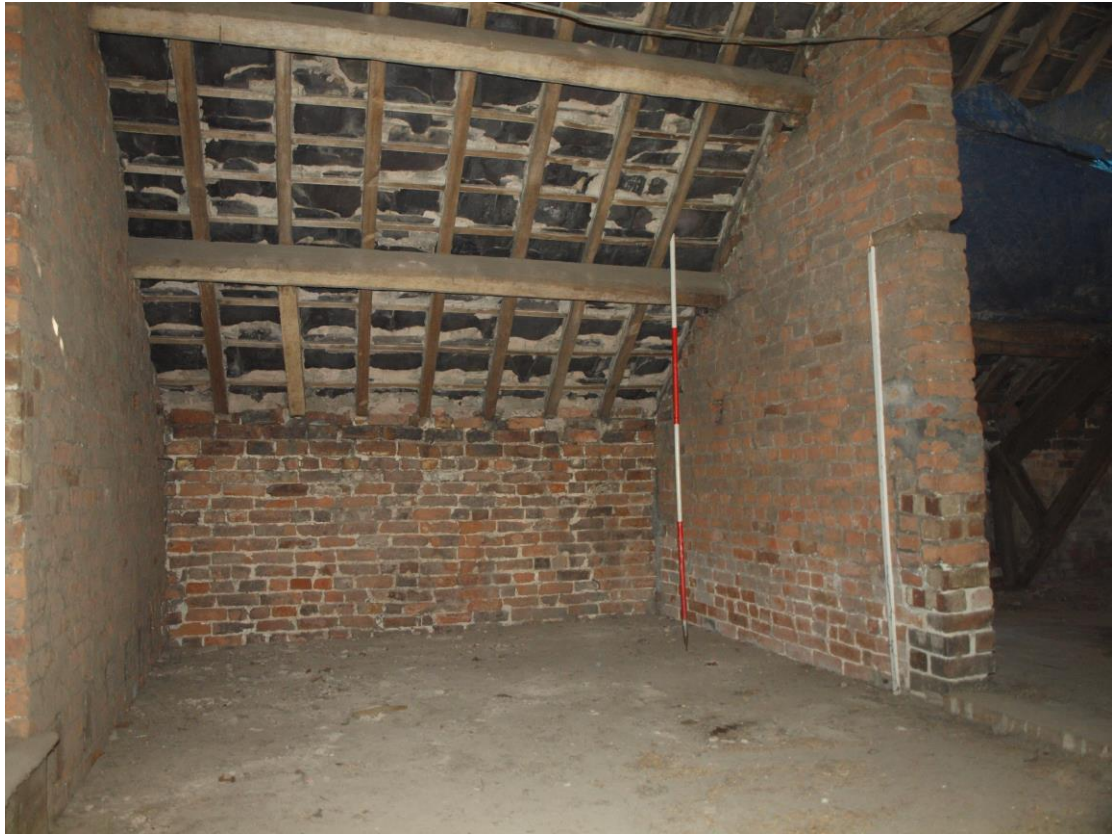
6.11 Room 2 (plates 26 & 27) is accessed via the doorway from room 1 as well as an identical doorway from room 3. The timber floor of this room is lower than that of room 1, and the timber joists of room 1 are visible in the wall. The south wall shows the top of the large barn door with the brick wall above. The purlins are again machine cut timber.

Plate 26: Room 2 showing top of barn door.

Plate 27: Other side of room 2

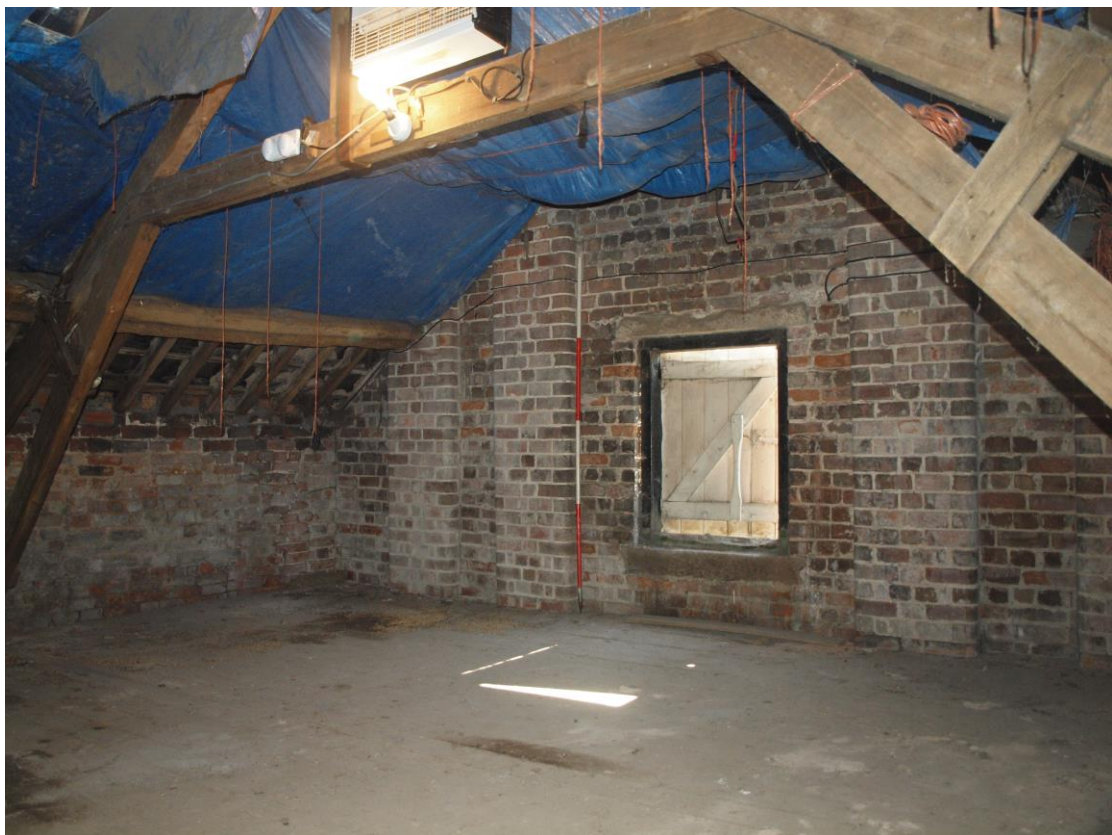
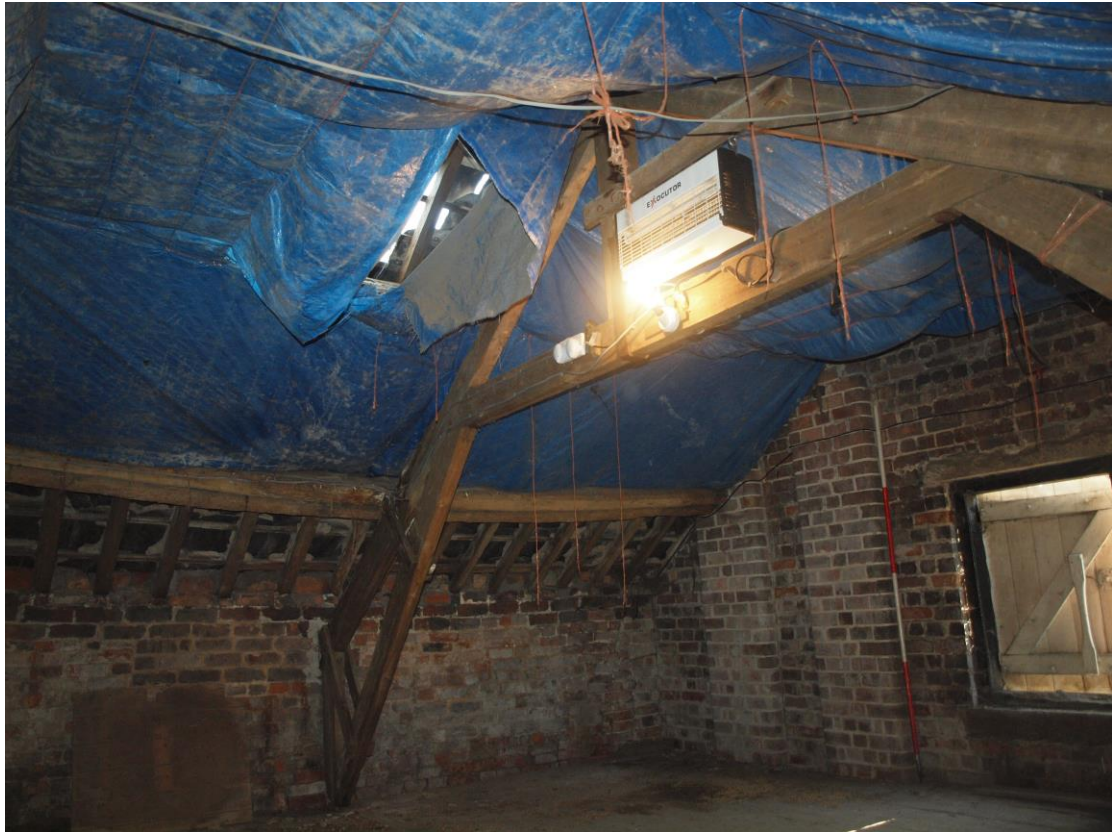
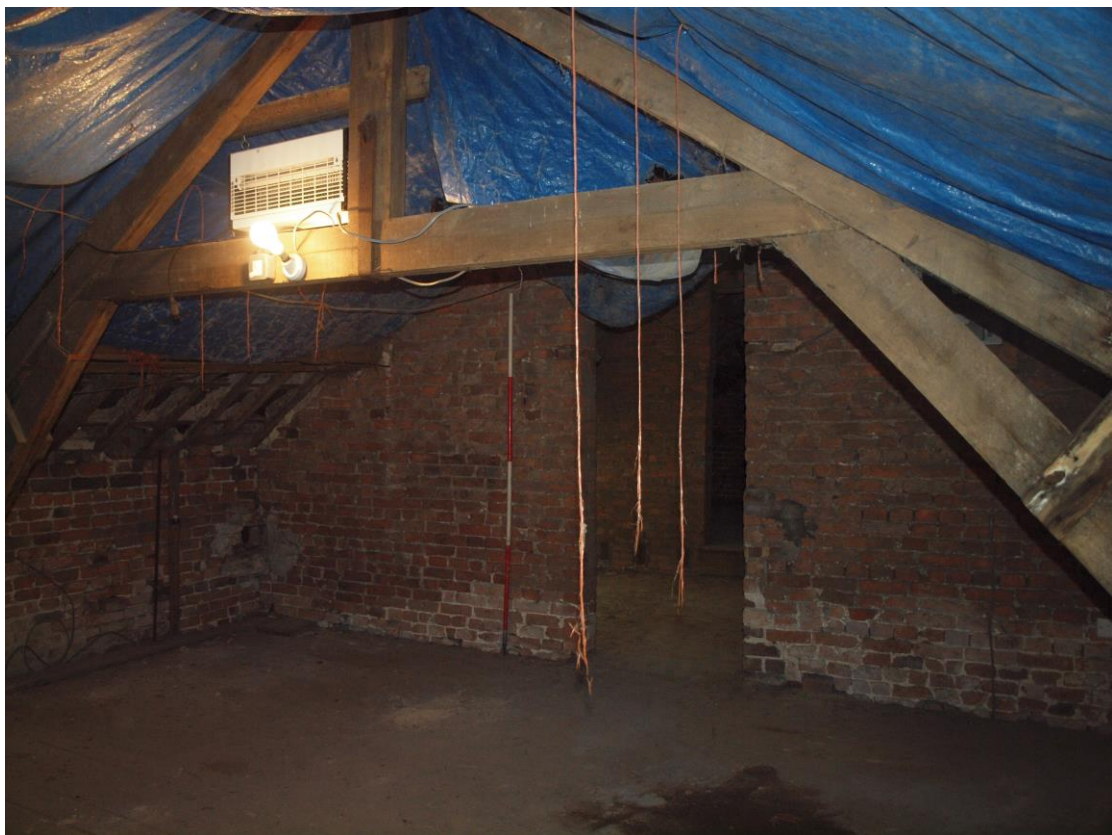
6.12 Room 3 (plates 28 - 30) is accessed via the hatch in the floor to the northwest corner. This has a machine cut timber truss running north - south with hand cut timber purlins. The truss itself is a half king post, with the tie beam located halfway up the principle rafters. Additional support is given to the principle rafters, with a brace below each, running from the tie beam to the wall. No carpenters marks or graffiti are visible. In the east wall a timber framed window is located centrally.

Plate 28: Room 3

Plate 29: Truss detail in room 3

Plate 30: Other side of room 3

- 7.4 The first floor was used for storage, with the floor of room 2 likely inserted later. The roof appears to have been rebuilt in the 20th century, with the truss and most of the purlins replaced.
- 7.5 The low extension to room 2 with the extraction vent appears to have been erected to house an engine for the mechanisation of some of the farm work in the 20th century. It does not appear on the 1945 OS mapping but is present by the time of the 1968 map. The lean-to was erected by 1893. It is unclear when the eastern gable was rebuilt although the brick size and shape suggest it was in the 20th century.
