**THE ARCHAEOLOGY CO.**

Dale Mill, Milnrow  
Archaeological Desk-Based Assessment

March 2021

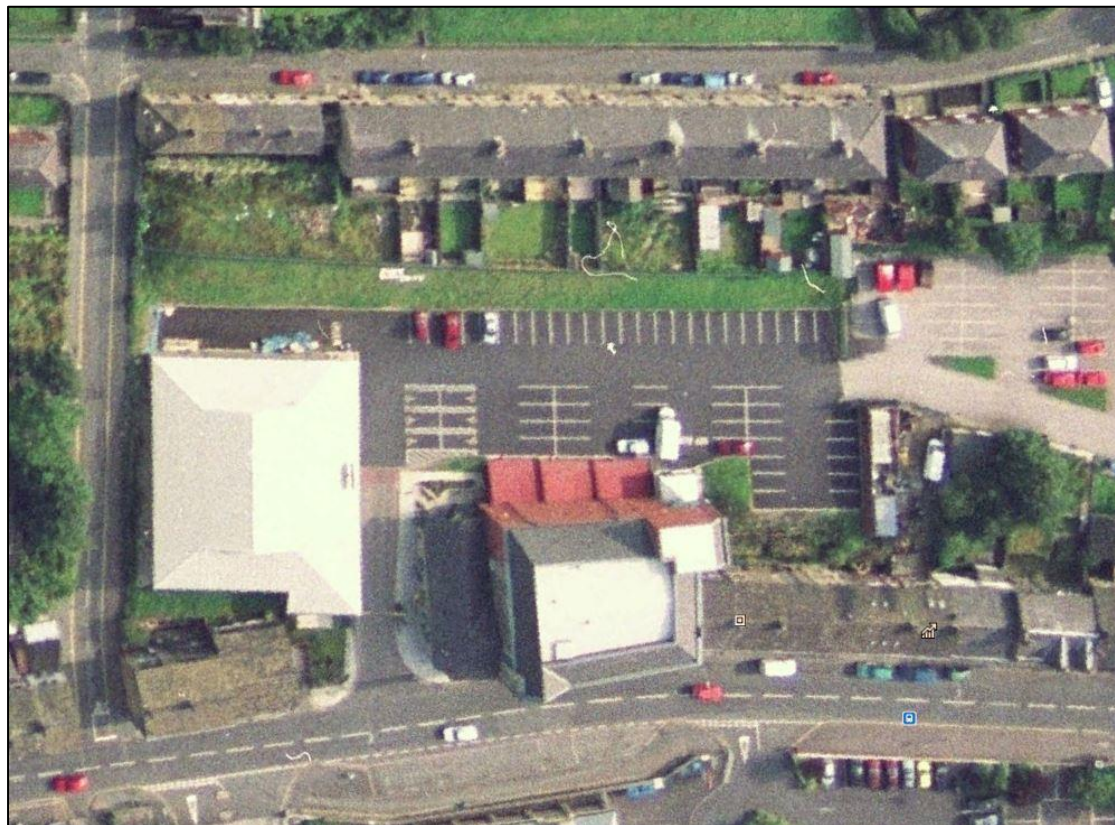
Figure 8: Aerial photograph of site from 2000 showing the modern construction to the left (Google earth)

lain vacant. Milnrow Spinning Mill was demolished and the land redeveloped for commercial uses in the later 20<sup>th</sup> century. By 2000 there was a large unit located to the west side of the site, directly behind 47 – 52 Dale Street. This newer development was also demolished by 2012 and the site now lies cleared as brownfield land (O'Flaherty 2016).

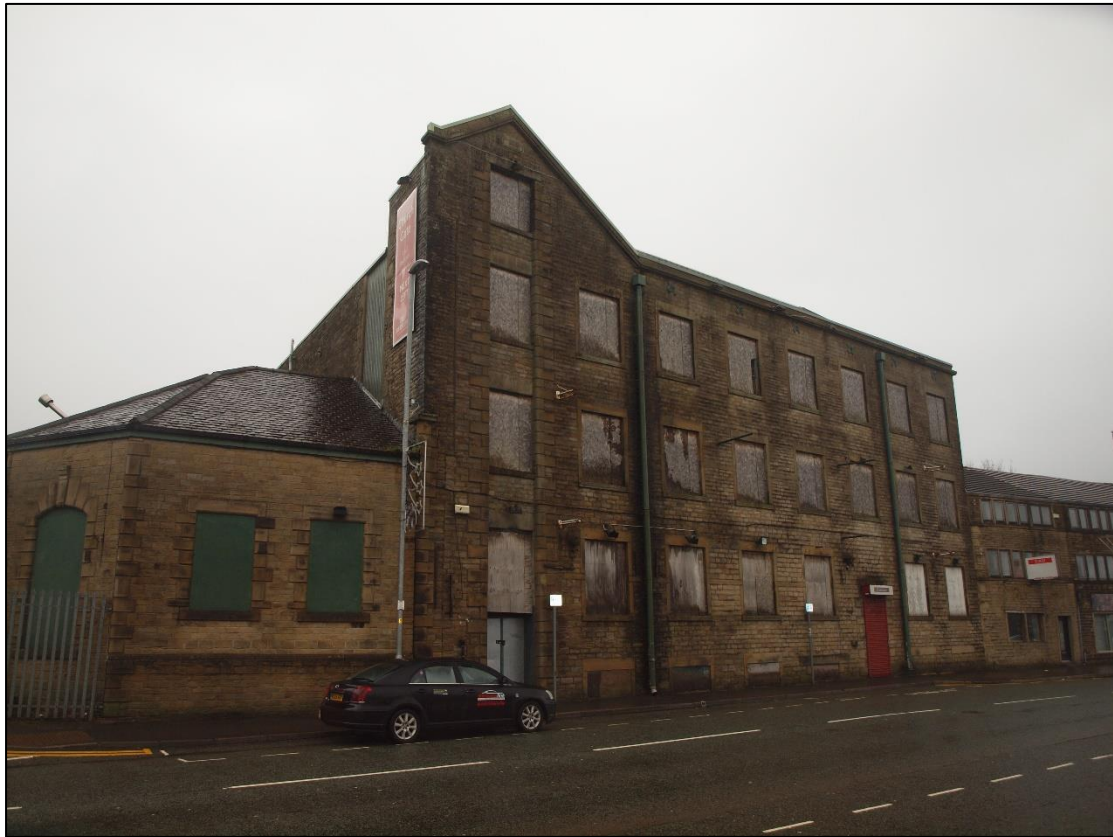
Plate 1: Dale Mill forming south end of site

- 3.5 The site was visited on the 28<sup>th</sup> January 2021 when a walk-over survey was performed and photographs taken. The site contains the remains of ‘Dale Mill’, at 53 Dale Street (the former warehouse), which was gutted by fire in 1992 and substantially rebuilt. The rest of the site contains a tarmac road running from the Dale Street onto the site, which turns to run east, behind the present building. The rest of the site is overgrown. The land is sloped down from north to south, and to the northern boundary the land slopes up steeply to meet the rear of the properties on Major Street.
