Hawthorn House, Edenfield
Historic Building Survey

November 2021

An archaeological building survey was required prior to the demolition of Hawthorn House, Edenfield. The work was carried out by Steven Price of The Archaeology Co.

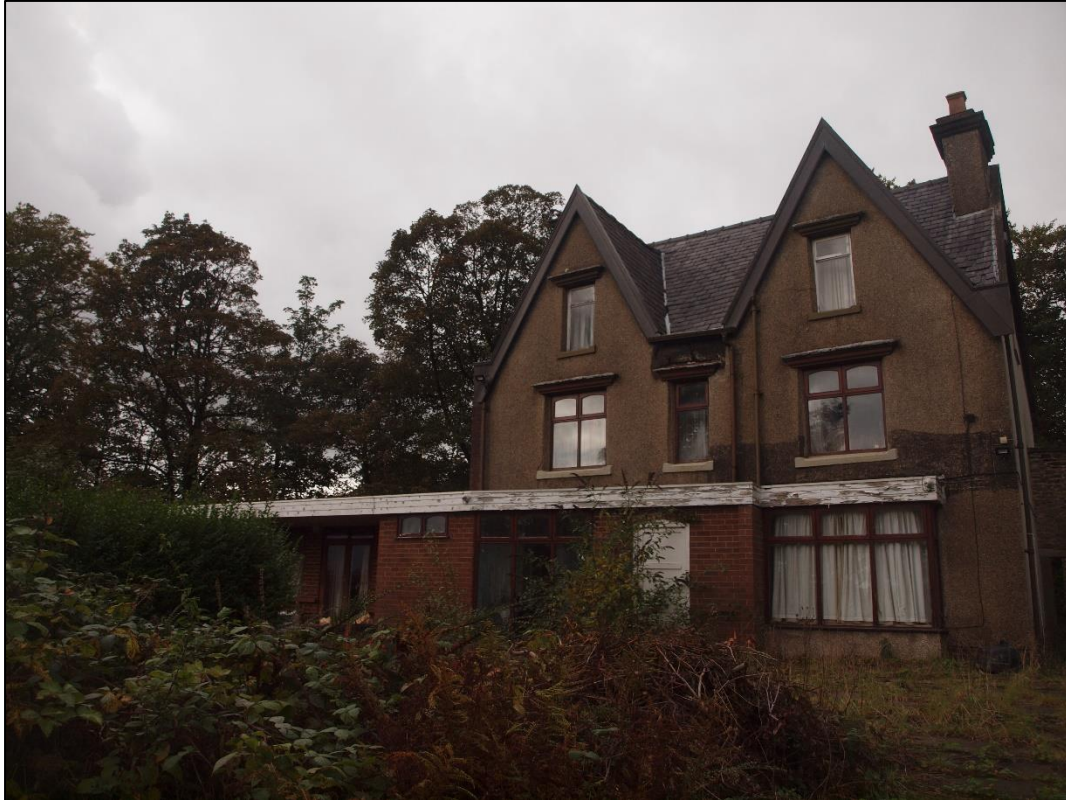
Plate 1: General shot of house from the south

- 6.1 (Plate 1) The building is a square three bay building with extensions to the west and south. It is three stories high plus basement and the whole is rendered externally. A pair of chimney stacks lie to the east and west gable ends and the slate covered roof is pitched to the north and south. The house has been modernised throughout.

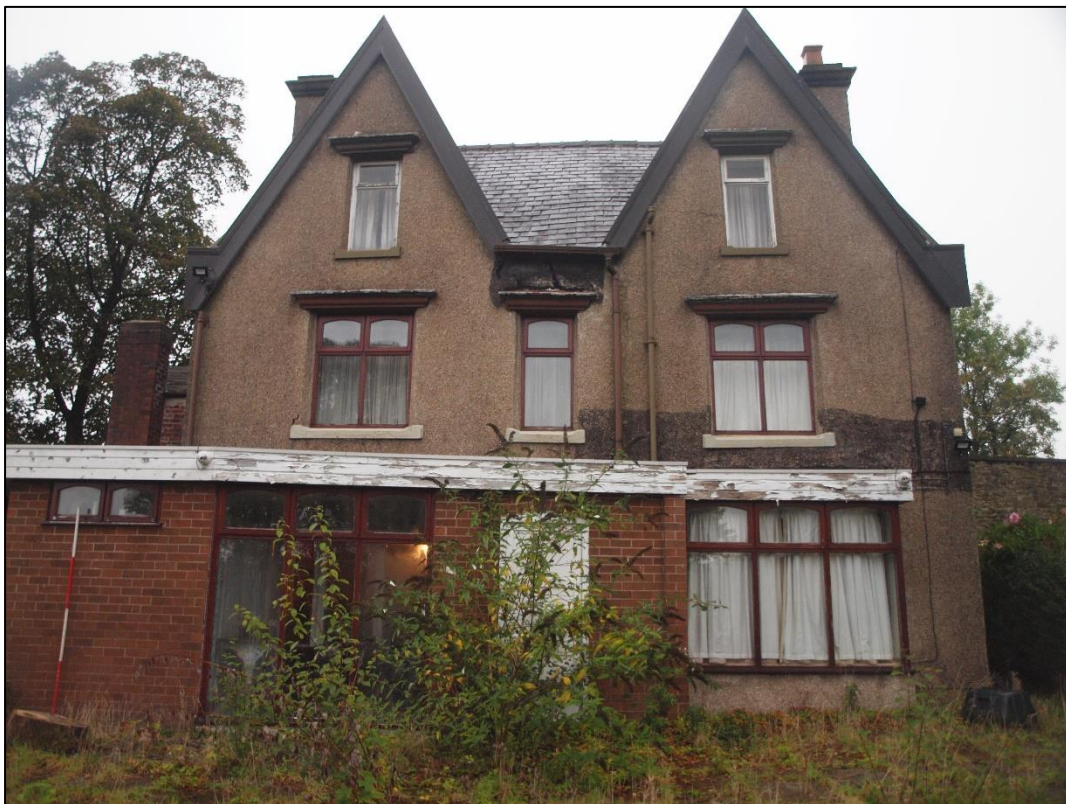
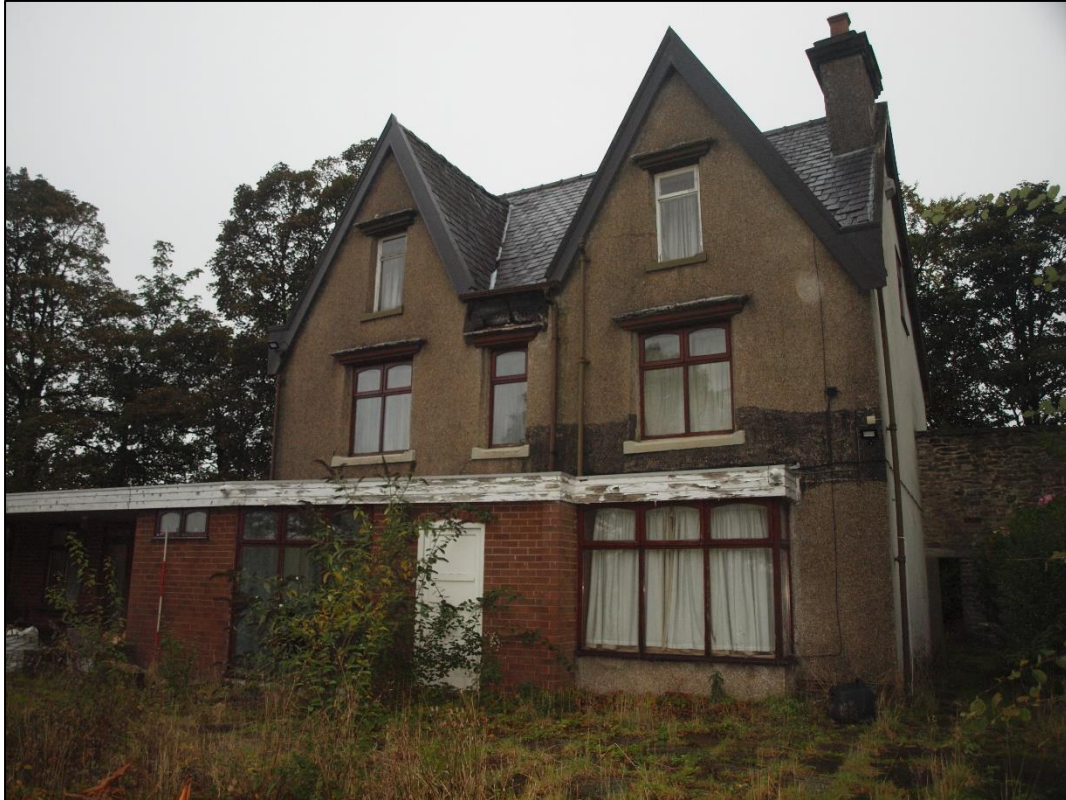
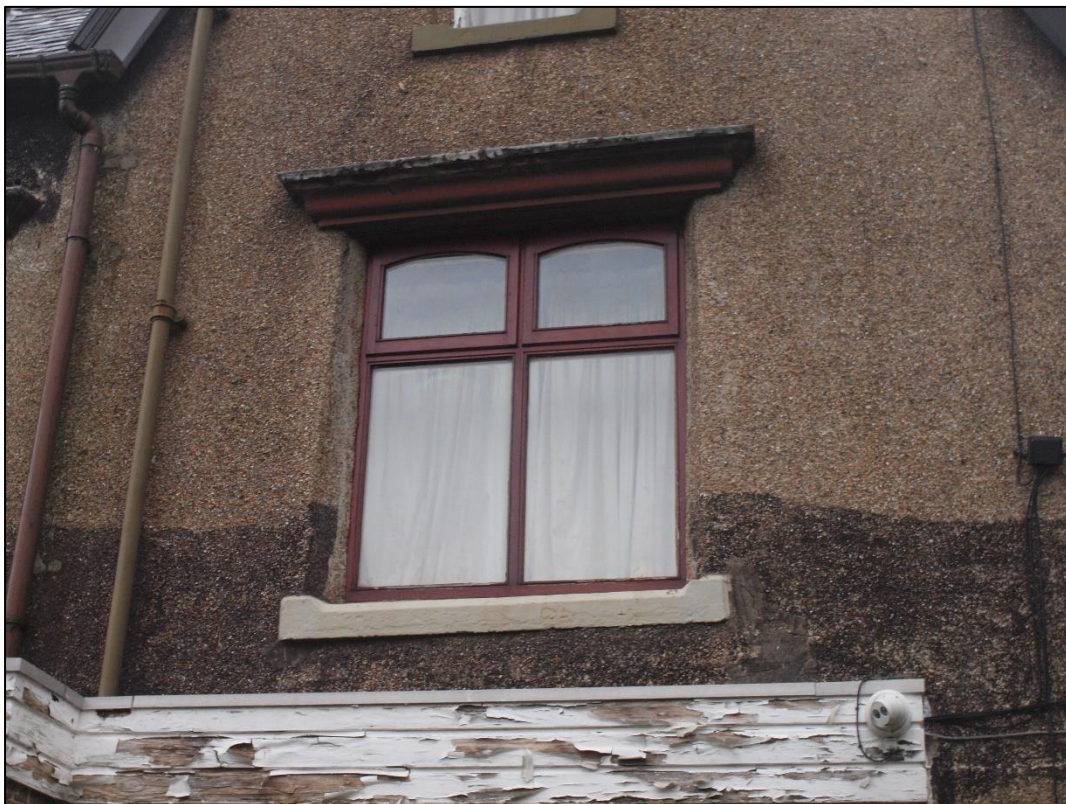
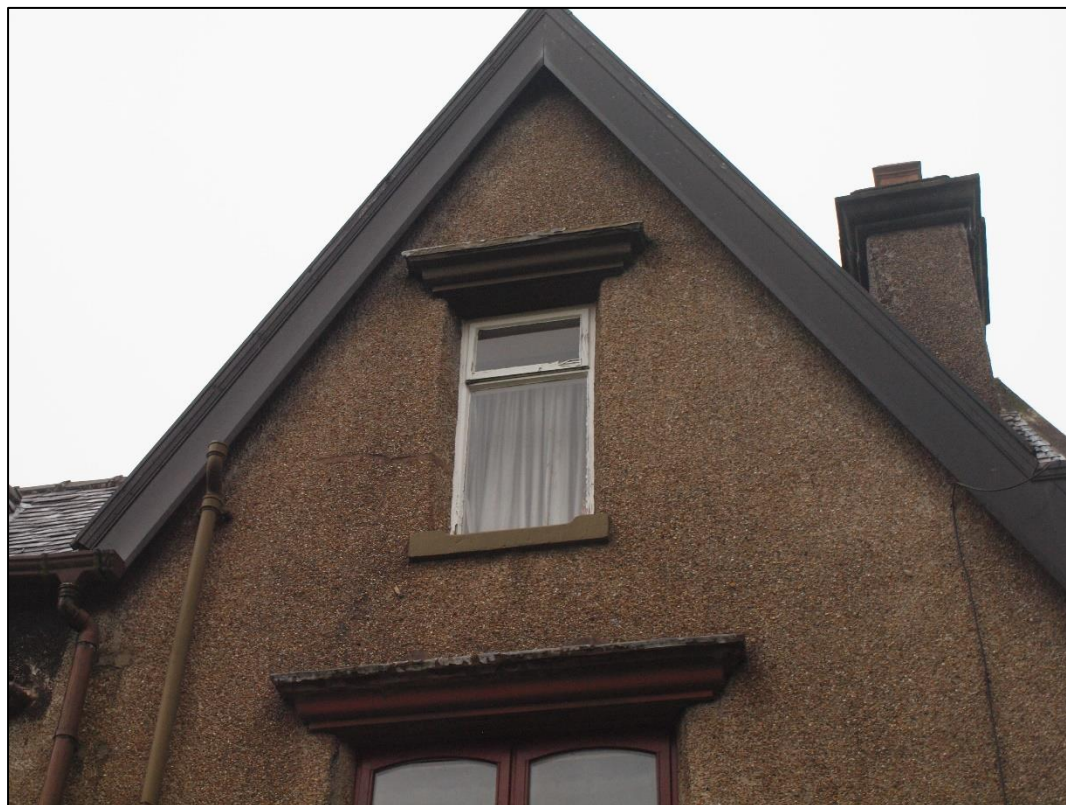
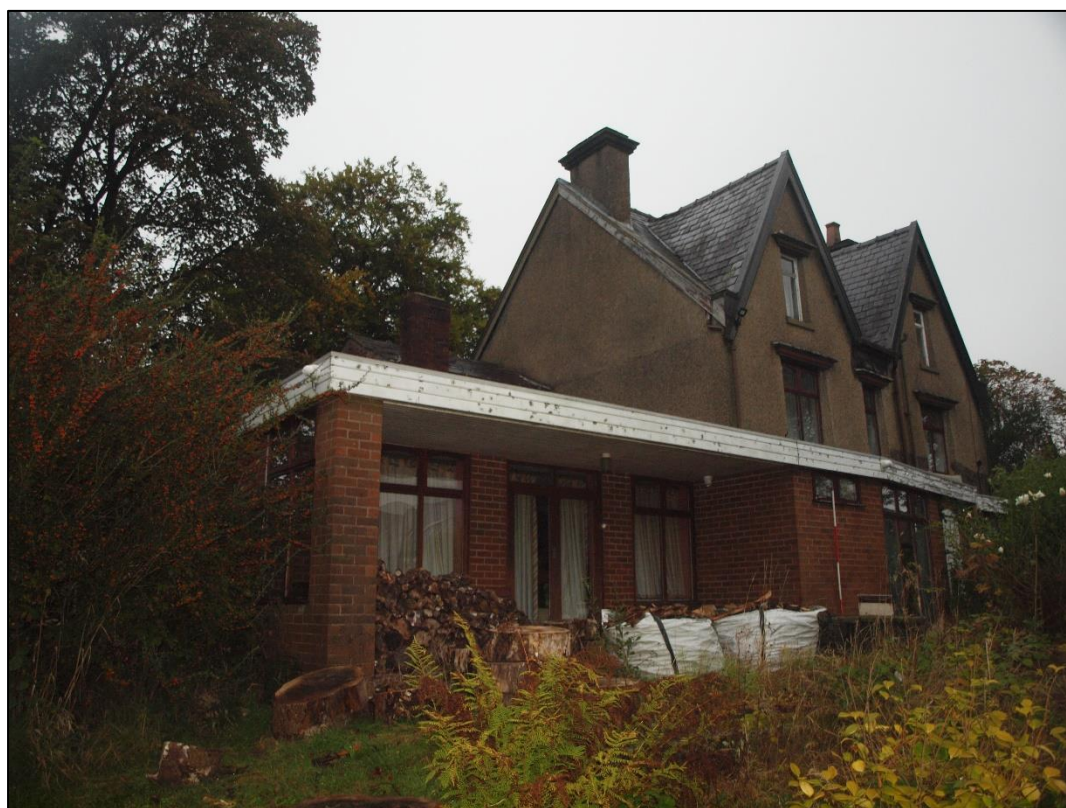
- 6.2 South elevation (Plates 2 - 6). This forms the former main frontage of the building. The ground floor is obscured by the later extension, which extends to the west. At the western end the extension appears as a bay window to the end bay of the house. This window is set forward from the main elevation slightly and contains a large three light window with a modern timber frame. To the east the extension protrudes again. This is brick built and contains a personnel doorway at the eastern end, with a large window to the west of this. West of this is a small portrait window high in the face. To the west the extension continues as a porch, with the elevation set back. This contains a pair of large portrait windows with large double doors between. At first floor level the face of the original house can be seen. As noted this is of three bays, with the east and west bays each containing a large portrait window with modern timber frame. A drip mould lies over and the chamfered cill is of sandstone. Between them, in the central bay is a smaller portrait window, with matching drip mould and cill. To the west the face of the earlier extension is visible. This is brick built and contains a landscape window in the centre. At attic level of the main house are a pair of gables to the east and west bays, each containing a portrait window with a modern timber frame. They each have a drip mould and chamfered sandstone cill.

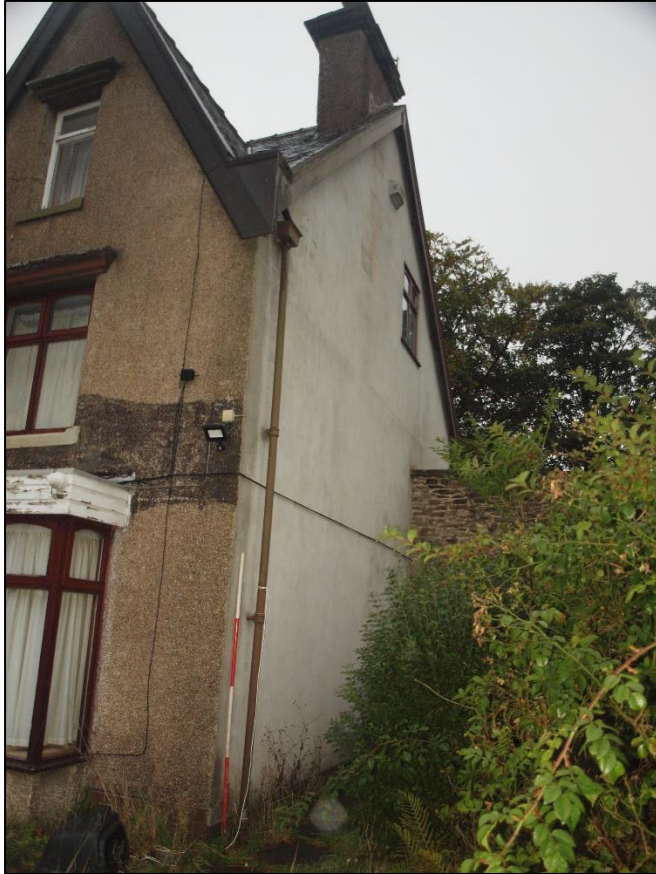
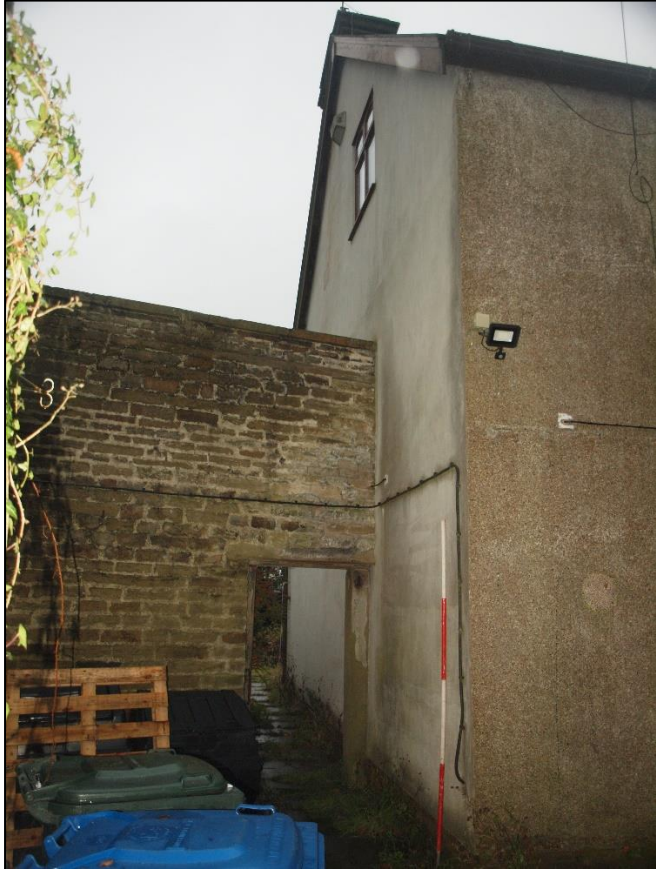
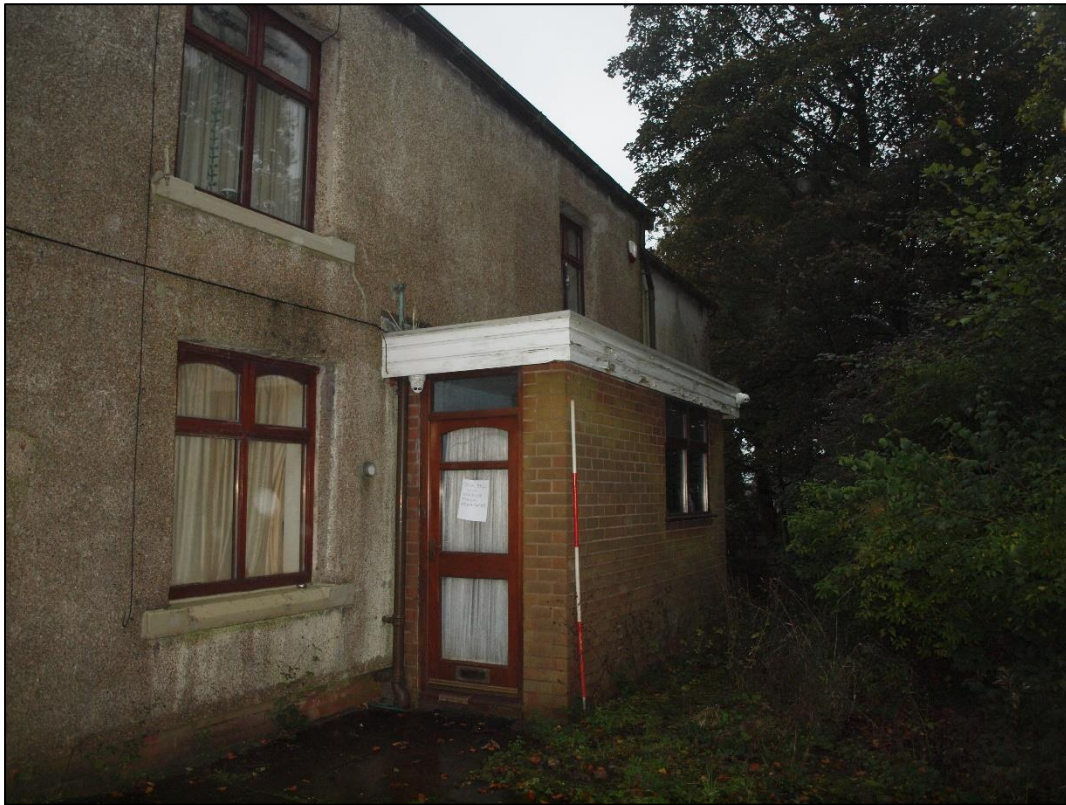
- 6.3 East elevation (Plates 7 - 9). This forms the gable end of the building. The face is rendered and featureless with the exception of a window at attic level, north of

centre. This has a modern timber frame and cill. To the north is the face of the single story porch extension, with a modern timber personnel door.

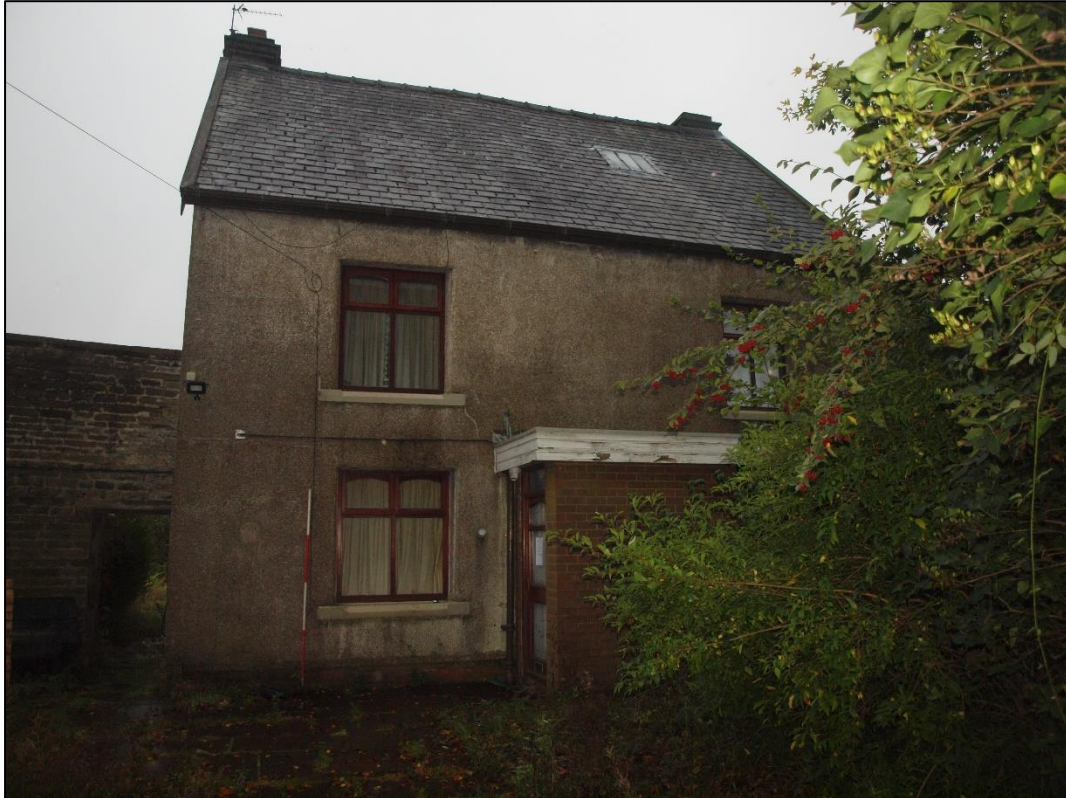
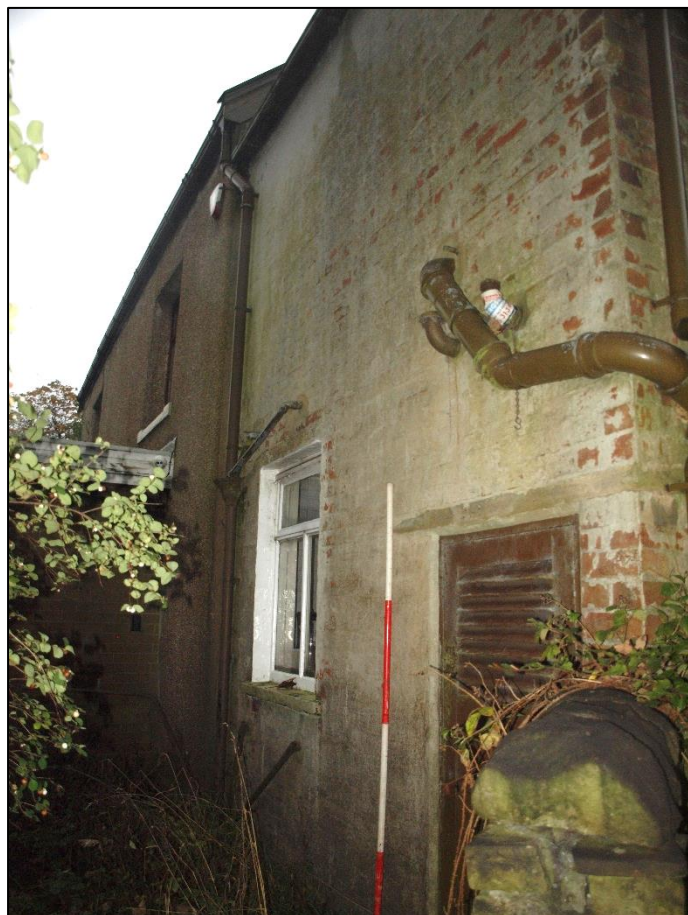
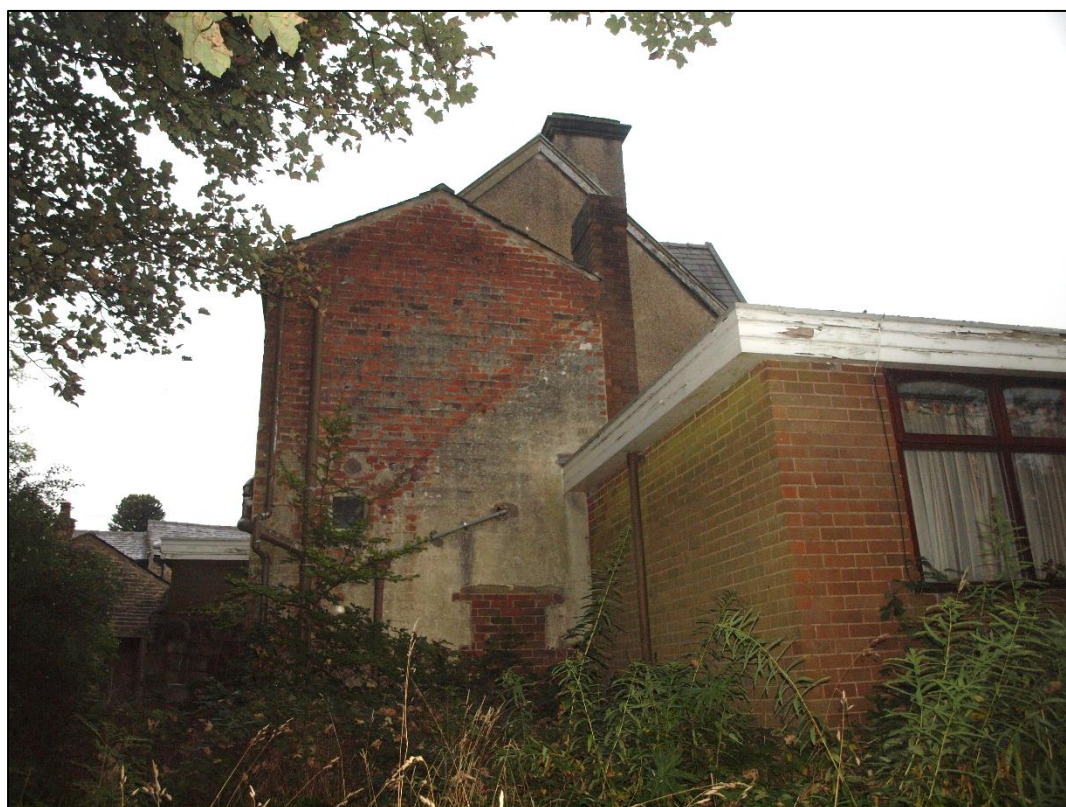
- 6.4 North elevation (Plates 10 - 12). This is the rear elevation of the main building. The bay to the east contains a large portrait window with modern timber frame to both ground and first floors. The rest of the ground floor is obscured by a later extension. The first floor contains a matching window to the west bay. The central bay is featureless. Unlike the south elevation, there are no attic windows, although a skylight lies to the west side in the pitched roof. The porch extension is brick built and contains a landscape window to the west side. Beyond this is the face of an earlier two story extension. This is brick built, although whitewashed, and contains a square window to the east with modern timber frame and louvered timber doorway to the west. To the west is the face of a single story later extension, which is featureless.

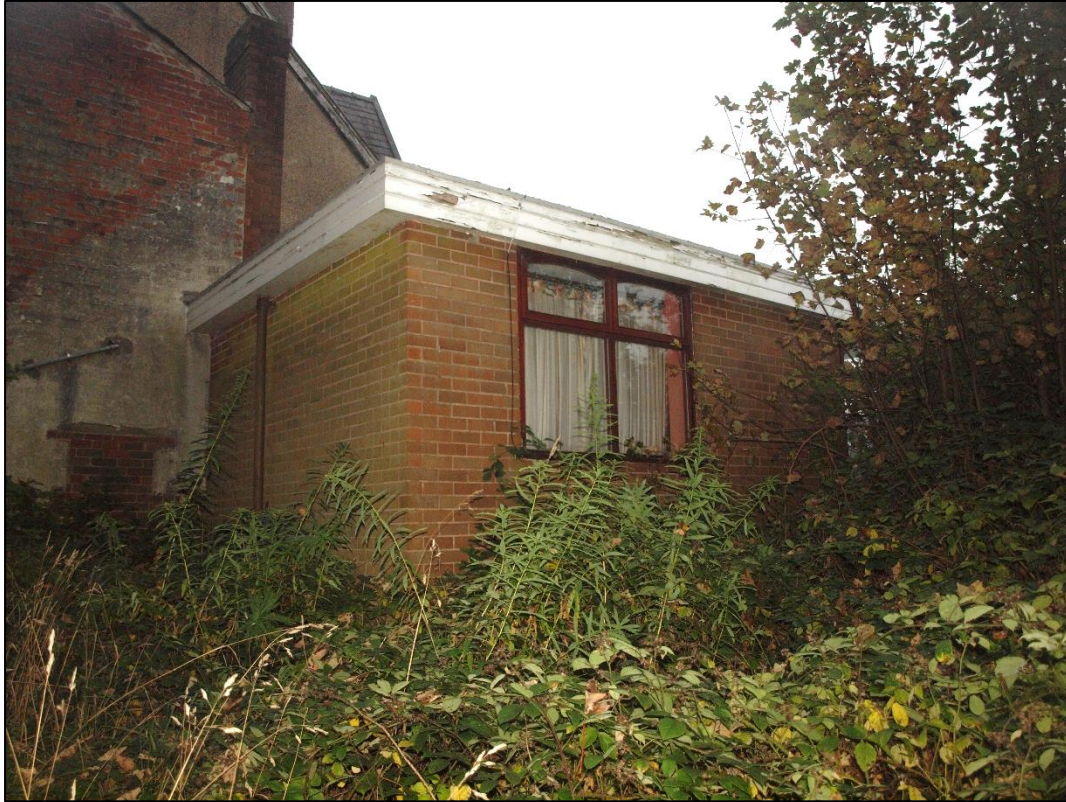
Plate 13: West elevation of western extension

- 6.5 West elevation (Plates 6 & 13). This forms the other gable end of the main building. This is once again rendered and is featureless. To the north side is the lower two-story brick extension. This contains a blocked square window to the southern side at ground floor level and a small square window to the north side. The whitewash has decayed here showing the English bond brickwork. To the south is the face of the single story later extension. This contains a modern landscape window to the northern end.

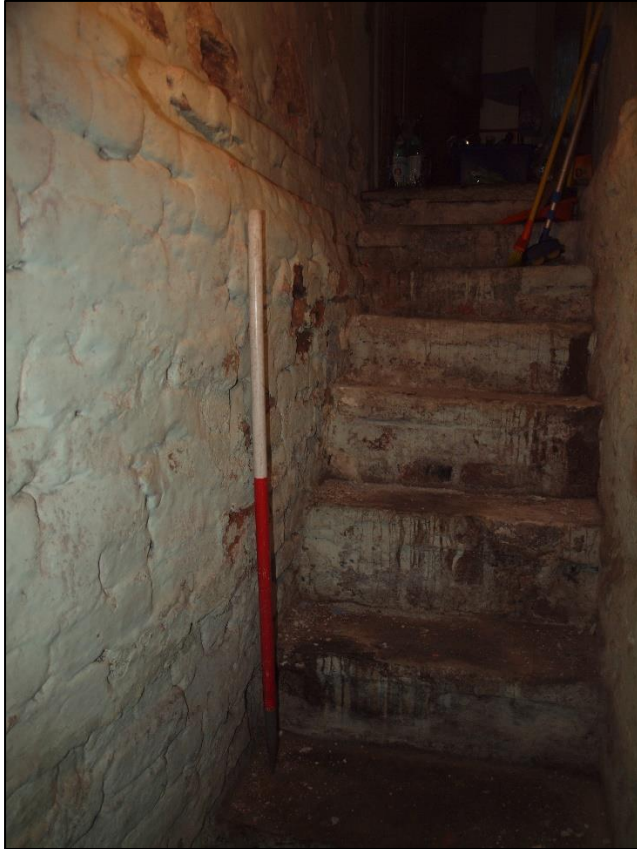
Plate 39: Stone and brick steps to basement

6.9 (Plates 39 – 44) The basement is accessed via a set of stone steps leading down to the east, directly below the staircase to the first floor. This leads down to a
