THE ARCHAEOLOGY CO.

Dock Road, Lytham St. Annes

Archaeological Strip and Record Report

September 2022

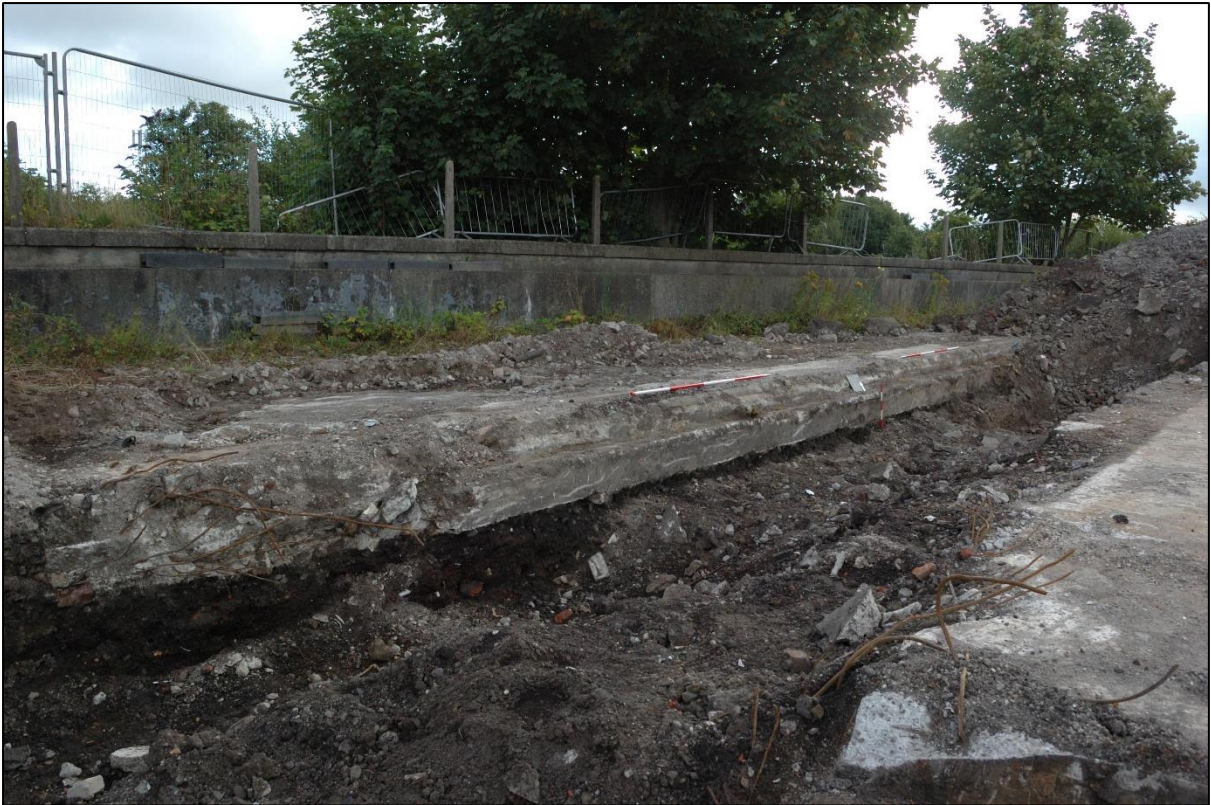
Plate 1: Stepped concrete sill [05]

- 6.2 The northern edge of the site contained a stepped concrete sill numbered context [05], this was 15.2m long by 0.85m wide and 0.6m thick and orientated east west (Plates 1 & 2). The concrete appeared relatively modern as it was reinforced with rebar. A small space separated this structure from a concrete rectangle context [06] made of the same material (Plates 3 & 4). This was also orientated east west and was interpreted as contemporary with structure [05]. Both structures were seen as components of a warehouse.

[05] A concrete elongated rectangle with a step on its southern side, 15.2m long by 0.85m wide and 0.6m thick. Located along the northern edge of the site. The concrete contained rebar demonstrating it was relatively modern.

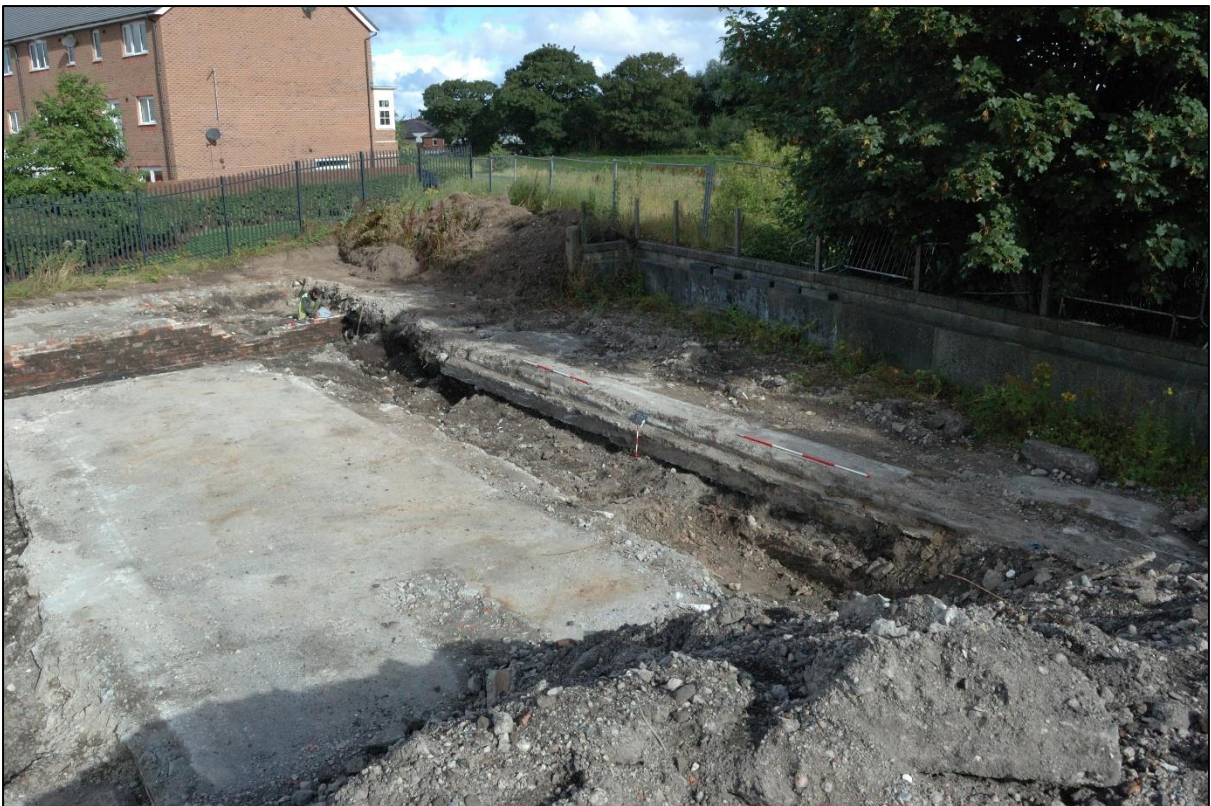
Plate 2: Contexts [05] and [06]

[06] A concrete rectangle 15.2m long by 3.7m wide and 0.3m thick. Located at the northern end of site and parallel to concrete [05]. This structure was contemporary with context [05].

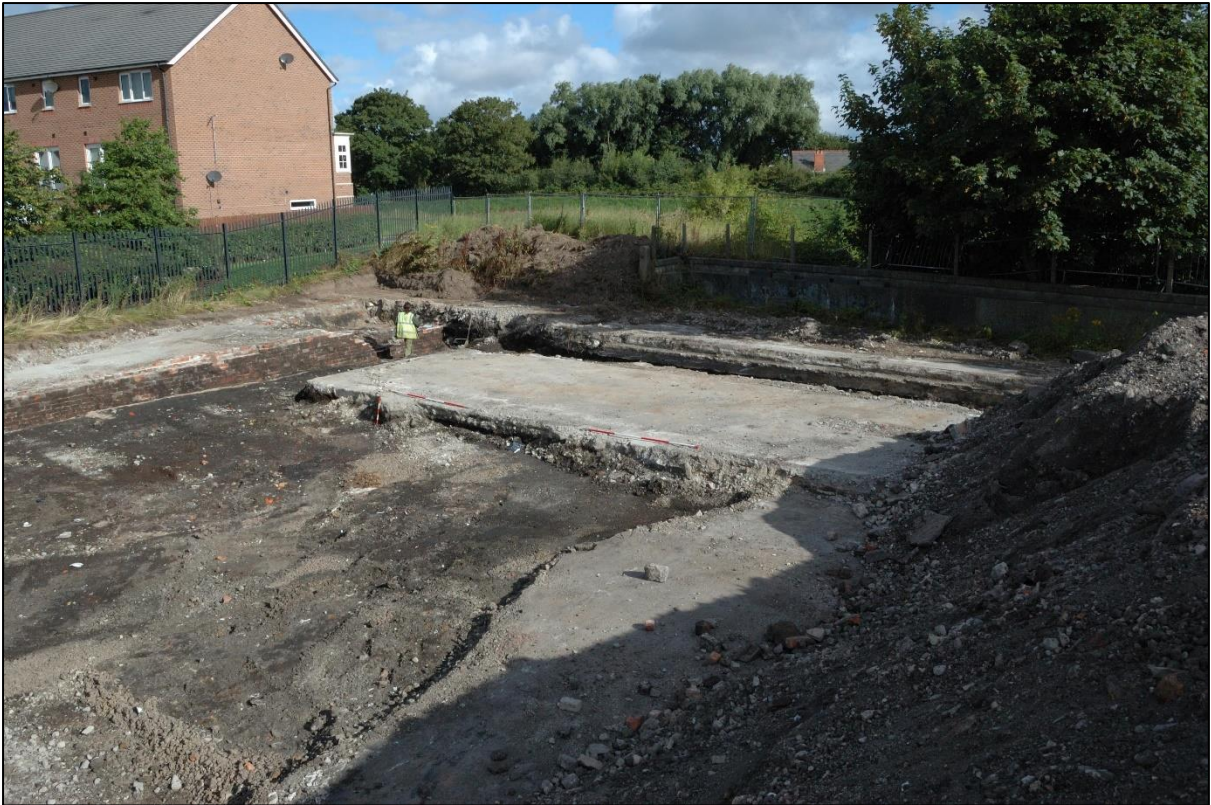
Plate 3: Contexts [05] and [06]

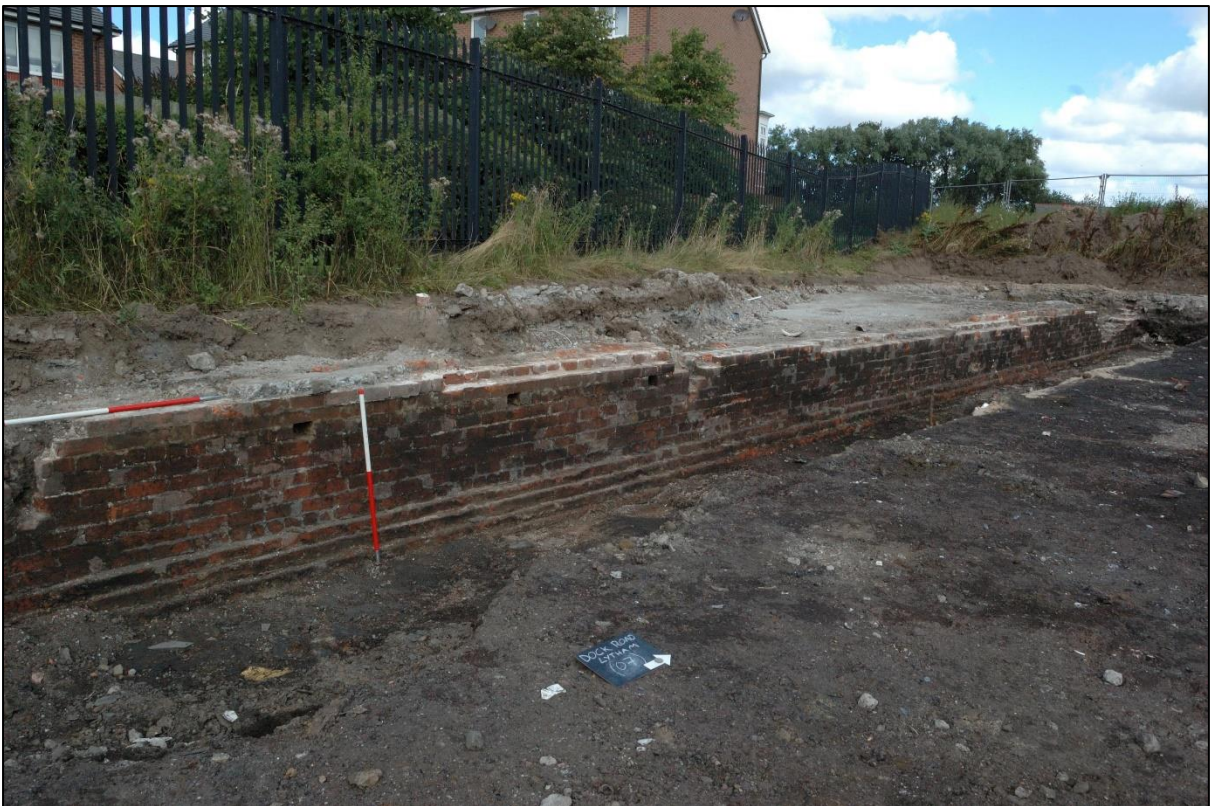
Plate 4: Wall [07] looking north

- 6.3 The western edge of site contained a brick wall [07] 23.4m long by 0.35m wide and 1.2m high, orientated north south and going under the baulk on the western extremity of the area of excavation (Plate 5). A slot was excavated along the wall's east facing elevation. The wall had a stepped foundation indicating it was designed for load bearing (Plate 6). Remnants of a concrete floor numbered context [08] were seen on the wall's western side

[07] A brick wall 23.4m long by 0.35m wide and 1.2m high. Constructed of bricks measuring 0.23m long by 0.11m wide and 0.7m thick. The wall was constructed of headers and stretchers bonded with a white gritty lime mortar, and was stepped at its base. The wall enclosed a concrete floor on its western side numbered context [08].

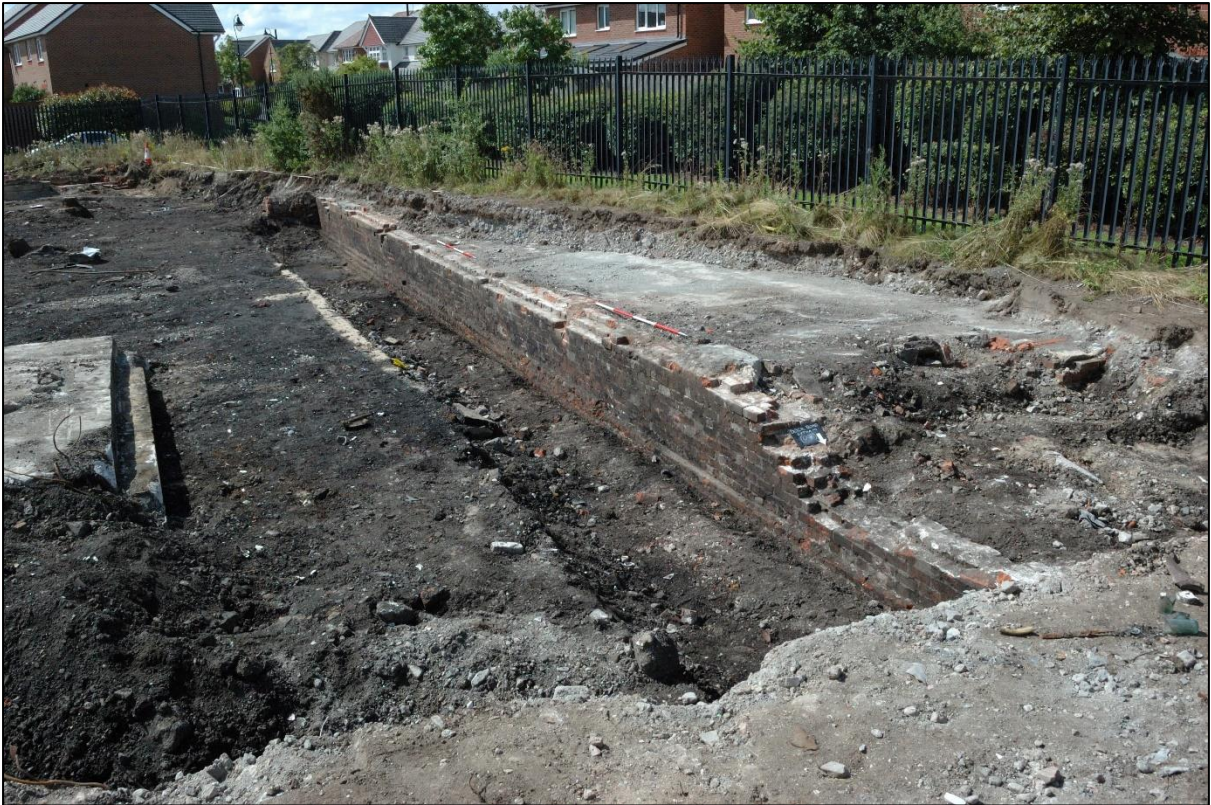
Plate 5: Wall [07] looking south

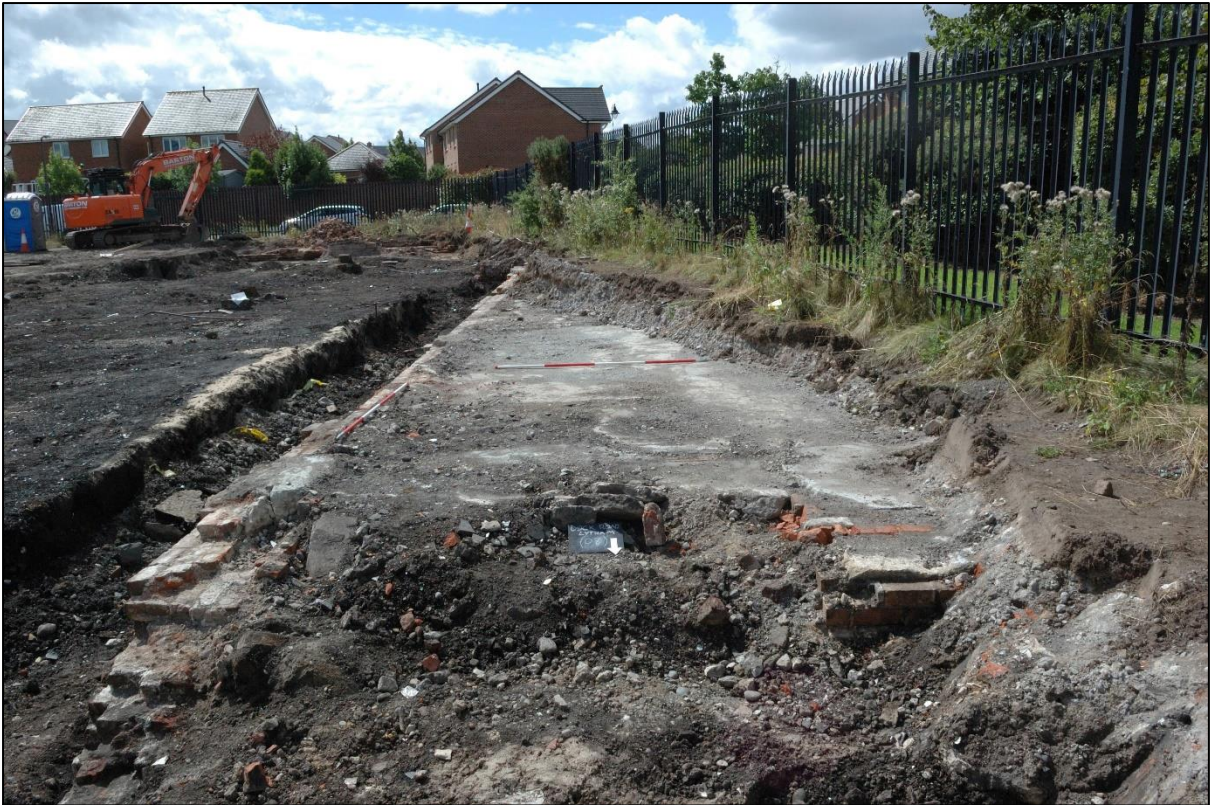
Plate 7: Concrete floor [08]

(Plate 7). The building was interpreted as a large warehouse. A layer of single blue slates numbered context (23) were seen at the wall's southern end, at the base of the foundation (Plate 8). The slates were located over a thin layer of beige mortar numbered context (24). These two deposits were both below the made ground composed of deposit (03) and it was unclear if they were associated with the construct of wall [07] or were an original bedding layer for deposit (03).

[08] A concrete floor 11.2m long by 4m wide and 0.1m thick located on the western side of the site. The floor was made of a grey concrete, and was only partially exposed. The floor was interpreted as the interior of a warehouse, with wall [07] as its eastern elevation.

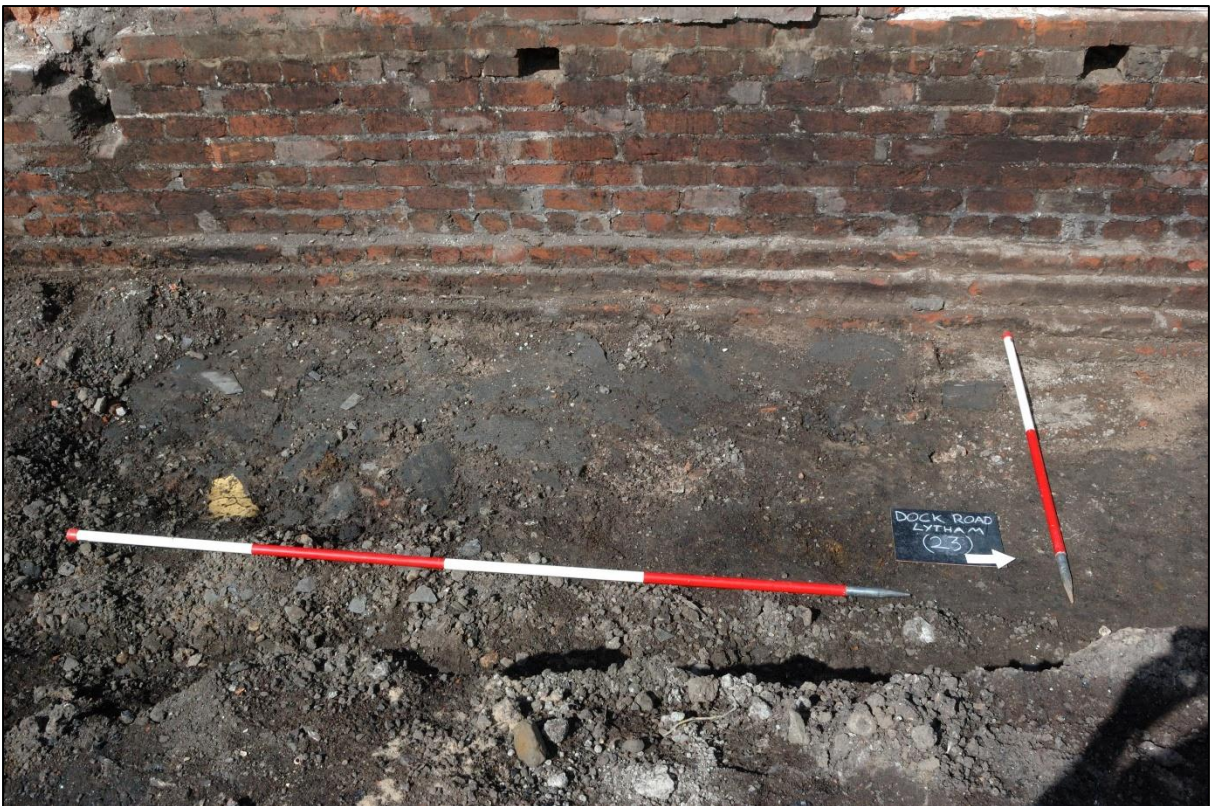
Plate 8: Layer of single blue slates (23)

(23) A single layer of blue grey slates 1.9m long by 0.9m wide located at the base of wall [07] at its southern end.

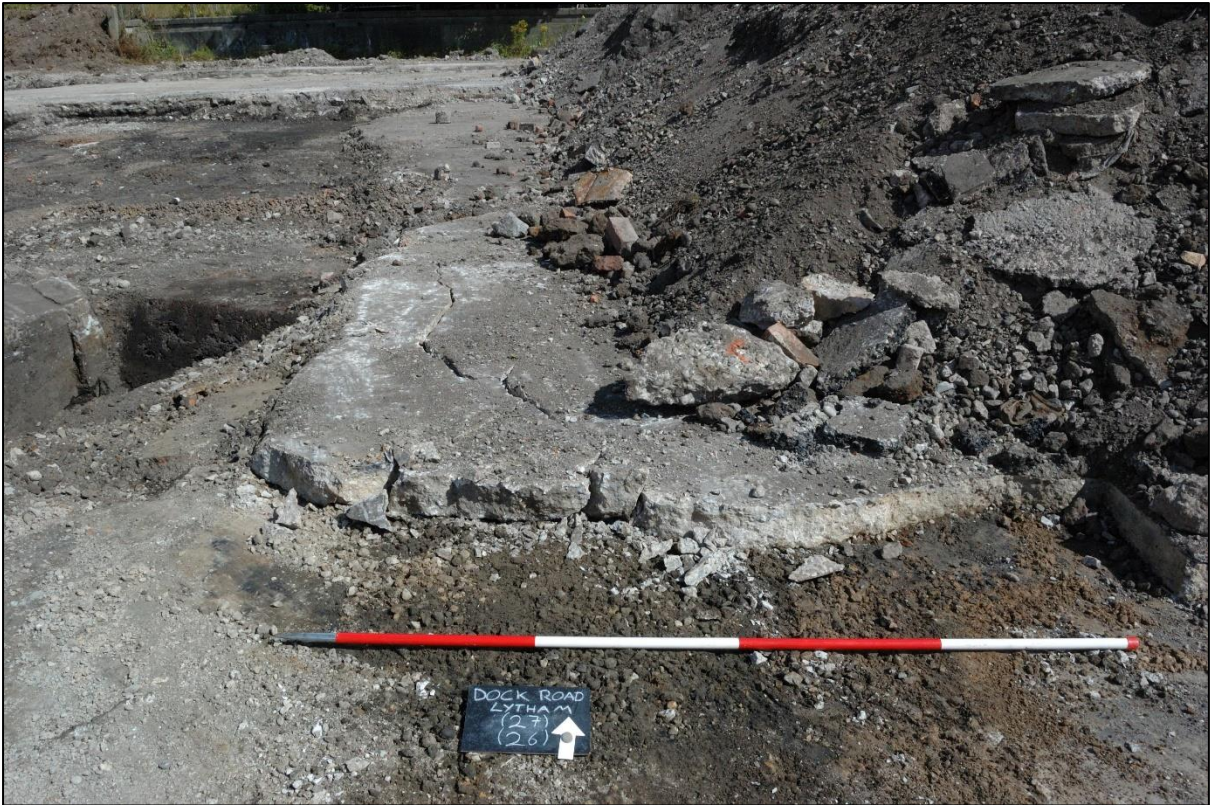
Plate 9: Concrete layers [26] & [27]

6.4 On the eastern edge of site and just south of concrete surface [06] was a truncated concrete floor context [27]. This was made of a light grey brown concrete 0.07m thick. The same concrete layer was also observed at the southeastern corner of site and was numbered context [31]. Obscuring the area between concrete [27] and [31] was a thicker concrete layer context [26]. This was a solid almost white concrete 0.19m thick and appeared to have been poured over the earlier lower quality concrete [27] and [31] indicating an upgrade (Plate 9). Within the area containing concrete [31] the concrete had enveloped a series of rails and associated fittings. Context [29] described a dislodged rail 3.78m long by 0.1m wide and 0.06m thick lying upside down next to a concrete beam slot context [34]. Parallel to this beam slot was a second rail context [30], which was still pinned to a sleeper (Plate 10). The rails had been orientated east west and were likely to have been used to transport materials in or out of a warehouse. A cast iron grooved door rail (Plate 11) orientated north south was identified at the rails eastern end, context [21] supporting this concept. A second door rail (Plate 12) context [10] was observed parallel and to the west of door rail [21]. Located at the northern end of this door rail was a large concrete pillar (Plate 13) numbered context [11]. The pillar was wider at its base measuring 1.2m in width and the top of the pillar measured 1m in width. The pillar was 1.27m high and had remnants of an upright iron girder on its upper surface. The concrete appeared relatively modern and the size and shape of the pillar indicated it was used for load bearing; this may have been for machinery or to support the ceiling. An identical pillar (Plate 14) numbered context [12] was observed a few metres to the north of pillar [11]. This construct was tilted on its side in deposit (03) suggesting an attempt to remove it had failed. A large grooved cast iron rail (Plate 15) numbered context [09] was exposed parallel and to the south east of door rail [10]. The rail measured 5.4m in length and 0.2m in width and was 0.09m thick. The rail was a larger gauge than the other rails seen in this area and it may have been used for a rolling crane. The rail appeared dislodged but was still partially

[26] A light grey irregularly shaped white concrete layer 0.19m thick located at the southeastern end of site. Overlies concrete layer [27].

[27] A thin mid grey concrete layer 0.07m thick exposed in patches and located on the eastern side of site below concrete layer [26].

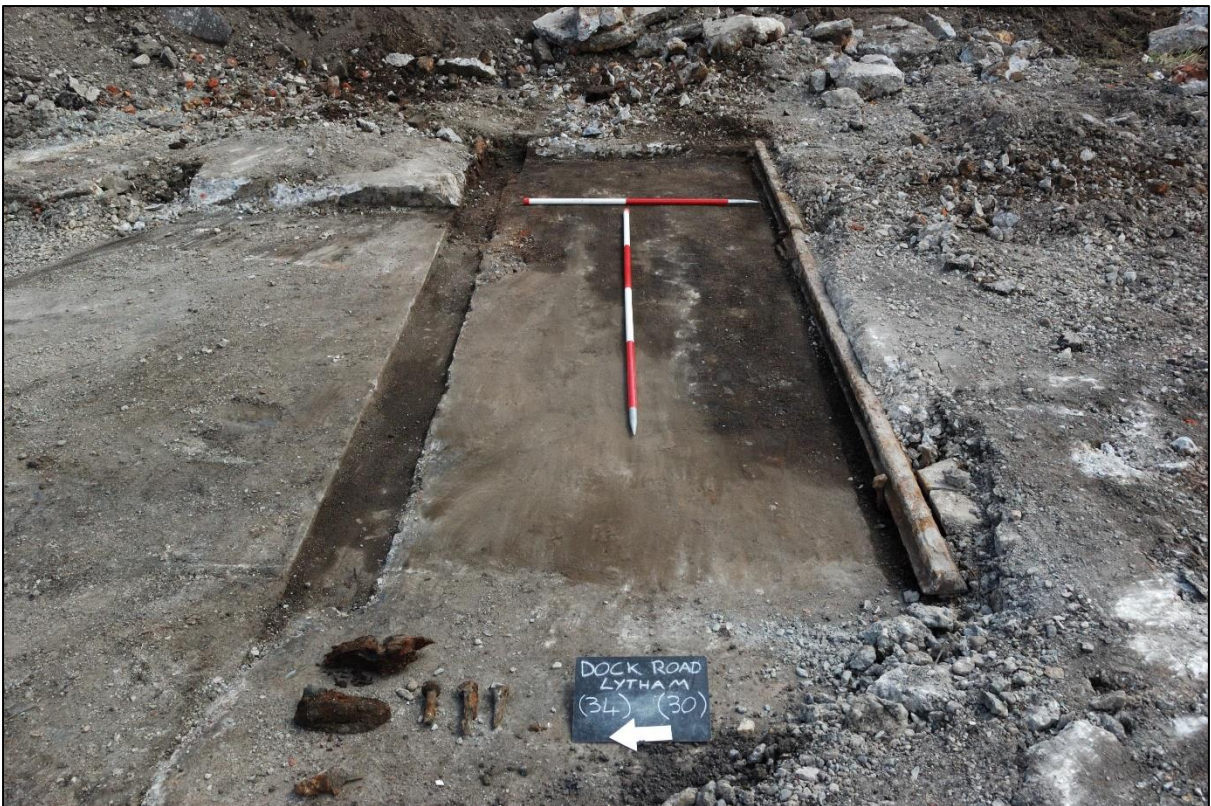
Plate 10: Beam slot [34] and rail [30]

[30] An iron rail 4.26m long by 0.1m wide and 0.06m thick, was still fixed to a wooden sleeper with iron pins. Orientated east west and located in the southeastern corner of site. Associated with rail [29].

[34] A rectangular slot in concrete slag [31] designed to house a sleeper for a rail, 4.26m long by 0.23m wide and 0.4m deep was orientated east west, and located next to rail [30].

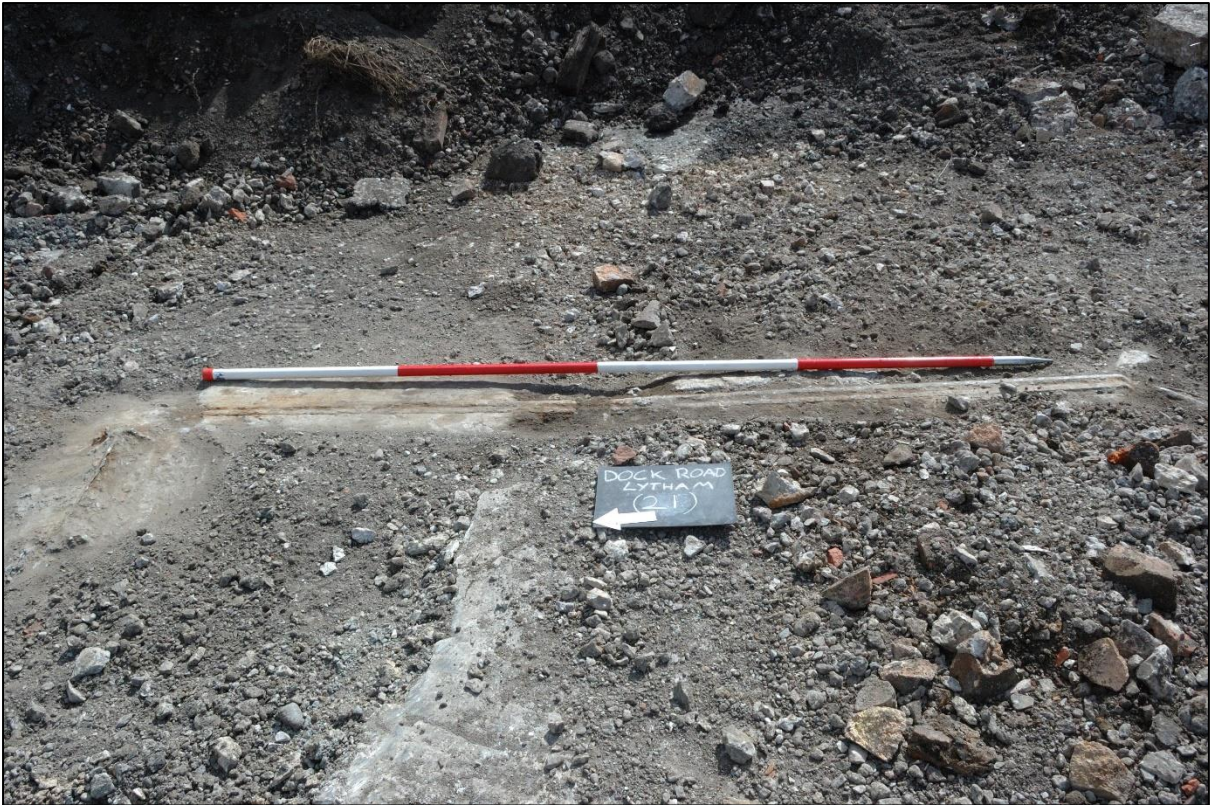
Plate 11: Cast iron door rail [21]

[21] An iron rail 3.7m long by 0.13m wide and 0.06m thick. Located to the east of and parallel to rails [09] and [10]. The gauge of the rail indicated it was a door rail.

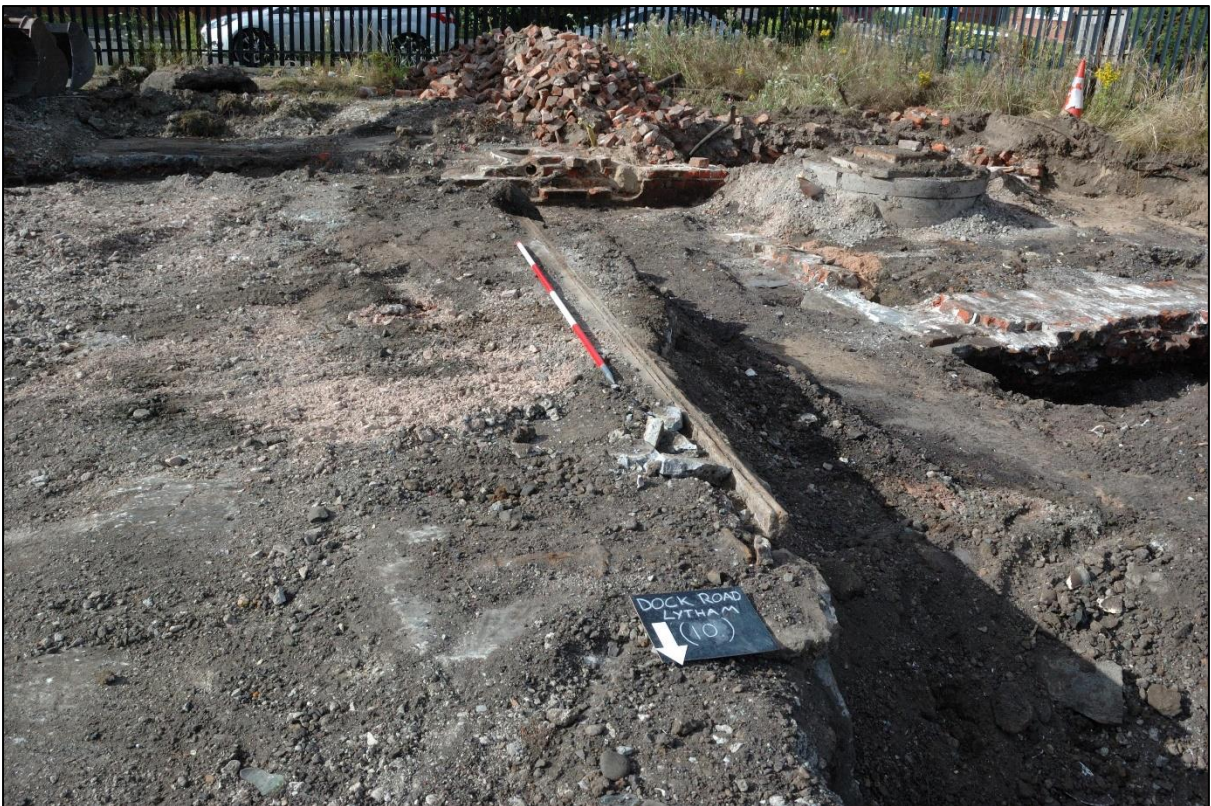
Plate 12: Rail [10]

[10] A grooved cast iron rail 4.6m long by 0.09m wide and 0.12m thick located to the west of rail [09] and encased in concrete layer [26]. The scale of the rail demonstrated this was a door rail.

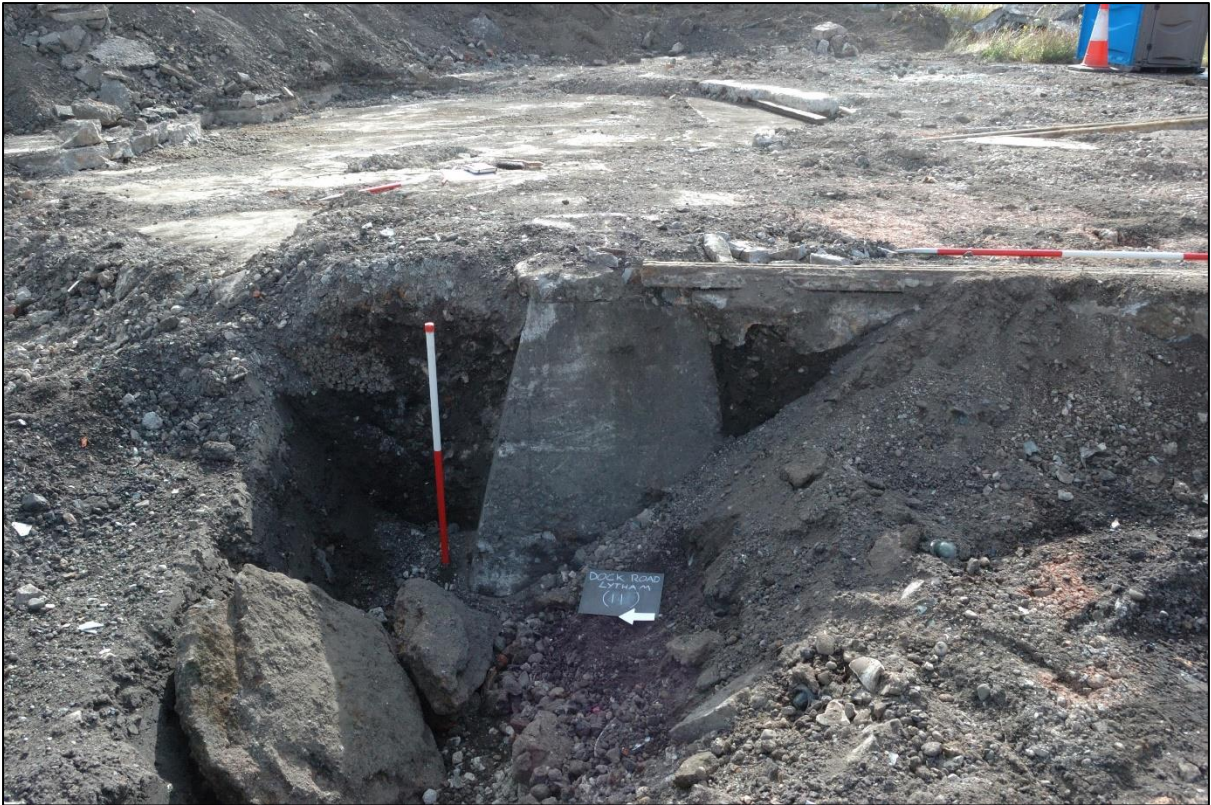
Plate 13: Concrete pillar [11] north of rail [10] above

[11] A triangular concrete pillar 1.27m high was 1m wide at its top and 1.2m wide at its base. Located at the northern end of rail [10]. The pillar contained remnants of a cast iron upright girder on its upper surface. The construct was interpreted as a load-bearing platform.

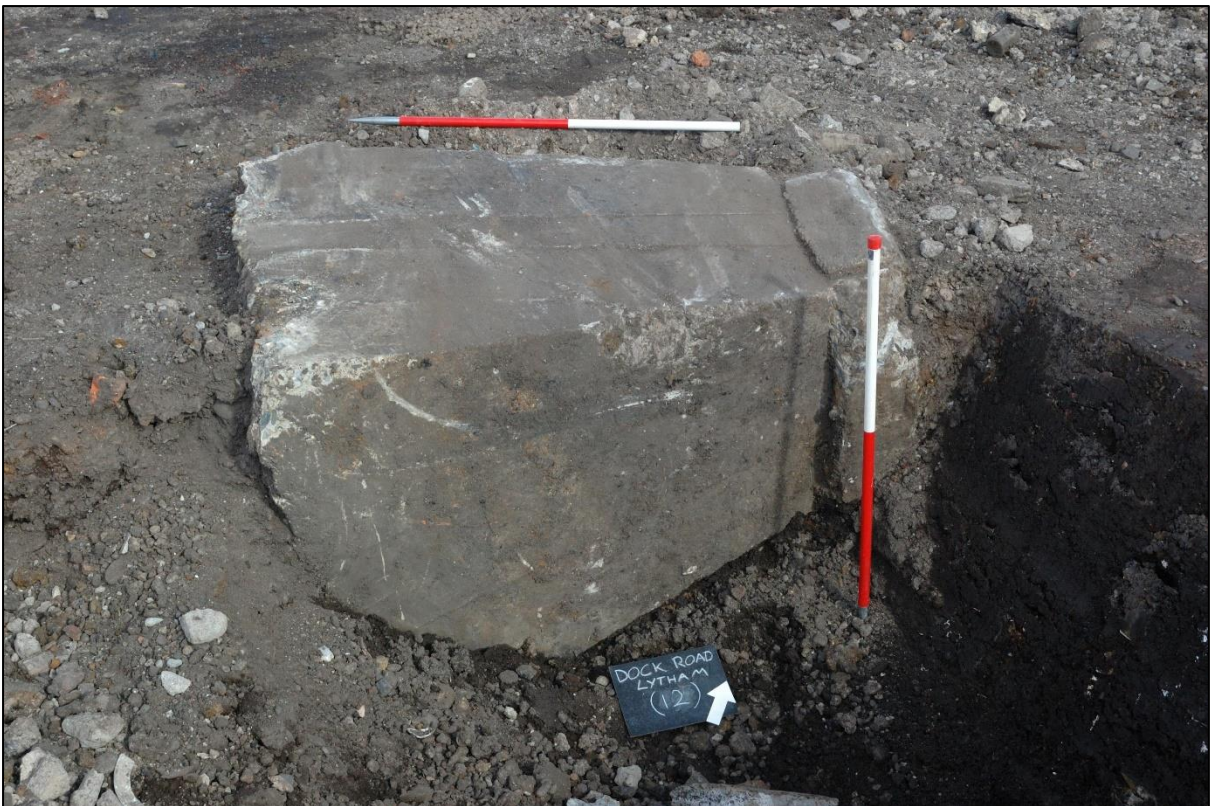
Plate 14: Matching concrete pillar [12], north of [11]

[12] A second concrete rectangular concrete pillar identical to pillar [11] and located to its north. This construct was on its side and partially buried in deposit (03).

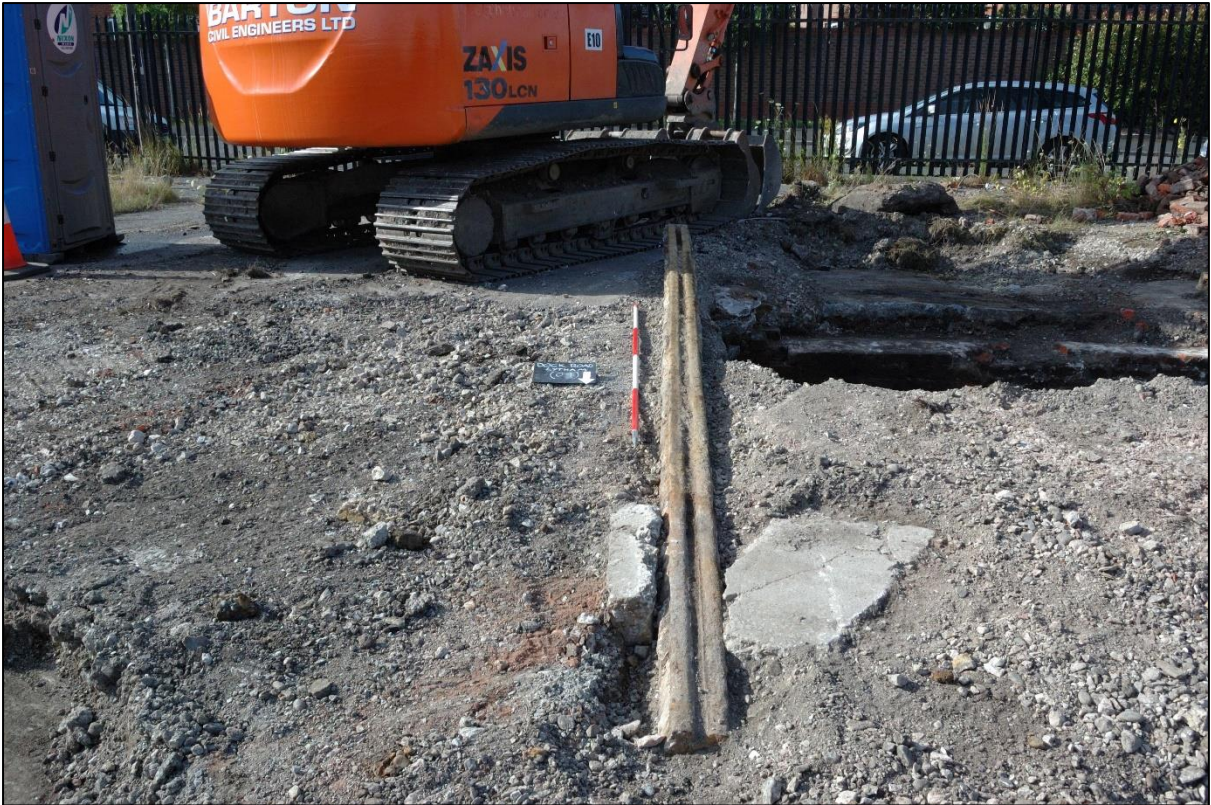
Plate 15: Grooved cast iron rail [09]

[09] A cast iron rail with a grooved centre 5.5m long by 0.2m wide and 0.09m thick located at the southern end of site and orientated north south. The iron rail appeared dislodged at its southern end but was still encased in concrete at its northern end. The rail may have been associated with a crane known to have crossed the site in a north south orientation.

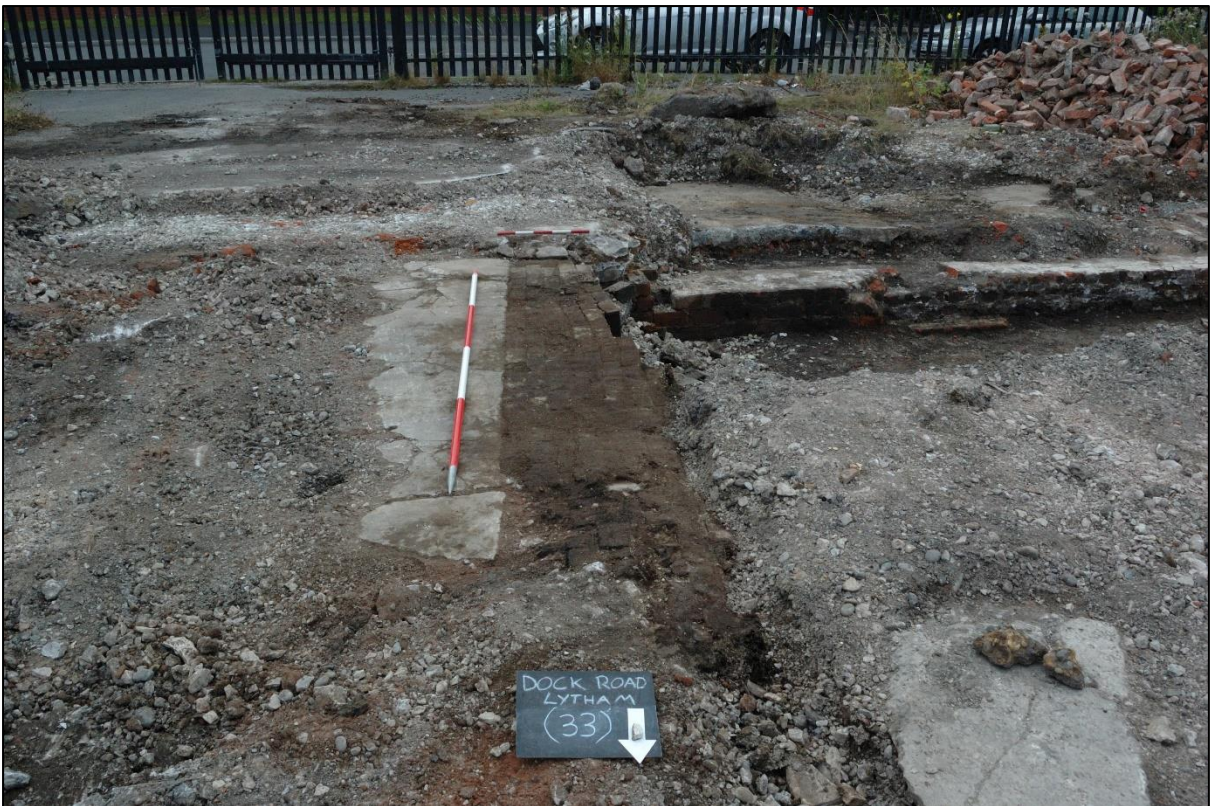
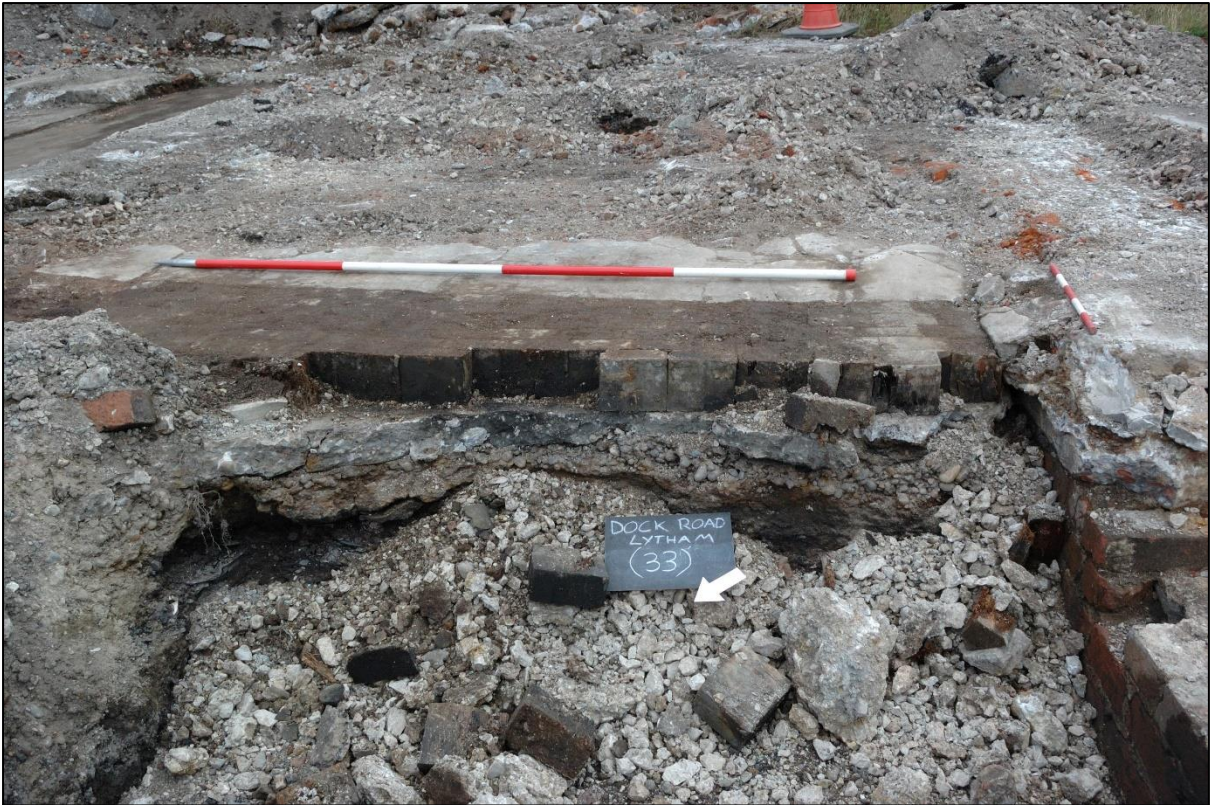
Plate 16: Wooden block surface [33]

Plate 17: Wooden block surface [33]

- 6.5 Below and parallel to the rail was a rectangular surface 3.3m long by 0.6m wide and 0.12m high made of upright wooden blocks (Plates 16 & 17). These were numbered context [33] and were thought to have been used as a semi flexible load-bearing surface. The blocks were located in concrete [27] a surface, which would have fared badly under any load owing to its lack of thickness.

[33] A small rectangle of wooden blocks set upright, 3.3m long 0.6m by wide and 0.12m high. Located under and in the same orientation as rail [09]. Appears to be associated with concrete surface [31] and [27]. Designed as a flexible load-bearing surface.

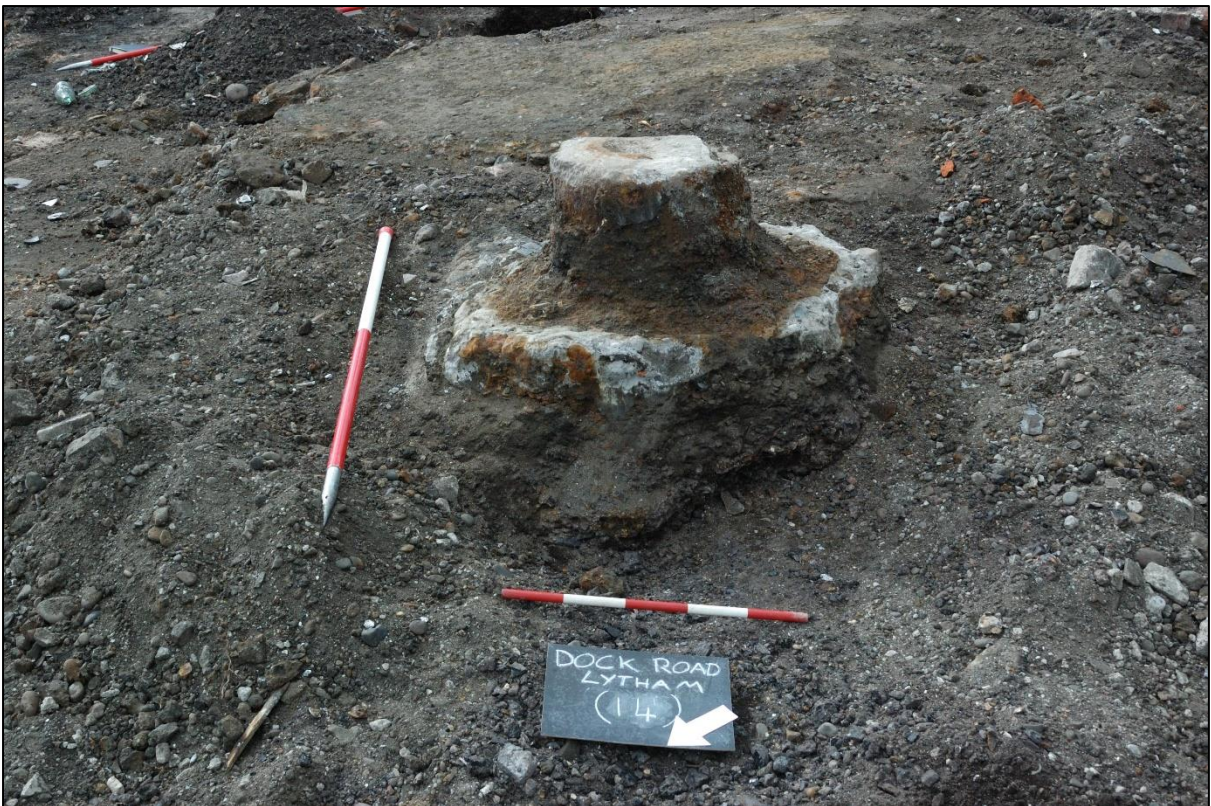
Plate 18: Concrete and iron stanchion [14]

- 6.6 Located in the centre of the site were a row of three identical concrete and iron fittings. Context [14] described the fitting at the south end of the alignment (Plate 18). Context [13] described the fitting in the centre of the site (Plate 19) and fitting [32] described the third fitting (Plate 20), which was encased in the south side of concrete surface [06]. The fittings were composed of a rough concrete with pebble inclusions encasing a wide iron tube with a smaller iron tube at its centre, also encased in concrete. The constructs were 1.1m wide and 0.67m high. Fitting [13] in the middle of the north south alignment was tilted into deposit (03). The alignment of the fitting indicated they had been used as supports for a building. Fitting [14] was located next to a truncated metallic floor numbered context [39]. The metallic nature of the floor suggested foundry waste.

[14] An identical structure to context [13] located to its north and partially dislodged.

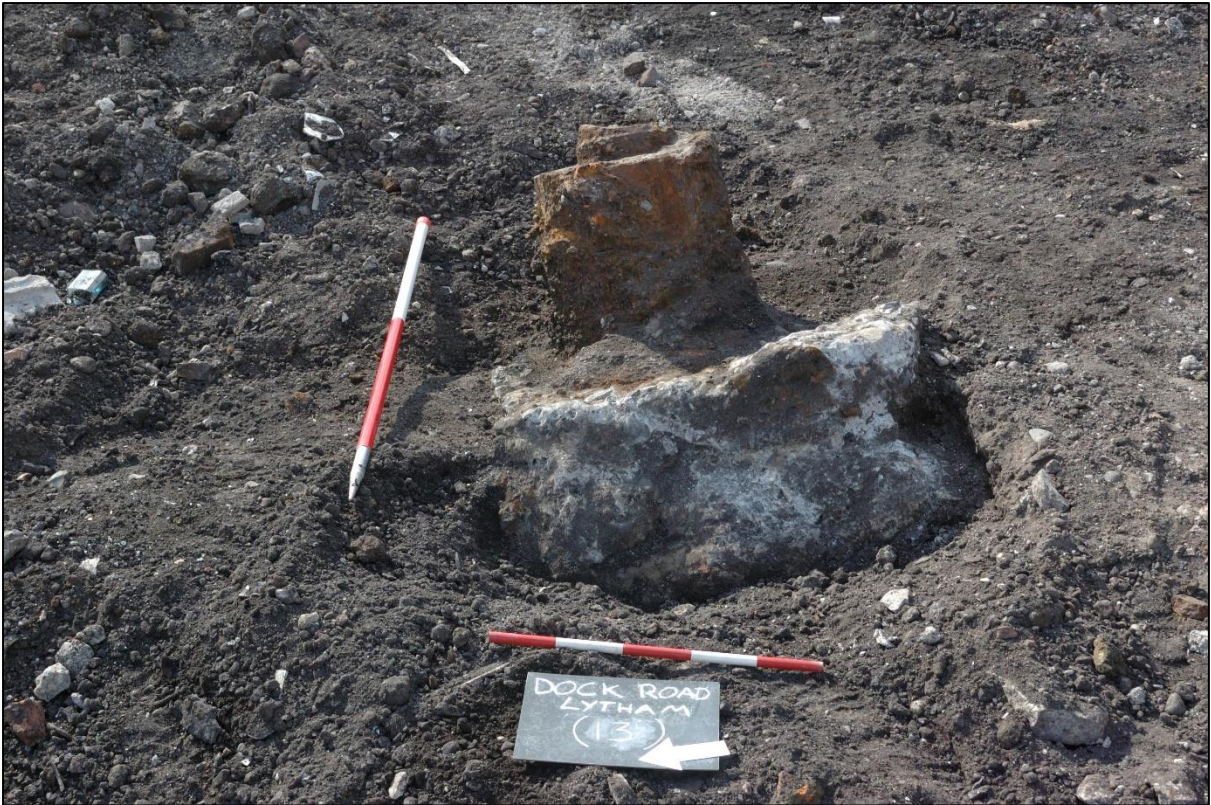
Plate 19: Concrete and iron stanchion [13]

[13] A cast iron and concrete construct 1.1m wide and 0.67m high located to the west of pillar [11]. The construct contained a wide cast iron tube with a smaller cast iron tube in its centre, both encased in a rough grey white concrete with pebble inclusions. The construct was partially buried in deposit (03). Two identical constructs [14] and [32] were seen to the north of [13] in a north south alignment.

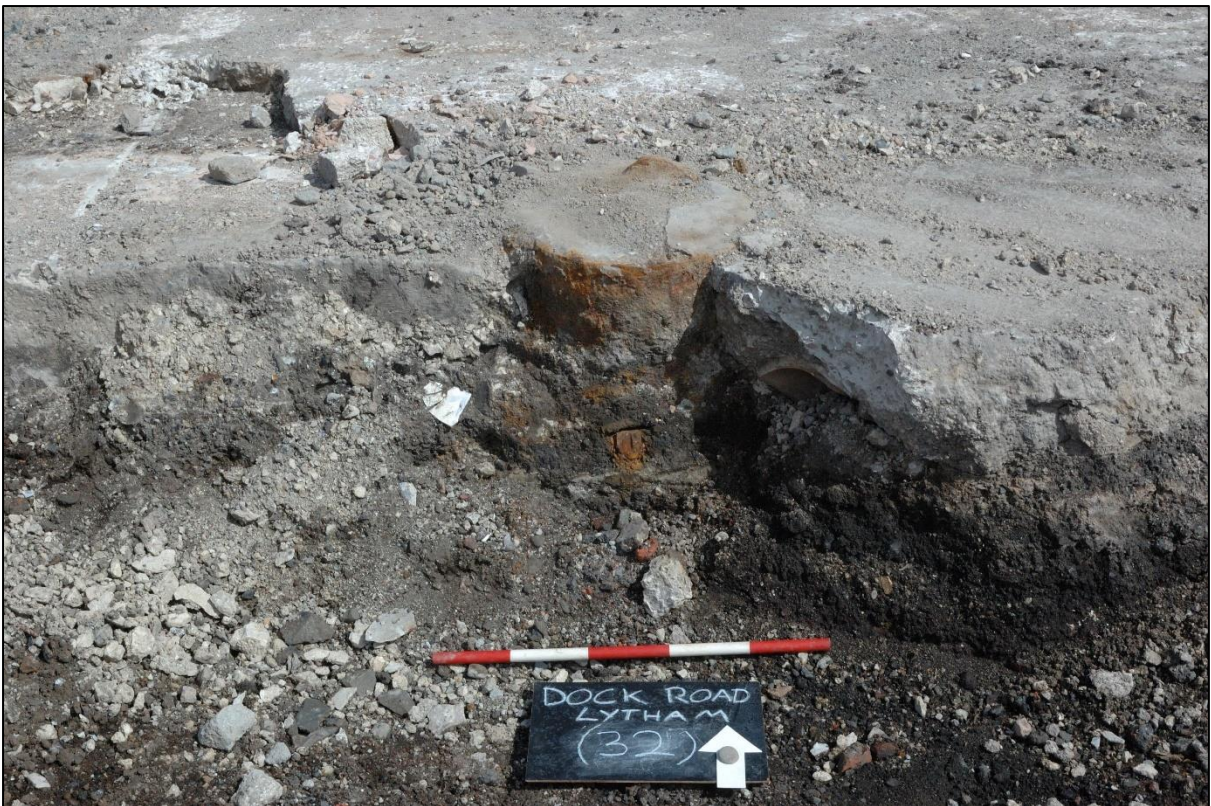
Plate 20: Concrete and iron stanchion [32]

[32] An iron and concrete construct identical to [13] and [14] was encased in concrete floor [06]. This formed the northern end of the constructs alignment.

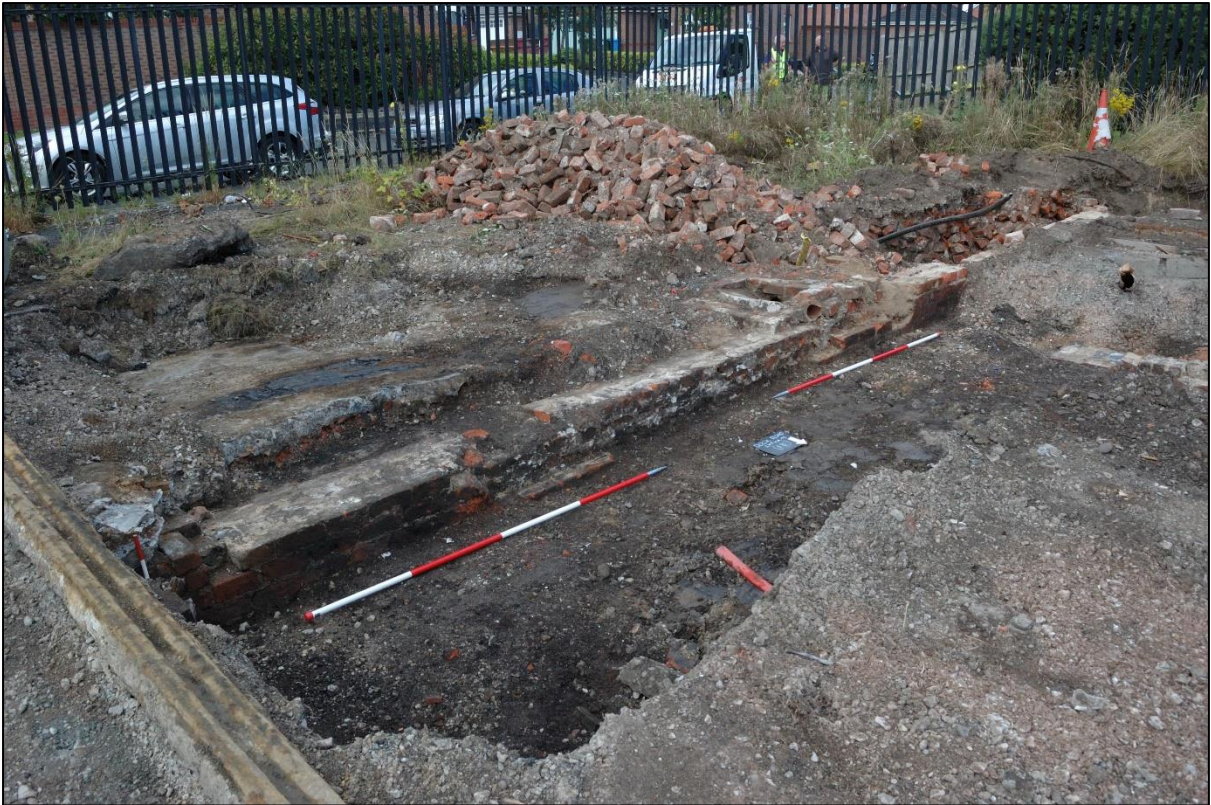
Plate 21: Wall [18]

- 6.7 The southern edge of the site contained a wall (Plate 21) context [18], which, was 12m long by 0.6m wide and 1.1m high. The wall was aligned east west and made up of headers and stretchers with a stepped foundation, and contained a cellared space at its western end (Plate 22). This was backfilled by a brick and beige mortar backfill context (22) measuring 4.7m in width, 4.7m long and 1.05m deep. This deposit was only partially excavated as it went beyond the limit of excavation (Plate 23).

[18] A brick wall 12m long by 0.6m wide and 1.1m high was located along the southern edge of the site and orientated east west. Constructed of headers and stretchers with a stepped

foundation bonded with a white gritty lime mortar. The wall formed the northern elevation of a warehouse with a cellared space.
